**Cableway put
to the test
at Hoover Dam**

Engineers conducted stress tests during the first week of April on the cableway that stretches between the walls of the Black Canyon walls.

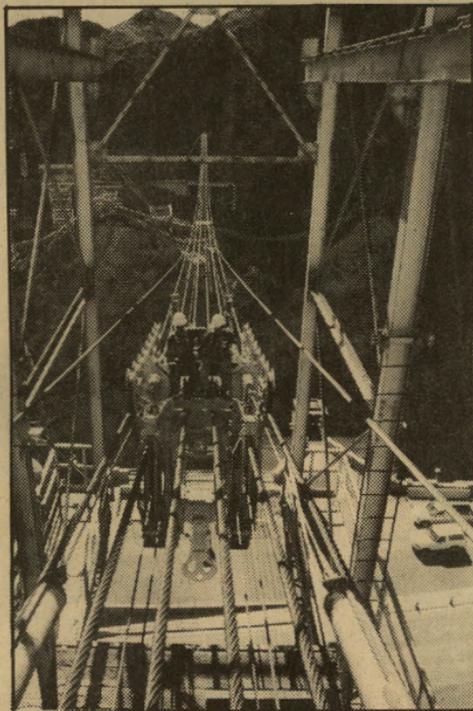
CARRIAGE RIDE — Six hundred feet above the Colorado River, workers finish testing the carriage for the cableway.

During the load testing at the beginning of April, slabs of concrete weighing as much as 20 tons were stacked on a cradle and dangled over the Colorado River.

The first load test was 25%, then 50%, then 100% and finally 125% of the rated capacity. The cableway successfully supported 187 tons.

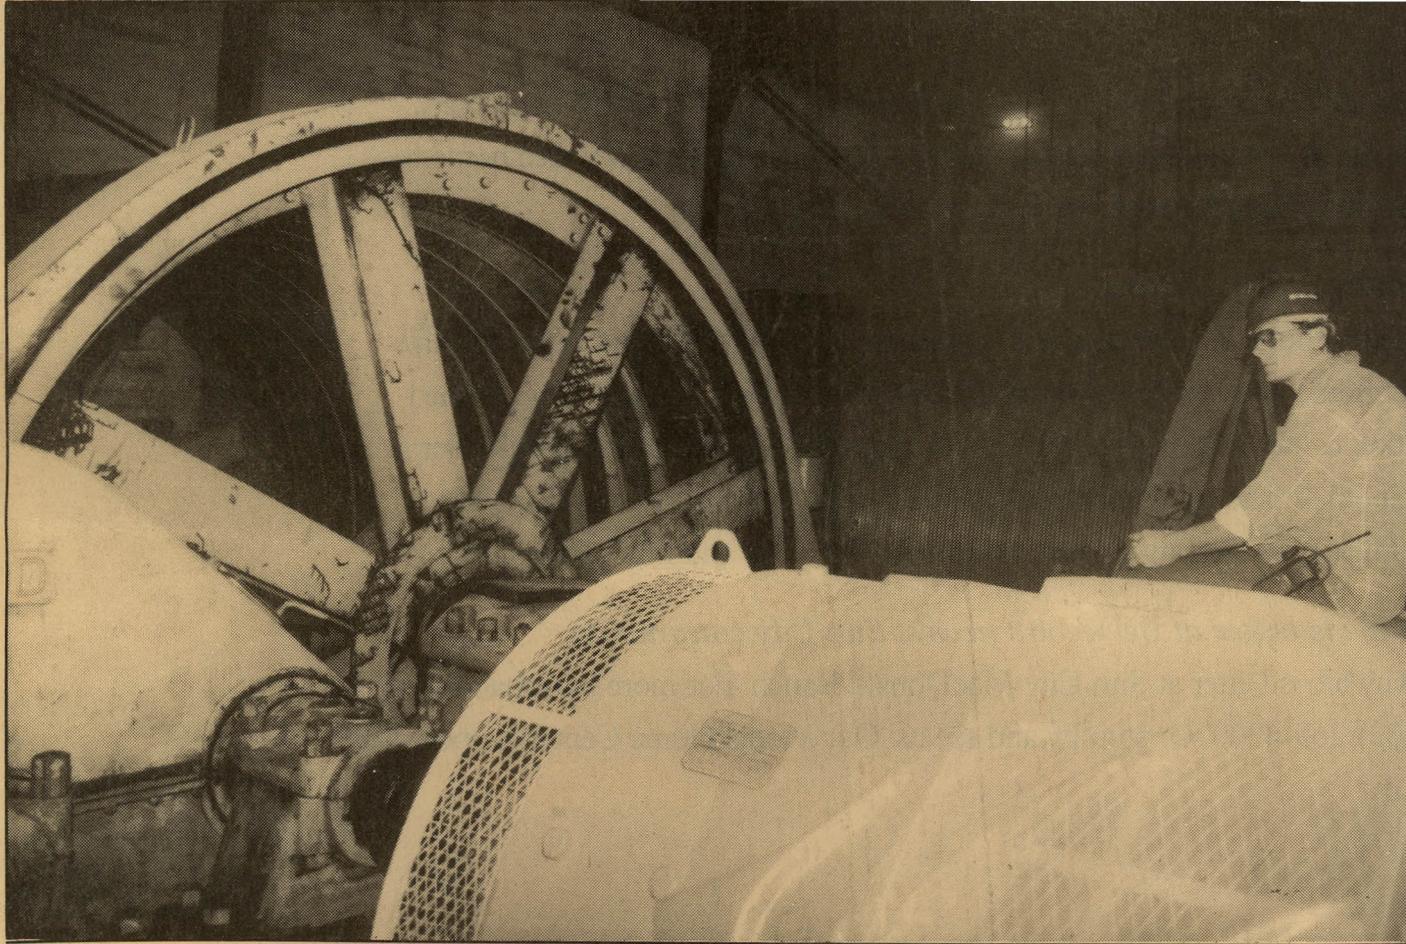
ABOVE — Rick Oltrogge controls the flow of cable from the huge spools at left, as it is released to span the 1,200-foot width of Black Canyon.

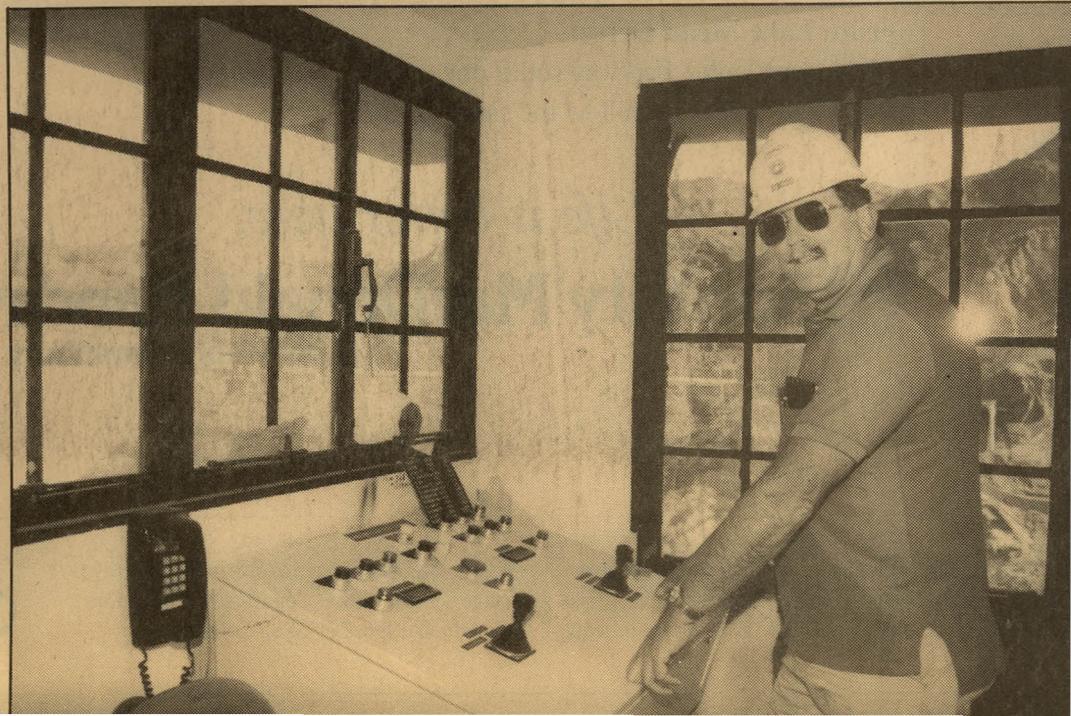
RIGHT — Construction inspector Bob Moore stands at the instrument panel in the cableway control station.

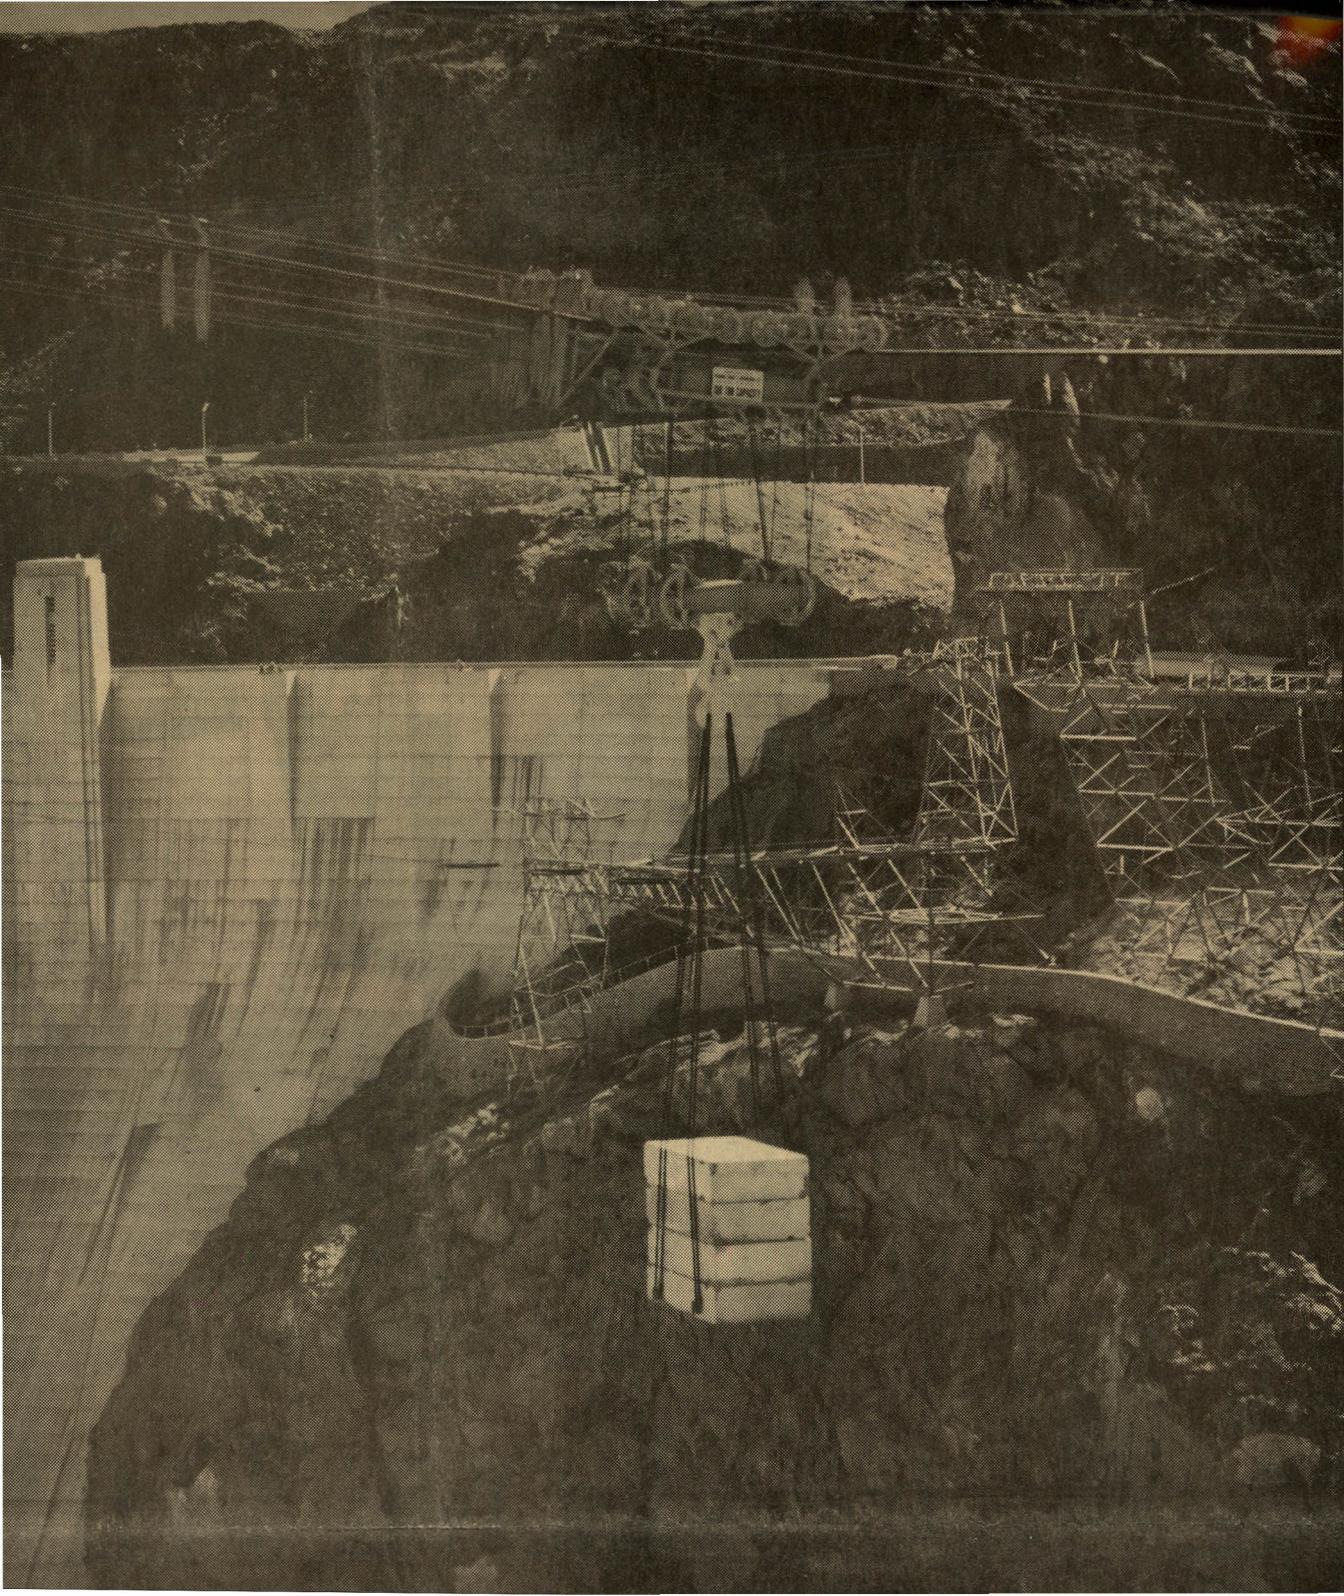
FAR RIGHT — Workers prepare a slab of concrete weighing close to 20-tons for a load test.
