# Gila River Basin Native Fishes Conservation Program: Arizona Game and Fish Department Final Report for Agreement F15AC01193, ARCC Modernization

January 2018

**COOPERATIVE AGREEMENT TITLE:** CAP Gila River Native Fishes Conservation Program with AGFD, F15AC01193

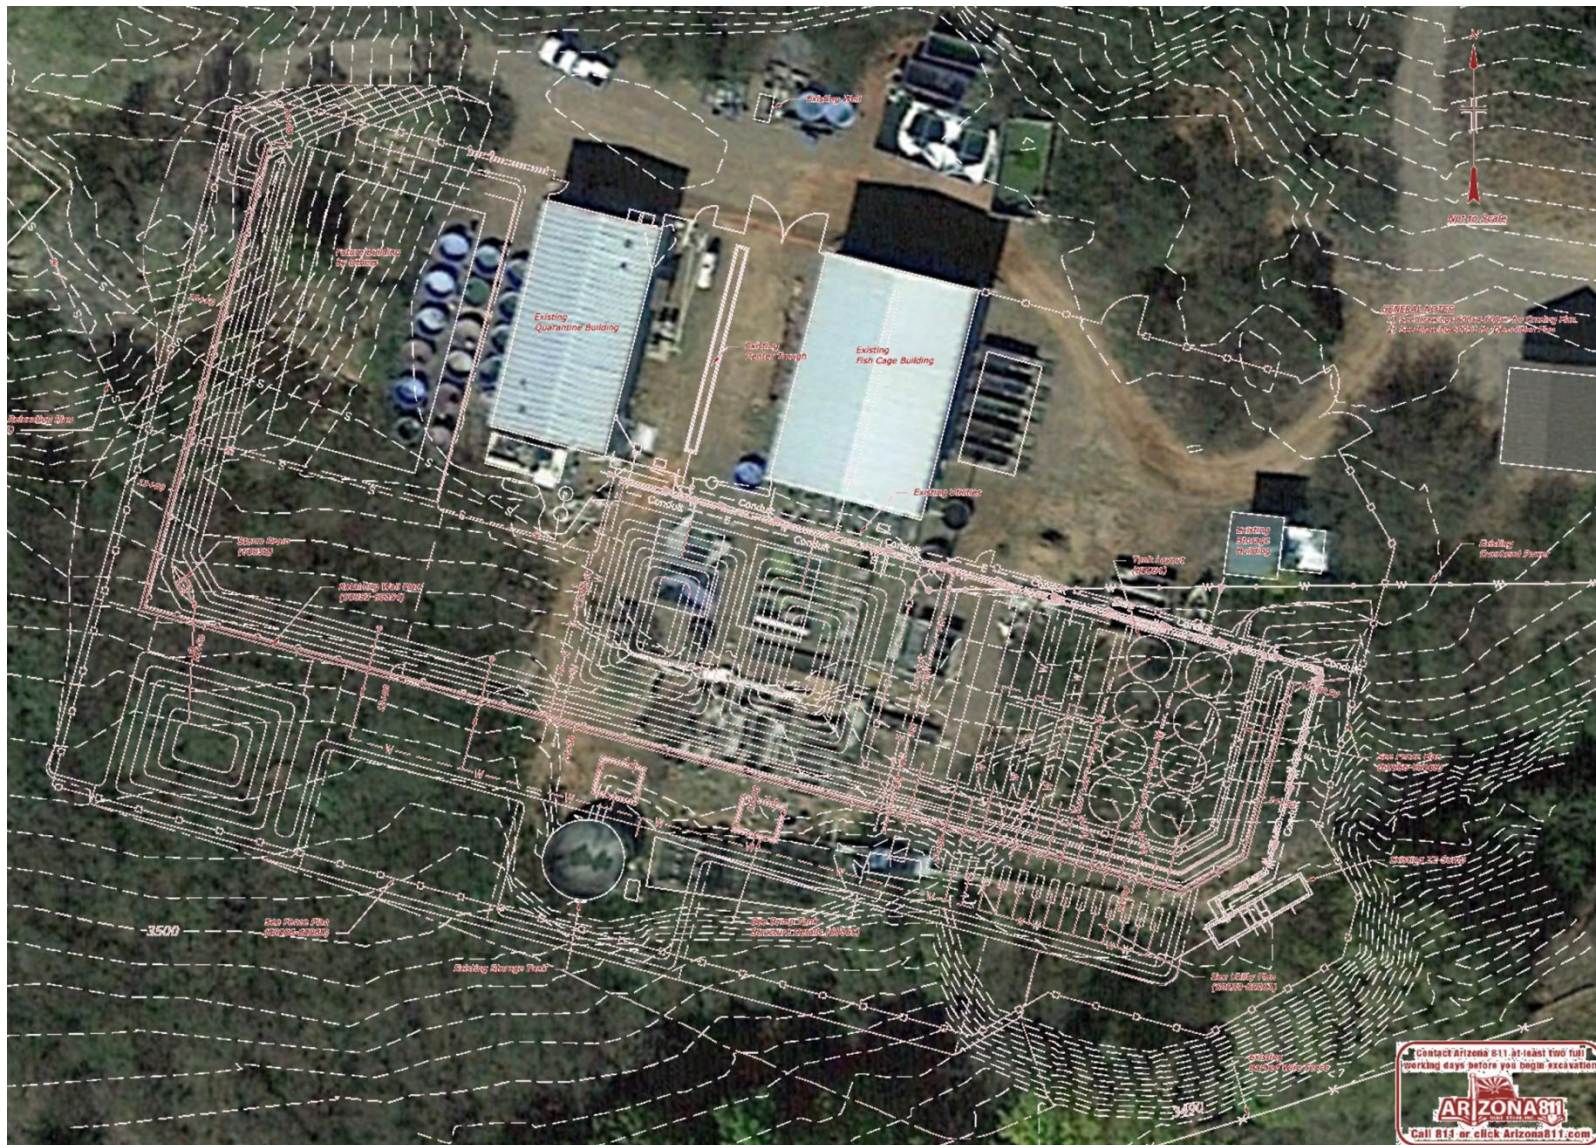
Figure 2: Overlay of construction drawings on aerial image of ARCC pre-renovation.

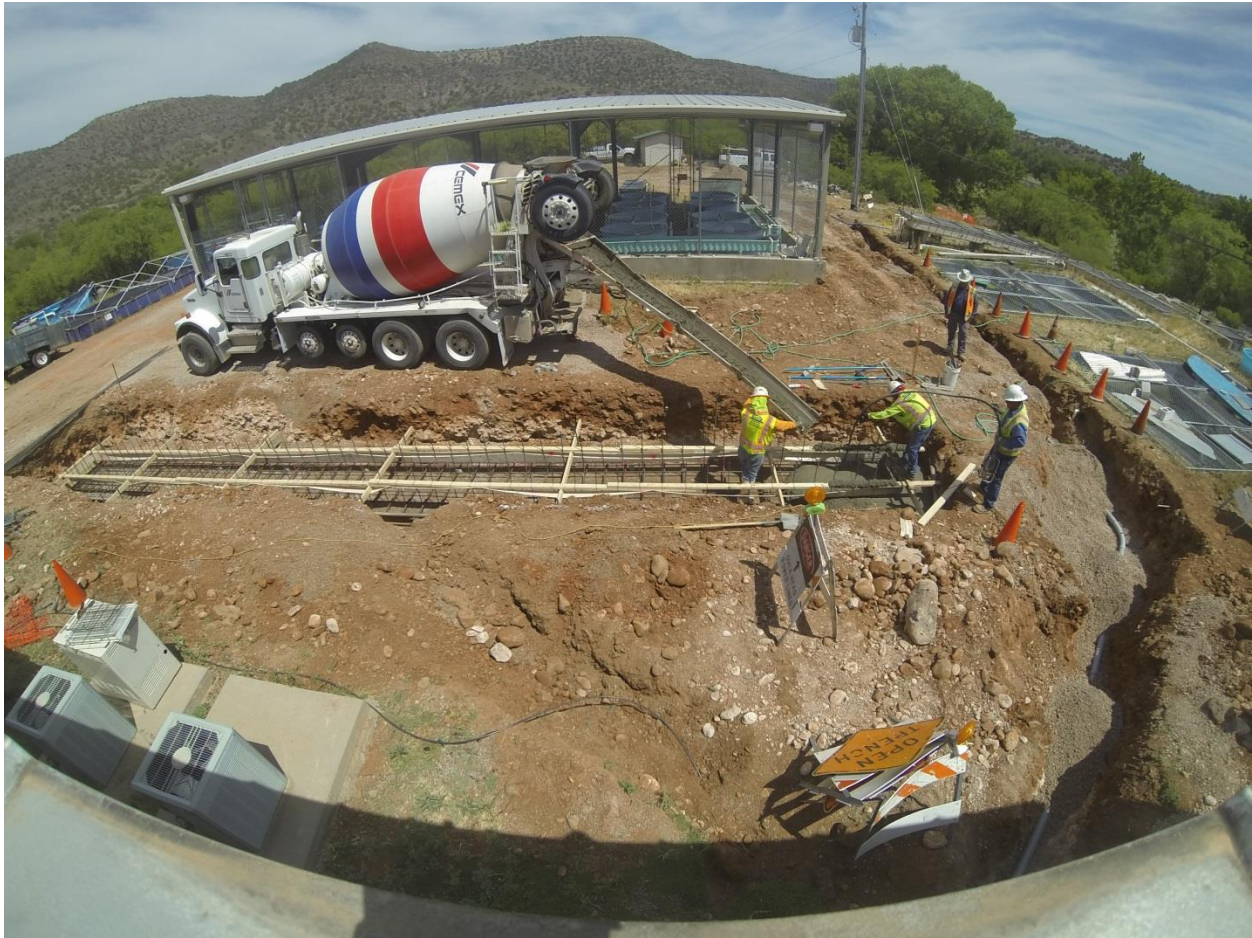
Figure A: Pouring concrete for the central trough of the Phase 1 raceways. Old ponds and tanks can be seen on the right side of the picture.

ARCC staff finished installation and plumbed the 20 new spawning raceways with collection sumps. Raceways receive water from ARCC's artesian well, but can also be filled during an emergency or for cleaning using the pressure water system. Raceways were fitted with individual variable speed programmable recirculation pumps to create spawning flows and a regenerative blower to provide supplemental aeration. Water from the 20 new raceways is collected in the central trough and can be sent to downstream ponds and tanks, or through a bypass to ZZ sump. A new electrical breaker box was installed to accommodate the increased power drawn by the new pumps. These final

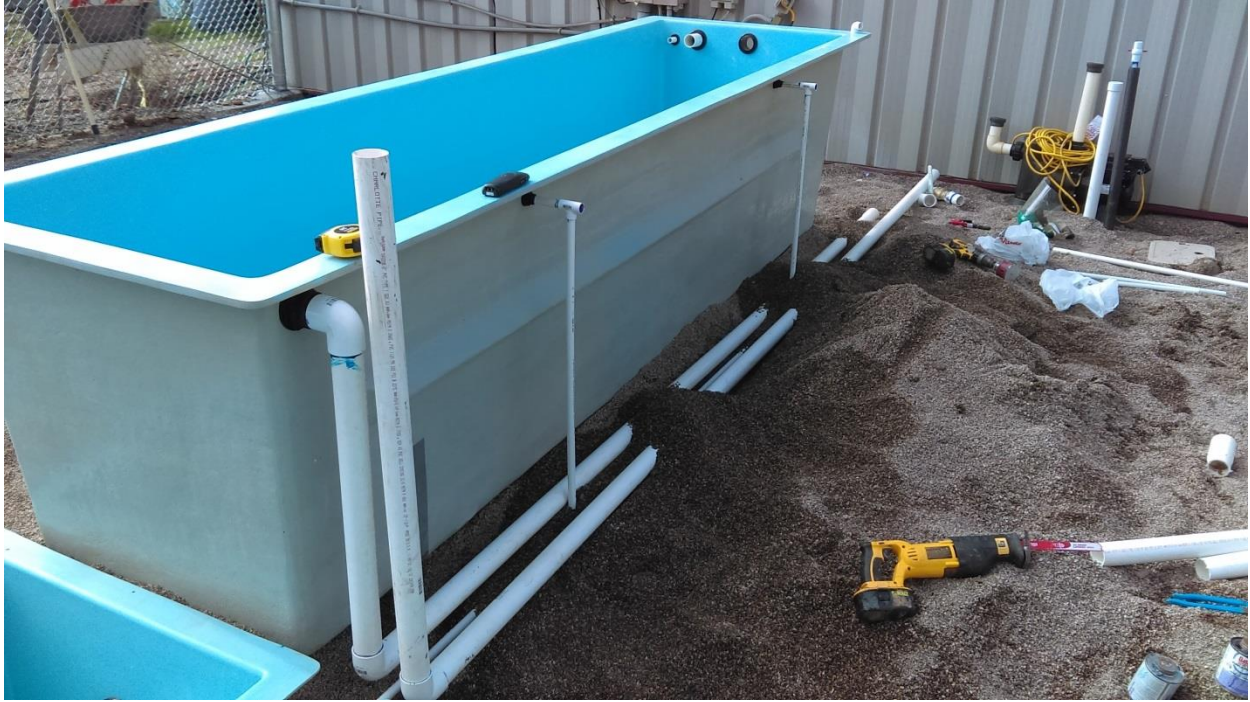
Figure B: Plumbing of new Phase 1 raceway, with collection sump on left.

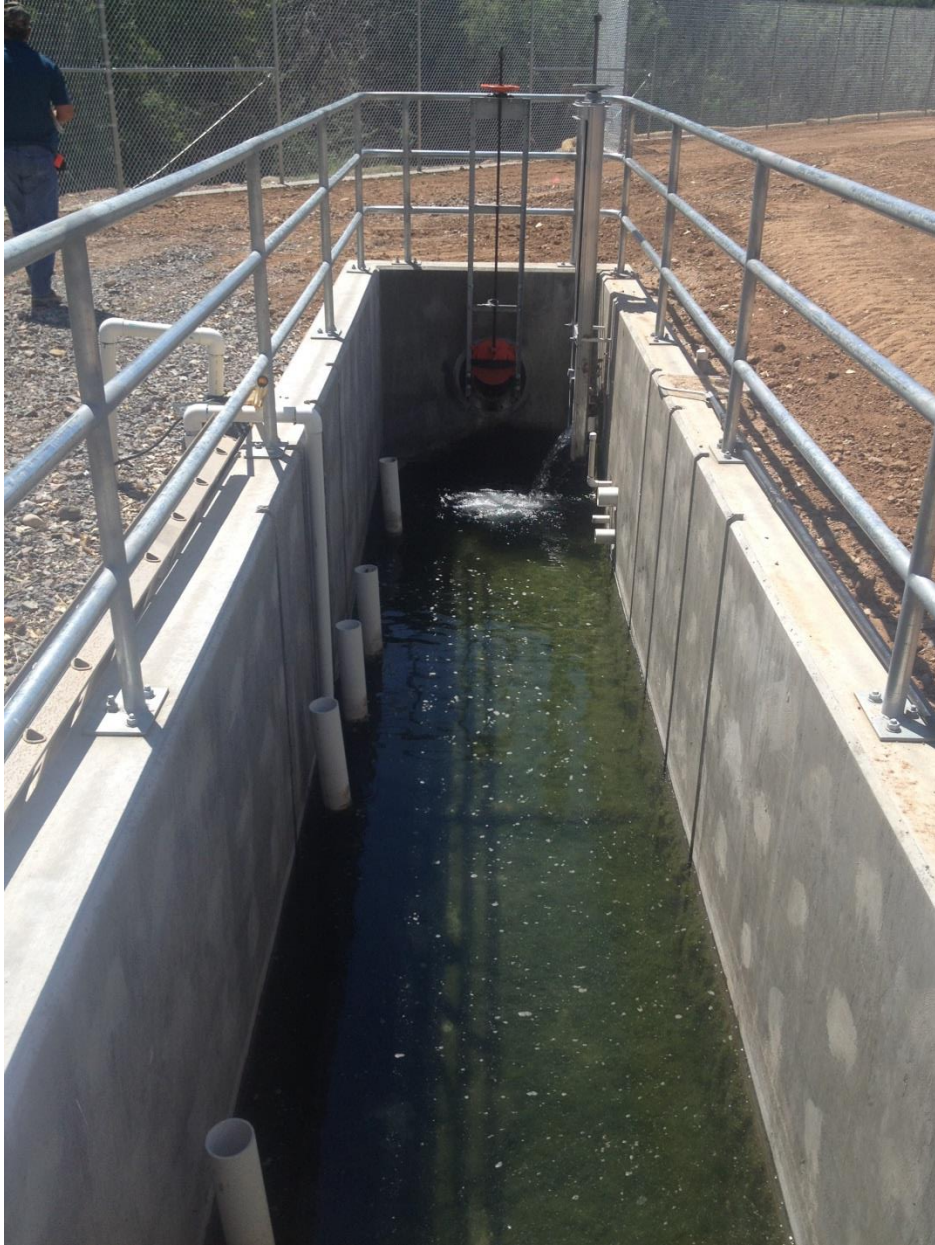
Figure C: ZZ Sump, located on the southeast, downstream area of the facility.

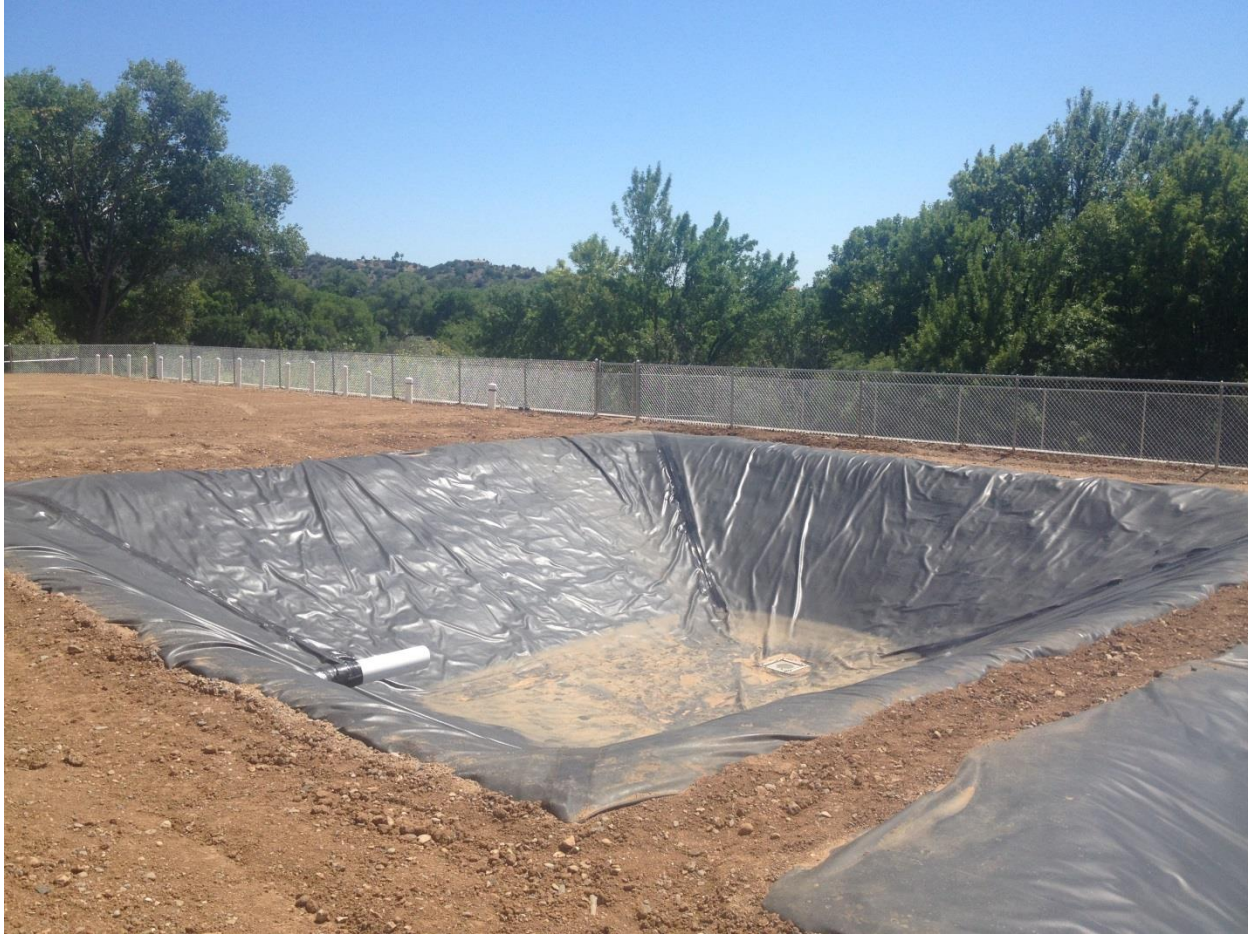
Figure D: Lined pond with 30,000 gallon capacity installed on the upper tier created by the Phase 2 retaining wall.

The retaining wall provided level space for other features that could then be installed on the resulting tier. These features installed during Phase 2 include two 30,000 gallon lined ponds with designated collection sumps (located below the retention wall) for easy gathering of fish when drained. Six 12' diameter by 5' deep round and eight 4' square fiberglass tanks were purchased to be installed on the pad next to the ponds. These tanks will be plumbed by Department staff. Contractors upgraded conduit throughout the facility to meet increased power demands and provide flexible wiring options for the future. The driveway was improved and expanded to accommodate the increased spatial extent of the facility, which now surrounded by 10' chain link fencing to increase security. Netted covering was installed over the Phase 1 caged area to deter predators.

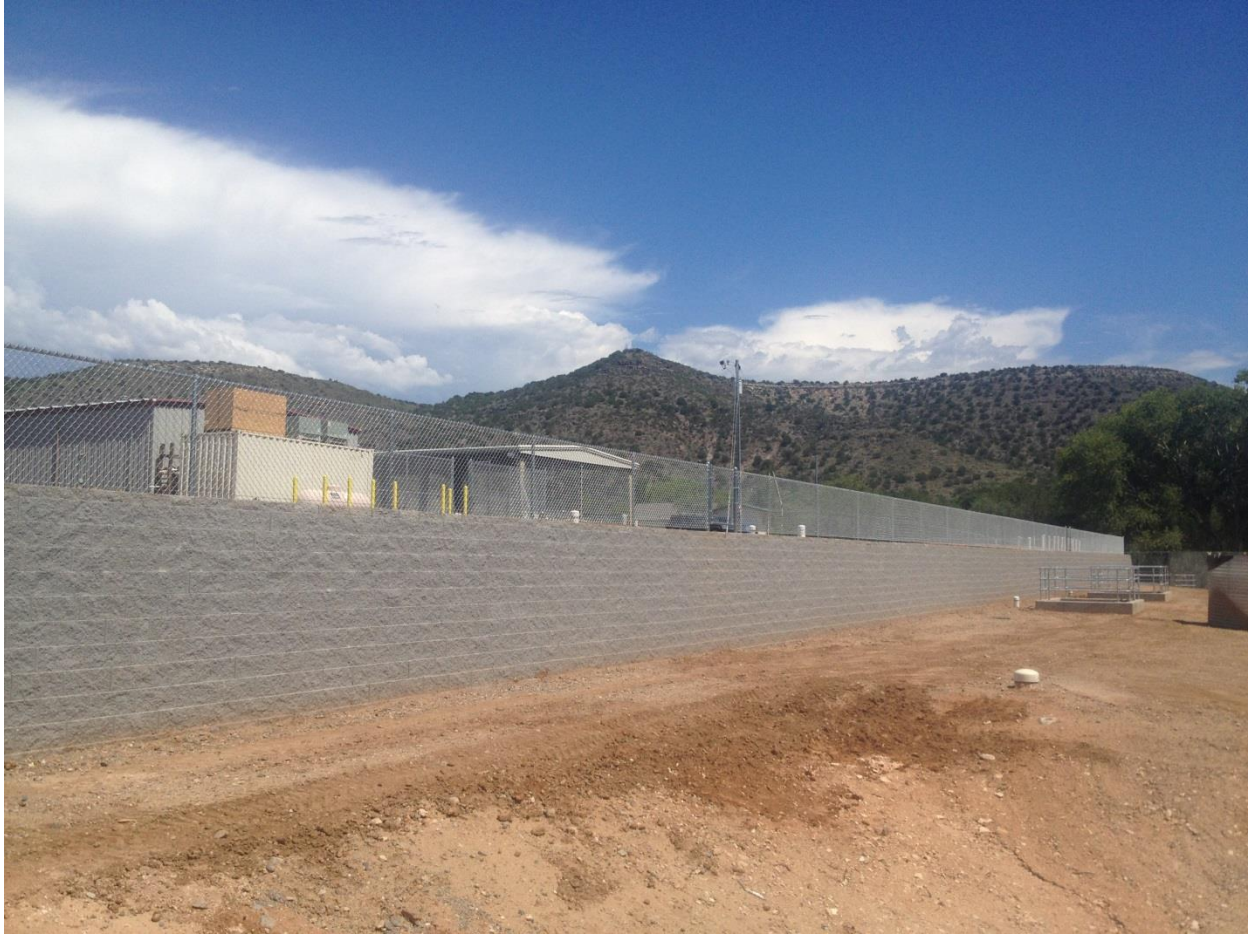
Figure E: Completed Phase 2 retaining wall. Collection sumps for the lined ponds are shown on the right side of the picture.

To increase holding capacity and research capabilities with future native fish conservation needs in mind, the special area of ARCC was expanded, and a retaining wall was designed in cooperation with the BOR engineers (Figure 1). This retaining wall effectively tiered the property providing level ground for fish holding structures such as lined ponds and tanks downstream of the existing cage and building, and also provided the foundation for a new multiuse building that will comprise Phase 3 of the renovation (Figure 2). Contractors were selected and construction on Phase 2 began in May 2017 after an extensive planning process. Coordination with USFWS and BOR on archaeological and Northern Mexican gartersnake monitoring occurred throughout clearing and the construction phase. Although some delays to the initial construction schedule occurred, the contractors were able to complete the project on time. The resulting retaining wall varies in height, but averages approximately six feet. The retaining wall was constructed with multiple locations for flow through piping to accommodate greater tank capacity in the future and increased flexibility in plumbing should tank systems need to be changed.
