Hydraulic Laboratory Technical Memorandum PAP-1021

Blue River Fish Barrier: Additional Physical Modeling to Optimize the Fish Barrier

U.S. Department of the Interior
Bureau of Reclamation
Technical Service Center
Hydraulic Investigations and Laboratory Services Group
Denver, Colorado

July 2010

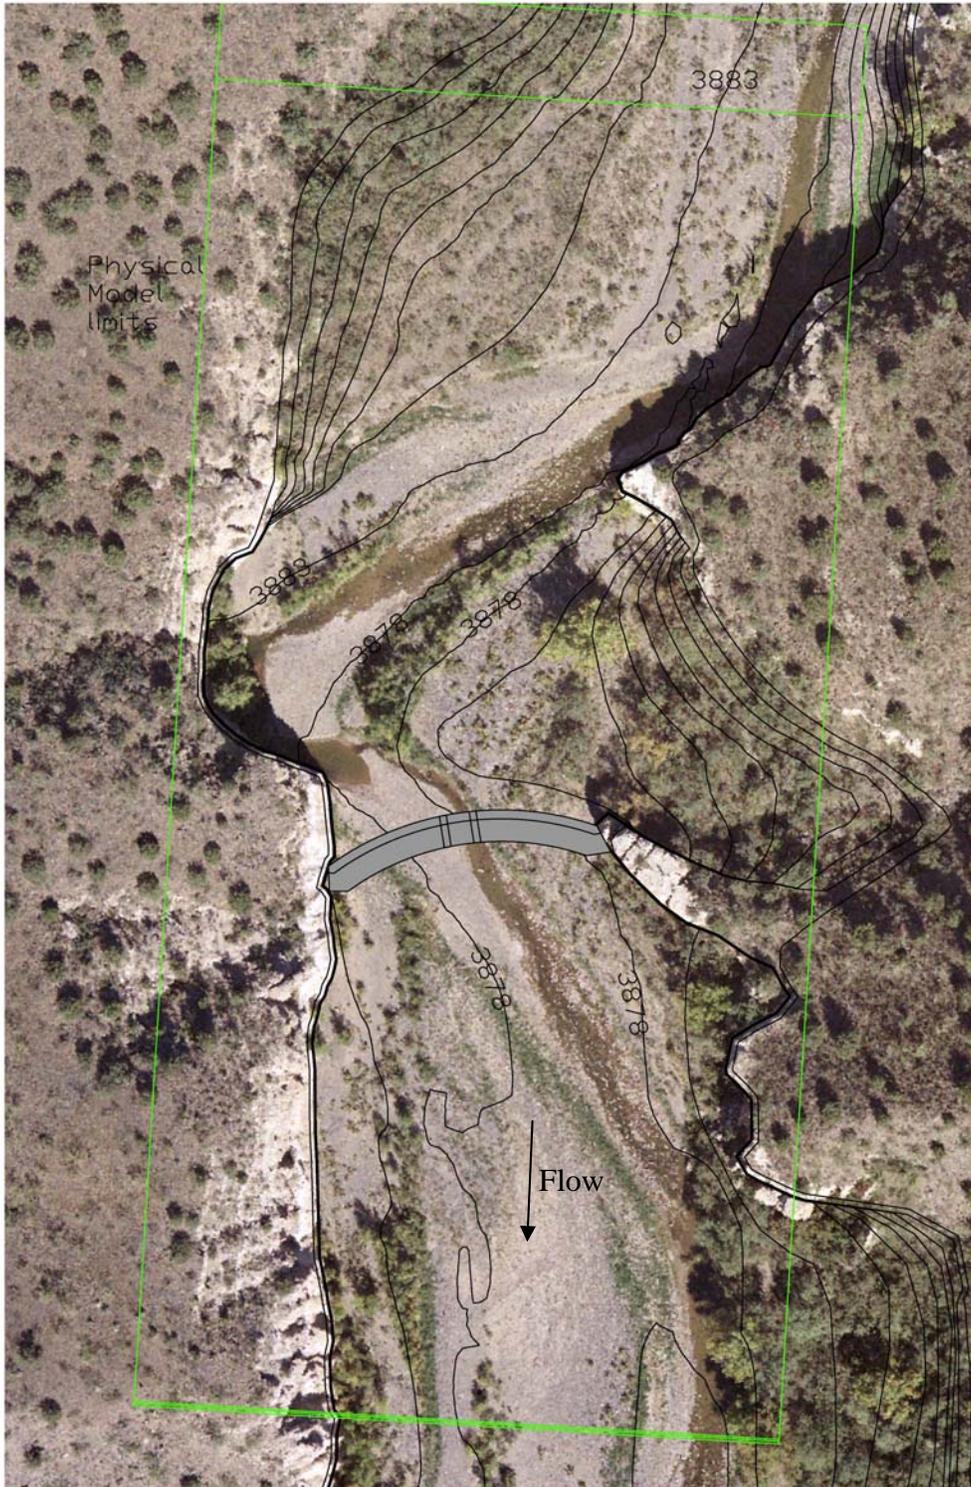
Figure 3. Existing conditions 5-ft contour map. At the sides the barrier is at elevation 3880.85 and 3879.7 in the center.

On the left side of the channel, some of the existing ground surface immediately upstream of the proposed barrier location is higher in elevation than the weir of the barrier (see Figure 3). The initial design called for the barrier to be constructed out of roller compacted concrete (RCC) and a deep scour wall to be placed upstream from the barrier. This would require a significant portion of the upstream topography to be excavated. The initial physical model was built assuming that the upstream topography would be backfilled at an elevation of 5 ft below the weir of the barrier.

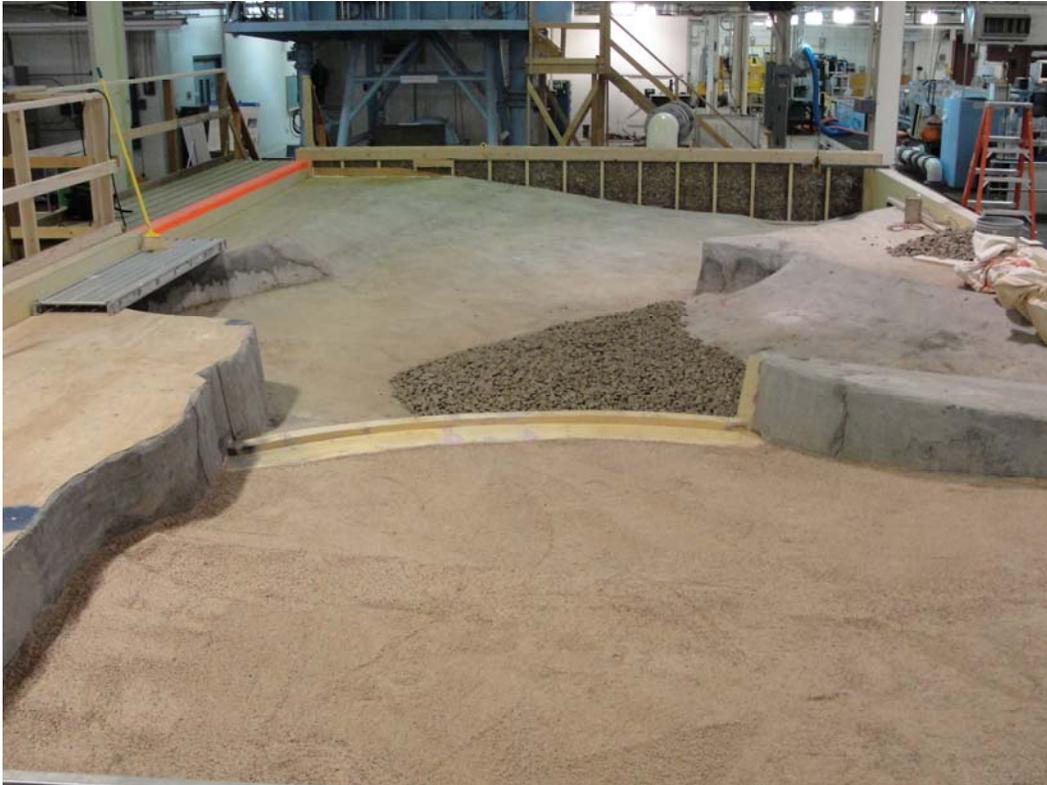
Figure 4. Physical model looking upstream at the lowered barrier and the upstream topography.

Numerical modeling of the original design showed that the upstream scour wall does not have to be as deep as originally planned, so other construction methods for the upstream scour wall are being explored. In this scenario, the excavation footprint might not be as large as originally expected, and the upstream topography would be left as-is, rather than being backfilled to a lower elevation. To model the effects of such a change, the unmodified existing topography upstream from the barrier was added into the model. This topography was modeled as non-transportable gravel, as shown in Figure 4.

Initial runs with the higher upstream topography showed that it caused the left side of the barrier to be hydraulically less effective. Much more of the flow was pushed to the right side. This significantly increased scour downstream from the barrier.

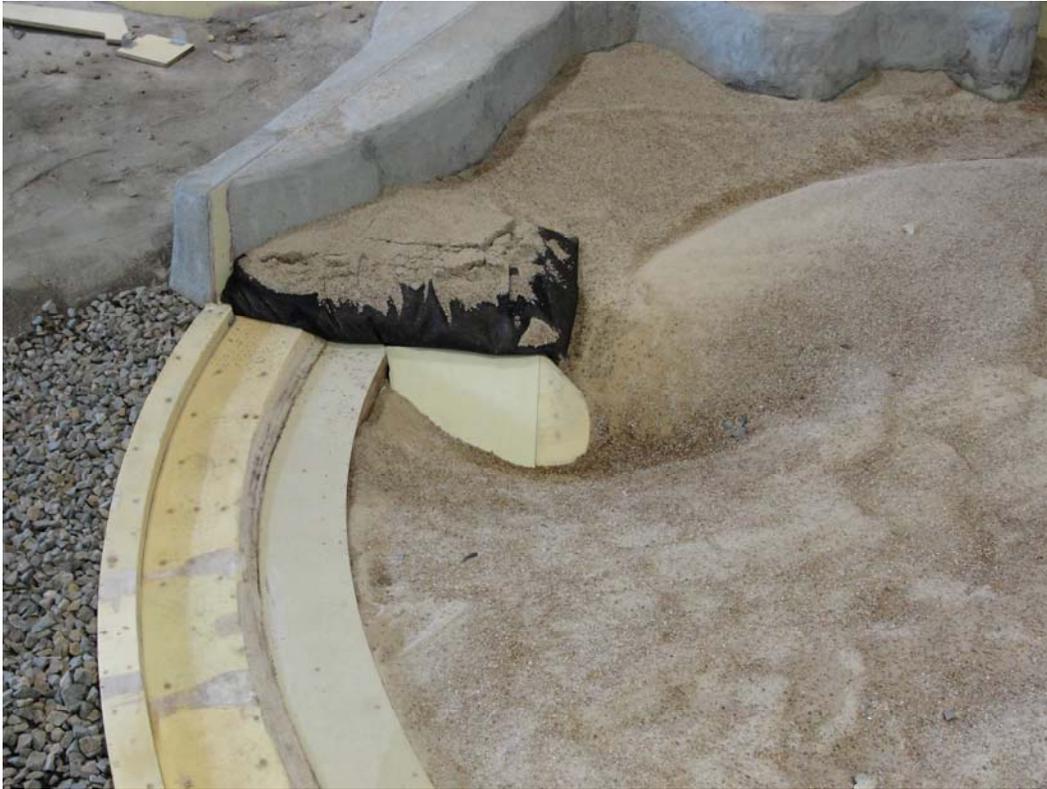
Figure 7. Recommended training wall configuration. Scour after the 100 yr event.

During the initial model studies the only way to prevent scour from revealing the toe of the structure was to stop the downstream eddy with a full-height training wall. An aesthetically pleasing proposal for the construction of a full-height wall was thus studied. This wall would be constructed from RCC with a side slope of 0.8:1 (h:v) up to the height of the deflection block, with the remaining portion of the wall composed of a soil berm with stabilized slopes, such as gabion baskets. The side slope of the proposed berm was 1:1. The RCC portion of the training wall was constructed in the physical model using plywood and high density foam. A black, flexible plastic screen material was used to stabilize the soil berm (see Figure 7).

This training wall performed well and was adopted as the recommended configuration. The flow conditions along the training wall varied enough from those associated with the vertical training wall that a modified wall alignment was chosen (see Figure 8). In this configuration, velocities along the soil berm during the 100-yr event were approximately 17 ft/s.

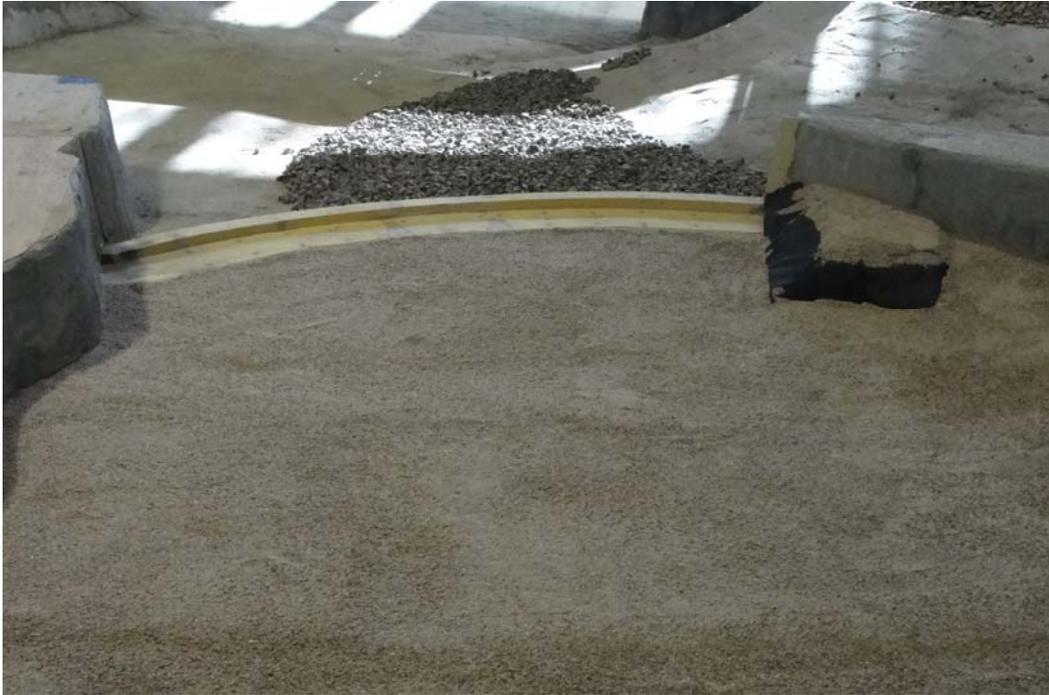
Figure 10. Recommended design with the existing downstream topography.

Figures 10-22 show the recommended design at the mean daily, 2-, 25-, and 100-yr flow conditions, and the resulting scour. Contour maps detailing scour and deposition relative to the pre-test river bed were obtained with photogrammetry techniques.

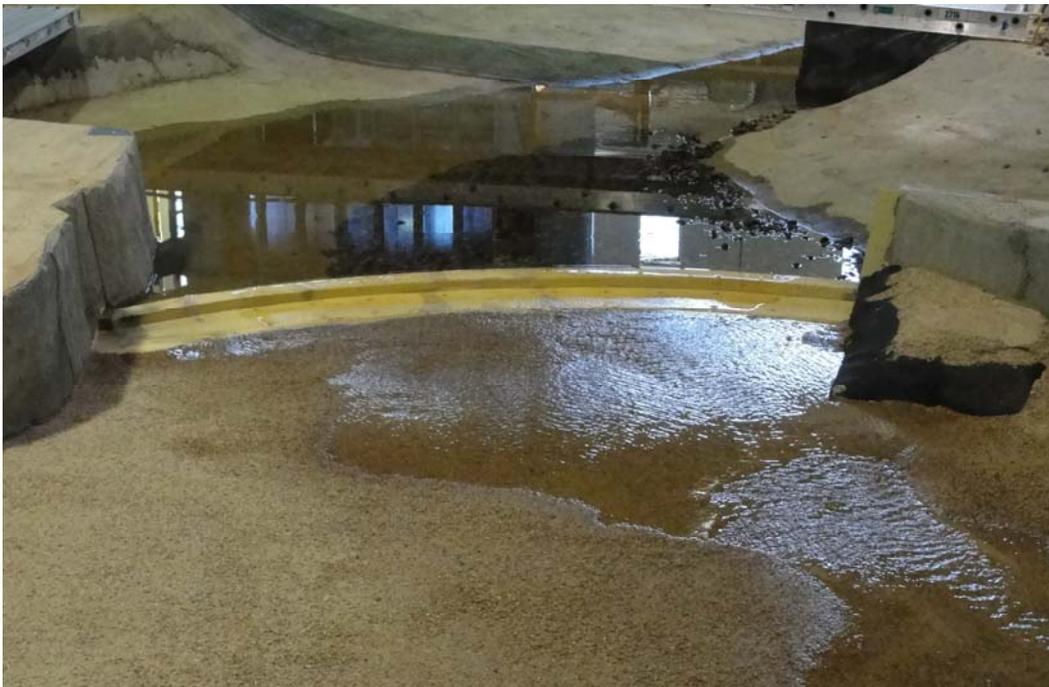
Figure 11. Recommended design at the mean daily discharge.

- Average depth of scour for clear water tests at the mean daily discharge is less than 1 ft.
- The apron is not backwatered during the mean daily discharge.

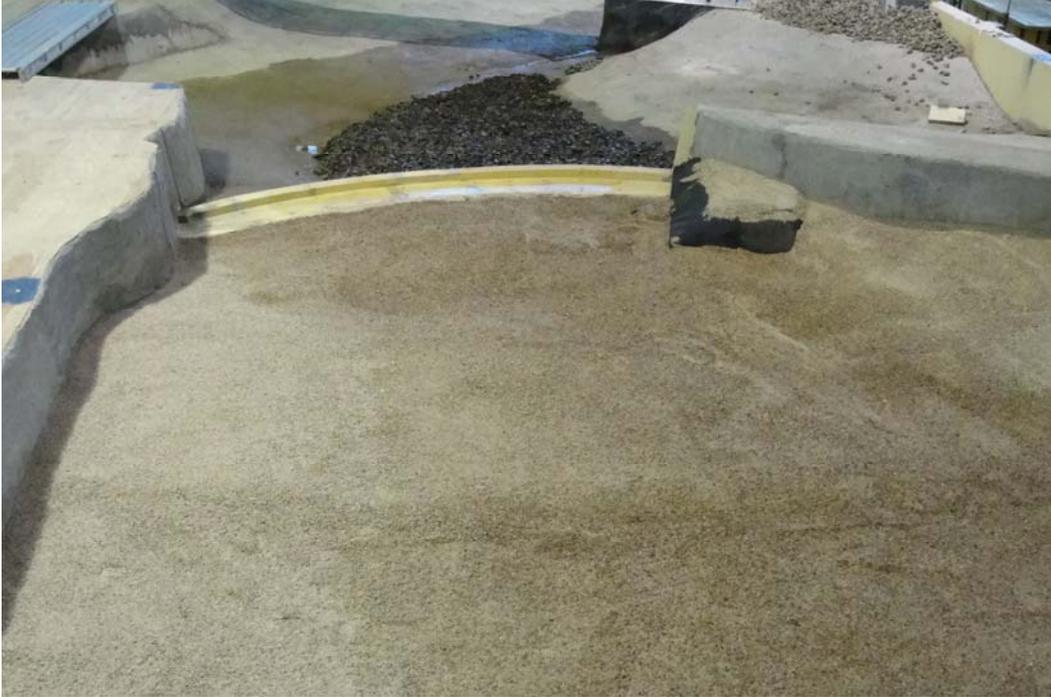
Figure 12. Recommended design showing scour after the mean daily discharge.

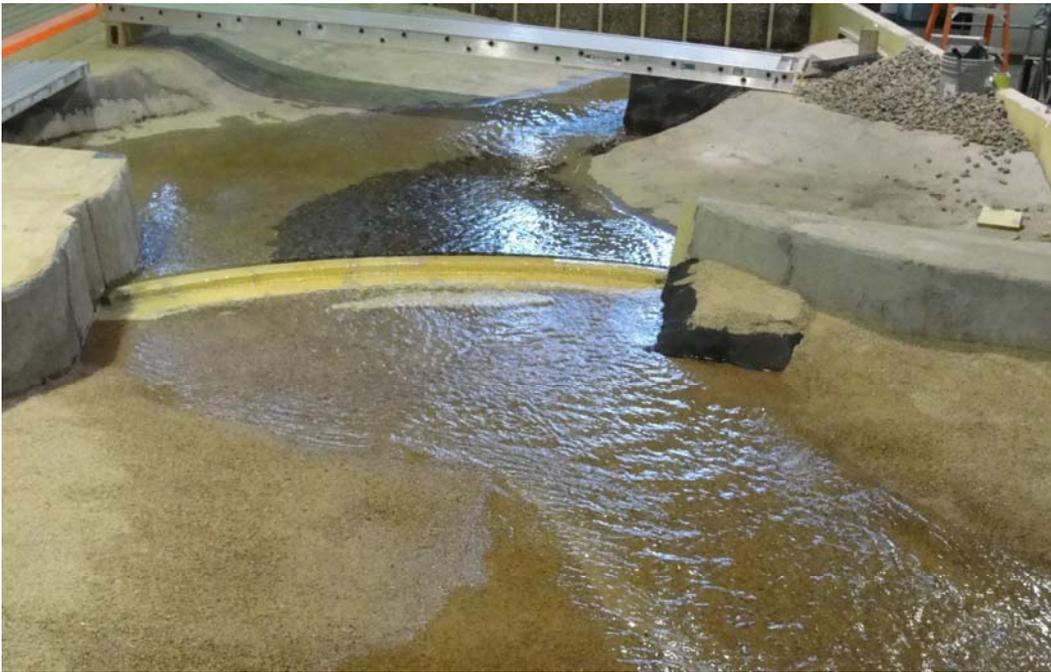
Figure 13. Recommended design at the 2-yr discharge.

- Average depth of scour for clear water tests at the 2-yr discharge is about 2 ft, located on the deflection block.
- At the 2-yr discharge 90 % of the apron is not affected by backwater; there are small backwater influences near the abutments.

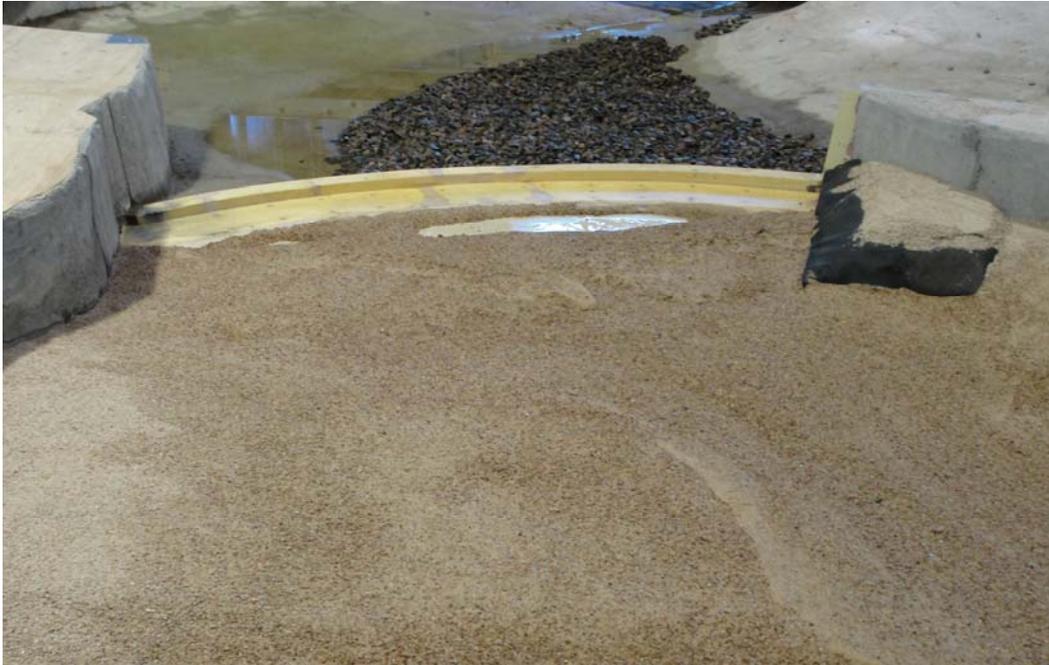
Figure 14. Recommended design showing scour at the 2-yr discharge.

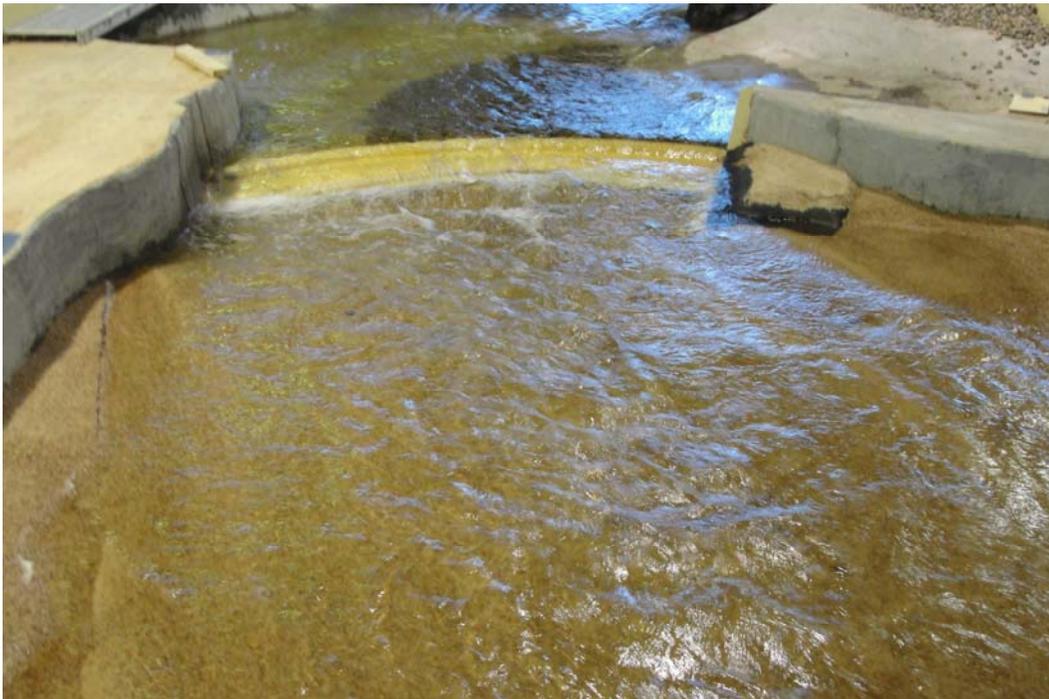
Figure 15. Recommended design at the 25-yr discharge.

- Average localized depth of scour for clear water tests at the 25-yr discharge is about 12 ft with holes reaching 16 ft.
- Average localized depth of scour for clear water tests at the 100-yr discharge is about 16 ft with holes reaching 26 ft.

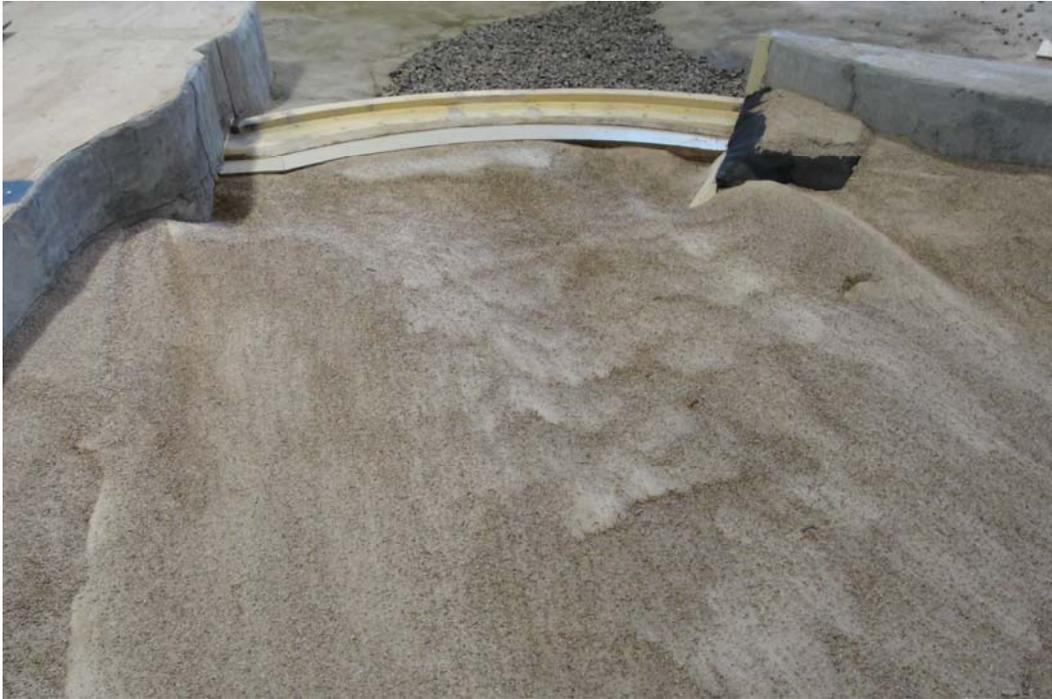
Figure 16. Recommended design showing scour at the 25-yr discharge.

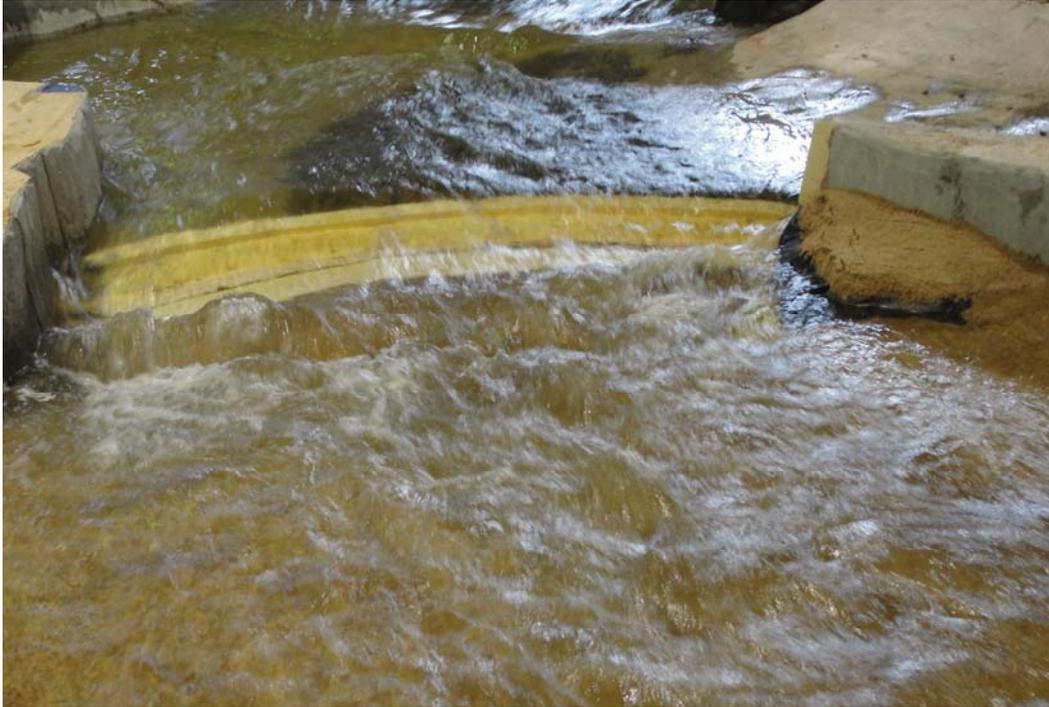
Figure 19. Recommended design at the 100-yr discharge.

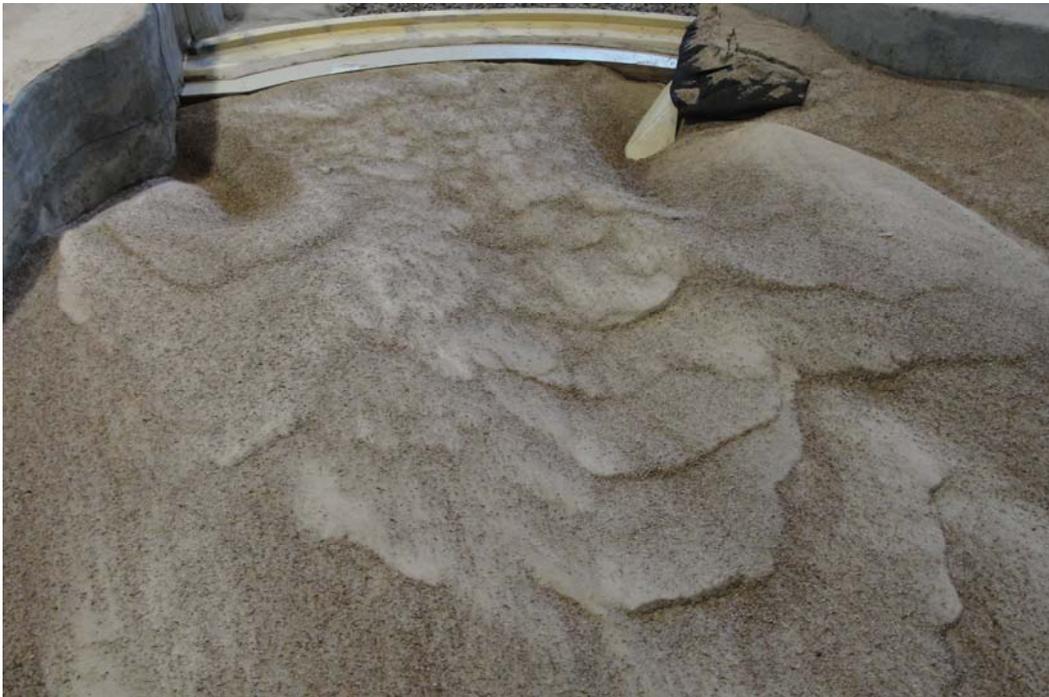
Figure 20. Recommended design showing scour at the 100-yr discharge.
