Granite Creek Fish Barrier

Site Investigation

June 2001

Prepared by the U.S. Bureau of Reclamation, Phoenix Area Office

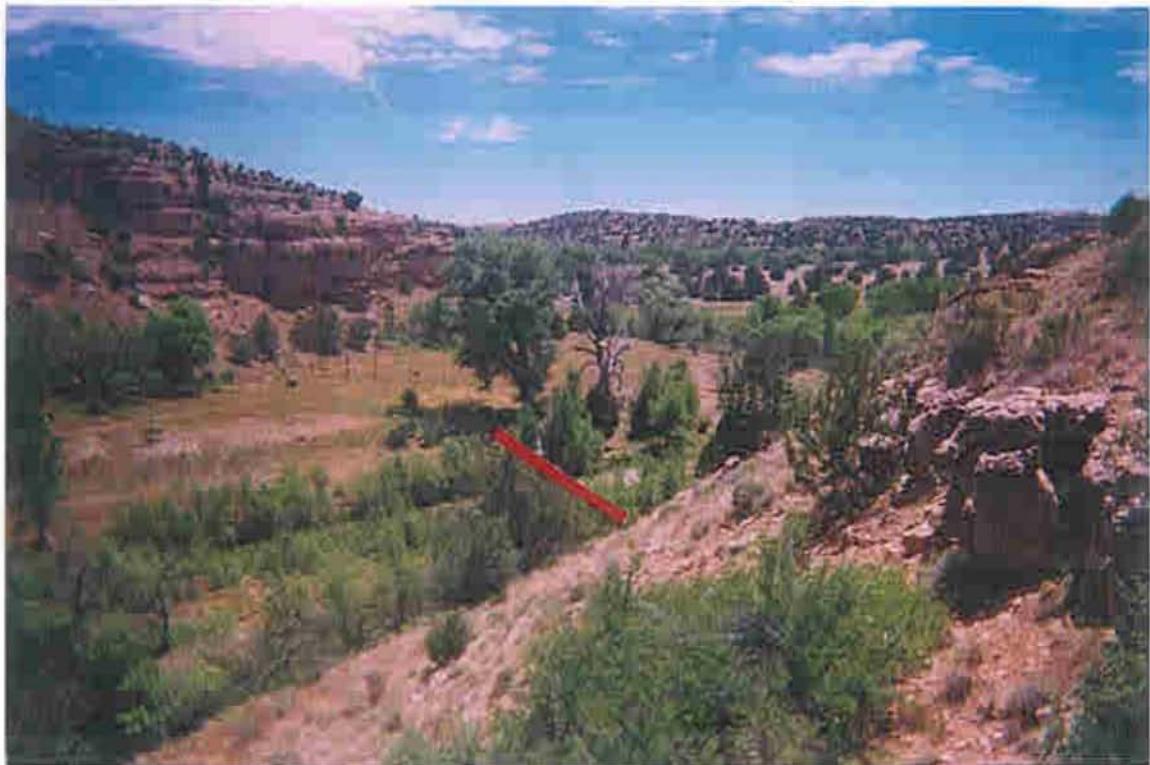
Photograph 1

Proposed fish barrier site, indicated in red, looking east and slightly upstream.

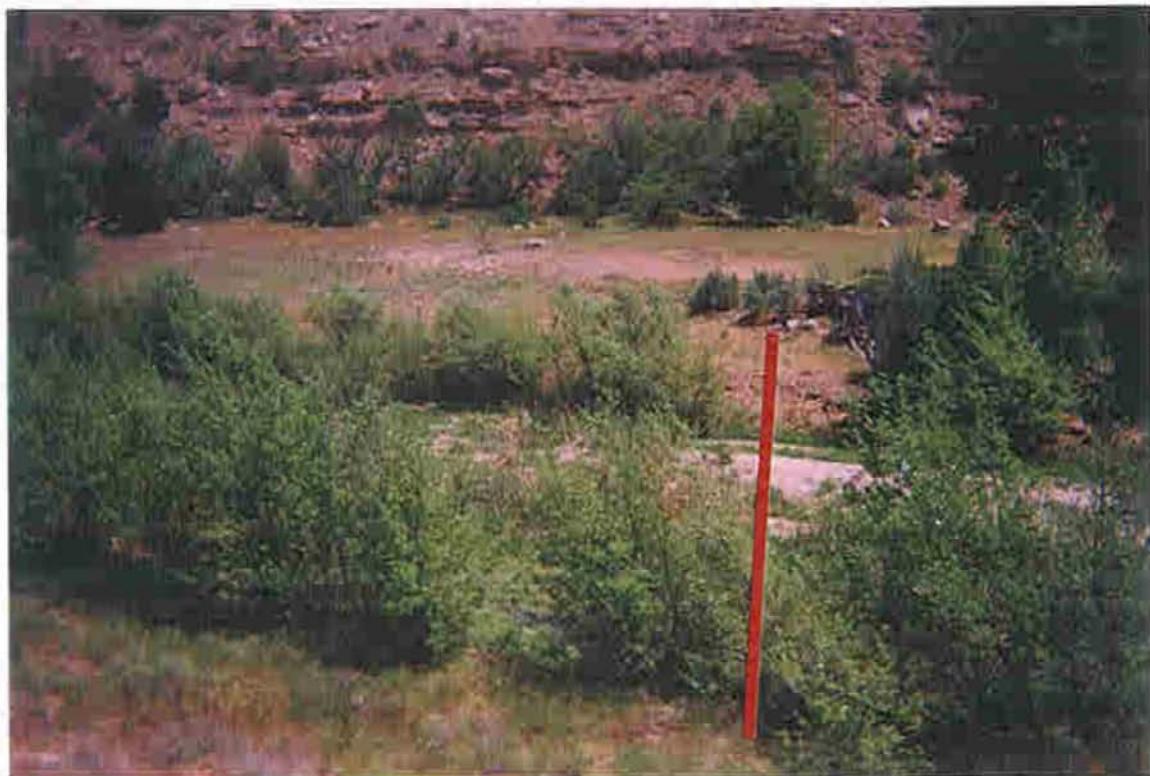
Photograph 2

Granite Creek at proposed fish barrier site, indicated in red. Photo taken from left canyon wall.

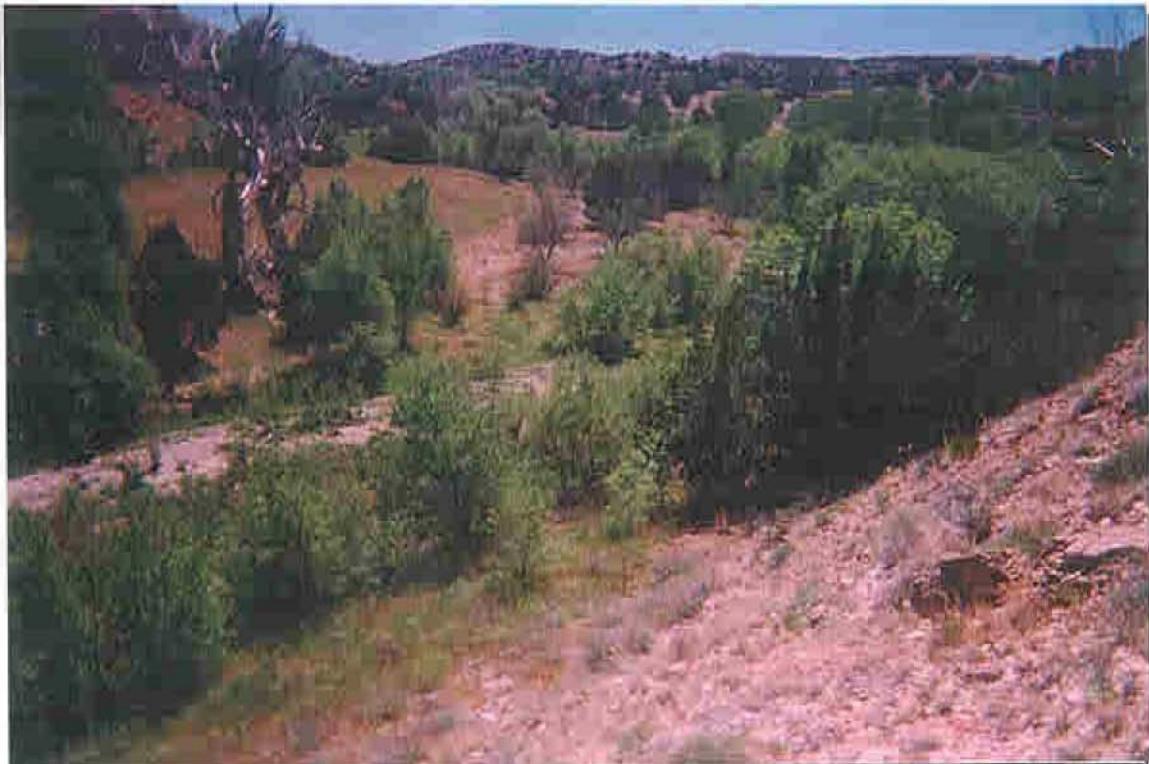
Photograph 3

Granite Creek just upstream of proposed fish barrier site. Taken from left canyon wall.

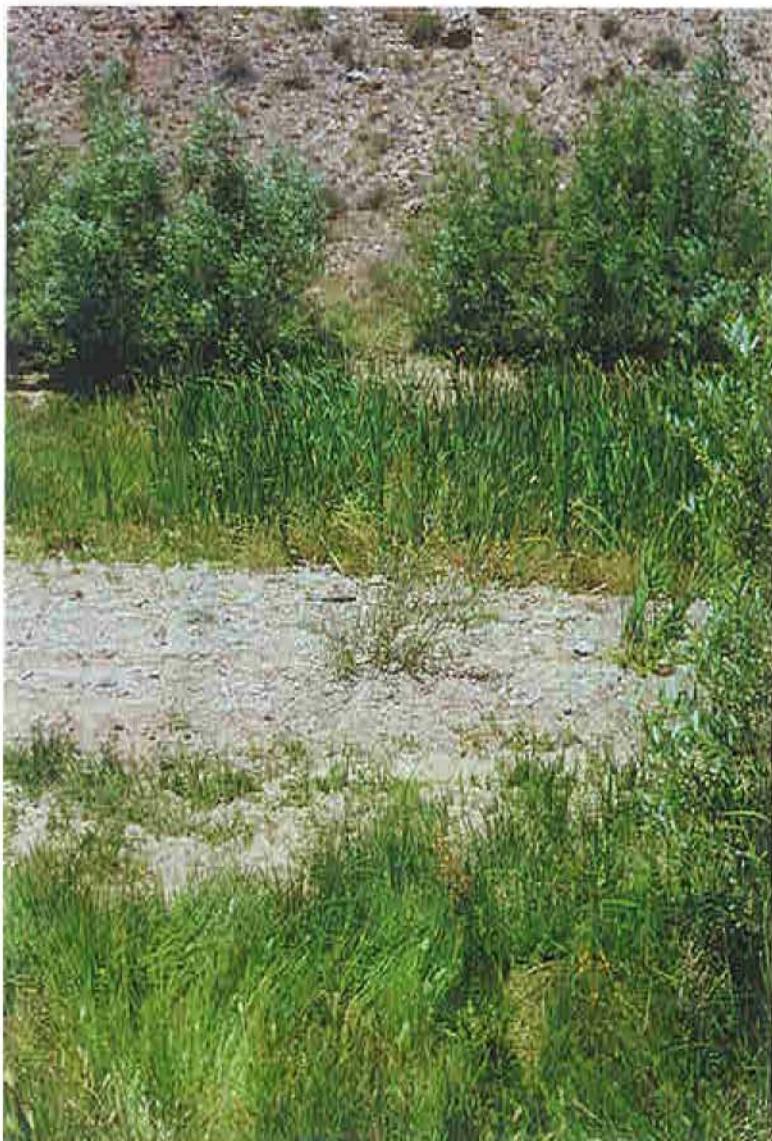
Photograph 4

Proposed fish barrier site from the right abutment.

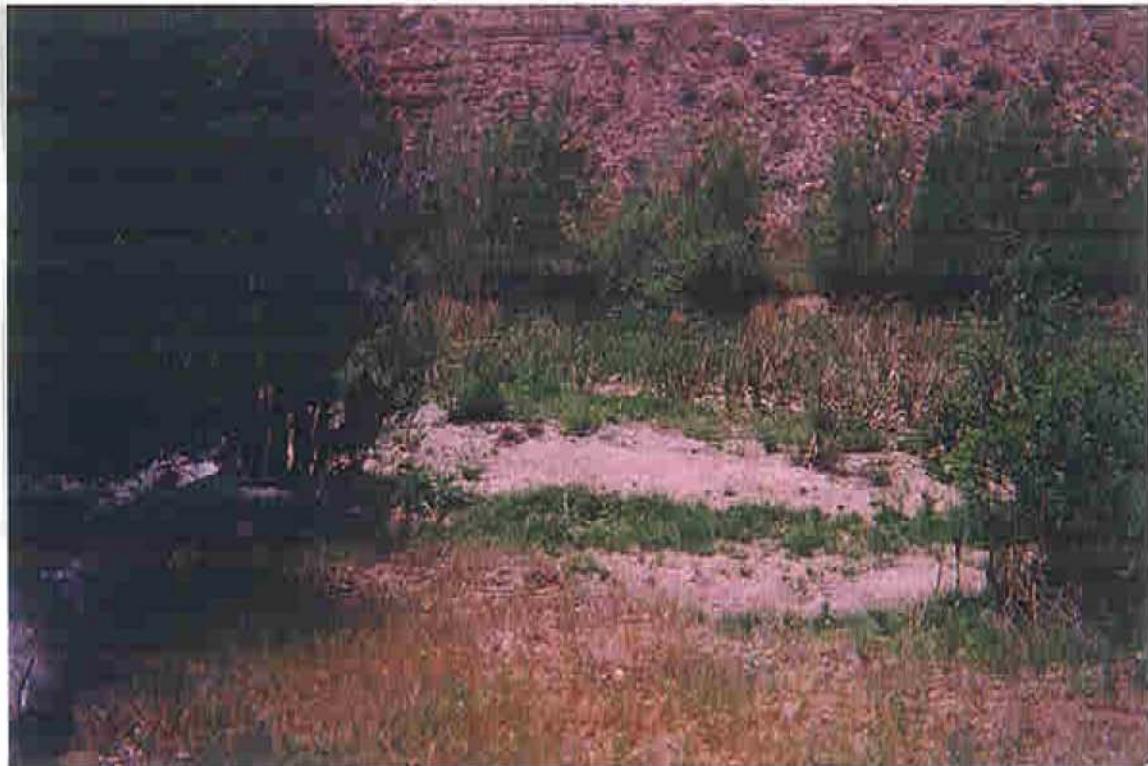
Photograph 5

View looking west at the active channel of Granite Creek. The stream channel is filled with alluvium consisting mostly of sand and gravel. Due to the proximity of the left canyon wall, cobbles and boulders may also be encountered in the excavation.

**Stream Channel** - The stream channel is filled with alluvium consisting mostly of sand and gravel. Due to the proximity of the left canyon wall, cobbles and boulders may also be encountered in the excavation.

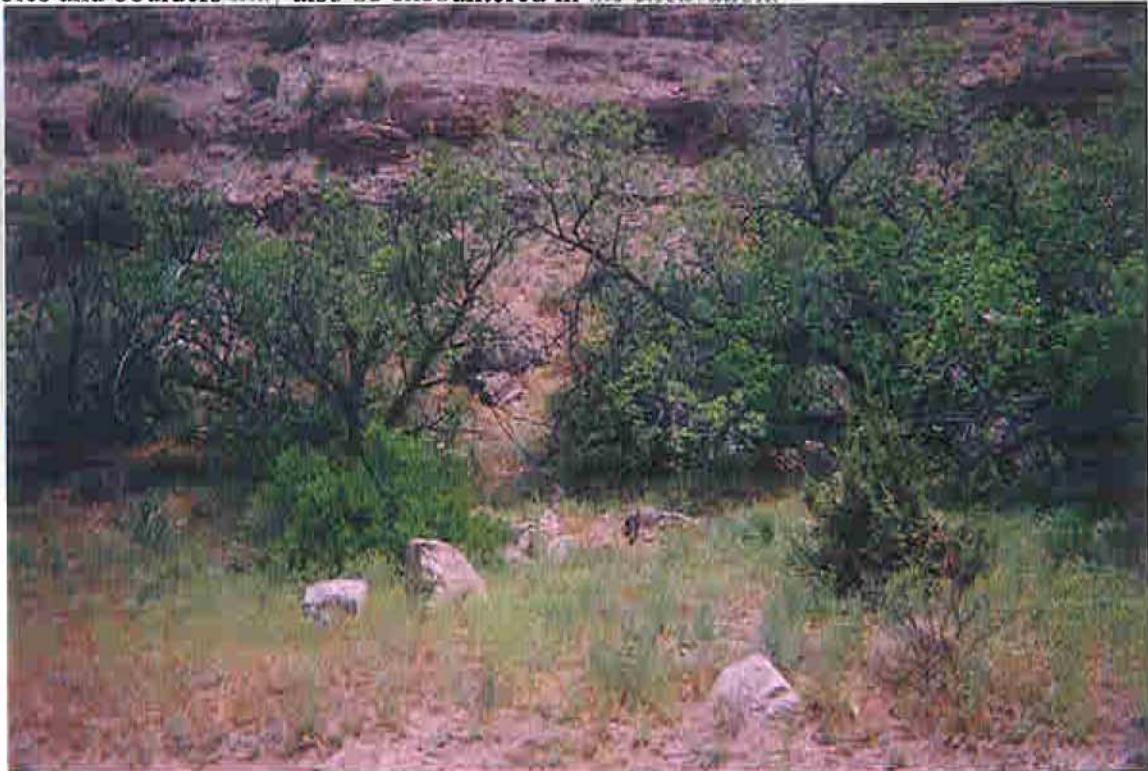
Photograph 6

View looking east at the right canyon wall of Granite Creek. Interbedded limestone and shale forms the canyon walls. Large boulders up to 7 yd<sup>3</sup> in size have accumulated on the ground surface at the bottom of the right canyon wall.

**Right Abutment** - The right abutment of the proposed fish barrier will be founded in alluvium. The alluvium at the surface is mostly sand with gravel and minor amounts of cobbles and boulders. Large boulders up to 7 yd<sup>3</sup> in size have accumulated on the ground surface at the bottom of the right canyon wall. Boulders may also be encountered in the excavation.

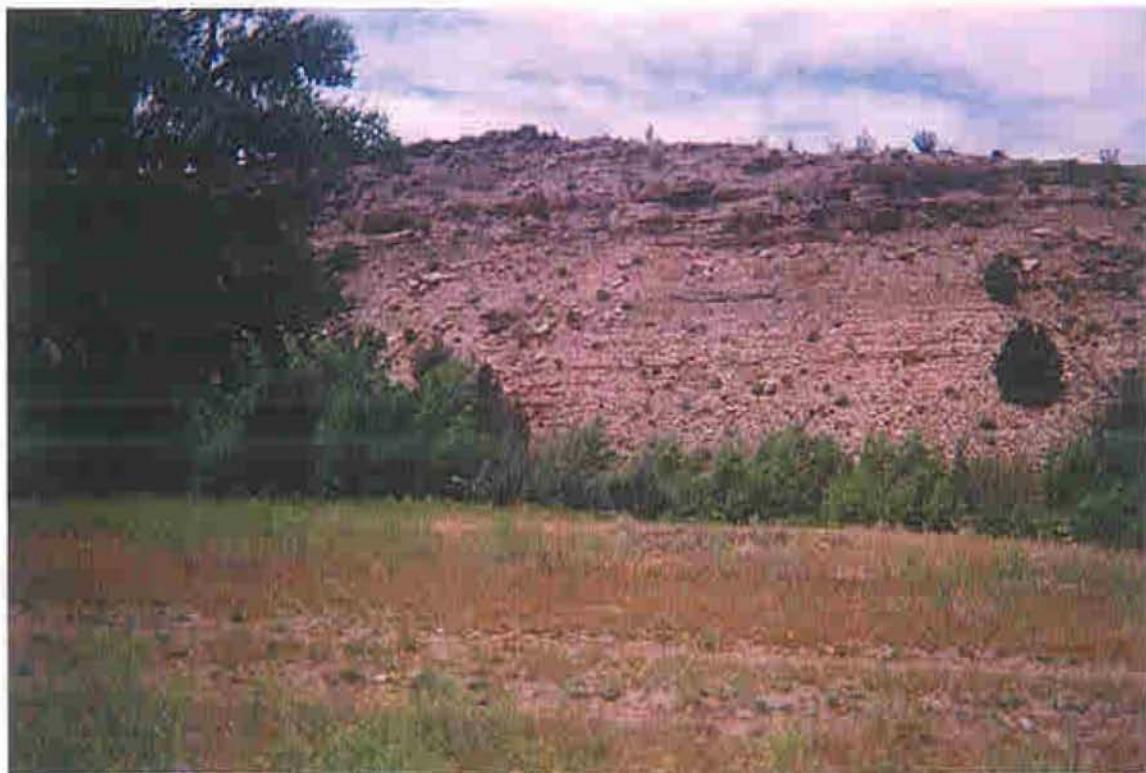
Photograph 7

View looking west along the centerline of the proposed fish barrier at the left canyon wall of Granite Creek. The site for the fish barrier was selected at a narrowing of the canyon walls. The canyon walls are approximately 180 feet high and consist of limestone with interbedded shale.

The site for the fish barrier was selected at a narrowing of the canyon walls. Profiles perpendicular to the stream (along the centerline of the proposed fish barrier) and along the thalweg of Granite Creek were conducted and are shown on Figures 3 and 4. The canyon walls are approximately 180 feet high and consist of limestone with thin (less than 6 in. thick) interbeds of shale.

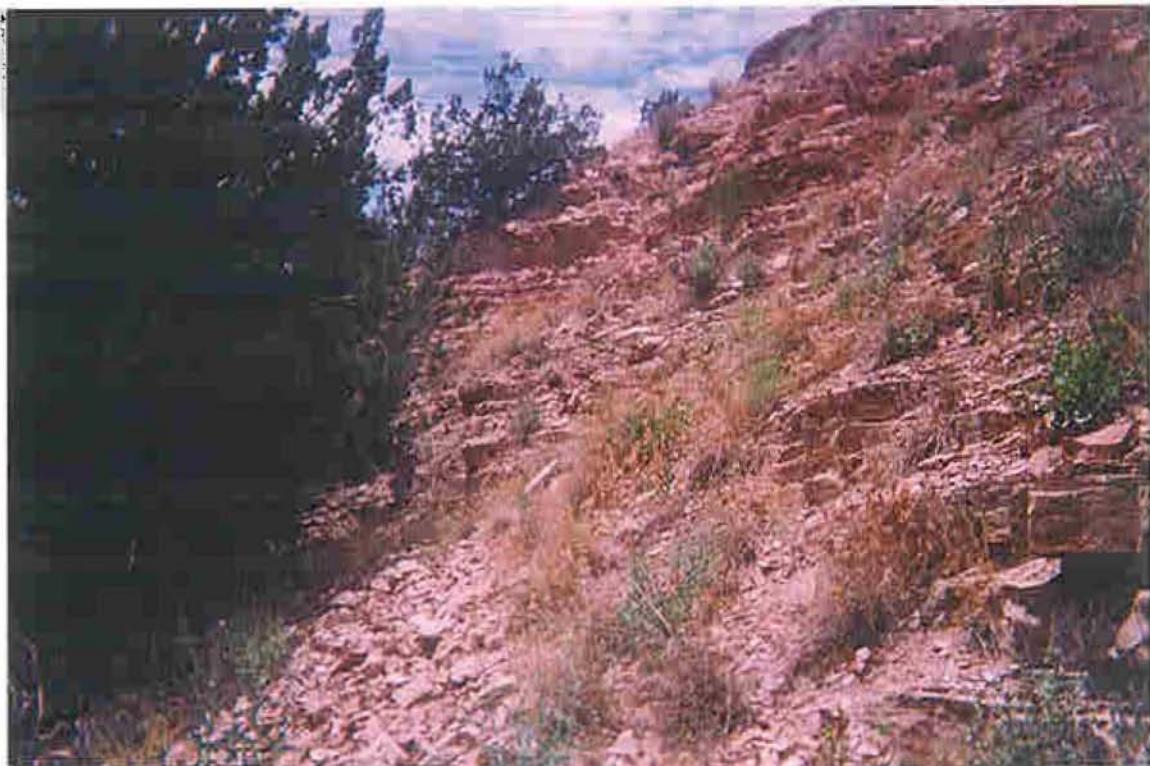
Photograph 8

View looking southwest at the left canyon wall of Granite Creek. The canyon walls slope at approximately 50 degrees and consist of limestone with interbedded shale.

**Left Abutment** - The left abutment will be founded on limestone with thin (less than 6 in. thick) interbeds of shale. The limestone is moderately hard and will require hard rock methods to excavate. The presence of the shale interbeds may permit a backhoe to pluck out blocks of limestone, especially near the surface.

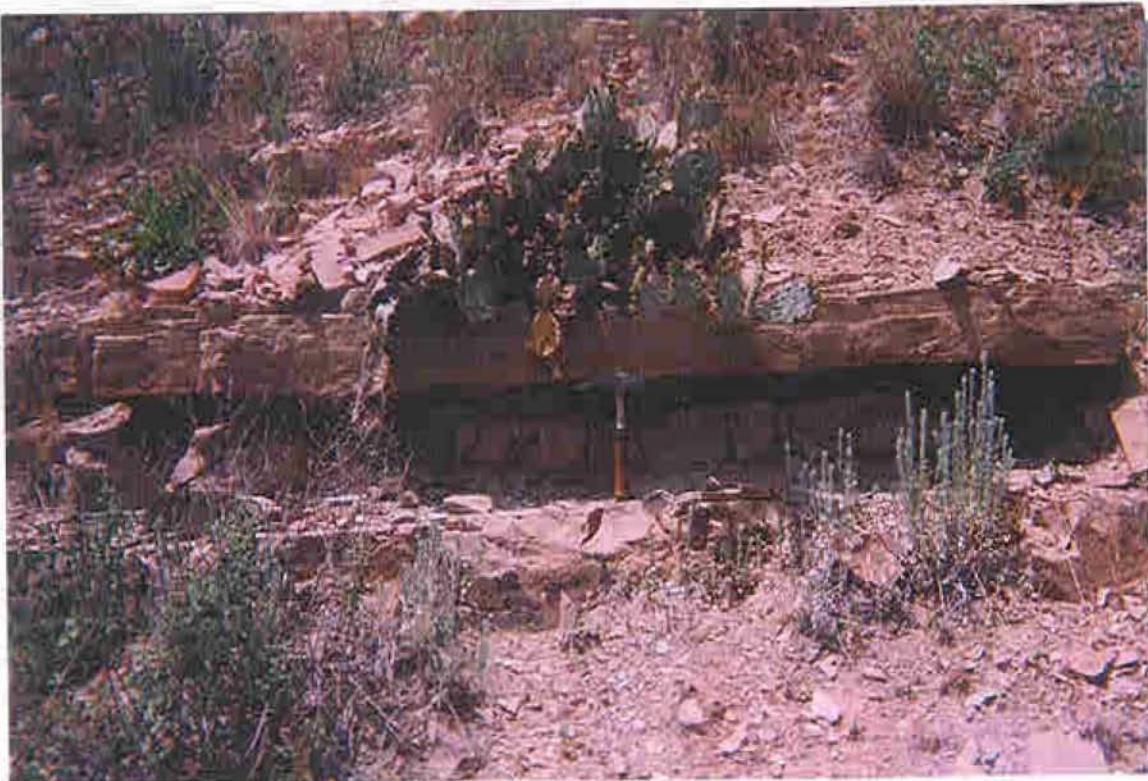
Photograph 9

Closeup of the interbedded limestone and shale forming the canyon walls. The limestone is brown, laminated to moderately bedded (bedding less than 0.03 to 0.6 ft. thick) and moderately hard. The shale is dark greenish gray, laminated and soft to moderately soft.

The limestone is brown (7.5YR5/3)<sup>1</sup>, aphanic, moderately hard (scratches with moderate pressure from a geologic pick, breaks with moderate hammer blow), and slightly weathered. The limestone is laminated to moderately bedded (less than 0.03 to 0.6 ft. thick), and has a strong reaction to hydrochloric acid (HCl).

The shale is dark greenish gray (10Y4/1), aphanic, soft to moderately soft (scratches with light pressure from a geologic pick, breaks with light manual pressure), and slightly weathered. The shale is laminated and has no reaction to HCl.

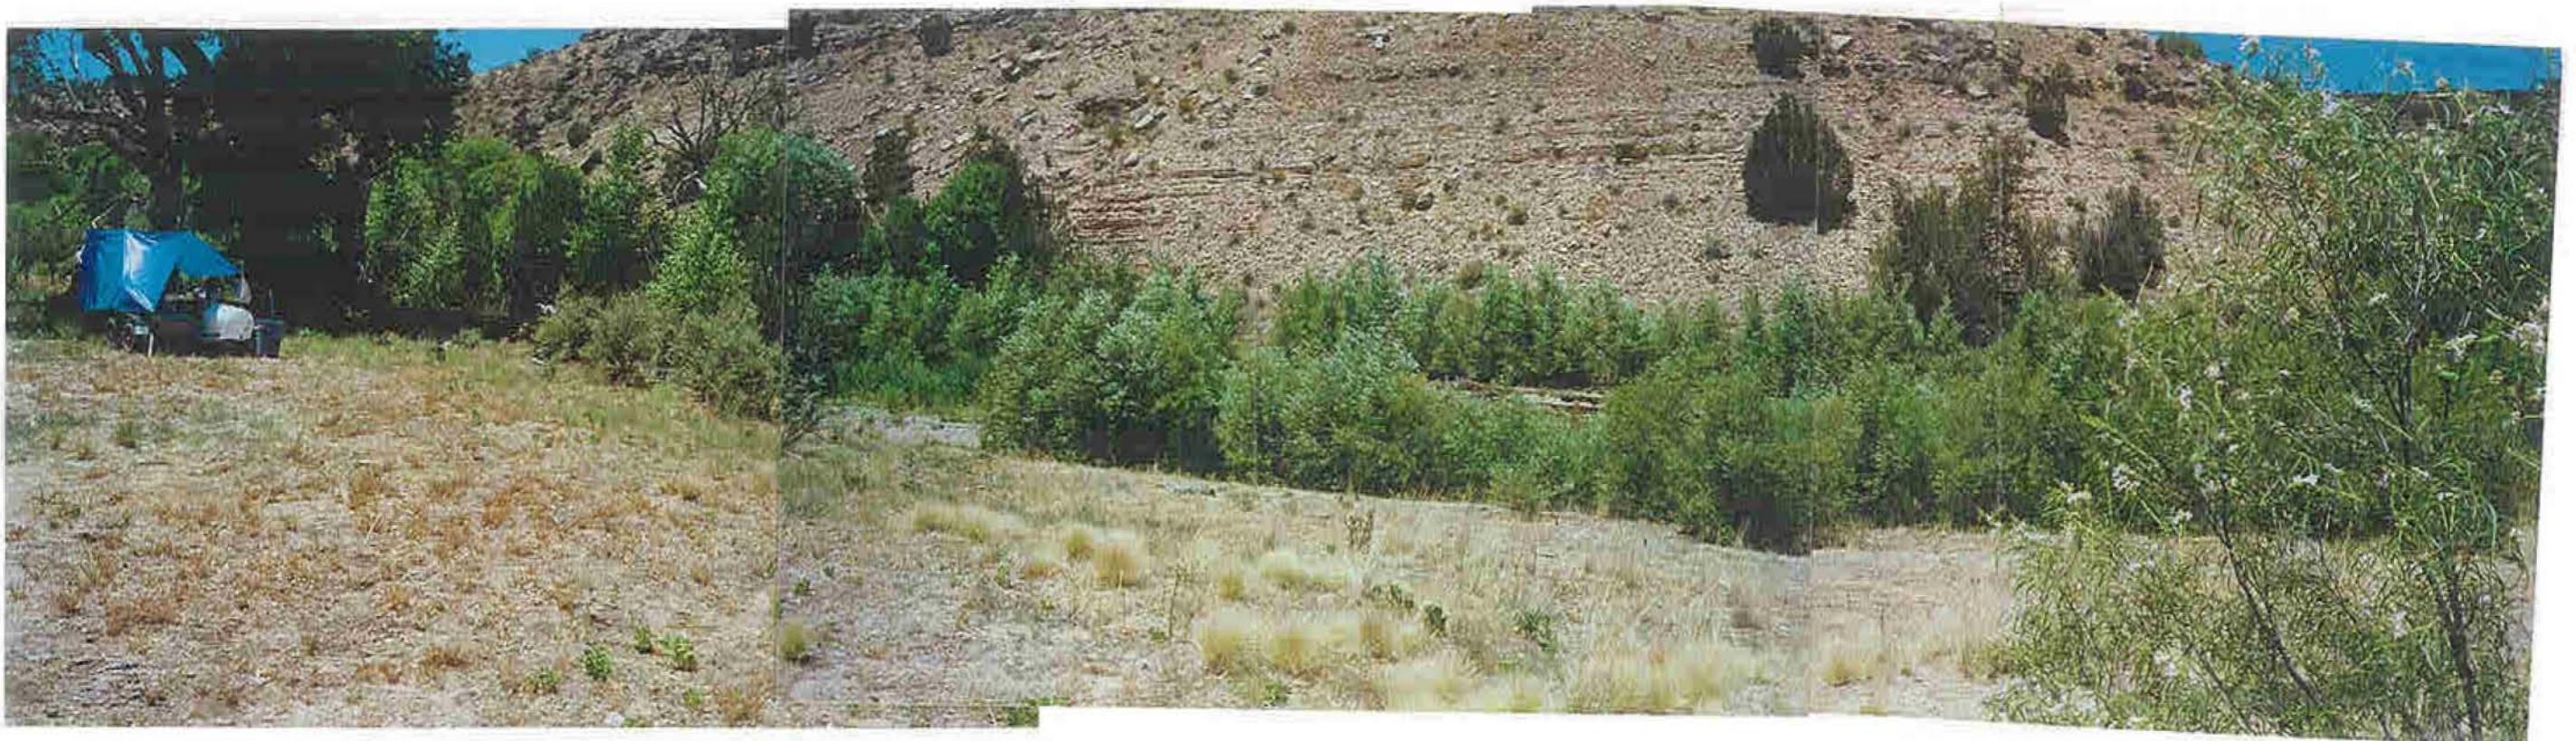
Photograph 10  
Proposed fish barrier site from terrace on right abutment.  
Photo by: J. Riley

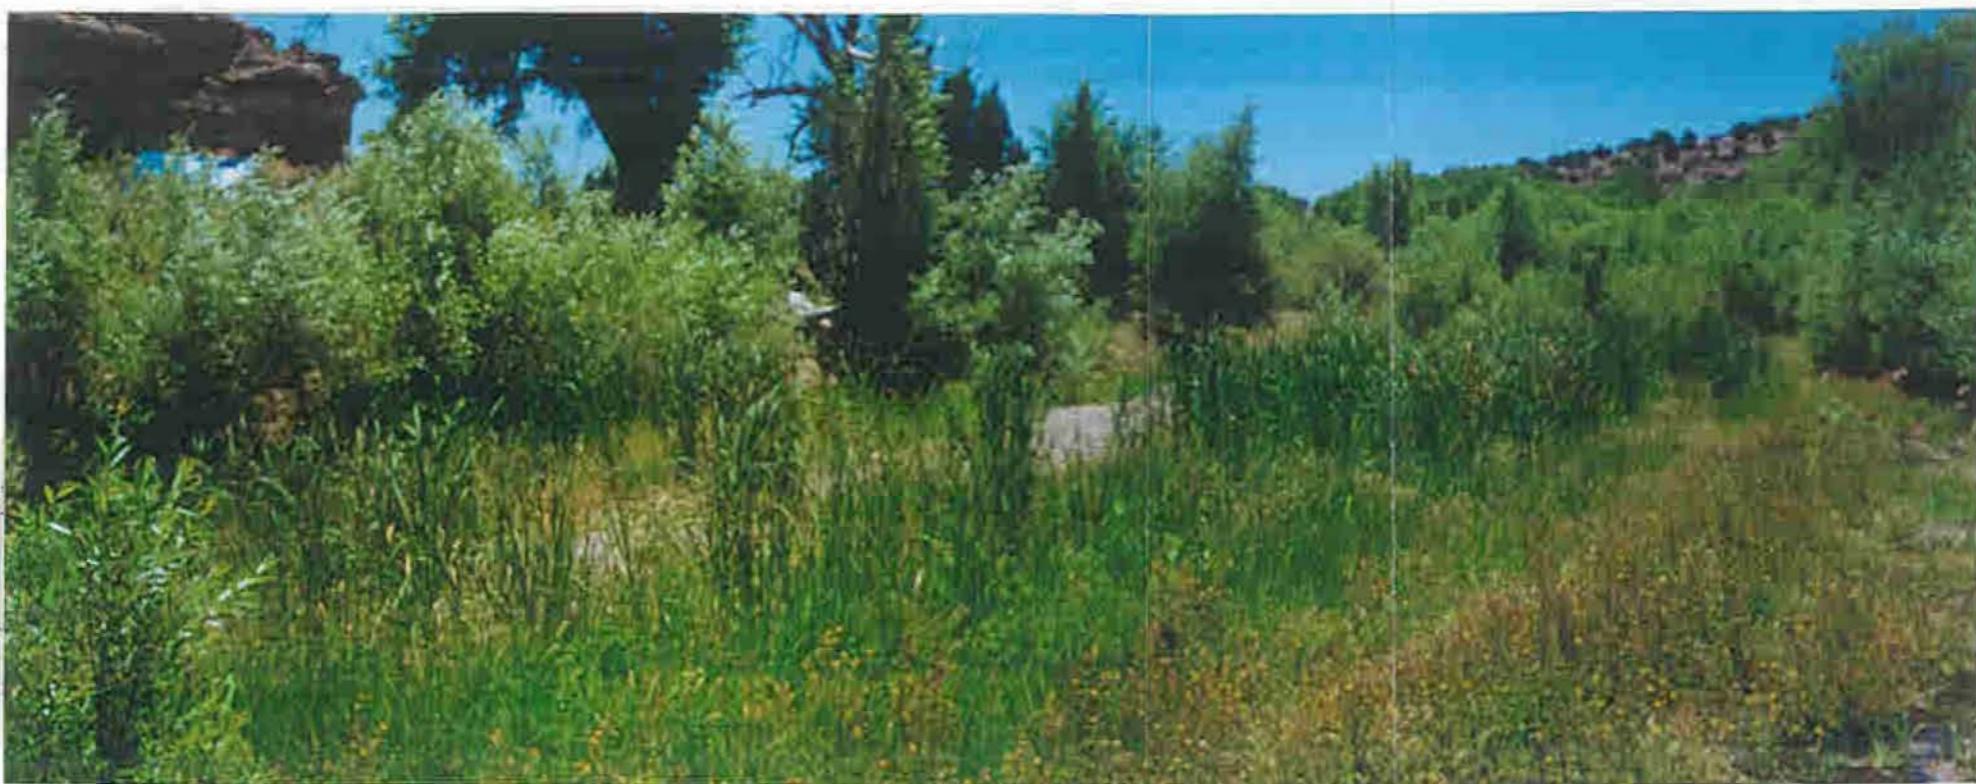
Photograph 12

Proposed fish barrier site from channel, looking upstream.

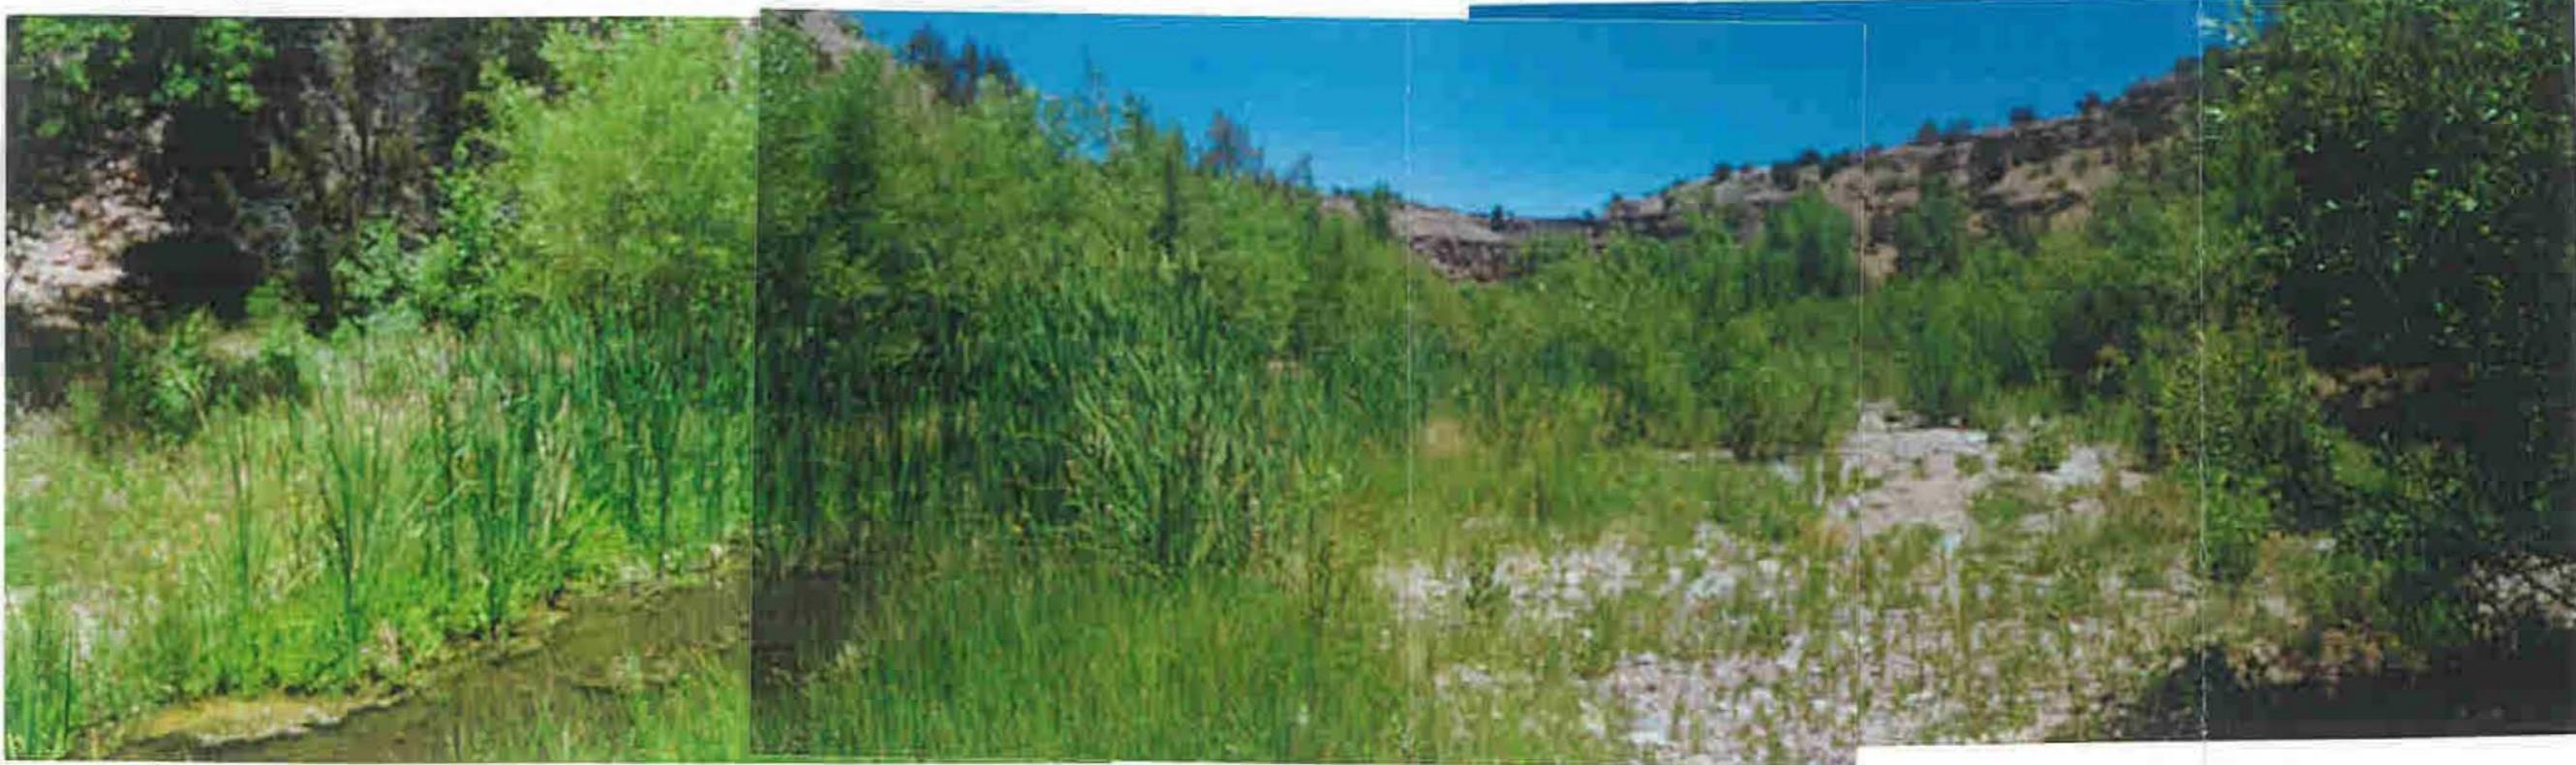
Photograph 13

Proposed fish barrier site from channel, looking downstream.
