Lewis Springs Fish Barrier

Phase 1 Investigations

March 2005

Prepared by the U.S. Bureau of Reclamation, Phoenix Area Office

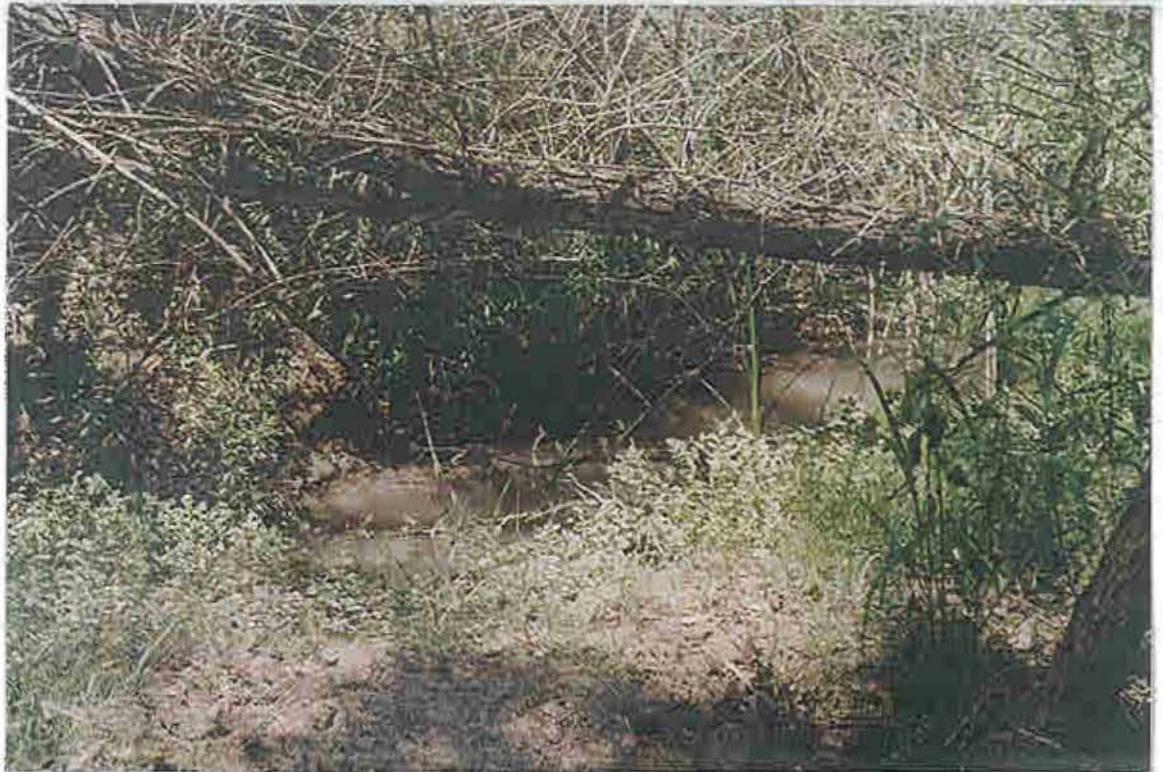
**Photo 1 - Near headwaters of Lewis Spring in Government Draw.**

A. General - The springs surface at the base of a hillside that forms the south bank of Government Draw, about 900 feet upstream of the railroad crossing (Photo 1). The springs appear to be a series of seeps that produce roughly 30 gallons per minute. Surface water upstream of the railroad crossing creates a dense riparian zone.

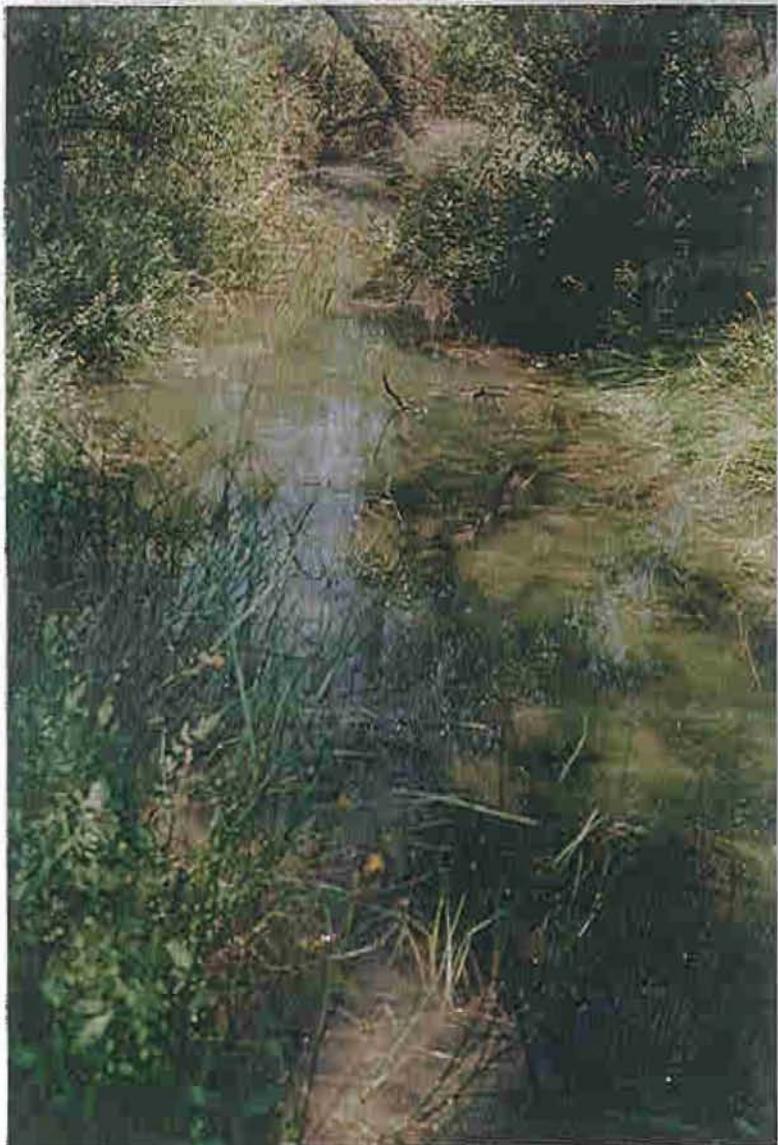
**Photo 2 - Typical pond downstream of Lewis Spring.**

B. Stream morphology - Upstream of the railroad crossing, the stream consists of a series of slow moving pools, up to 8 feet wide, within an approximately 130-foot wide riparian zone (Photos 2 and 3). Dense vegetation and thick grasses make the silty channel fairly stable. Channel slope is about 1.1%.

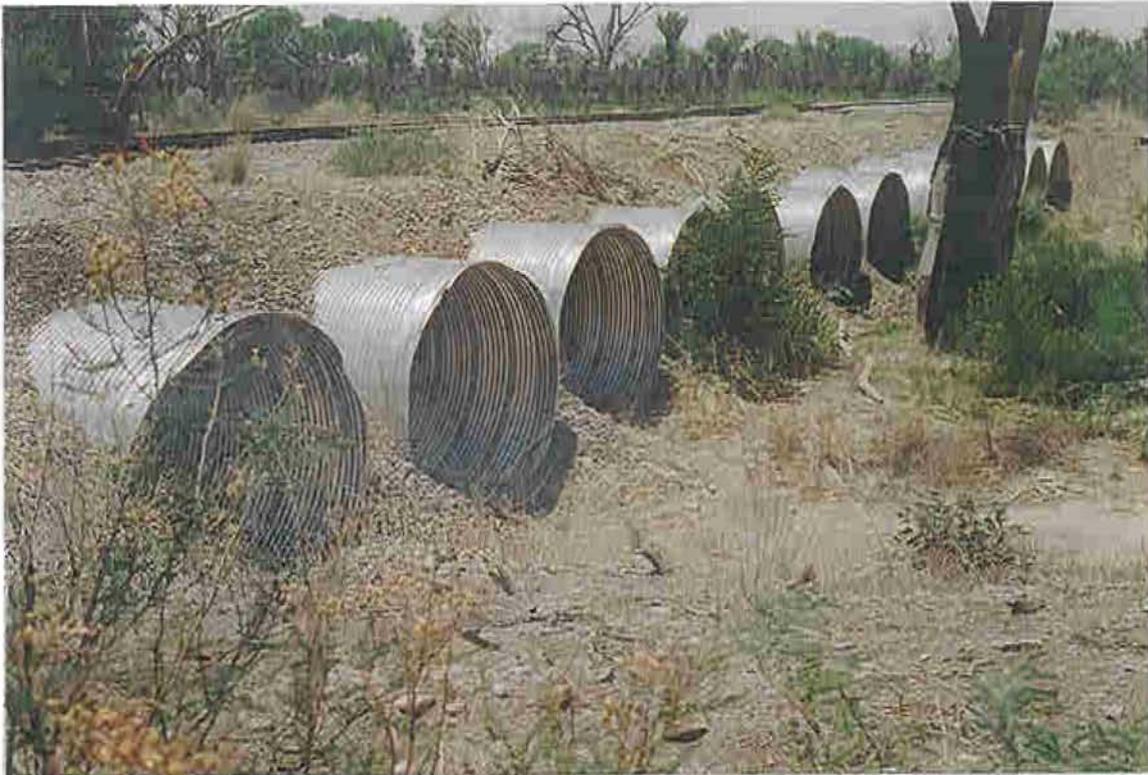
Photo 5 - Upstream side of the railroad crossing. Twelve 9-foot CMP's.

C. Site at Railroad Crossing - This concept envisions using the corrugated metal pipe culverts (Photo 5) to house the barrier. 3-foot drop structures would be placed at the downstream end of each of the 12 culverts (Photo 6). This would effectively reduce the cross-sectional area of the culverts by 29%. The advantages of this option are that abutment work is not required, few materials are required, and construction costs would be low.

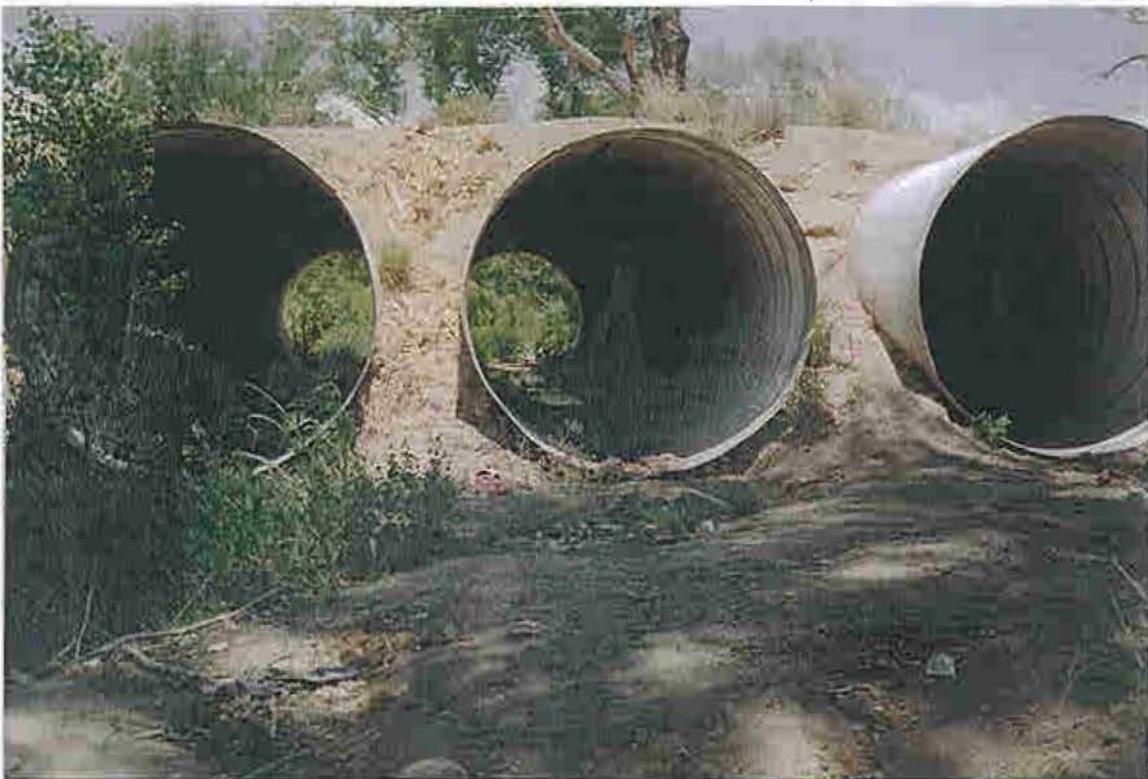
Photo 6 - Downstream end of railroad crossing culverts.

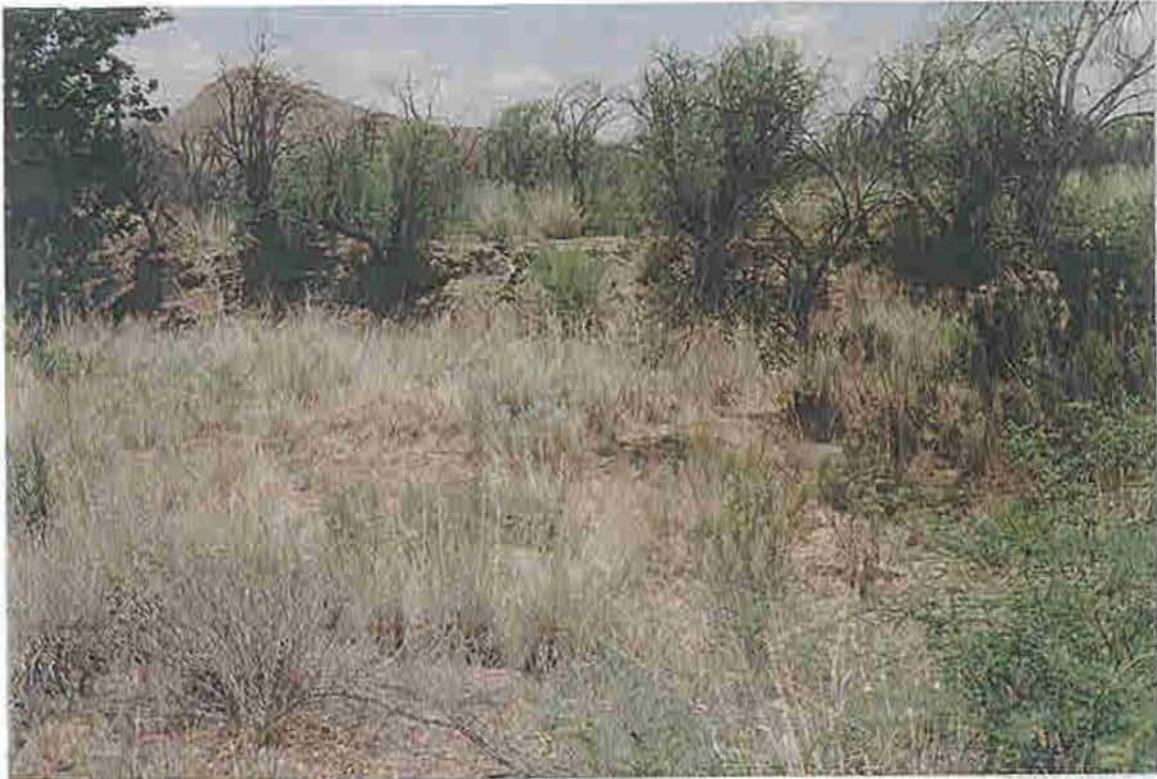
Photo 7 - Site 300 feet downstream of railroad crossing. Looking north along alignment at right abutment.

D. Site 300 Feet Downstream of Railroad Crossing (Photos 7 and 8) - This site would minimize effects to the riparian habitat, although further studies are needed to determine if San Pedro River flooding would inundate the barrier. Additional surveys would be required to define the sedimentation effects at the railroad crossing. Southern Pacific Railroad would receive a grade control benefit from a barrier at this site that could potentially offset sediment concerns.

The distance between banks is 97 feet. The banks are easily erodible alluvial deposits 5 to 6 feet above the stream thalweg. Substantial bank stabilization work would be required to prevent erosion around the end of the structure.

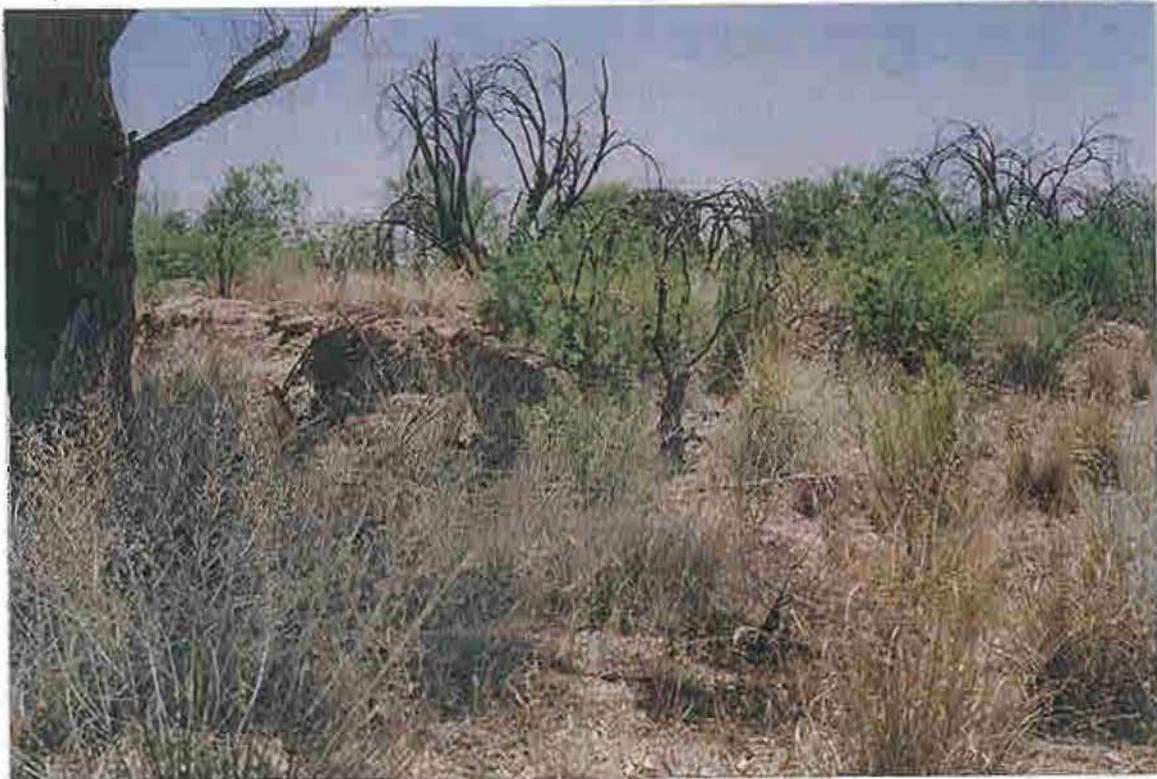
Photo 8 - Site 300 feet downstream of railroad crossing. Looking south along alignment at left abutment.

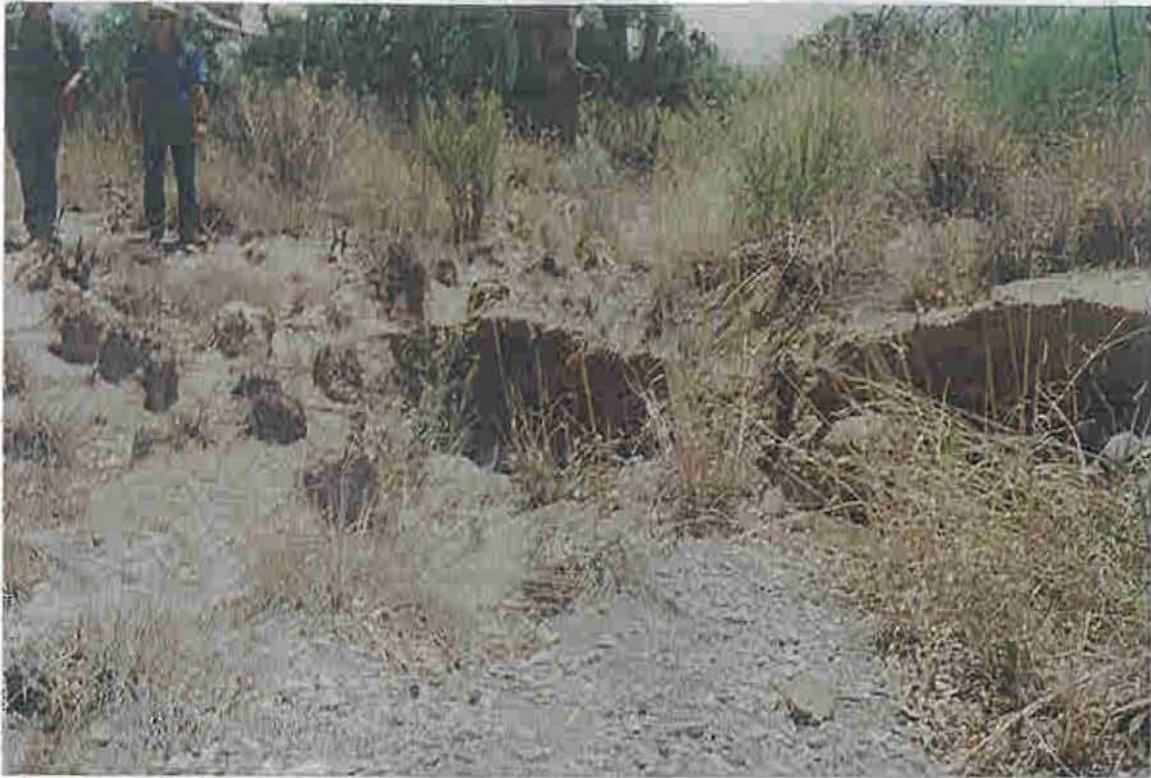
**Photo 9 - Headcutting notch  
30 feet downstream of  
downstream barrier site.**

A 2-foot deep headcut (Photo 9) is occurring about 90 feet downstream of the barrier site and would need to be considered by the engineer. The potential exists for another currently stable headcut drop at the San Pedro confluence to begin working its way upstream (Photo 10).
