Blue River Fish Barriers
Feasibility Study
for
Clifton Ranger District, U.S. Forest Service
Clifton, Arizona
February 1998

Prepared by the U.S. Bureau of Reclamation, Phoenix Area Office

Blue River Fish Barriers Feasibility Study

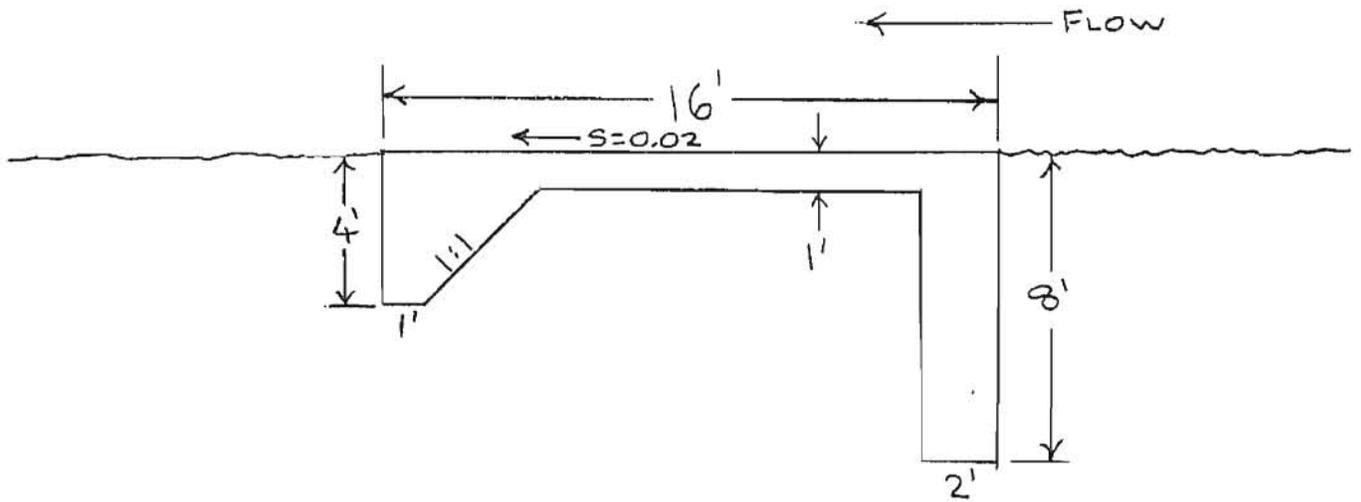
JUAN MILLER CROSSING
VEHICLE ONLY OPTION

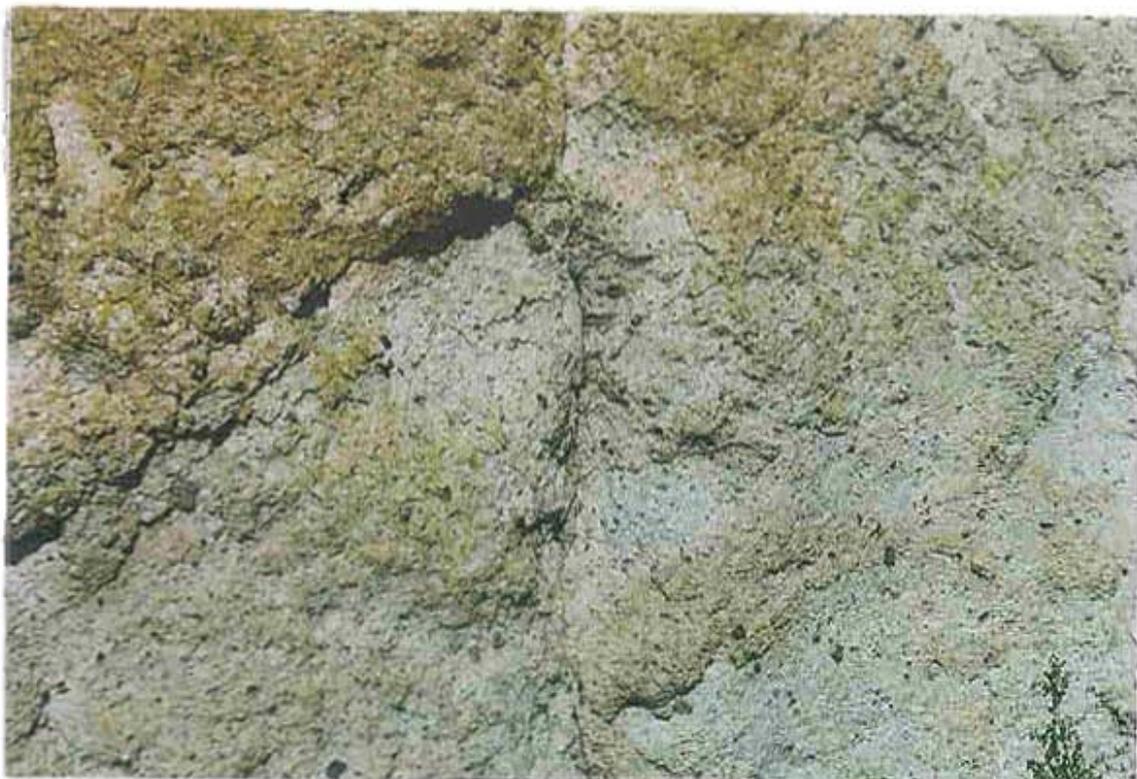
Photo 5 Blue River Fish Barrier October 16, 1997
Close up of massive lithic tuff exposed along the Blue River. This tuff is underlain by basaltic andesite and overlain by bedded tuff and is typical of all of the sites examined. The rock is generally moderately hard to hard on the surface but is drummy in places.

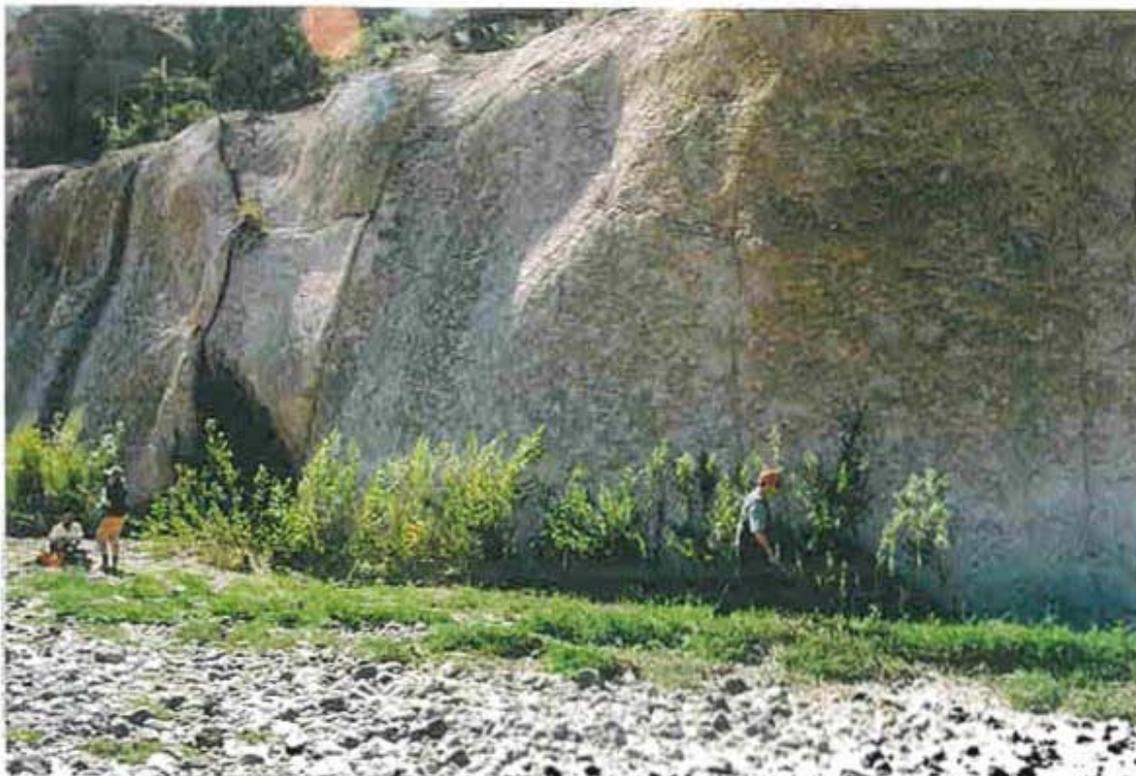
Photo 6 Blue River Fish Barrier October 16, 1997
Right abutment of Site 2. Rock is massive lithic tuff and photo shows two steep fractures and overhang near the proposed centerline. The centerline could be shifted upstream to avoid a potential slope movement along the fractures.

There is a potential for a wedge failure at the right abutment of Site 2; the excavation should be performed upstream of this feature to prevent destabilization. Sealing of the vertical joints on the left abutment of Site 2 should be considered to prevent water flow and possible fish migration in the future if the joint filling washes out. This can be done by filling with concrete to the height of the barrier.

Site 2 Geologic Considerations - Similar to Site 1. There is a potential wedge failure downstream of centerline on the right abutment.

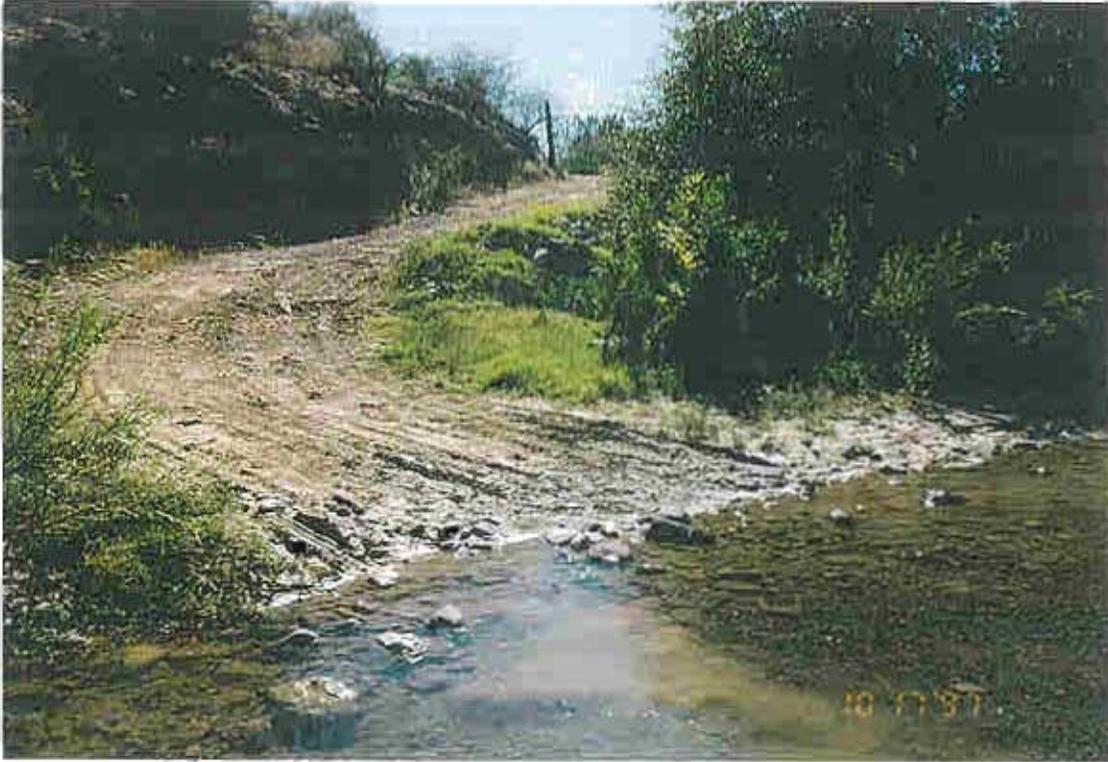
Photo 11 Blue River Fish Barrier October 17, 1997
View looking eastward of Juan Miller Crossing from the Blue River. Bedded tuff is in the background.
