NAVAJO PROJECT OPERATION AND MAINTENANCE PLAN

Submitted to: Bureau of Reclamation

Submitted by: Salt River Project

Revision 12.0

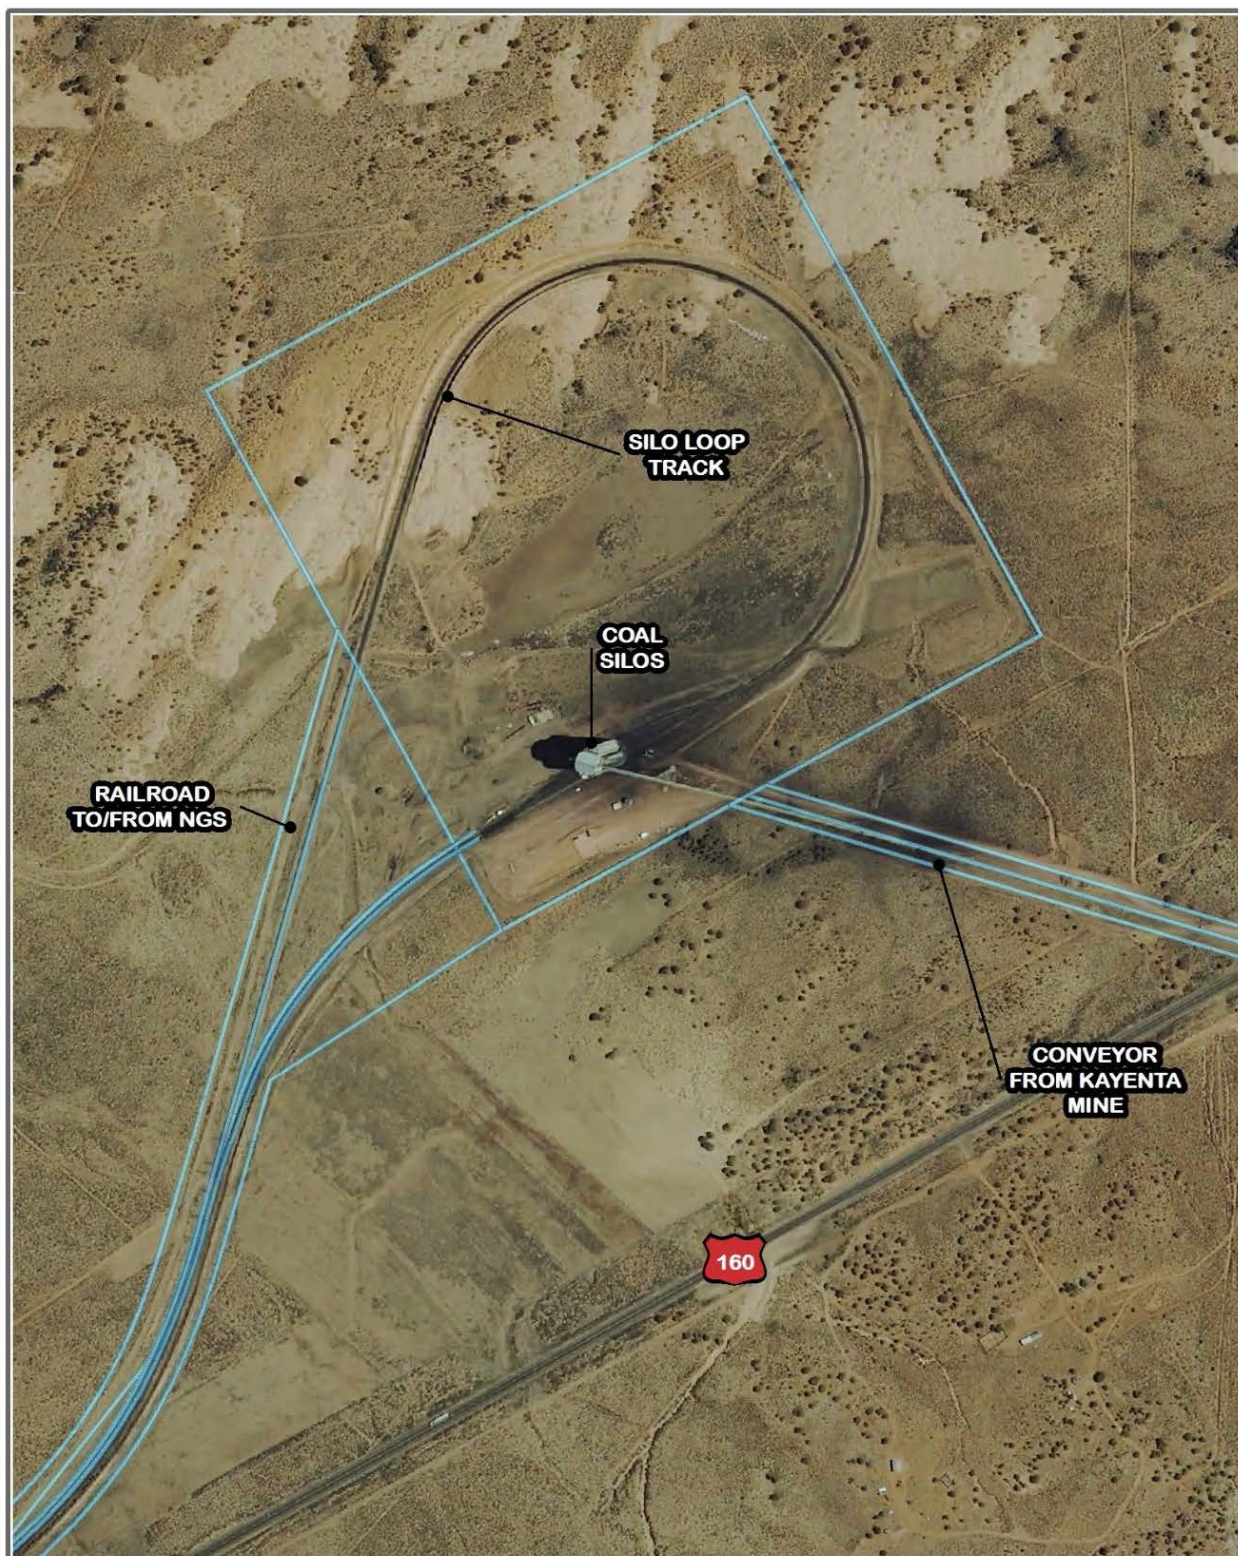
Figure 6 - Coal Loading Site.

The four storage silos at the coal loading site are constructed of steel-reinforced concrete and are tied together into a single structure (**Figure 6**). Trains are loaded out of two of the four silos at a time for transport to NGS. Typically, an 8,000-ton train (e.g., 80 cars at 100 tons/car) can be loaded in about 40 minutes. The BM&LP Railroad and associated facilities (e.g., Midway Station, catenary) are operated, maintained, improved, modified and moved within the ROW as needed by SRP (see description below).

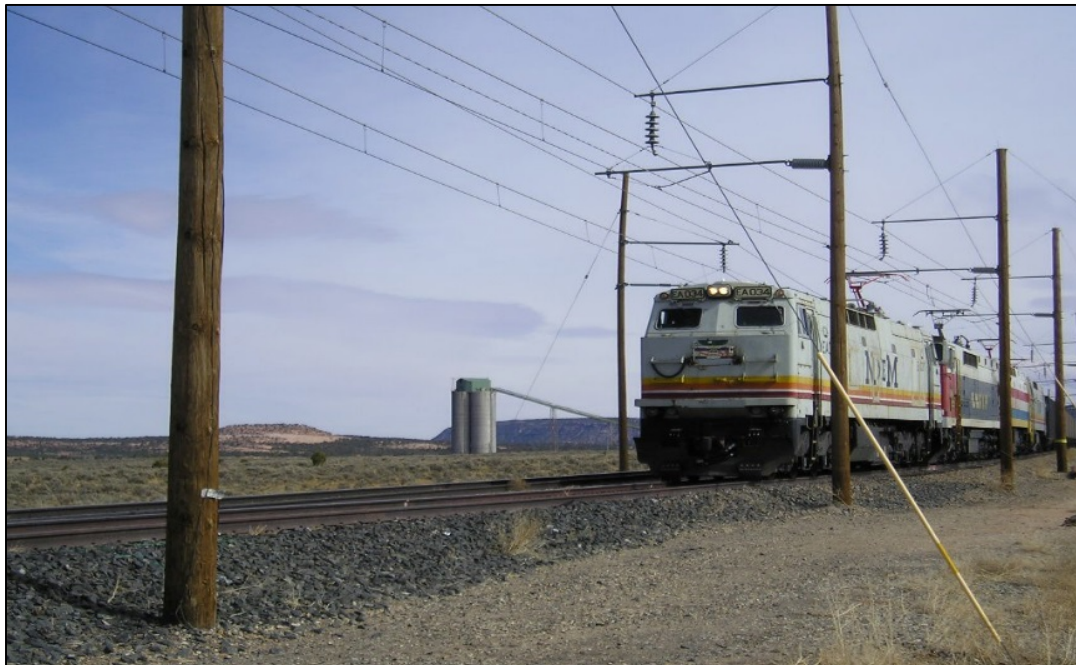
Figure 7 - Coal Delivery Train.

The Black Mesa & Lake Powell railroad (BM&LP Railroad) (**Figure 7**) is used to deliver coal from KM to NGS (**Figures 1 and 2**). The track extends 78 miles northwest across the Navajo Reservation from the coal loading site at Black Mesa on the north side of Highway 160 to NGS. Including the railroad loops at each end, the total length of the system is about 80.4 miles. As the BM&LP Railroad is a private railroad and a closed system that does not connect with any other railroads, it is not under the jurisdiction of the Federal Railroad Administration (FRA). When NGS is running at full capacity, the train runs 24 hours a day 7 days a week and completes three round-trips per day, delivering approximately 8,000 tons of coal per trip. A round trip normally takes 6 to 7 hours.

BM&LP Railroad currently uses bottom dump hopper cars manufactured by Freight Car America, Trinity, Ortner, and Gunderson. The cars are loaded from silos using an overhead loadout chute system in a completely concreted area. Each car is loaded with a maximum of 100 tons of coal. The cars are filled to a level below the top to minimize spillage and exposure to the

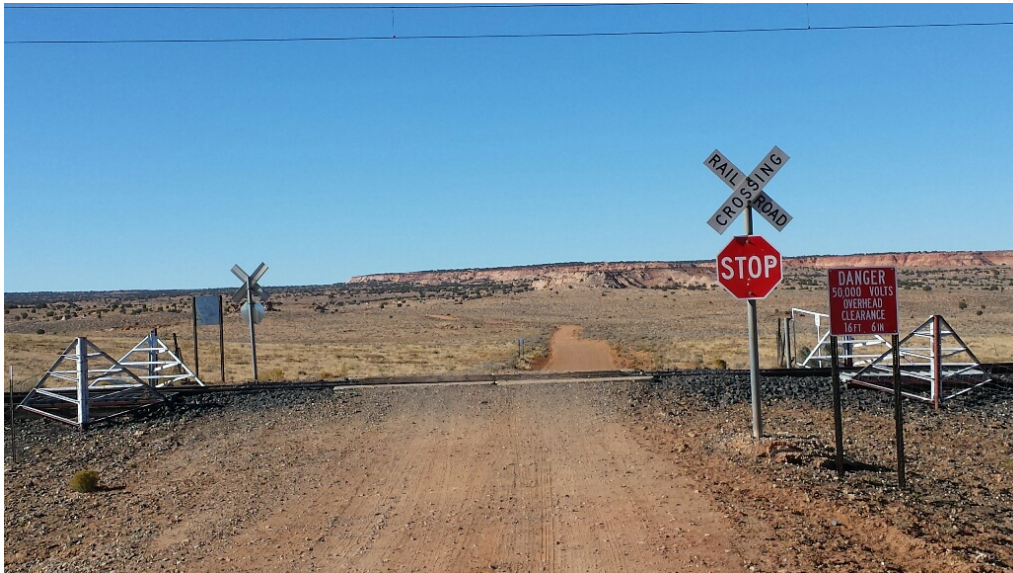
Public safety warning devices at 36 low-use public crossings include a Railroad Cross Buck warning sign and STOP signs (**Figure 8**). The four crossings located at mile posts 31, 42, 55, and 66 have electronic warning lights and bells as additional safety warnings to the public (**Figure 9**). In addition to the other safety features, crossing arms are installed at mile post 66 where State Highway Route 98 crosses the rail line (**Figure 10**). When an incident involves the train and a motor vehicle, the Navajo Nation police are notified by SRP to investigate the incident. There have been approximately 10 to 15 incidents involving the train and motor vehicles, including three incidents in the past 15 years.⁴

Figure 8 - Mile Post 36 Low-Use Road Crossing.

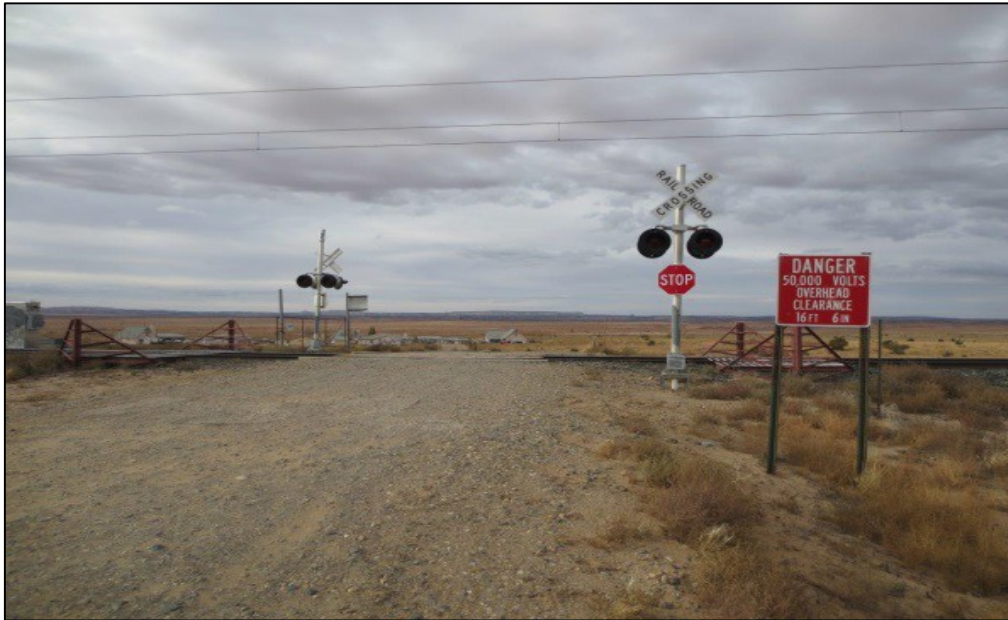
Figure 9 - Railroad Crossing at Mile Post 58. (Typical of Mile Posts 31, 42, 55, 66).

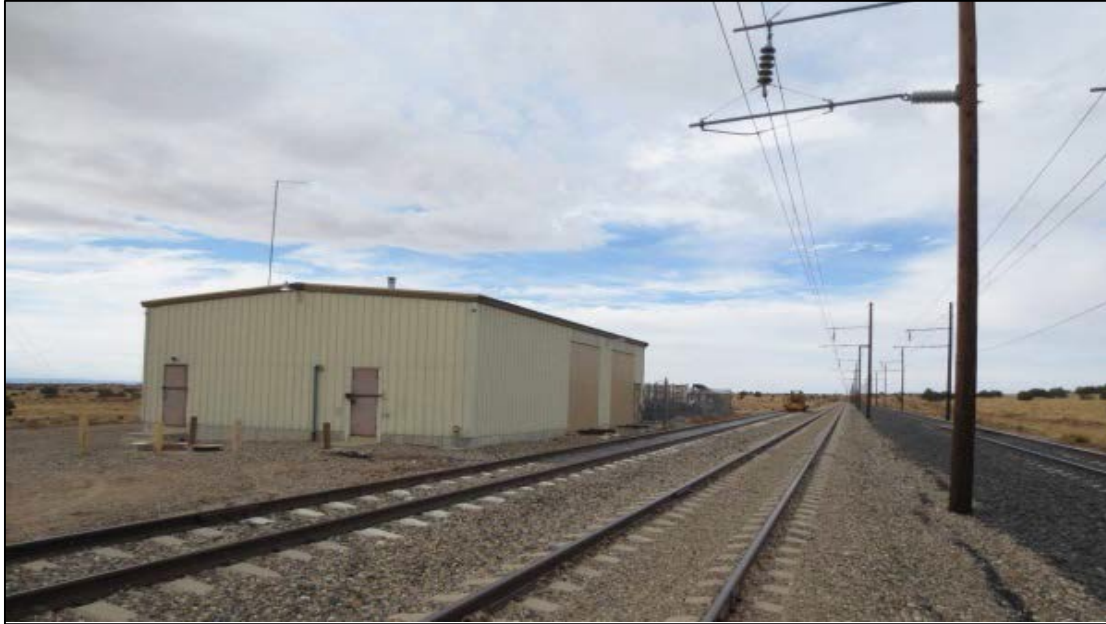
Figure 11 - Midway Station.

The Midway Station located at mile post 42 (**Figure 11**) may be used as a crew assembly location, a pullout siding for railroad cars and locomotives, a maintenance facility, and a warehouse to store rails, track switch components, cross ties, other track hardware and supplies,

and small quantities of chemicals used for maintenance purposes (e.g., WD-40, 10W hydraulic oil).

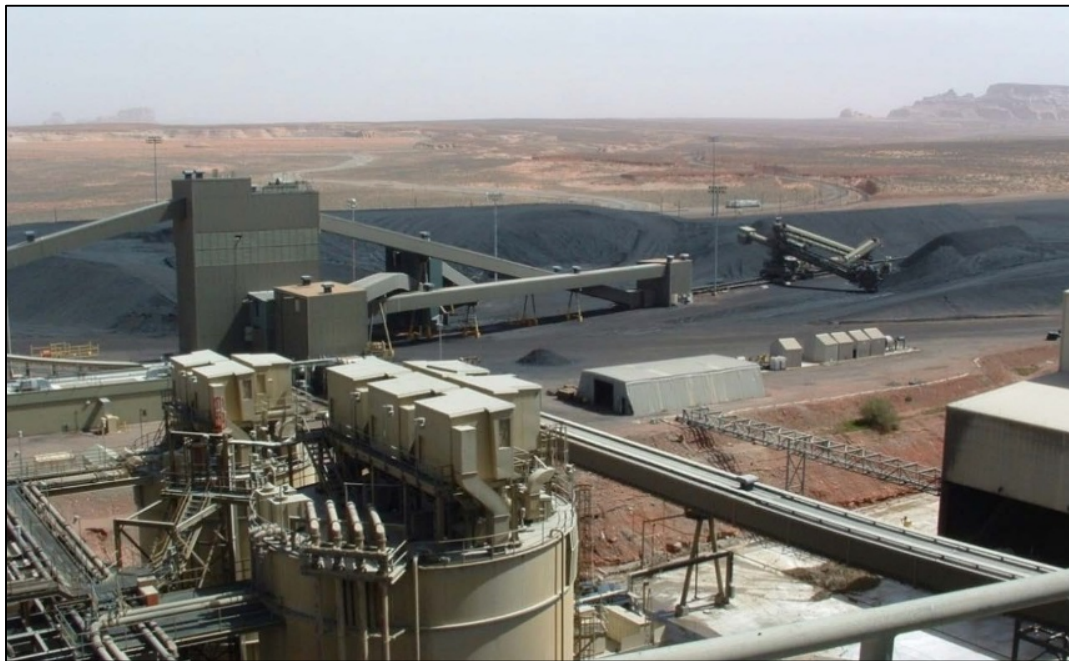
Figure 12 - NGS Coal Yard.

Low sulfur bituminous coal from KM is the primary fuel for the three units at NGS. Approximately 8.2 million tons of coal per year are used at NGS for power generation. The coal yard is located on the north side of NGS (**Figure 12**). As previously described, the coal is delivered to NGS by the railroad via a 50-kV electric train with 100-ton-capacity bottom-dump hopper cars. The coal is crushed to a 2-inch size at the mine for ease of handling and transport. At full load, the three power plant units burn coal at a rate of approximately 1,000 tons per hour. Ongoing maintenance keeps the coal handling system efficient, safe, and able to control combustible coal dust particulates.

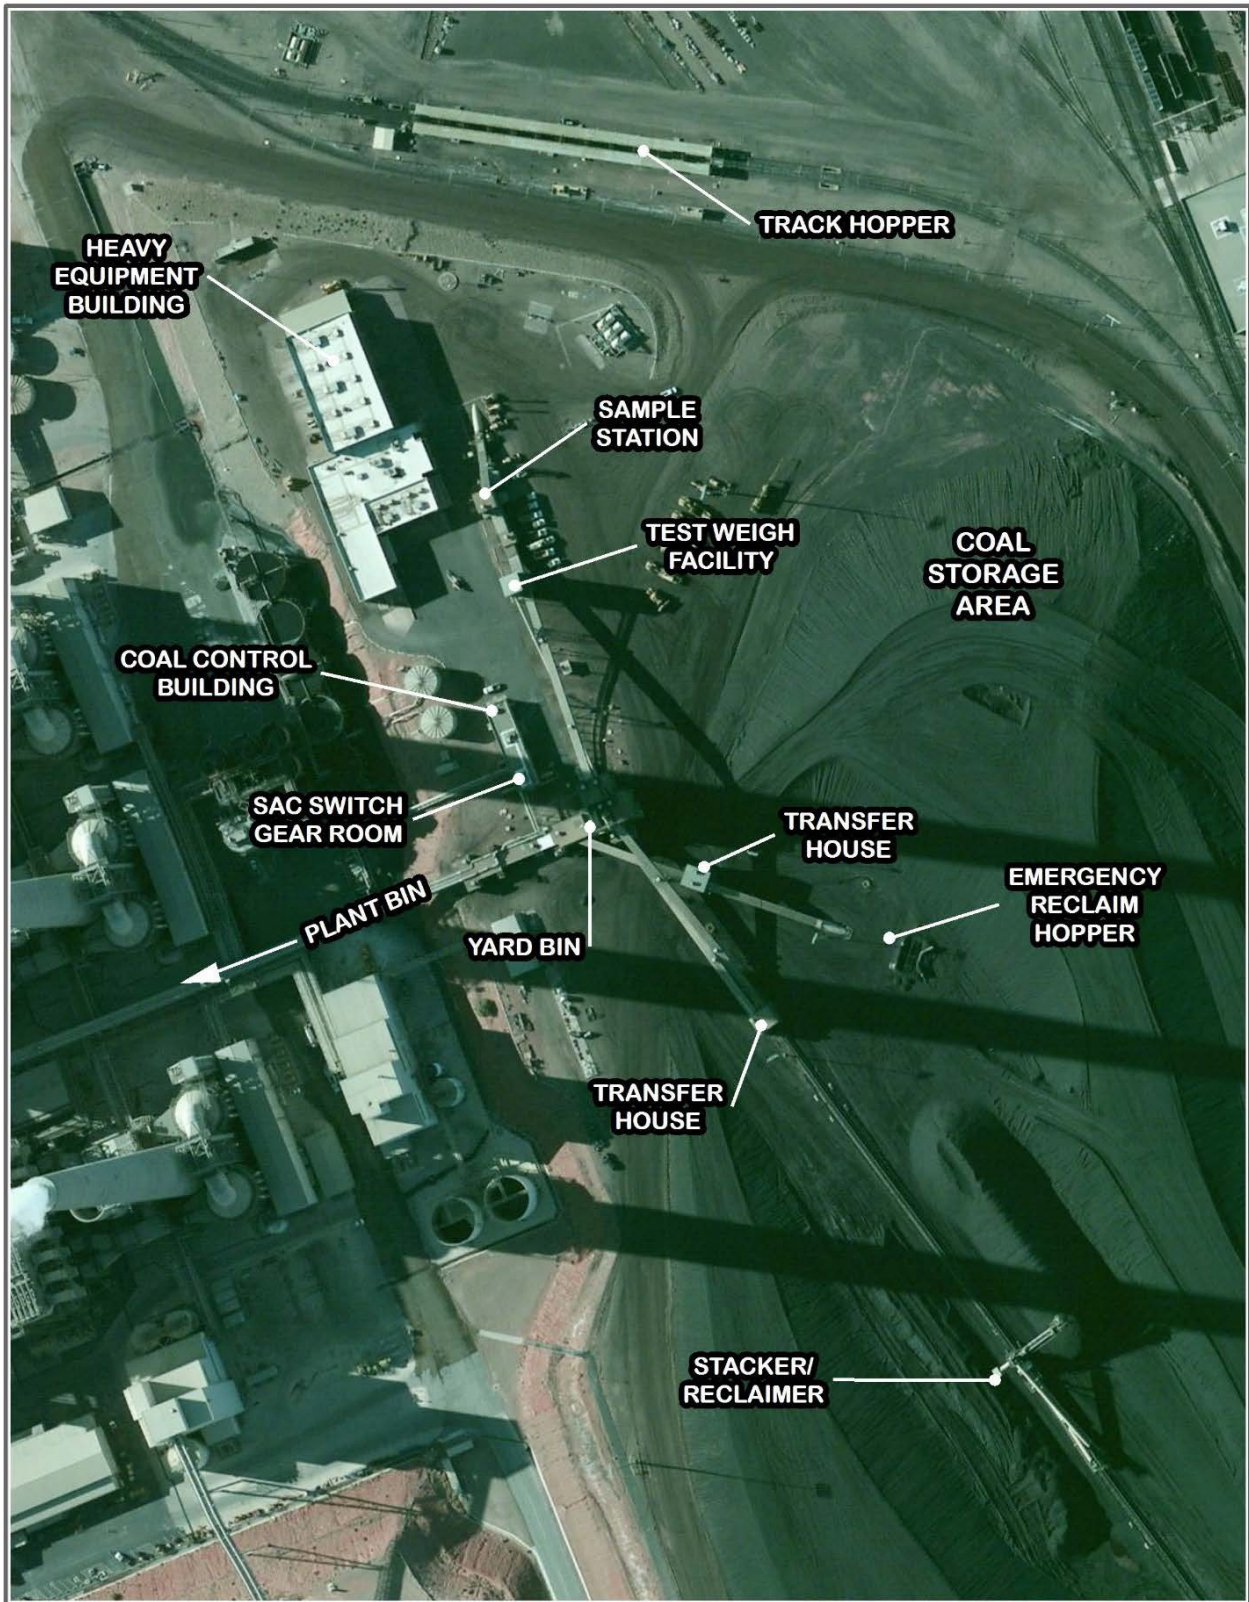
Figure 13 - Coal Handling Facilities at NGS.

Once a full train arrives at the plant site, it slowly travels through the track hopper building (**Figure 13**) where the coal is dumped from the bottom-dump hopper cars at a manually controlled speed into 12 underground enclosed hoppers. Each hopper's capacity is 1,050 tons, giving the track hopper a total capacity of 12,600 tons.

All 12 hopper feeders discharge coal onto a horizontal conveyor belt running underneath the track hoppers. The coal is then transported by a series of belt conveyors to the coal sampling station which removes a small continuous coal sample from the main coal stream for testing of sulfur content, moisture, ash, and BTUs per pound of coal. The coal is then transported to the yard bin and then to the plant bin where it is distributed to each unit's silos.

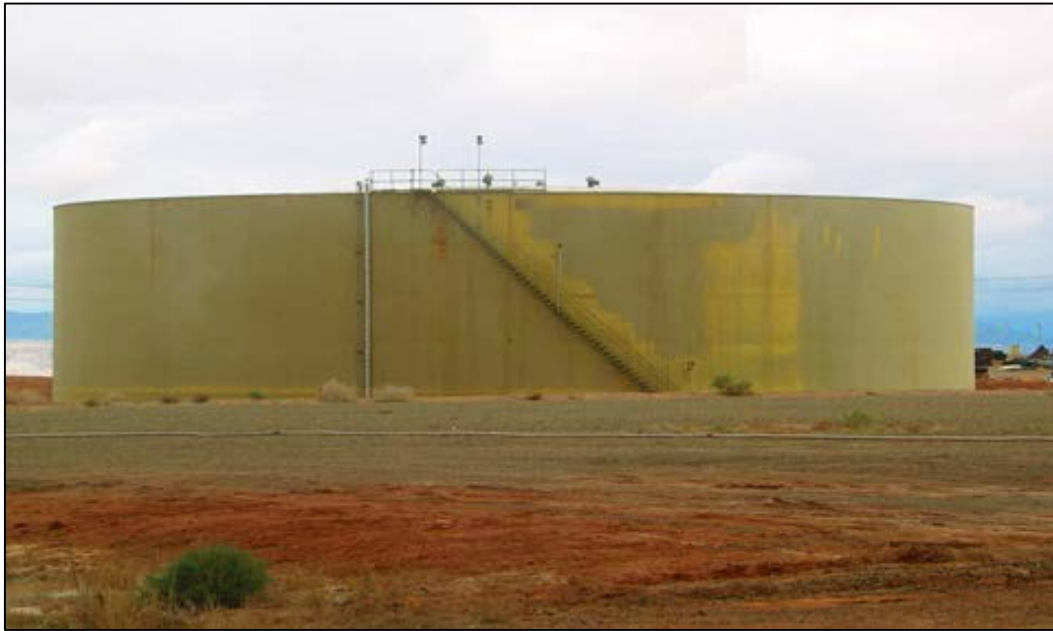
Figure 14 - Primary Fuel Oil Storage Tank.

The on-site fuel oil system is composed of a 120,000-barrel bulk fuel oil storage tank (**Figure 14**), a day tank, three fuel oil burner supply pumps, one fuel oil recirculation pump, two fuel oil transfer pumps, and an array of piping that allows for multiple configurations to pipe oil from

The on-site fuel oil system is a recirculation system where oil is pumped as needed from either the day tank or the bulk tank by the burner supply pumps to the power plant, maintaining a set pressure. The oil that is not used at the power plant recirculates back to the day tank or bulk tank to be reused in the system. The recirculation pump is used during low-flow conditions. The fuel oil transfer pumps are used to transfer fuel from incoming supply trucks to either the bulk storage tank or the day tank. Ongoing activities include operation, maintenance and improvements of equipment and systems.

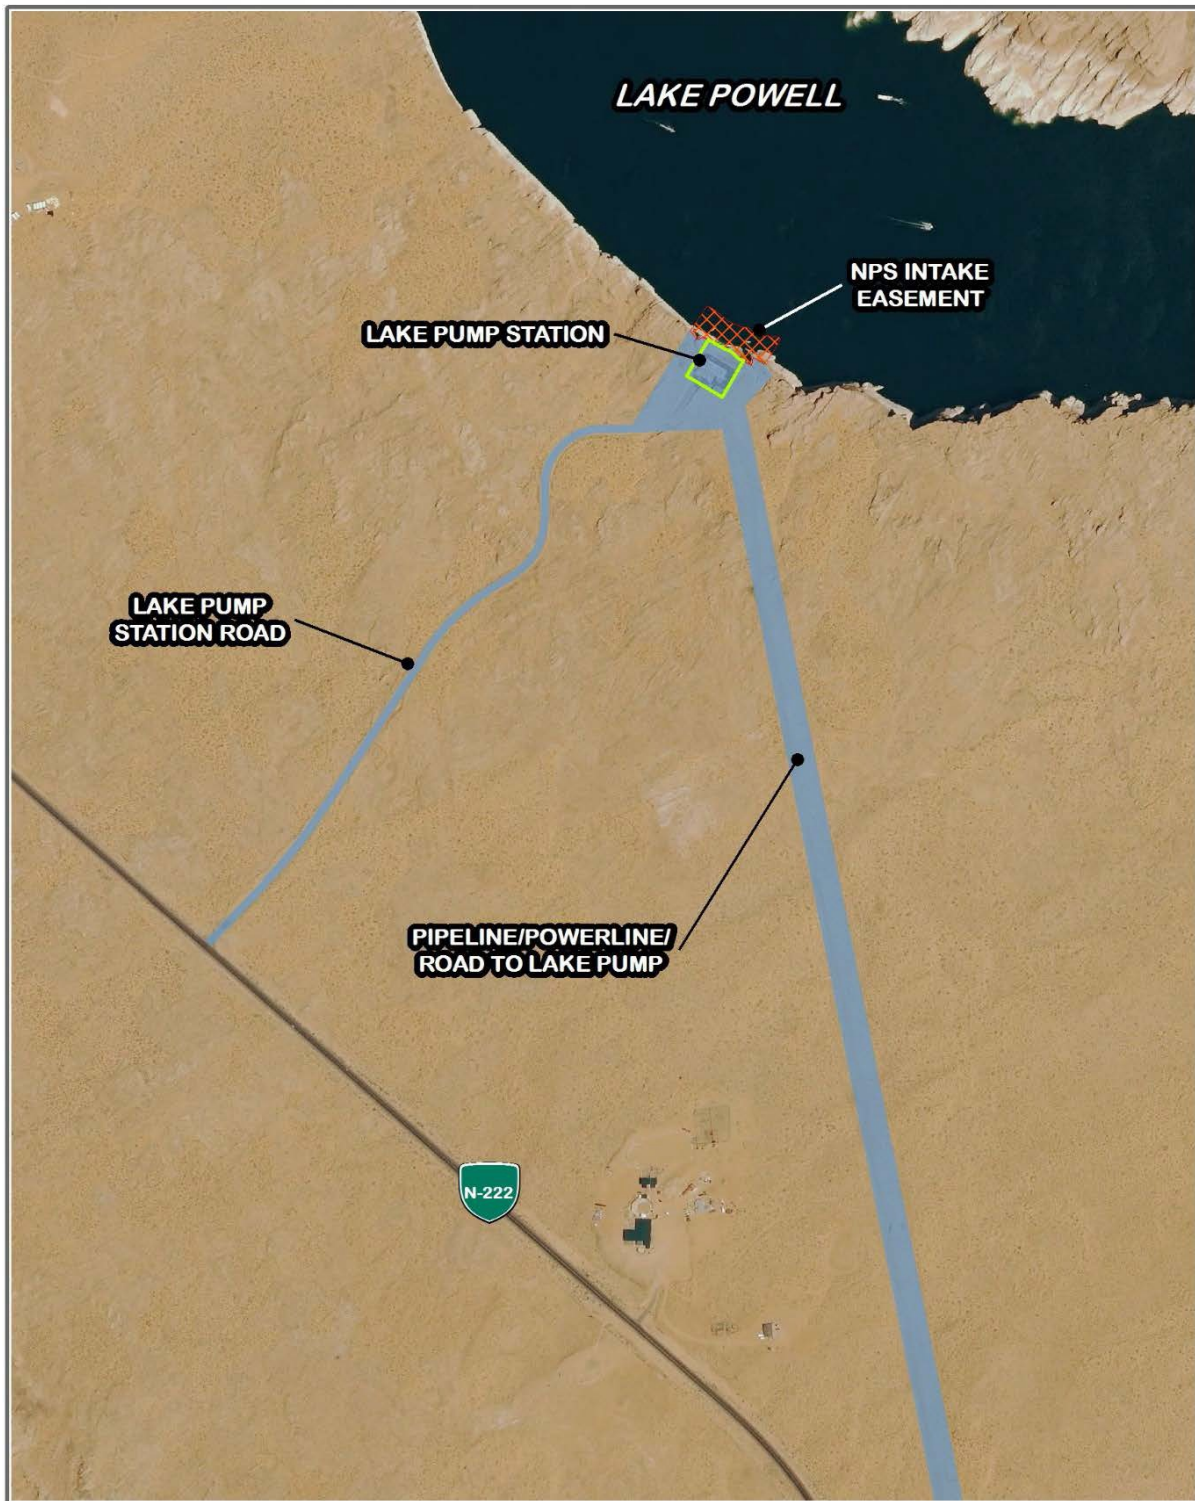
NGS was constructed near Lake Powell to ensure it had a dependable supply of cooling water for its three electric generating units (**Figure 1**). The lake pump station is located at an elevation of 3,734 feet and is adjacent to the lake shore on a parcel of land leased to NGS by the Navajo Nation (**Figure 15**). The site includes the water intake wells and buildings that house pumps and electrical transformers. The entire make-up water requirement for NGS Units 1, 2, and 3 is obtained from Lake Powell and pumped via two 30-inch supply lines to the generating station. NGS has an annual allocation of 34,100 acre-feet per year for consumptive use and an allocation for 5,900 acre-feet for non-consumptive use for a total allocation of 40,000 acre-feet per year. Over the past 15 years, annual water use has varied from about 16,000 up to 29,000 acre-feet per year.

Five submersible first stage pumps lift the lake water to five second-stage booster pumps via independent pipelines. The five corresponding second-stage booster pumps are horizontal and discharge the raw lake water at rates equal to the three-unit plant maximum make-up flow requirement of 28,000 gallons per minute into a discharge manifold. The discharge manifold is connected to two 30-inch concrete cylinder supply lines. The supply lines discharge at the power plant site into two 11-foot-diameter 27-foot-high influent tanks that feed the respective station make-up water clarifiers.

Figure 15 - NGS Lake Powell Water Intake at the Lake Pump Station and Pipeline.

The concrete cylinder pipelines for transporting the water to NGS, and the power lines from the plant's switchyard to the lake pump station for powering the pumps, are located within a 2.85-mile-long ROW. The pipelines are buried from 5 to 20 feet deep. The power lines, along with communications and control cables (fiber optic cables), are suspended from single wooden poles ranging from approximately 40 feet to 55 feet tall. Cathodic protection wells and monitors are also located within the ROW.

Normal access to the lake pump station for operations and maintenance personnel is from Arizona State Highway Route 98 to Navajo Nation Route 222, then by Navajo Nation Route 22-B, the unpaved lake pump station road (**Figure 15**).

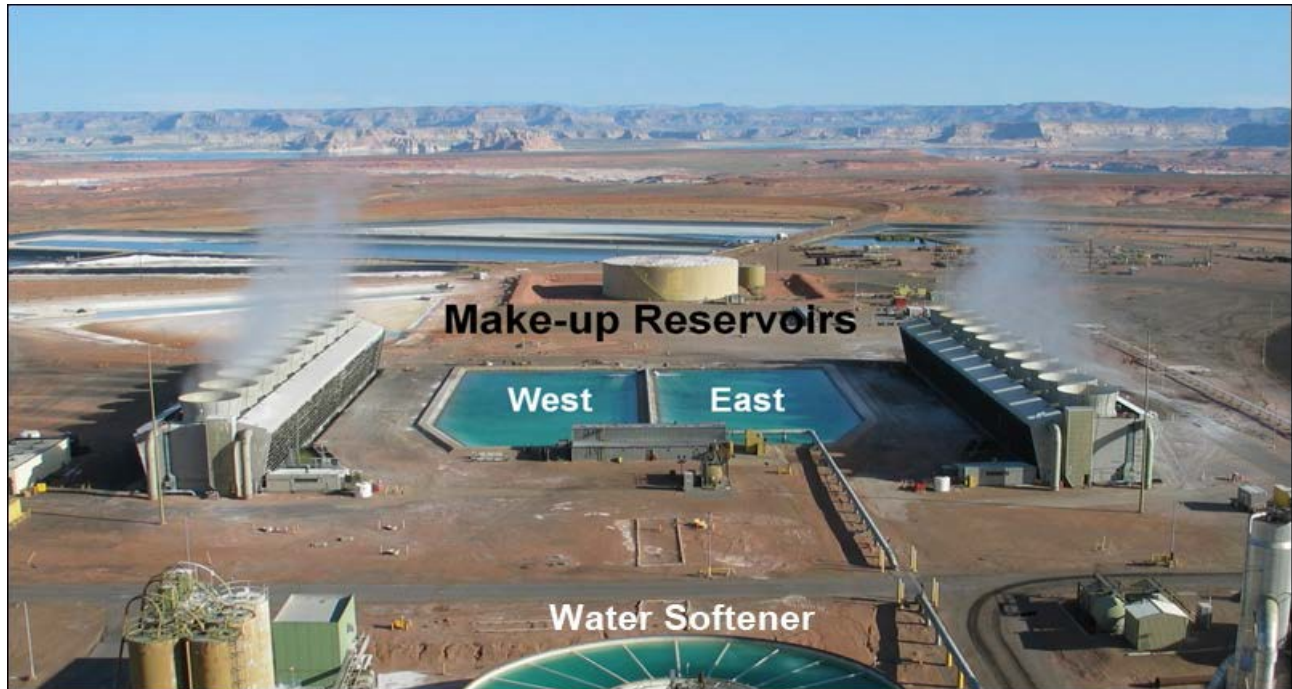
Figure 16 - Make-up Reservoirs Near Cooling Towers.

The cooling towers at NGS are part of the circulating water system that provides cooling water to the main turbine condensers and bearing cooling water systems. NGS has six cooling towers, two per unit. Each cooling tower is about 400 feet long (**Figure 16**). Water requirements for the system are provided by two pumps per unit (one for each cooling tower), which draw water out of a basin at the bottom of the cooling towers and then pumps the water to the main condenser. At the main condenser, the circulating water goes through metal tubes where it absorbs heat from the steam exiting the unit's turbine. As the turbine steam is cooled and condenses, the water falls to the bottom of the main condenser. The heated circulating water then returns to the cooling towers to be cooled by evaporation and then pumped back to the main condenser.

circulating water system to keep solids at a desired level (**Figure 16**). Make-up reservoirs are filled by gravity flow from water softeners near the cooling towers. The make-up reservoirs serve all six cooling towers.

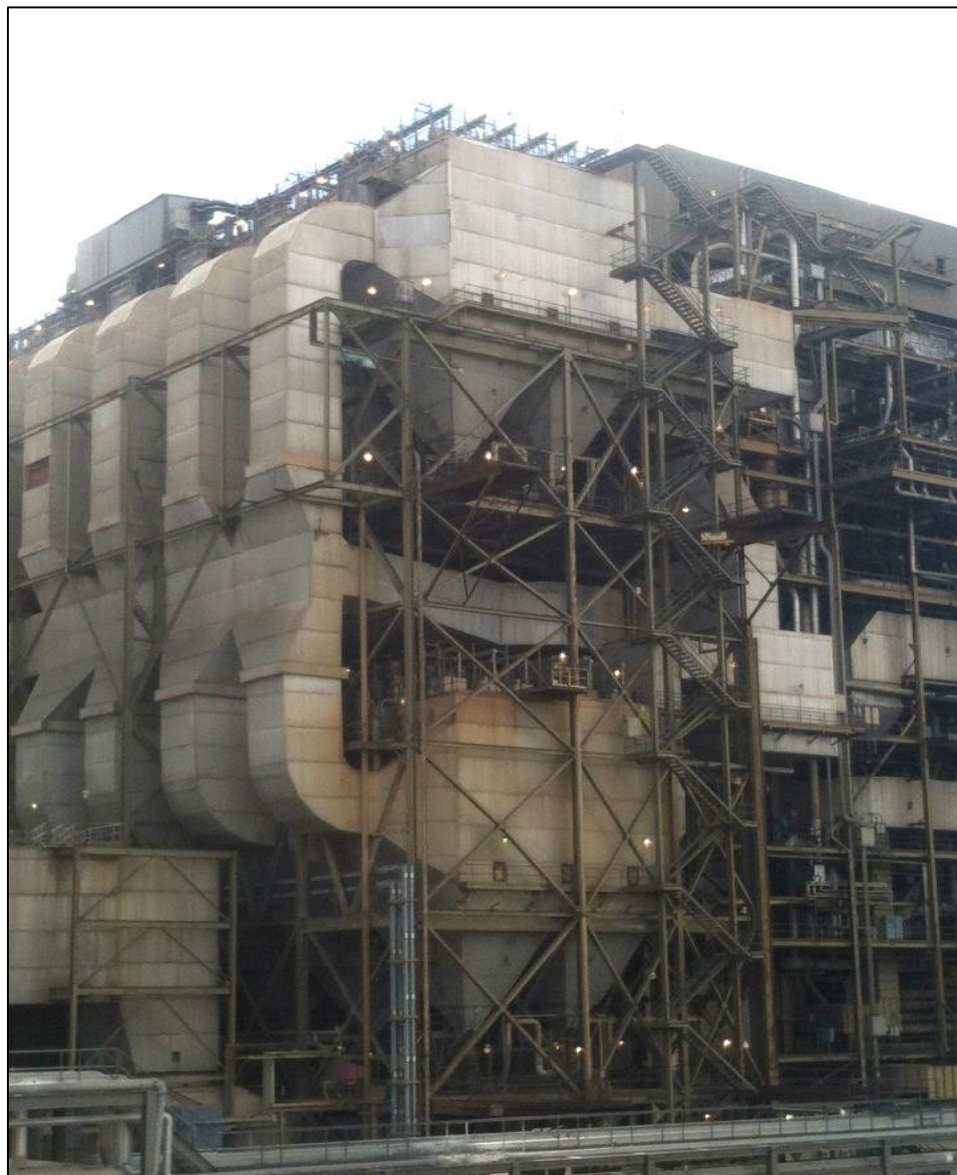
Figure 17 - Hot-side Electrostatic Precipitators (Upper and Lower Decks).

The NGS hot-side electrostatic precipitators are designed to remove 99.5% of fly ash from the flue-gas before it is discharged from the stack (**Figure 17**). Electrodes within the precipitators are given a negative electrical charge and adjacent plates (curtains) are positively charged. The flue-gas is forced through the precipitators where the negatively charged fly ash is attracted to the opposite charged curtains. Rappers above the curtains are used to knock the fly ash captured by the curtain into the hoppers below. The precipitators are classified as “hot-side” because they are placed before the air preheaters in the flue-gas flow path. Ongoing operation and maintenance are anticipated for the precipitators.

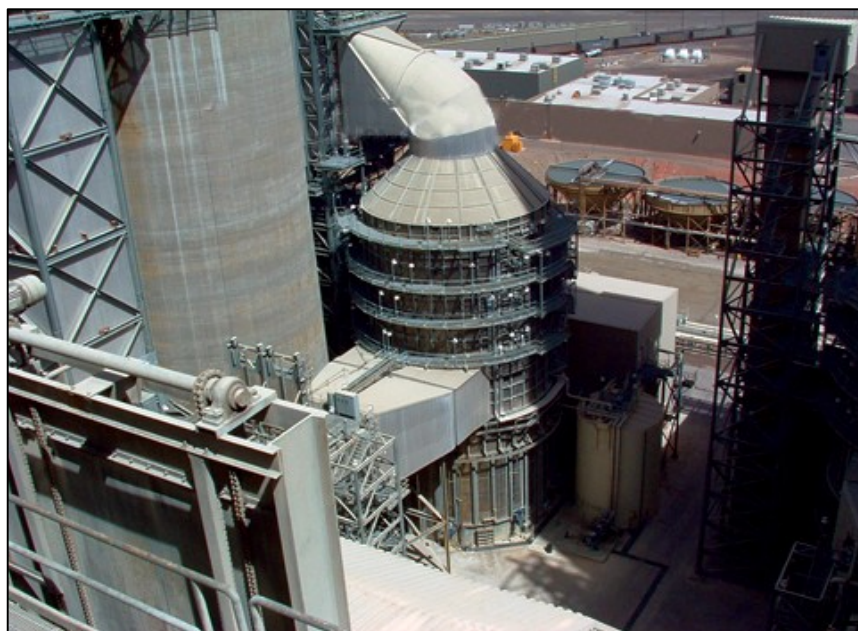
Figure 19 - Absorber Vessel.

NGS installed SO₂ scrubbers – also known as flue gas desulfurization (FGD) systems -- on all three units between 1997 and 1999 (**Figure 18**). These scrubbers remove at least 90% of SO₂ from plant flue gas. The system uses a limestone slurry mix to chemically remove the SO₂. The slurry is sprayed downward into an absorber vessel in which the flue-gas also passes (**Figure 19**).

The flue-gas is forced through the limestone slurry spray allowing a chemical reaction to take place that absorbs SO₂ into the slurry. The SO₂-rich slurry then has oxygen added to it to turn it into a neutral substance (calcium sulfate or gypsum). Next, the gypsum is dewatered leaving a solid substance that is disposed of at the on-site ash disposal site and the filtrate solution is returned to the limestone slurry process. Each scrubber system is equipped with a spare pump to ensure continuous availability of the pollution controls.

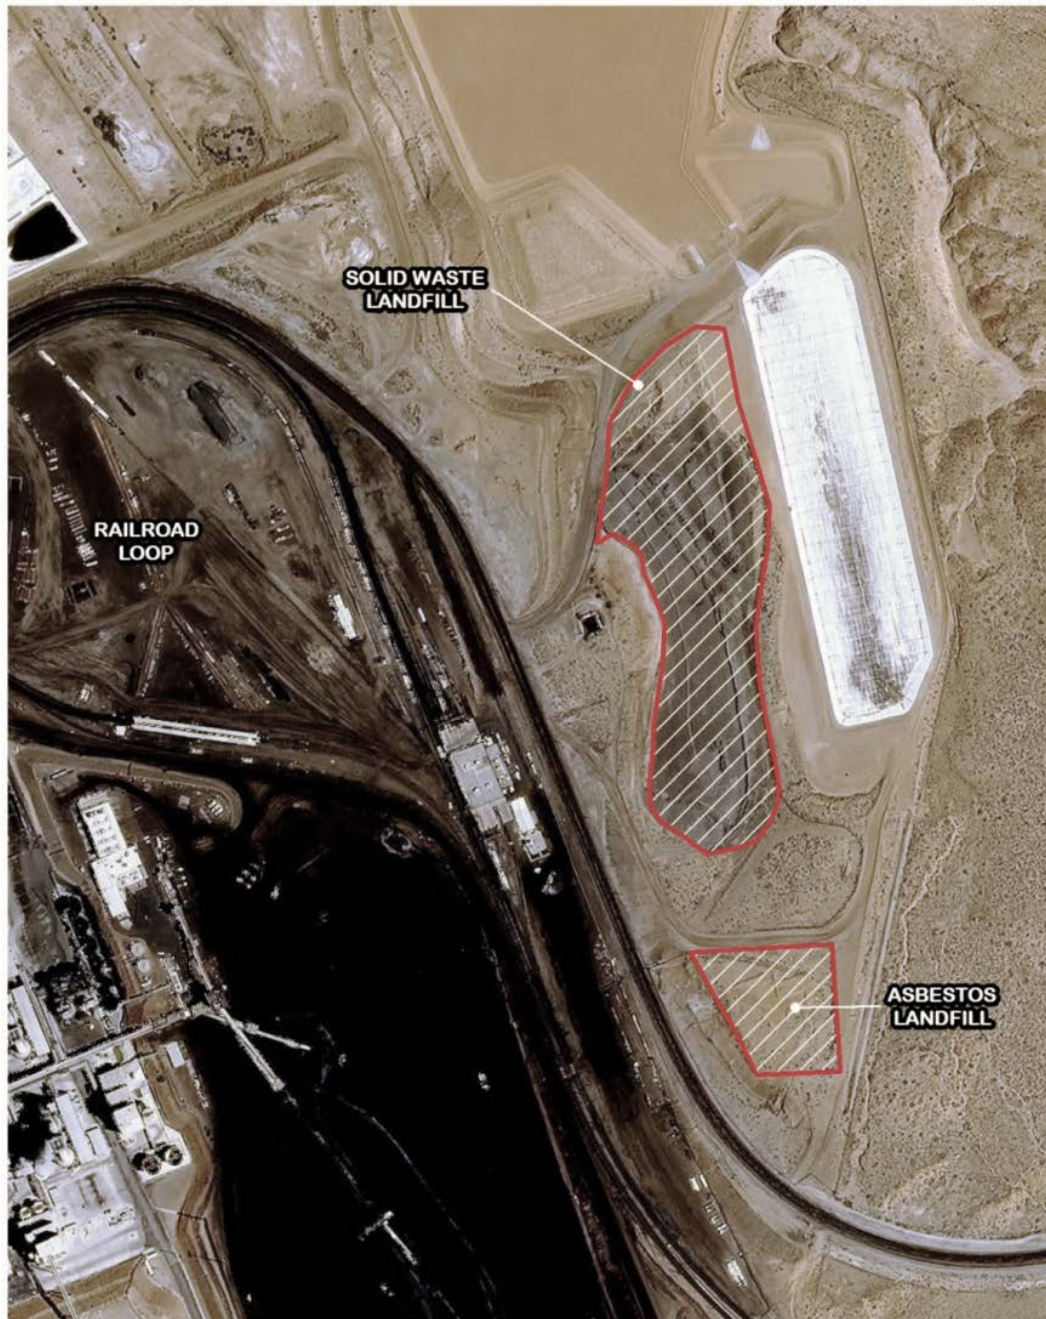
Figure 21 - Solid Waste and Asbestos Landfills.

- At the end of each operating day, or at least once every 24-hour period while the site is in continuous operation, the asbestos-containing material deposited at the site during the operating day or previous 24-hour period is covered with at least 6 inches of compacted non-asbestos-containing material.
- Once the asbestos debris has been covered with soil, no excavation or other disturbance of the asbestos waste is done without EPA notification.

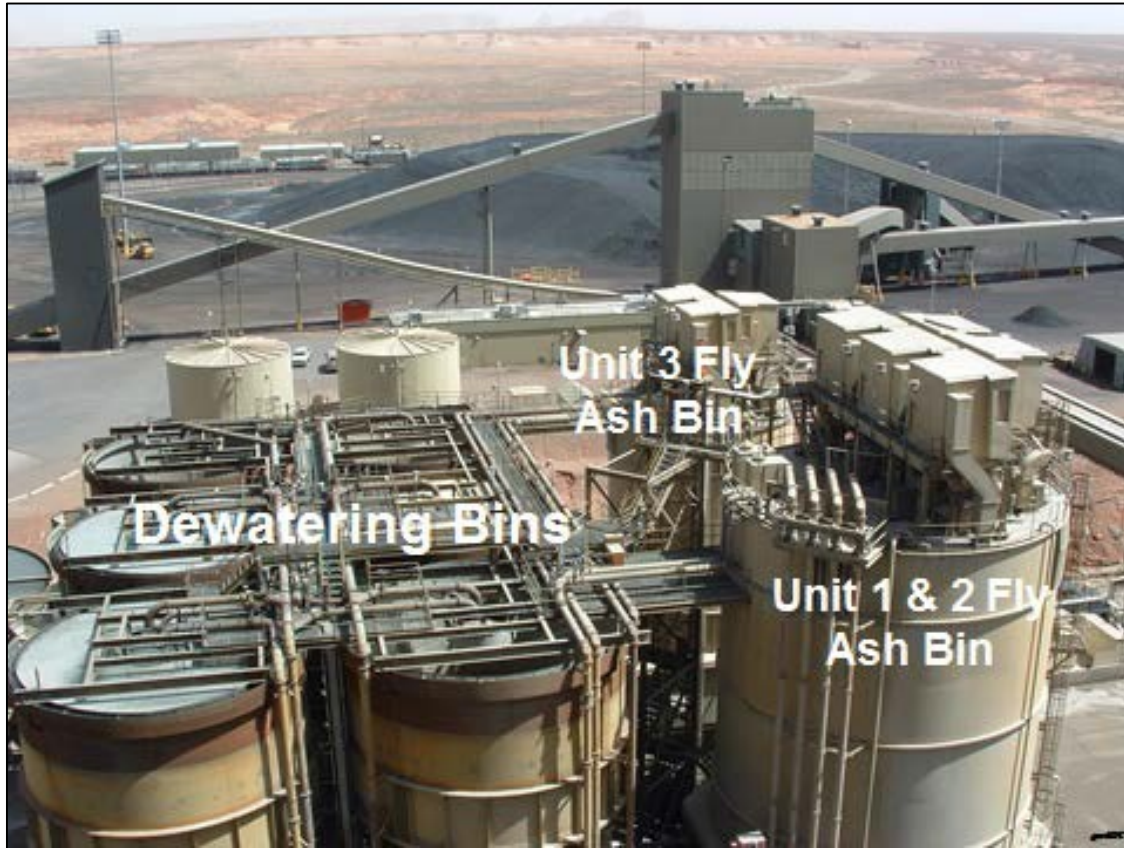
Figure 22 - Ash and Dewatering Bins.

SO₂ scrubber solid waste in the form of FGD-gypsum is also transported by truck to the ash disposal site. The FGD-gypsum contains approximately 12% moisture with the majority of the water reclaimed through a vacuum belt filter. The filter filtrate solution is accumulated in a filtrate tank and recycled back into the limestone grinding process. The remaining dry FGD- gypsum material is then transported to the ash disposal site since there is currently no economical local market for wallboard or agricultural uses.

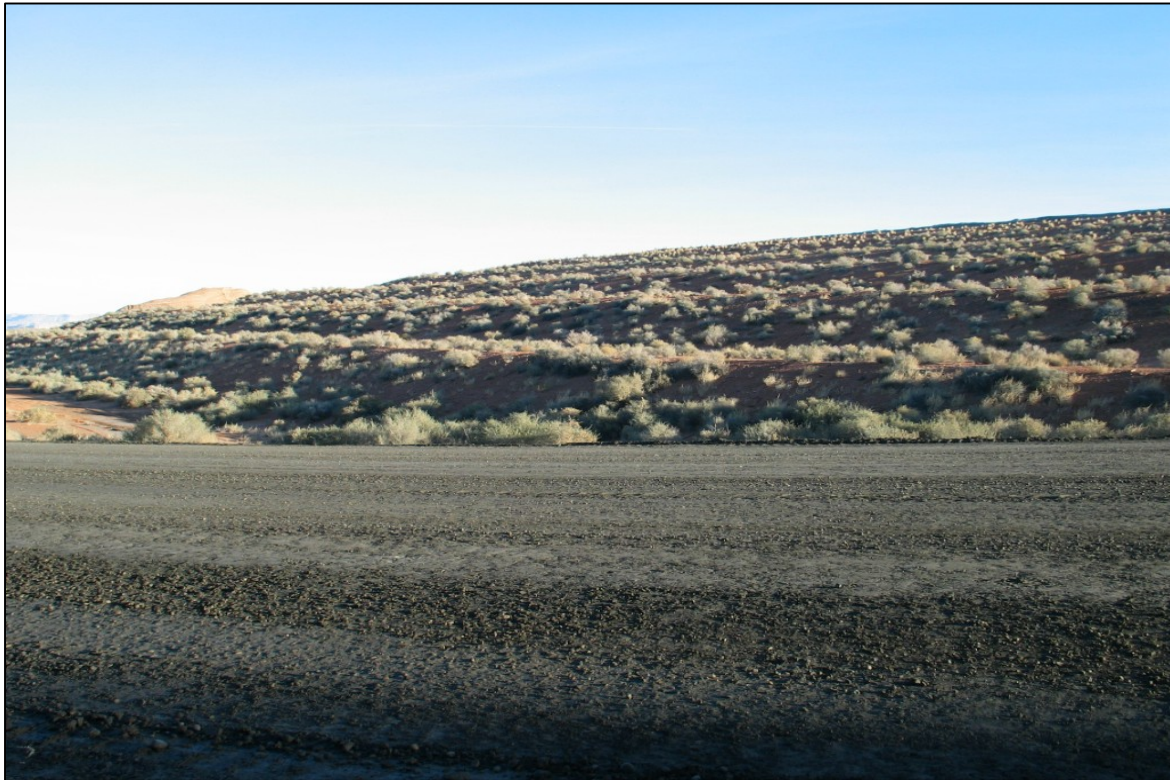
Figure 25 - Front Face of Ash Disposal Berm.

- The initial bottom layer of CCR material is placed on/against the sandstone bedrock or on compacted dune sand formations.
- The embankments of the terraces are constructed in layers or lifts not to exceed 15 vertical feet. The embankment foundation and every lift of storage material involve the steps of placing, spreading/grading, watering, and compacting, with the final top layer being covered with a 2-foot-thick layer of native soils.
- The resulting embankments are benched onto the adjacent natural ground and the bench areas are sloped to divert or minimize runoff (**Figure 26**).

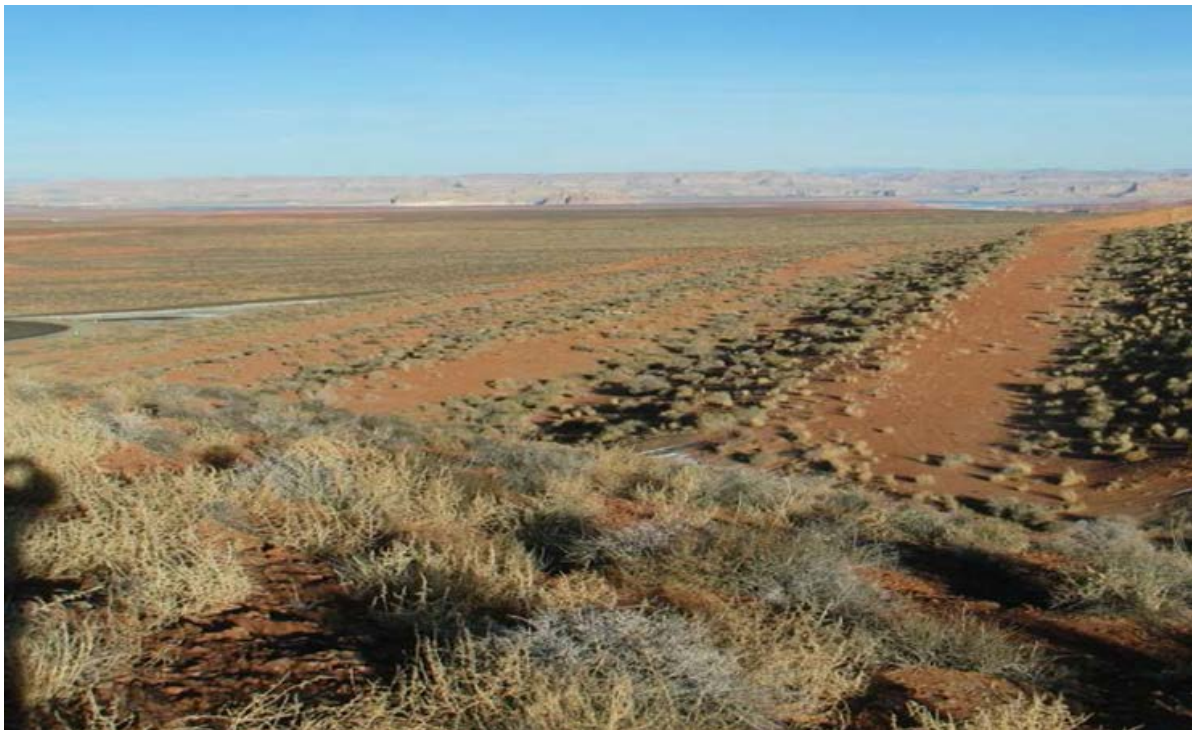
Figure 26 - Terraced Slopes of Ash Disposal Berm.

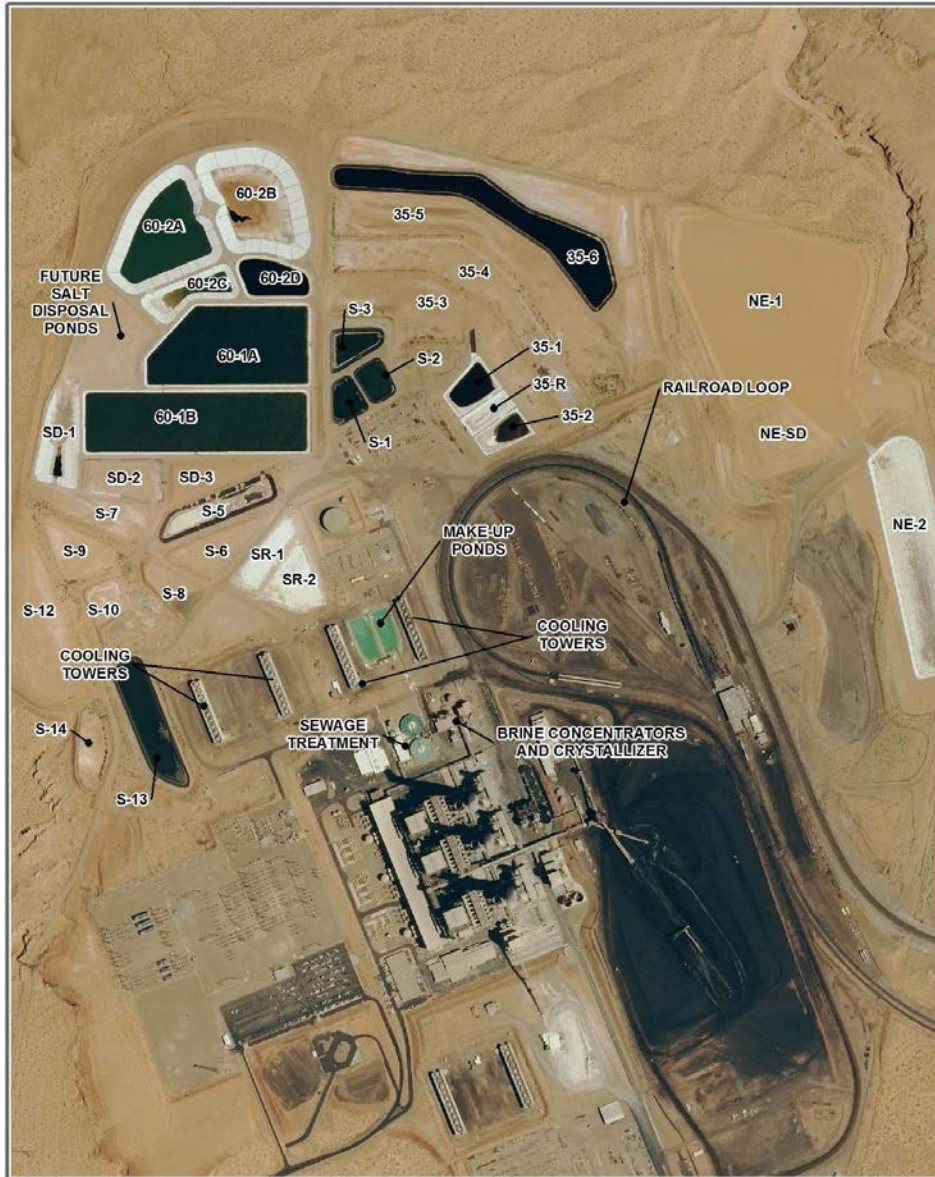
Figure 28 - Wastewater Management Ponds.

The wastewater stream from the BCs goes to the crystallizer, where it is further treated. The high-purity product water from the crystallizer is recycled and reused in the NGS circulating cooling water systems and the crystalized solid waste is disposed of in the lined salt disposal ponds. The BCs and crystallizer are integral parts of the overall NGS ZLD system. Prior to delivery to the BCs or crystallizer, most of the wastewater generated by the plant goes to intermediate storage ponds. Additional ponds are used for storing solid waste and for slurry sludge from the Water Treatment Reactivators (softeners). Most of the slurry sludge is used in the FGD process and helps minimize limestone usage. The wastewater management process is shown in the flow chart in **Figure 27** and the wastewater management pond locations are shown in **Figure 28**. The following is a detailed description of the operation of the various wastewater ponds.

- 60-series ponds are double-lined with leak detectors between and under the linings.
 - The 60-1 A and B ponds receive high dissolved solids water from concentrated cooling tower blowdown and stormwater runoff from the S-13 pond.
 - Water is pumped back to BCs for treatment and is then recycled for use in the plant.
 - The 60-2 A, B, C, and D ponds receive water containing high concentrations of solids flushed from the crystallizer when it is necessary to shut it down for maintenance activities.

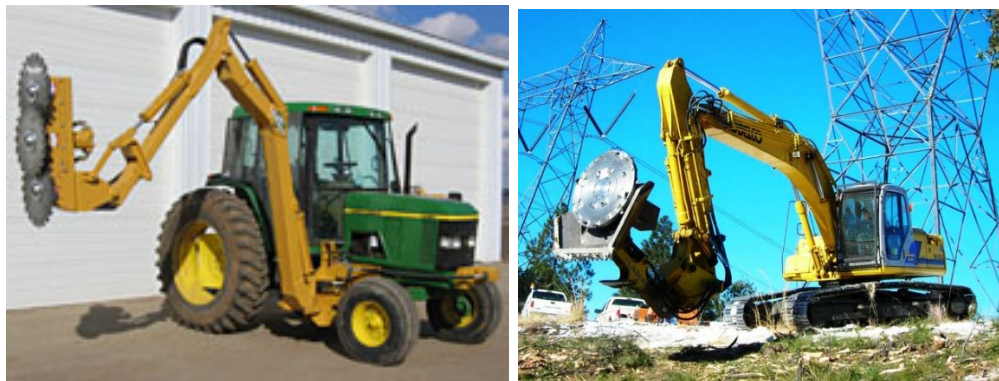
Where approved for use on the STS (see below), herbicide treatments are the preferred method of treatment to maintain corridor vegetation. On the WTS, and areas on the STS that are not treated with herbicide, mowers and/or hand cutting is used to maintain vegetation within the rights-of-ways. Mowing equipment include tractors with a cutting device that mulch or cut vegetation and leave it in place (**Figure 31**). Hand crews work alongside of the mower or behind

Figure 31 - Example of Mowers Used by APS for Vegetation Maintenance of the STS.

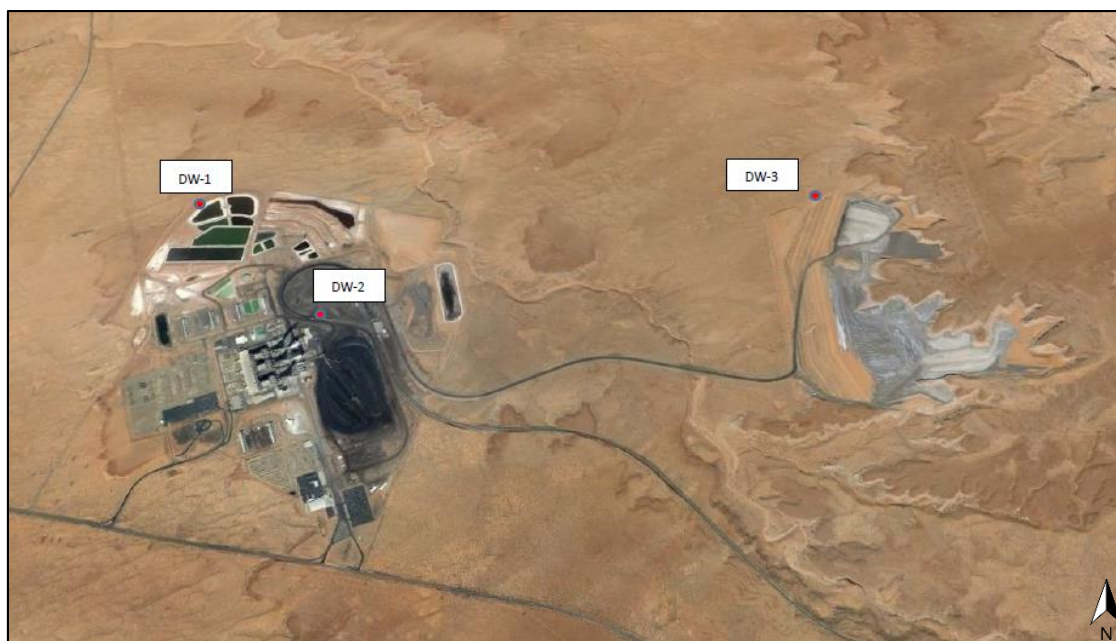
Three deep monitor wells (DW-1, DW-2, and DW-3) are covered under the *Groundwater Protection Plan* and monitor groundwater conditions in the N Aquifer at depths of 1,200 to 1,500 feet bgs. The wells are located at the north end of the ash disposal area (DW-3), in the railroad loop of the plant site (DW-2), and near Pond 60-2A at the north end of the plant site (DW-1); see Figure 8. These deep wells are monitored semi-annually for depth to groundwater and water quality parameters.

Figure 8: Deep Wells Covered Under the Groundwater Protection Program
