NAVAJO PROJECT OPERATION AND MAINTENANCE PLAN

Submitted to: Bureau of Reclamation

Submitted by: Salt River Project

Revision 12.0

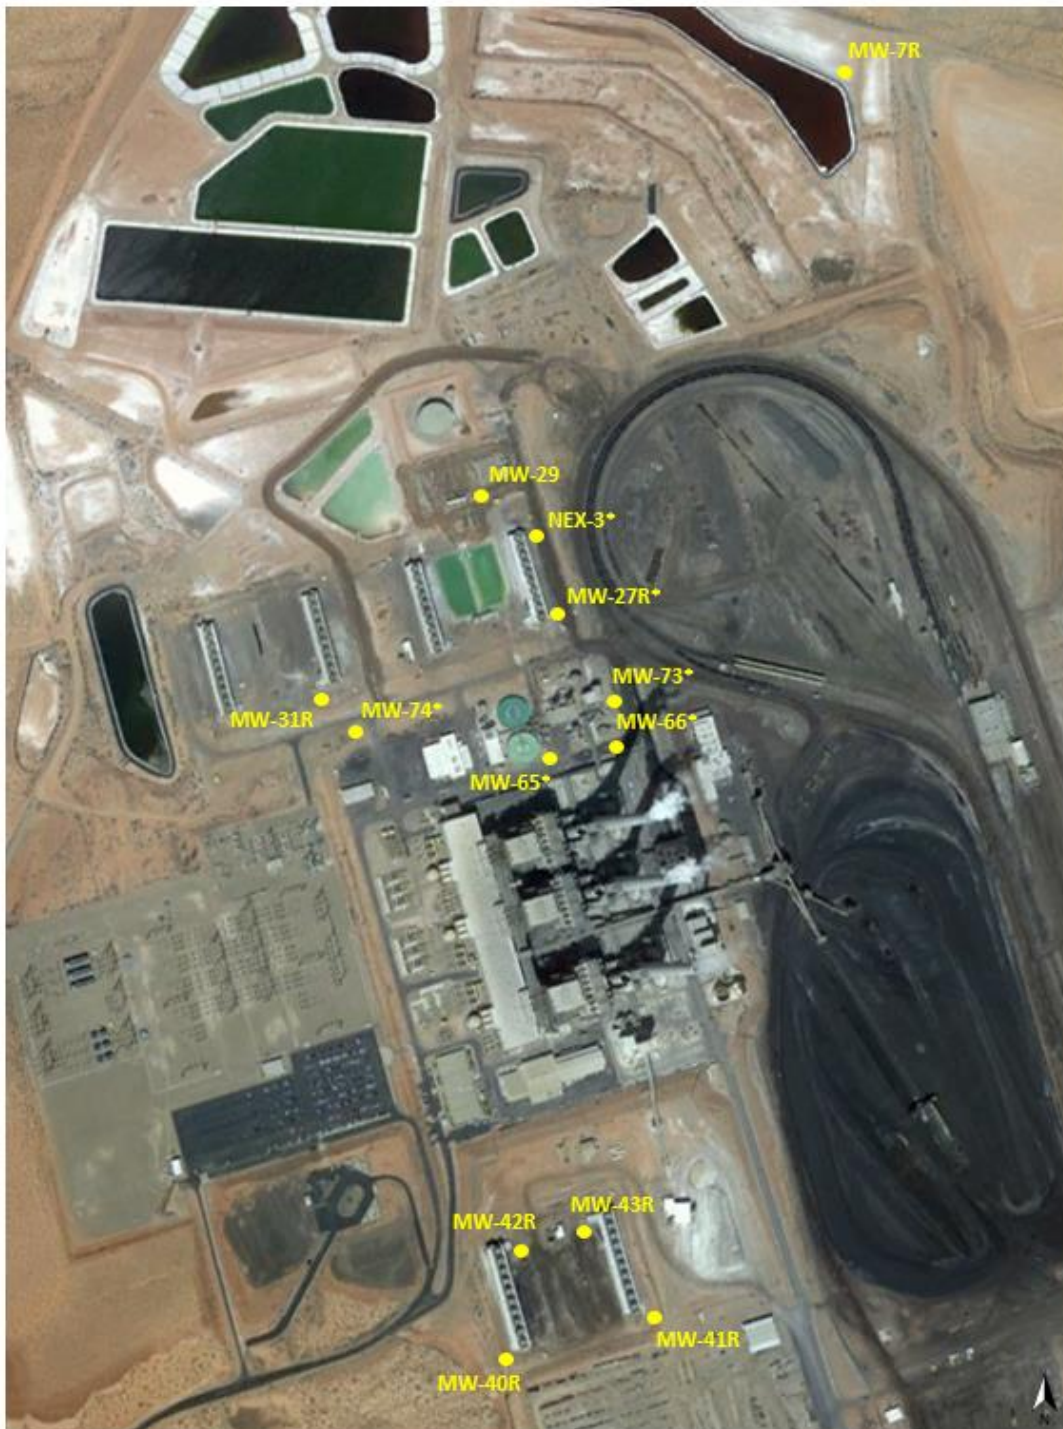
Figure 9: Active Monitor Wells near Potential Areas of Perched Water

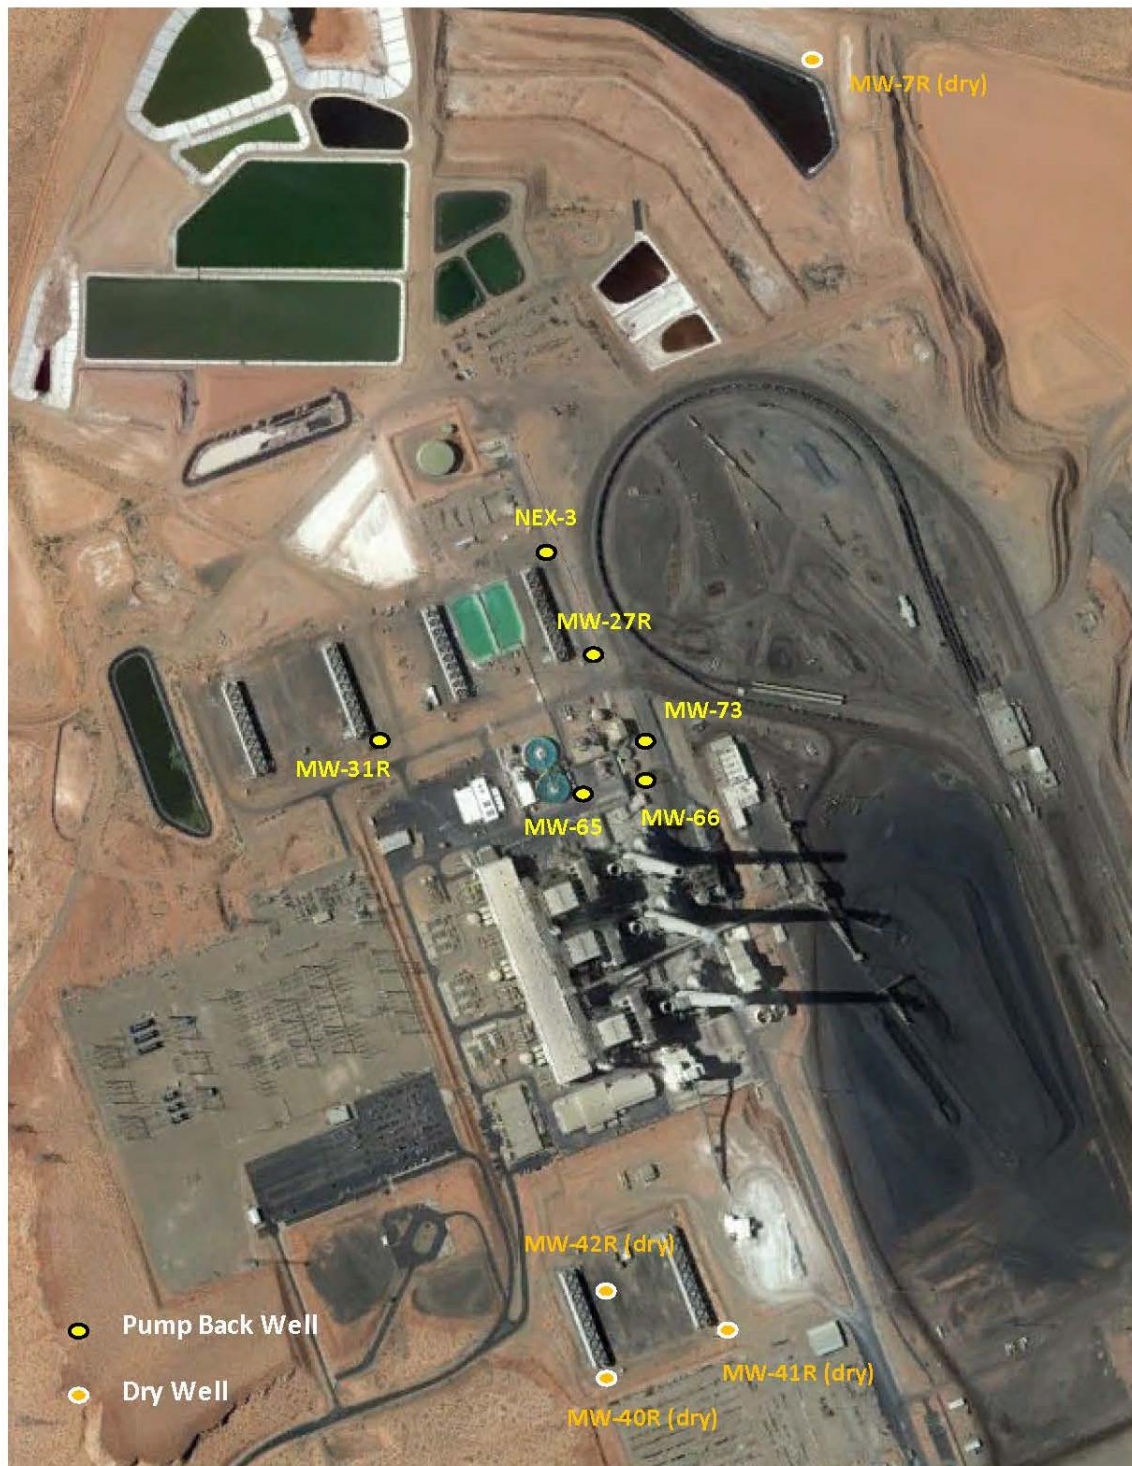
Figure 1. Well Pump Back Location Map.

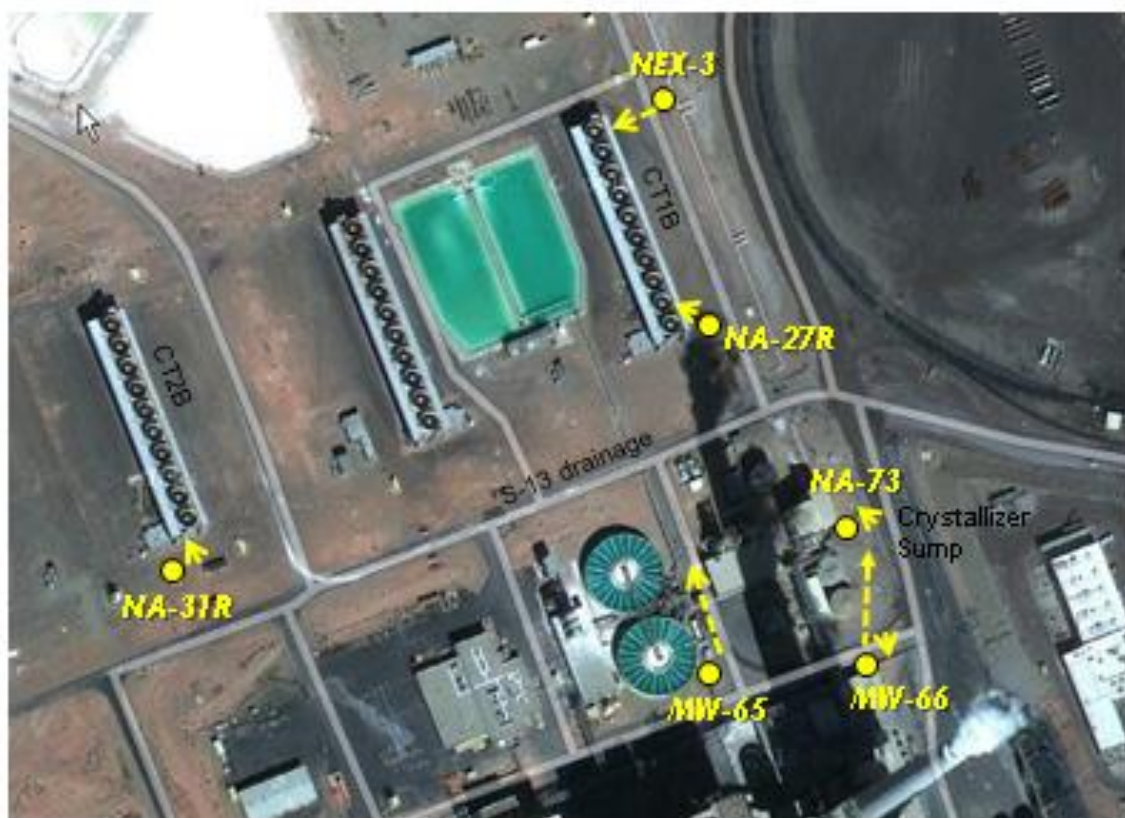
Figure 2. Well Pump Back Discharge Locations.

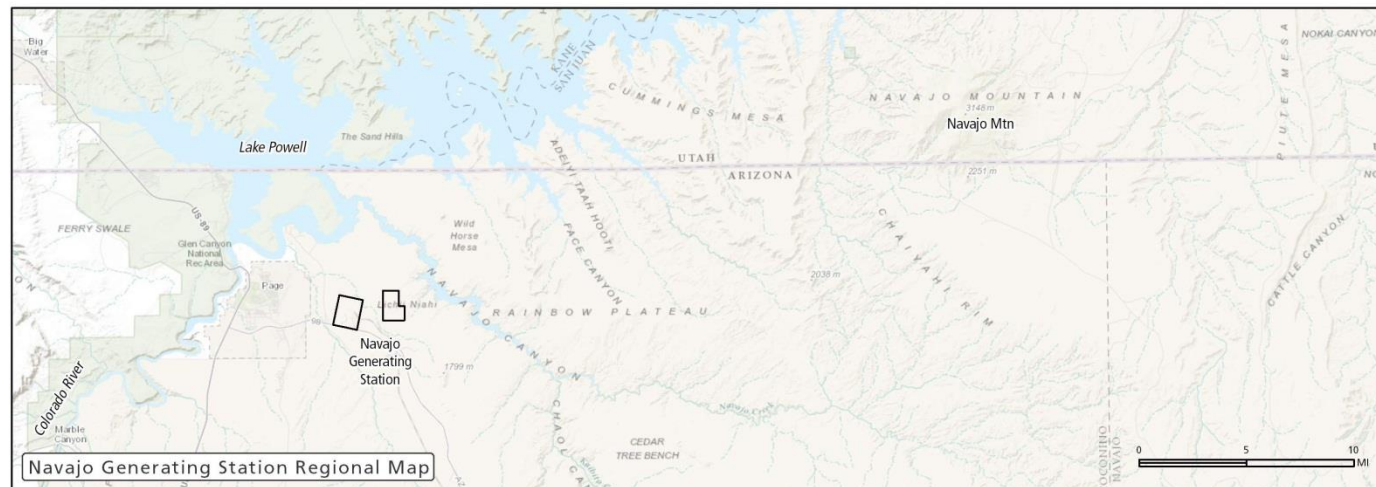
Figure 2: Navajo Generating Station Groundwater Data

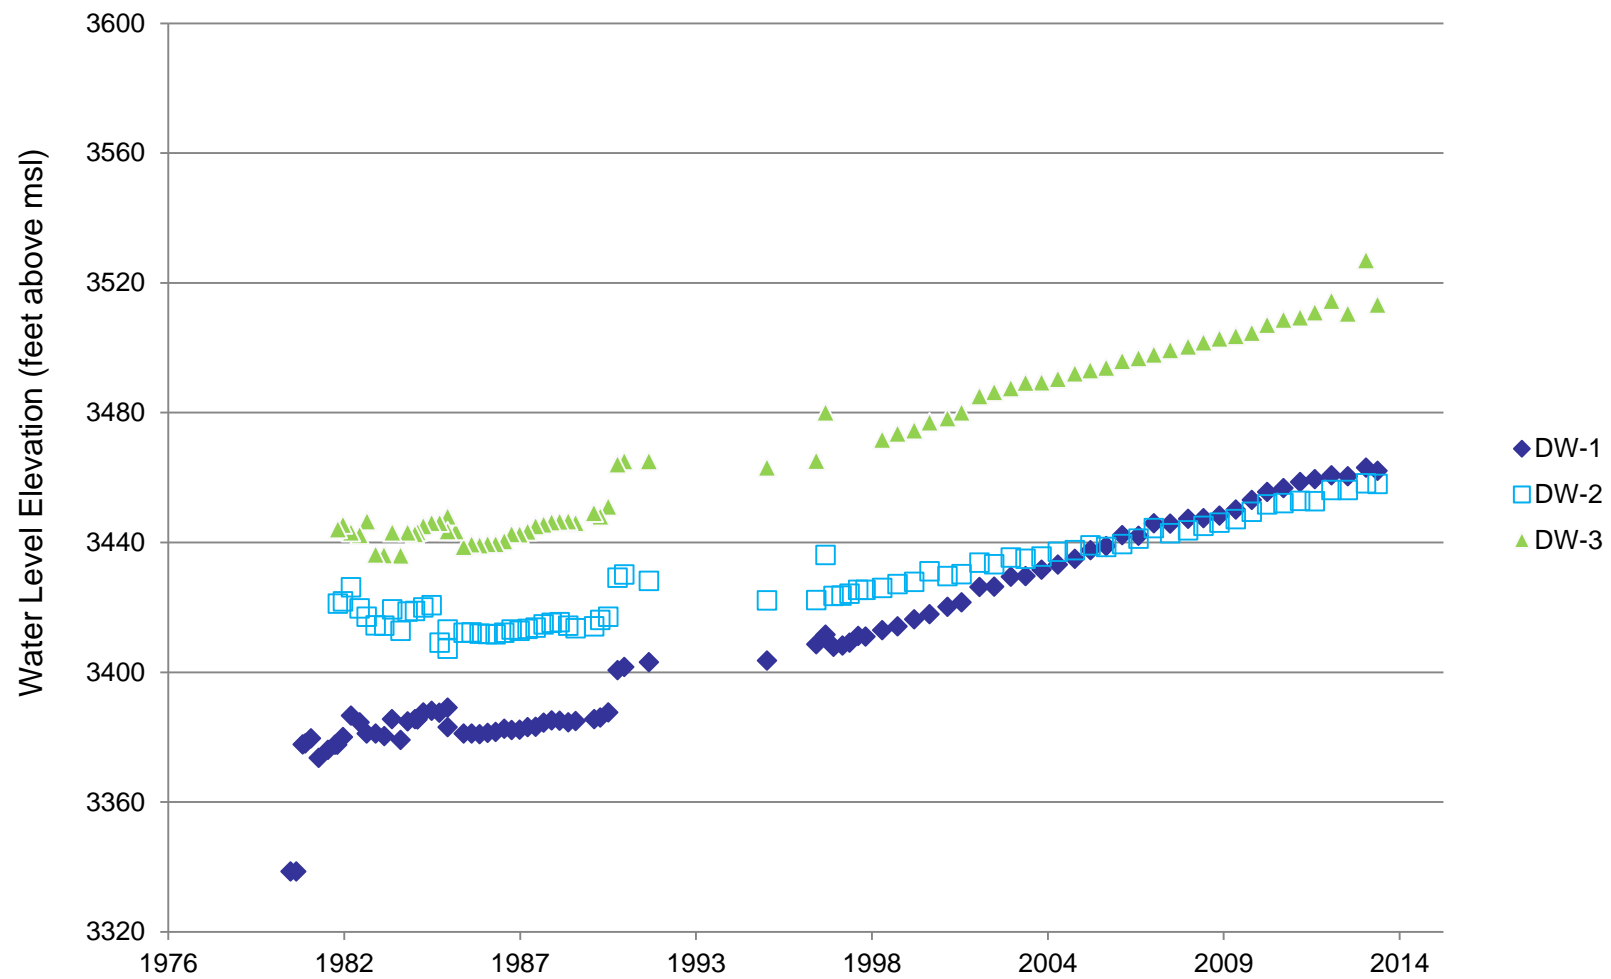
Figure 6a. Water Level Hydrographs of NGS Deep Wells relative to land surface and Lake Powell maximum reservoir

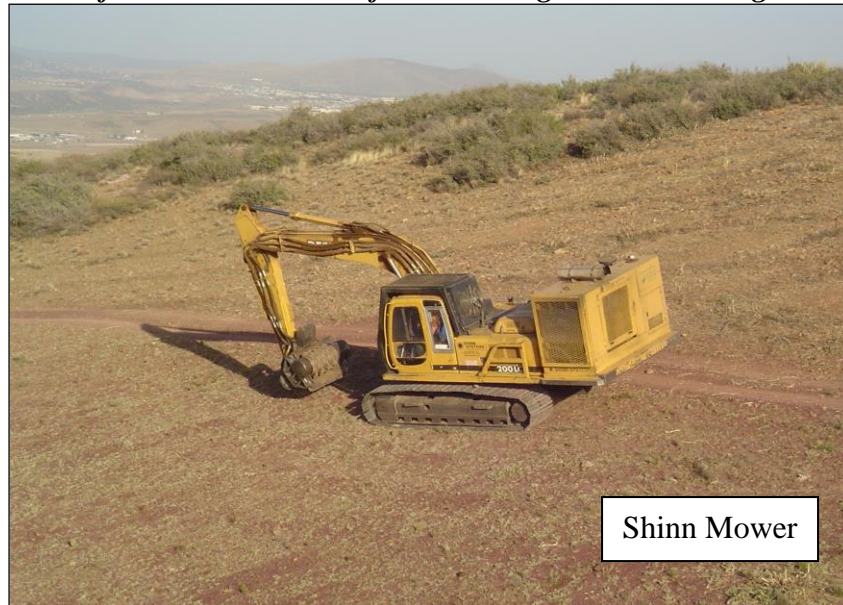
Figure 2: Photos of Mowers to be used for 500-2 Vegetation Clearing

Shinn Mower

The mower is operated by one driver and one grounds-person. The grounds-person directs the mower and may operate a chainsaw to cut trees that the mower is unable to access. Hand crews may also follow after the mower to clean up, scatter debris, and prune or remove trees that the mower could not access. All vegetation is mulched by the mower and left on site in the corridor piled no higher than four inches.

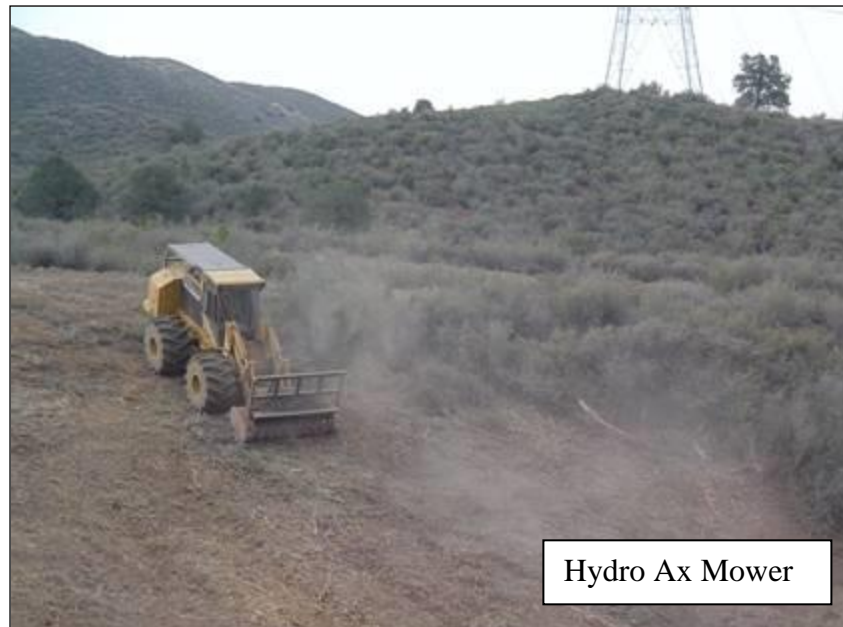
Hydro Ax Mower
