## Habitat Restoration on the Lower Colorado River: Demonstration Projects 1995-2002

U.S. Department of the Interior  
Bureau of Reclamation  
Lower Colorado Region

January 2003

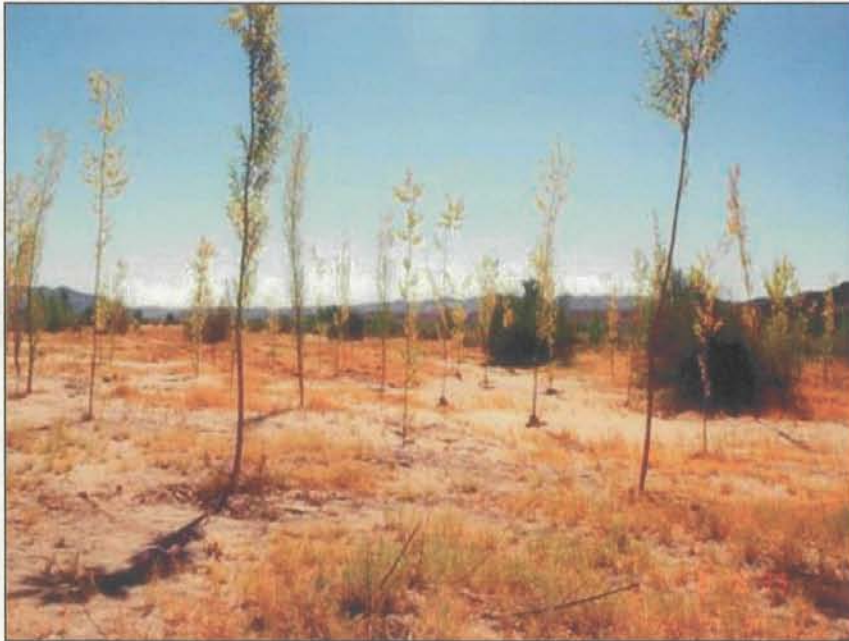
# Planet Ranch Restoration Site

March 1995

The trees at Planet Ranch were planted with the spacing of a mature riparian forest following years of competition for sunlight and other resources. In contrast, cottonwood and willows seedlings observed following flooding and natural recruitment in 1993 on the Bill Williams River were established in near solid patches. As they grew and self-thinned, trees still remained directly adjacent to each other, creating a remarkably cool atmosphere within the patch. In many places, some trees within these original patches continue to grow within 2-5 feet of each other after ten years (B. Raulston, pers. obs., December 2002). The microclimate within these patches may provide a necessary function for survival of seedlings and young trees under the harsh desert climate. Without improved seeding techniques, it will be difficult to create such an atmosphere through re-vegetation.

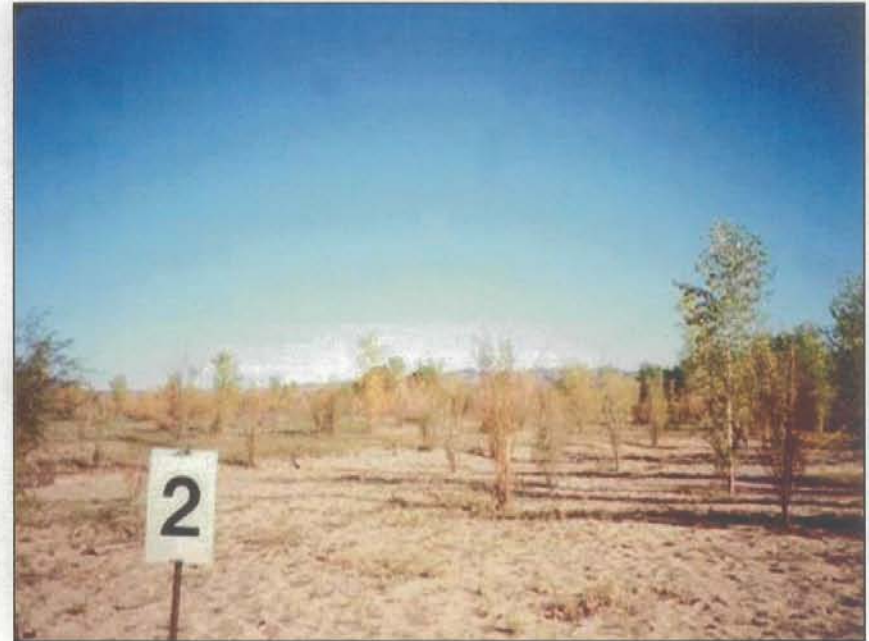
November 2000

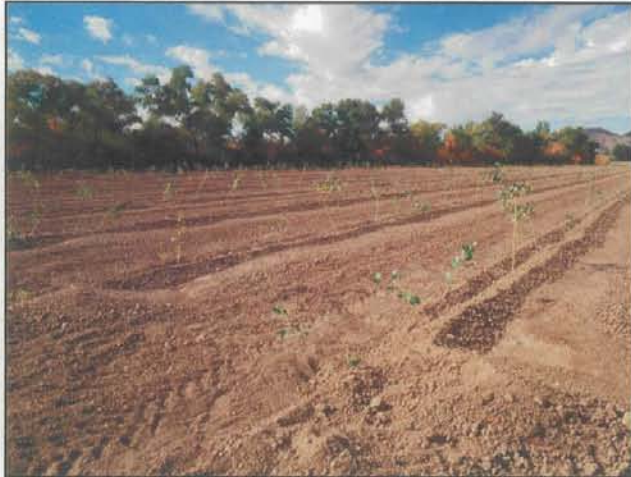
# Pratt Restoration Site, March 1999

Newly planted trees.

For the first year, survival of cottonwoods planted from rooted stock and poles was 89% and 85%, respectively. Survival of willows from rooted stock and poles was 100% and 87%, respectively. After three attempts at seeding, germination was observed on 4 May 1999.

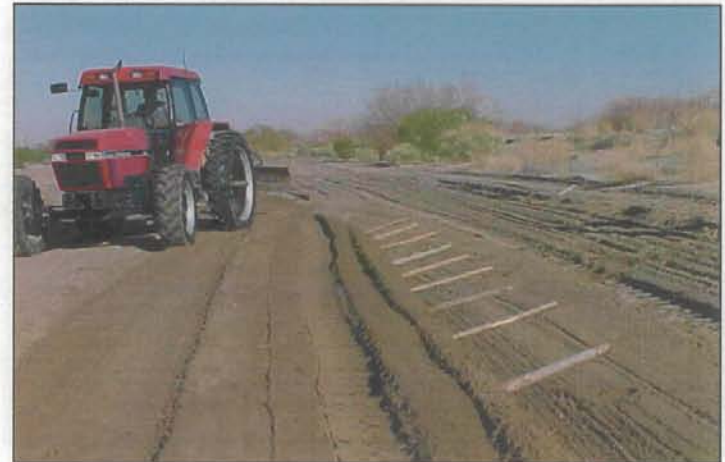
Poles planted at an angle within furrow.

stored in shade until planted. On 31 March, 46 cottonwood and 47 willow poles were planted at a slight angle (not vertically) with approximately 1/3 of the base buried. Poles were planted at an angle in an attempt to create denser growth at the ground to mid-story level within the canopy than would be obtained from vertically-planted poles.

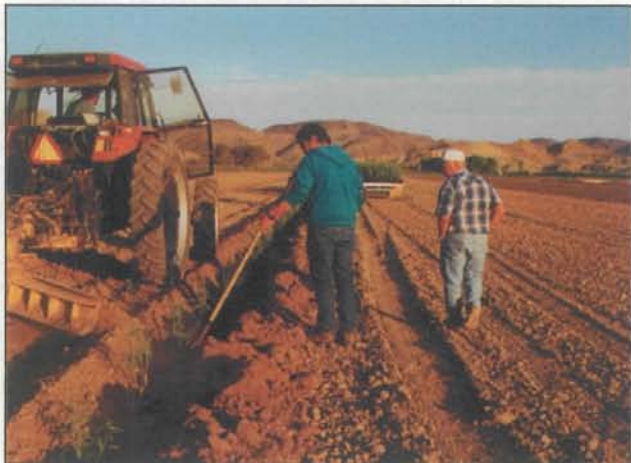
Planting potted plants in furrows created by tractor.

On 30 March, 1999, 712 Fremont cottonwood trees and 699 Goodding willow trees from rooted nursery stock were planted in rows within two separate areas approximately 24 m x 213 m each. As the furrows were created using a tractor blade, plants were removed from pots and placed into the furrows. The root ball of each plant was then covered by driving a tractor equipped with an angled blade lowered adjacent to the furrow which pushed the soil back into the furrow. Occasionally, a minimal amount of work with hand tools was required to ensure that the entire root ball was buried and that the shoot of the plant was not covered by soil.

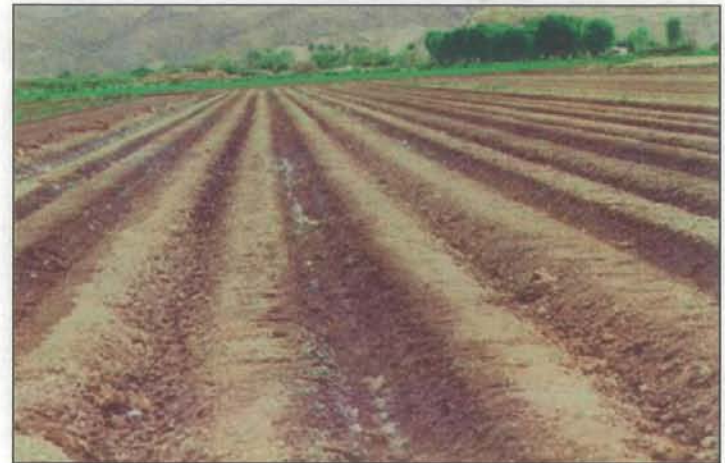
Cottonwood & willow seeds scattered in wet furrows.

Seeds were collected from cottonwood and willow trees along the lower Gila River, in the vicinity of Yuma, Arizona between 23-26 March 1999. One dozen nylon mesh bags measuring 60 cm x 90 cm were filled to capacity with branches containing open seed pods. The bags were stored indoors until 31 March. Beginning at 0700 on 31 March, seeds were scattered over 2 areas measuring 11 m x 213 m and 28 m x 213 m and separated by areas planted with rooted stock. Two additional bags containing both cottonwood and willow seed were collected and dispersed, on 13 and 14 April, and on 26 and 27 April 1999. Throughout seeding, the site was irrigated to keep the surface wet.

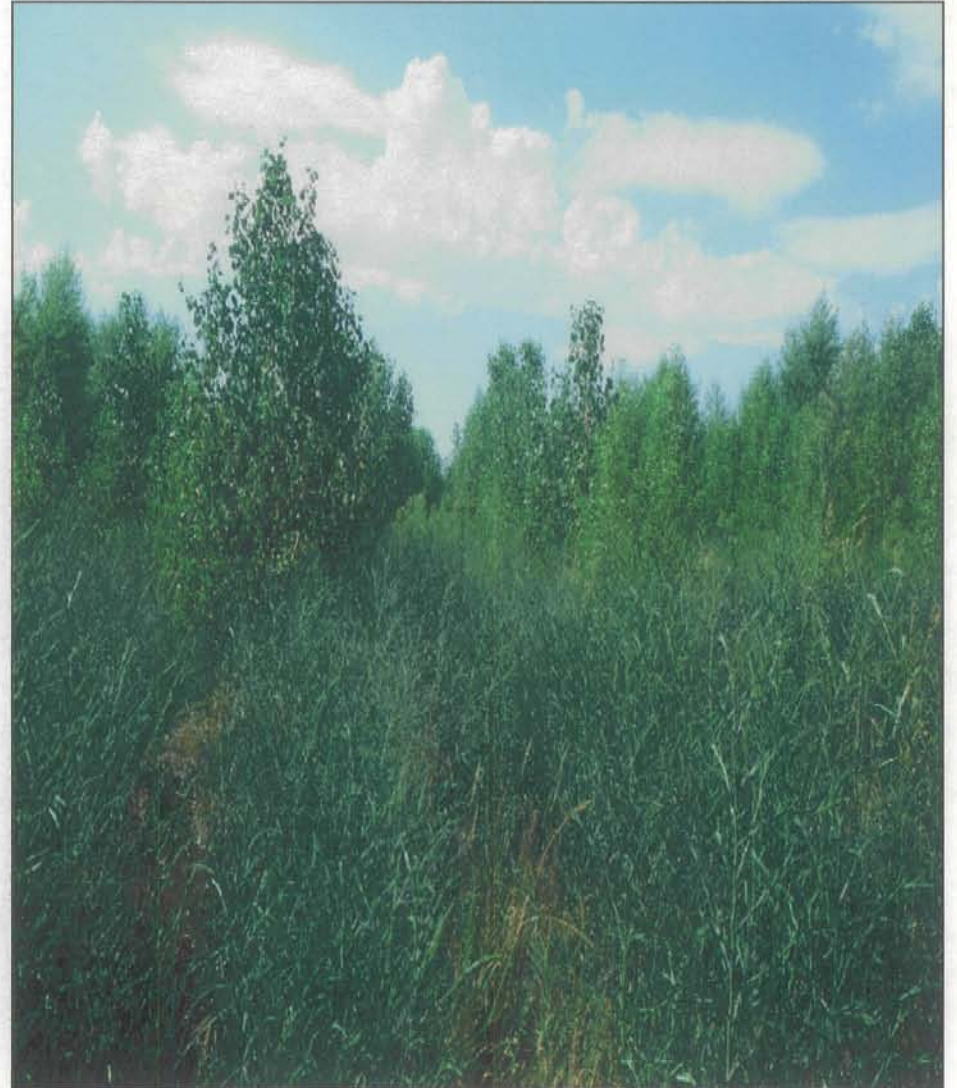
# Pratt Restoration Site

Tree Ht 6-8 m, Sep 2002

At the Pratt Site, saltcedar became established in the seeded areas, but not in areas planted with nursery stock or poles. Almost no saltcedar (or any other shade-intolerant shrub or tree species) were found in areas planted in 199 with rooted stock. These trees grew very rapidly,

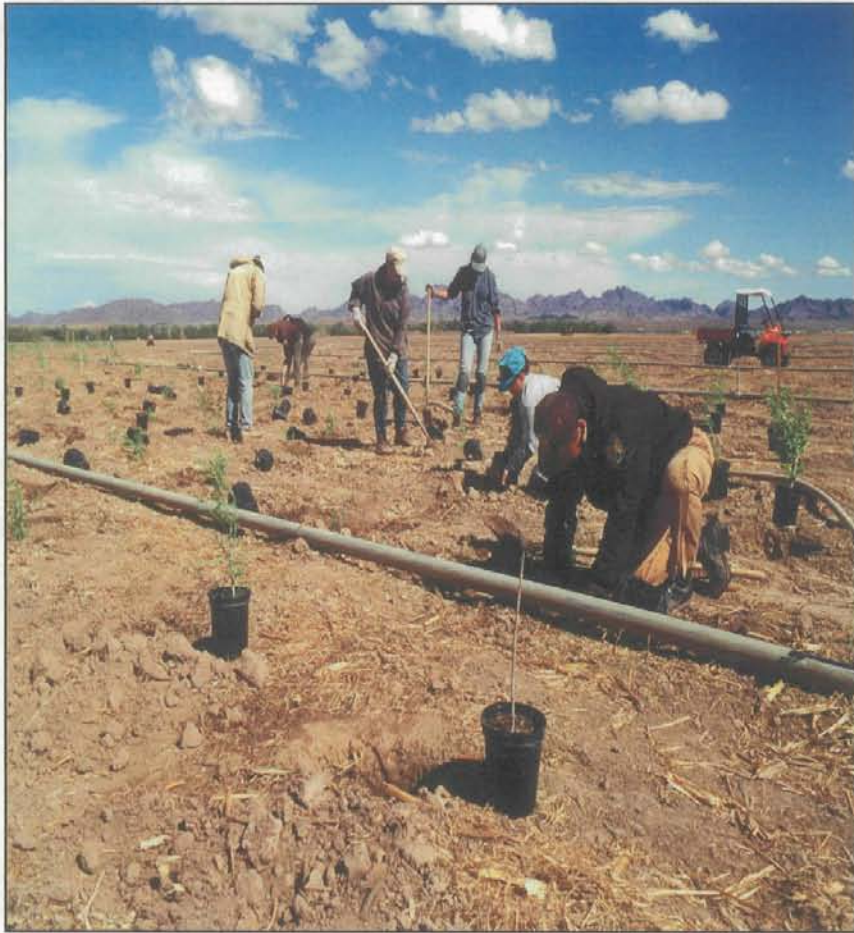
Planting rooted nursery stock, Apr 1999.

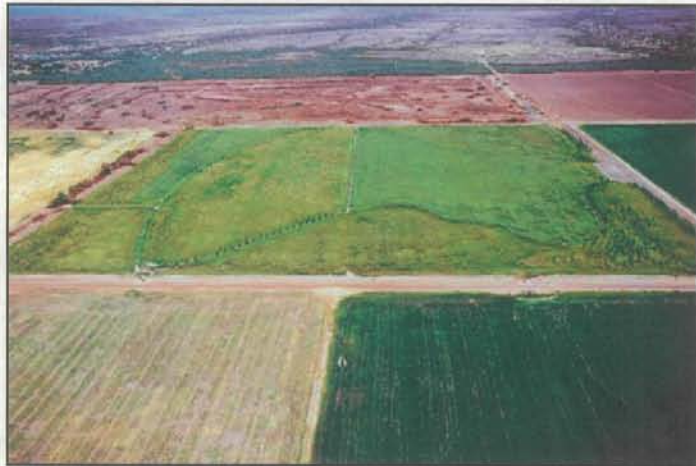
# Nature Trail Restoration Site

Aerial View, July 2000

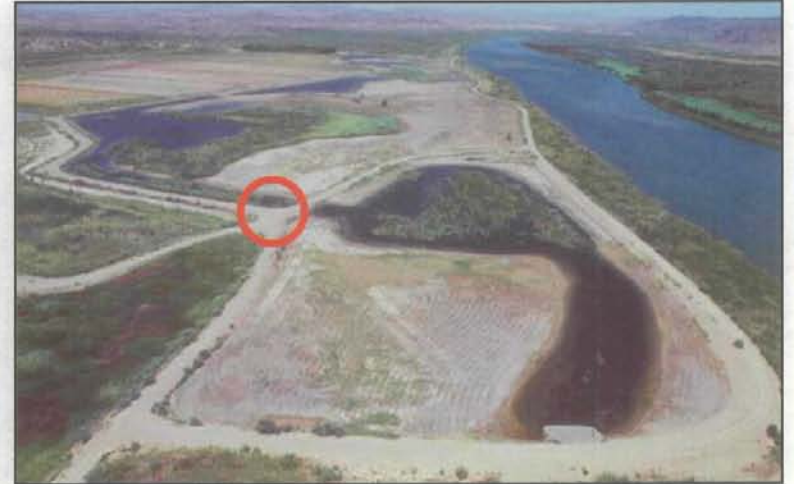
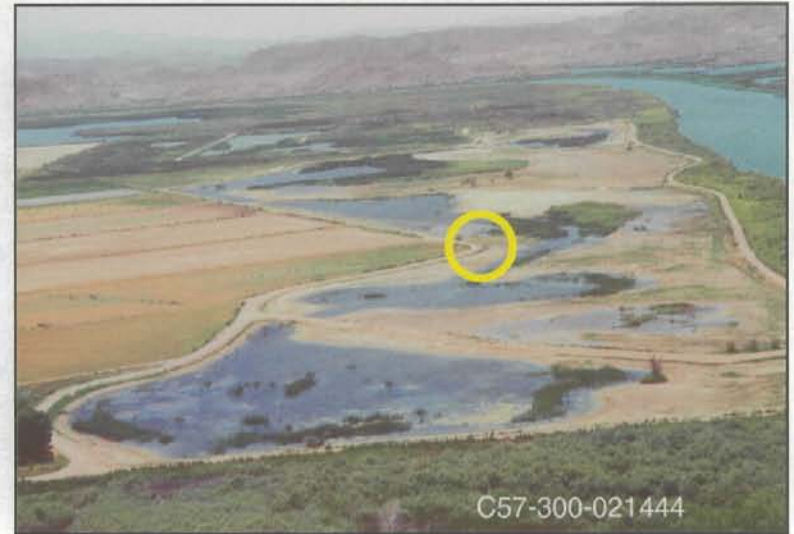
**After**

(Note: red and yellow markers correspond to same locations on “before” and “after” photos.)

After construction: Deeper ponds,  
increased surface area, cattails dominate.

This site required extensive site preparation, including the excavation of 5 ponds totaling 14 ha of open water for future native fish rearing. The ponds are connected by water control structures and water is pumped into the highest pond from either the LCR or from a nearby well. The lower ponds are filled by gravity. The area around each pond slopes upwards slightly, forming 21 ha of emergent and riparian wetland habitat. The water in the ponds can be raised enough to flood these surrounding areas. The area around each pond was designed for planting with riparian vegetation and irrigating by overflowing the ponds (Figure 2).
