## **2014 Inadvertent Overrun Payback**

### **Certification Report**

February 26, 2015

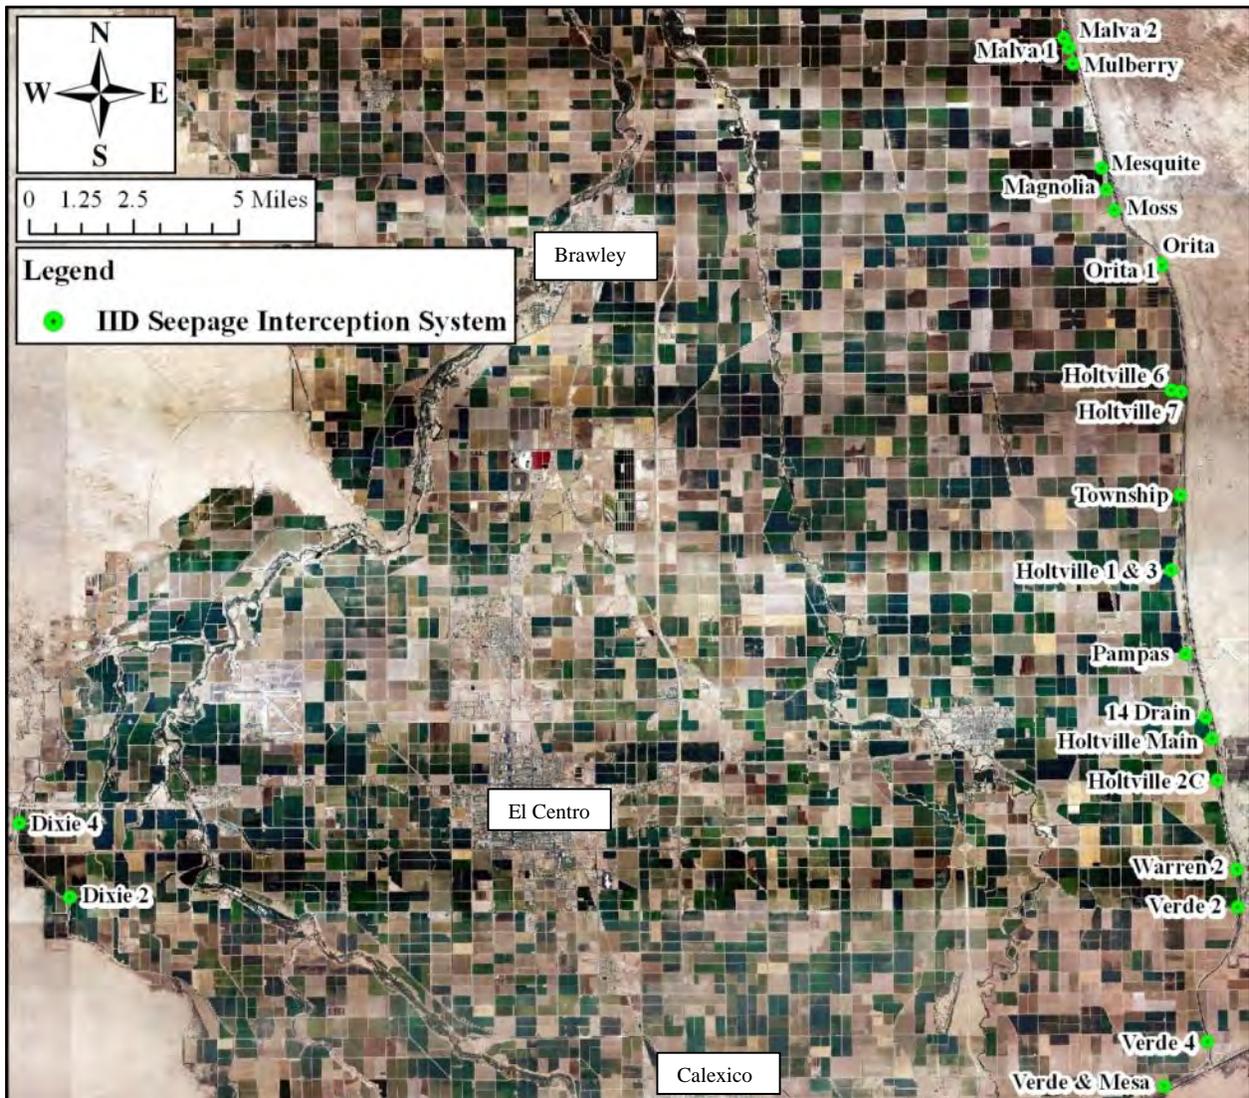
IID’s Main Canal Seepage Interception System was the first efficiency conservation program to be implemented to meet IID’s water transfer obligations under the QSA and other related agreements. This project consists of the installation and operation of pump stations, collection sumps, and appurtenant structures in open drains that run parallel to certain reaches of main canals located in areas of highly permeable soils. These open drains were constructed along main canals decades ago to intercept and carry seepage to the Salton Sea to relieve adjacent agricultural lands of high water tables associated with canal seepage. The Main Canal Seepage Interception System is estimated to have the capacity to collect 30,000-40,000 ac-ft of seepage water from existing interceptor drains and pump these flows back into the main canals to supply downstream water users and reduce IID’s delivery at Imperial Dam. In total, 22 pumping stations were constructed at the lower ends of interceptor drains and are operated to maintain drain water levels within six inches of historical levels to prevent interference with normal drainage and induction of additional seepage from the main canals. The locations of the 22 pump stations are shown in Figure 1.

Figure 1. Location of 22 Main Canal Seepage Interception Stations

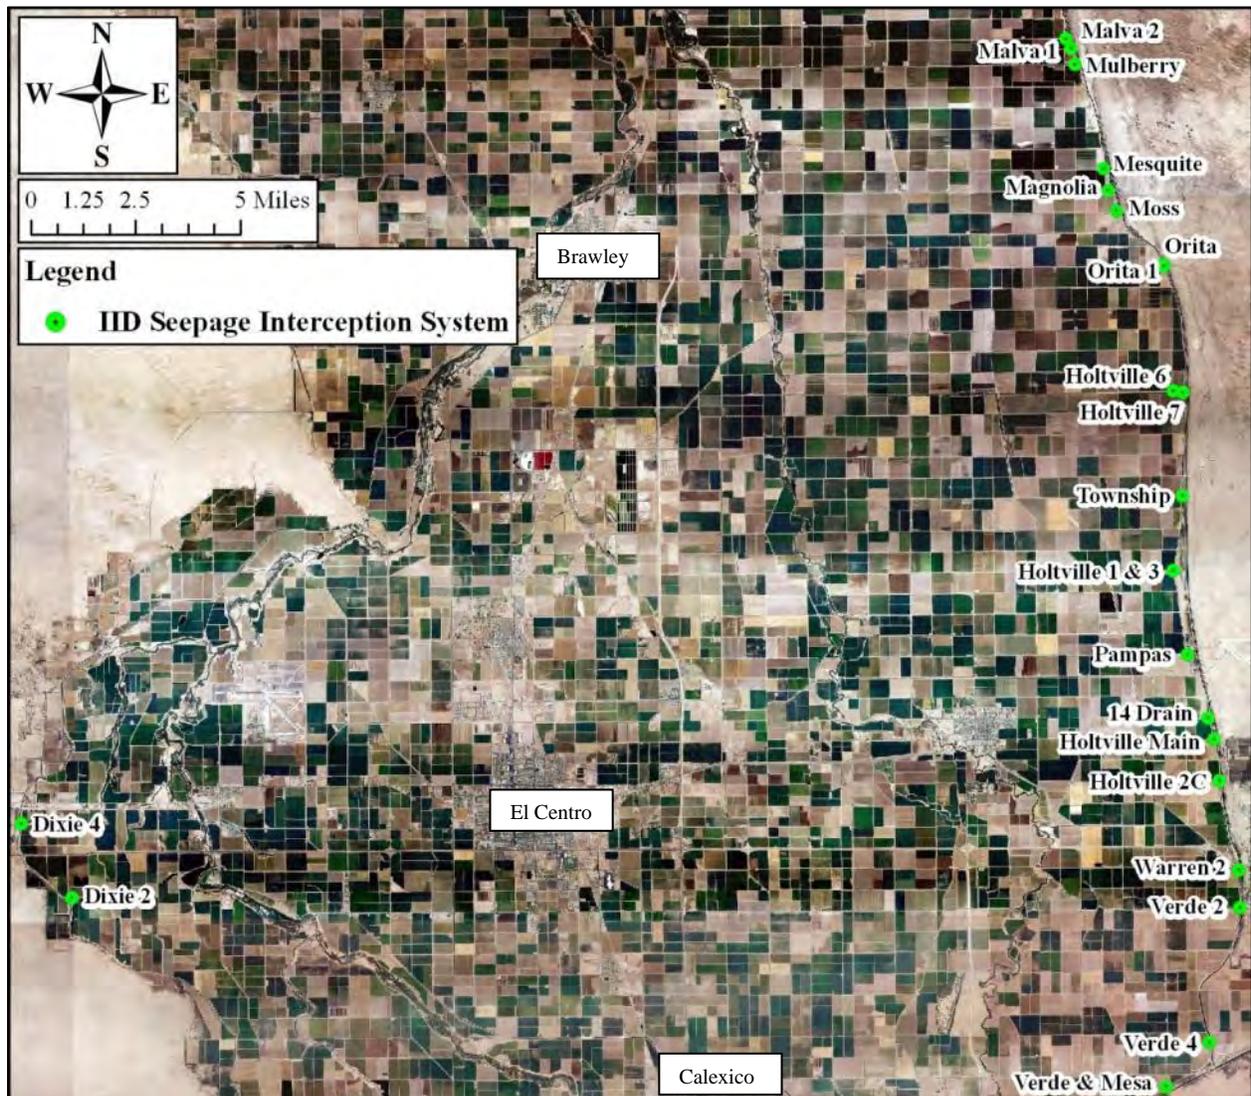
Figure 1 Map depicting locations of 22 Main Canal Seepage Interception stations

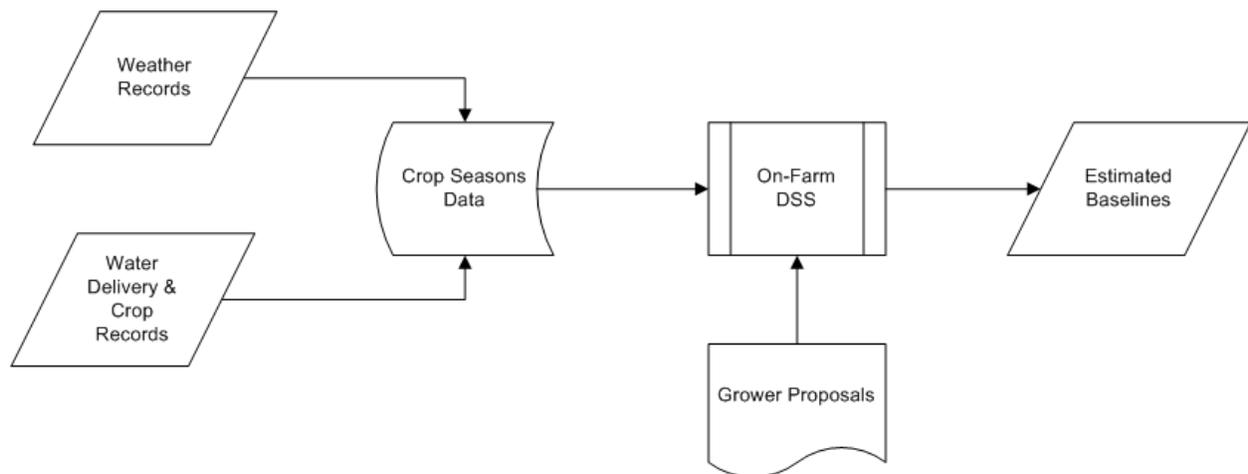
**Figure 1. Basic data requirements for baseline calculation**

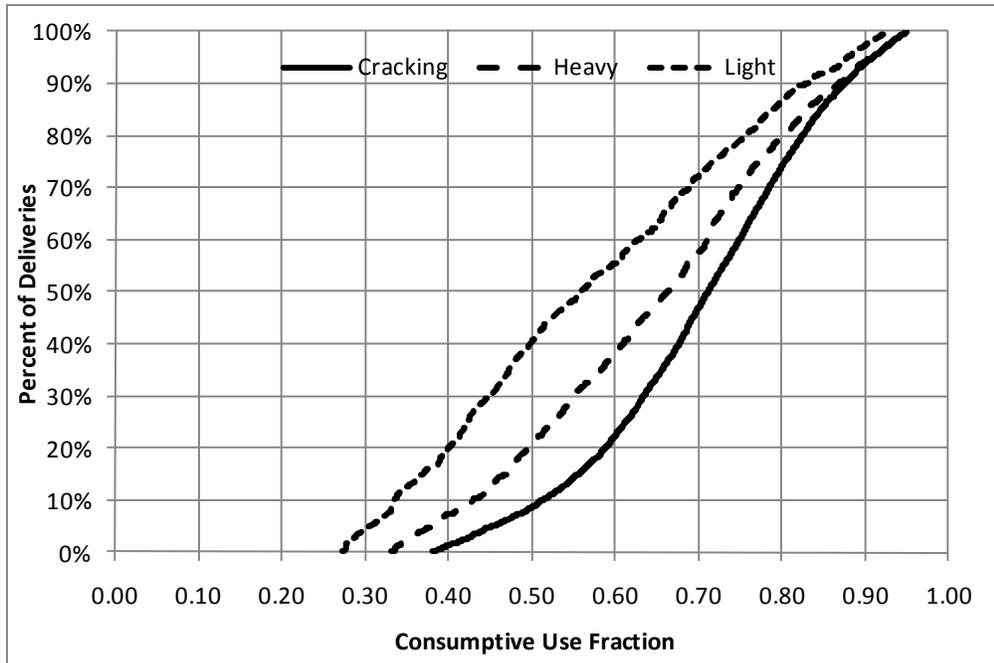
Figure 2. Sample CUF distributions for alfalfa grown on different soil types

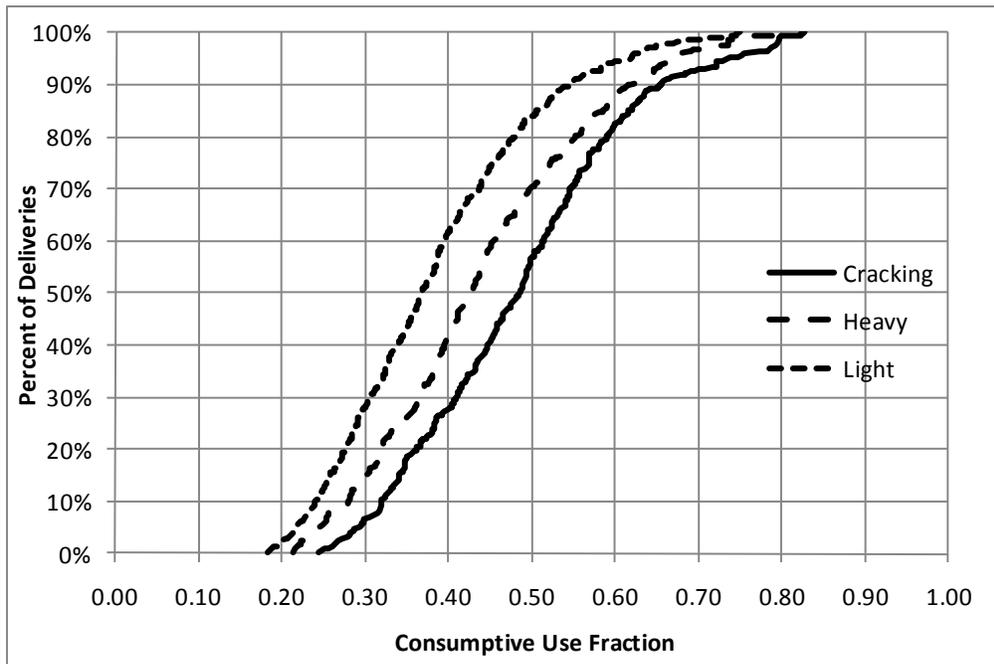
Figure 3. Sample CUF distributions for carrots grown on different soil types

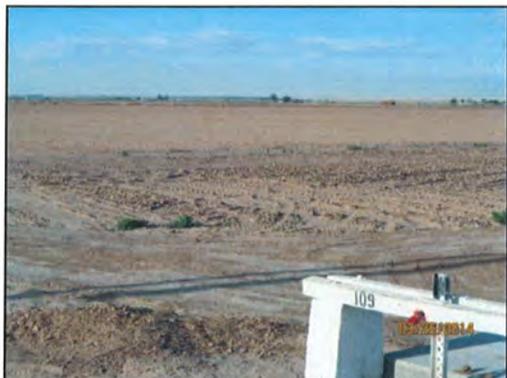
10.

Photo No. 10: Disked, fallow.

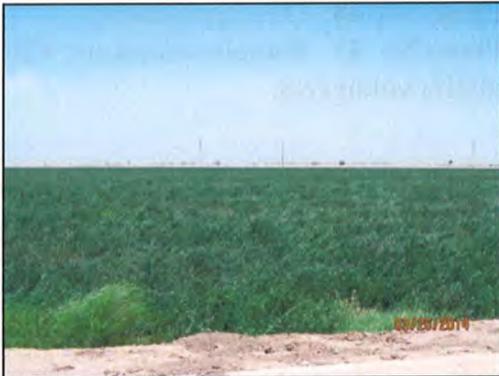
47.

Photo No. 47: Standing alfalfa crop  
purportedly not irrigated after 1/1/2014.Reclamation has confirmed that no  
2014 water deliveries have been made  
to this field. Reclamation will monitor  
through satellite imagery to re-verify its  
fallow condition.

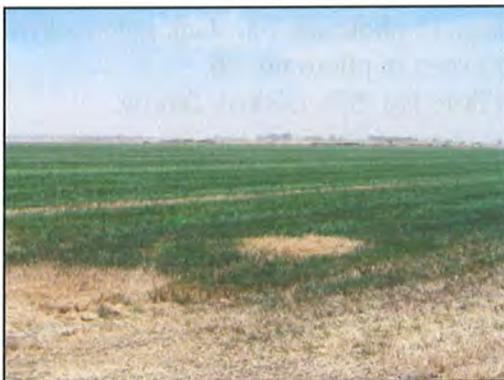
53.

Photo No. 53: Green oat regrowth.

Reclamation has confirmed that no 2014 water deliveries have been made to this field. Reclamation will monitor through satellite imagery to re-verify its fallow condition.

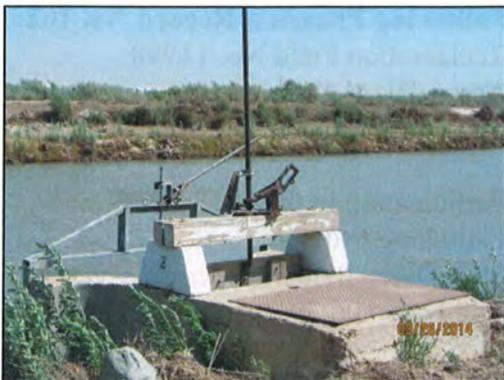
58.

Photo no. 58: Main gate is unlocked.

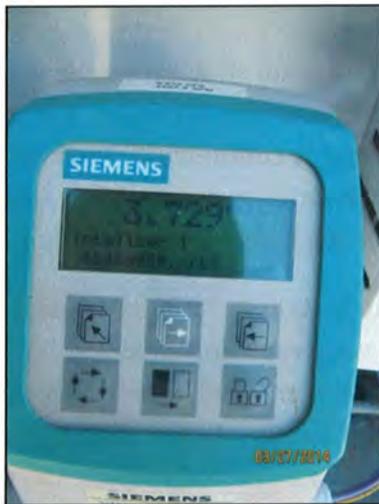
3.

Photo No. 3: Close-up photo of the readout on the sonic flowmeter showing the instantaneous flowrate to be 3.729 cfs at the IIS MCSIS Holtville 6 Pumping Station at the instant the photograph was taken.

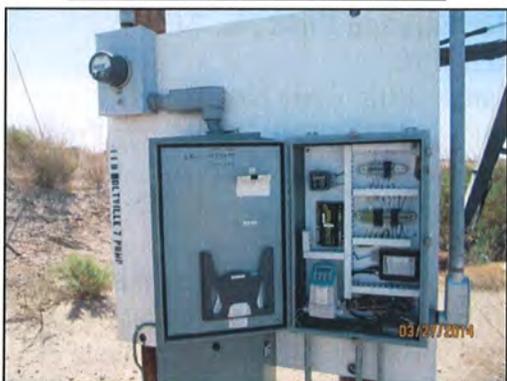
**IID MCSIS Location: Holtville 7 Pump Station**  
Avg. Oper. Pump Rate during three-day period 3/23-25/2014: 5.99 cfs.  
Outlet pipe dia.: 16".

Photo No. 4. Pump Station Instrumentation within the Electrical and Controller Panel. When photo was taken the instantaneous pump rate was 0.00 cfs and the electrical conductivity of water in the pipe was 1.73 microSiemens/centimeter (mS/cm).

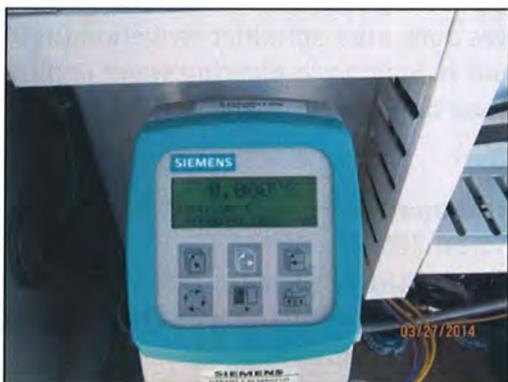
Photo No. 5. Close-up photo of the readout on the sonic flowmeter showing the instantaneous flowrate to be 0.00 cfs at the IIS MCSIS Holtville 7 Pumping Station when this photo was taken. A large tracked backhoe was digging muck out of the drainway pump inlet channel to facilitate pumping during our visit.

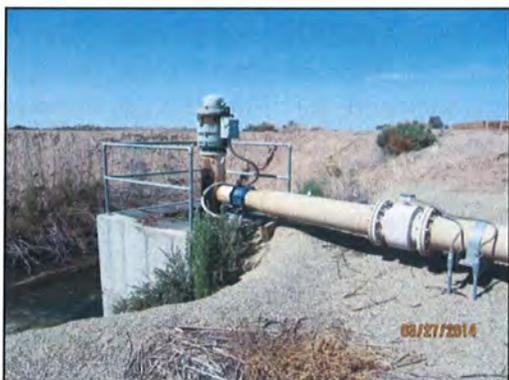
Photo No. 6. IID MCSIS Holtville 7 motor, pump and its 16-inch outlet pipe.

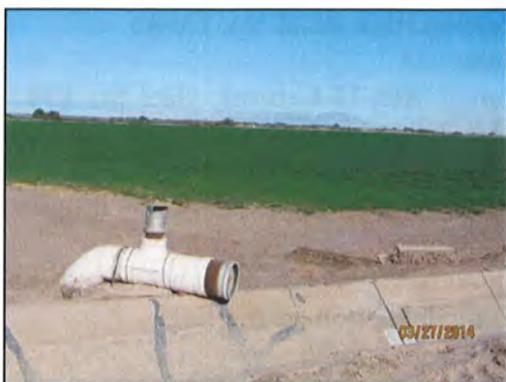
3.

Photo No. 3- Pipeline outlet delivery point into supply ditch –thus allowing collected and pumped tailwater to be applied to an adjoining field; part of a permanent, cascading TRS.

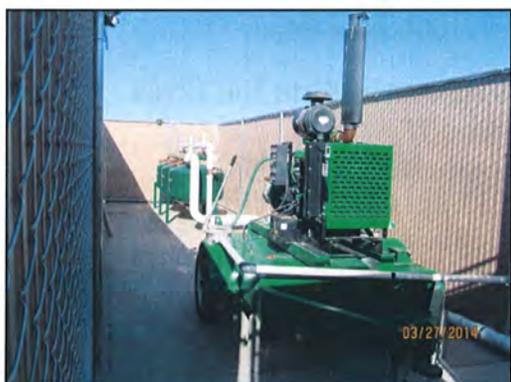
5.

Photo No. 5: Power & pumping unit for permanent drip irrigation system; filtration system in far end of pump system yard.

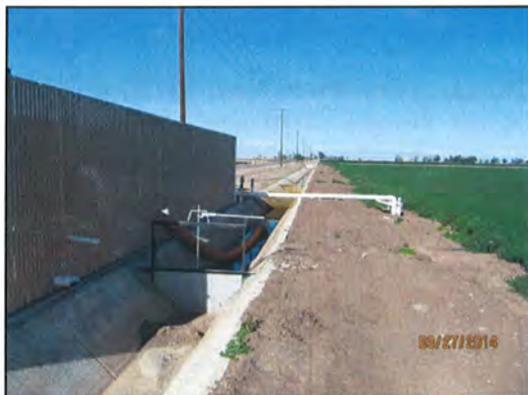
6.

Photo No. 6: The pump system's flexible orange inlet pipe seen in photo draws water from the concrete ditch through the drip irrigation filtration system and discharges into white pipeline seen in rear of the photo and hence into buried drip irrigation pipeline network.

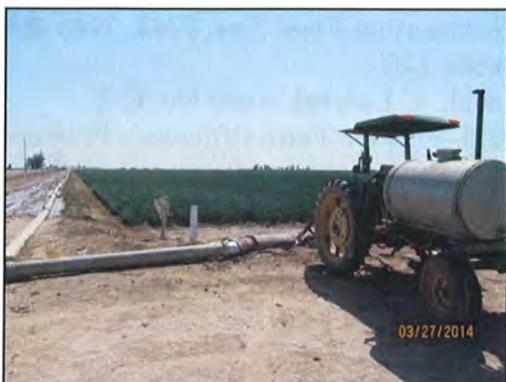
11.

Photo No. 11: Crop is onions that will be dehydrated for market. Photo shows tractor power unit for pumping water through pipeline seen in photo to the top end of the field. Pipe-end joint gasket appears to be missing due to water on ground seen in photo. Tractor was not operating at time of our visit.

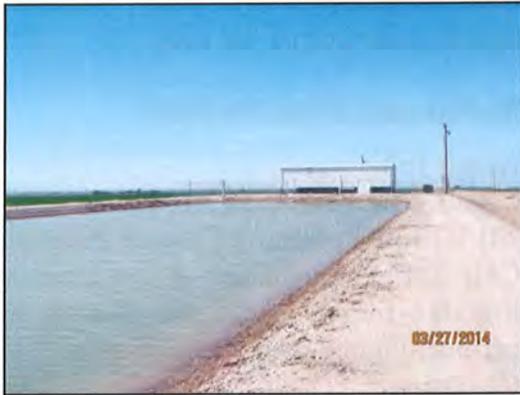
15.

Photo No. 15: Pumping plant and small reservoir water supply for permanent drip irrigation system seen in photo.

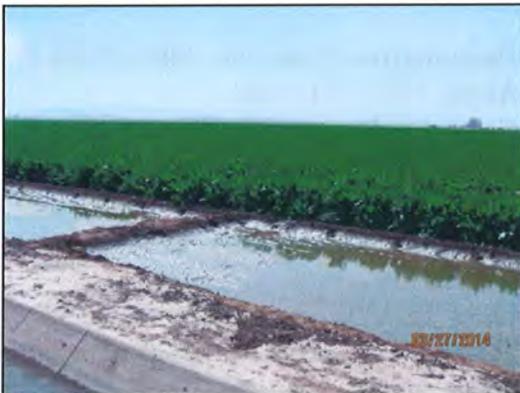
23.

Photo No. 23: Beet field onto which the sprinkler pipe will be laid once the onion crop on the east side of the road has been harvested. The beet development is sufficient the crop could be harvested *if* the beet dump was ready for this crop – but the delivery date is further into this year. The beets are on rows that run East to West and water is in a delivery channel constructed so each row can be irrigated. Only every other row was being irrigated at this time.

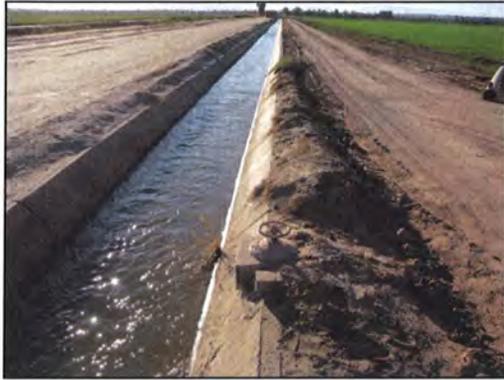
17.

Photo No. 17: Outlet into head ditch of adjacent fields.
