Evaluation of a Cylindrical Wedge-Wire Screen System at Beal Lake, Arizona 2006

Phase II Testing

January 2007

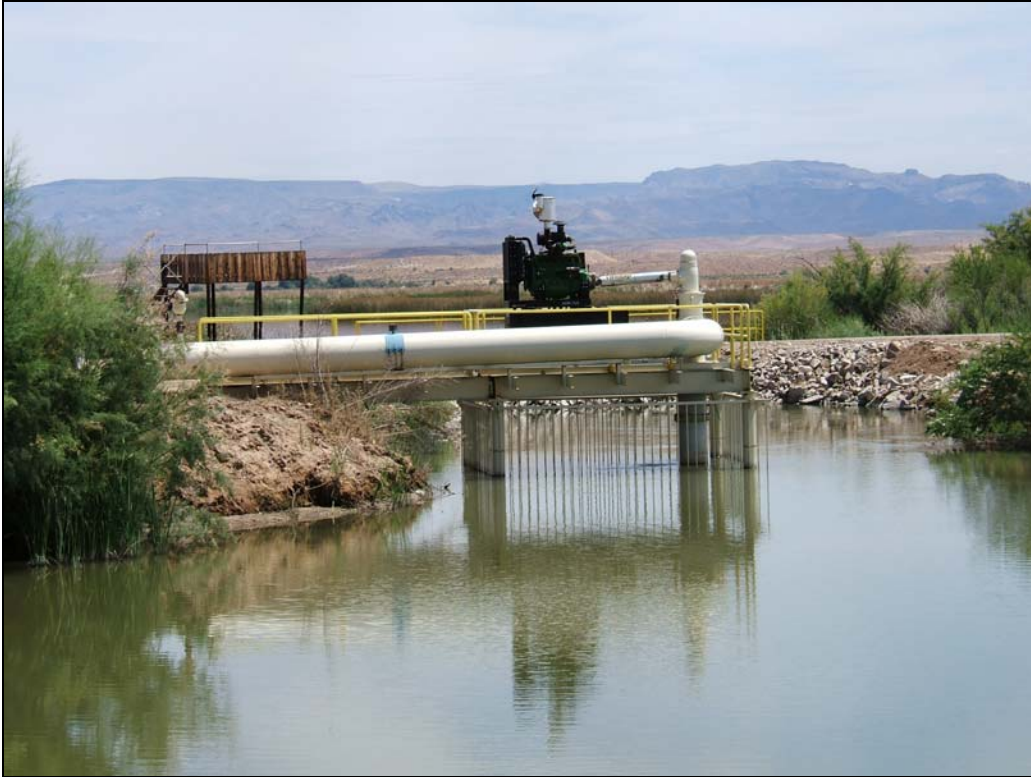
Figure 5. Irrigation pump and location of screen samples deployed at Beal Lake, Havasu National Wildlife Refuge.

A total of forty screen coupons, one-half comprised of a CuNi alloy and one the other half consisting of 304 stainless steel (stainless steel) measuring approximately 4 inches in length and 4 inches in width were procured. Half of the screens (10 CuNi alloy; 10 stainless steel) were deployed at the irrigation pump located adjacent to the rock structure at Beal Lake (Figure 5). The remaining half were deployed at the pump station located on the inlet canal of Martinez Lake (Figure 6).

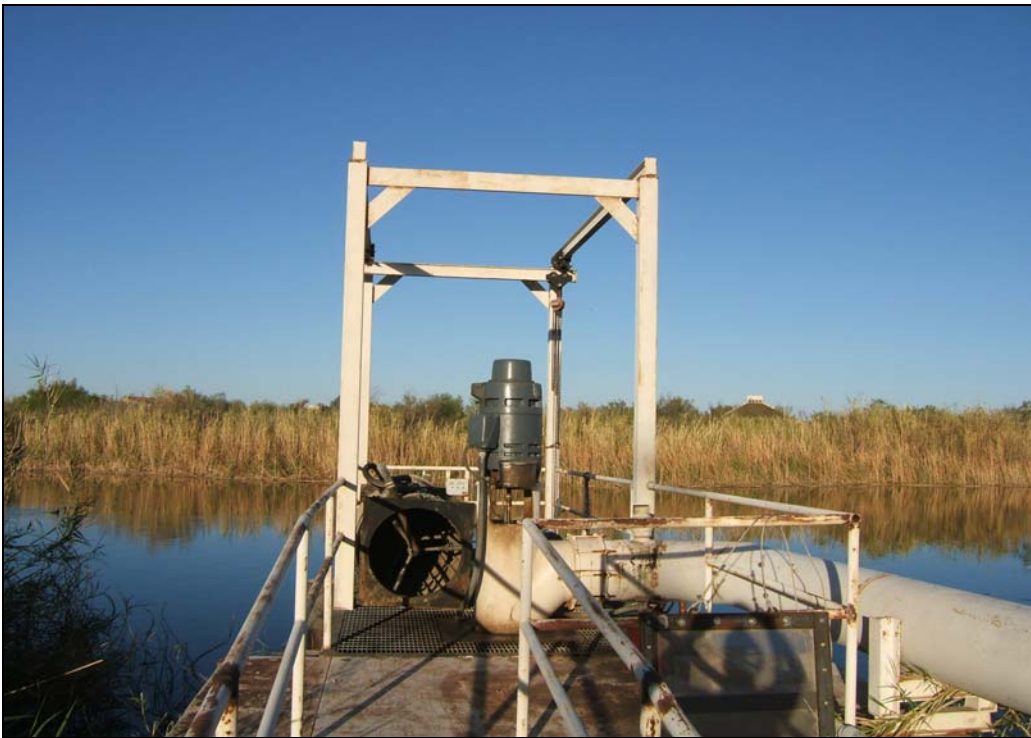
Figure 6. Irrigation pump and location of screen samples deployed at Martinez Lake inlet canal, Imperial National Wildlife Refuge.

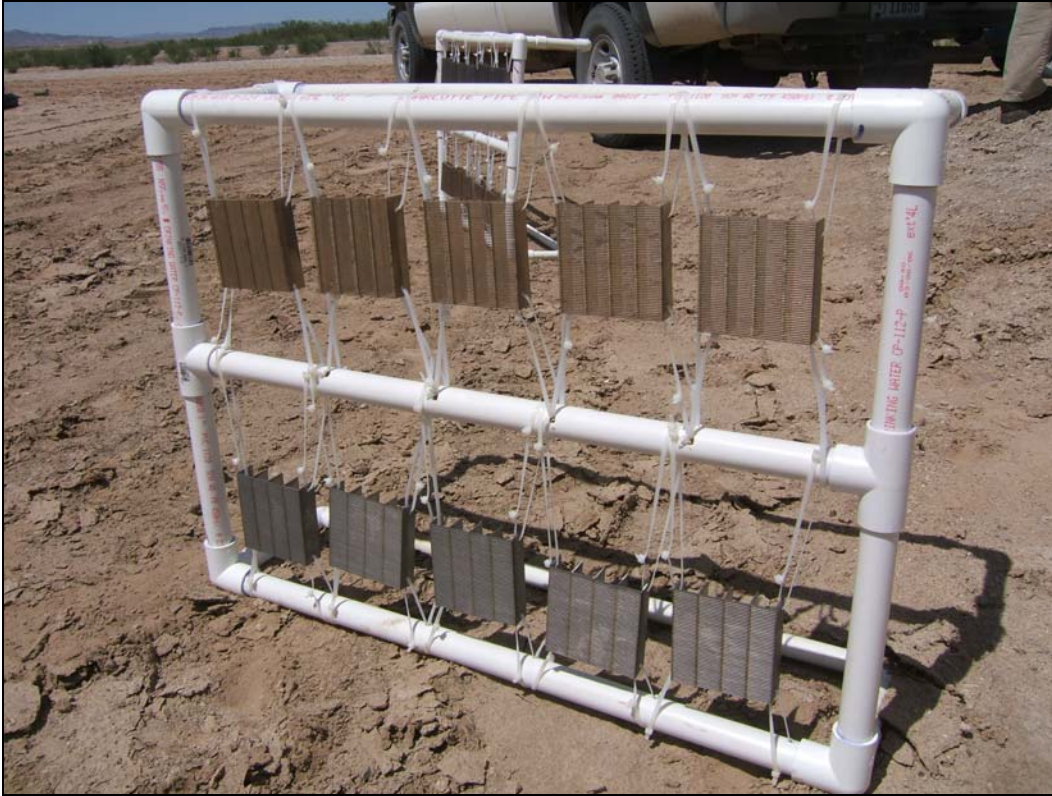
Figure 7. Screen coupons attached to PVC frame using nylon zip-ties prior to deployment.

Frames to support the screen coupons in the water column were fabricated using Poly Vinyl Chloride (PVC) pipe (schedule 40) and heavy-duty PVC glue (Figure 7). A 1/8 inch hole was drilled in each corner of the coupons, and nylon zip-ties were used to suspend the screens within the PVC frame. The zip-ties were used as they provided adequate holding strength, and facilitated easy removal of the coupons. Coupons were attached to the frames and the frames were suspended with the wedge-wire oriented in a horizontal direction. Each frame contained five CuNi coupons and five stainless steel, and a total of two frames were suspended at each test location. On each frame the CuNi and stainless steel coupons were alternated from top to bottom to ensure even distribution in the water column. At each location, samples were oriented facing the northern horizon and suspended from an existing pump intake platform approximately 4 feet below the water surface. Nylon rope was used to secure the PVC frame to the side of each pump station. Care was taken to insure that the samples did not come into contact with each other, the PVC frame, or the steel framing of the pump platform.

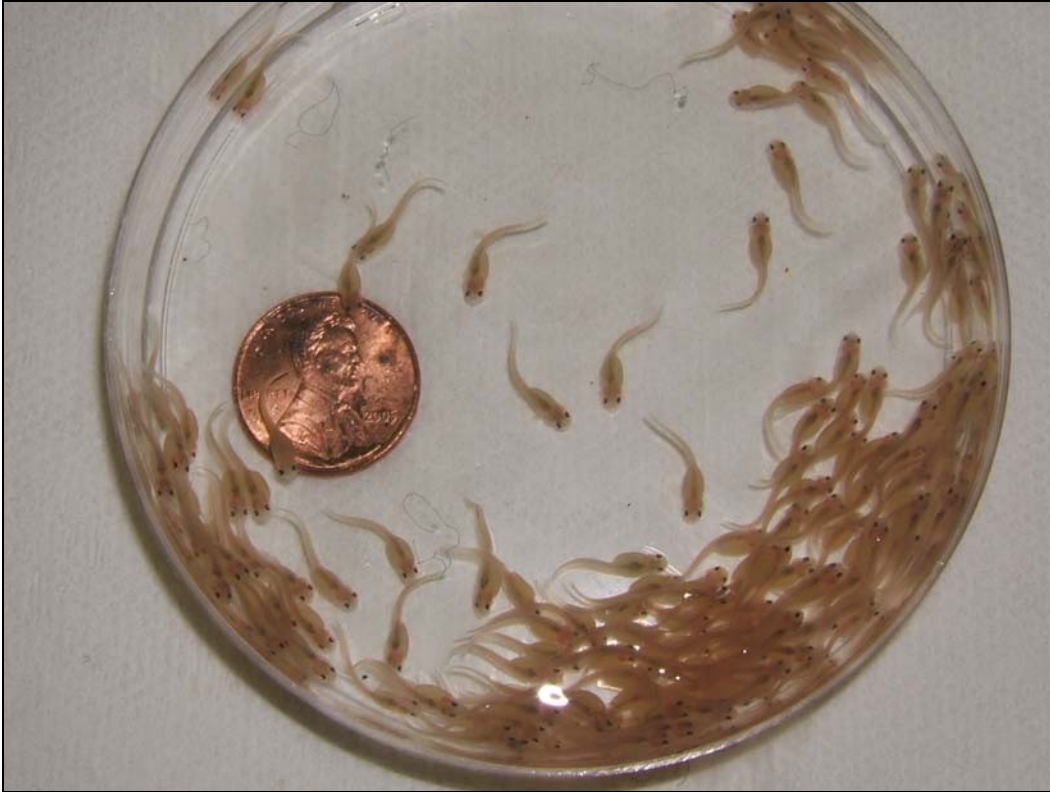
Figure 9. Size perspective of newly emerged blue catfish larvae.

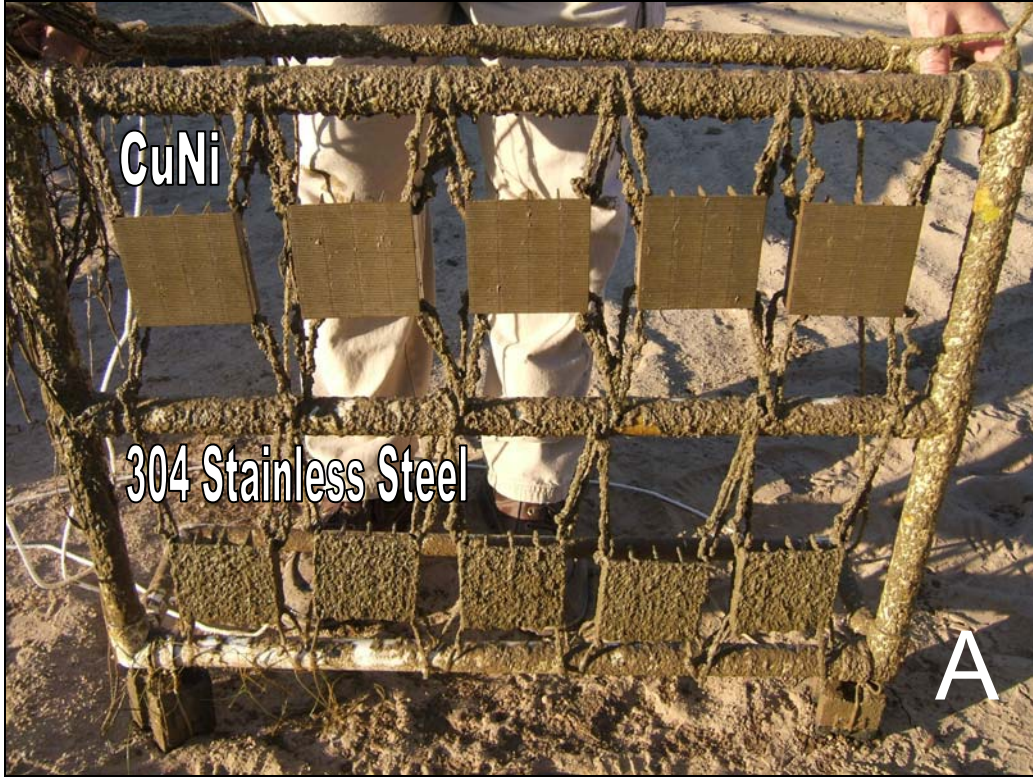
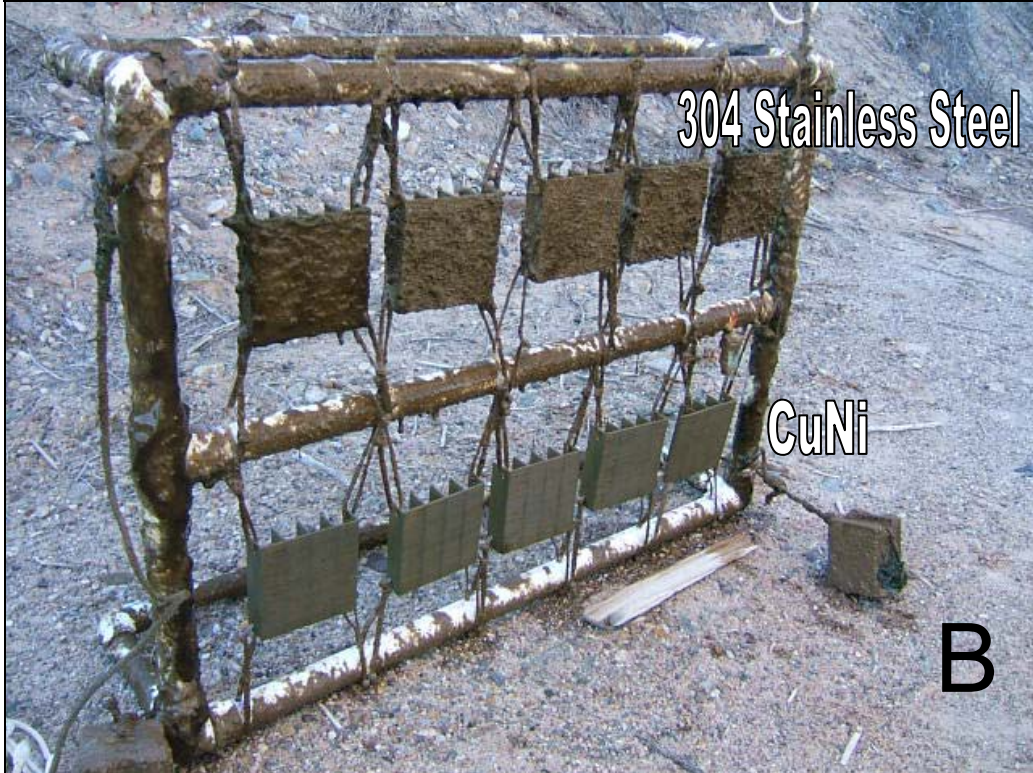
Figure 10. Biofouling of test coupons prior to cleaning at Beal Lake (A) and Martinez Lake inlet canal (B) for sample interval April – June.

type of fouling material differed among sampling periods. In June, the stainless steel coupons were enveloped with thick mats of green filamentous algae (mainly *Cladopora spp.*), which entrapped silt and debris, and formed a thick gelatinous mixture that completely covered the entire surface of the coupons (Figure 10). In September, visual observations indicated that the stainless steel coupons also had more biofouling than the CuNi samples. However, during this sampling period, the screen coupons were covered predominately with large mats of cyanobacterial dominated by *Tolypothrix spp.* rather than filamentous algae. These mats were also embedded with silt and debris, and formed a thick gelatinous layer over the entire surface of the coupons. This layer provided a substrate for aquatic invertebrates to inhabit. In November, the amount of biofouling material on the stainless steel coupons appeared to be less than observed during the earlier sampling intervals, and consisted mainly of attached insect larvae and pupa. The taxonomic composition of the invertebrates recovered from the screen samples are presented in Appendix B.

Similar to what was observed at Beal Lake, the stainless steel coupons deployed at Martinez Lake had extensive biofouling when compared to the CuNi screen coupons. The primary biofouling agent for all sample intervals consisted of dense detrital/microbial mats that formed thick gelatinous substrate with heavy sediment buildup over the entire surface of the test coupons (Figure 10). As observed at Beal Lake, attached insect larvae and pupa and other invertebrates were also prevalent on all of the stainless steel screens. However, unlike the samples at Beal Lake, the amount of biofouling did not appear to decrease in November on samples deployed at Martinez Lake when compared to June and September samples; the extent of biofouling remained visibly dissimilar compared to the CuNi coupons throughout the duration of the study.

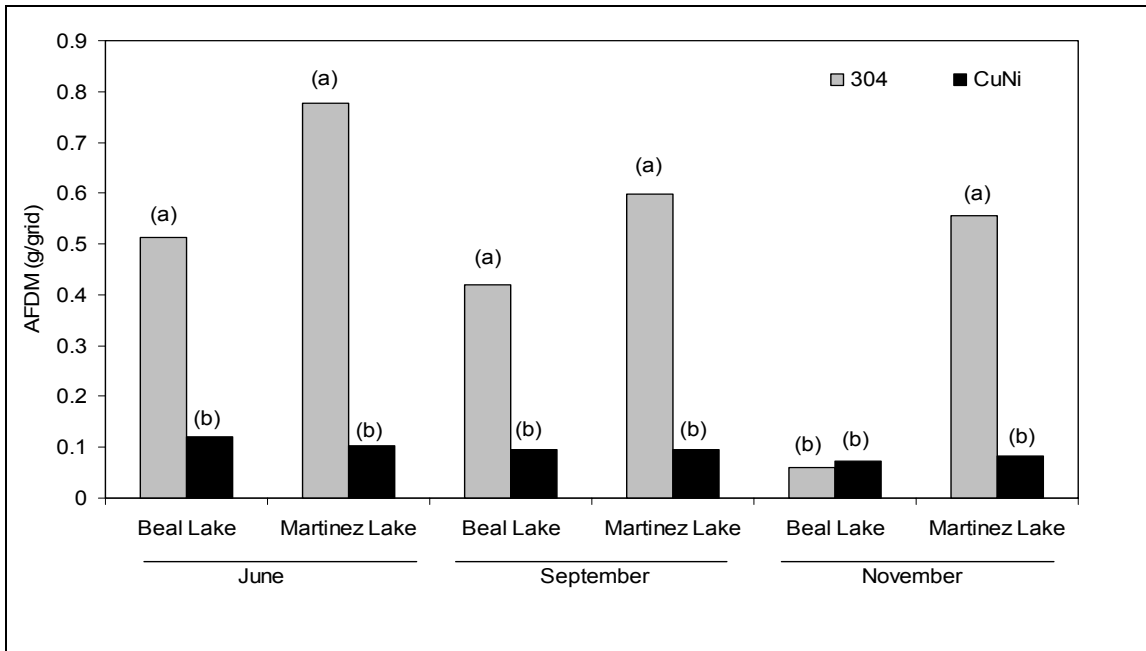
Figure 11. Ash Free Dry Mass (AFDM) averaged by screen type at each location during each sampling period. Significant differences ($p < 0.05$) are indicated by different alphabetic superscripts.

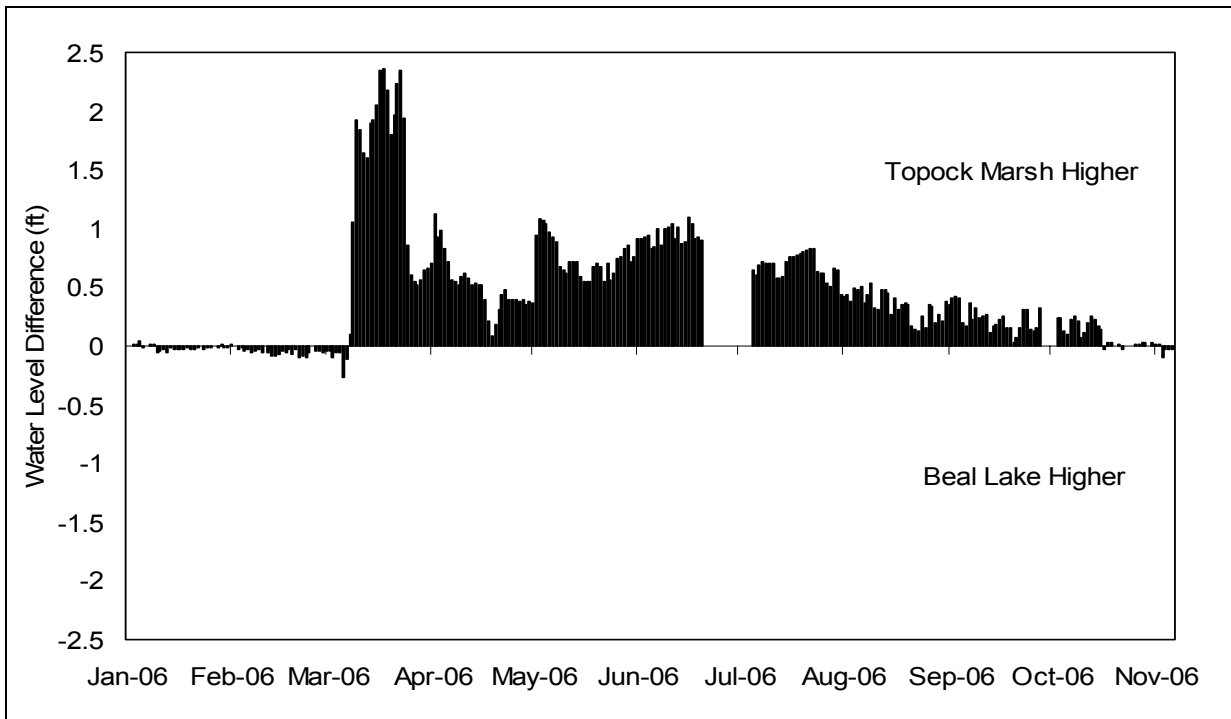
Figure 13. Mean daily water level differences between Topock Marsh and Beal Lake, 2006. Water level differences from 21 June to 4 July were removed from analysis.

Water levels on either side of the rock structure were monitored through 2006. Water levels remained approximately 0.5 to 1.0 ft lower in Beal Lake than Topock Marsh throughout the summer and early fall. This was likely attributed to management actions that required the screen system to be closed and the water level of Beal Lake to be drawn down in April. Water flow into Beal Lake was restored by early May, however, water levels on either side of the rock structure did not return to equilibrium until late October, when evapotranspiration rates decreased.

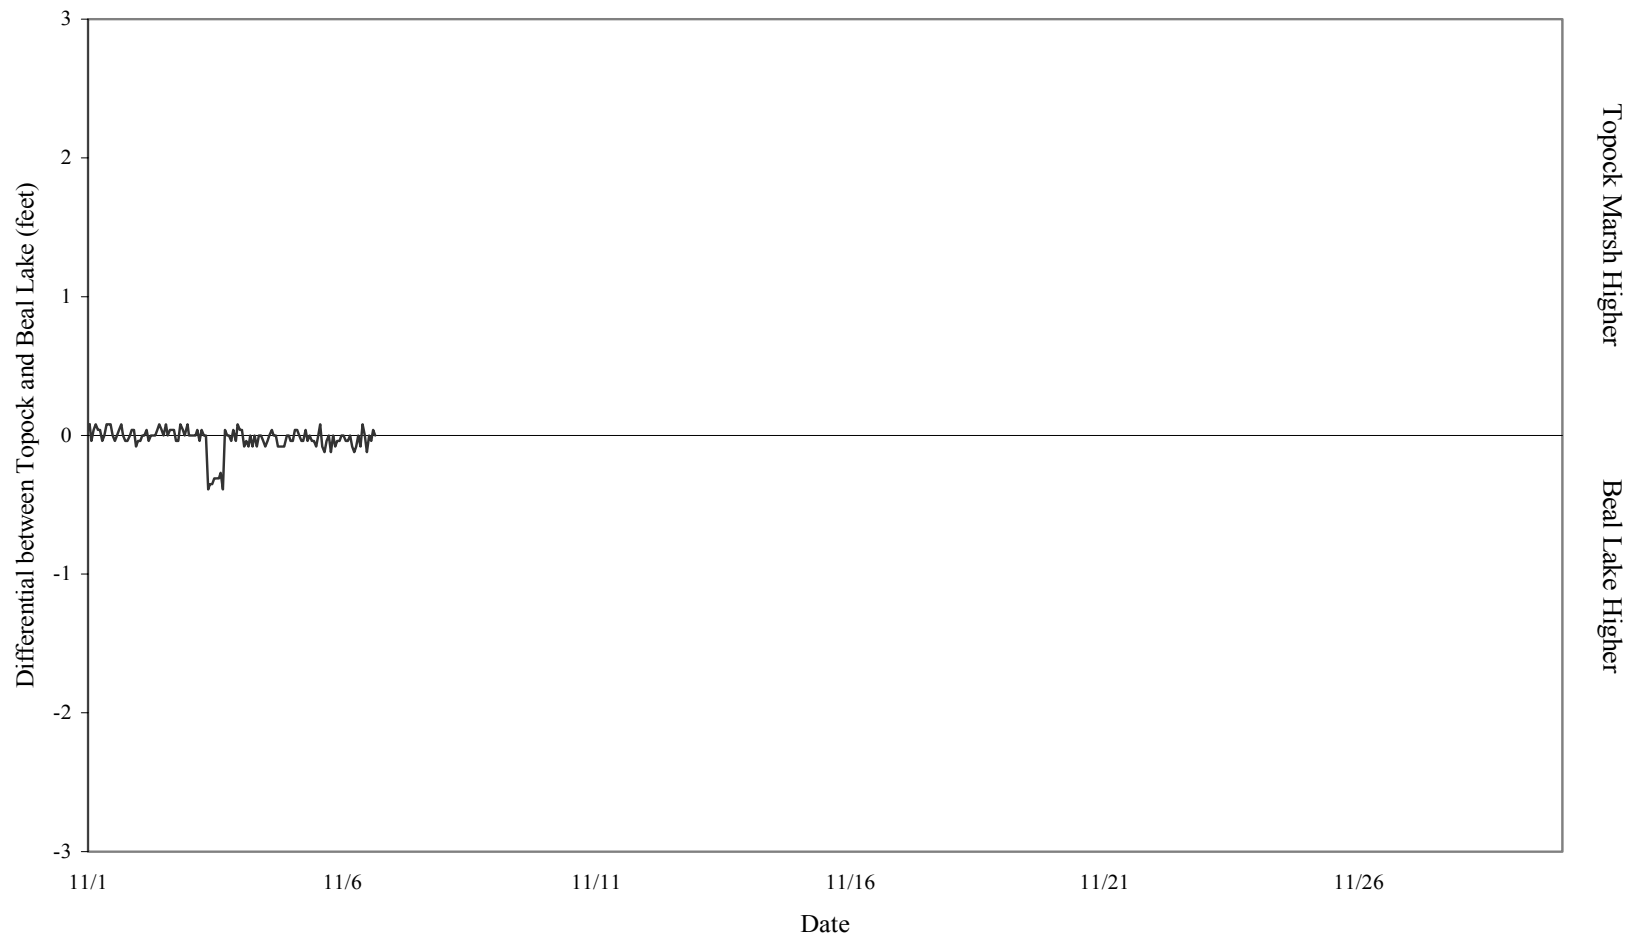
Appendix Figure C-11. Water level differential between Beal Lake and Topock Marsh, November 2006.
