## Zebra & Quagga Mussel Research Program

### RESEARCH NOTE

#### *Preliminary Evaluation of Quagga Mussel Fouling Potential for Cu-Ni (90-10) Wedge Wire Screen*

**ZQMRP-2009-RN-01**

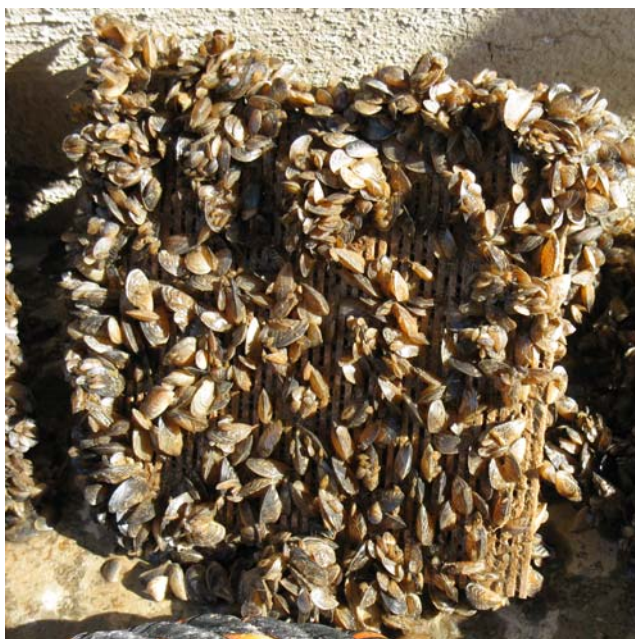
Figure 2 show the extent of fouling that was observed. Both screen panels were heavily fouled, suggesting that Cu-Ni (90-10) does not prevent settlement and in fact is susceptible to nearly complete occlusion in a very short period of time for the conditions at Lake Havasu.

**Figure 2.** - Quagga mussel settlement on Cu-Ni (90-10) wedge wire screen sample.

It is recognized that the conditions for mussel colonization in Lake Havasu are very favorable. Whether other regions of the western U.S. will be as susceptible to such extensive infestation remains to be determined. It should also be noted that this study was not conducted under actual service conditions.

However, considering the velocity criteria for which typical fish screens are designed, the results would likely remain unchanged. Although anecdotal at this point, these preliminary findings suggest that Cu-Ni (90-10) may not be an effective control solution for fish screens under all conditions.
