Zebra & Quagga Mussel Research Program

RESEARCH NOTE

Field Evaluation of Coatings to Deter Attachment of Quagga Mussels

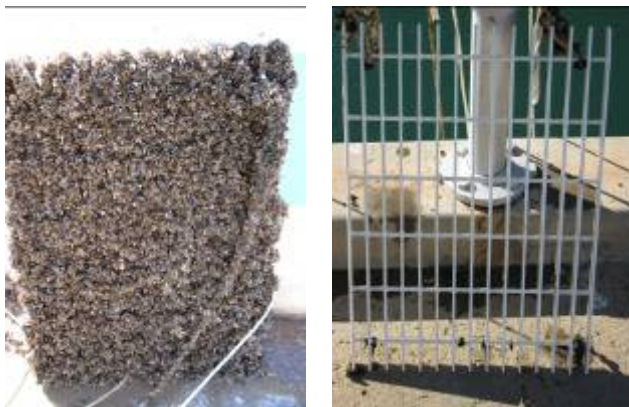
Figure 1. – Uncoated steel grate after 7 months (left). Non-toxic foul release coated steel grate (right).

The study began in May 2008 at Parker Dam and involved 20 different coatings to deter the attachment of mussels. After 7 months of exposure, 16 coatings were removed from the study due to moderate to heavy fouling. Four coatings have been identified that may prevent attachment of mussels. Figure 1 shows the effectiveness of some coatings to deter attachment. Further studies are needed to fully evaluate the coatings for durability and obtain projected service life information.

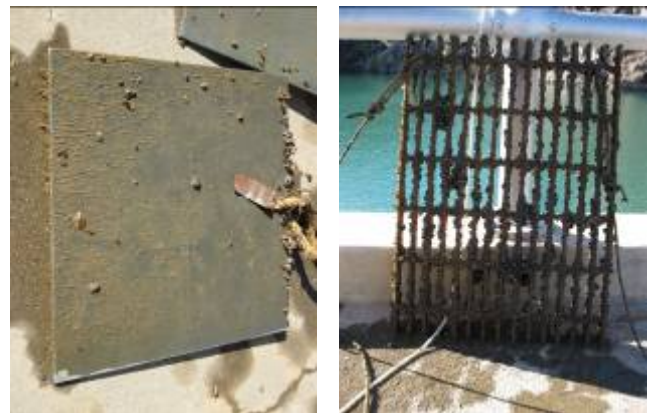
Figure 2. Flame sprayed zinc metallizing contrast between plates (minimal flowing conditions) and grates (flowing conditions).

Figure 2 shows the contrast of fouling that was observed between the grates exposed to flow and plates exposed to minimal flow.
