Subject: Agreement No. R16AP00113 Final Project Report & Closeout Documentation

Advanced Metering Infrastructure Program

Final Project Report

**City of Big Bear Lake, Department of Water and Power
41972 Garstin Drive / P.O. Box 1929
Big Bear Lake, Ca. 92315**

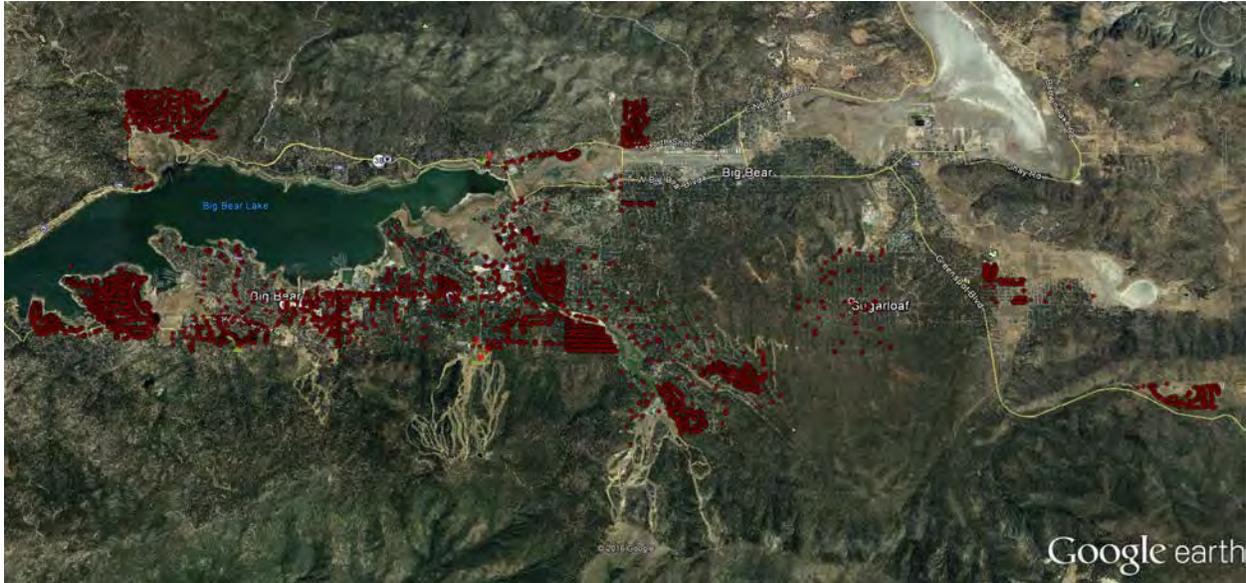
The map below depicts the AMI meter installations as of the time when DWP submitted its grant application to USBR in January of 2016.

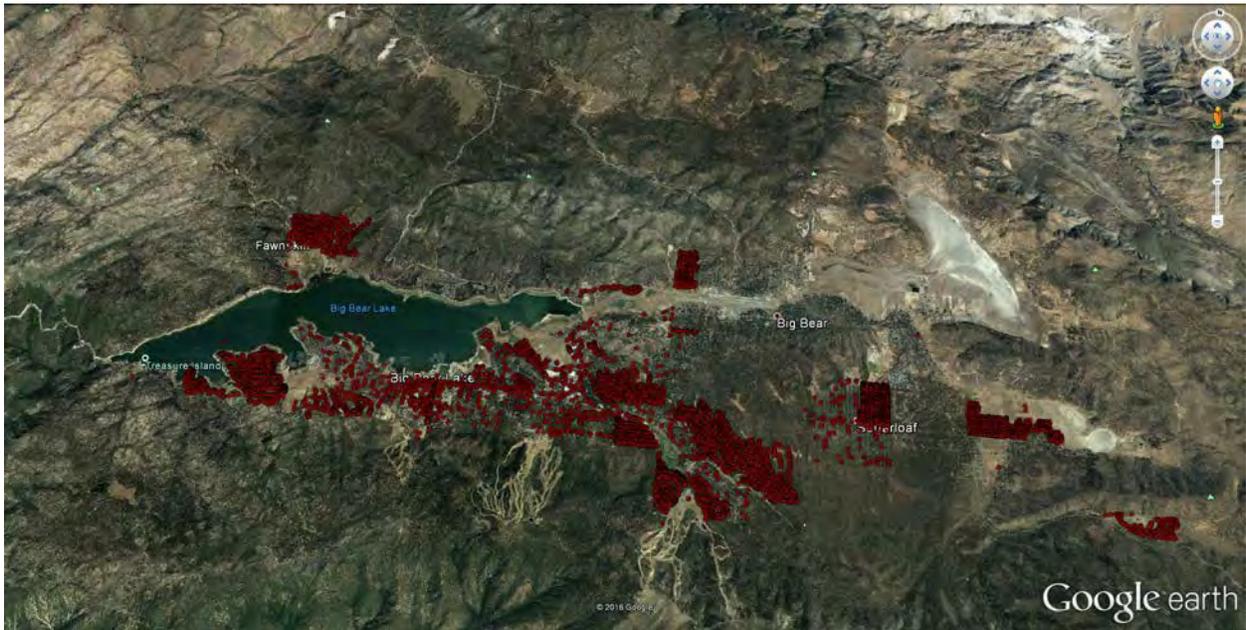
The map below depicts the AMI meter installations when DWP completed installation of the 5,000 AMI meters, which were partially funded by the USBR grant, March of 2017. About 3,400 meters were installed between January of 2016 and March of 2017.

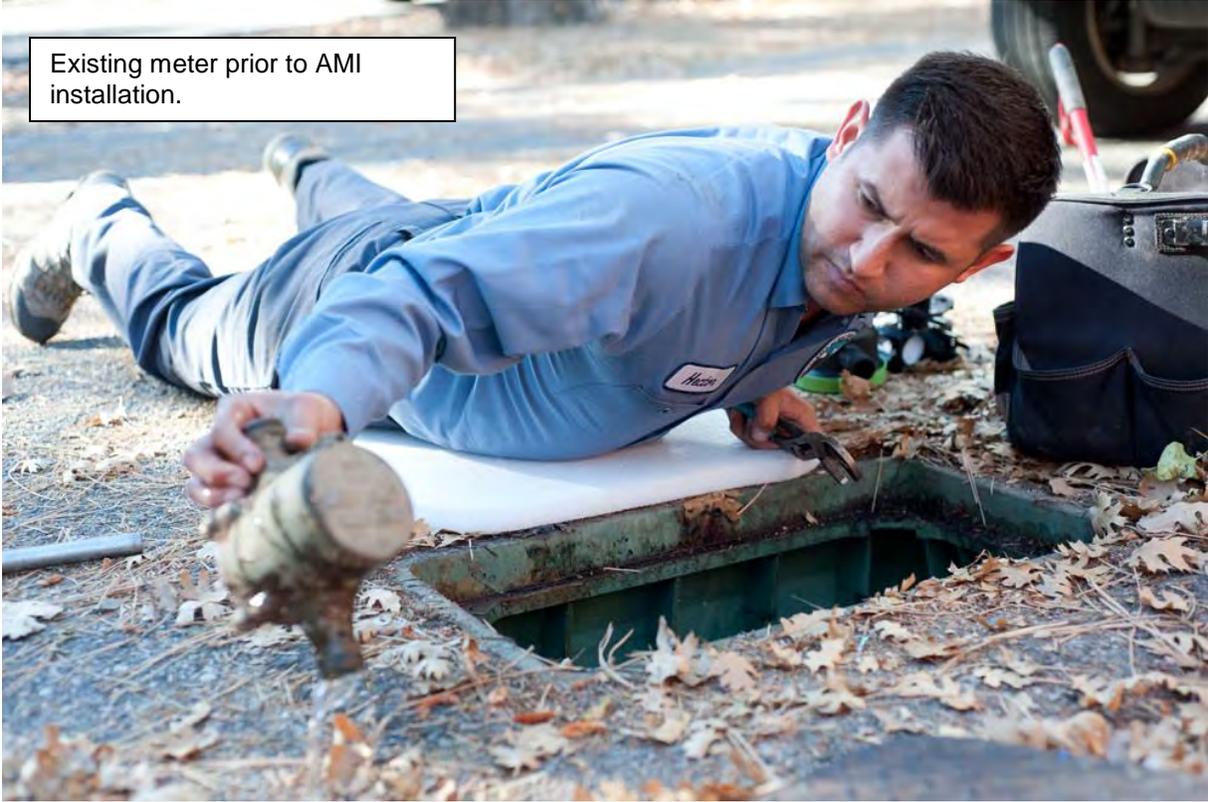
Existing meter prior to AMI installation.

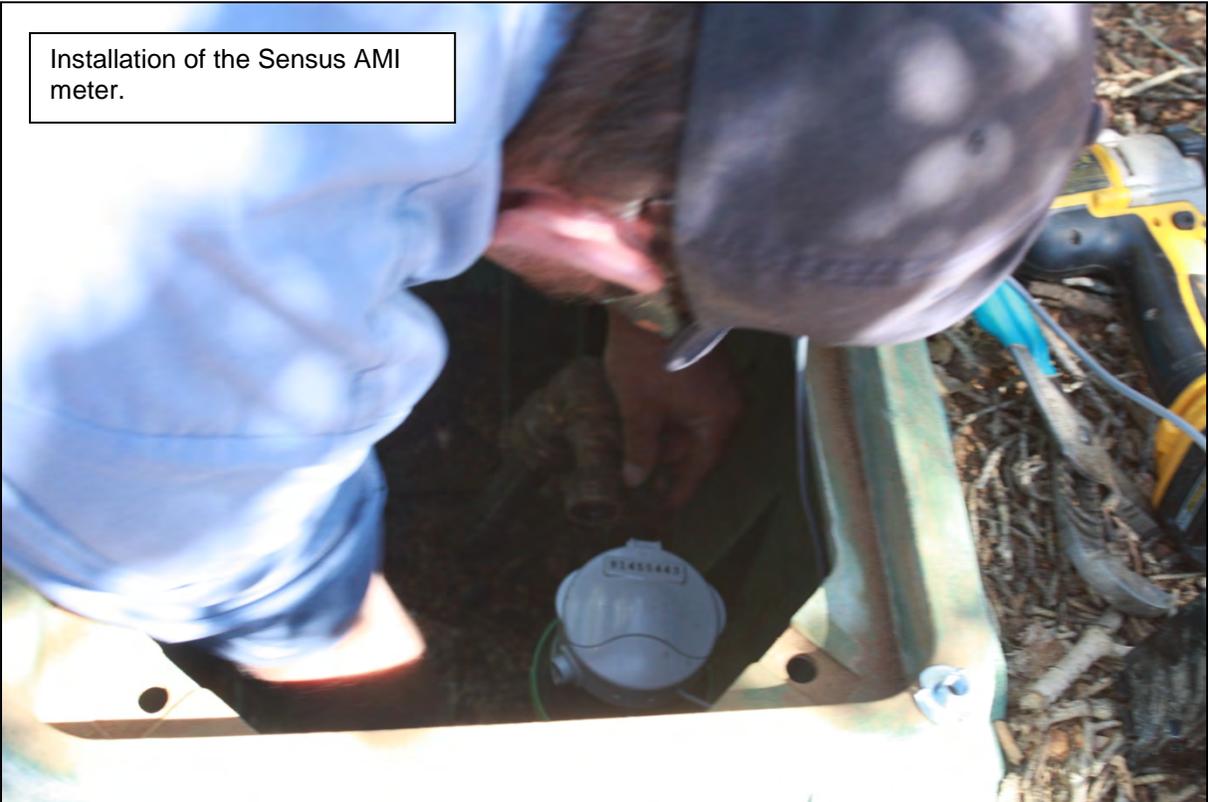
Installation of the Sensus AMI meter.

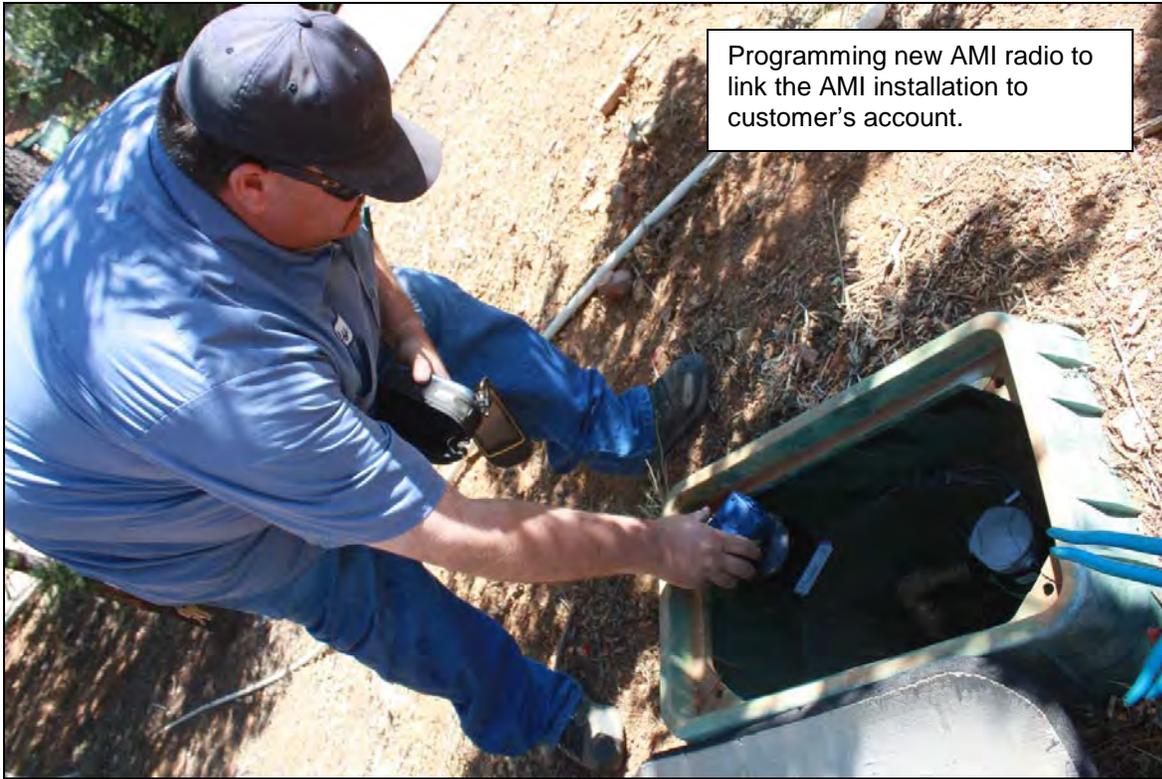
Programming new AMI radio to link the AMI installation to customer's account.

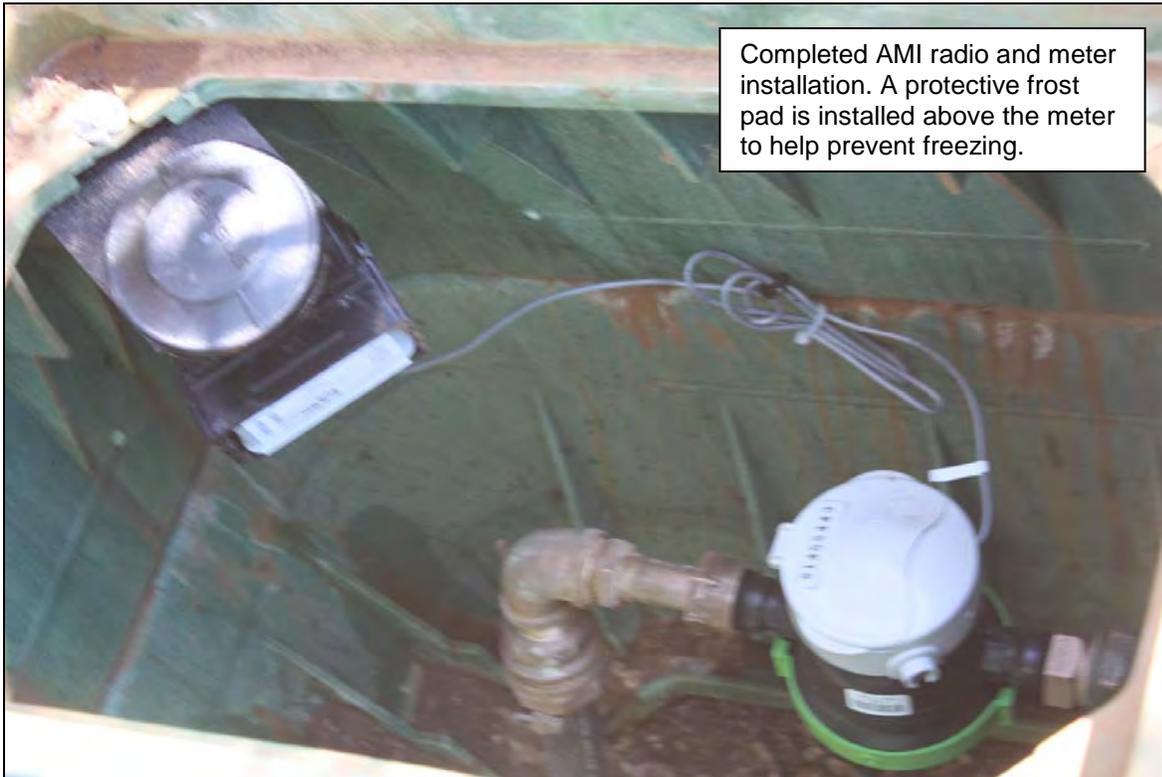
Completed AMI radio and meter installation. A protective frost pad is installed above the meter to help prevent freezing.
