# APPENDIX A

## Aerial Photos of the Project Area

## **Bankline Stabilization Design Plan and Screening of Alternatives**

**MEMORANDUM****Needles-Topock Erosion Protection, Screening of Alternatives**

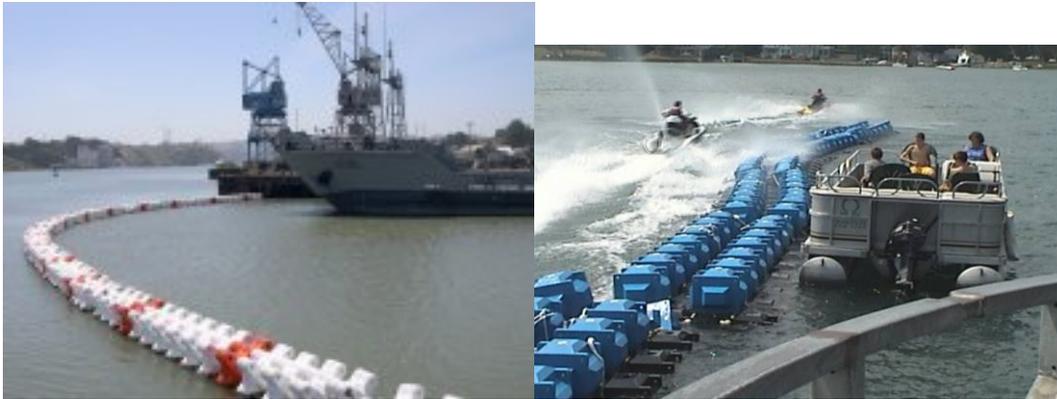
Figure 17. Wave Attenuators

Block shapes have been developed to dissipate wave energy. A couple different types are shown below in Figure 17. The configuration used is dependent on its purpose and location and is, to some degree, based on experience. Therefore, the arrangement may need to be adjusted once in place. This can be performed relatively easily.
