Tracy Technical Bulletin 2015-5

Hydraulic Evaluation of Hydrolox Traveling Screen in the Secondary Channel of the Tracy Fish Collection Facility

U.S. Department of the Interior
Bureau of Reclamation
Mid-Pacific Region and
Denver Technical Service Center

June 2016

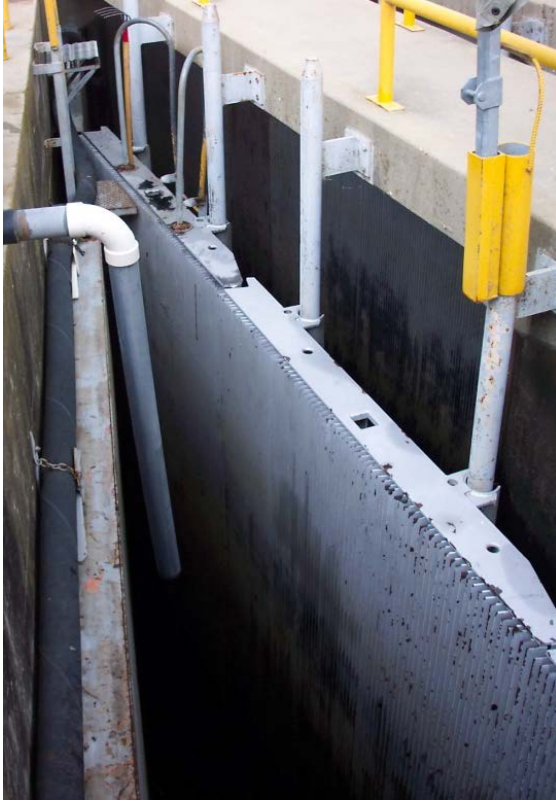
Figure 2. Original louver system in secondary channel.

The original louvers in the primary and secondary channel consisted of a series of vertical slats placed at 1-in (2.5-cm) spacing with slats oriented normal to the flow direction. The louvers are designed to generate disturbances in the flow field that fish avoid. Fish maintain a distance off of the louver face, while sweeping flow is intended to guide fish along the louver line and into the bypasses (Figure 2).

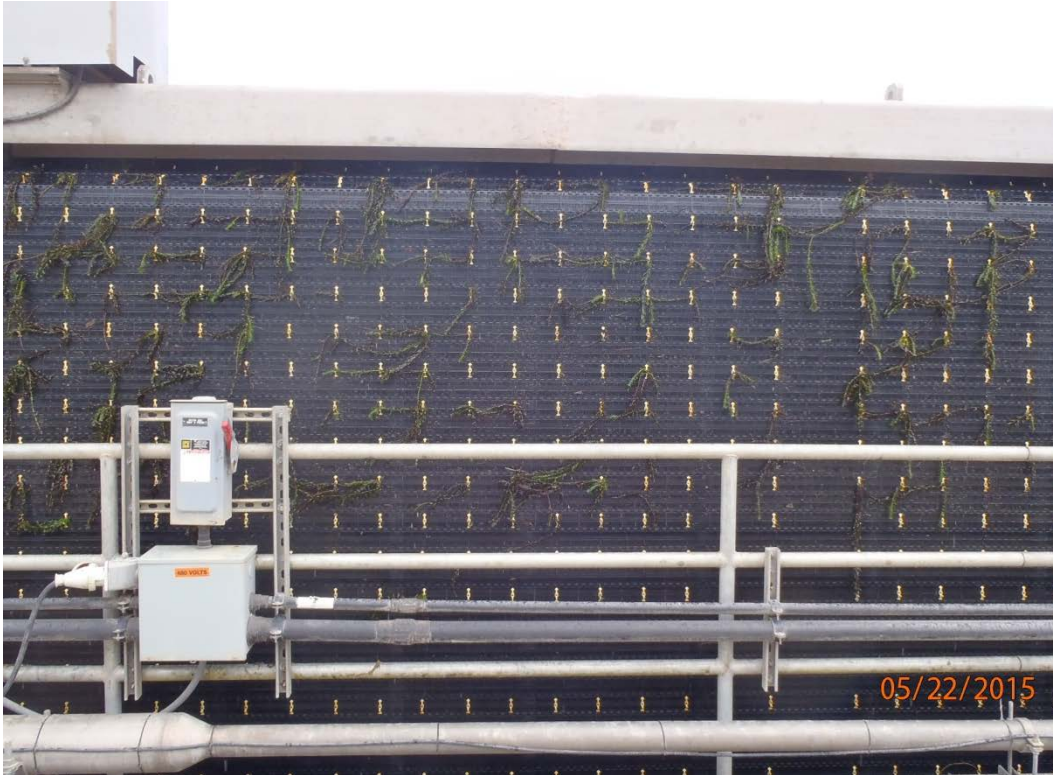
Figure 3. Debris pegs on the Hydrolox traveling screen loaded with the pond weed, Egeria.

tanks. Egeria, a common pond weed, is the primary debris load encountered at the TFCF (Boutwell and Sisneros 2007). Water hyacinth, a free-floating aquatic plant, and woody debris are also entrained at the TFCF. The design of the Hydrolox screens includes the recommended debris pegs which are intended to remove channel debris (pegs were specifically designed for Egeria removal) without needing to dewater the screens (Figure 3).

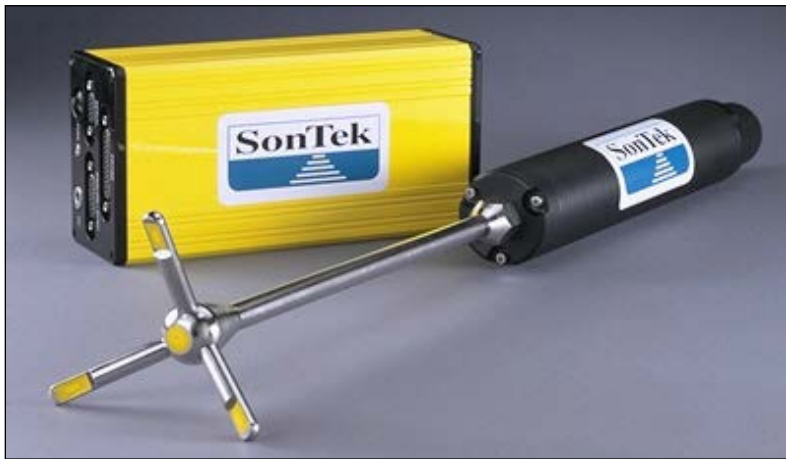
Figure 4. SonTek/YSI Field ADV probe and splash-proof signal processing module.

The major component of the hydraulic evaluation was making velocity measurements over the majority of the four traveling screen panels. Three-dimensional velocity measurements were taken 3 inches from the screen face using a SonTek/YSI acoustic Doppler velocimeter (ADV) as shown in Figure 4. The 16 MHz Micro ADV has an accuracy of $\pm 1\%$ of the measured velocity with a velocity range from ± 0.003 to 8.2 ft/s. Data were acquired at sampling rates of 25 Hz, allowing for the measurement of turbulence characteristics of the flow.

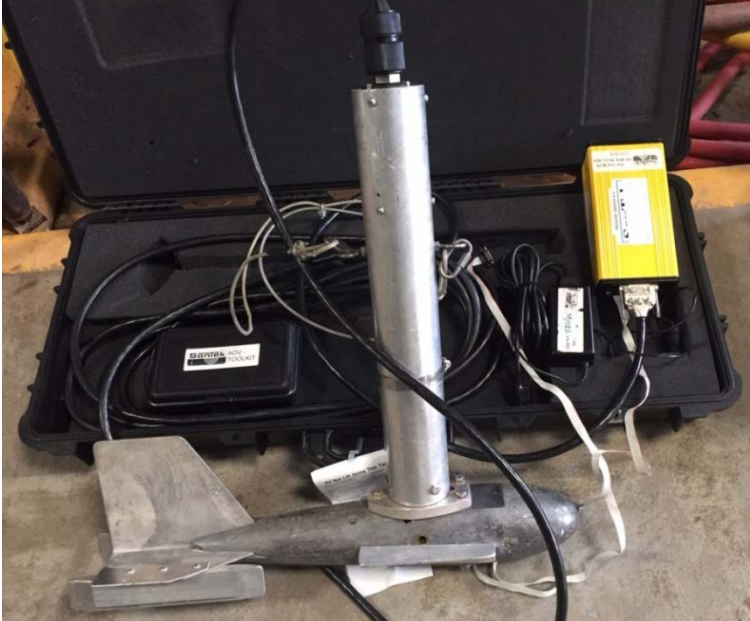
Figure 5. SonTek/YSI Micro ADV deployment setup used for the Hydrolox screen evaluation. The ADV probe is mounted inside a 2-in diameter aluminum tube. The sounding weight maintains the ADV position into the flow and offset 3 in from the screen face.

depth starting at the surface and working downward. Velocities were measured at three longitudinal positions across the screen before lowering the weight to the next water depth. At the mid-level (50 %) and near-bottom (80 %) depths, the sounding weight had to be pulled upstream using a tagline to compensate for the drag on the ADV probe.

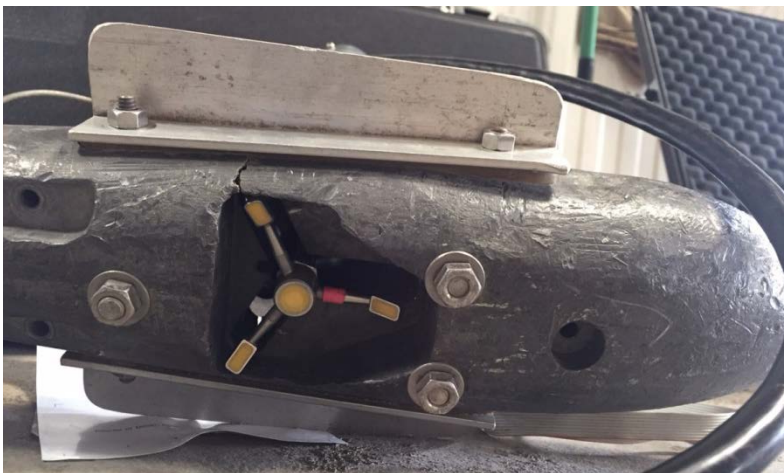
Figure 6 Close-up view of the SonTek Micro ADV probe's orientation inside the sounding weight. The arm with the red tape indicates the x-axis for this probe.

Approach velocities (perpendicular to the screen face), sweeping velocities (parallel to the screen face), and vertical velocities were measured with the ADV. The ADV was mounted inside a modified 50-lb sounding weight which was used to maintain the velocity probe's orientation with respect to the screen and to hold the probe stationary during data collection (Figure 5). The modified sounding weight has been used many times by the authors, and does not interfere with the sweeping or approach velocity measurements. The ADV was maintained at a distance of 3 inches from the screen face by metal fins that were retrofit to the sounding weight's body (Figure 5). The ADV probe head was positioned just above the bottom of the sounding weight and fixed in a position so the x-axis of the probe was parallel to the screen face (Figure 6).

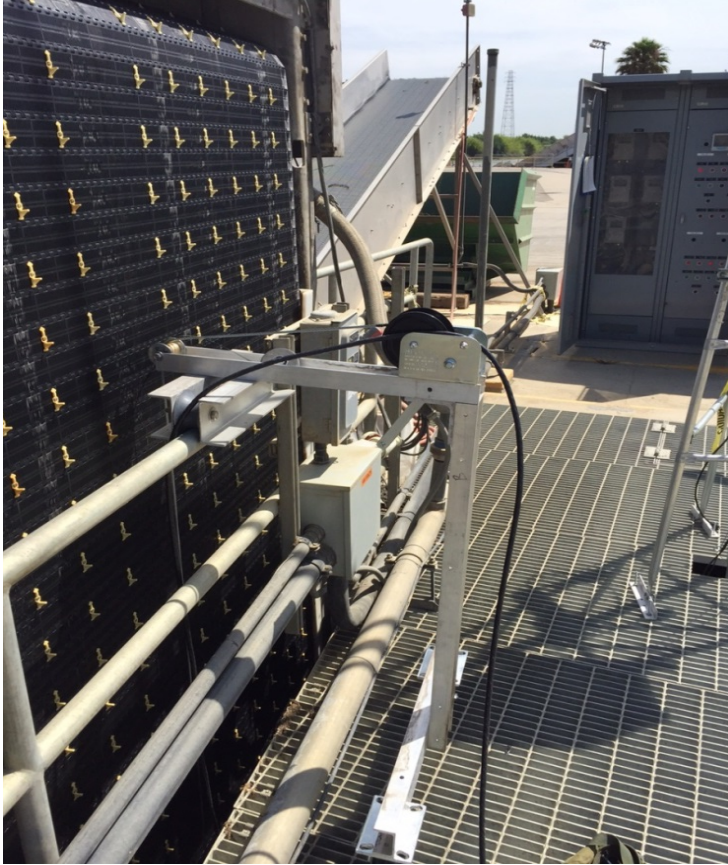
Figure 7. Photograph of Hydrolox screen panel No. 1 with yellow debris pegs. The velocity probe winch and trolley system is shown in the foreground. The conveyor debris collection system is shown in the background.

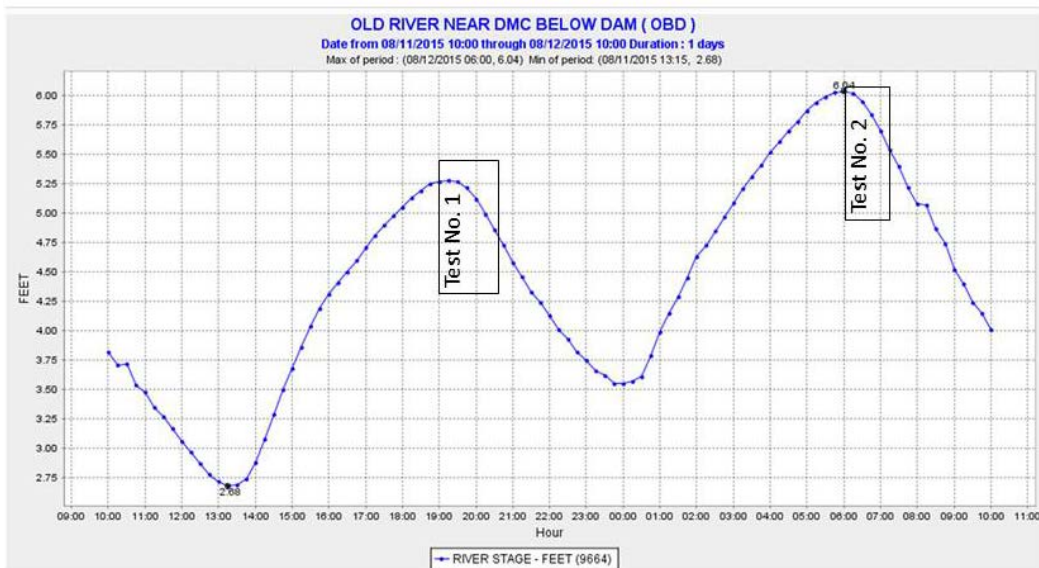
Figure 8. Tide conditions near the Tracy Fish Collection Facility during hydraulic evaluation data collection. The two test periods are indicated.

Two sets of velocity data were collected. Target secondary channel velocities were 3.0-3.5 ft/s to correspond to operating criteria when salmon are present, and less than 2.5 ft/s to correspond to operating criteria for striped bass, catfish, shad, and other fish (State Water Resources Control Board 1978). To maximize submergence on the screen, data were collected during high tides. High tides occurred from 19:00 to 20:30 on August 11, 2015 and from 06:00 to 08:00 on August 12, 2015. Figure 8 shows stage data from a gaging station on Old River near the Delta Mendota Canal and the two testing periods.

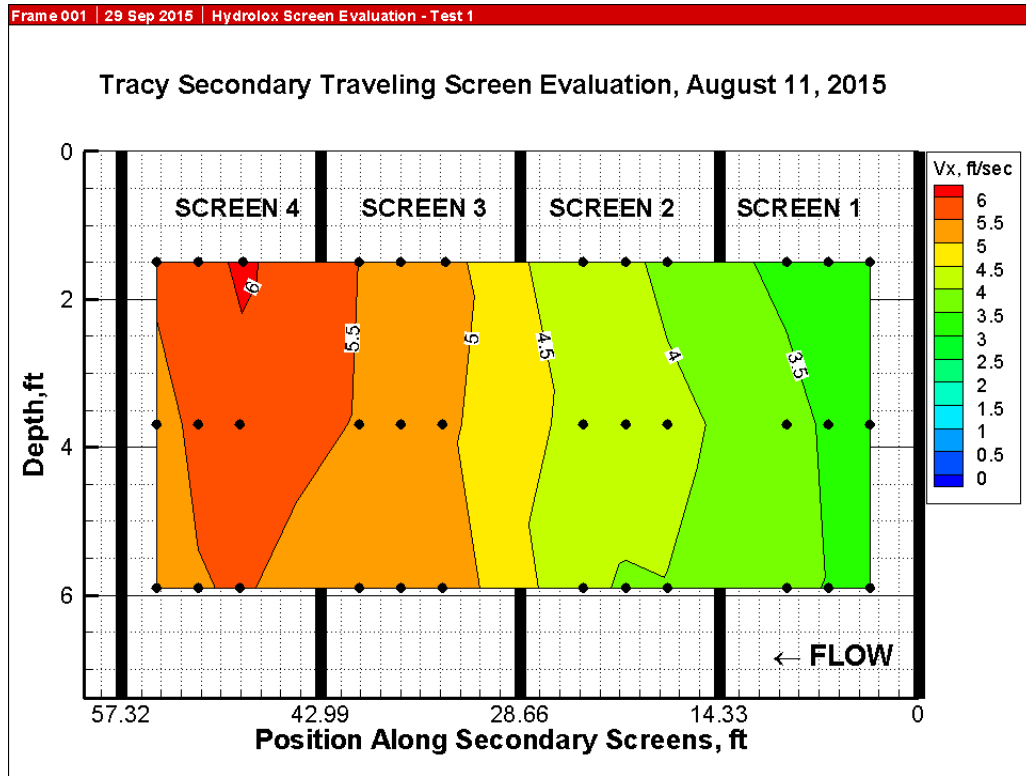
Figure 10. Test No. 1 sweeping velocity contours for a secondary channel velocity of 2.52 ft/s. The black dots represent velocity measurement locations.

Contours of the measured sweeping velocities (V_x) are displayed in Figure 10. Sweeping velocities increased from Screen 1 to Screen 4 as flow constricts down

to the bypass entrance. The overall average sweeping velocity was 4.59 ft/s with an average turbulent fluctuation of ± 0.20 ft/s. The overall average vertical velocity (V_z) was 0.03 ft/s with an average turbulent fluctuation of ± 0.11 ft/s. Tabular velocity data for Test No. 1 can be found in Appendix B.
