Tracy Technical Bulletin 2015-5

Hydraulic Evaluation of Hydrolox Traveling Screen in the Secondary Channel of the Tracy Fish Collection Facility

U.S. Department of the Interior
Bureau of Reclamation
Mid-Pacific Region and
Denver Technical Service Center

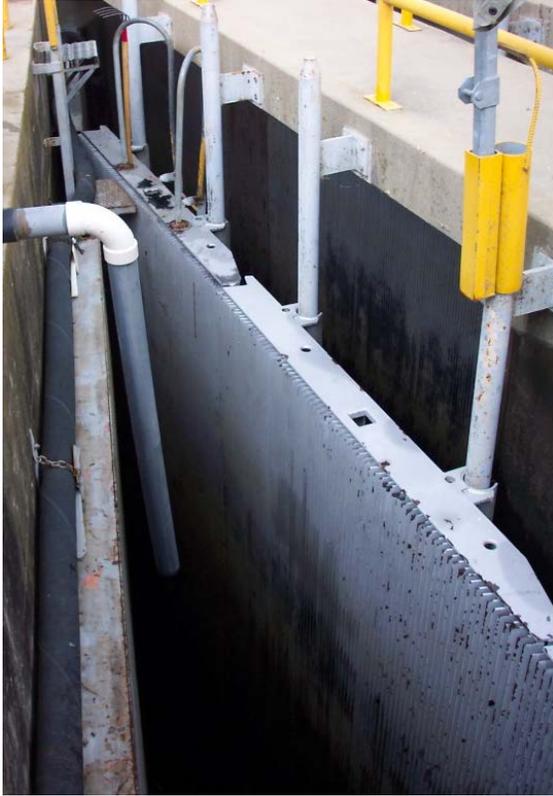
Figure 2. Original louver system in secondary channel.

The original louvers in the primary and secondary channel consisted of a series of vertical slats placed at 1-in (2.5-cm) spacing with slats oriented normal to the flow direction. The louvers are designed to generate disturbances in the flow field that fish avoid. Fish maintain a distance off of the louver face, while sweeping flow is intended to guide fish along the louver line and into the bypasses (Figure 2).

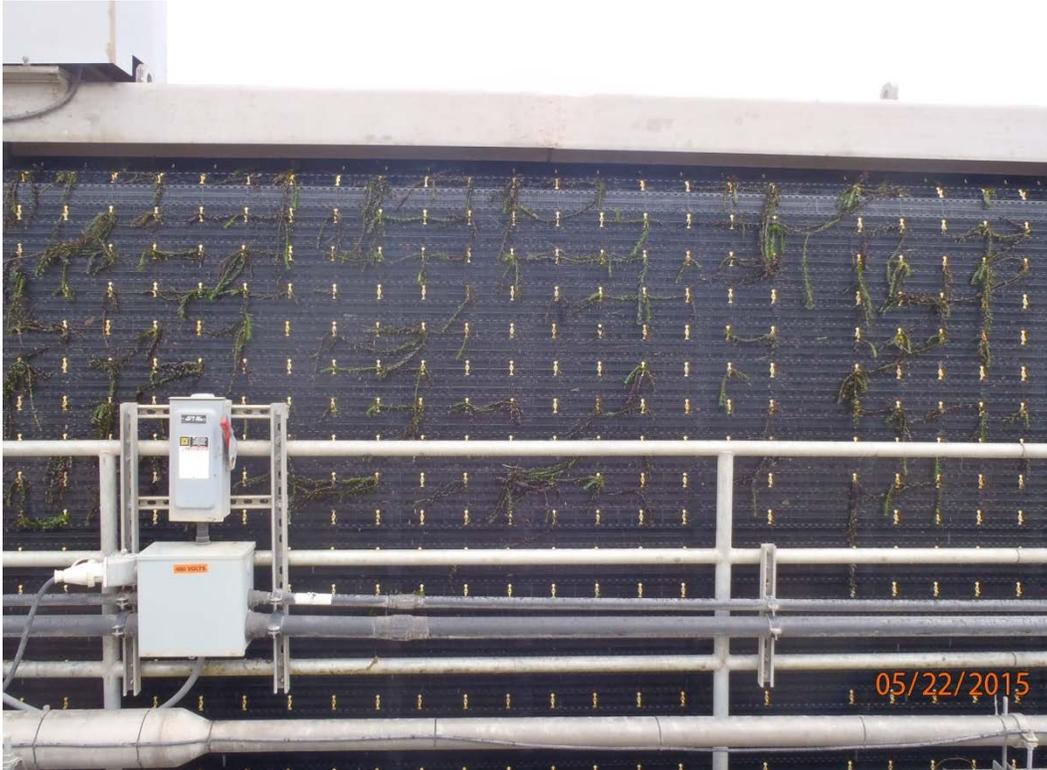
Figure 3. Debris pegs on the Hydrolox traveling screen loaded with the pond weed, Egeria.

tanks. Egeria, a common pond weed, is the primary debris load encountered at the TFCF (Boutwell and Sisneros 2007). Water hyacinth, a free-floating aquatic plant, and woody debris are also entrained at the TFCF. The design of the Hydrolox screens includes the recommended debris pegs which are intended to remove channel debris (pegs were specifically designed for Egeria removal) without needing to dewater the screens (Figure 3).

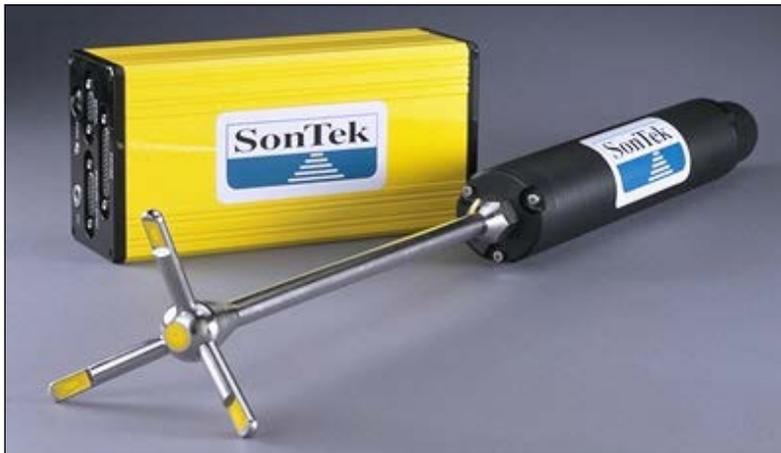
Figure 4. SonTek/YSI Field ADV probe and splash-proof signal processing module.

The major component of the hydraulic evaluation was making velocity measurements over the majority of the four traveling screen panels. Three-dimensional velocity measurements were taken 3 inches from the screen face using a SonTek/YSI acoustic Doppler velocimeter (ADV) as shown in Figure 4. The 16 MHz Micro ADV has an accuracy of $\pm 1\%$ of the measured velocity with a velocity range from ± 0.003 to 8.2 ft/s. Data were acquired at sampling rates of 25 Hz, allowing for the measurement of turbulence characteristics of the flow.

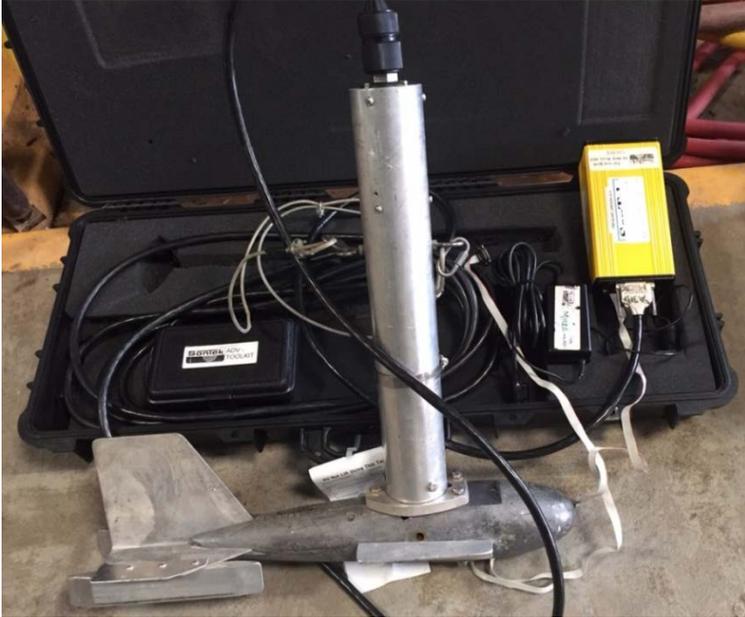
Figure 5. SonTek/YSI Micro ADV deployment setup used for the Hydrolox screen evaluation. The ADV probe is mounted inside a 2-in diameter aluminum tube. The sounding weight maintains the ADV position into the flow and offset 3 in from the screen face.

depth starting at the surface and working downward. Velocities were measured at three longitudinal positions across the screen before lowering the weight to the next water depth. At the mid-level (50 %) and near-bottom (80 %) depths, the sounding weight had to be pulled upstream using a tagline to compensate for the drag on the ADV probe.

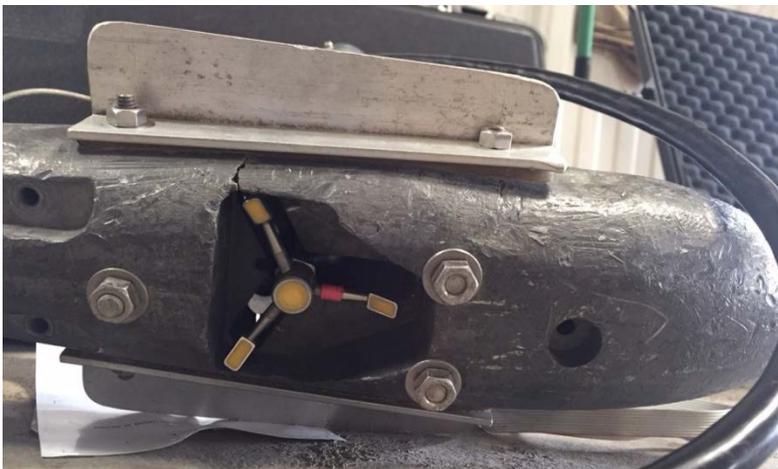
Figure 6 Close-up view of the SonTek Micro ADV probe's orientation inside the sounding weight. The arm with the red tape indicates the x-axis for this probe.

Approach velocities (perpendicular to the screen face), sweeping velocities (parallel to the screen face), and vertical velocities were measured with the ADV. The ADV was mounted inside a modified 50-lb sounding weight which was used to maintain the velocity probe's orientation with respect to the screen and to hold the probe stationary during data collection (Figure 5). The modified sounding weight has been used many times by the authors, and does not interfere with the sweeping or approach velocity measurements. The ADV was maintained at a distance of 3 inches from the screen face by metal fins that were retrofit to the sounding weight's body (Figure 5). The ADV probe head was positioned just above the bottom of the sounding weight and fixed in a position so the x-axis of the probe was parallel to the screen face (Figure 6).

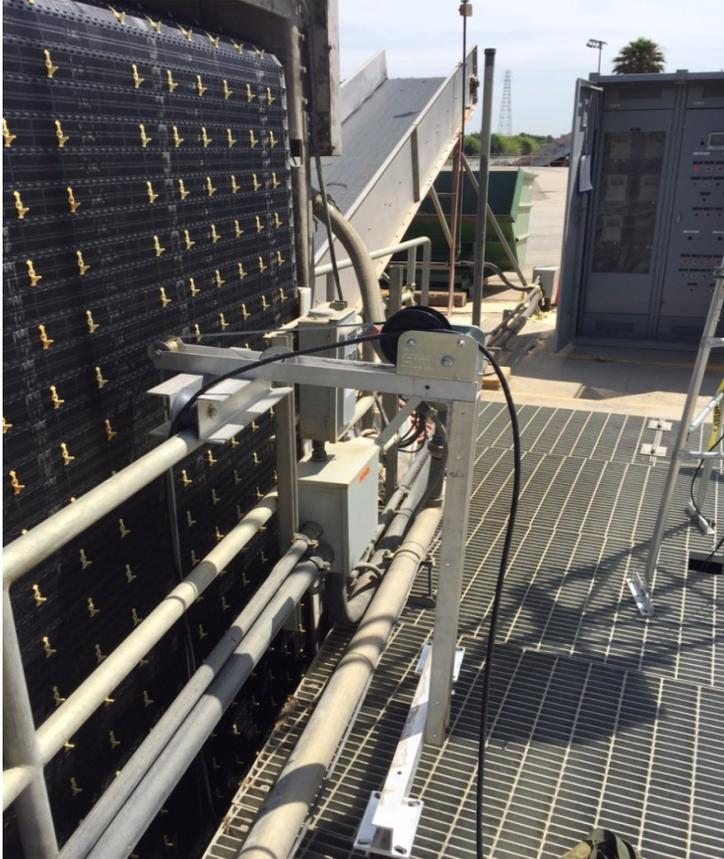
Figure 7. Photograph of Hydrolox screen panel No. 1 with yellow debris pegs. The velocity probe winch and trolley system is shown in the foreground. The conveyor debris collection system is shown in the background.
