**Site Assessment for California Red-  
Legged Frog for the Battle Creek Salmon  
and Steelhead Restoration Project—  
Jeffcoat East and West, Willow Springs,  
and Asbury Project Sites**

January 2005

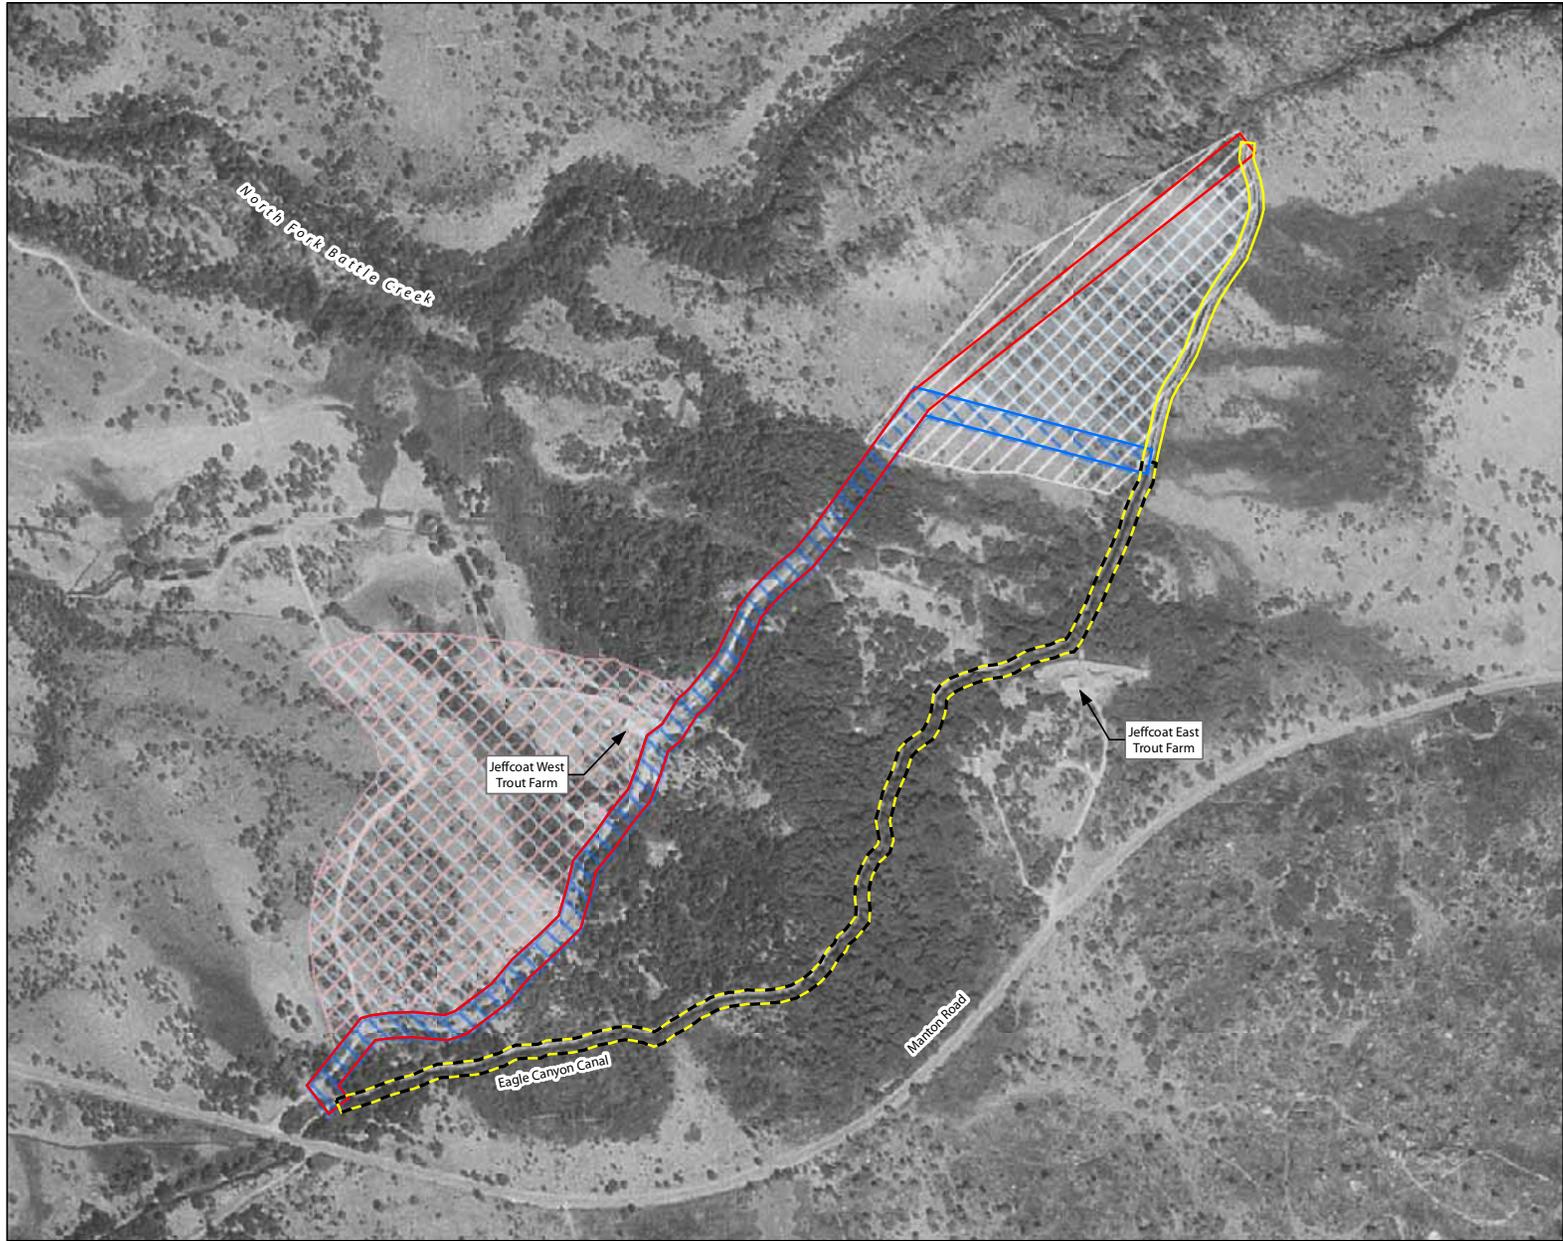
**FIGURE 2**  
 PROPOSED CONSTRUCTION AREAS AT THE  
 JEFFCOAT EAST AND WEST MITIGATION SITE

Four different pipeline alignments are proposed at the Jeffcoat East and Jeffcoat West facilities (Figure 2). The four different alignments include:

**Alternative A, Cross-Country Alignment**—The Alternative A pipeline alignment will follow a new “cross-country” alignment downslope of the present canal (Figure 2). This alignment is approximately 4,500 feet (1,372 m) long, and the construction corridor will be approximately 80 feet (24 m) wide along the length of this alignment. The first leg of the pipeline alignment extends from the Eagle Canyon Canal flume across open rangeland that crosses an existing drainage. As the route continues southwest, it parallels an existing access road through the Jeffcoat West facility. This route would avoid all spring sources associated with the Jeffcoat East facility (located east and uphill of Eagle Canyon

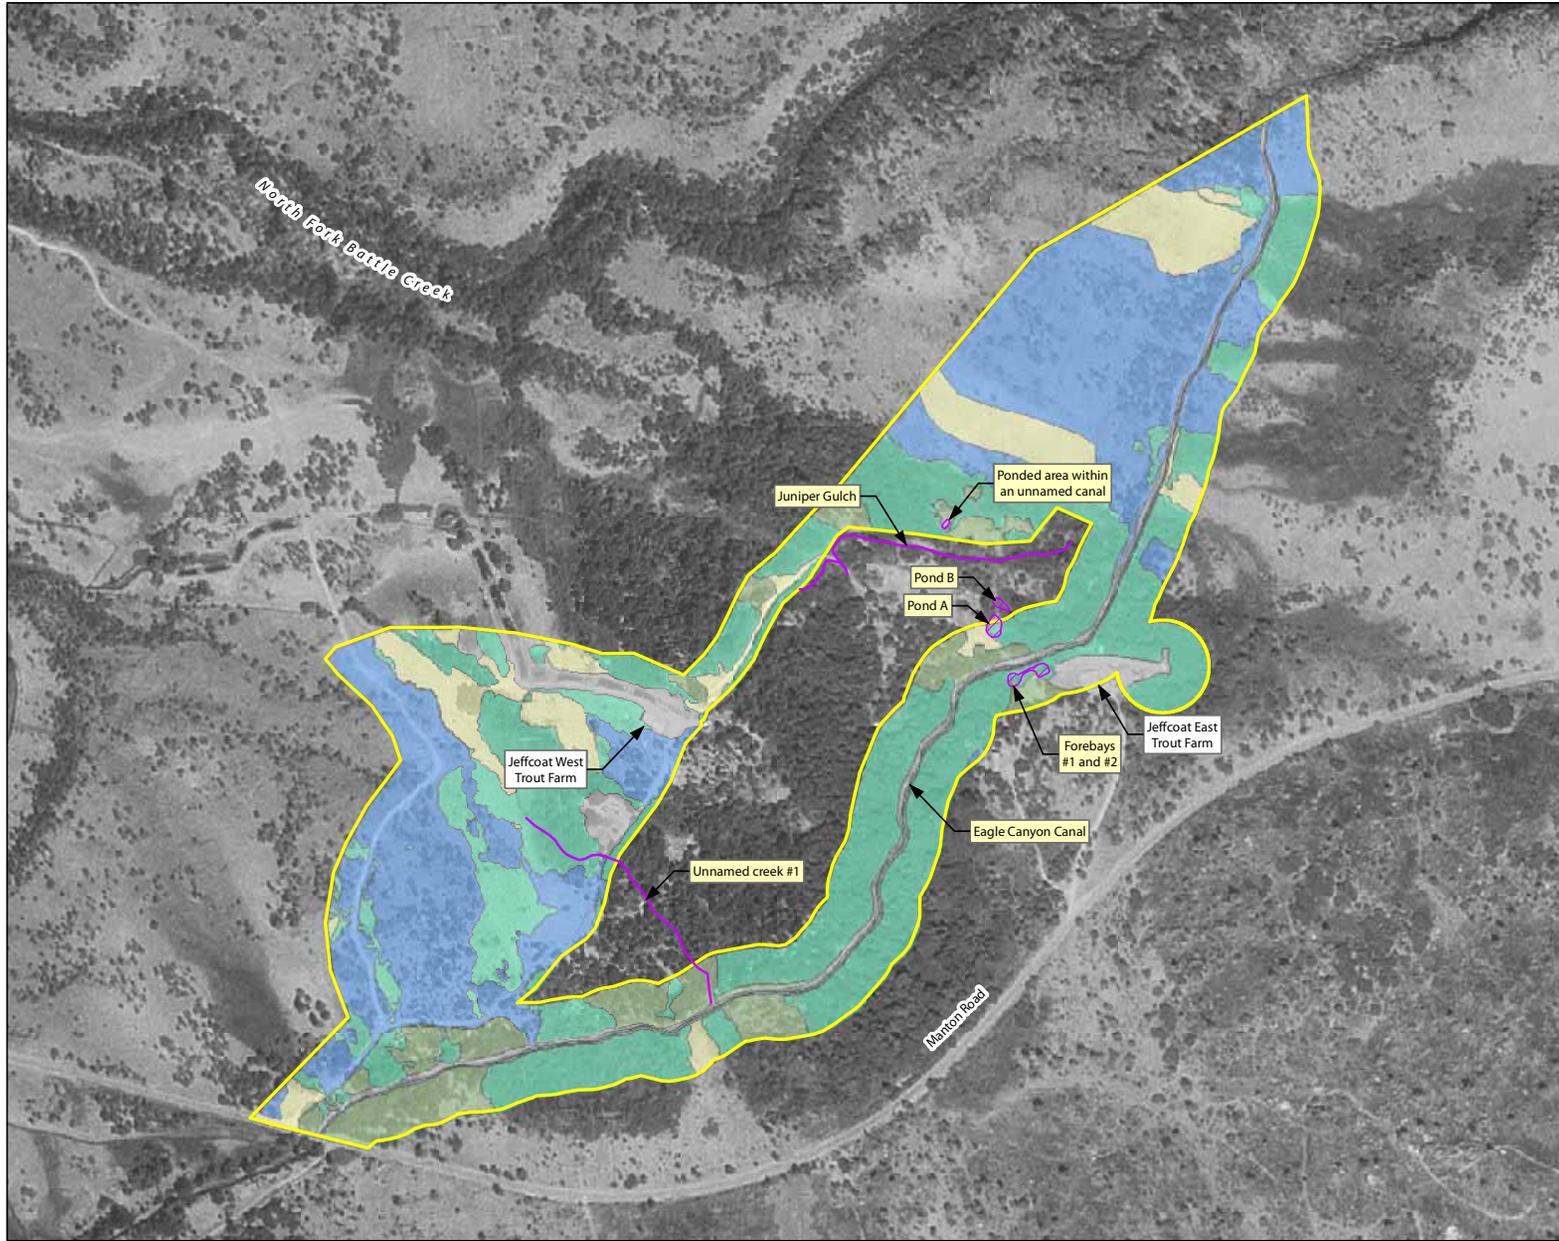
**FIGURE 5**  
 AREAS ASSESSED FOR SUITABILITY FOR CALIFORNIA RED-LEGGED FROG AT THE JEFFCOAT EAST AND WEST MITIGATION SITE

Pond A is located north of Eagle Canyon Canal, on the eastern side of the study area (Figure 5). The pond is approximately 80 feet (24 m) long by 60 feet (18 m) wide (Figure 6). Depth of the pond could not be determined because of a layer of algae and sludge on the surface of the pond. The pond is completely surrounded by vegetation such as willows, cattails, sedges, and various grasses. The surrounding upland consists of oak woodland, disturbed grassland, and patches of dense wetland vegetation. Upland vegetation included curly dock (*Rumex crispus*), willows (*Salix* sp.), white alder (*Alnus rhombifolia*), valley oak (*Quercus lobata*), yellow star-thistle (*Centaurea solstitialis*), and various grasses.

Forebays #1 and #2 are located south of Eagle Canyon Canal on the eastern side of the study area (Figure 5). It appears that water is diverted from the Eagle Canyon Canal to flow through fish rearing facilities and then is returned to the canal. Before returning to the canal, the water pools within two forebays just west of the fish rearing facility. Forebay #1 could be viewed from the fish rearing facility; however, forebay #2 was not visible from this point and could not be accessed from other points because of the presence of the canal. Forebay #1 is connected to forebay #2 through a short channel. Forebay #1 is approximately 50 feet (15 m) long by 50 feet (15 m) wide with a depth of 1–2 feet (0.3–0.6 m) (Figure 7). The substrate is silt and cobble. There was a fair amount of emergent and floating vegetation along the edges of the forebay. Vegetation surrounding the pond included watercress, willows, and Himalayan blackberry. No red-legged frogs, other amphibians, or fish were observed in the forebay. Forebay #1 appears to provide suitable breeding and refuge habitat for red-legged frogs. It is likely that forebay #2 is similar to forebay #1 because of their close proximity, and it is assumed that this area also provides suitable habitat for red-legged frogs.

Eagle Canyon Canal flows along the eastern edge of study area (Figure 5). The canal has steeply cut banks that are concrete lined (Figure 8). The upper edges are covered with cobble and grassy vegetation. Silt and cobble cover the canal bottom. Water flow in the canal was moderately swift, and water depth was approximately 1 foot (0.3 m). Surrounding vegetation consists of valley oak, live oak (*Q. wislizenii*), and white alder. No red-legged frogs, other amphibians, or fish were observed in the canal. Because of the steep banks and moderately swift flowing water, Eagle Canyon Canal does not appear to provide suitable breeding, refuge, or dispersal habitat for red-legged frogs.

Unnamed creek #1 is located in the southern portion of the study area (Figure 5). Traveling southwest to northeast, this unnamed creek is the first visible creek that is crossed by the access road through the study area. The creek was dry except for a small puddle near the culvert (Figure 9). The creek channel was approximately 4 feet (1.2 m) wide and has low-sloped banks. Depth of the creek is probably ranges from a few inches to a foot deep when flowing. The substrate consists of silt and cobble. Vegetation along the creek consists of grasses, Himalayan blackberry, white alder, and valley oak. No red-legged frogs or other amphibian species were observed in the creek; however, the creek was not walked because of the presence of an aggressive dog. It appears that the creek would provide appropriate refuge and dispersal habitat for red-legged frogs, but based on the vegetation present in the creek, it is unlikely to hold water long enough to support breeding.

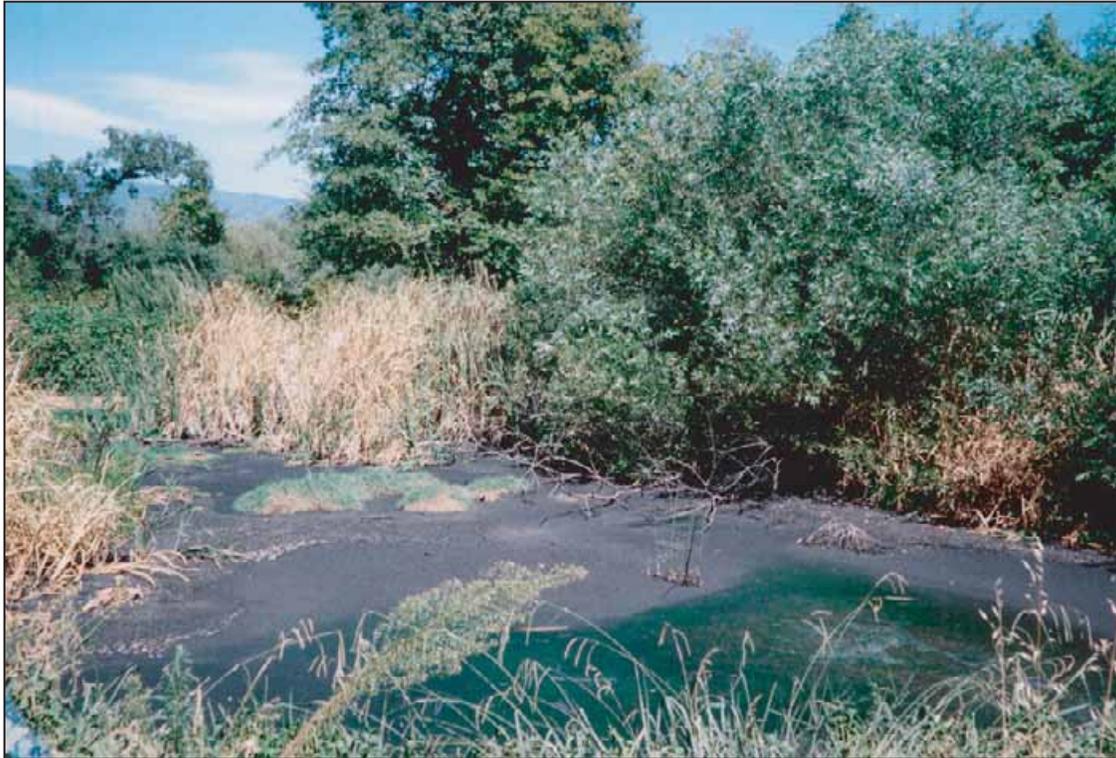
Pond A.

The upland vegetation was very dense and tall. Pond A is used to grow bloodworms to use as fish food for the MLTF. Fish wastes are placed in the pond to create conditions that are suitable to grow bloodworms. The condition of Pond A was very poor at the time of the site assessment. The pond emitted a strong putrid smell and appeared severely polluted. No red-legged frogs, other amphibians, or fish were observed in the pond. Pond A appears to provide appropriate breeding and refuge habitat for red-legged frogs; however, its use as a bloodworm breeding area may decrease the quality of the habitat.

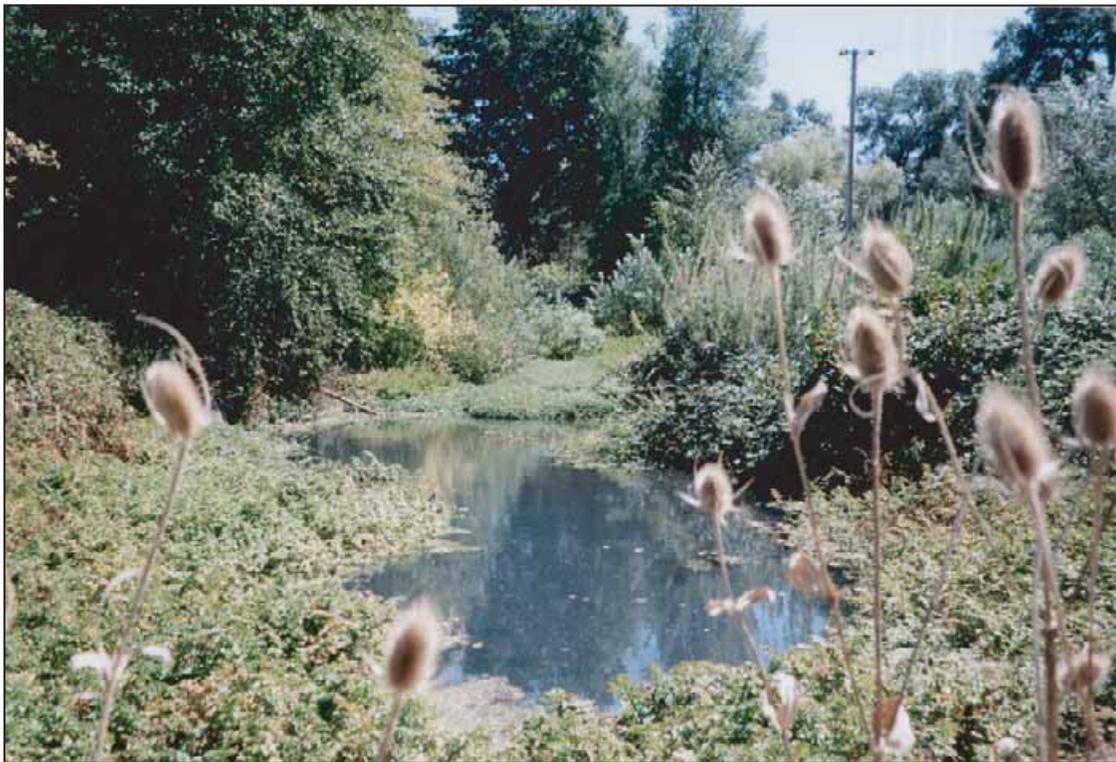
Pond B.

Pond B is located north of Pond A, just outside the study area (Figure 5). This pond is approximately 60 feet (18 m) long by 25 feet (8 m) wide with a depth of 1–2 feet (0.3–0.6 m) (Figure 6). Pond B was viewed from its northwest side. The entire pond is surrounded by vegetation consisting mainly of watercress (*Rorippa nasturtium-aquaticum*) and Himalayan blackberry (*Rubus discolor*). A fair amount of algae and floating vegetation were present in the pond. A large number of cattails (*Typha* sp.) to the north of the pond indicate that there is flow from the pond northward. This area was damp but did not appear to pond. Pond B shares upland with Pond A. This pond is also used to grow bloodworms for the MLTF. Although the condition of pond B was fair during the site visit, this pond could become foul during other times of the year, as indicated by Pond A. No red-legged frogs, other amphibians, or fish were observed in the pond. Pond B appears to provide appropriate breeding and refuge habitat for red-legged frogs; however, its use as a bloodworm breeding area may decrease the quality of the habitat.

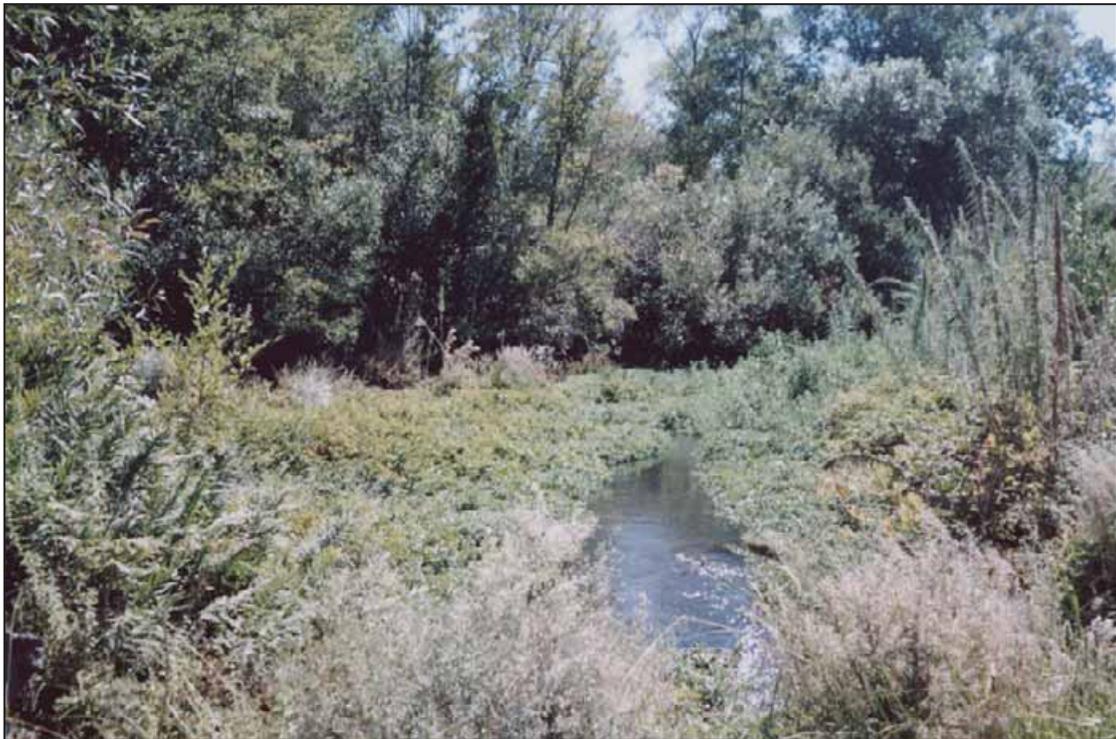
Juniper Gulch.

Juniper Gulch crosses the access road through the study area at two locations and parallels a portion of the study area (Figure 5). This creek is obscured from sight along a substantial portion of its length because of dense vegetation. The portion of the creek that was most visible and accessible occurs near the point where the road heading northeast curves to the east. Evaluation of this creek was made from this location. Juniper Gulch is a small stream ranging from 1 to 4 feet (0.3 to 1.2 m) wide with an average depth of 12 inches (30 cm) (Figure 7). The channel width may actually be larger, but its edges are obscured by dense vegetation. The substrate consists of silt and cobble. On the south side of the road, there is a small run near the culvert, which becomes a slow-flowing pooled area (Figure 7). On the north side of the road, the creek is almost completely covered by low growing wetland vegetation. Streamside vegetation consists of Himalayan blackberry, white alder, willows, and ferns. The surrounding upland consists of oak woodland and patches of dense wetland vegetation. No red-legged frogs, other amphibians, or fish were observed in the creek. Juniper Gulch appears to provide suitable breeding, refuge, and dispersal habitat for red-legged frogs.

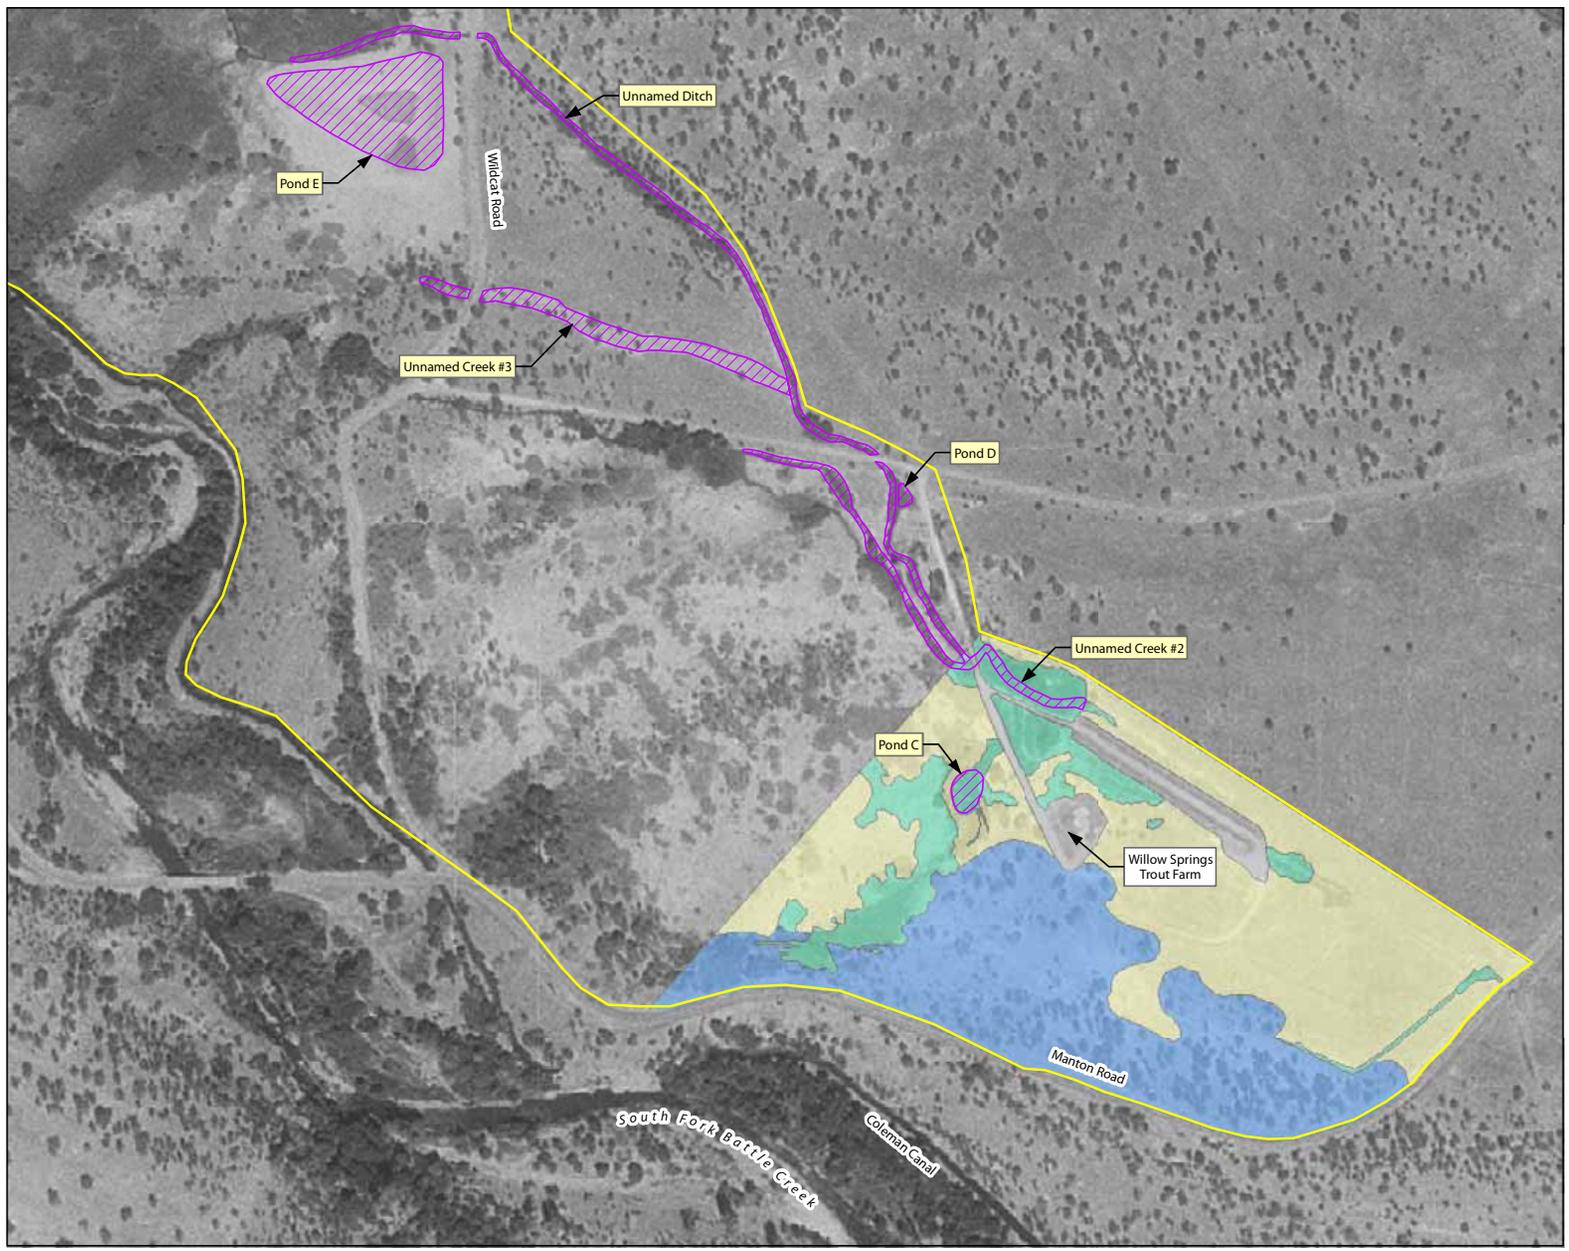
**FIGURE 10a**

Pond D is located near the hatchery entrance in the northeastern portion of the study area (Figure 10a). The maximum size of the pond is approximately 50 feet (15.2 m) by 25 feet (7.6 m), but the area that was ponded during the survey was about 35 feet (10.7 m) by 15 feet (4.6 m) (Figure 12). The depth of the pond was

Pond E is located near the center of the study area (Figure 10a) and is approximately 260 feet (79.2 m) long by 130 feet (39.6 m) wide (Figure 13). Pond depth ranged from a foot to several feet deep. The pond was created by a large borrow pit. The southern corner of the pond has emergent vegetation consisting of cattails; the remainder of the pond does not have emergent vegetation. The pond perimeter is moderately sloped and covered with cobble and grasses. No red-legged frogs, other amphibians, or fish were observed in the pond. The upland consists of oak woodland. Pond E provides suitable breeding and refuge habitat for red-legged frog.

An unnamed ditch crosses Wildcat Road, just northeast of Pond E (Figure 10a). Water in this ditch comes from unnamed creek #3. The ditch is 3 feet (0.9 m) wide and has a silt, gravel, and cobble substrate (Figure 13). Depth of water was approximately 6 inches (15.2 cm). Water in the creek was fairly slow flowing with a few riffles. The slopes of the ditch are low to moderately sloped and covered with cobble, boulders, grasses, and Himalayan blackberry. Low-growing emergent or floating vegetation was present along the edges of the ditch. No red-legged frogs, other amphibians, or fish were observed in the ditch. The

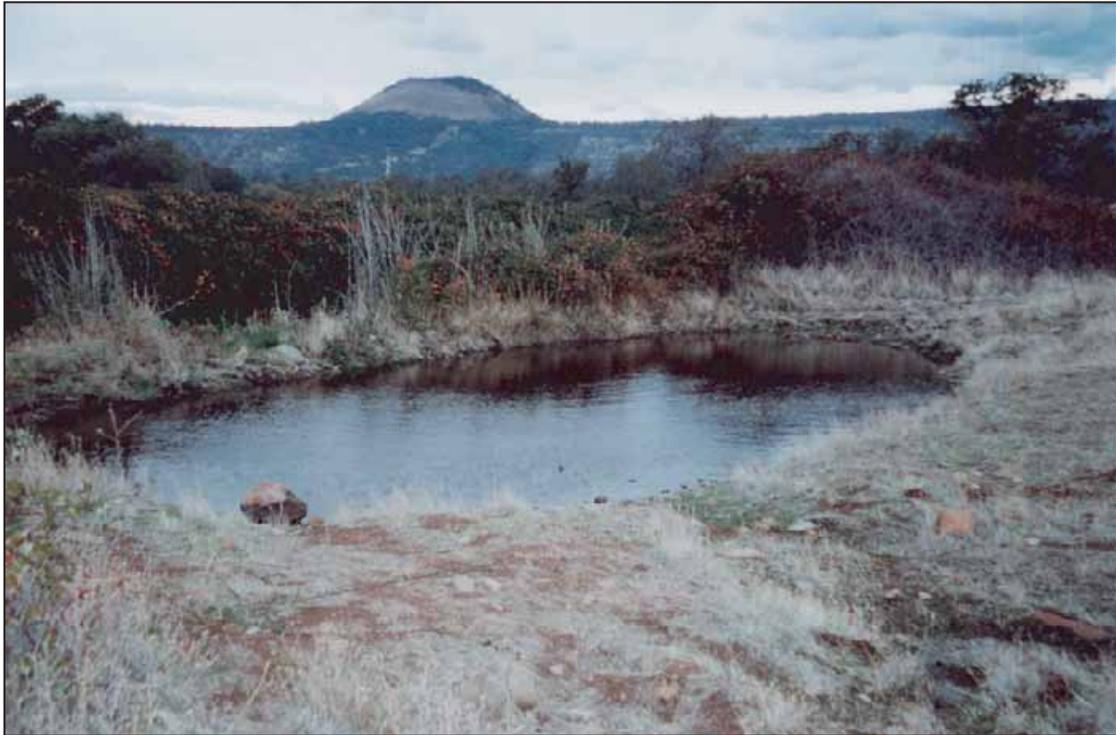
about 1 foot (0.3 m) at the time of the survey but could reach a maximum depth of approximately 2 feet (0.6 m). The pond appears to be filled by an irrigation pipe and from spillover from the creek when the water level gets high. There was no emergent vegetation within Pond D. The perimeter of the pond was covered with grassy vegetation. No red-legged frogs, other amphibians, or fish were observed in the pond. The upland consists of oak woodland. Because of the shallow depth and lack of emergent vegetation, this pond does not appear to stay inundated long enough to provide appropriate breeding or refuge habitat for red-legged frogs.

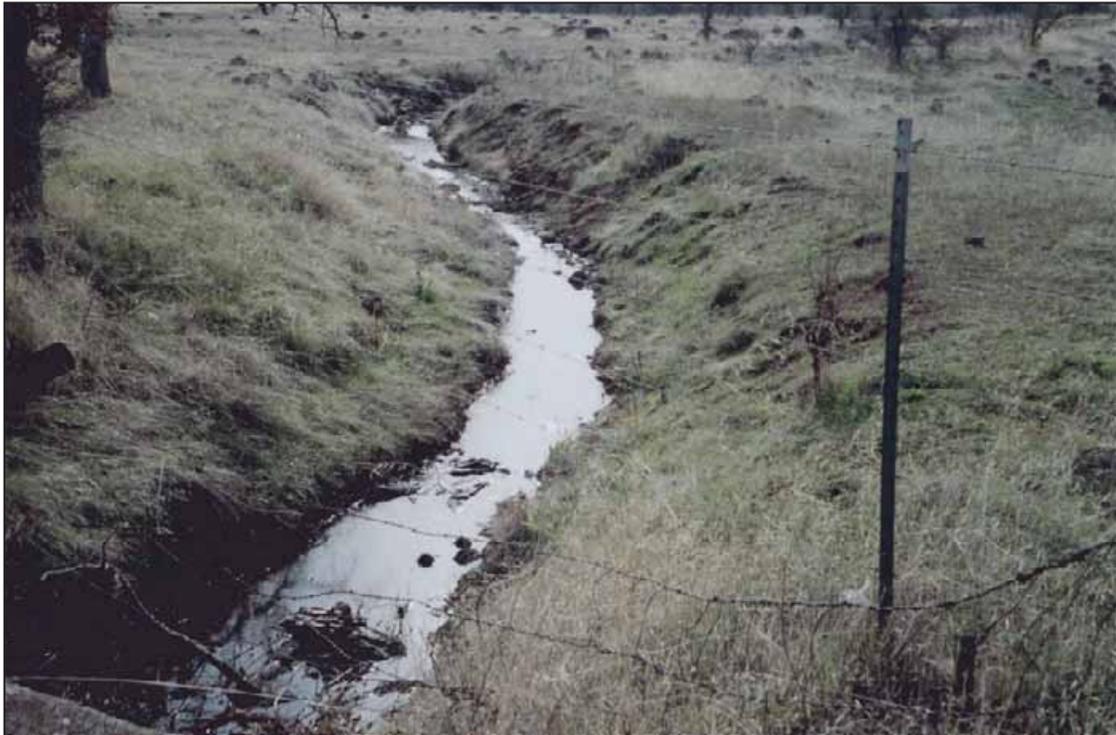
**Figure 14**  
**Wildcat Canal at Wildcat Road near the**  
**Willow Springs Mitigation Site**

Wildcat Canal is located at the northwest end of the project site (Figure 10b). The canal was viewed from the point where Wildcat Road crosses it (Figure 4). The north (upstream) side of the canal was dry; the south (downstream) side had shallow standing water (less than 6 inches [15.2 cm]) (Figure 14). The canal is 2–3 feet (0.6–0.9 m) wide with a silt bottom with some cobble and woody debris. The banks of the canal are moderately sloped and are covered with grassy vegetation. The upland consists of oak woodland. The canal may provide dispersal habitat for red-legged frog but does not appear to provide appropriate breeding or refuge habitat.

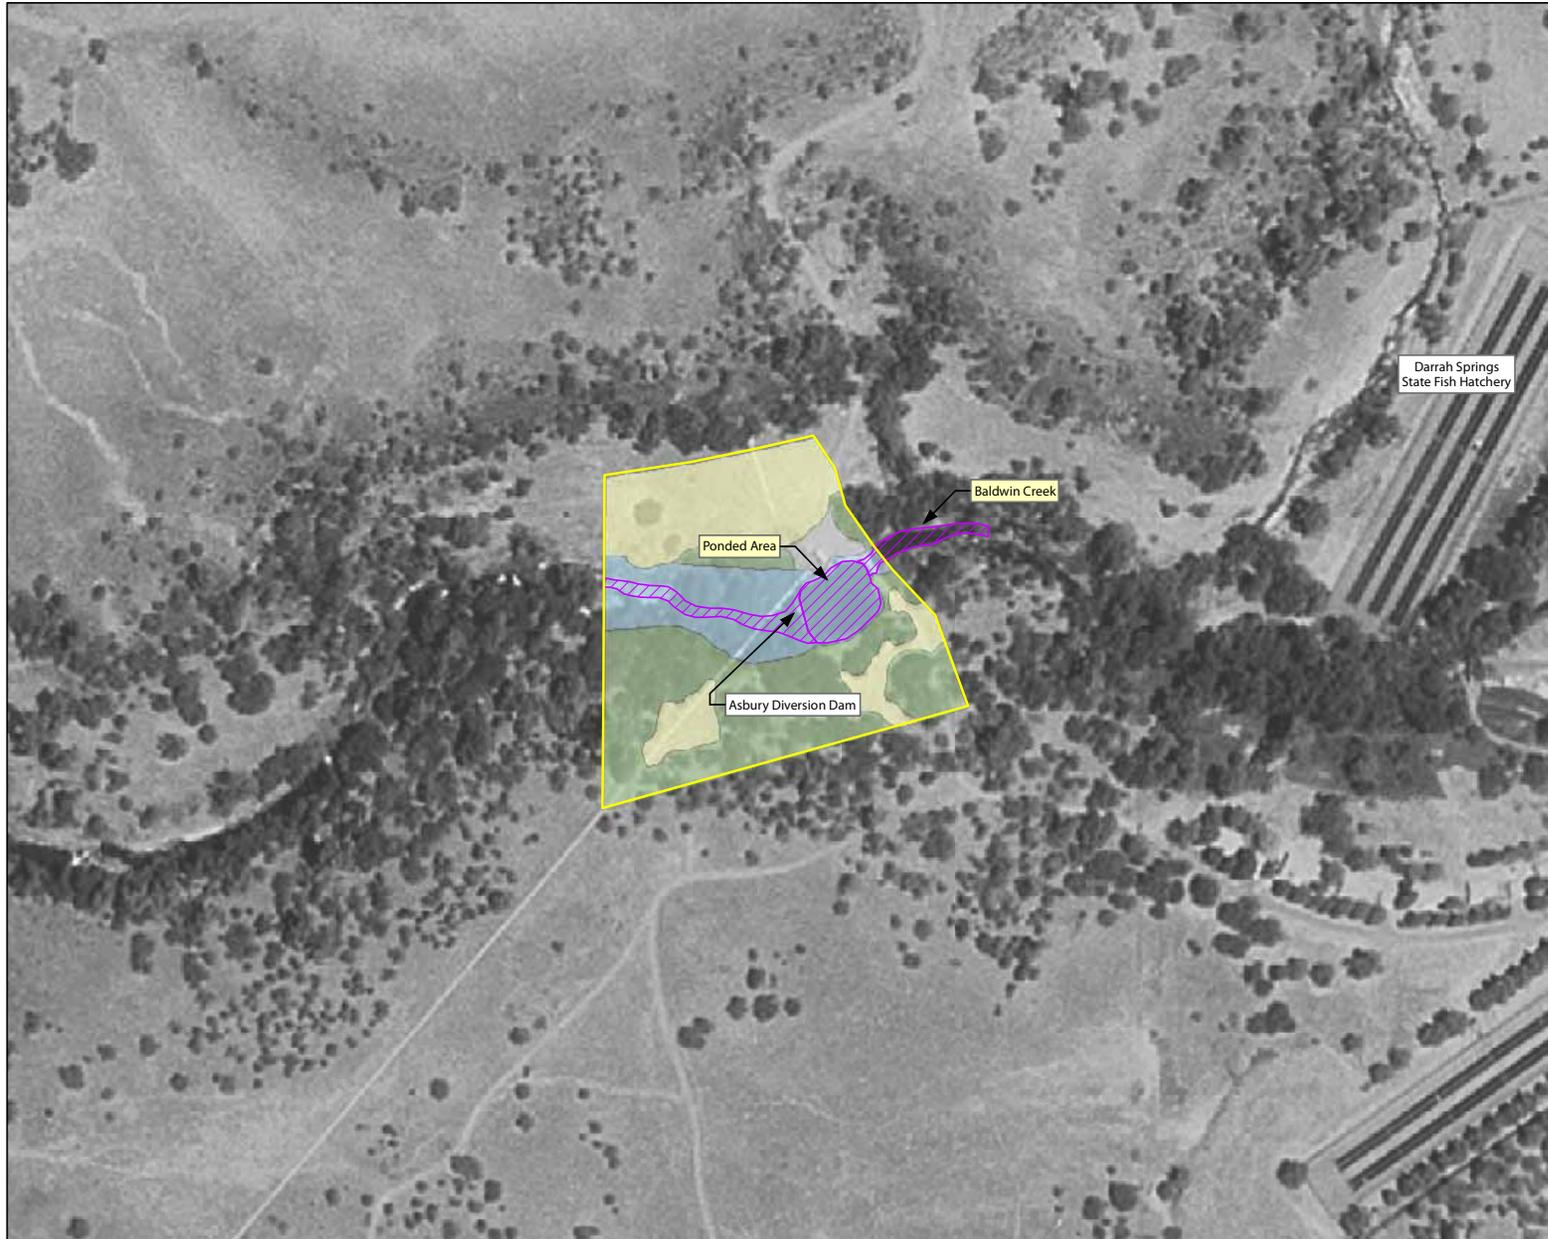
**FIGURE 15**

Baldwin Creek passes through the middle of the Asbury Diversion Dam study area (Figure 15). The Asbury Dam has created a large ponded area within the creek (Figure 16). This ponded area is approximately 100 feet (30.5 m) long by 100 feet (30.5 m) wide. An island within the ponded area is covered with Himalayan blackberry, small alders, and cattails. The ponded area is 1–4 feet (0.3–1.2 m) deep and has a silt and cobble bottom. Approximately half of the perimeter of the ponded area is concrete lined. Another quarter of the perimeter of the pond is steeply sloped and covered with Himalayan blackberry. The remainder of the pond perimeter is gently sloped and covered with low-growing vegetation and a small valley oak. Fish were observed in the ponded area but no red-legged frogs or other amphibians were observed. This ponded area appears to provide suitable breeding habitat for red-legged frog, however the steep edges on the majority of the pond and the presence of fish decrease the suitability.

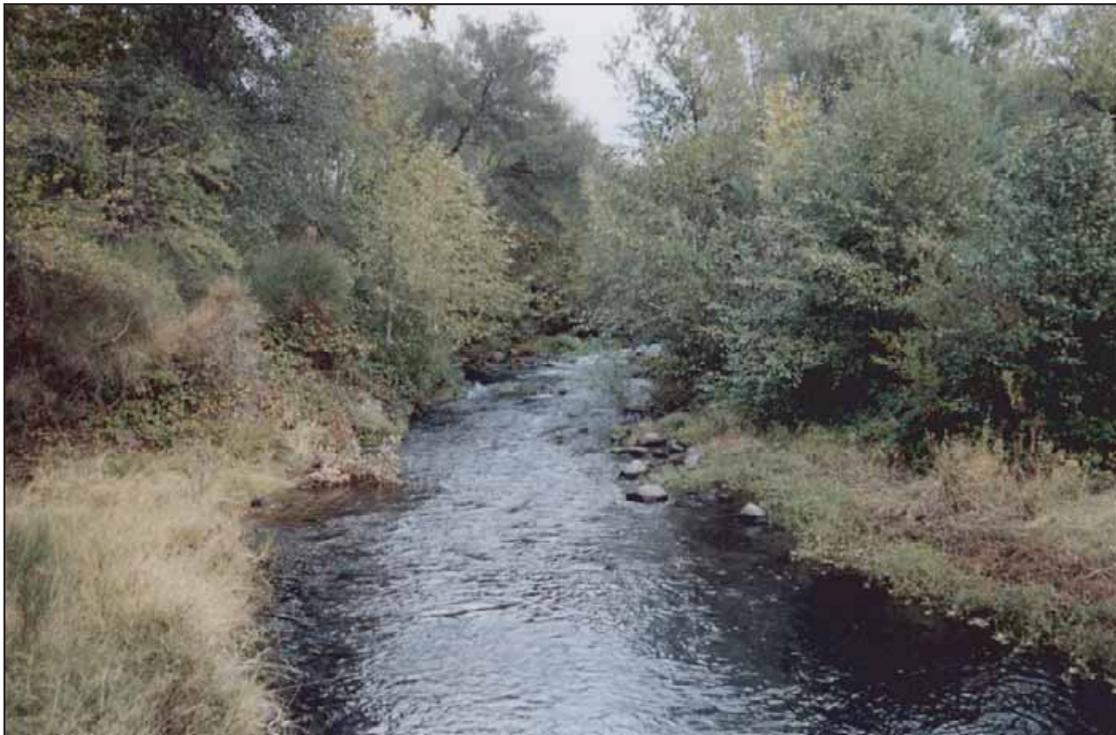
Baldwin Creek - upstream of ponded area.

Baldwin Creek upstream of the ponded area is approximately 20 feet (6.1 m) wide with a bedrock and boulder substrate (Figure 16). The flow is moderate with riffle and run. No pooled areas were observed from the road overcrossing. The banks of the creek are gently sloped and covered with grassy vegetation. Vegetation alongside the creek includes alders, willows, Himalayan blackberry, and valley oak. Baldwin Creek upstream of the ponded area does not provide suitable habitat for red-legged frogs because of the unsuitable substrate and lack of pooled areas and emergent vegetation.

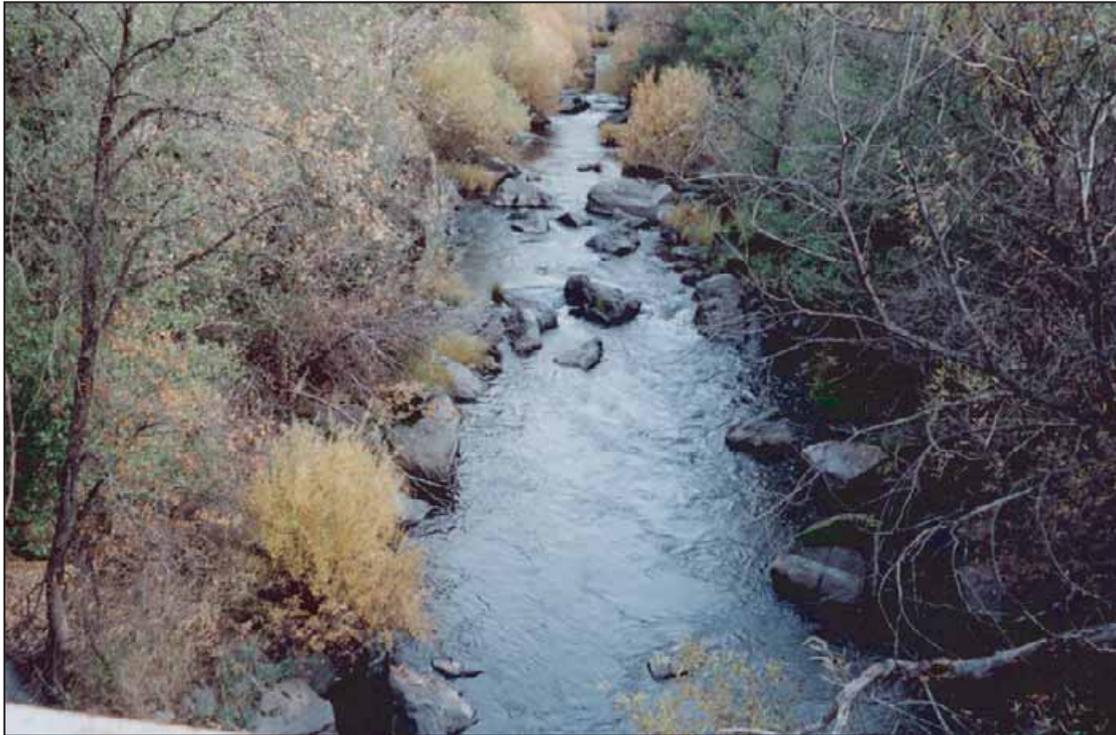
North Fork Battle Creek.

North Fork Battle Creek is within 1 mile (1.6 km) of the Jeffcoat East and West and Willow Springs mitigation sites. North Fork Battle Creek was evaluated from the Wildcat Road overcrossing (Figure 4). North Fork Battle Creek is a fast-flowing stream with a boulder, cobble, and gravel substrate (Figure 17). The creek is dominated by riffle and run, and no pooled areas were visible from Wildcat Road. However, a few slower backwater areas are present. Vegetation adjacent to the creek consists of willows, oaks, and grasses. The canopy over the creek is fairly open. Although a few backwater areas may provide suitable areas for red-legged frogs, the majority of the creek did not appear to provide suitable breeding, dispersal, or refuge habitat because of the high flow-rate, rocky substrate, and lack of pool habitat.

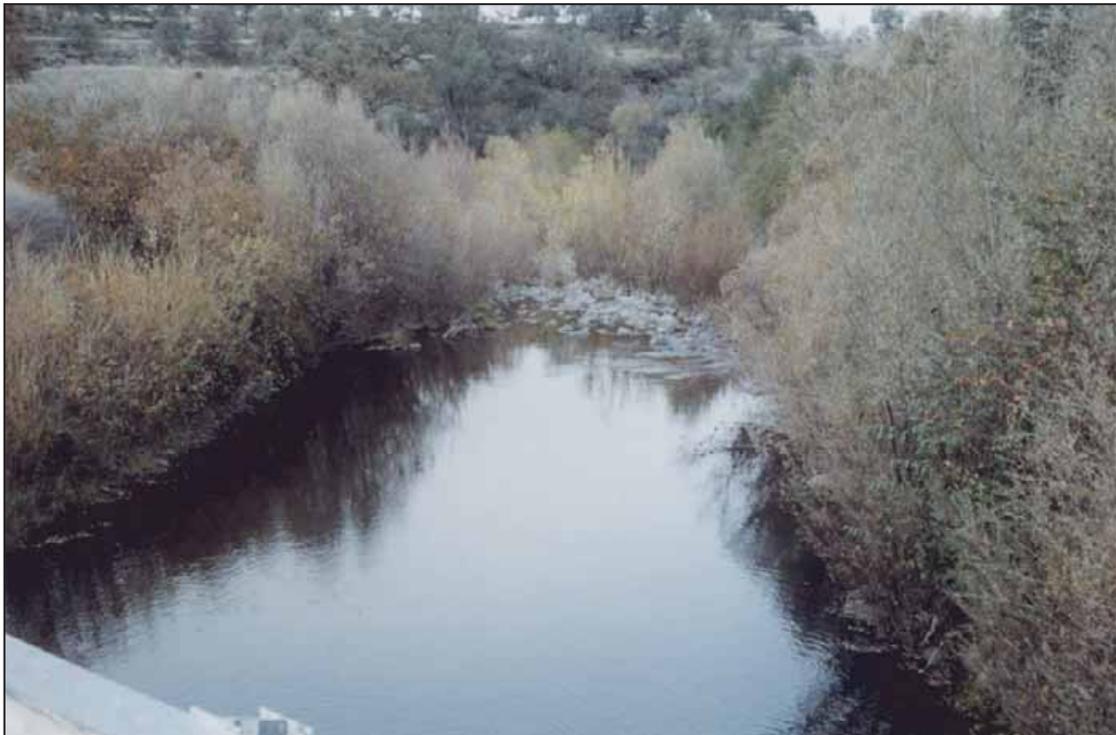
South Fork Battle Creek.

South Fork Battle Creek is within 1 mile (1.6 km) of the Willow Springs and Asbury sites. South Fork Battle Creek was evaluated from the Manton Road overcrossing (Figure 4). The creek is approximately 40 feet (12.2 m) wide and 1-foot (0.3 m) to several feet deep. Upstream of Manton Road the creek is

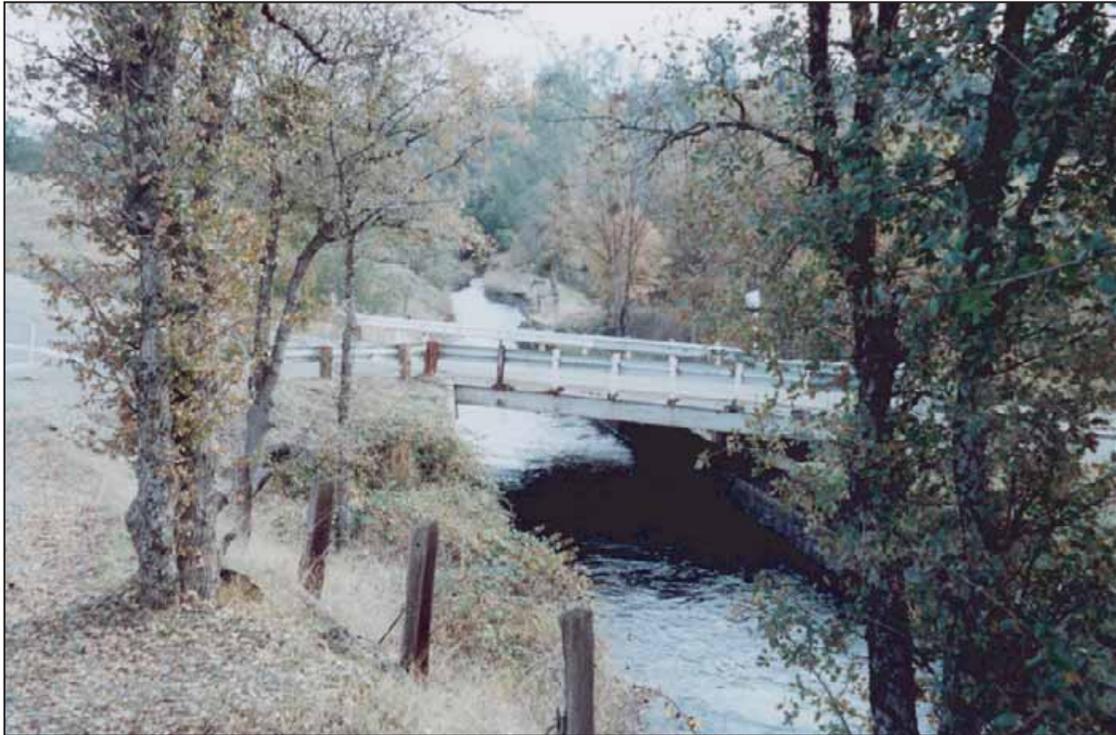
Coleman Canal.

Coleman Canal is within 1 mile (1.6 km) of the Willow Springs and Asbury sites. Coleman Canal was evaluated from the Manton Road overcrossing (Figure 15). Near the Manton Road crossing, the canal is concrete lined, but the banks are dirt farther from the road. The canal sides are steeply sloped with some cobble and grassy vegetation along them (Figure 18). Water flow in the canal was moderately swift. Coleman Canal does not provide suitable habitat for red-legged frog because of the steep banks and swift water flow.

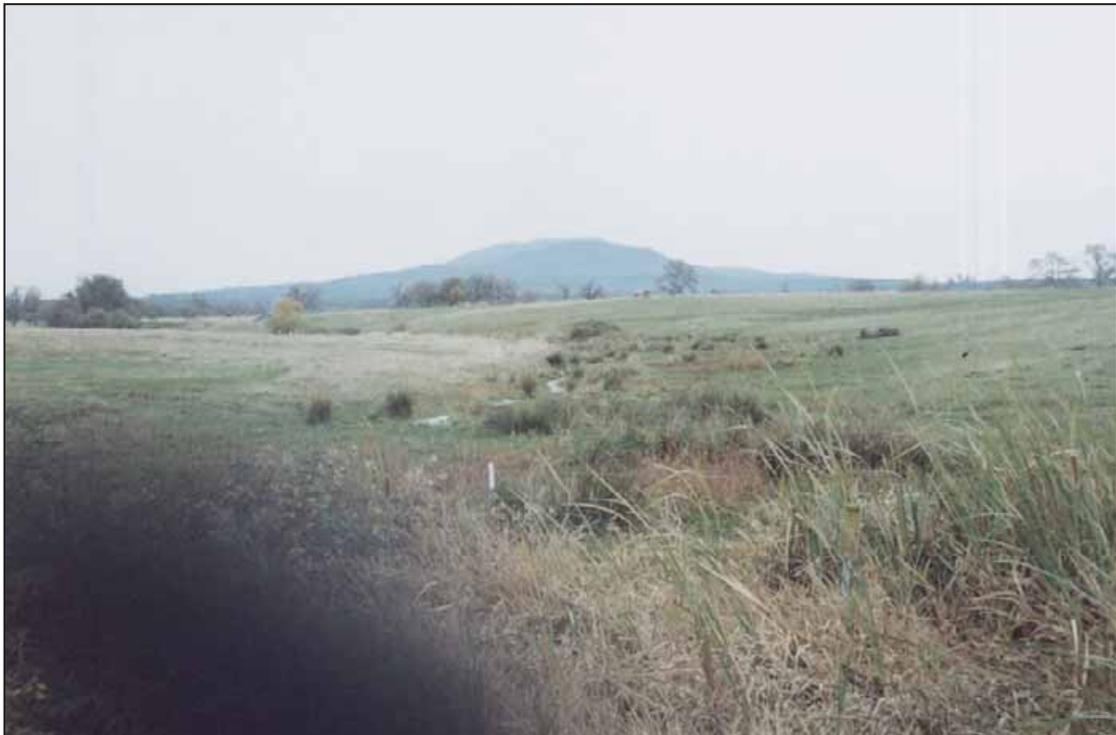
Tributary of Battle Creek #1.

Tributary of Battle Creek #1 is within 1 mile (1.6 km) of the Willow Springs and Asbury sites. This tributary was evaluated from the Manton Road overcrossing (Figure 15). Tributary of Battle Creek #1 consists of a small (1–3 feet [0.3–0.9 m] wide) meandering stream through a pasture (Figure 18). The stream is shallow (approximately 6 inches) and has a silt substrate. The upstream portion of the stream has cattails and rushes within and adjacent to the stream. Himalayan blackberry and grassy vegetation are also present adjacent to the stream. The downstream portion of the stream has only grassy vegetation along its edges. The stream consists of runs; no pools were visible from the roadway. The upland consists of grassland and oak woodland. Tributary of Battle Creek #1 provides suitable refuge and dispersal habitat for red-legged frog. It is unlikely to provide suitable breeding habitat because of the lack of deeper pooled areas.

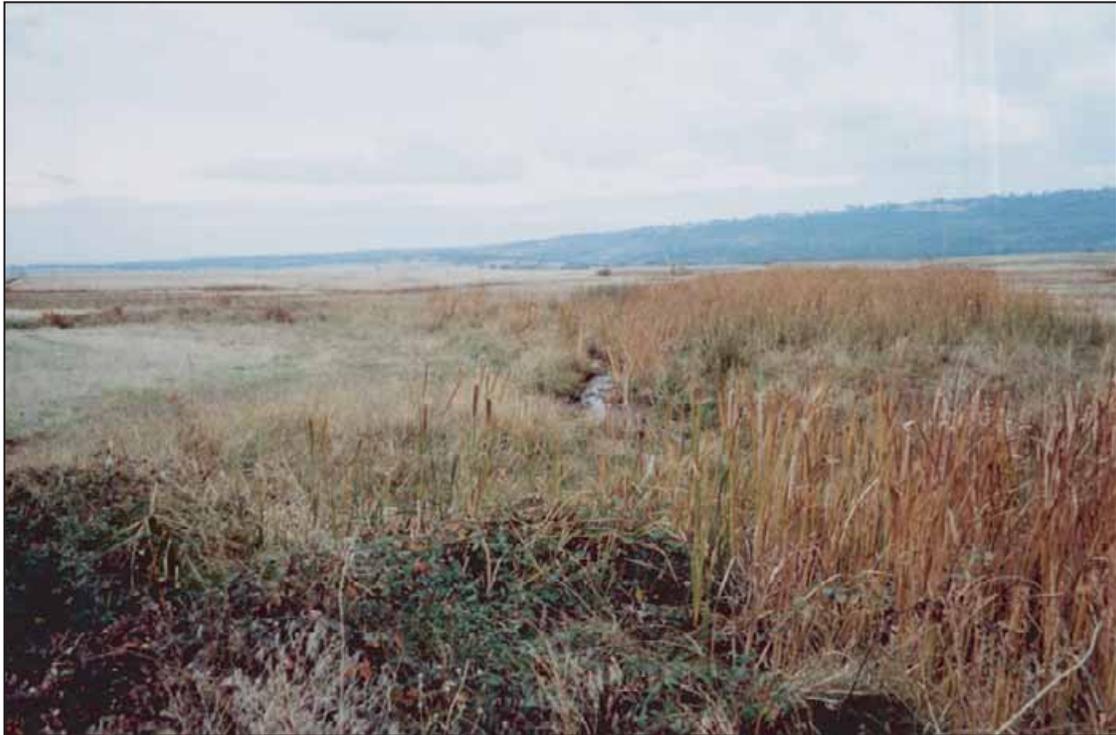
Tributary of Battle Creek #2.

Tributary of Battle Creek #2 is within 1 mile (1.6 km) of the Willow Springs Mitigation Site. This tributary was evaluated from the Manton Road overcrossing (Figure 15). Tributary of Battle Creek #2 consists of a small (1–2 feet [0.3–0.6 m] wide) stream through a ranchette (Figure 19). The stream is very shallow (3–6 inches [7.6–15.2 cm]) and has a silt substrate. Both the upstream portion and downstream portion of the stream have a pooled area adjacent to the roadway. Cattails are present in and adjacent to the stream. Other

streamside vegetation includes Himalayan blackberry and grasses. The upland consists of pasture and oak woodland. Fish were observed in the stream. Tributary of Battle Creek #2 provides suitable refuge and dispersal habitat for red-legged frog. It is unlikely to provide suitable breeding habitat because of the lack of deeper pooled areas.
