2010 Construction Photos

Battle Creek Salmon and Steelhead Restoration Project

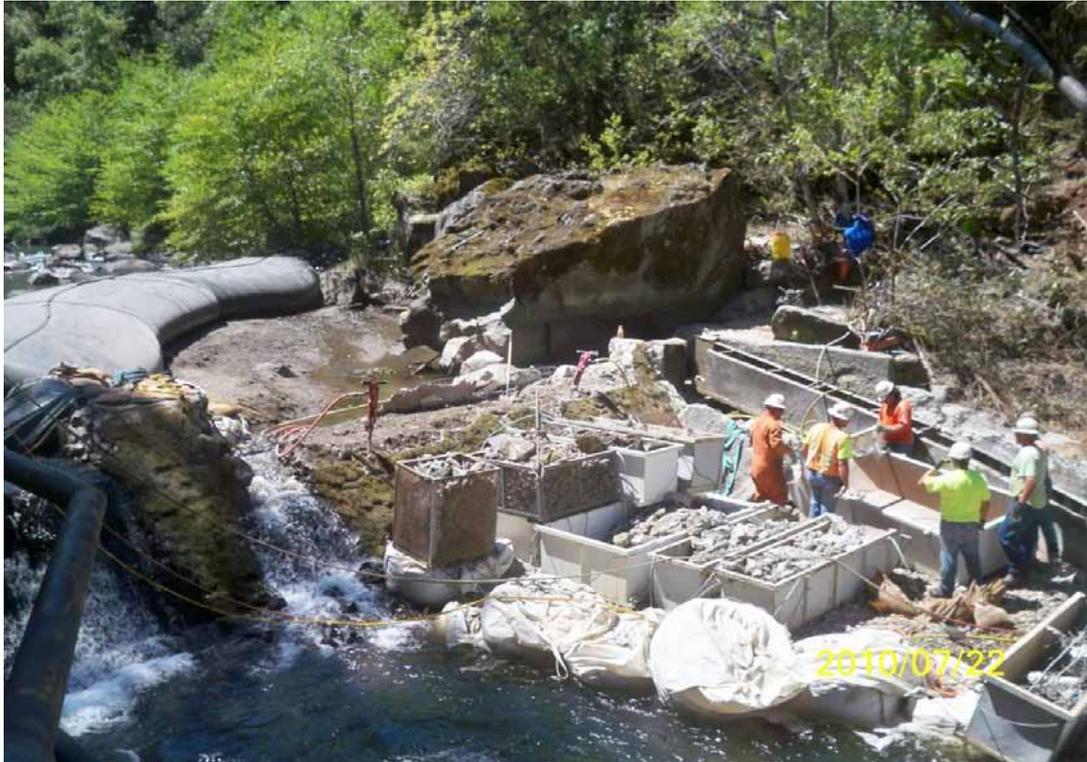
Wildcat Diversion Dam: Prime Contractor Services Group (CSG) and subcontractor Ford Construction Company Inc. (FCCI) demolishing the right side of the masonry dam behind a cofferdam.

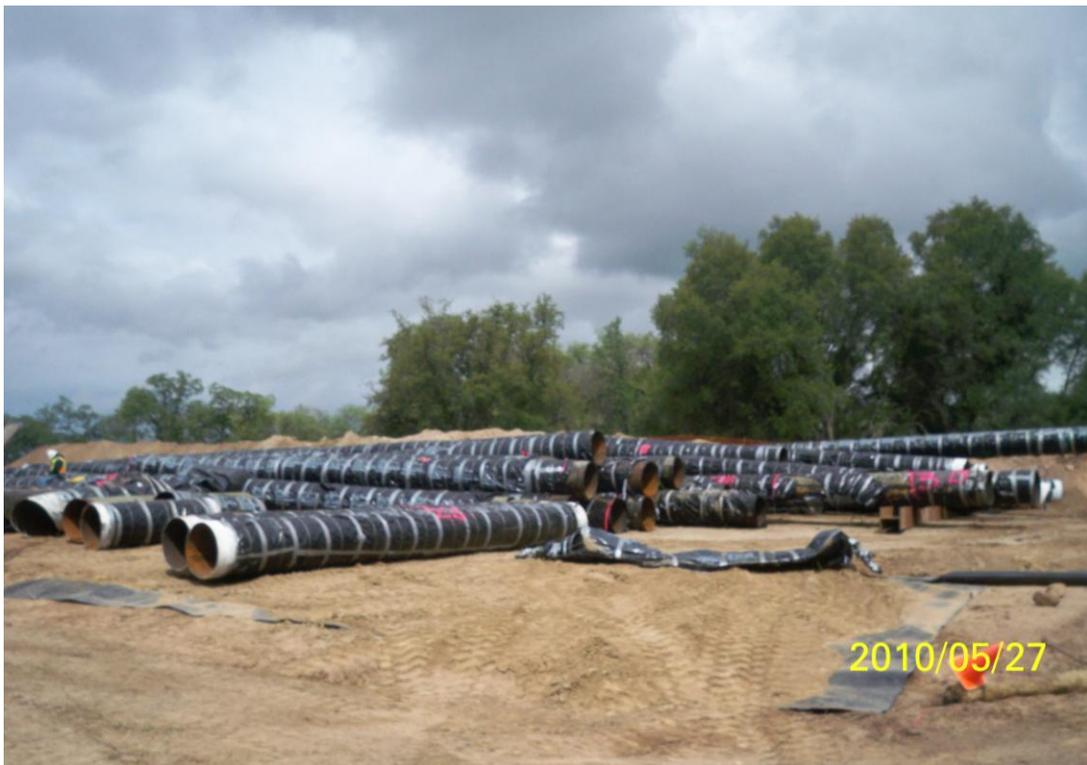
Wildcat Diversion Dam: Approximately 5,500 feet of steel pipeline were removed and disposed.

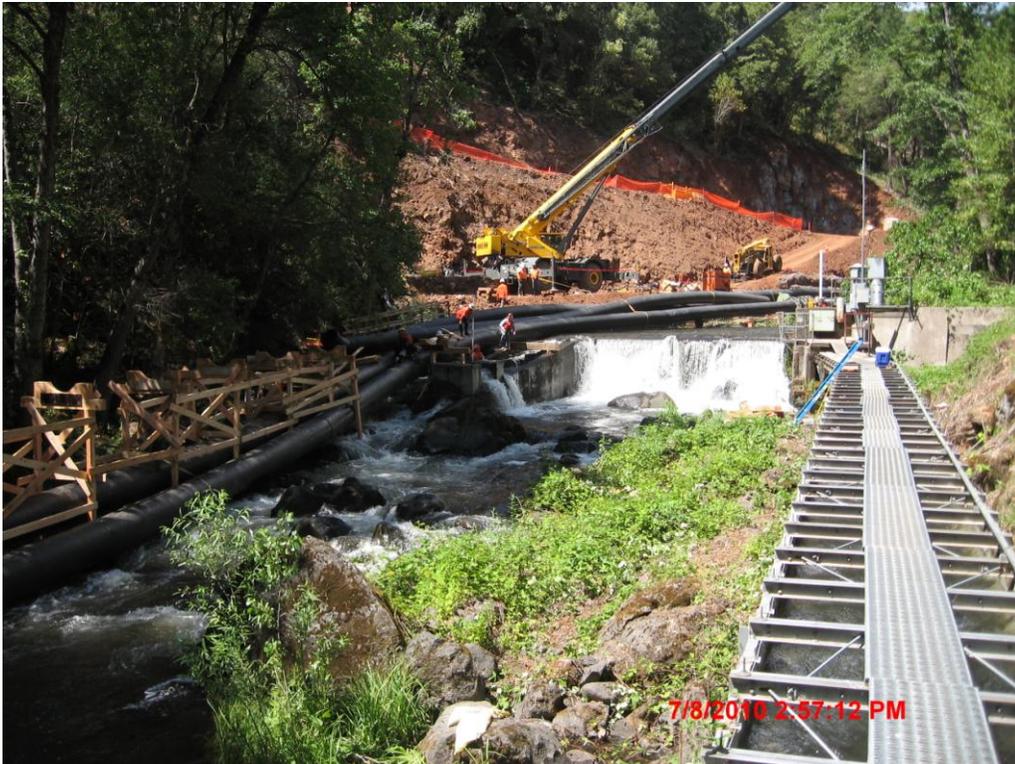
North Battle Creek Feeder: Upstream view of the dam and existing flume showing prime contractor Syblon Reid installing high-density polyethylene (HDPE) diversion pipes.

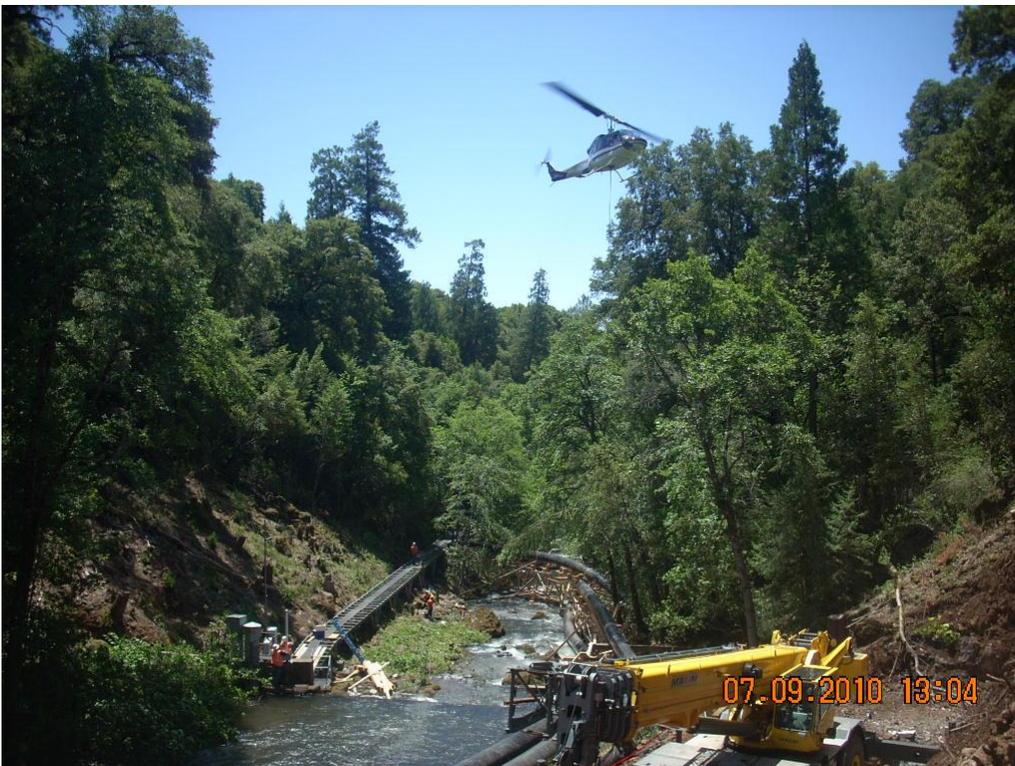
North Battle Creek Feeder: Downstream view of the dam as segments of the HDPE diversion pipes are flown in by subcontractor PJ Helicopters.

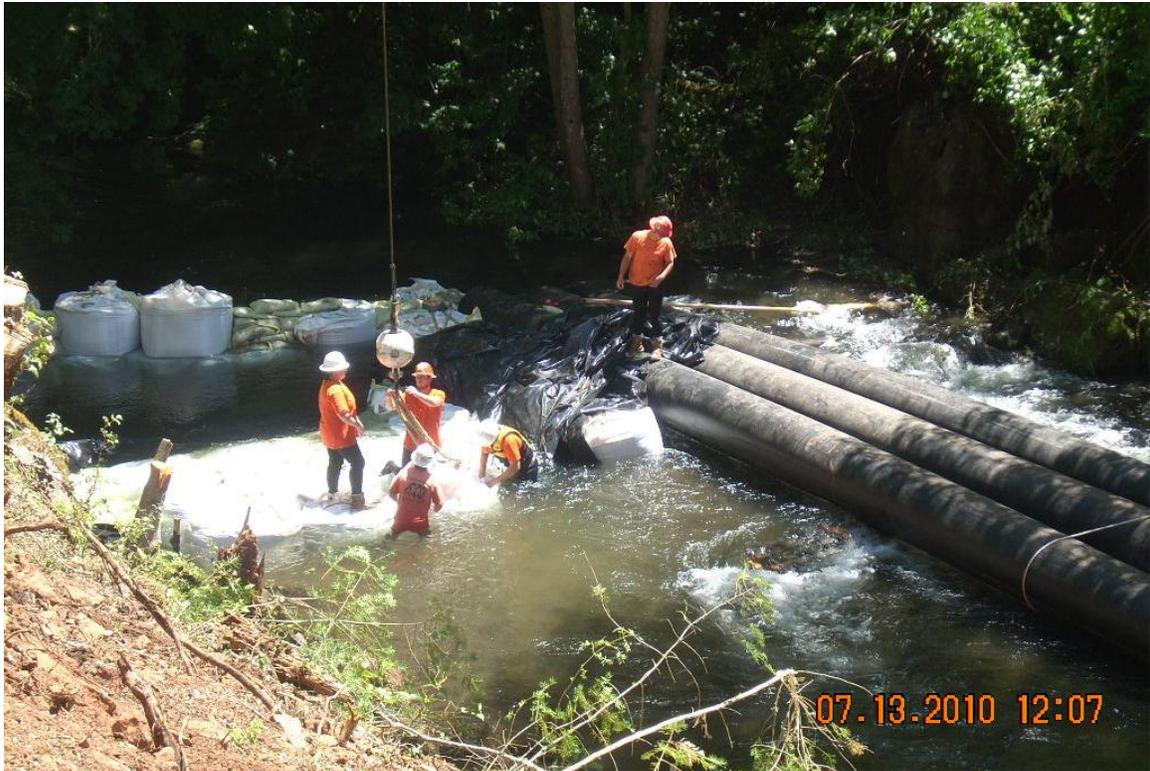
North Battle Creek Feeder: Installation of the supersack cofferdam and HDPE diversion pipes.

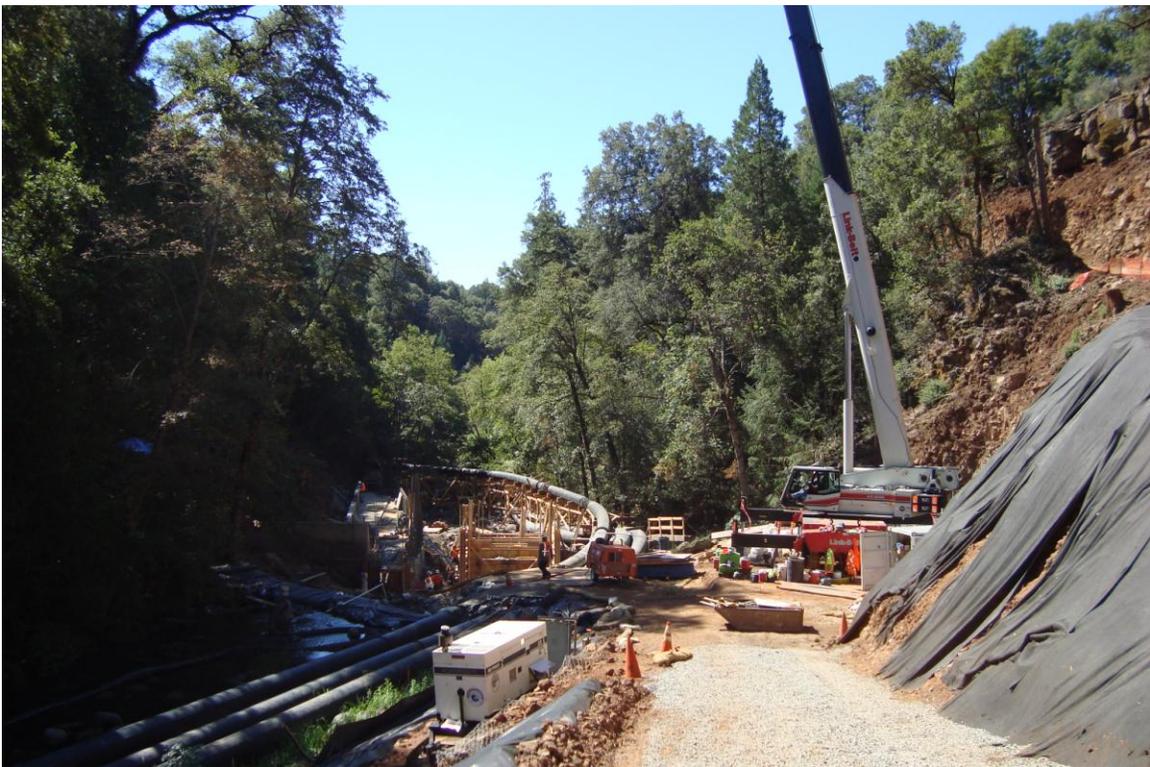
North Battle Creek Feeder: Downstream overview of the construction work site. Photo taken on 9/14/2010.

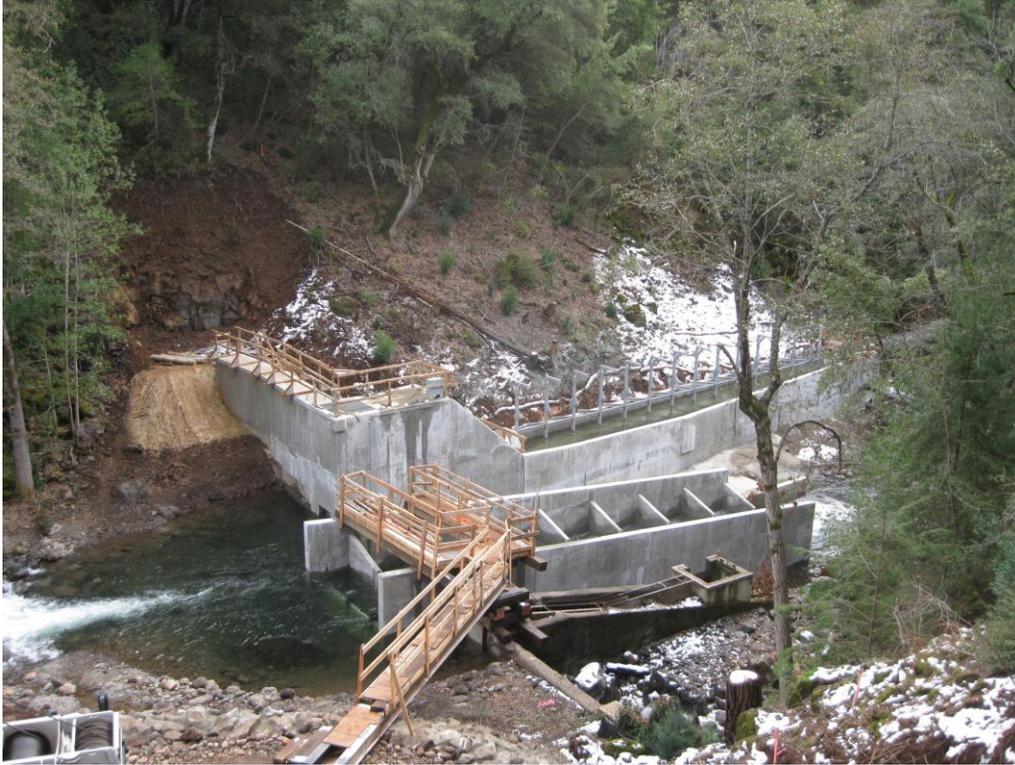
North Battle Creek Feeder: Overview of the new pool and chute fish ladder and fish screen. Photo taken on 11/30/2010.

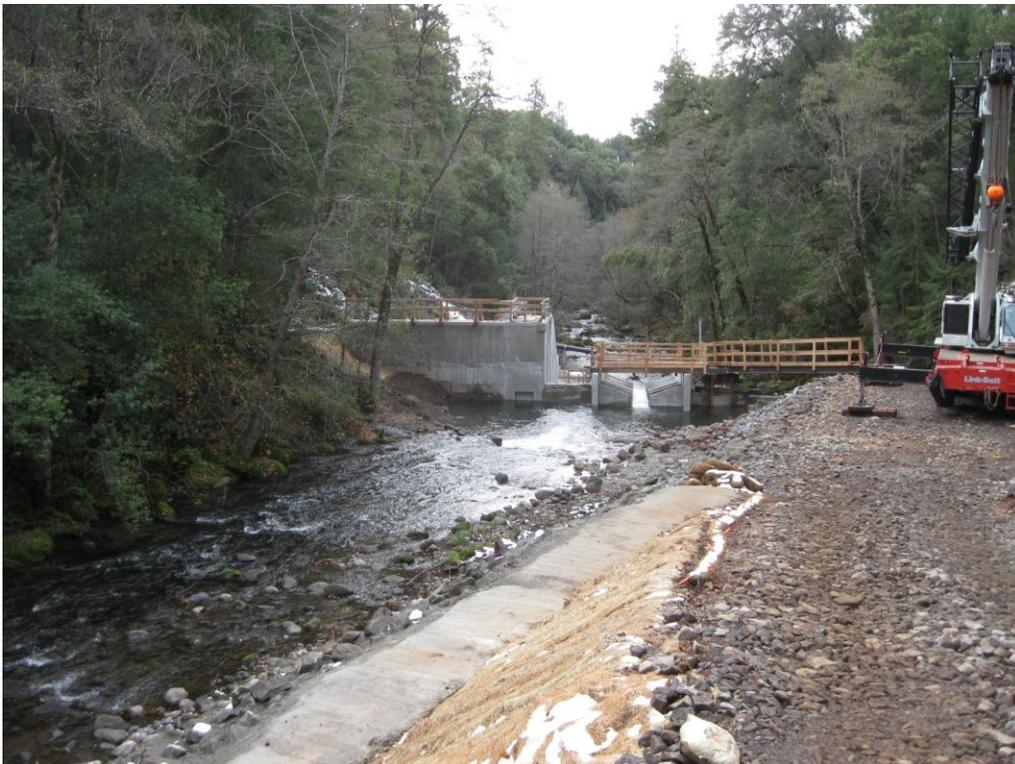
North Battle Creek Feeder: Looking downstream with the new access road on right, pool and chute fish ladder at center, and canal headwork structure on left. Photo taken on 11/30/2010.

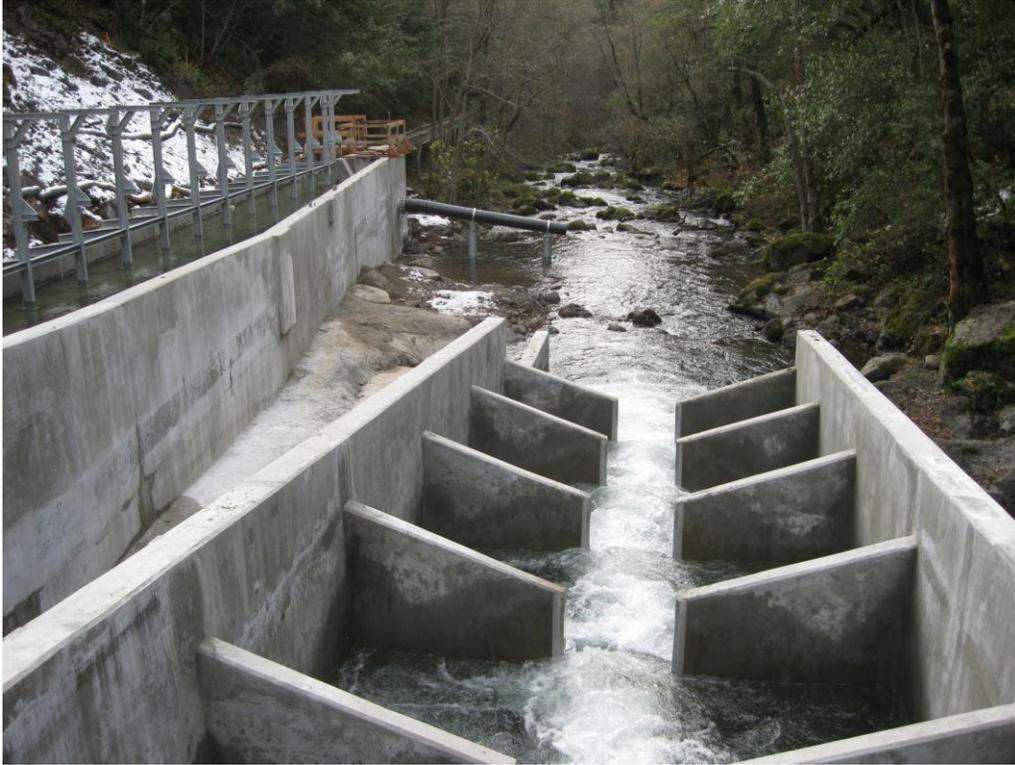
North Battle Creek Feeder: Looking downstream of creek, center is the new pool and chute fish ladder and left is the fish screen. Photo taken on 11/30/2010.

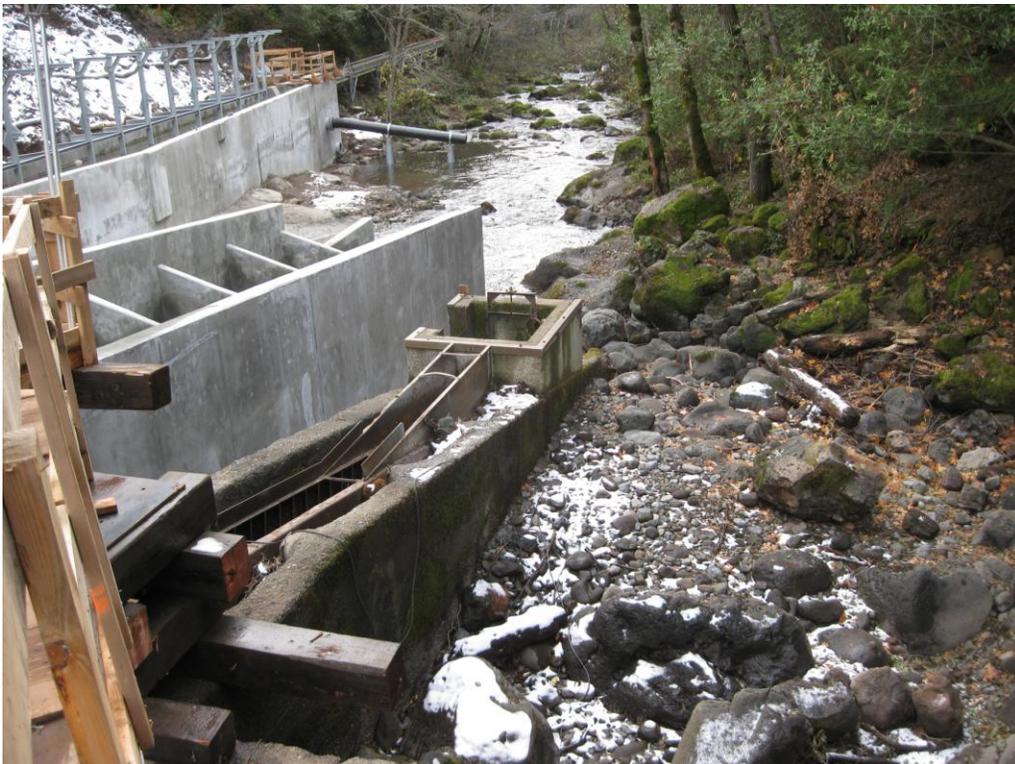
North Battle Creek Feeder: Comparison view of the old Alaskan-steep pass (right) and new (center left) pool and chute fish ladder. Photo taken on 11/30/2010.

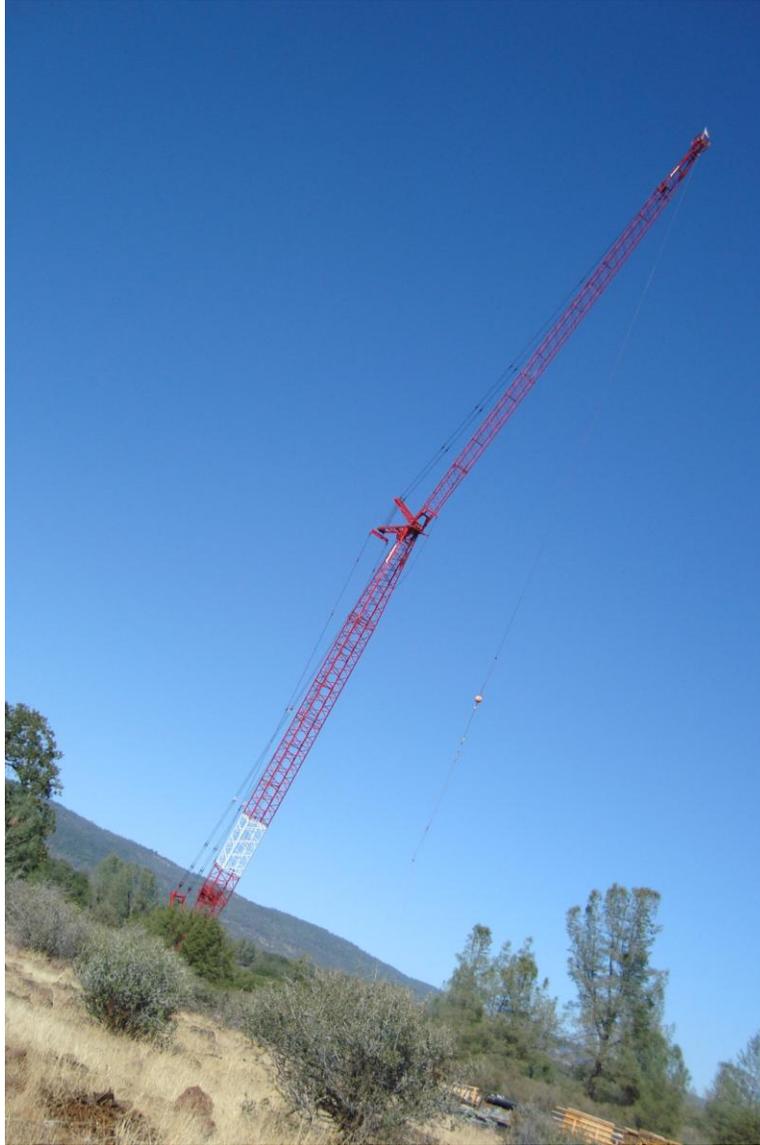
Eagle Canyon Diversion Dam: Material and equipment are lowered into the Eagle Canyon worksite using 275-ton Manitowoc 999 crane, which has an approximate reach of 220 feet. Photo taken on 9/14/2010.

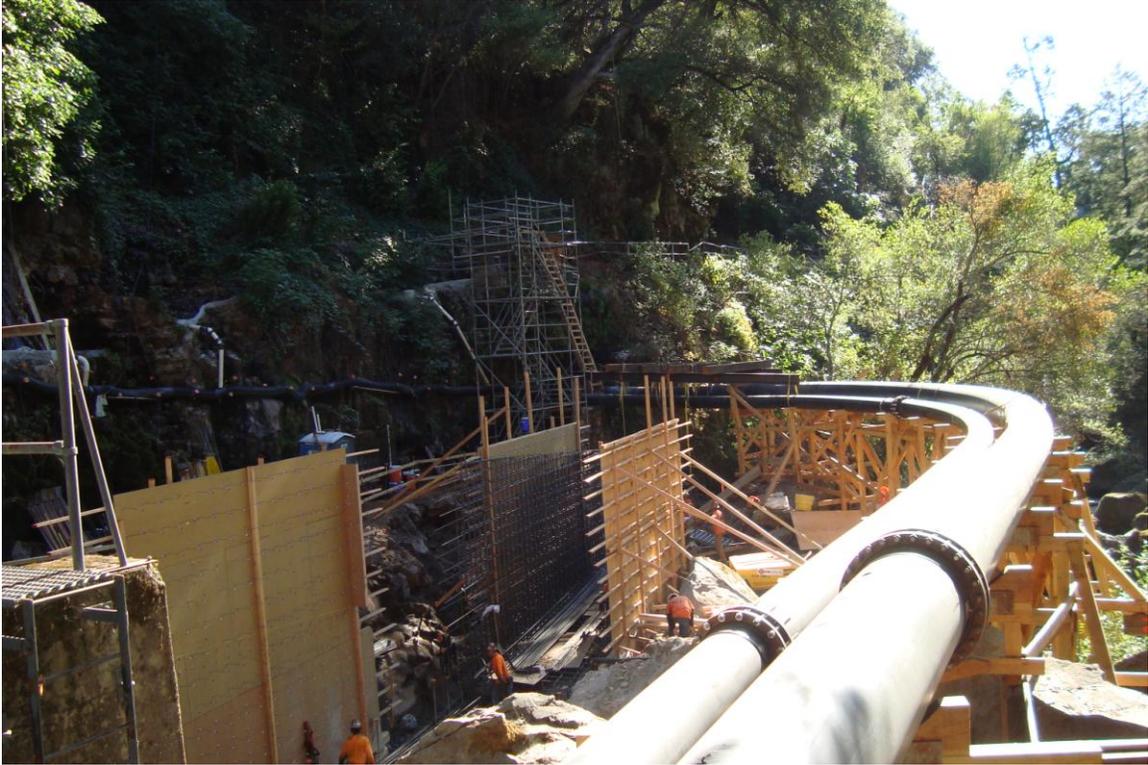
Eagle Canyon Diversion Dam: Portion of creek flows are bypassed back into Eagle Canyon Canal via two HDPE pipes supported on timber stands. Photo taken on 9/14/2010.

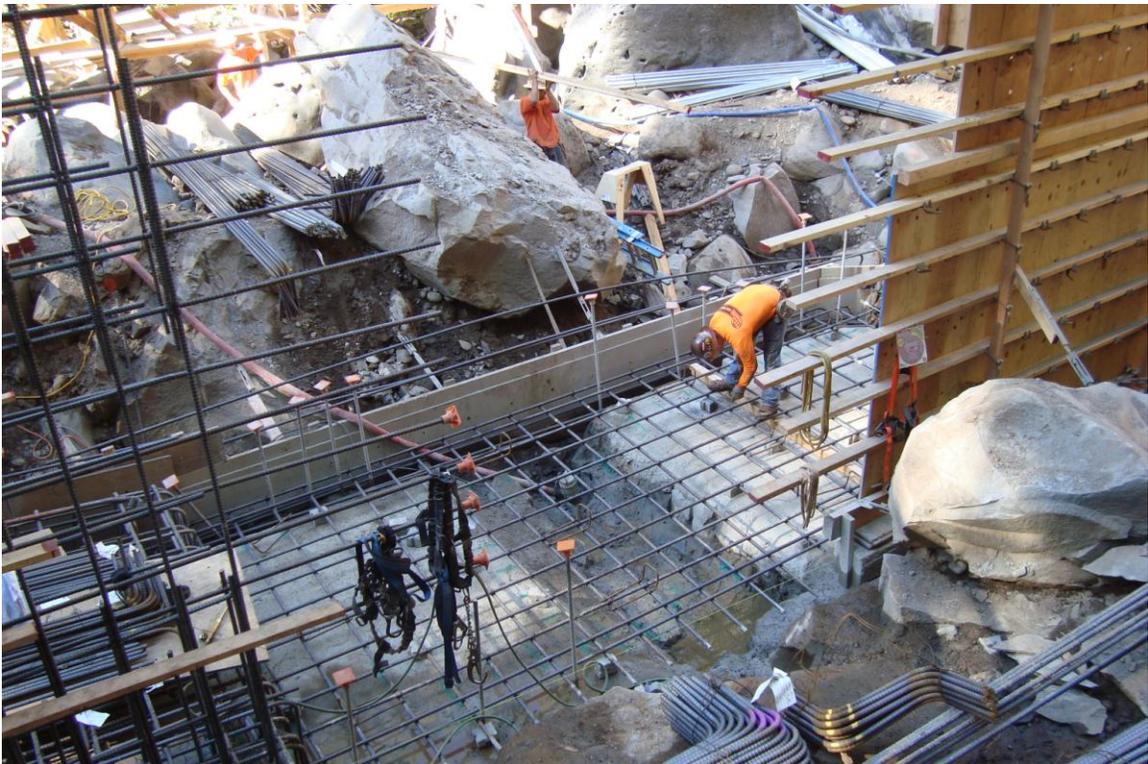
Eagle Canyon Diversion Dam: Note formwork and steel reinforcement for floor and walls of new vertical slot fish ladder. Photo taken on 9/14/2010.

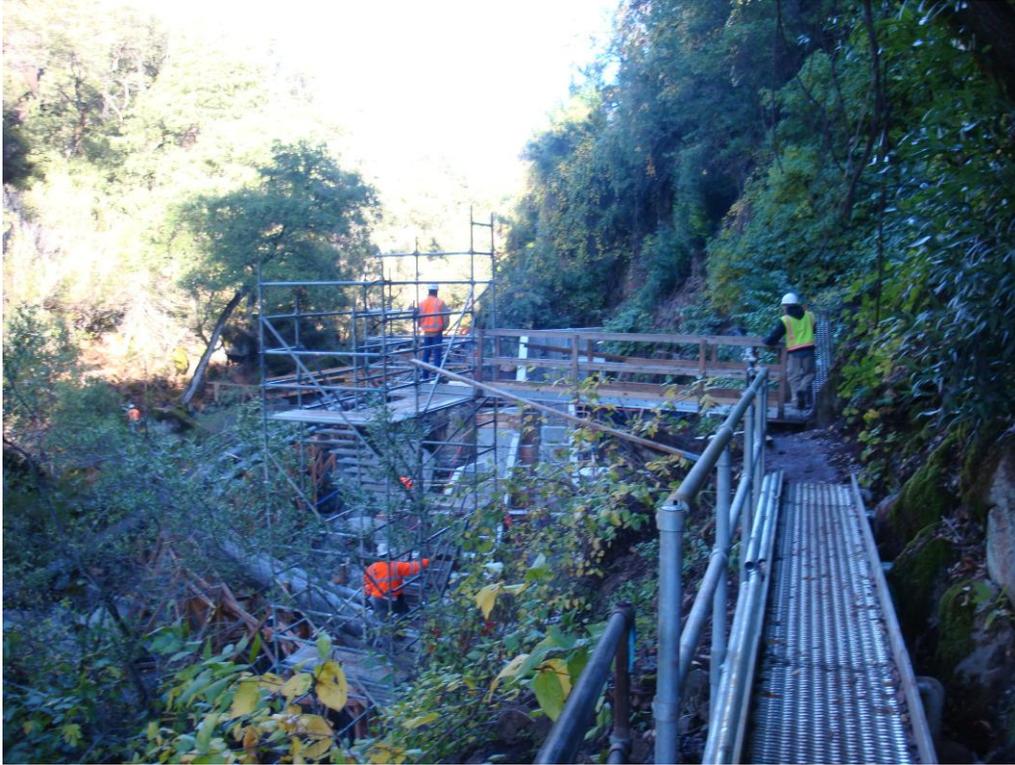
Eagle Canyon Diversion Dam: Temporary scaffolding between improved access trail and new fish passage facility. Photo taken on 11/08/2010.

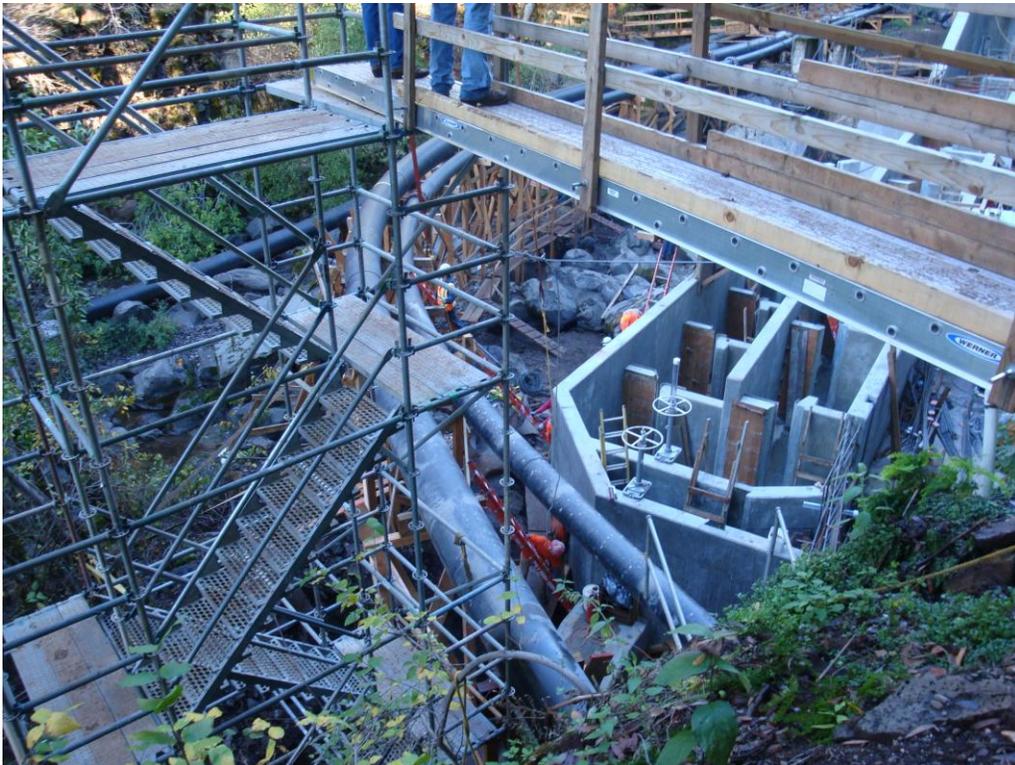
Eagle Canyon Diversion Dam: Temporary 50 feet high scaffolding to access dam work site. Note creek diversion pipeline on upper left, canal bypass pipelines on lower center, and vertical slot fish ladder on right. Photo taken on 11/08/2010.

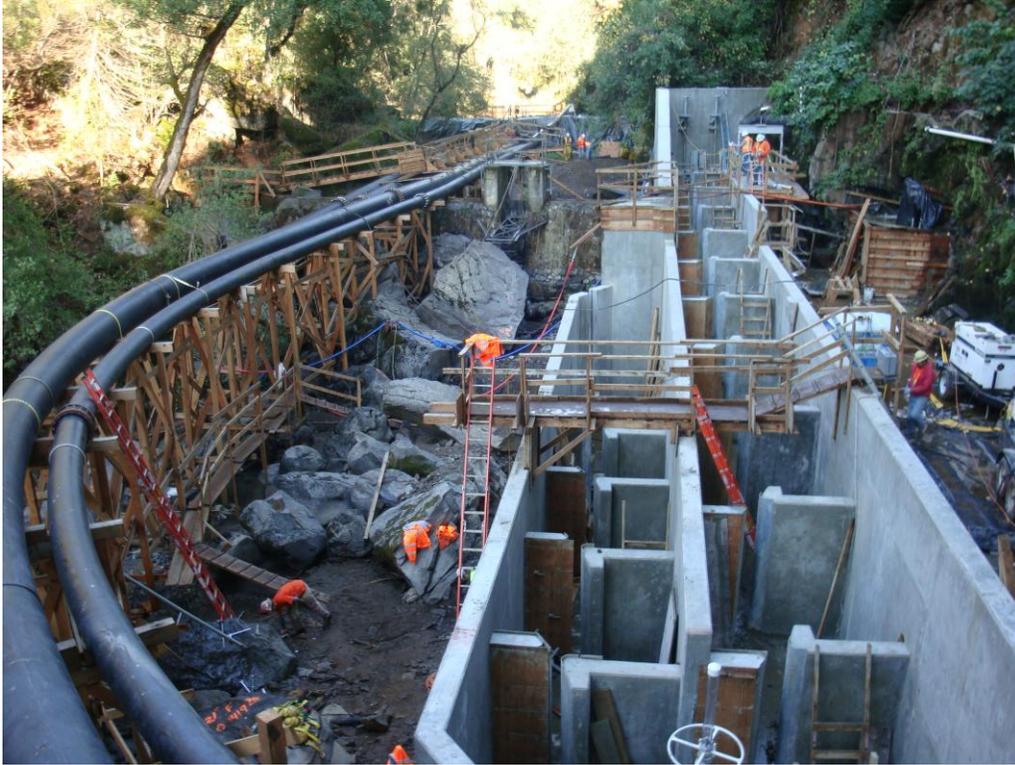
Eagle Canyon Diversion Dam: On left are creek diversion and canal bypass HDPE pipelines, and concrete formwork for vertical slot fish ladder on right. Photo taken on 11/08/2010.

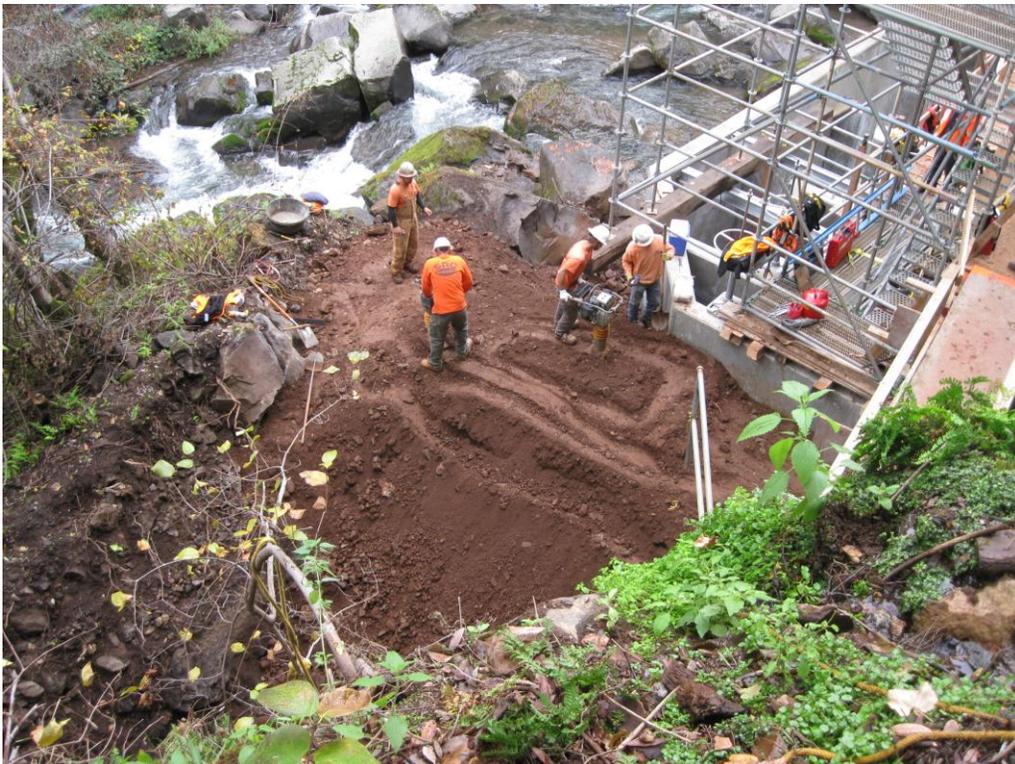
Eagle Canyon Diversion Dam: Earthwork to compact new pad for scaffolding access from Eagle Canyon trail down to the dam. Photo taken on 11/30/2010.

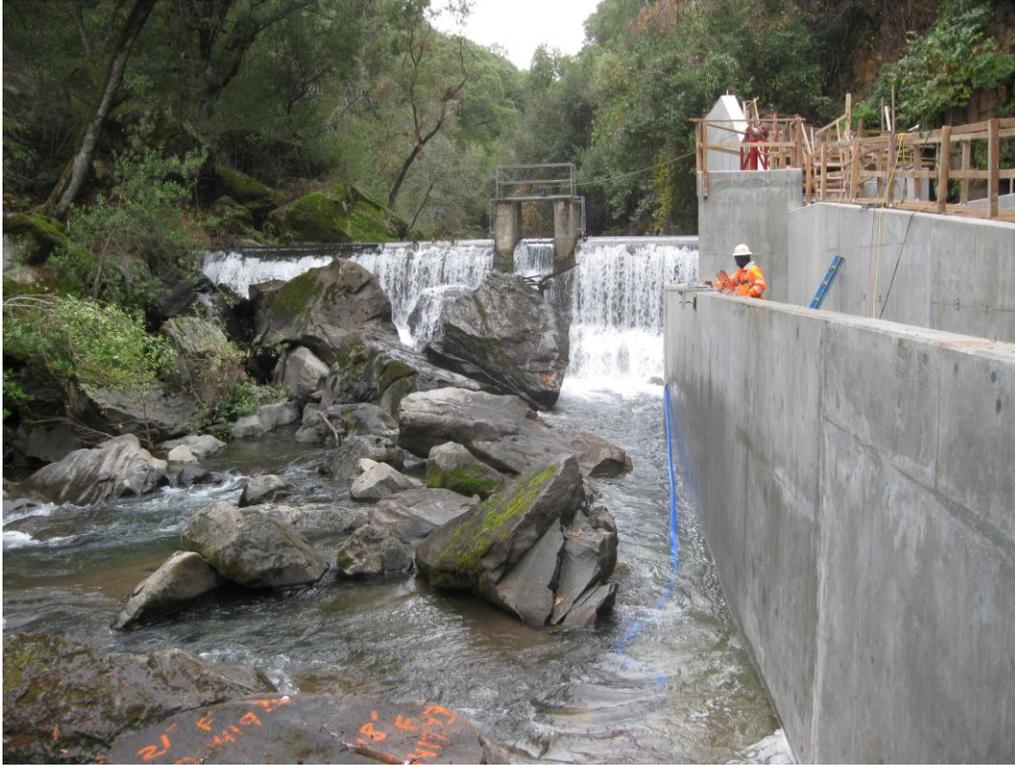
Eagle Canyon Diversion Dam: Looking upstream at the dam and on right is the new vertical slot fish ladder. Photo taken on 11/30/2010.

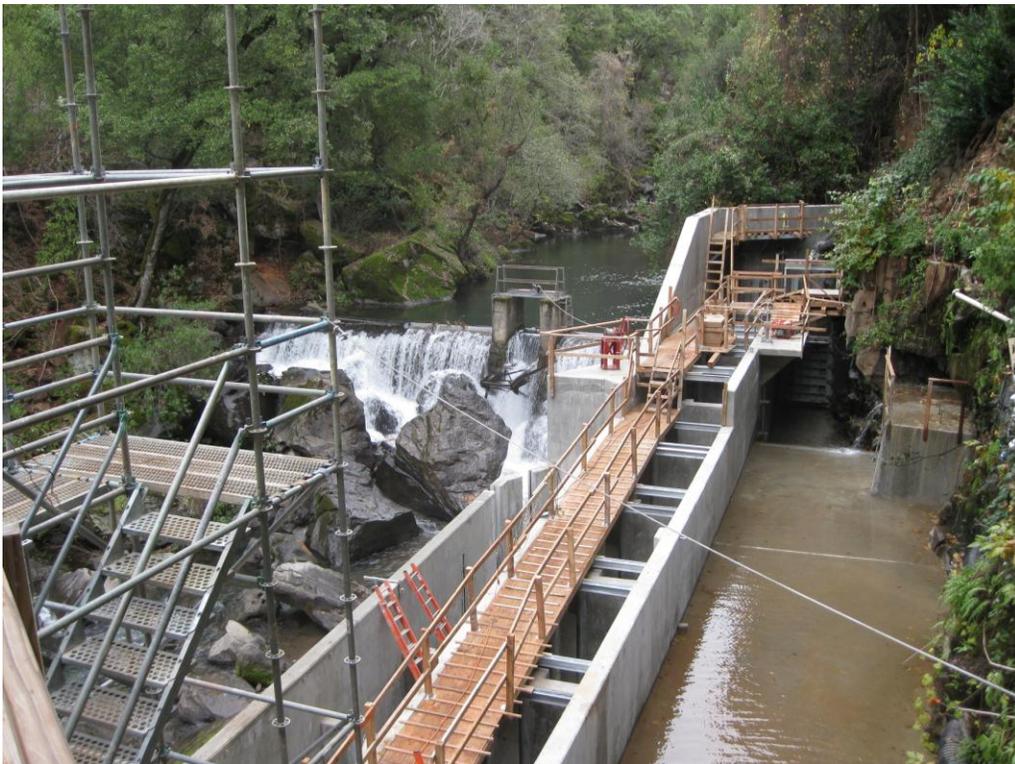
Eagle Canyon Diversion Dam: Looking upstream at temporary timber walkway to the canal headworks, which is installed above the vertical slot fish ladder, to allow PG&E winter operation. Photo taken on 11/30/2010.

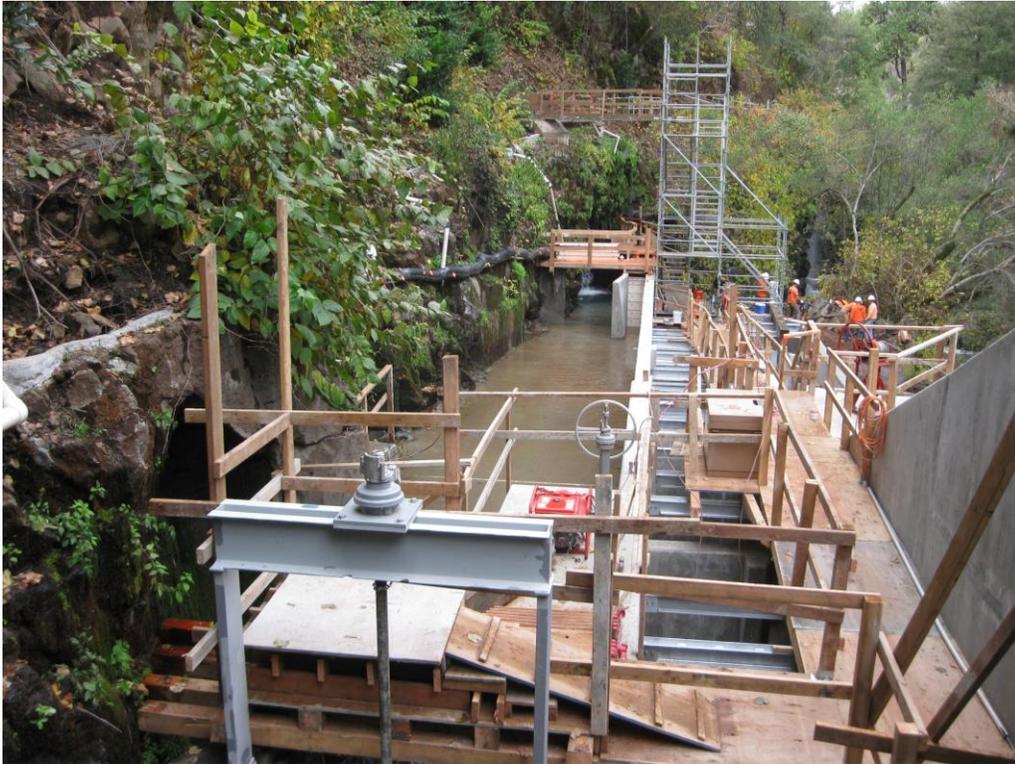
Eagle Canyon Diversion Dam: Looking downstream of canal headworks, future fish screen on left, vertical slot fish ladder with temporary timber walkway on right. Note that water for hydropower enters through the headworks, lower left and is conveyed through the future fish screen channel (left) to Eagle Canyon Canal. The fish ladder is currently blocked to prevent fish migration until completion of the fish screen. Photo taken on 11/30/2010.
