August 2015 Construction Photos

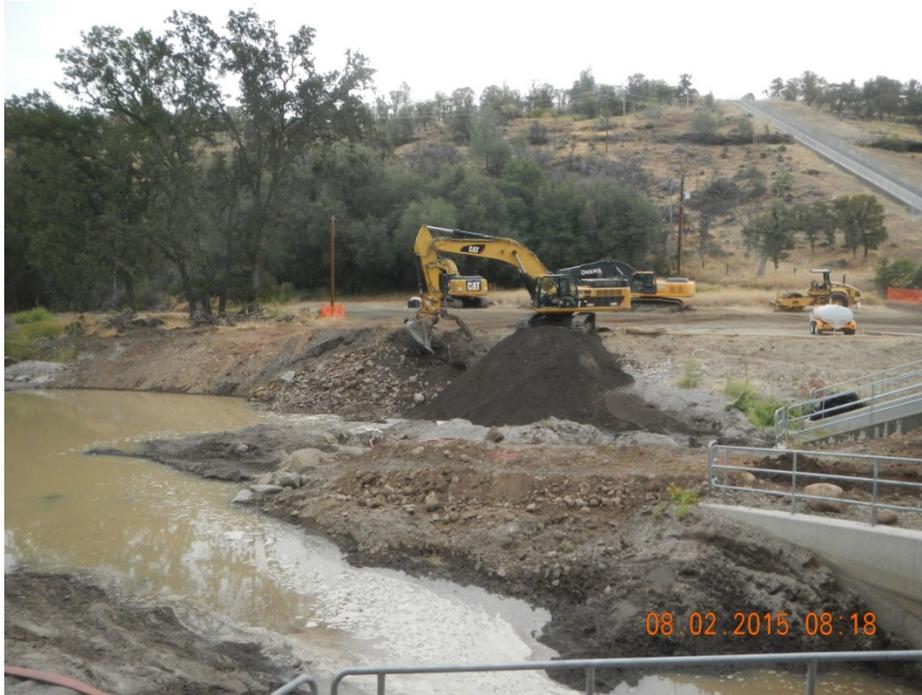
Coleman Diversion Dam/Inskip Powerhouse: The Contractor is using a CAT 345D excavator to stockpile the materials excavated from the Coleman Canal basin.

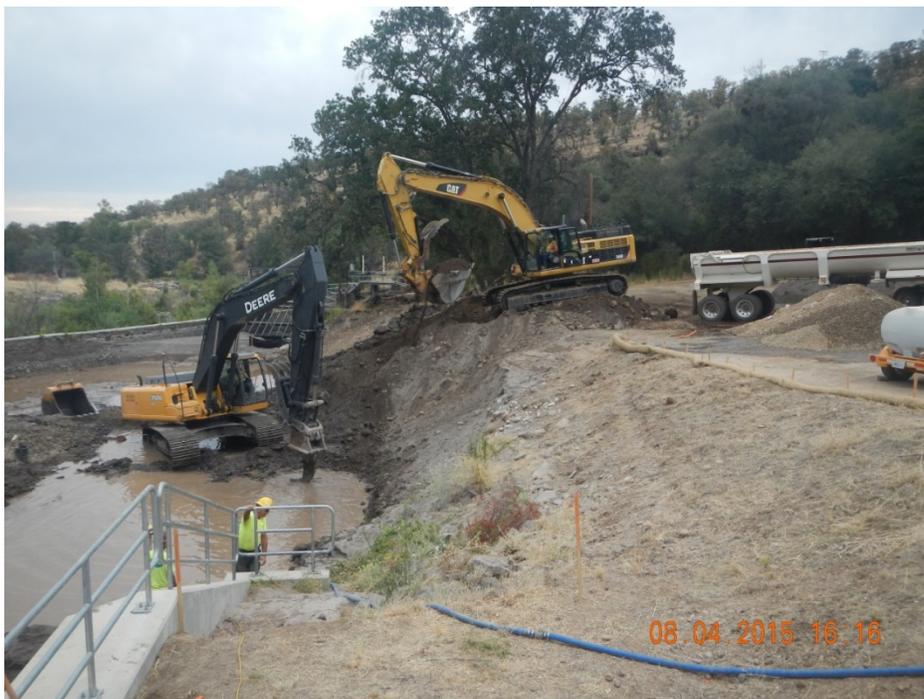
Coleman Diversion Dam/Inskip Powerhouse: The Contractor is using a JD 350 with a ripper attachment to break the bedrock while the CAT 345D excavator is loading spoils into the end dump trucks for disposal.

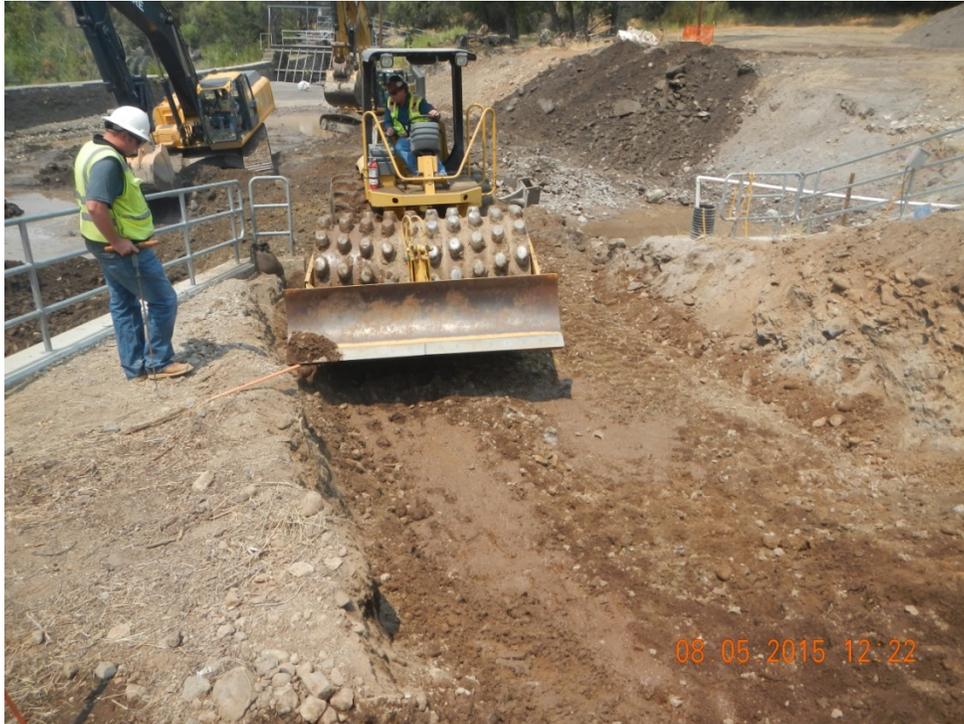
Coleman Diversion Dam/Inskip Powerhouse: The Contractor is preparing the subgrade of the concrete access ramp under the supervision of a geo-technical engineer.

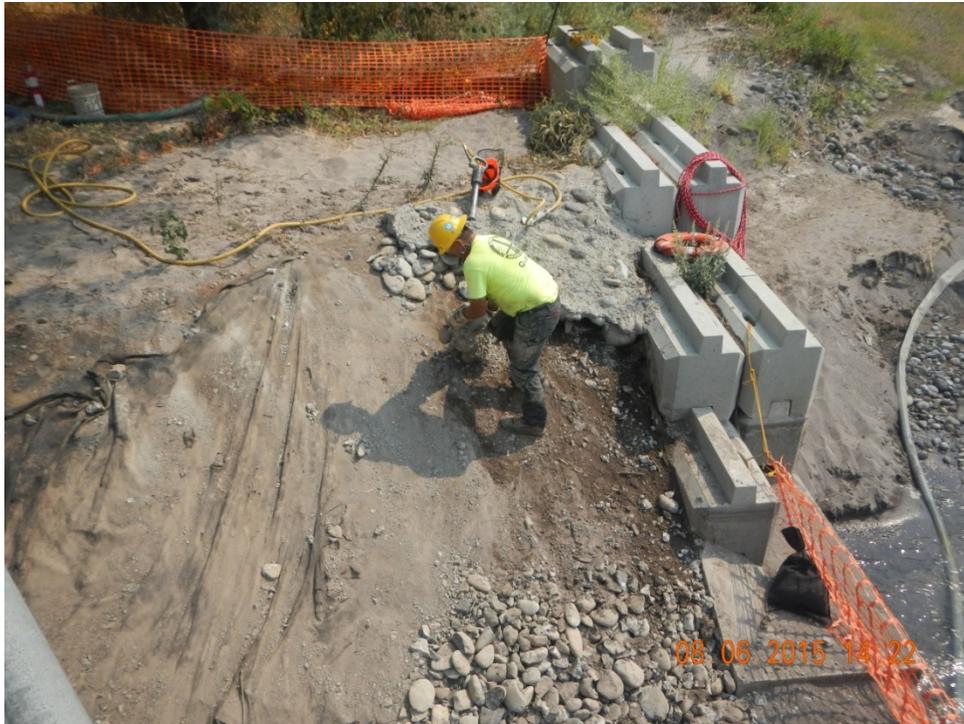
Coleman Diversion Dam/Inskip Powerhouse: The Contractor is working on removing section of the eroded concreted rock slope protection (RSP) that could not be reached with an excavator.

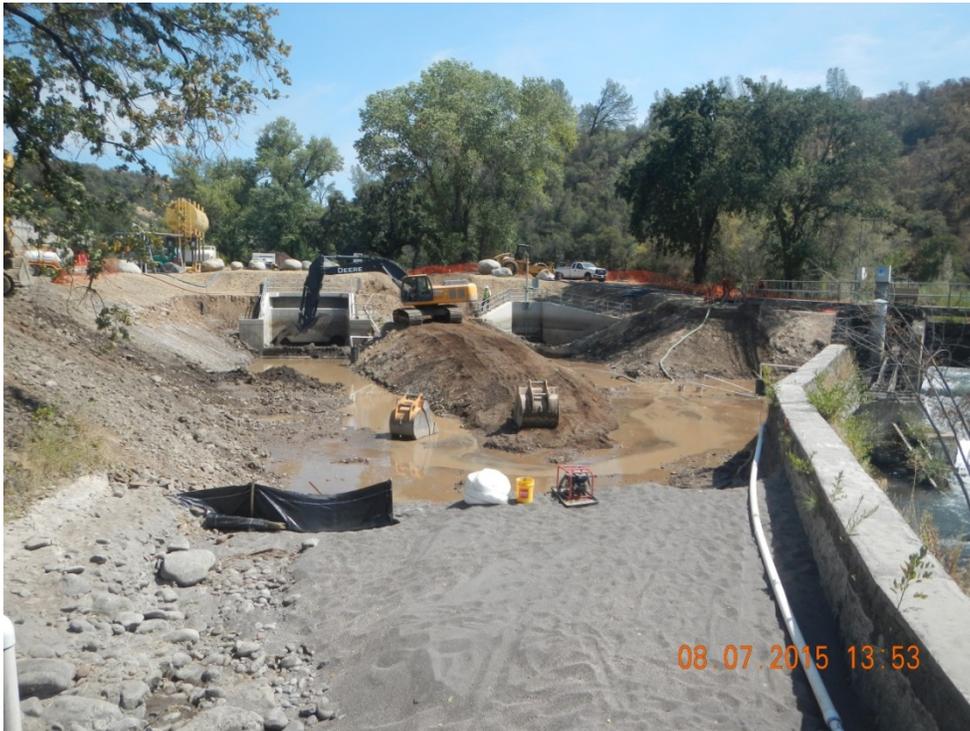
Coleman Diversion Dam/Inskip Powerhouse: Looking upstream of Coleman Canal entrance as the Contractor works on removing the storm deposit sediment and eroded RSP in the canal basin.

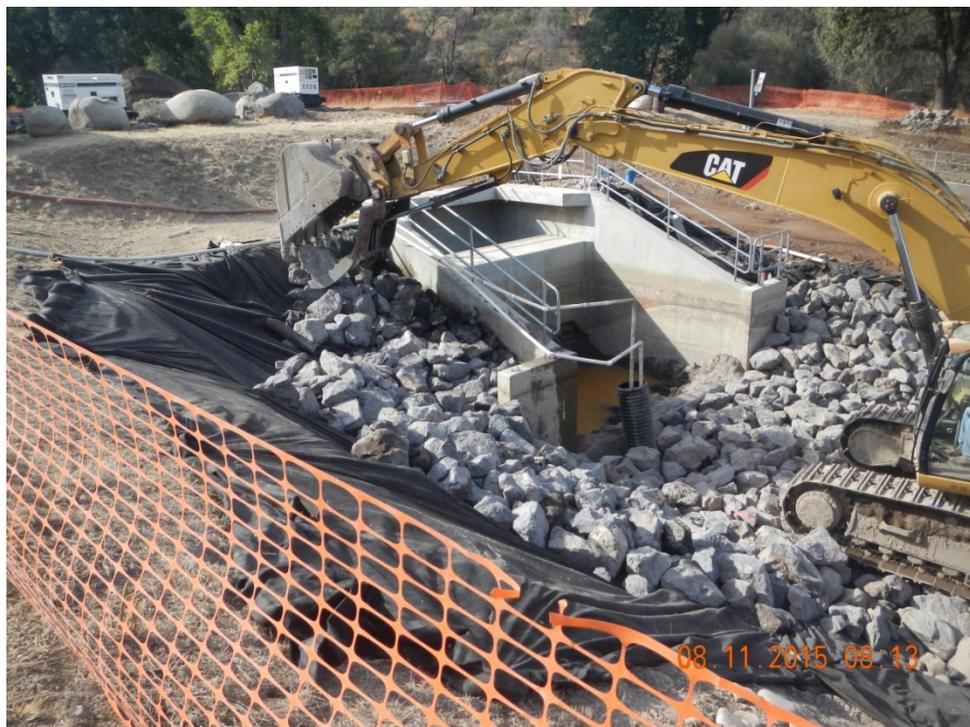
Coleman Diversion Dam/Inskip Powerhouse: The Contractor is using the CAT 345D excavator to place riprap around the penstock bypass baffled outlet.

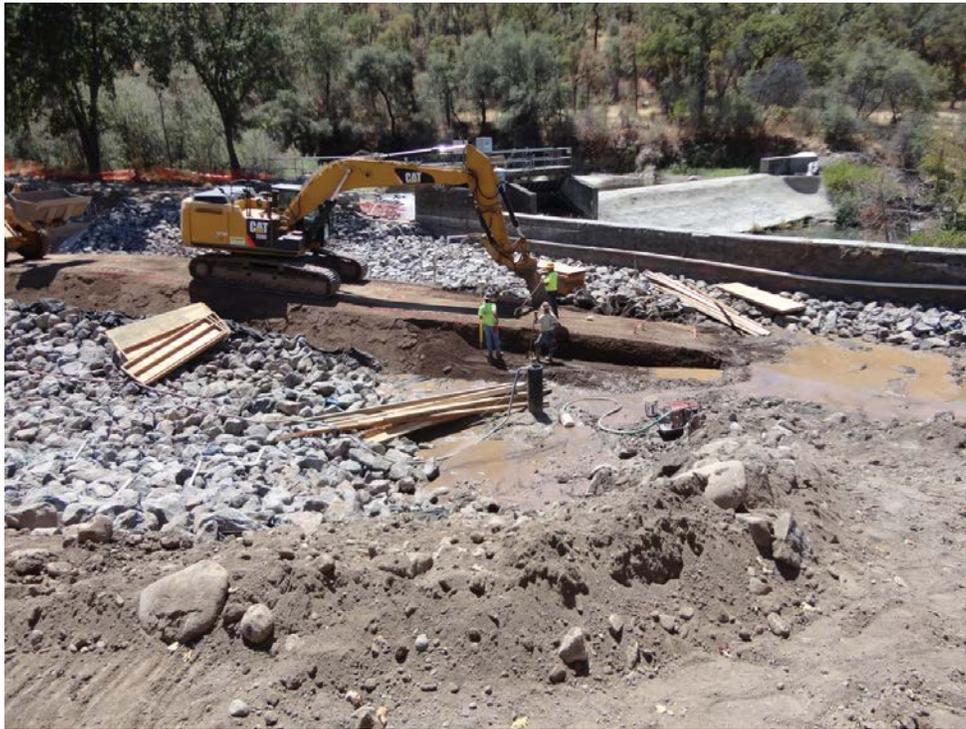
Coleman Diversion Dam/Inskip Powerhouse: The Contractor is using the CAT 329E excavator with 2' bucket to excavate the footing for the new concrete canal access ramp.

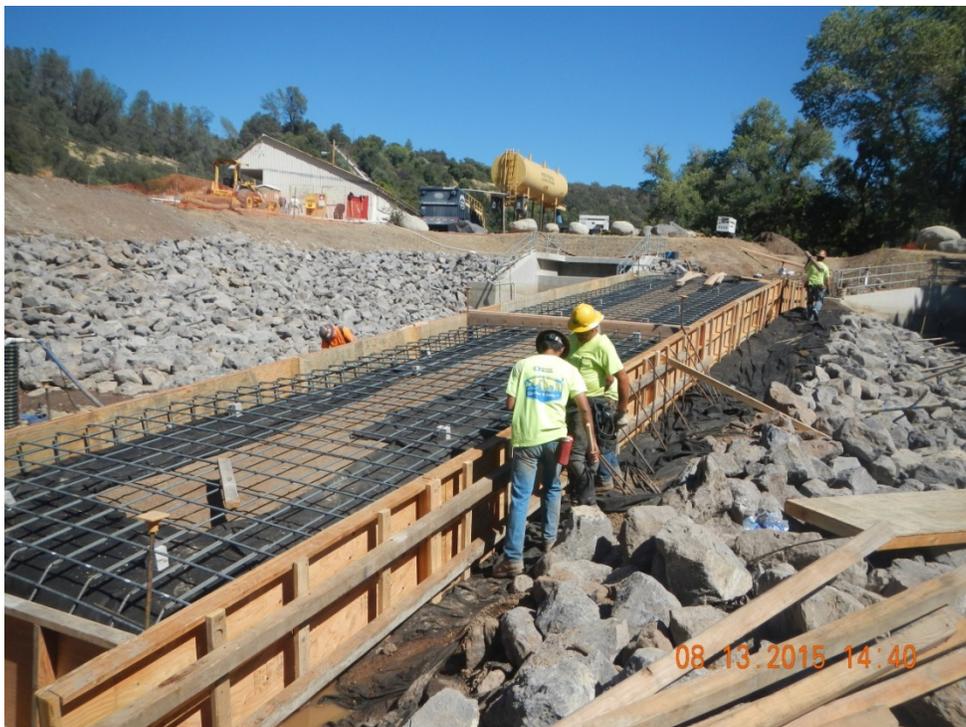
Coleman Diversion Dam/Inskip Powerhouse: The Contractor is setting up forms for the new concrete canal access ramp.

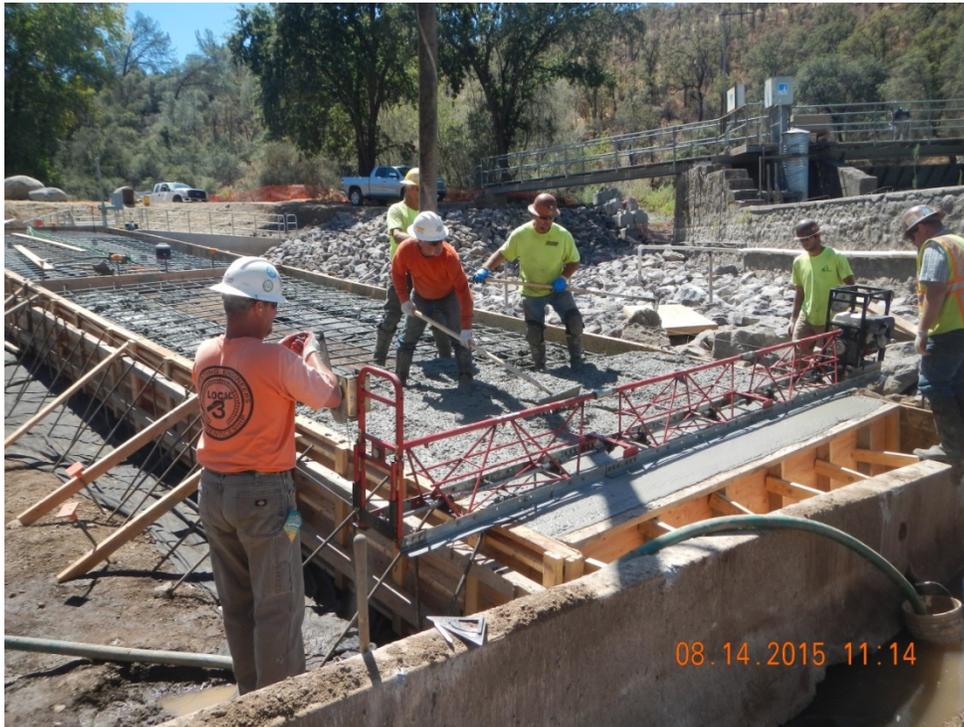
Coleman Diversion Dam/Inskip Powerhouse: The Contractor is placing concrete at the canal access ramp slab #4 and using a vibratory truss screed to consolidate the concrete.

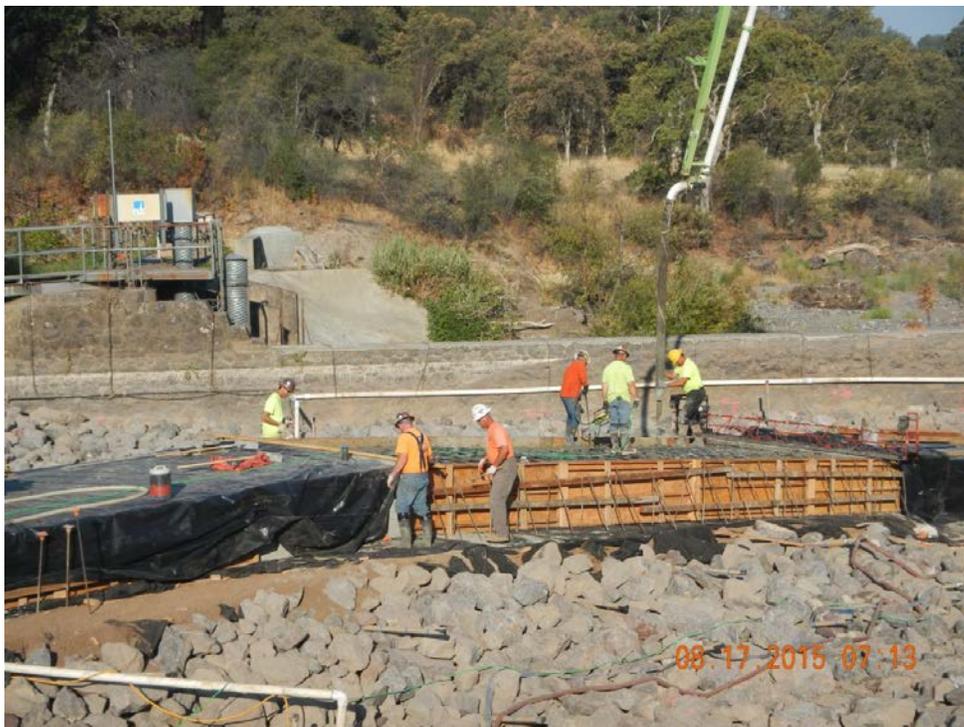
Coleman Diversion Dam/Inskip Powerhouse: The above photo shows the Contractor placing concrete at the canal access ramp slab #3.

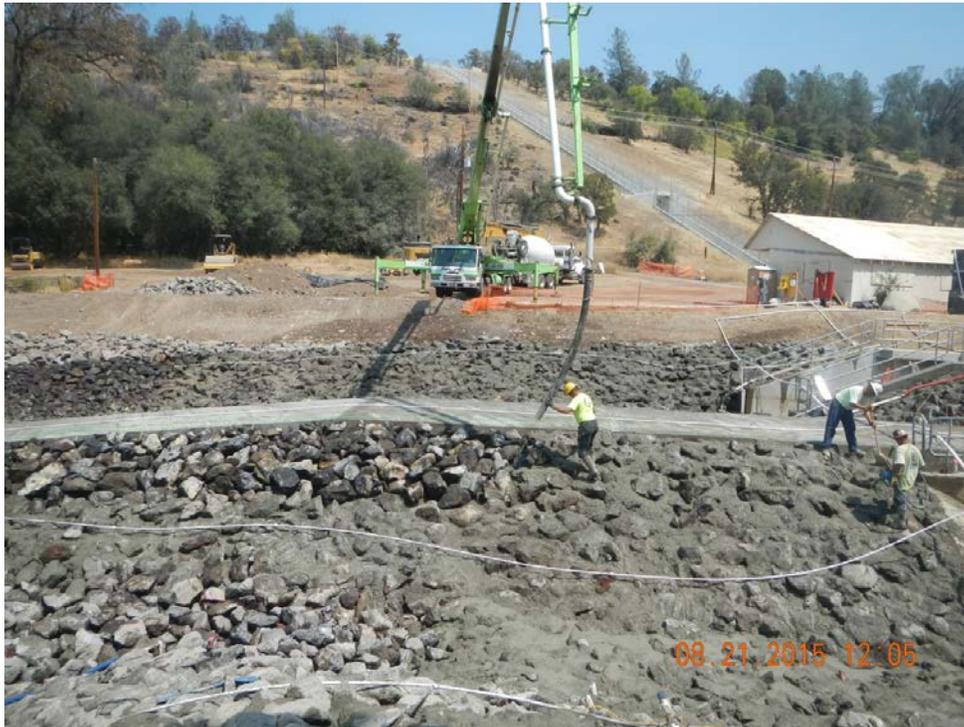
Coleman Diversion Dam/Inskip Powerhouse: The Contractor is placing grouted on the new RSP, the left side of the concrete canal access ramp.

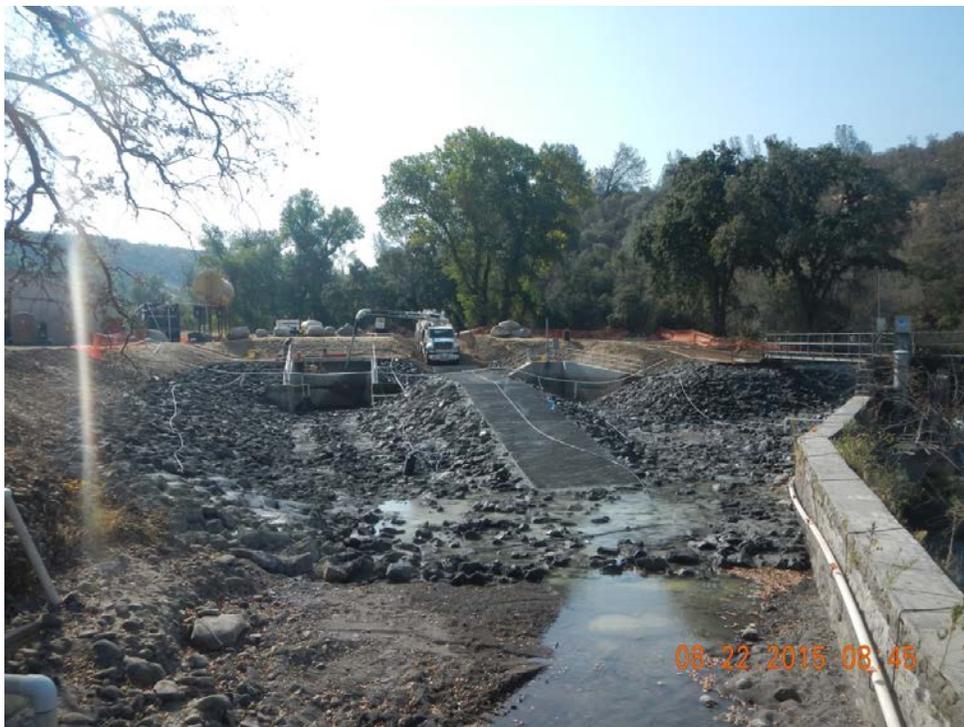
Coleman Diversion Dam/Inskip Powerhouse: The above photo shows the completed placement of the concreted RSP and canal access ramp.

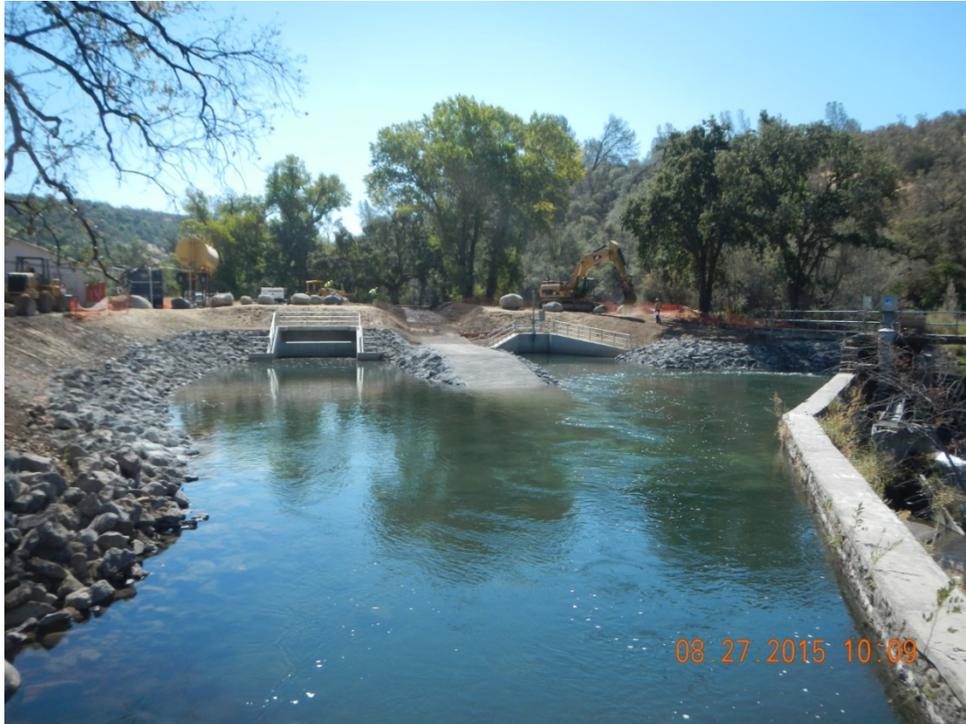
Coleman Diversion Dam/Inskip Powerhouse: The above photo shows the completed work and Coleman Canal being watered up.

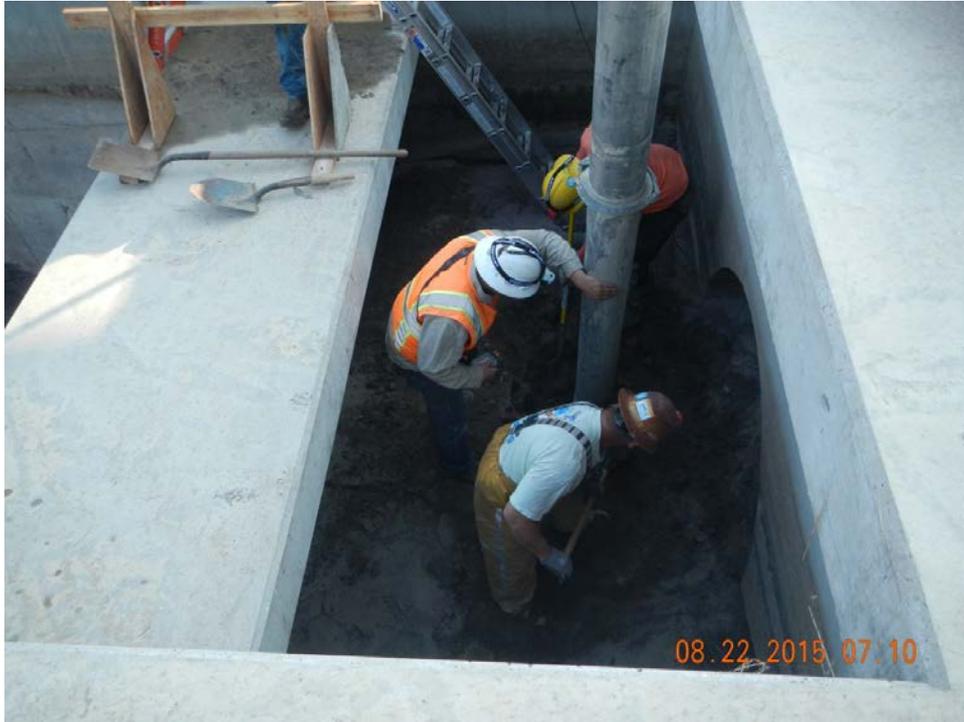
Coleman Diversion Dam/Inskip Powerhouse: The Contractor is using an 8" vacuum nozzle to remove the sediment behind the penstock bypass baffled outlet structure.

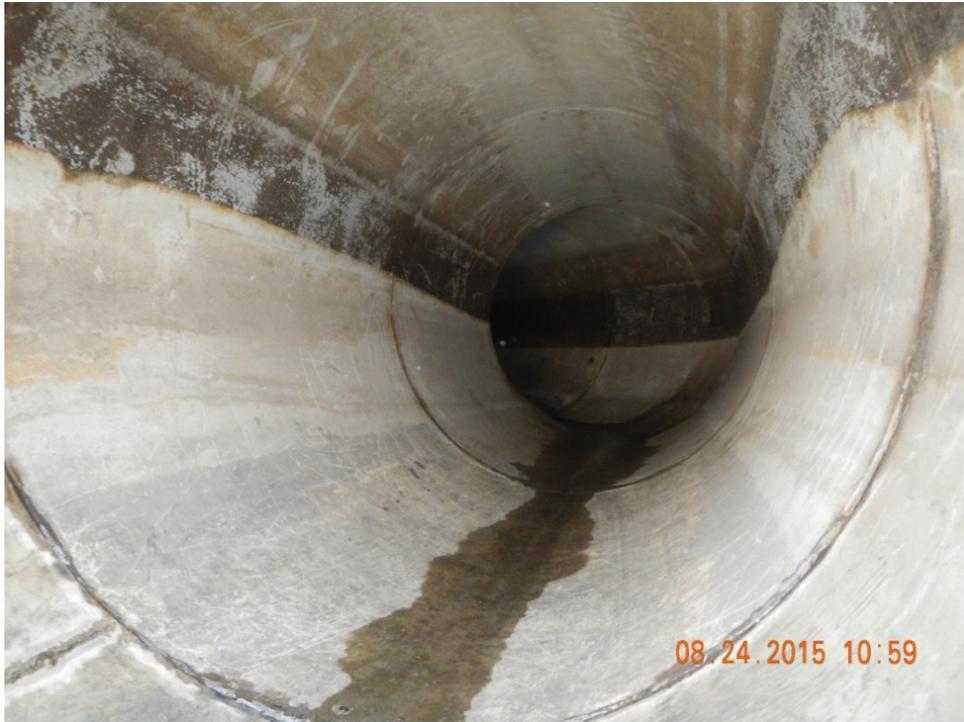
Coleman Diversion Dam/Inskip Powerhouse: The above photo shows the cleaned 72" diameter penstock bypass pipeline, where sediment removal was completed by laborers with hand tools and an 8" vacuum truck nozzle.

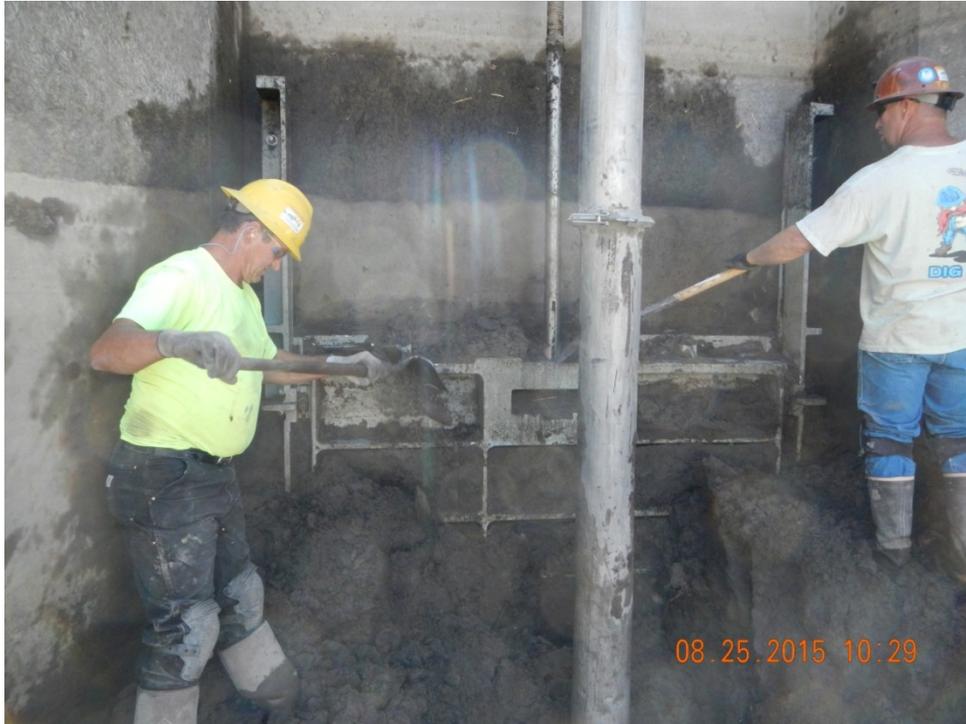
Coleman Diversion Dam/Inskip Powerhouse: The Contractor is working to clear the sediment from the slide gate at the tailrace connector outlet.

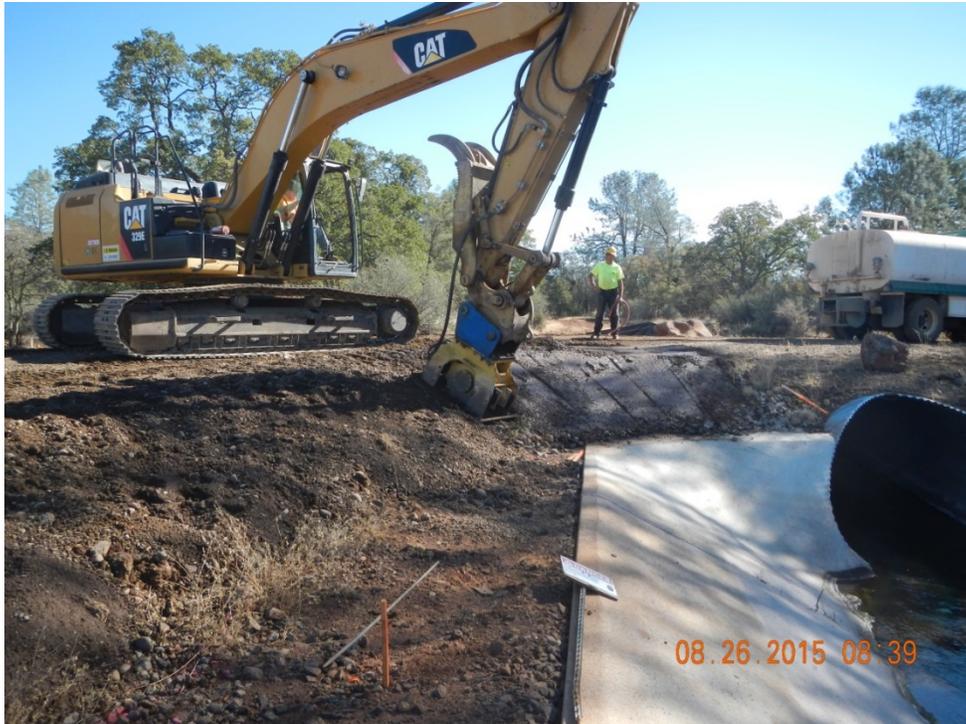
Coleman Diversion Dam/Inskip Powerhouse: The Contractor is compacting the embankment at Eagle Canyon Canal crossing with the vibratory plate compactor attached to the excavator.
