December 29, 2010

**Response of the Giant Garter Snake
(*Thamnophis gigas*) to Water
Primrose (*Ludwigia hexapetala*)
Removal at the Cosumnes River
Preserve**

**Final Report Submitted to the Central
Valley Project Conservation Program -
Habitat Restoration Program**

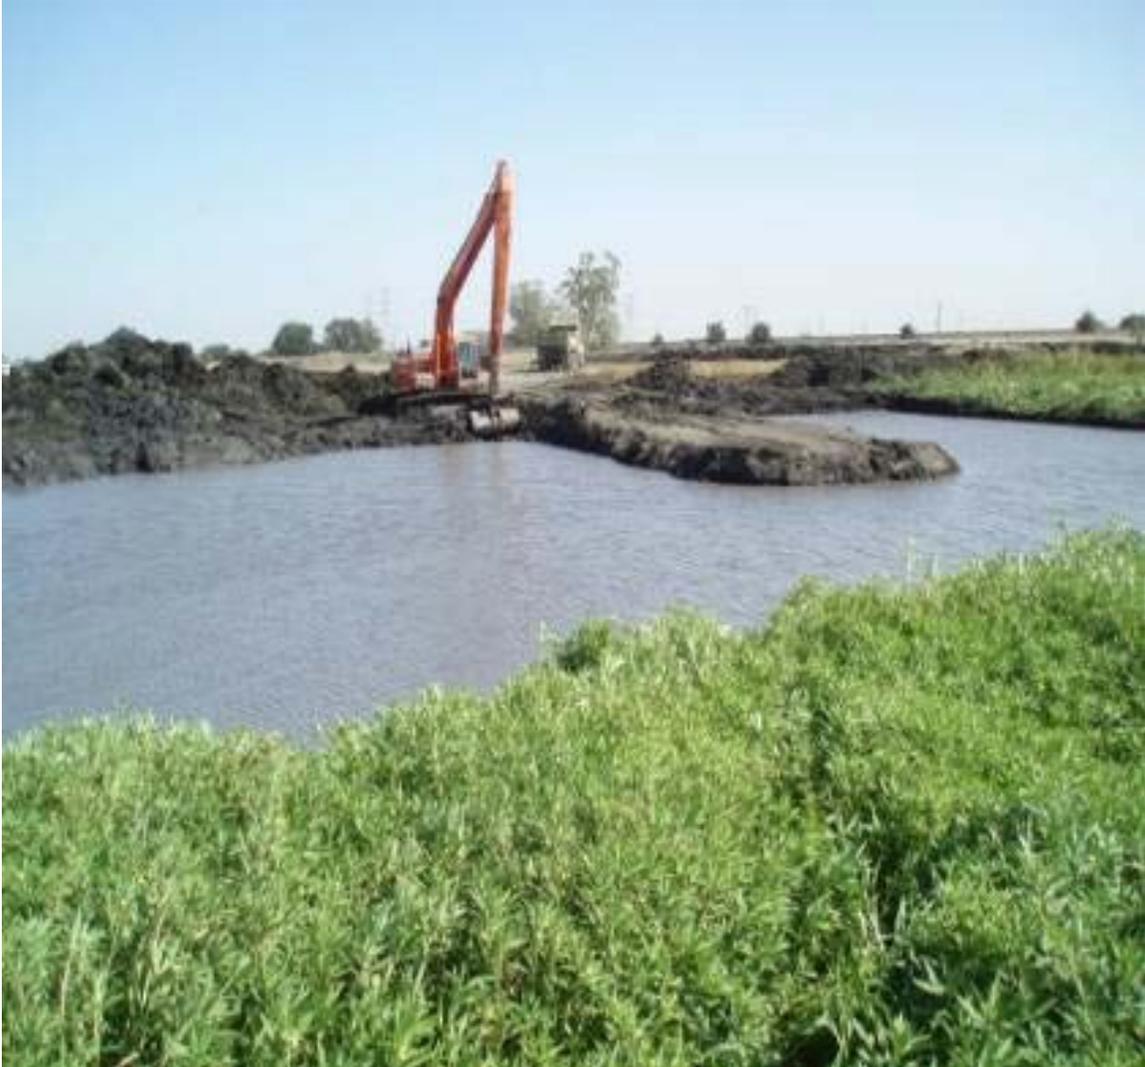
Figure 7a. Excavation and construction of the earthen excavation pads, which were left in place after construction.

Prior to beginning the excavation of the live primrose and biomass, a bulldozer was used to build excavation pads that were approximately 12 feet wide and 4 feet deep to allow the equipment access into the primrose infested area (**Figure 7a**). A 60-foot long-reach excavator with a 35 to 50-foot effective reach, depending on material density and compaction, *etc.*, was then used from stationary locations inside the open-water area footprint to remove the live primrose, its accumulated biomass, and underlying sediment. A series of three earthen excavation pads were eventually constructed in order to provide access to the farthest corners and edges of the newly restored open-water area.

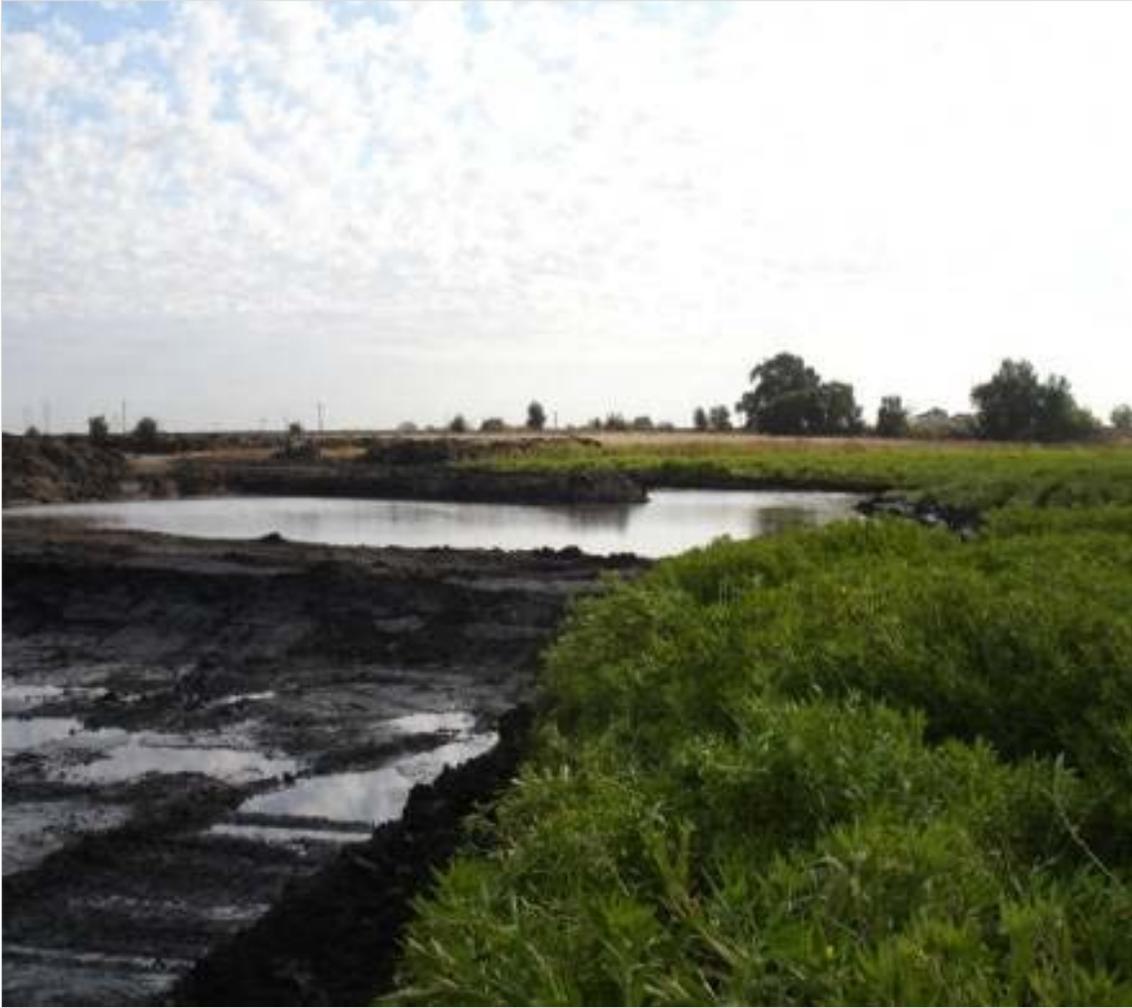
Figure 7b. Earthen weir ensuring pond drawdown remains even rather than unidirectional with regard to elevation.

When completed, the newly restored open-water pond ranged in depth from two feet on the east side to approximately six feet on the west side as planned. The pond was subdivided east to west by a low dirt weir (**Figure 7b**) to ensure the natural drawdown of the pond was relatively even throughout the entire surface area, rather than unidirectional towards the deepest end (**Figure 8**).

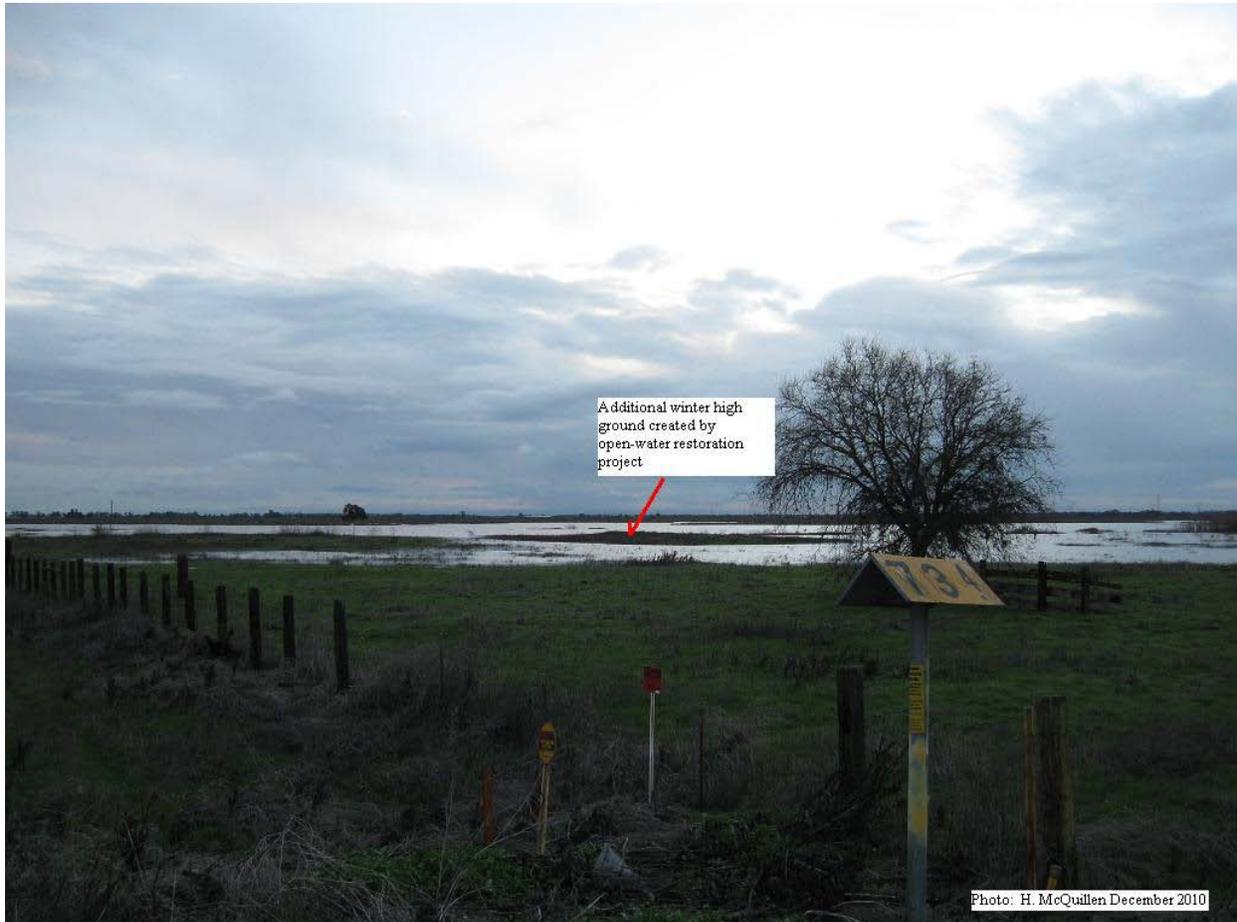
The most immediate result of this Project was the successful restoration of approximately one-acre of open-water foraging habitat for GGS without any adverse effects to individual snakes or the population overall. The second immediate result of the Project was the creation of an approximate one-acre area of additional high ground that can serve as a summer aestivation or winter hibernacula area for GGS, especially during winter flooding events such as the December 2010, 11,000 cubic feet per second (cfs) event (as measured at Michigan Bar) shown in **Figure 11**.

The importance of using the excavated spoils to build additional high ground immediately adjacent to the newly restored open-water foraging area cannot be understated for this location, as was shown in **Figure 11** above. Based on radio telemetry data collected nearly a decade ago, many of the GGS are known or thought to spend the winter in the Union Pacific Railroad grade and the adjacent available upland areas. However, winter rains frequently cause torpid snakes residing in the adjacent uplands to flee their winter hibernacula in advance of approaching flood waters. This can result in higher rates or mortality due to predation of slow-moving snakes and/or the simple lack of high ground above the flood water. This conclusion is easily corroborated by the hundreds of people that are displaced from their homes each year by floods. Based on our observations of the December 2010 flooding event at Snake Marsh, future restoration project should plan to use the spoils from excavation activities to build additional high ground that is even higher than the area that was created in 2008. Future upland enhancement sites should be able to stay above flood levels from at least 30,000 cfs events (as measured at Michigan Bar). Doing so will contribute significantly to the survival and recovery of GGS at this site.

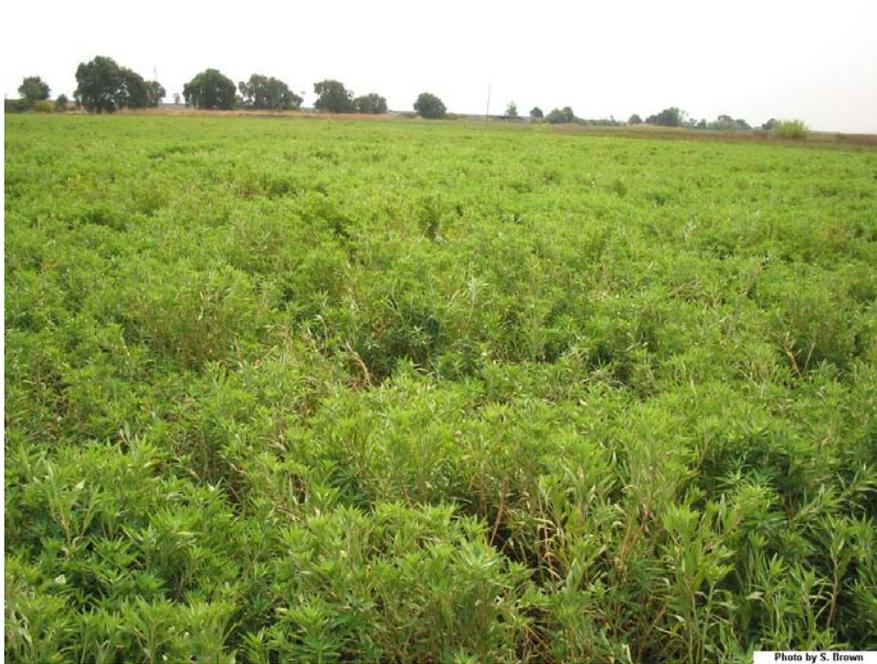
Figure 13a. Pattern of primrose growth at restoration site one year prior to the restoration effort (September 2007)

The pattern of primrose growth one year before the start of the Project is shown in **Figure 13a** (September 2007). **Figure 13b** depicts the pattern of primrose growth approximately 2 months prior to the start of the Project (July 2008). Following restoration, the patterns of primrose growth in the newly restored open water varied significantly according to water depth and between years 2009 and 2010. Very little primrose growth was observed in the restored area in 2009 (**Figure 13c**). The only area of the pond with more than roughly two feet of lateral primrose growth was the eastern edge (the shallowest side of the pond at two feet deep), which showed about 8-10 ft of re-growth. Water levels remained bank-full throughout the GGS active period. The minimal primrose growth and high water levels allowed the amount of open water to remain very similar to the intended design.

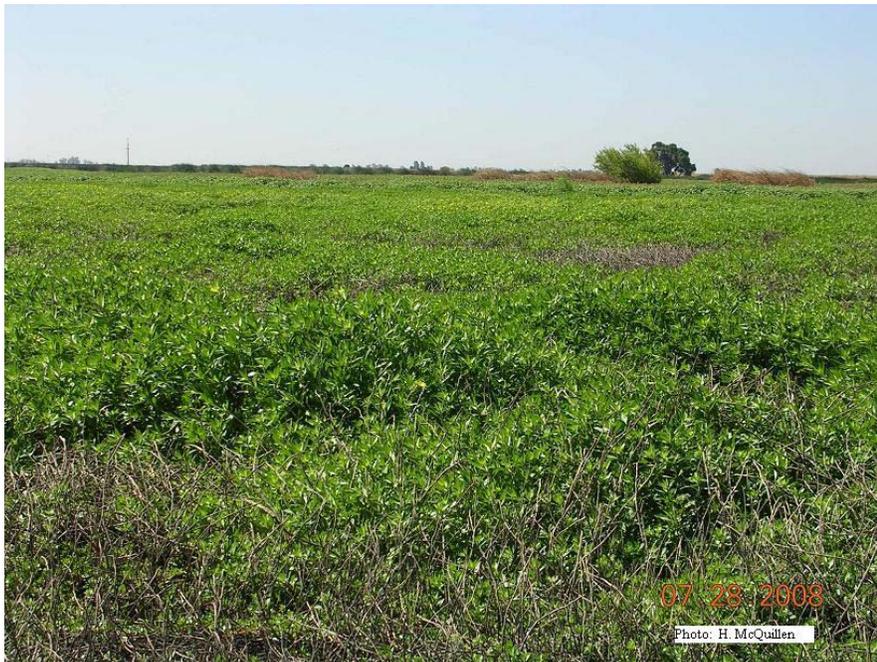
Figure 13b. Pattern of primrose growth at the restoration site approximately two months prior to restoration effort (July 2008)

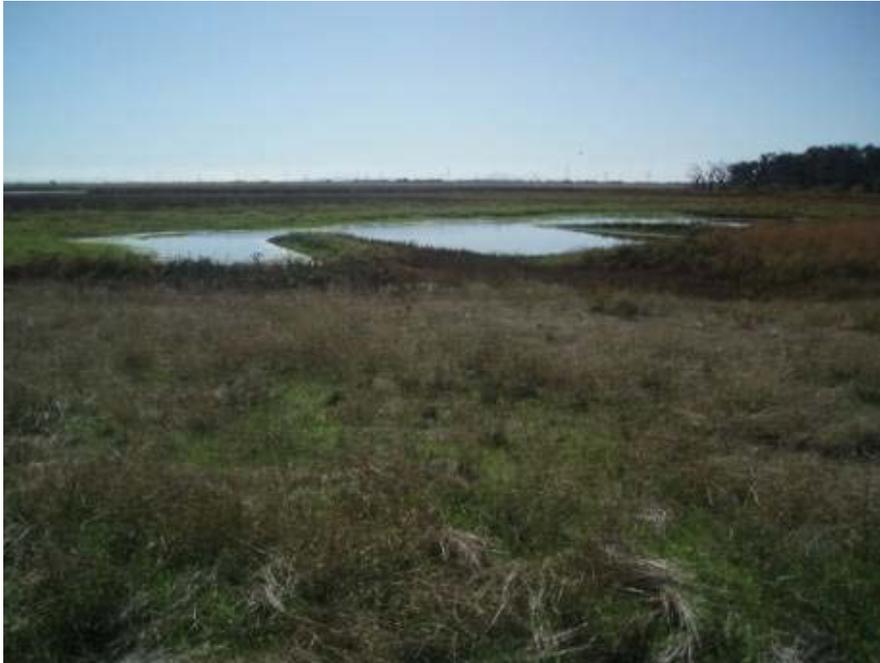
Figure 13c. Pattern of primrose growth at the restoration site in 2009

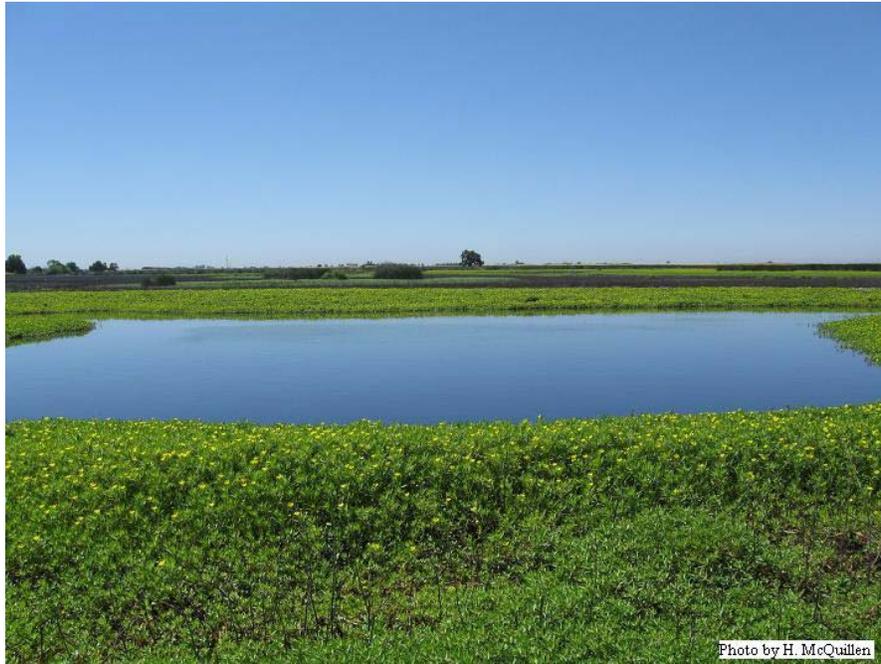
Figure 13d. Substantial open water with plenty of edge habitat for foraging and basking giant garter snakes remains in the restored area in spite of re-growth of primrose (3-4 foot deep area, June 2010)

During the summer of 2010 water levels dropped considerably and primrose re-growth was substantial in some portions of the pond, whereas other portions of the pond continued to provide substantial open-water foraging habitat for giant garter snakes (**Figure 13d**). As expected, the shallowest end of the pond (at two feet deep) had the earliest lateral expansion of the invasive primrose. Most reaches of the pond's shoreline showed 4.5-6 m (15-20 ft) of lateral primrose growth, and emergent stems sprouted from most of this length. By September 2010, primrose from the bank and the parallel construction pad closest to the east end of the pond had grown together on the surface, each side extending 7-8 m (22-26 ft) (**Figure 13e**). As of late October 2010, the eastern part of the restored pond had drawn down naturally and was completely dry while the remainder of the deeper end continued to hold water and provide foraging habitat for the GGS. In the eastern third of the pond, Lateral primrose stems had been stranded on mud as the water receded and these stems had firmly rooted in the soil (**Figure 13f**). The western, six-foot deep portion of the pond showed primrose re-growth as well but it still provided ideal foraging and basking habitat for giant garter snakes. By September 2010, emergent primrose extended about 4.5 m (15 ft) from the westernmost bank and about 1.5 m (5 ft) from the western-most parallel construction pad. The solitary floating stems from these two shorelines occasionally met across the 15 m (50 ft) of basin (**Figure 13g**). As of late December 2010, there was still approximately ½ meter of water remaining in the western half of the newly restored pond, thereby still supporting GGS prey species until the winter rains. However, primrose in the remaining inundated areas was also likely rooted, judging by the difficulty of pushing through submerged matted stems in October 2010 order to measure water depth.

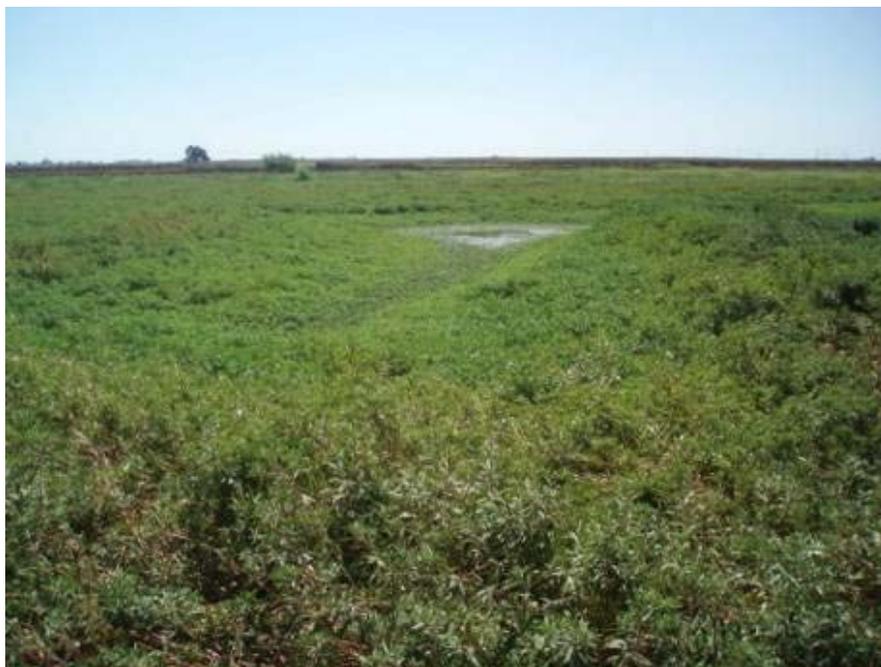
Figure 13e. Pattern of primrose growth at the shallow, 2-foot deep end of the restoration site in late summer 2010. Little to no foraging habitat value to giant garter snakes in late summer.

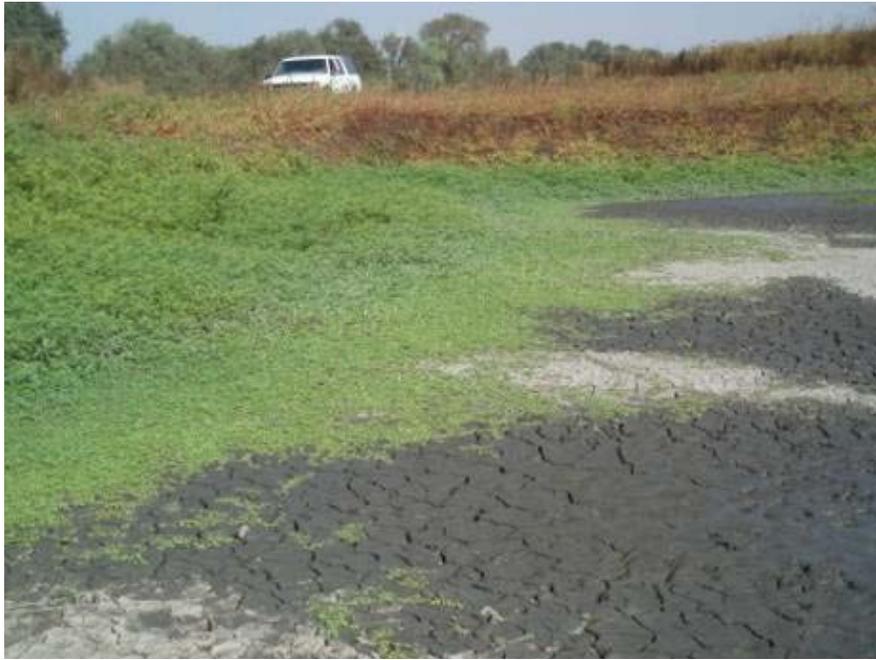
Figure 13f. Stranded primrose in pond after drawdown and drying

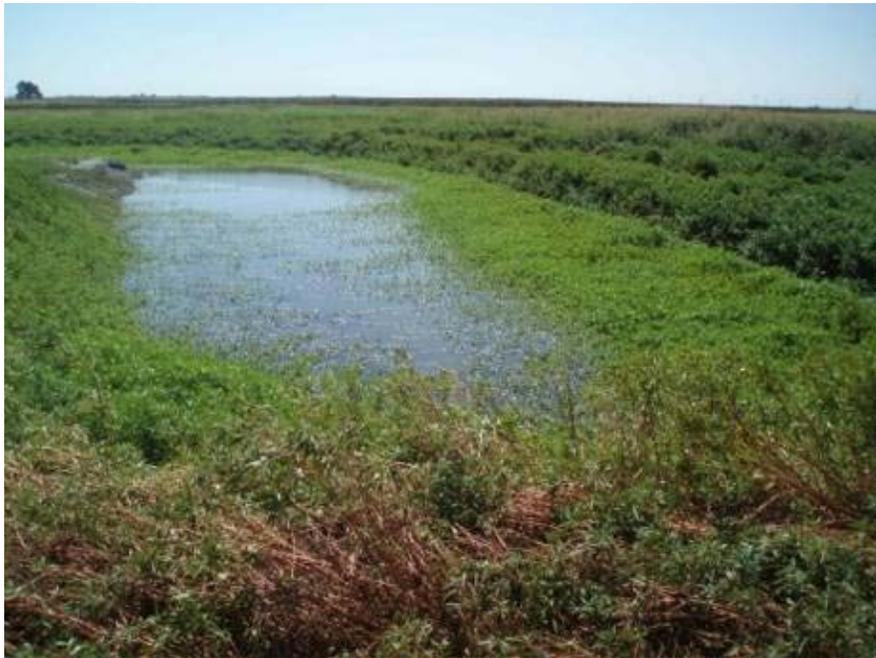
Figure 13g. Pattern of primrose growth at the deeper, 6-foot end of the restoration site in 2010. Still holding water into late summer and providing foraging habitat for giant garter snakes.
