Klamath CAPP Private Pumps Field Testing Technical Memorandum

Project: Klamath CAPP Engineering Support Services

Subject: Klamath CAPP Private Pumps Field Testing

Date: May 7, 2015

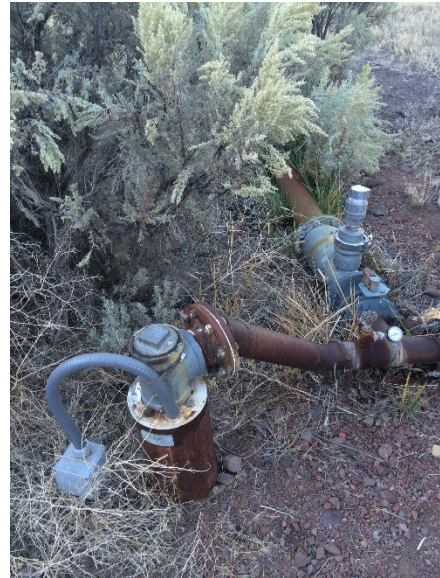
A new pump and motor were installed in 2012, but the new motor continually caused blown breakers in the electrical panel. The original motor, which was originally installed in 1996, was reinstalled with the new pump and this configuration has remained in place since 2012. Three sprinkler lines were open during field testing, which reduced the pumping flowrate to 335 gpm and increased discharge pressure to 88 pounds per square inch (psi). The measured wire-to-water efficiency of the well pump is higher than expected, likely due to the pump providing less flow and more TDH than the design point of the pump. The results of the analyses indicate that the efficiency of the pump and motor would still be high had testing occurred during irrigation season with the pump operating at (or closer to) the design point. Similarly, the energy signature of the pump and motor would improve (decrease) during normal system operations with the pump operating at (or closer to) the design point. A summary of the existing equipment assessment results is shown in **Table 5**.

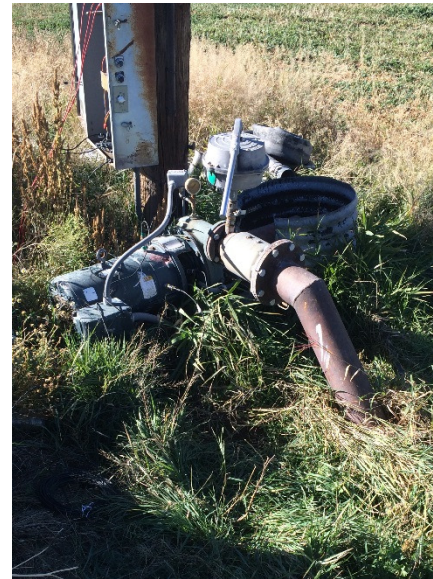
The pump is vibrating in the orange “restricted operation” section of the ISO standard and the motor is vibrating in the yellow “unrestricted operation” section of the ISO standard.

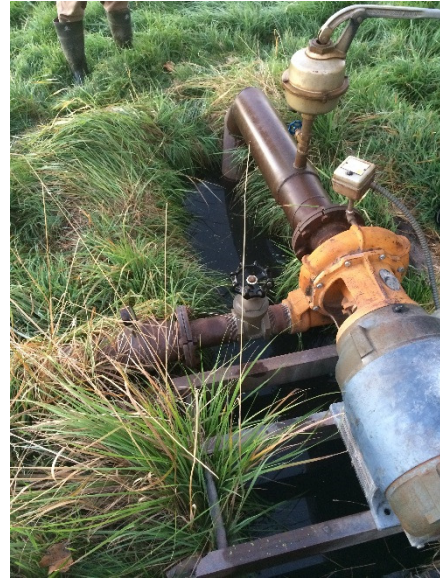
The pump is vibrating in the orange “restricted operation” section of the ISO standard and the motor is vibrating in the green “newly commissioned machinery” section of the ISO standard.

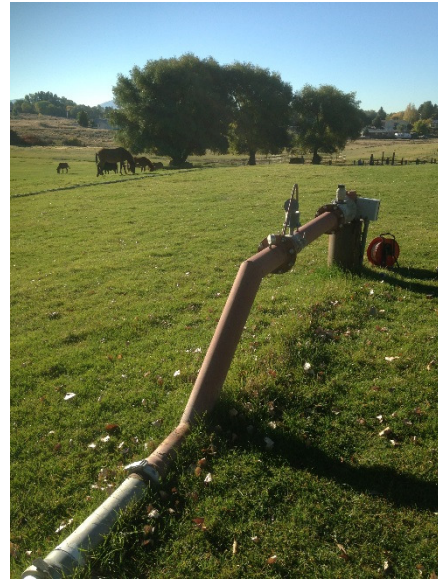
The Facility 5 well has a submersible 700 gpm pump and 40 HP motor that pumps groundwater into sprinkler and hand lines that are used to irrigate a combined 20 acres of pasture, hay and grass fields, typically between May and October. The owner has the ability to open and close sprinkler lines as needed to meet the irrigation needs of the system. These needs typically require operating the pump for 24 hours per day for 6 days, and then keeping the pump off for approximately 10 days. The system can also be irrigated with water from a ditch that can be boosted from the ditch into the Facility 5 system with a 500 gpm, 20 HP pump and motor. This surface water booster pump is the owner's preferred pump to supply the system, but recent dry years have made supply to this pump unreliable. Supply to this pump was not available during field testing and therefore it was not tested.

A vibration analysis was not performed because the well has a submersible pump and motor, making it impossible to connect the vibration monitoring equipment to the pump or motor.

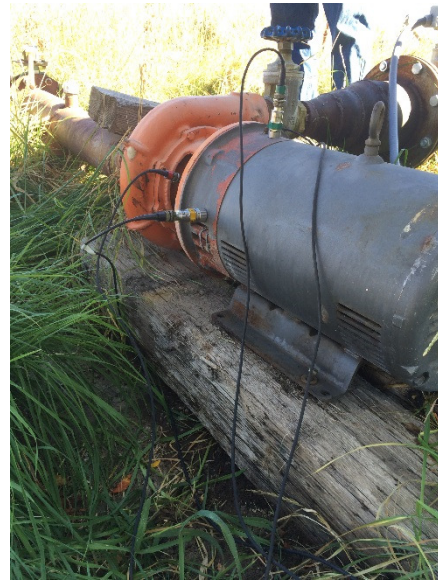
A vibration analysis was not performed on the submersible well pump and motor because the vibration monitoring equipment could not be connected to the pump or motor. Vibration data was collected for the surface water booster pump, which revealed that the pump and motor are both vibrating in the red “damage occurs” section of the ISO standard.

If a new 450 gpm submersible well pump and 40 HP motor (and an assumed 70 percent wire-to-water efficiency) is installed to replace the existing well equipment, the annual energy consumption is estimated to decrease to 87,216 kWh, which represents a 14.3 percent (14,592 kWh) savings. If a new surface water booster pump with the same capacity (and an assumed 70 percent wire-to-water efficiency) were to replace the existing equipment, the annual energy consumption is estimated to decrease to 22,971 kWh, which represents a 40.8 percent (15,837 kWh) savings. The decreases in energy consumption assume there is no supplemental supply.

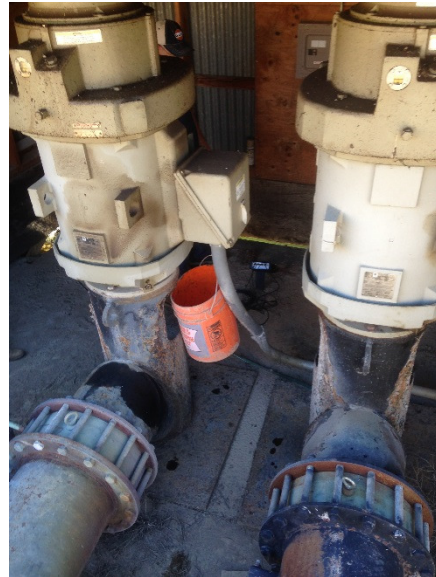
The Surface Pump 1 pump and motor are vibrating in the yellow “unrestricted operation” section of the ISO standard and the Surface Pump 2 pump and motor are vibrating in the green “newly commissioned machinery” section of the ISO standard. The well pump is vibrating in the yellow “unrestricted operation” section of the ISO standard and the well motor is vibrating in the green “newly commissioned machinery” section of the ISO standard.

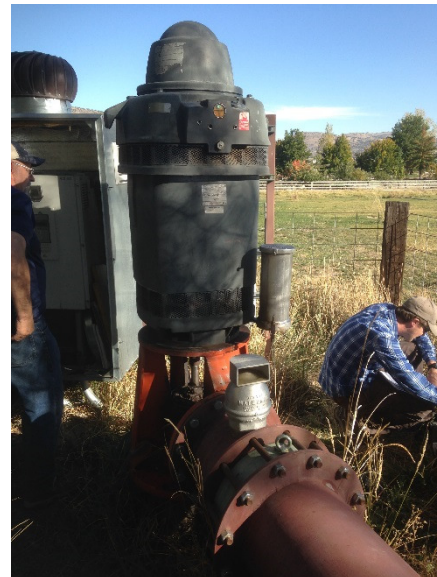
The wire-to-water efficiency of the two surface pumps and motors is good (at or above 70 percent) based on the results of the field testing. This energy signature is likely due to the pumps being only 10 years old and properly sized for the pumping application, and having a roof to protect the equipment from weathering.

The well pump and motor also have a good energy signature based on an estimated TDH of 129 feet when operating at 60 Hz. Suction head was not able to be measured in the field due to the owner's well sounder being stuck in the well column, and discharge pressure was not able to be measured because the owner's pressure gauge was broken and standard fittings could not be used to connect the testing pressure gauge to the discharge pipe. The owner indicated that the well's static water depth was 42 feet. RH2 estimated the pumping water depth to be 60 feet and the discharge pressure to be 30 psi, resulting in a TDH of 129 feet when head losses are considered. A summary of the existing equipment assessment results is shown in **Table 15**.

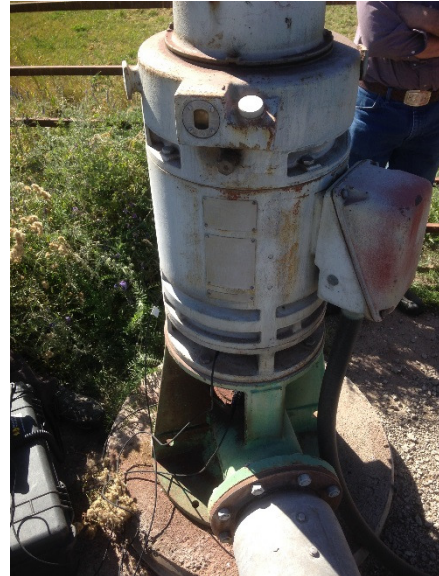
The pump is vibrating in the yellow “unrestricted operation” section of the ISO standard and the motor is vibrating in the orange “restricted operation” section of the ISO standard.

If a new 540 gpm pump and 40 HP motor with the capacity required to meet the irrigation needs of the system (and an assumed 70 percent wire-to-water efficiency) are installed to replace the existing equipment, the annual energy consumption is estimated to decrease to 24,778 kWh. This decrease represents a 9,221 kWh savings (27.1 percent) compared to the existing pumping equipment.

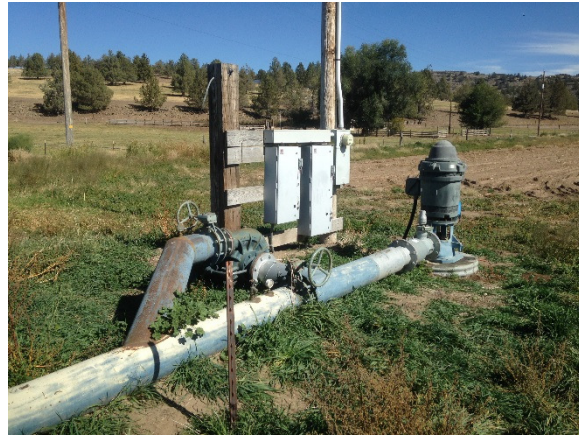
The pump is vibrating in the green “newly commissioned machinery” section of the ISO standard and the motor is vibrating in the yellow “unrestricted operation” section of the ISO standard.

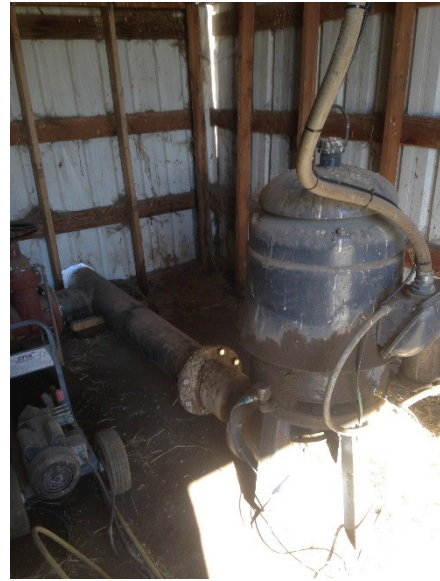
The Hot Well Pump No. 1 pump and motor are both vibrating in the orange “restricted operation section of the ISO standard. The Hot Well Pump No. 2 pump is vibrating in the green “newly commissioned machinery” section of the ISO standard and the motor is vibrating in the yellow “unrestricted operation” section of the ISO standard.

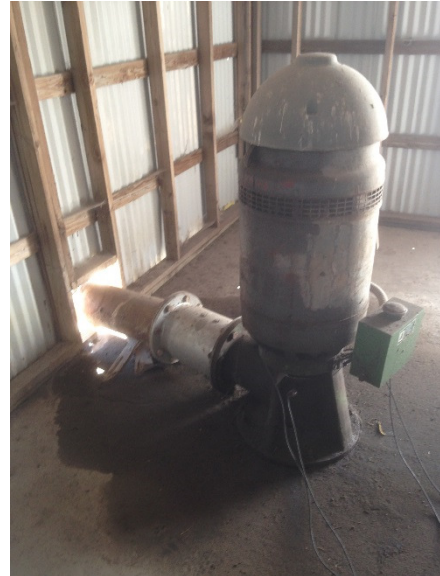
Due to the varying nature of the system operation, assumptions were made to estimate the pump's annual energy consumption shown in **Table 21**. Each pump was assumed to operate six hours per day, year-round. Based on these operation characteristics, the estimated annual energy consumption for both pumps is 128,843 kWh, and the breakdown of estimated annual energy consumption for each pump is shown in **Table 21**. The power consumption of Hot Well Pump No. 2 is approximately twice as much as Hot Well Pump No. 1, but Hot Well No. 2 provides 50 to 60 percent more supply than Hot Well No. 1. It is recommended that Hot Well Pump No. 1 be utilized more frequently than Hot Well Pump No. 2 to reduce energy consumption. If Hot Well Pump No. 2's runtime was reduced by 50 percent, and Hot Well Pump No. 1's runtime increased to maintain the same supply to the system, it is estimated that the annual energy consumption of the two well pumps would decrease 5,604 kWh to 123,238 kWh.

No energy savings are anticipated for the Hot Well No. 1 or No. 2 pumps with new equipment due to the better-than-expected wire-to-water efficiency of the existing equipment. However, energy savings can be realized if Hot Well Pump No. 1 is utilized more frequently than Hot Well Pump No. 2.

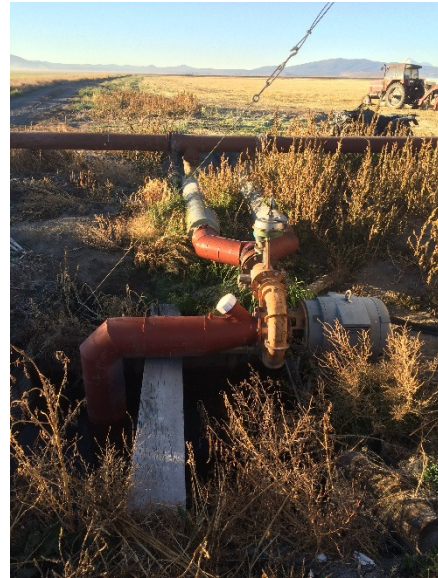
The pump is vibrating in the orange “restricted operation” section of the ISO standard and the motor is vibrating in the yellow “unrestricted operation” section of the ISO standard.

If a new 1,250 gpm pump and 100 HP motor with the capacity required to meet the irrigation needs of the system (and an assumed 70 percent wire-to-water efficiency) are installed to replace the existing equipment, the annual energy consumption is estimated to decrease to 62,167 kWh. This decrease represents a 7,460 kWh savings (10.7 percent) compared to the existing pumping equipment.

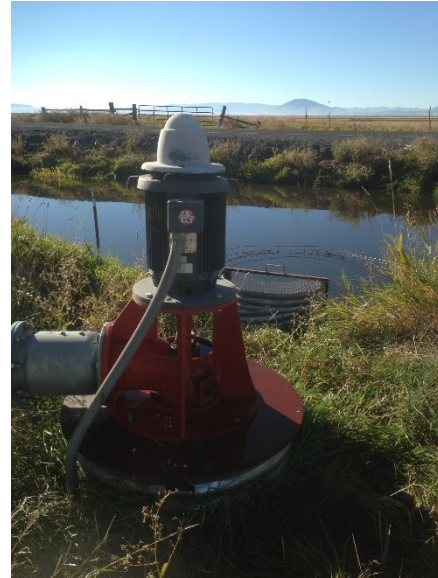
The pump is vibrating in the green “newly commissioned machinery” section of the ISO standard and the motor is vibrating in the orange “restricted operation” section of the ISO standard.

If a new 1,000 gpm pump and 20 HP motor with the capacity required to meet the irrigation needs of the system (and an assumed 70 percent wire-to-water efficiency) are installed to replace the existing equipment, the annual energy consumption is estimated to decrease to 4,306 kWh. This decrease represents a 720 kWh savings (14.3 percent) compared to the existing pumping equipment.

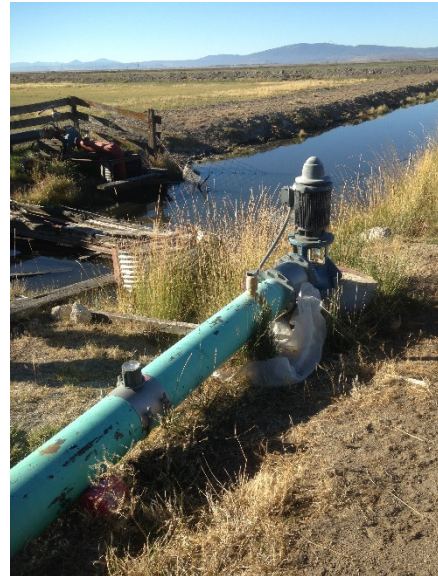
The pump configuration during field testing was similar to the configuration during normal irrigation operations. No throttling valve exists for the pump, so only one data point was collected during the field visit. The measured wire-to-water efficiency of the pump is very poor based on the field data. A summary of the existing equipment assessment results is shown in **Table 27**.

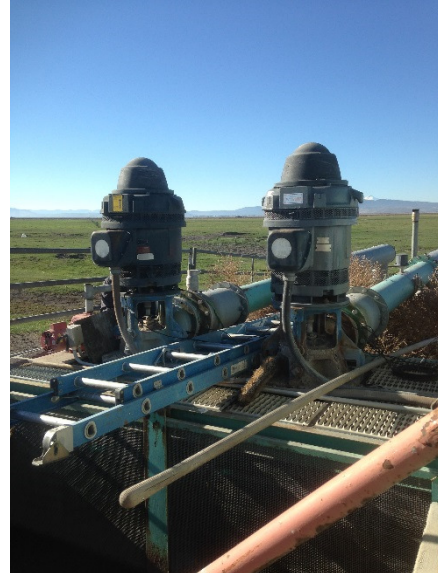
The south pump and motor are both vibrating in the yellow “unrestricted operation” section of the ISO standard and the north pump and motor are both vibrating in the green “newly commissioned machinery” section of the ISO standard.

If new 1,025 gpm pumps with 50 HP motors with the capacity required to meet the irrigation needs of the system (and an assumed 70 percent wire-to-water efficiency) are installed to replace the existing equipment, the annual energy consumption is estimated to decrease to 82,092 kWh. This decrease represents a 14,592 kWh savings (15.1 percent) compared to the existing pumping equipment.

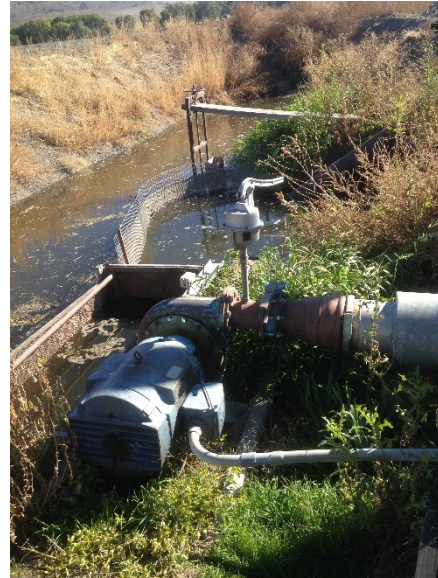
The pump configuration during field testing was similar to the configuration during normal irrigation operations. No throttling valve exists for the pump, so only one data point was collected during the field visit. Flow and discharge pressure data was not able to be measured during field testing. Instead, estimates of 1,200 gpm and 55 psi at the pivot were made based on the owner’s knowledge of the system. The measured wire-to-water efficiency of the pump is very good based on the field data. A summary of the existing equipment assessment results is shown in **Table 31**.
