RECLAMATION

MID-PACIFIC CONSTRUCTION OFFICE
Willows, California

Construction Progress Report L-29

November 2017

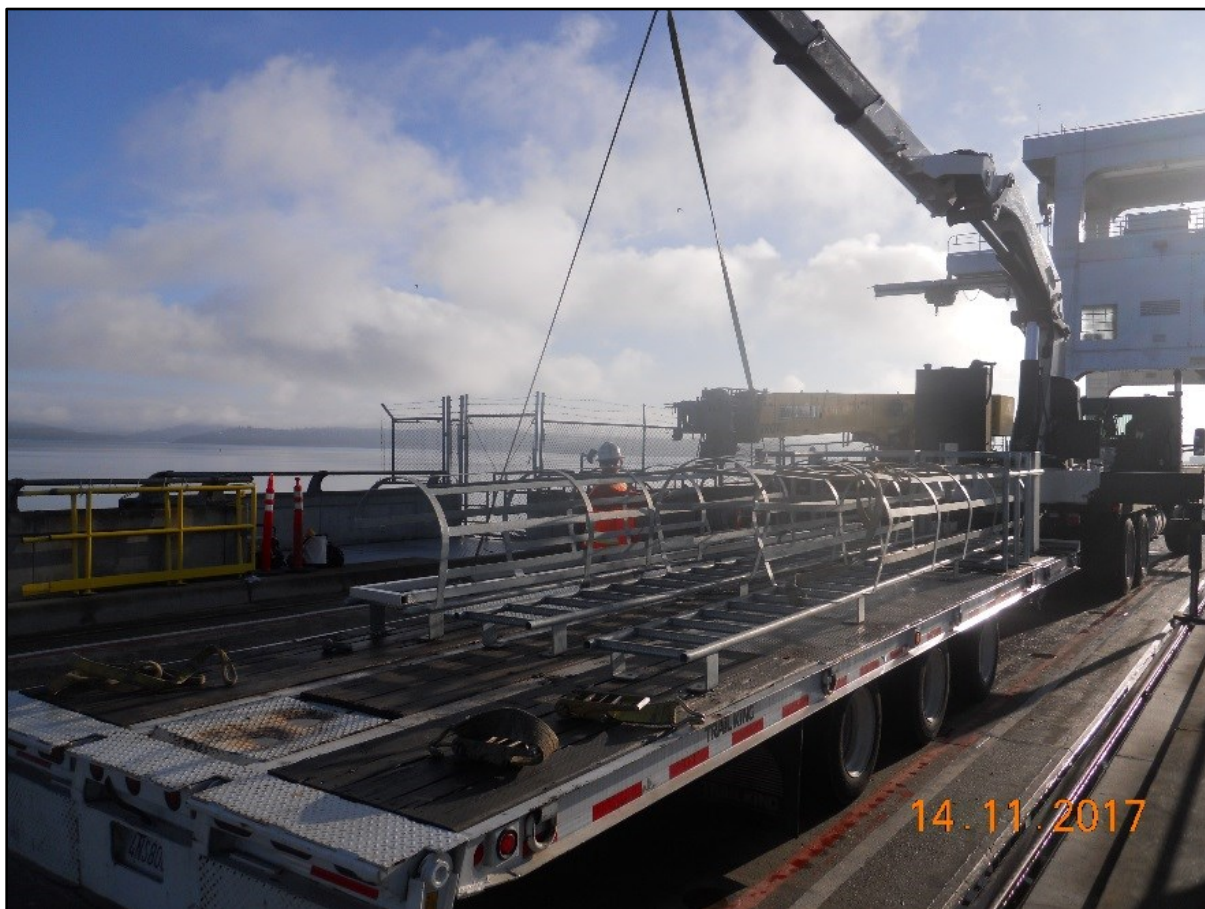
A View of the Ladders, Landings, and Wire Ropes being Delivered to the Job Site.

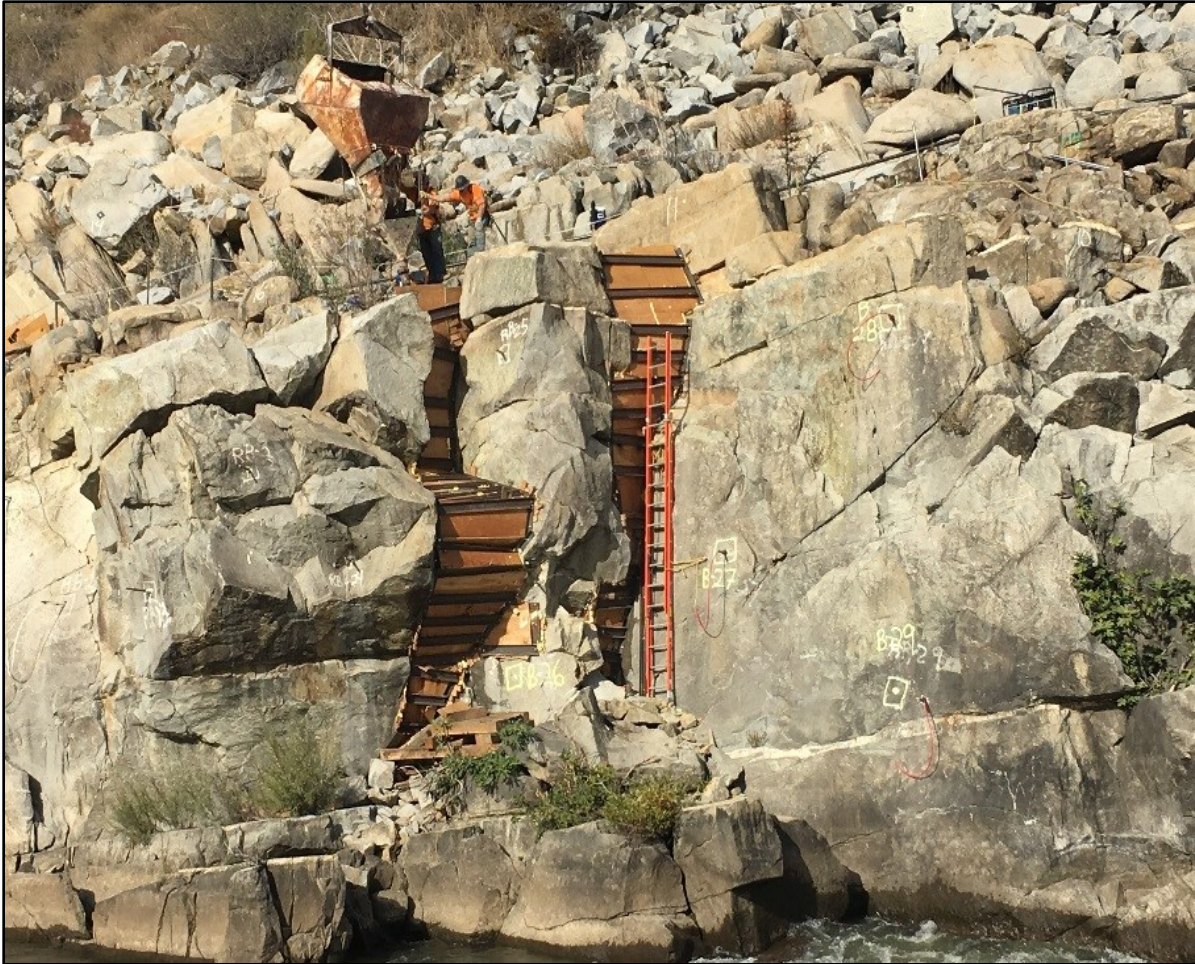
**Folsom Dam Auxiliary Spillway American River Phase V – Right Bank
Stabilization
A View of the Dental Concrete Formwork at the entrants**

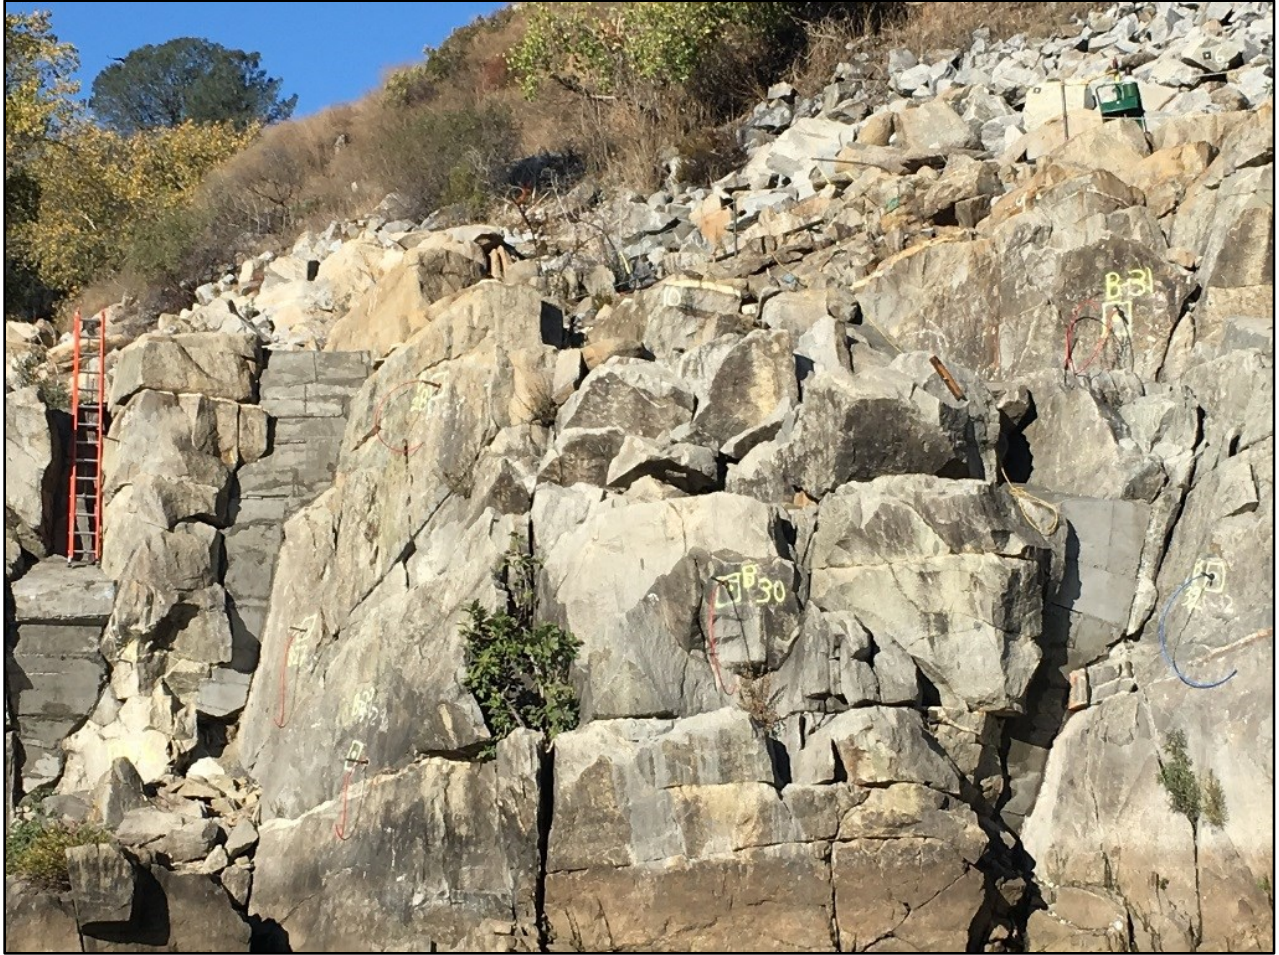
**Folsom Dam Auxiliary Spillway American River Phase V – Right Bank
Stabilization
A View of the Dental Concrete Formwork at the entrants after being poured**

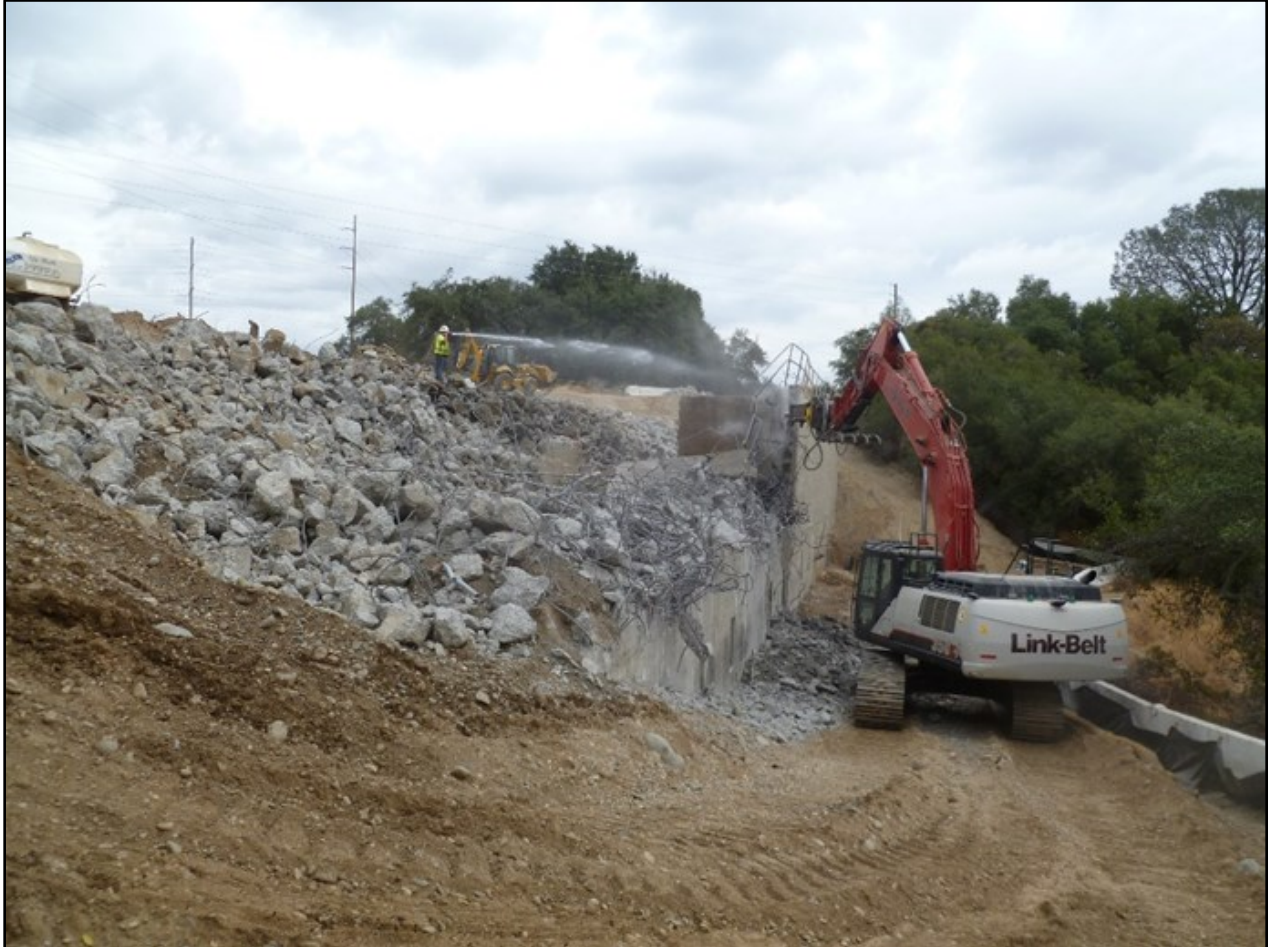
Folsom Aggregate Structure Demolition, Removal & Disposal
The Excavator using the Hydraulic Hammer to Demolish the Concrete Aggregate Sorting Structure.

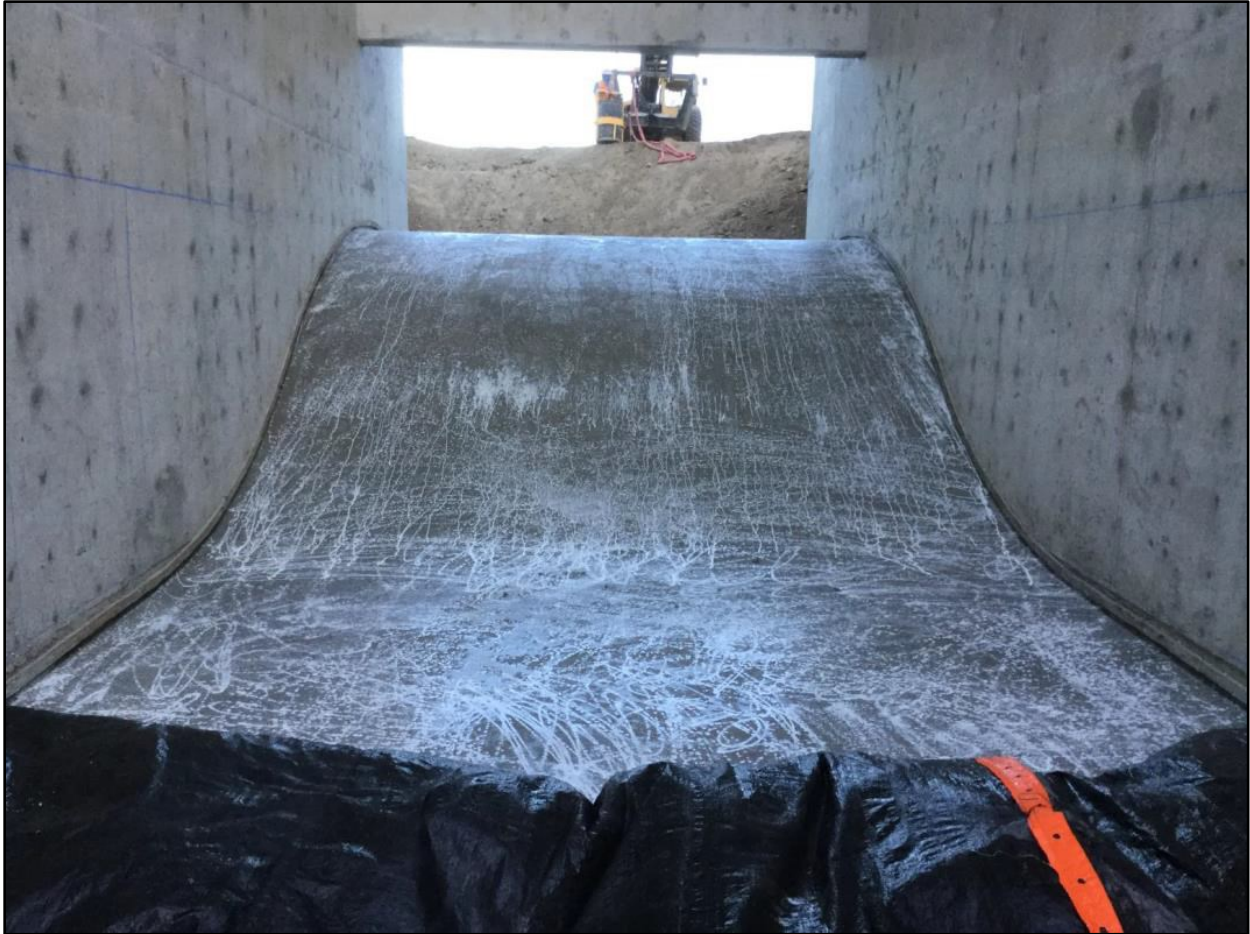
**Stampede Dam, Dam Safety Modifications
A view of the Ogee Crest**

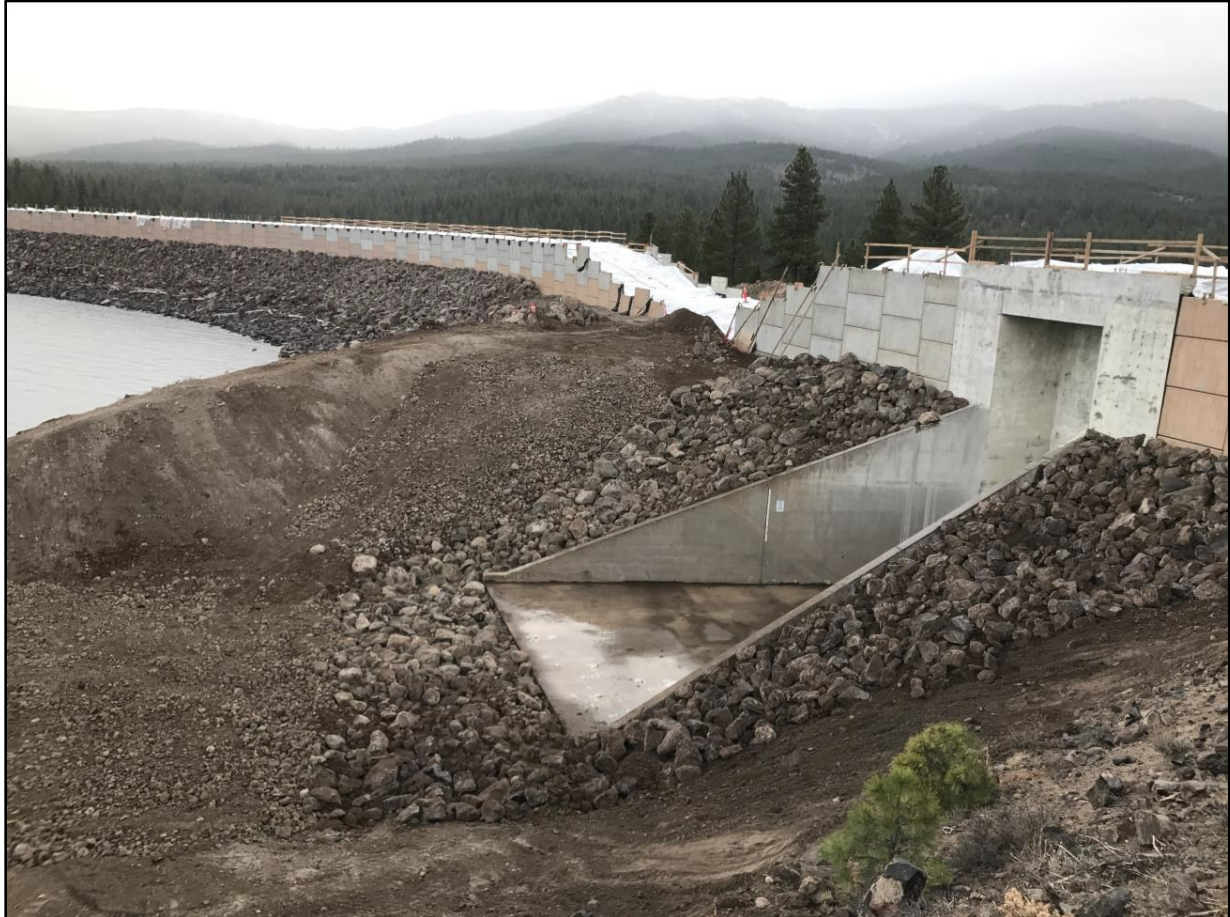
Stampede Dam, Dam Safety Modifications
A view of the Stabilized Spillway Inlet Channel and Mechanically Stabilized Earth
Paneling.

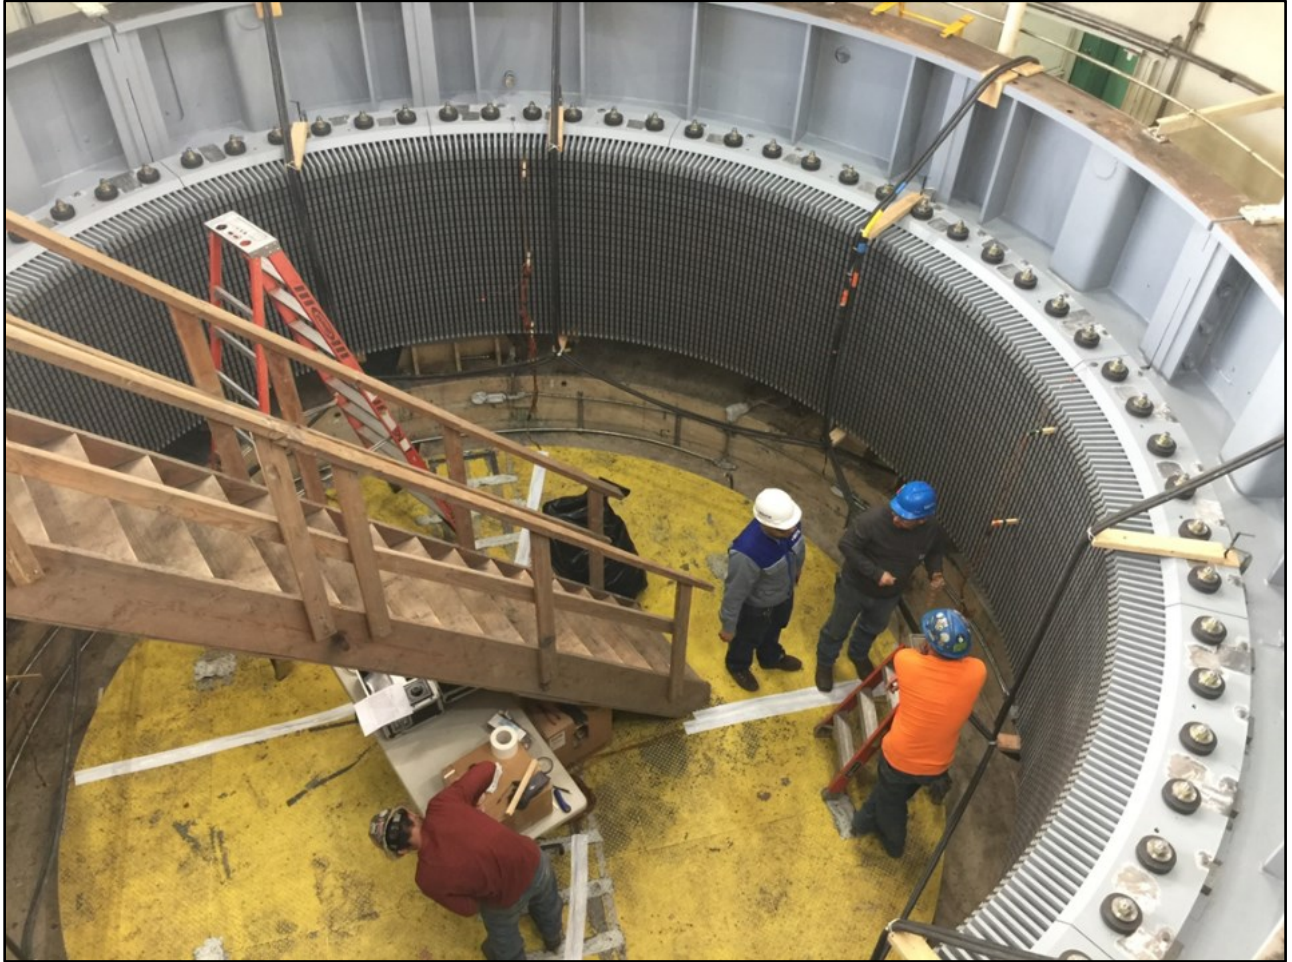
The magnetization core “Loop” test was conducted on the finished core stack. The core was wrapped with 4/0 AWG cable which was connected to an engine/generator set that produced enough current to get the unit up to working flux. An infrared camera was used to record the heat change of the core every ten minutes for one hour while at magnetic flux and every ten minutes during cool down looking for a five degree Celsius change which meant repairs were needed. No such change was recorded so the core was accepted.

**Trinity Powerplant Generator Rewinds
A View of the Stator Core being Prepared for Testing.**

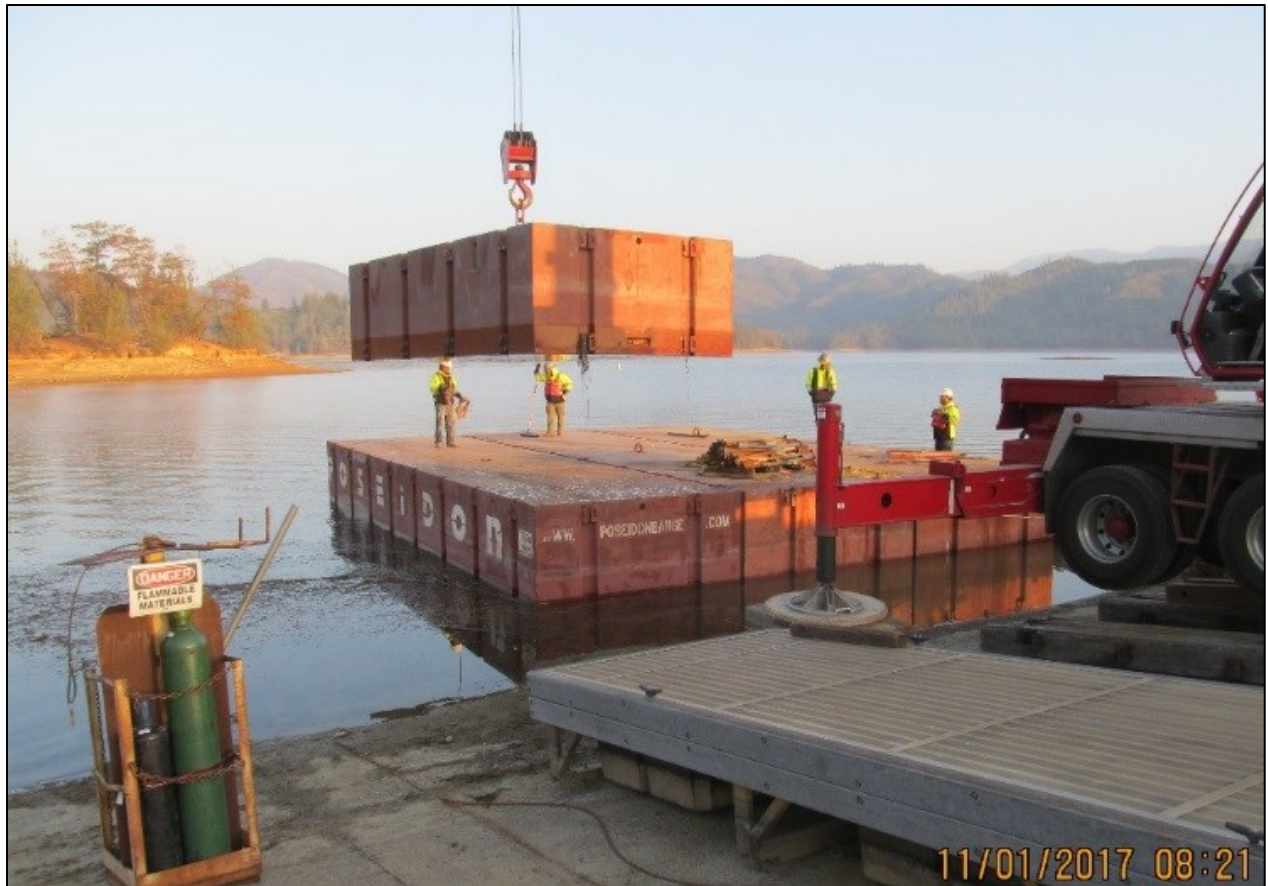
**Whiskeytown Lake, Spring Creek Temperature Control Curtain
A View of the Contractor Disassembling the Barge.**

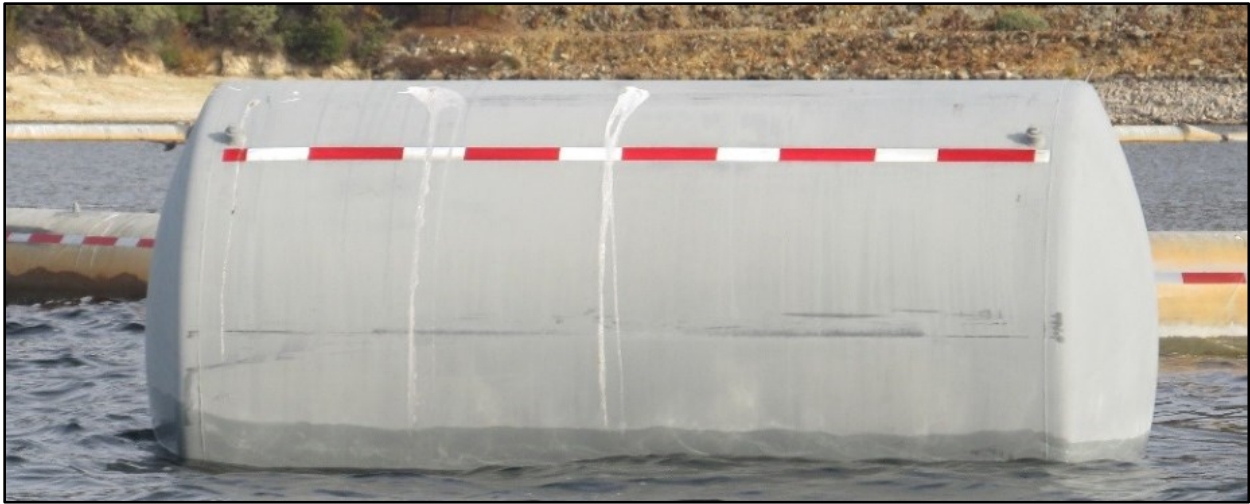
Due to wave action and other site activities, the completion of reflective tape placement was performed intermittently and around other activities. Some tape adhesion to upper boom float tanks failed early in the month, due to water and incorrect installation procedures. Once the Contractor worked solely on this task and corrected their installation procedures, the failed reflective tape was replaced and remaining sections installed properly without issue. The Contractor continued tank rehabilitation by replacing bushings and chain connections, foam filling the tanks, and repairing cracked welds. The location of failed welded seams was determined by pressurizing the upper boom float tanks with an air compressor and checking the tanks both manually and visually. Underwater welding was not in the capacity of the contractor. Application of a zinc repair coating (ZRC) was applied to welds and other uncoated metals. Disassembly of the dive barge was completed this reporting period. Some of the barge pieces were staged on semi-trailers for removal from the Brandy Creek Marina parking area. BCI then vacated the site. The Contractor's lock was removed from the access gate and the United States Bureau of Reclamation (USBR) lock was then connected the gate chain.

**Whiskeytown Lake, Spring Creek Temperature Control Curtain
An Image of Some of the New Reflective Tape after Being Installed.**

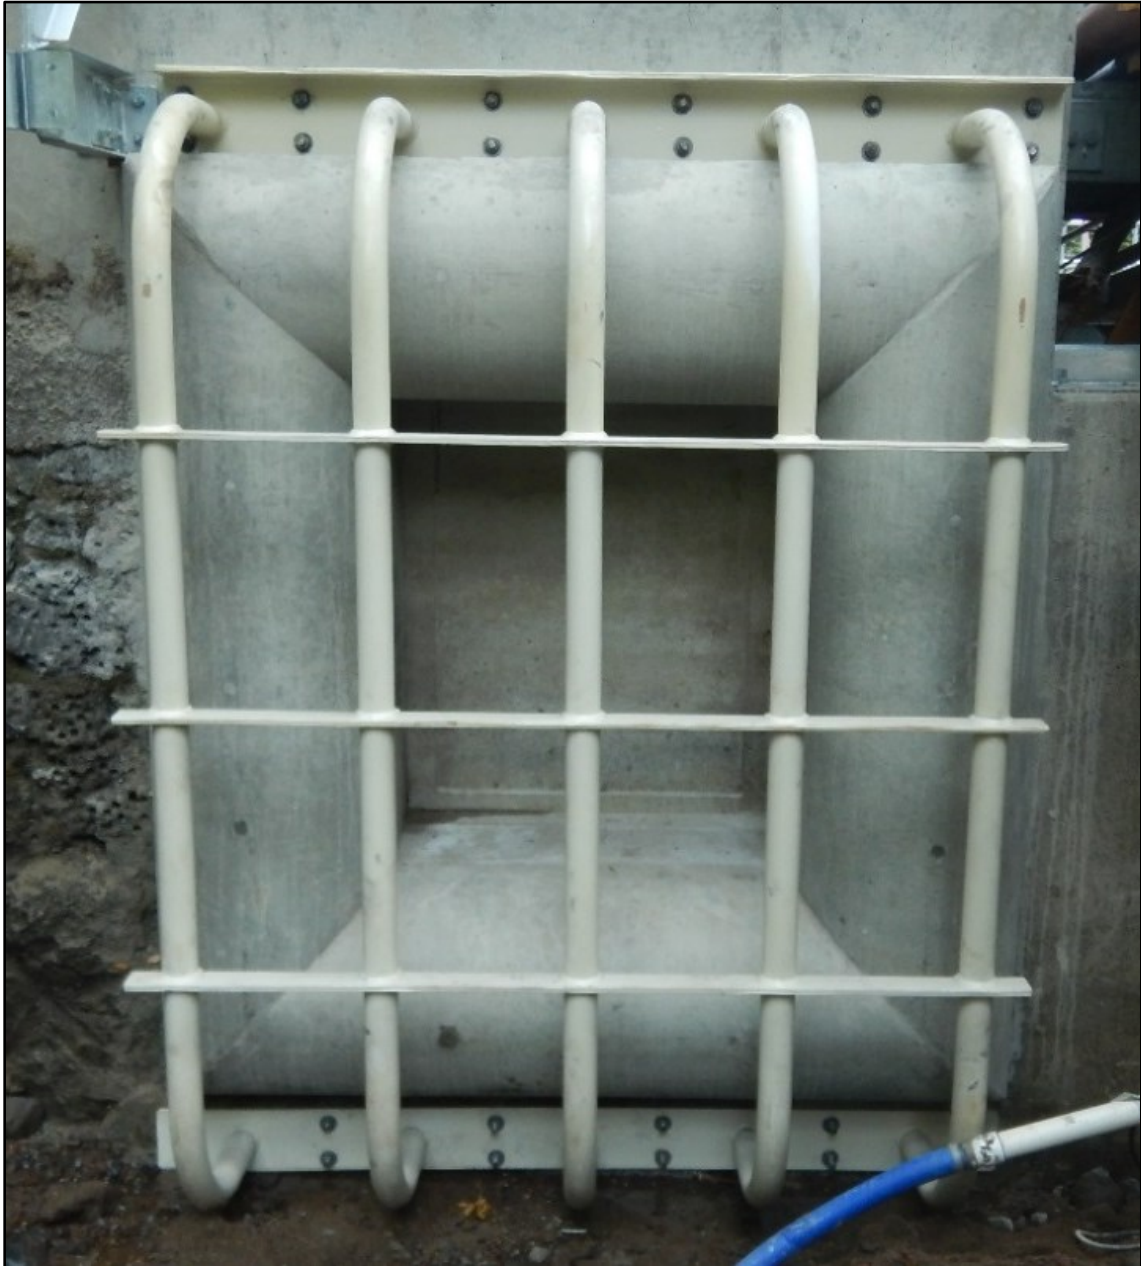
**North Fork Screens and Ladder Completion Contract
A View of the New Bullnose Trash rack on the North Battle Creek Feeder
Diversion Dam.**

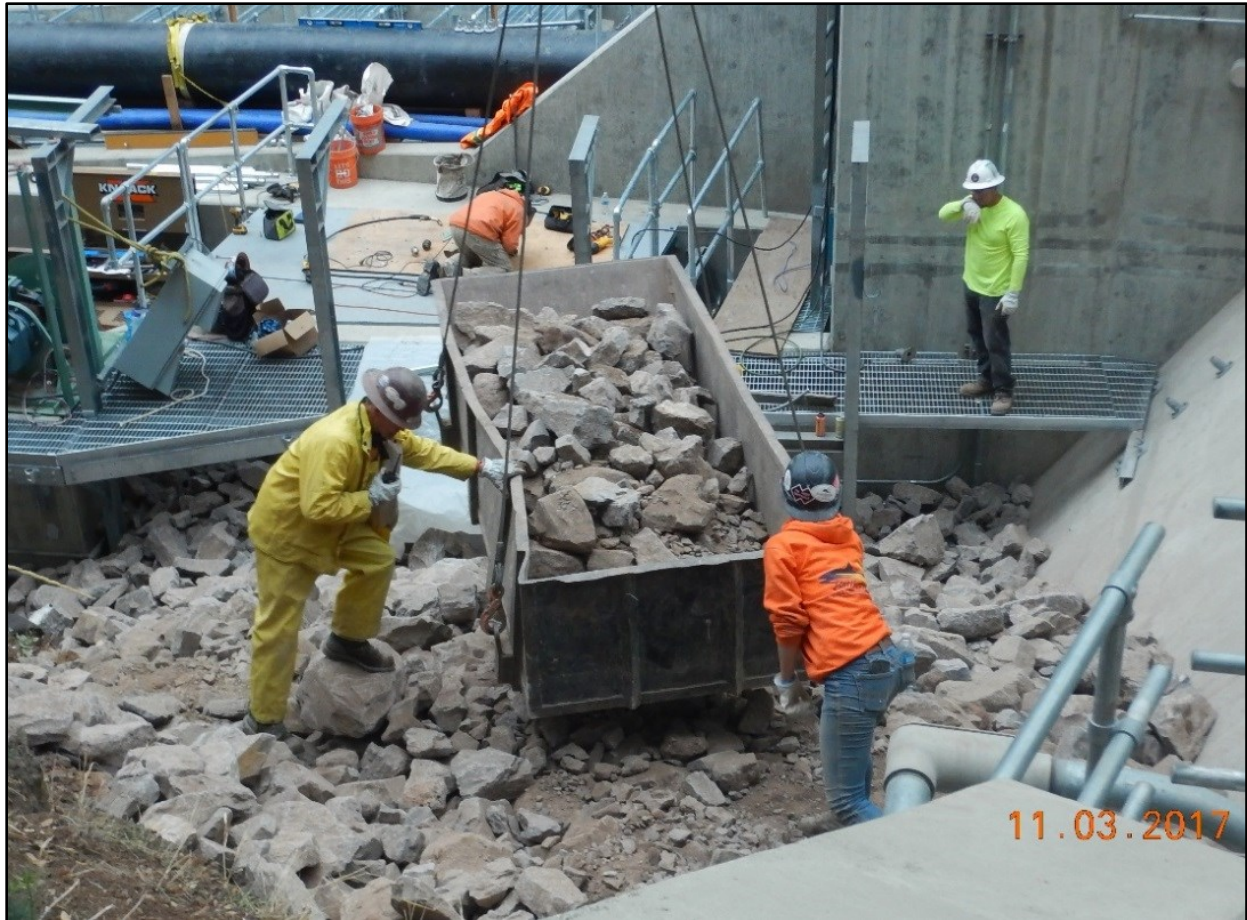
**North Fork Screens and Ladder Completion Contract
Riprap being Installed on the downstream left abutment.**
