Attachment 1 Shoreline Erosion Technical Memorandum

Geologic Technical Report

Shasta Lake Water Resources Investigation, California

**United States Department of the Interior
Bureau of Reclamation
Mid-Pacific Region**

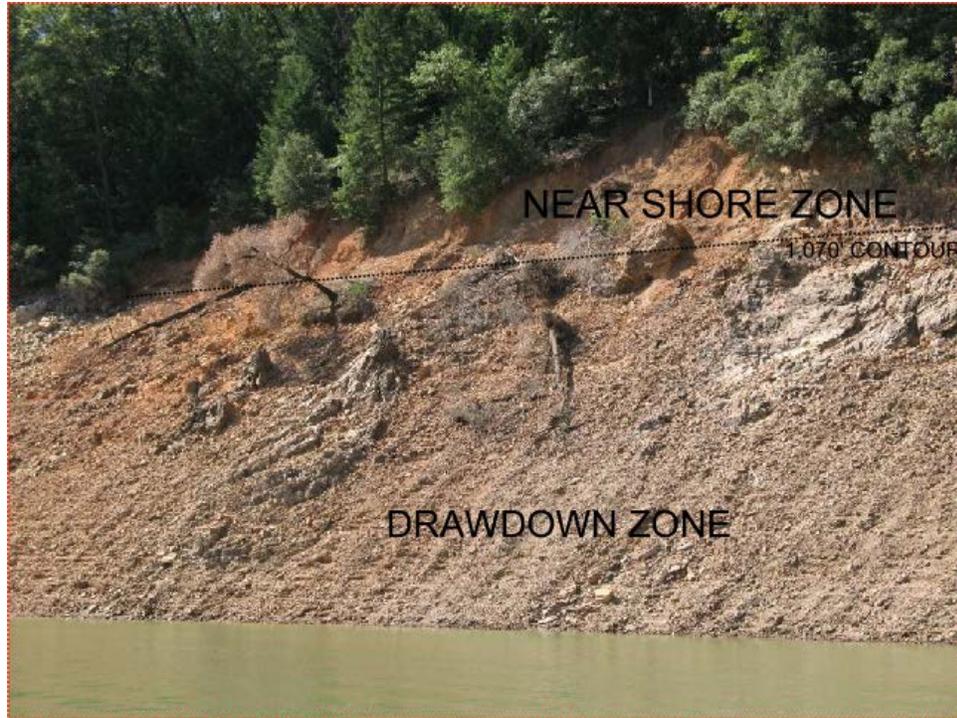
1
2
3 **Figure 2-1. Picture of Shoreline Showing near Shore and Drawdown Zones**

32 erosional force within this zone (Figure 2-1). This zone is also a depositional
33 area during full pool conditions. Sediment deposited in this zone is remobilized
34 as the reservoir is drawn down. Channel incision is common in this zone
35 especially where stream channels intersect it, or the slope is steep and
36 convergent.
