State of California — The Resources Agency
DEPARTMENT OF PARKS AND RECREATION
PRIMARY RECORD

*Resource Name or #: (Assigned by recorder) W. Liberty Road @ Traynor Lateral culvert

*P11. Report Citation: (Cite survey report and other sources, or enter "none.") Windmiller, R., K. L. Finger and C. Roland-Nawi. 2011. Gray Lodge Water Supply Project. Cultural Resources Inventory and Evaluation, Butte County, California. Ric Windmiller Consulting Archaeologist. Submitted to Harvey Consulting Group, LLC. Copies available from the Northeast Information Center, California State University, Chico.

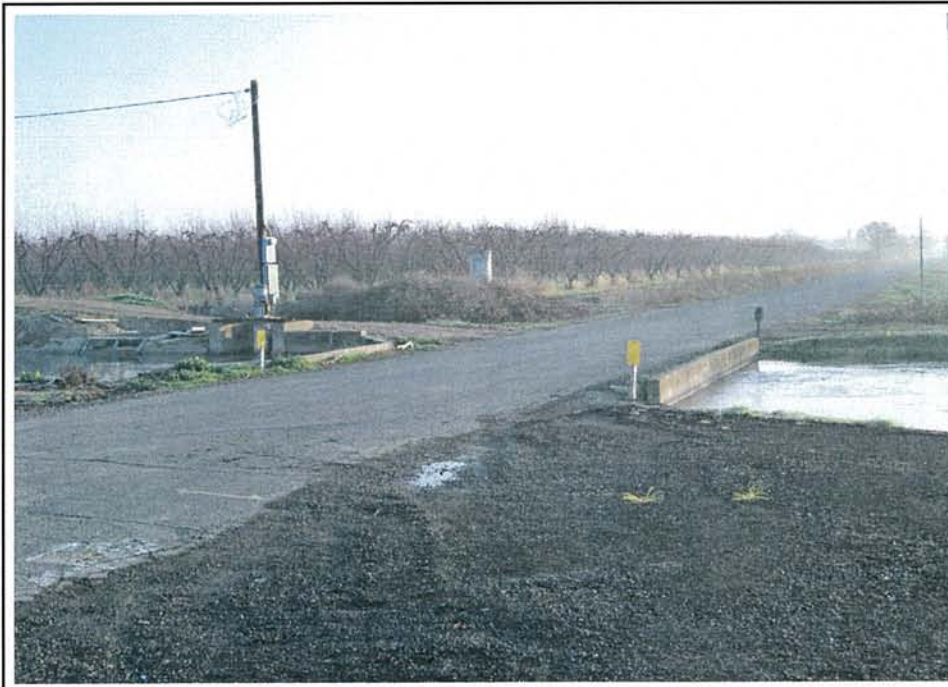
Concrete box culvert consisting of a 12 foot wide intake flanked by two eight foot long concrete "wings." The culvert was apparently cast in place in Traynor lateral and supports the two lane West Liberty Road crossing. A date of "1920" is inscribed in one wall of the culvert. The road crossing is paved in asphalt over concrete. Further construction details are not available due to the high level of water in Traynor lateral, which obscures most of the concrete structure.

P5b. Description of Photo: (view, date, accession #) Looking northeast: 12-17-2011

Construction date is 1920. There are no apparent alterations other than resurfacing the crossing with asphalt.

This reinforced "poured in place" concrete box culvert is similar in design to other road and farm crossings associated with Traynor and other canal laterals in the Biggs-West Gridley Water District's system. The canal system originated with digging channels from the Feather River west to the Biggs-Gridley area beginning in 1905. By 1920, both the Sutter Butte Canal and the Western Canal appear on county survey maps. However, few of the laterals, which formed a large part of the systems, are delineated. From the 1920s through the 1950s, there was a trend within the county to convert privately owned irrigation systems into public entities through the formation of water districts. In 1942, the Biggs-West Gridley Water District was formed. The water district undertook a number of improvements in the 1950s and 1960s, including the replacement of all wooden bridges. All farm and road crossings are now poured in place, one or two barrel box culverts, or concrete slab "bridges."

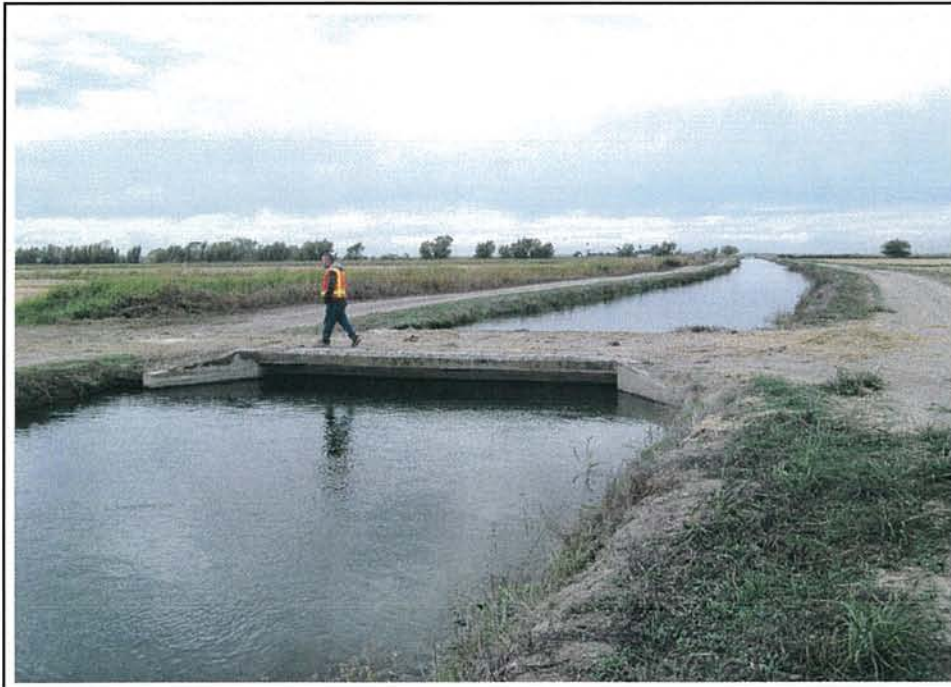
Concrete culvert with bonded concrete erosion wall on downstream north bank of Belding lateral at Riley Road. Road surface is gravel. Culvert appears to have been poured in place to accommodate the unimproved portion of Riley Road, which is gated one-eighth mile to the south at the corner of Lively and Riley roads. No alterations are apparent. Water level was too high to note any further construction details.

P5b. Description of Photo: (view, date, accession #) Looking southwest: 11-03-2011

Construction date is unknown. There are no apparent alterations.

This reinforced "poured in place" concrete box culvert is similar in design to other road and farm crossings associated with Belding and other canal laterals in the Biggs-West Gridley Water District's system. The canal system originated with digging channels from the Feather River west to the Biggs-Gridley area beginning in 1905. By 1920, both the Sutter Butte Canal and the Western Canal appear on county survey maps. However, few of the laterals, which formed a large part of the systems, are delineated. From the 1920s through the 1950s, there was a trend within the county to convert privately owned irrigation systems into public entities through the formation of water districts. In 1942, the Biggs-West Gridley Water District was formed. The water district undertook a number of improvements in the 1950s and 1960s, including the replacement of all wooden bridges. All farm and road crossings are now poured in place, one or two barrel box culverts, or concrete slab "bridges."

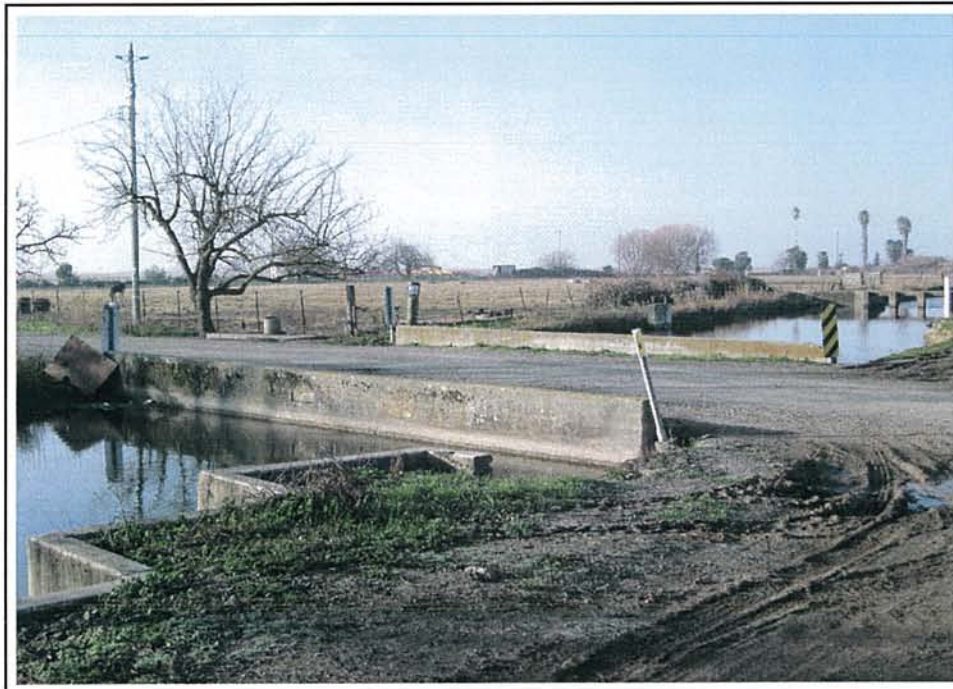
Concrete box culvert with low raised sides poured in place in Belding lateral at Farris Road crossing approximately five miles southwest of Biggs. The approximately 28 foot wide crossing is paved in crumbling asphalt. Farris Road south of the crossing is asphalt paved. North of the crossing, Farris Road is graded gravel. No date of construction was found on the concrete. Water level was too high in the lateral to determine further construction details. No significant alterations are noted.

P5b. Description of Photo: (view, date, accession #) Looking southwest: 12-17-2011

This reinforced "poured in place" concrete box culvert is similar in design to other road and farm crossings associated with Belding and other canal laterals in the Biggs-West Gridley Water District's system. The canal system originated with digging channels from the Feather River west to the Biggs-Gridley area beginning in 1905. By 1920, both the Sutter Butte Canal and the Western Canal appear on county survey maps. However, few of the laterals, which formed a large part of the systems, are delineated. From the 1920s through the 1950s, there was a trend within the county to convert privately owned irrigation systems into public entities through the formation of water districts. In 1942, the Biggs-West Gridley Water District was formed. The water district undertook a number of improvements in the 1950s and 1960s, including the replacement of all wooden bridges. All farm and road crossings are now poured in place, one or two barrel box culverts, or concrete slab "bridges."

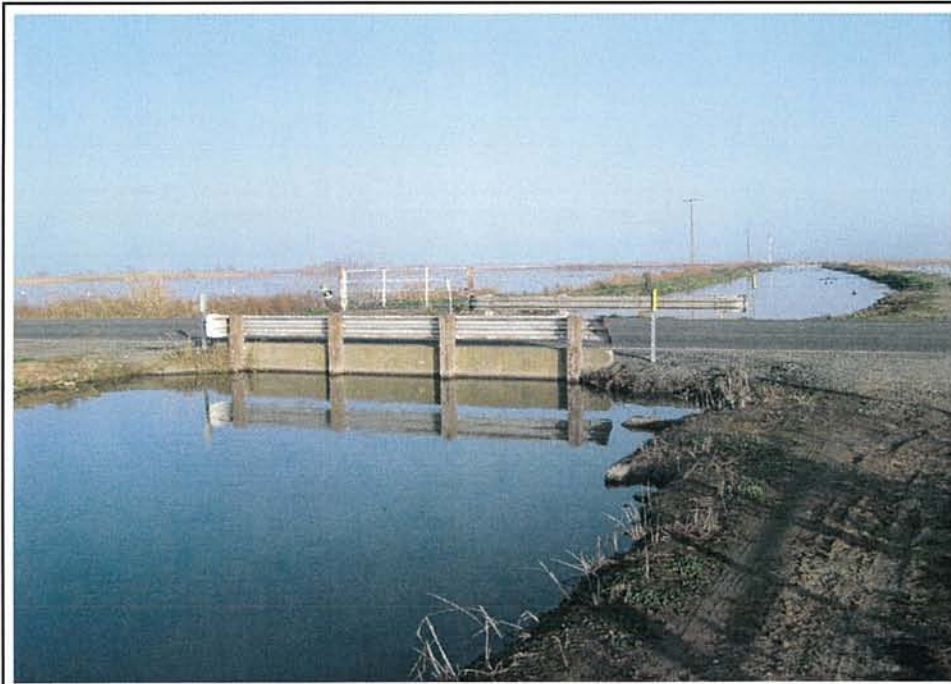
Concrete box culvert with a span of approximately 20 feet marks the Colusa Highway crossing of Schwind lateral approximately six miles west of Gridley. Wood posts are affixed to both intake and outflow sides of the culvert to which metal guard rails are bolted. A date of 4-1985 is painted on the guard rails, which may have been subsequent alteration to the culvert. The two-lane roadway is asphalt paved.

P5b. Description of Photo: (view, date, accession #) Looking northwest; 12-17-2011

Construction date is unknown. Metal guard rails appear to have been added in 1985. There are no other apparent alterations.

This reinforced "poured in place" concrete box culvert is similar in design to other road and farm crossings associated with Schwind and other canal laterals in the Biggs-West Gridley Water District's system. The canal system originated with digging channels from the Feather River west to the Biggs-Gridley area beginning in 1905. By 1920, both the Sutter Butte Canal and the Western Canal appear on county survey maps. However, few of the laterals, which formed a large part of the systems, are delineated. From the 1920s through the 1950s, there was a trend within the county to convert privately owned irrigation systems into public entities through the formation of water districts. In 1942, the Biggs-West Gridley Water District was formed. The water district undertook a number of improvements in the 1950s and 1960s, including the replacement of all wooden bridges. All farm and road crossings are now poured in place, one or two barrel box culverts, or concrete slab "bridges."

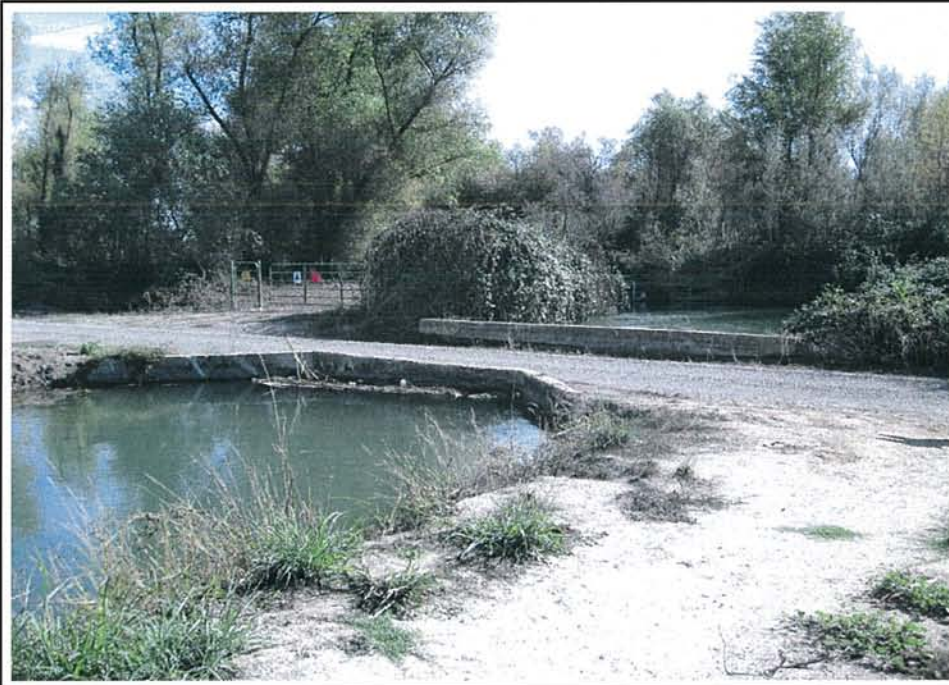
Concrete box culvert at West Evan-Reimer Road crossing of Rising River (formerly Traynor) lateral located approximately four miles southwest of Gridley. Slightly raised downstream (south) side of culvert is approximately 20 feet long. Culvert intake is approximately 12 feet wide with two concrete wing walls. Narrow roadway is graveled. Water level was too high to observe further construction details. No alterations are apparent. No construction date was observed on the exposed concrete.

*P4. Resources Present: ☐ Building ☒ Structure ☐ Object ☐ Site ☐ District ☐ Element of District ☐ Other (Isolates, etc.)
P5b. Description of Photo: (view, date, accession #) Looking southeast; 10-27-2011

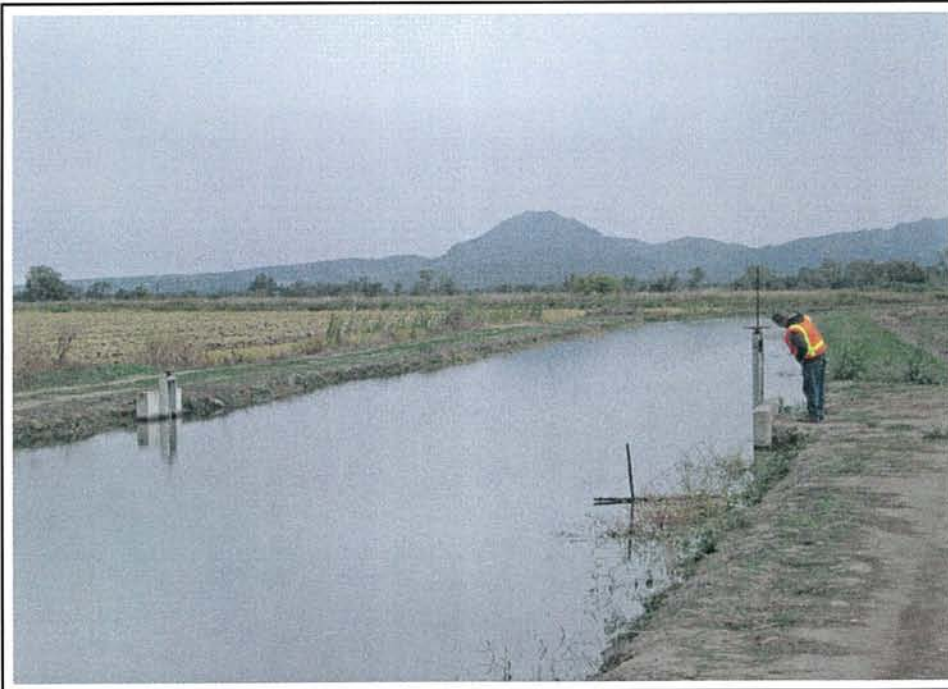
P5b. Description of Photo: (view, date, accession #) looking south from Feature 14, 11-3-2011

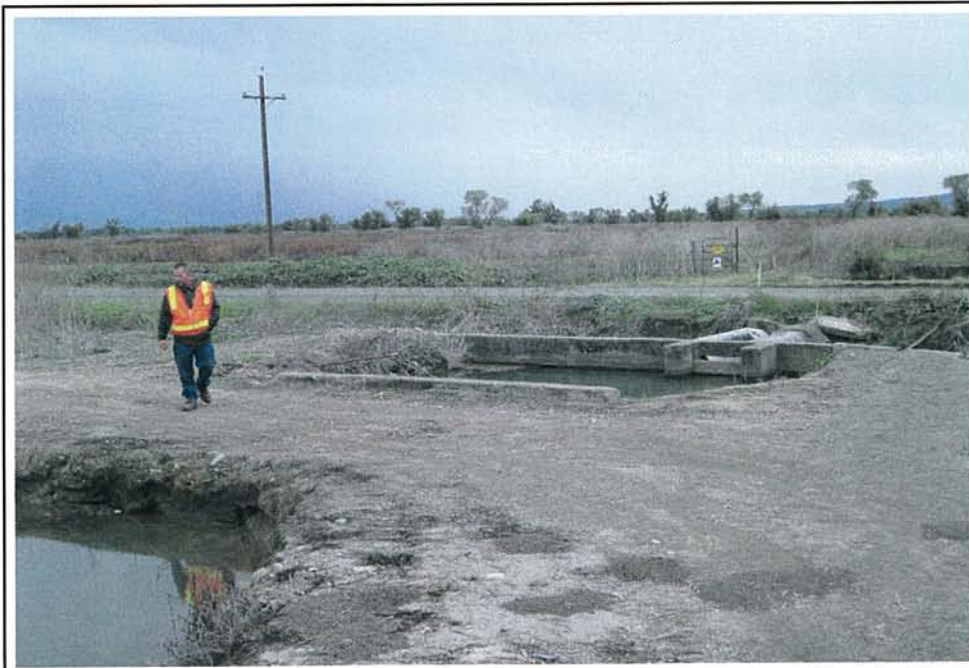
South terminus of Segment A at Feature 14, W. Liberty Road looking southeast

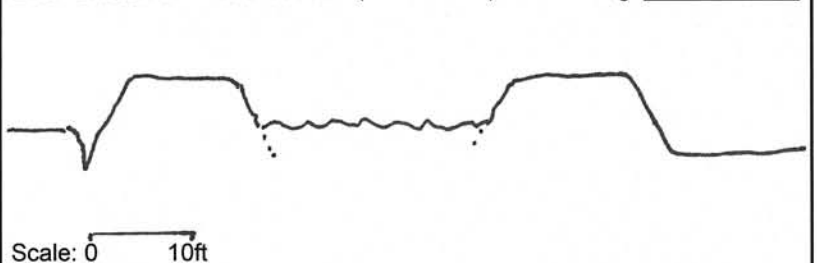
L4e. Sketch of Cross-Section (include scale)

Facing: South

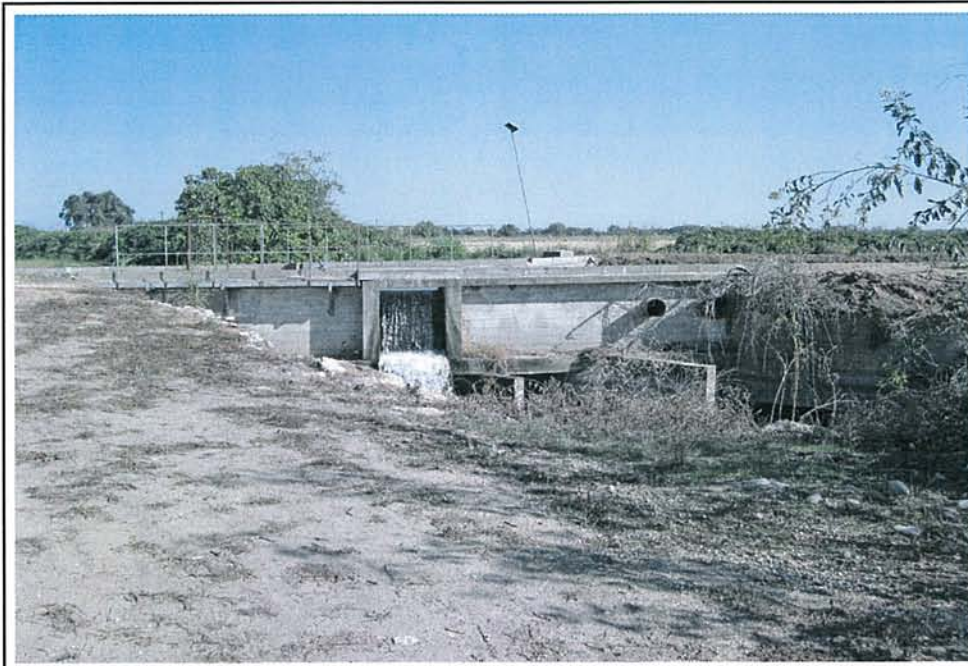
Traynor lateral flumed crossing.
Feature 4 looking east, 10-28-2011

Only datable features exhibit 1959-1960 dates. Others are obviously older and newer.
