Environmental Assessment

Natomas Central Mutual Water Company's Sankey Road Check Structure Automation Project Mid-Pacific Region

EA-14-06-NCAO

August 2015

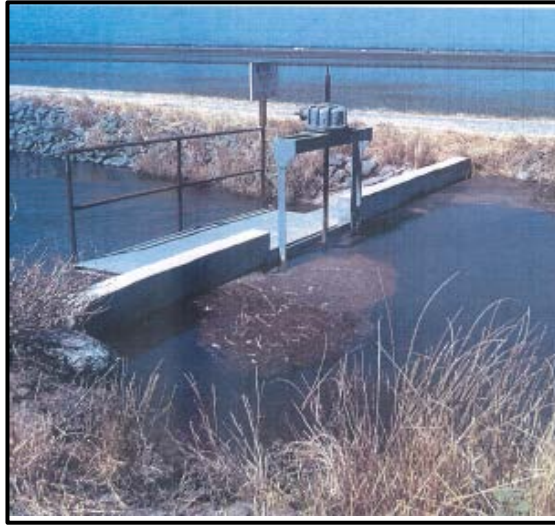
Figure 2-1. Northern Main Canal and the existing Sankey Road check structure. Image is looking southwest from Sankey Road.

Demolition of the existing structure (Figure 2-1) would occur over a few days in the winter months when the canal is closed for typical canal maintenance activities. The process would include use of a 40-ton crane operating from the canal maintenance roads to remove large sections of the existing weir and an excavator/backhoe working from the canal access road to clean up remaining demolition debris. The estimated 30 tons of cement and unusable miscellaneous materials expected from demolition would be hauled to an appropriate landfill or recycled. The existing canal access roads and the shoulder of Sankey Road would be used for staging of heavy equipment (see Figure 2-3).

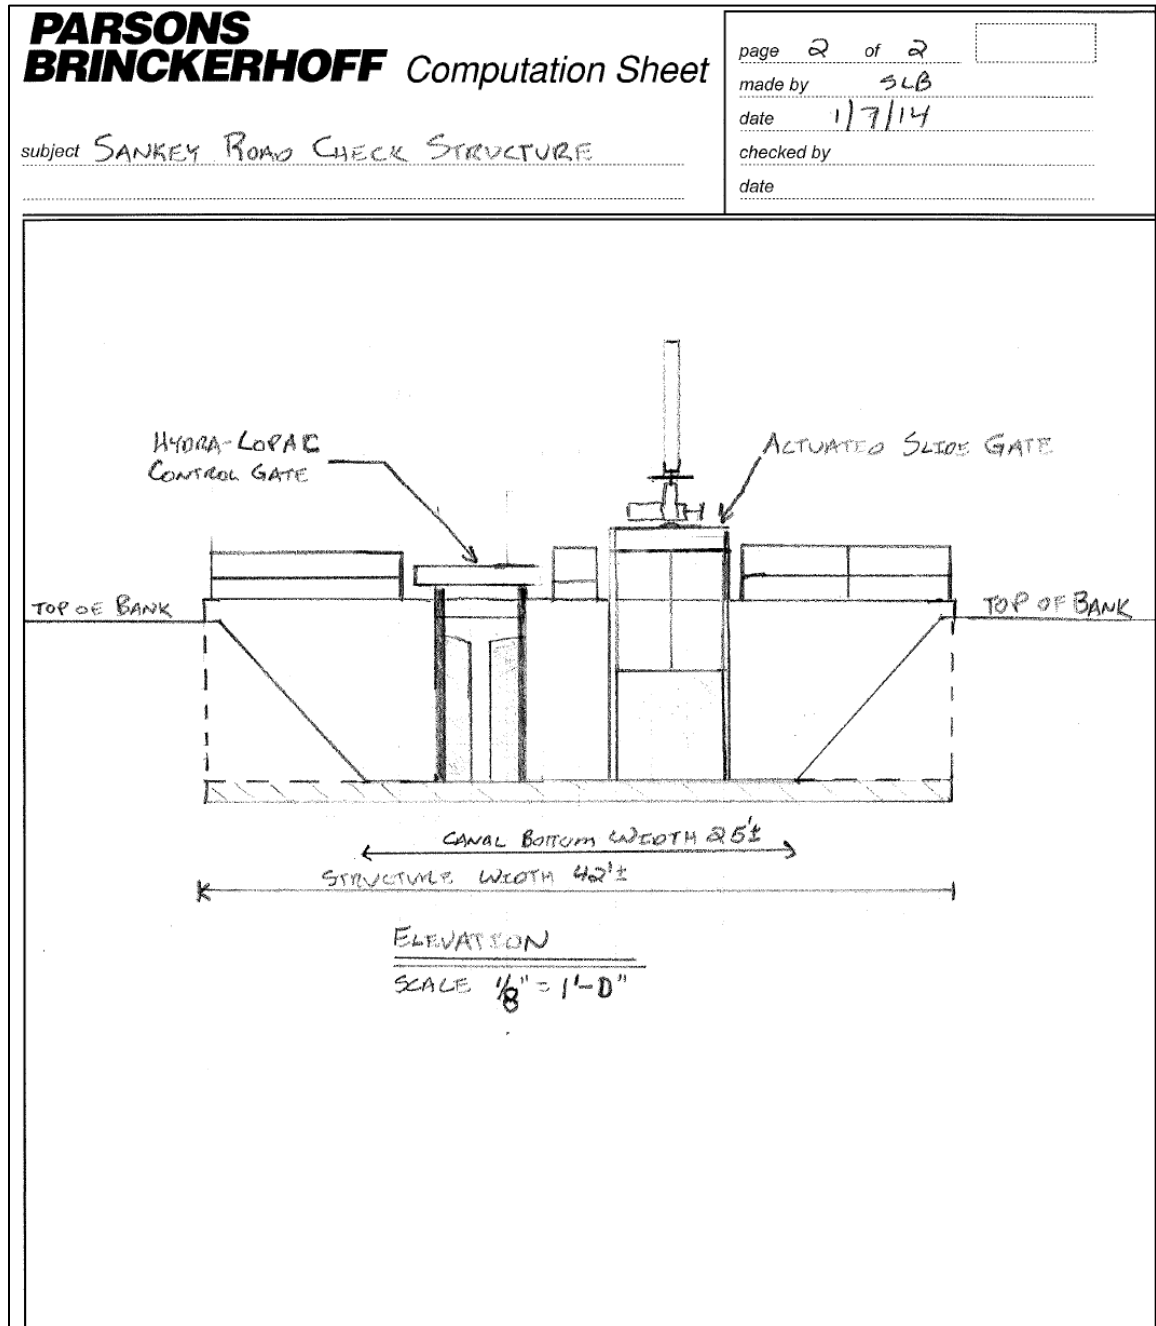
Appendix B (cont'd). Hydra-LoPac Automated Gate Structure Design (page 2 of 2)
