Appendix D
Hydrology and Geomorphology
(taken from Appendix A of ECAM)

Appendix G
*Upper Truckee River Middle Reach Preliminary
Restoration Alternative South Lake
Tahoe, El Dorado County, California*
Report of Historical Significance of
Cultural Resources, Judith Marvin and
Linda Thorpe, Foothill Associates,
October, 2007

**UPPER TRUCKEE RIVER MIDDLE REACH
PRELIMINARY RESTORATION ALTERNATIVE
SOUTH LAKE TAHOE, EL DORADO COUNTY,
CALIFORNIA**

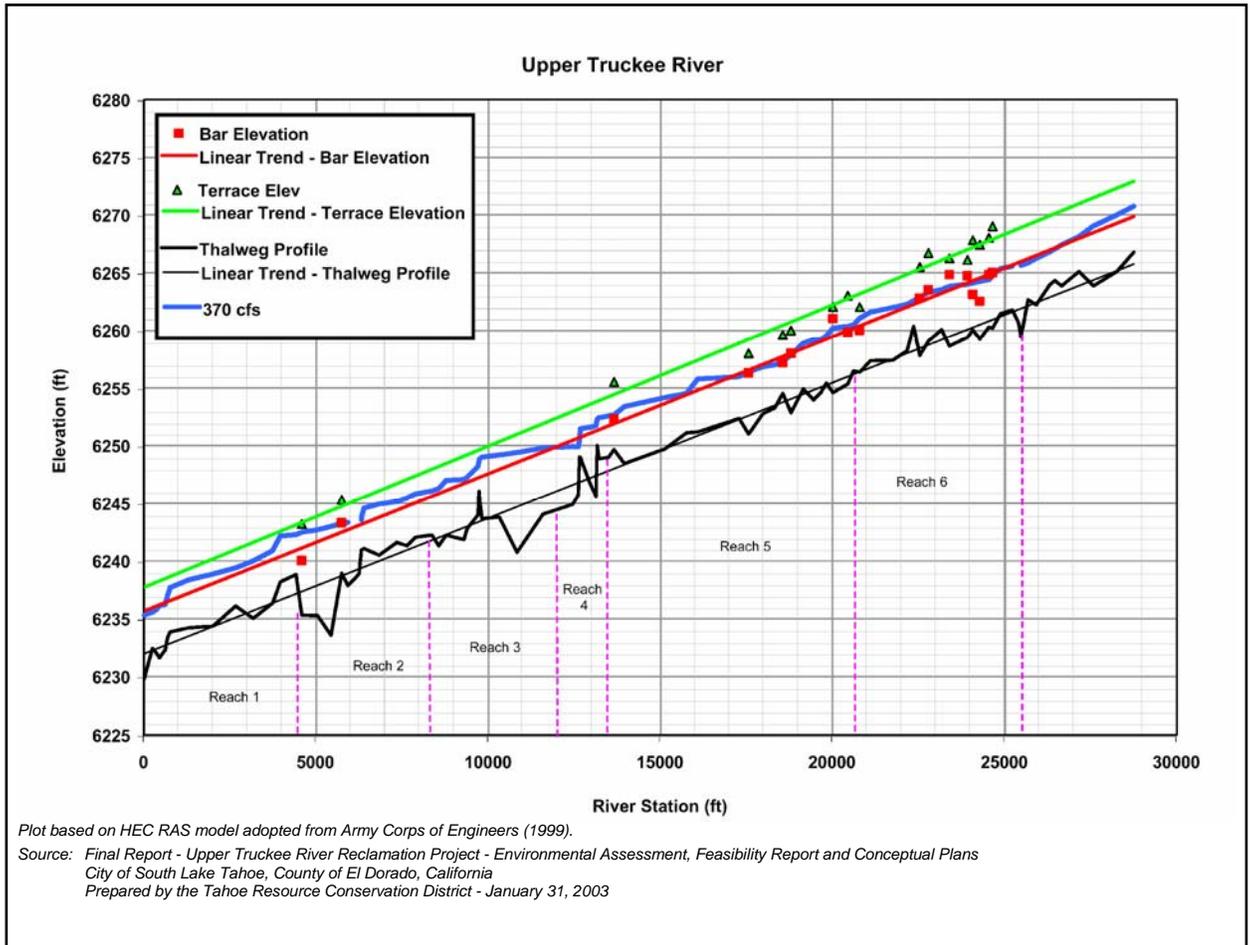
Longitudinal Plot of Valley Flat (Terrace), In-channel Bars, and Thalweg Elevations with 370 cfs Water Surface Profile

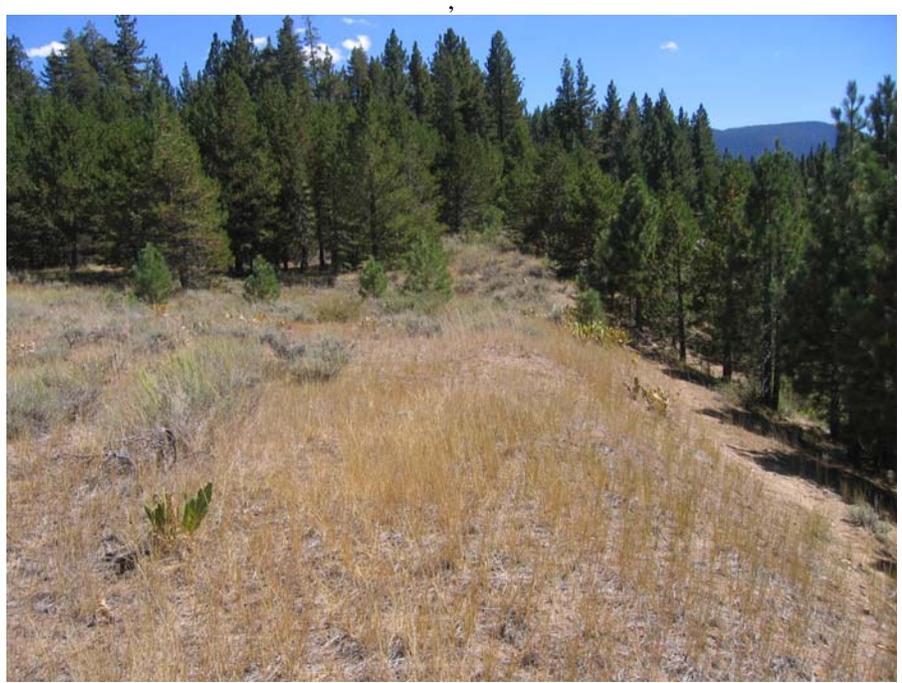
P5b. Description of Photo: (View, date, accession #)

*P3a. Description: Describe resource and its major elements. Include design, materials, condition, alterations, size, setting, and boundaries. The site consists of a widespread refuse scatter consisting of "hotel china" and early 1900s and some 1920s ceramics and cans. It seems to consist of a few shallow refuse dumps dispersed and spread across the adjoining flat, resulting in a consistent but low-density scatter over a large area. The refuse appears to be dumped from the Fallen Leaf Lake Lodge, located to the west, on the shore of Fallen Leaf Lake, dating to the 1910s to the 1920s.

Overview of south end of scatter (view S, 3 September 2006).

*A7. Site Condition: Good Fair Poor (Describe disturbances.): Flat has been disturbed by heavy equipment, probably during the channelization of the river.

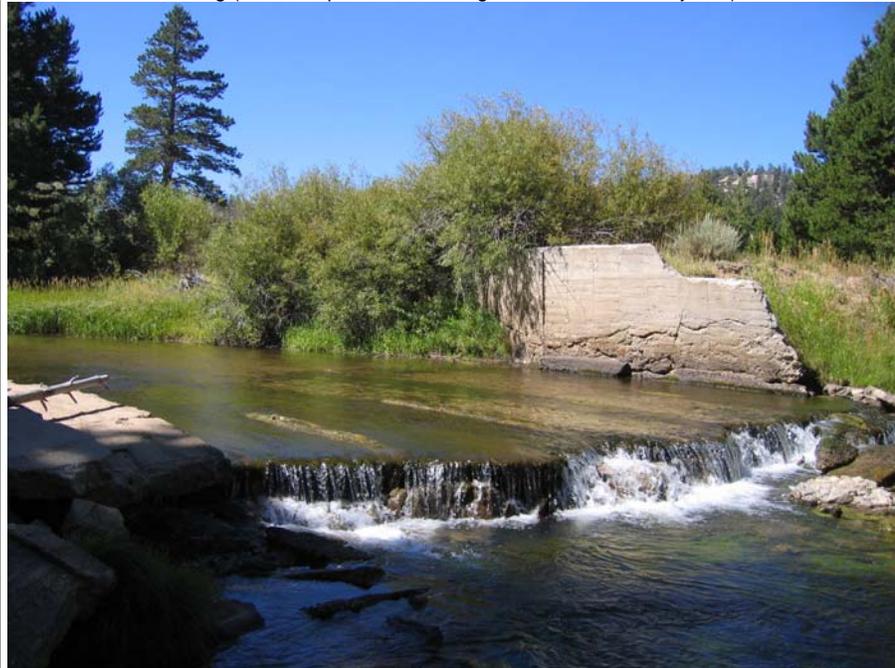
P5b. Description of Photo: (View, date, accession #) Overview Resource No. 32 Dam (view SW, 3 September 2006).

*P3a. Description: Describe resource and its major elements. Include design, materials, condition, alterations, size, setting, and boundaries. This is the collapsed remains of a board-formed concrete irrigation dam in the Upper Truckee River. The only standing section is along the west bank of the river, while the remainder of the sections have collapsed into the river. The 20-foot long standing wall, paralleling the riverbank, measures seven feet high and eight inches thick, with a four-foot long wing on the upstream side. The corresponding wall on the east bank has fallen sideways into the river, with the wing wall partially erect. An eroded but intact poured concrete ridged slab (ca. 20 feet wide) covers the river bed between the dam walls. Rubble from the collapsed dam sections lies downstream of the dam site.

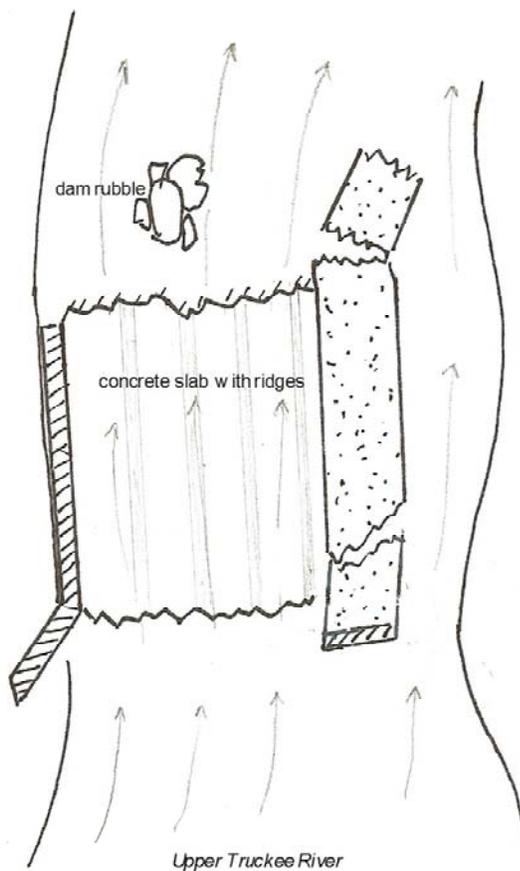
- KEY**
- Standing Wall and Wing
 - Collapsed Wall
 - Stream Flow

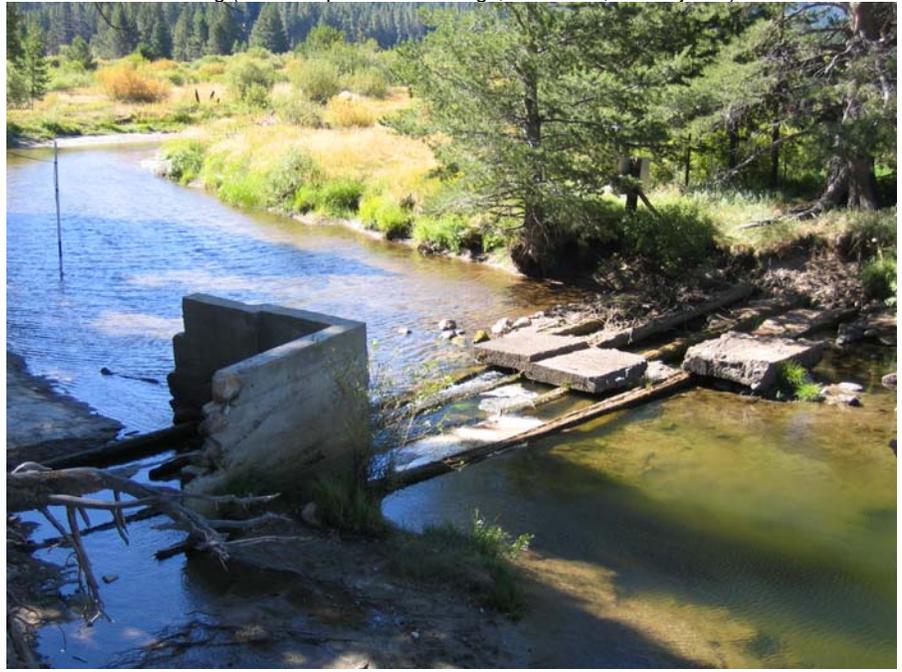
P5b. Description of Photo: (View, date, accession #)

*P3a. Description: Describe resource and its major elements. Include design, materials, condition, alterations, size, setting, and boundaries). This is the collapsed remains of a board-formed concrete irrigation dam in the Upper Truckee River. An L-shaped section on the east bank of the river is the only standing section of this dam. This section is freestanding, as it has been breached between the bank and the section. The remainder of the sections have collapsed into the river, with the water coursing over them. The standing section measures seven feet tall. Large timbers run under it (ca. 35-45 feet) from bank to bank. The timbers are displaced and askew, but still intact.

Overview Resource No. 33 Dam (view SW, 3 September 2006).
