UNITED STATES DEPARTMENT OF THE INTERIOR
BUREAU OF RECLAMATION

FINDING OF NO SIGNIFICANT IMPACT

INSTALLATION AND REHABILITATION OF STREAM GAGES ON THE SAN JOAQUIN RIVER,
FRESNO, MADERA, MERCED AND STANISLAUS COUNTIES, CALIFORNIA

FONSI-07-130

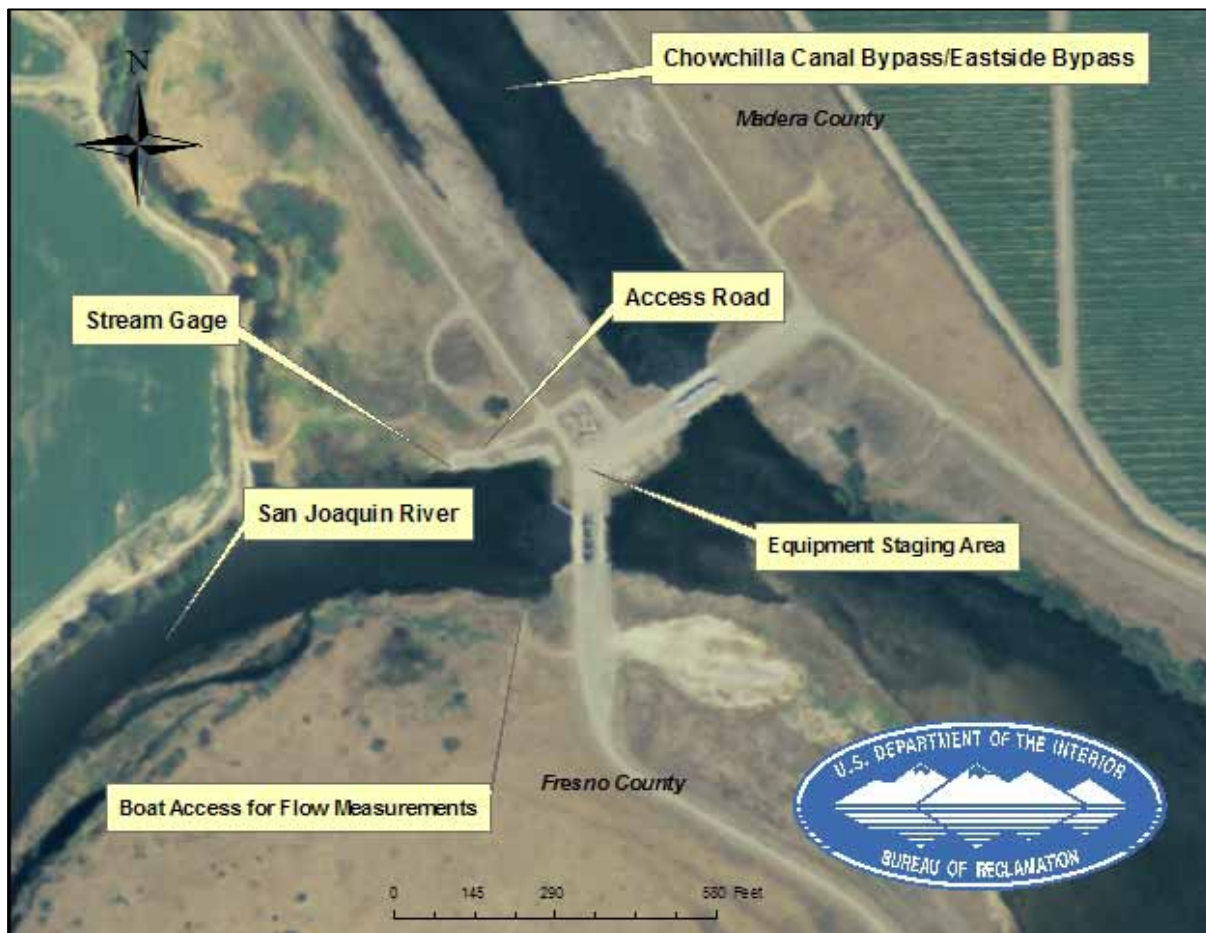
Figure 2: Aerial view of site showing stream gage, access road, equipment staging area and existing boat access for flow measurements.

Access to the site would be from the existing gravel and dirt roads on the project levee system (Figure 2). Equipment would be staged in the gravel parking area at the site (Figure 5). No excavation would be required for the installation of this system. The equipment required would include a pickup truck, and various hand held tools such as a t-post driver. The installation would take a crew of two approximately 3 days to complete. Boat access would be required to take discharge measurements at high flows during operation of the gage. Boat access would be gained via the existing dirt road on the left bank downstream of the structure (Figure 2). Boat access would be required approximately once per month during high flow periods.

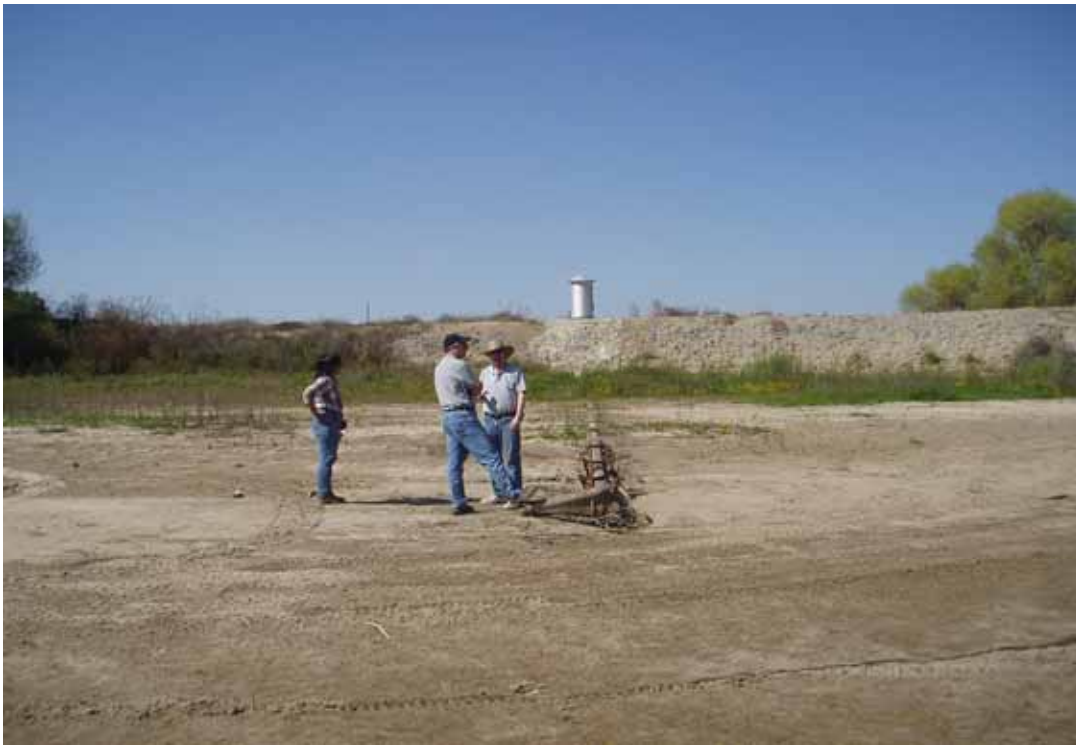
Figure 3: Existing stream gage showing communication line in foreground and stilling well structure on top right stream bank in background.

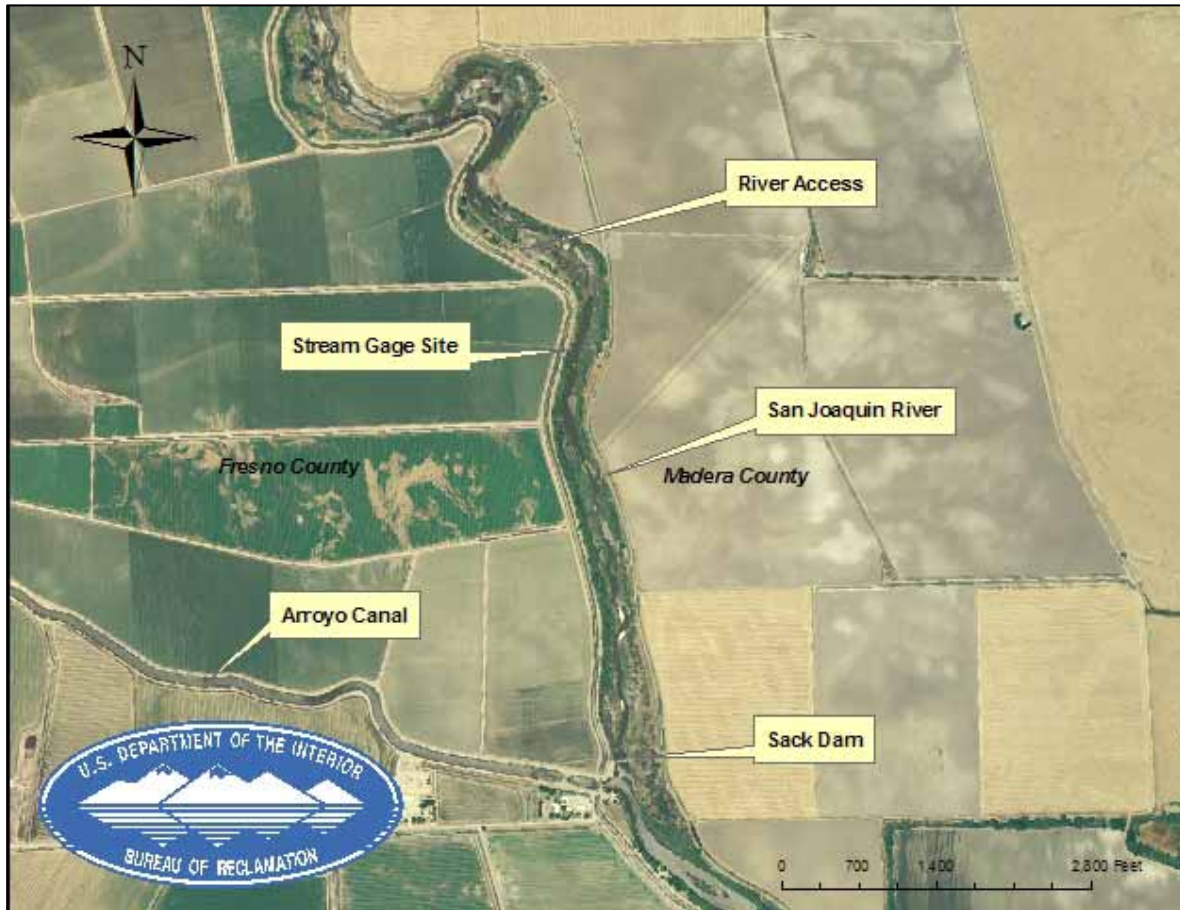
Figure 6: Aerial view of site with relevant project features.

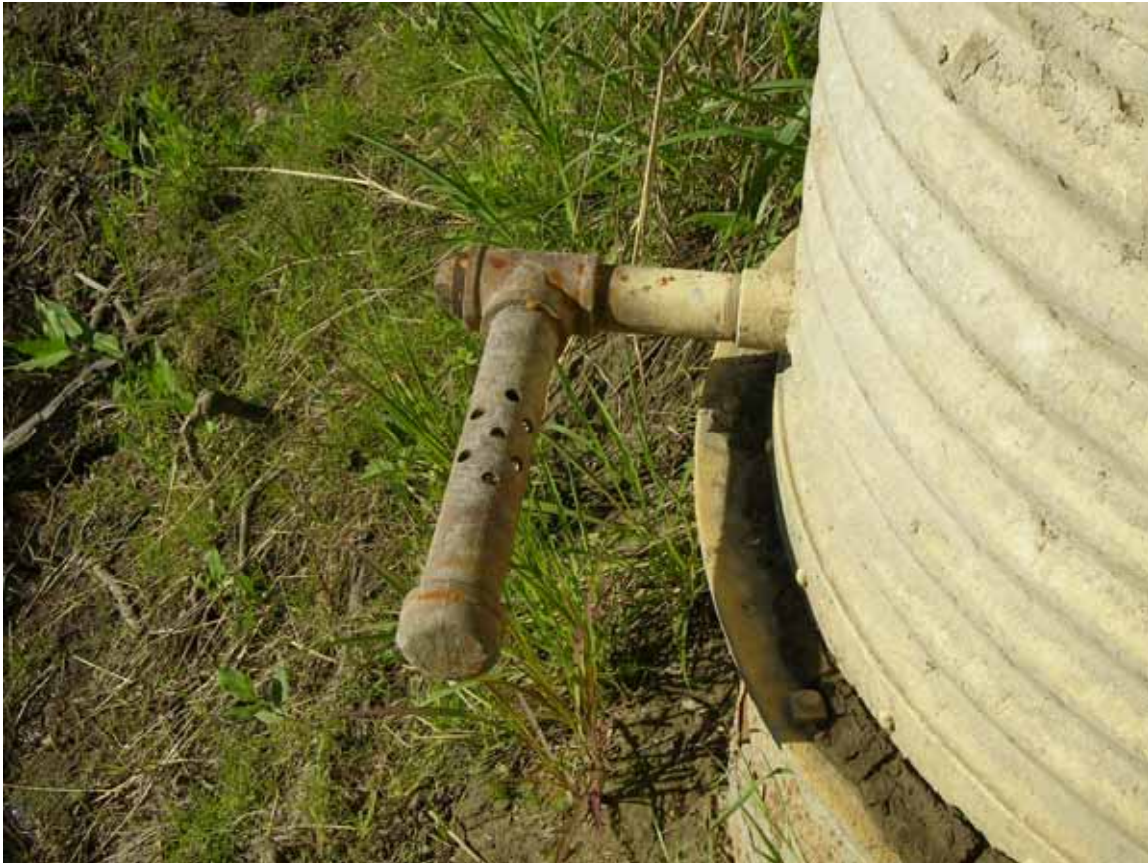
Figure 7: Two-inch diameter metal pipe protruding from the bottom of the corrugated metal housing.

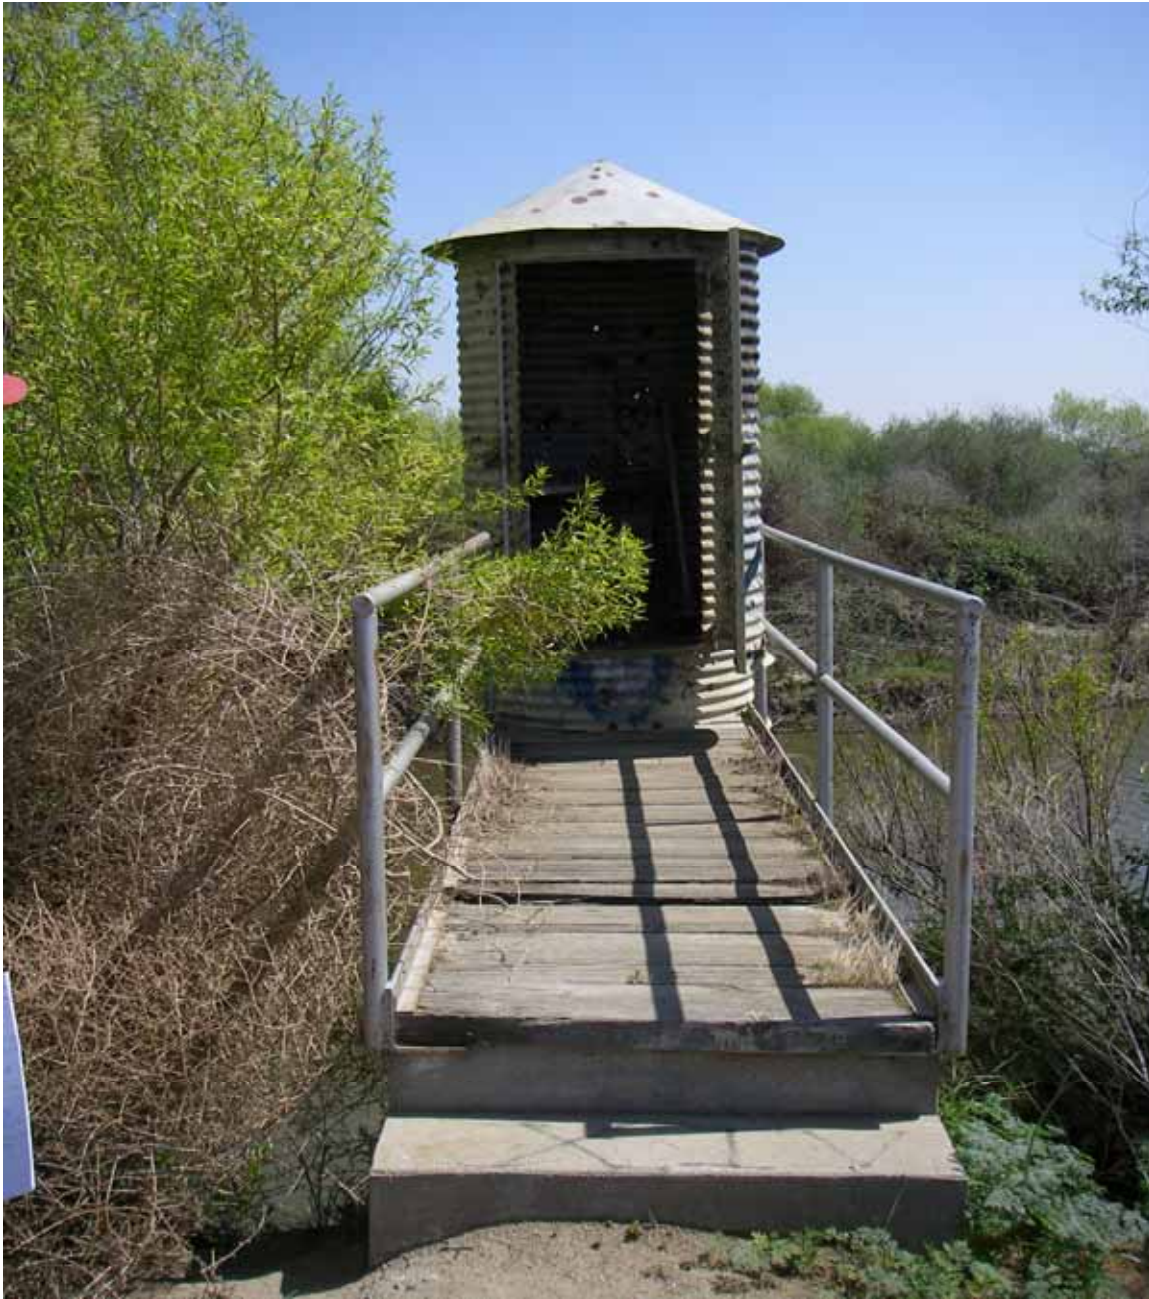
Figure 8: San Joaquin River below Sack Dam station house and walkway.

The stream gage station is located on the left bank of the San Joaquin River approximately 0.7 miles downstream from Sack Dam at RM 181.1, approximately 7 miles east of the town of Dos Palos (Figure 6). The gage house is located at 36°59'38.35"N Latitude and 120°30'5.29"W Longitude (T11S R13E Section 12 of the Oxalis Quadrangle). The station is currently not operational and has only been used intermittently since 1954, when the U.S. Geological Survey (USGS) ceased using it as a monitoring station. Reclamation used the station for monitoring stream flow in the early 70s. Currently, the station is abandoned and the corrugated metal housing has no equipment inside (Figure 8).

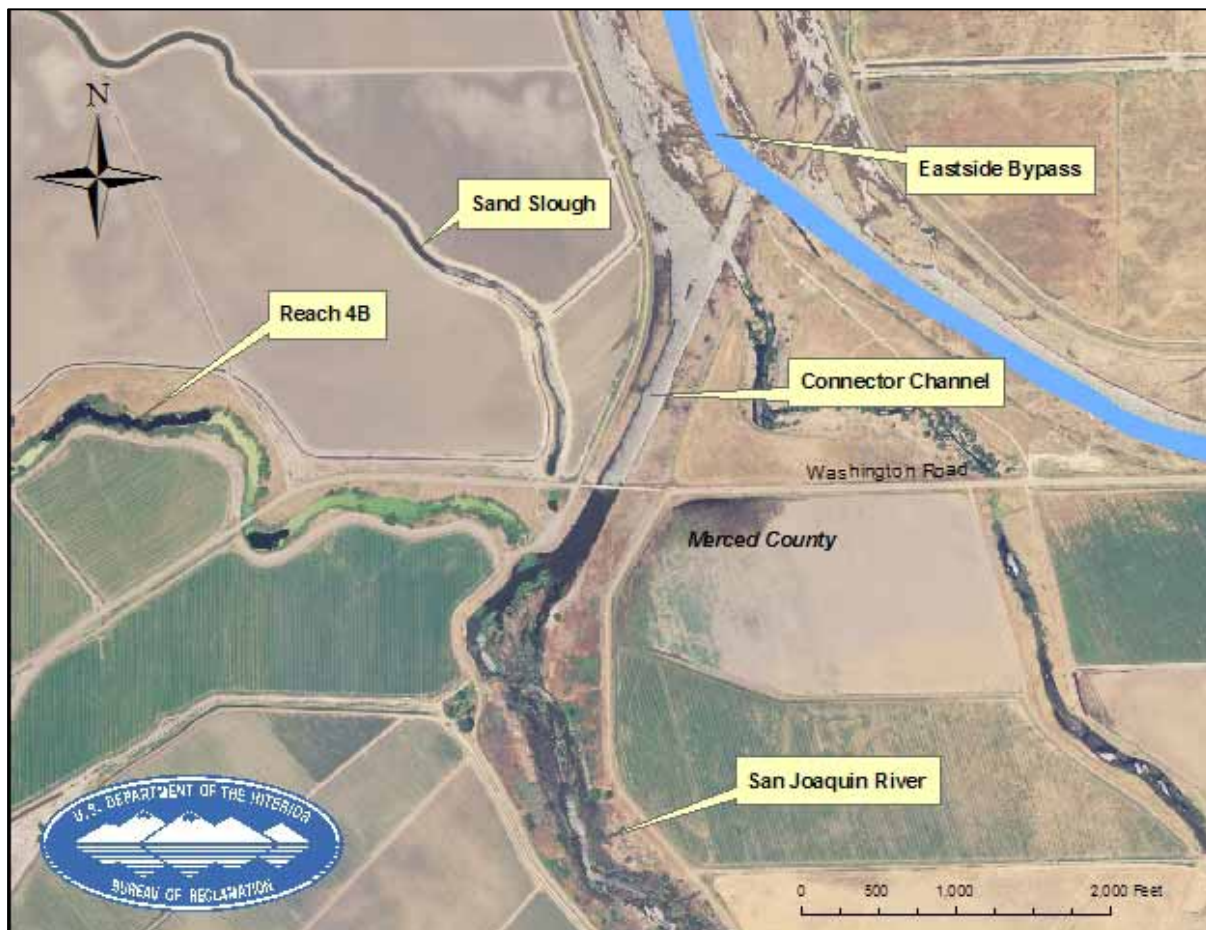
Figure 10: Top of Reach 4B Area Hydraulic Features.

The San Joaquin River is diverted to the Eastside Bypass (Figure 10) at Reach 4B. Therefore, during most years, the flow through Reach 4B is intermittent drainage and only during high water events. Very little flow data has been collected, especially under low-flow conditions in this reach. A decision has not been made on whether or not the Eastside Bypass will be used for the river restoration project high flows. Therefore, both the original river channel and the Eastside Bypass would need flow monitoring stations. Currently, there are no flow monitoring stations near the top of Reach 4B.

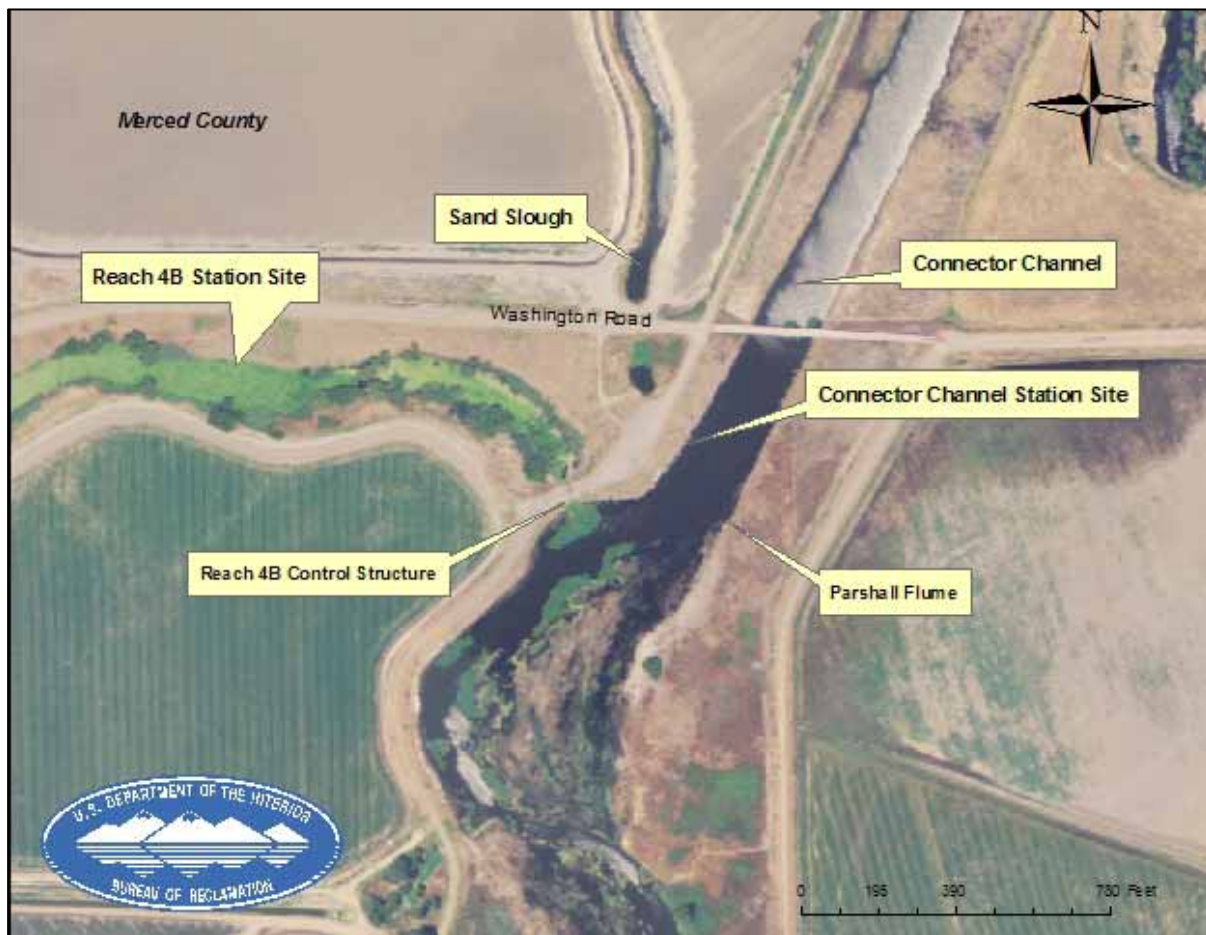
Figure 11: Reach 4B and Connector Channel Flow Monitoring Station Sites.

The locations of the proposed new monitoring stations are shown in Figure 11. One would be located in the River at Reach 4B and the other located in the Connector Channel that connects the river to the Eastside Bypass (T9S R13E Section 31 of Santa Rita Bridge Quadrangle) in Merced County.

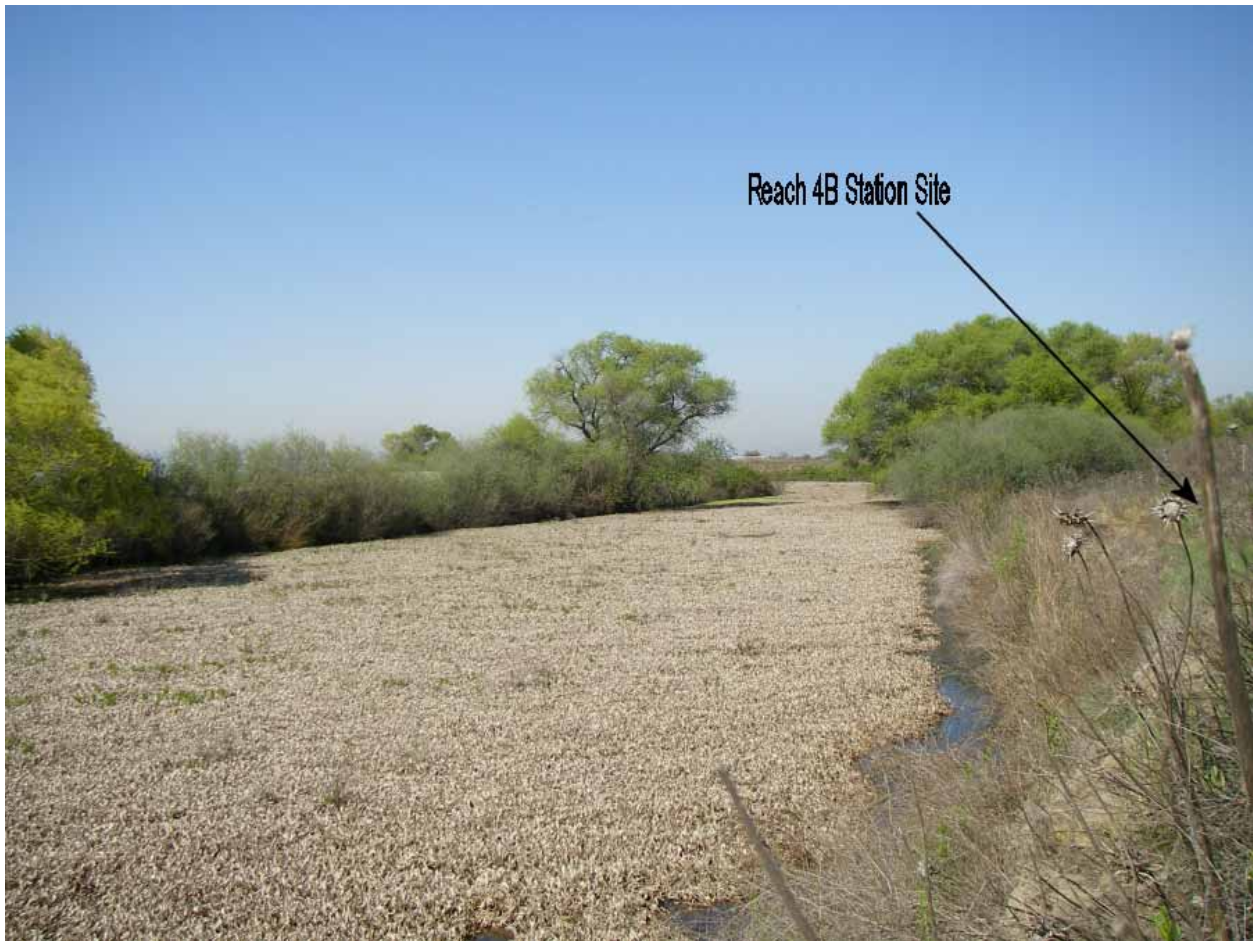
Figure 13: Looking downstream on the Reach 4B channel below the control structure.

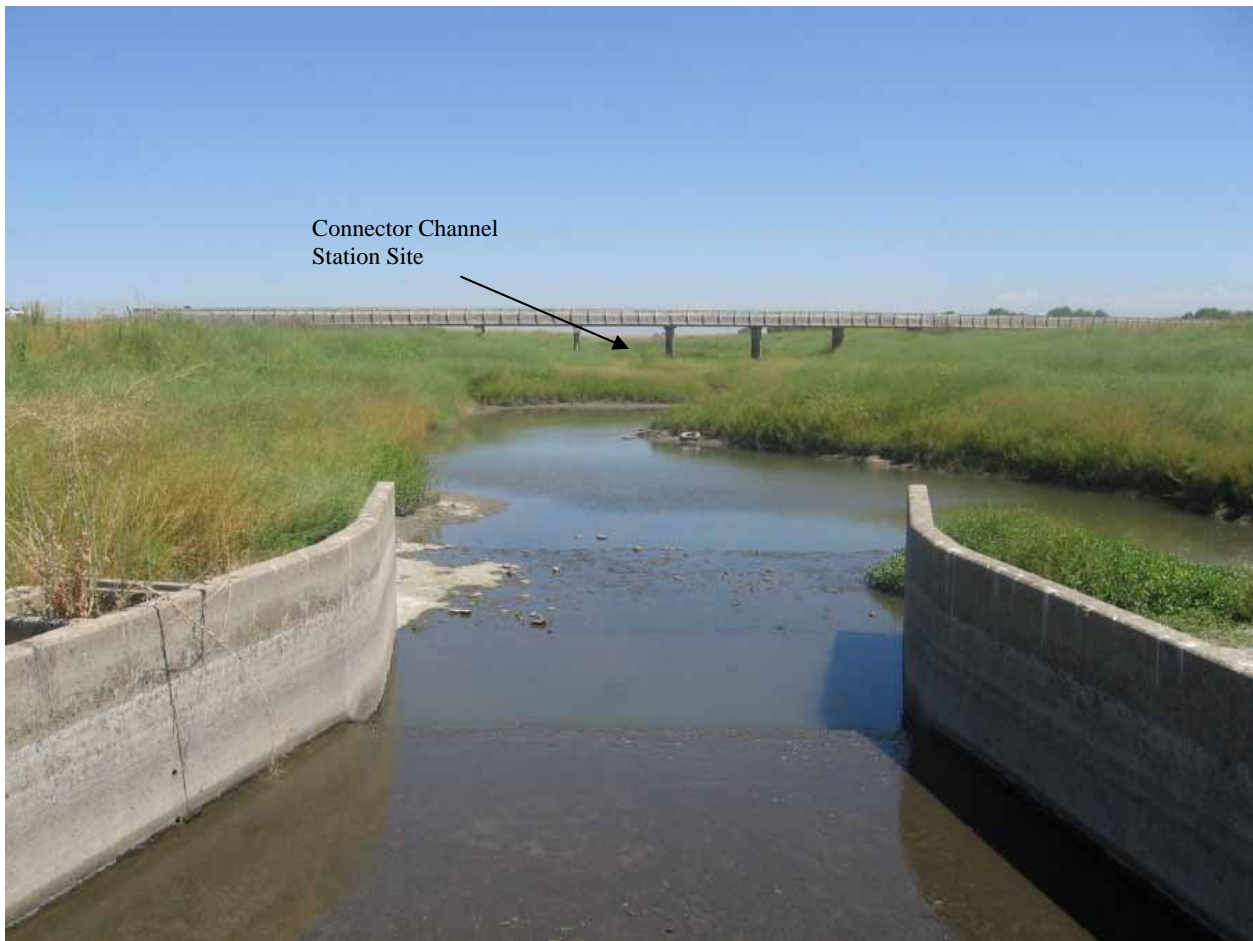
Figure 14: Looking at the Connector Channel downstream from the Parshall Flume to the Washington Street Bridge.

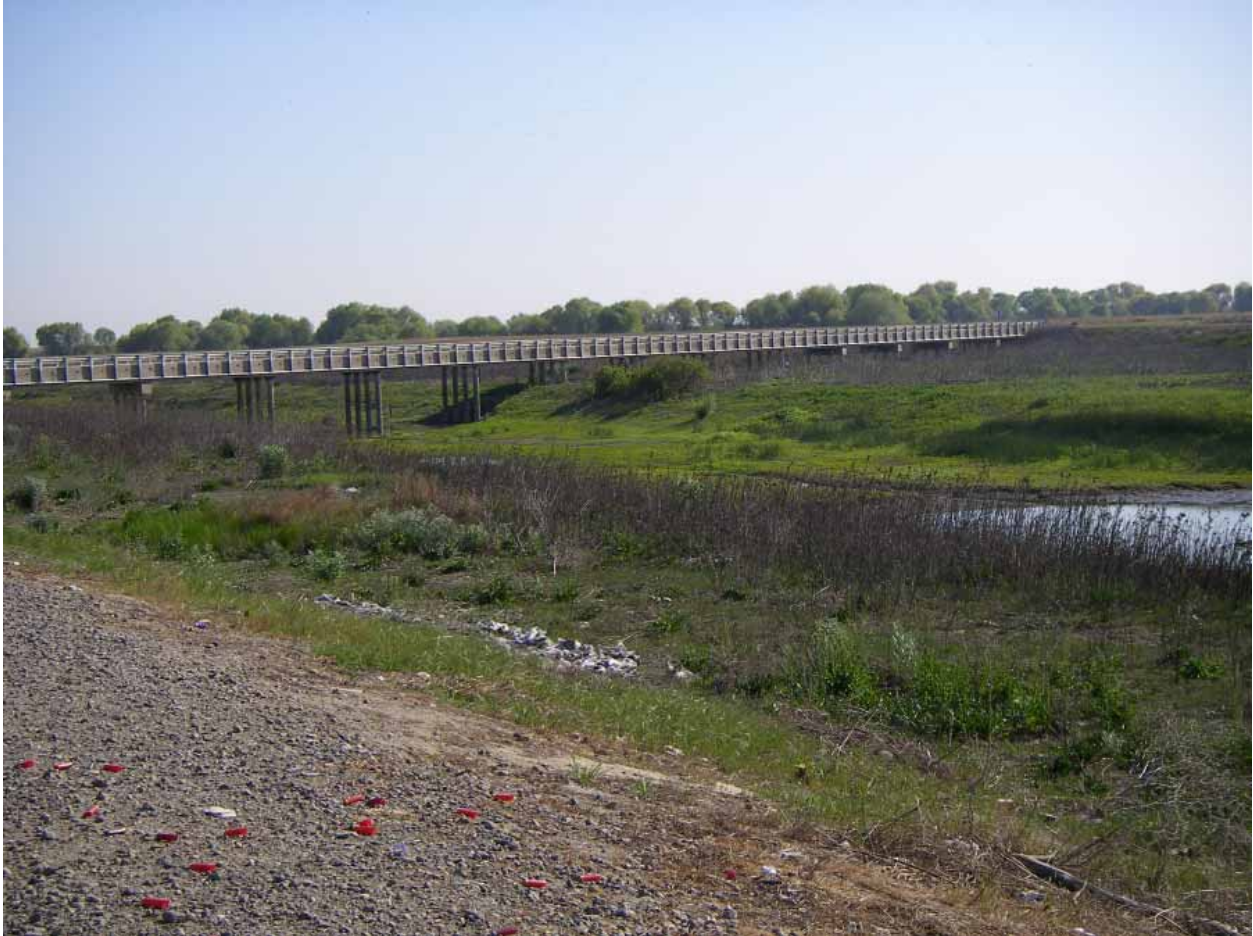
Figure 16: Looking at Washington Road Bridge downstream of Parshall Flume.

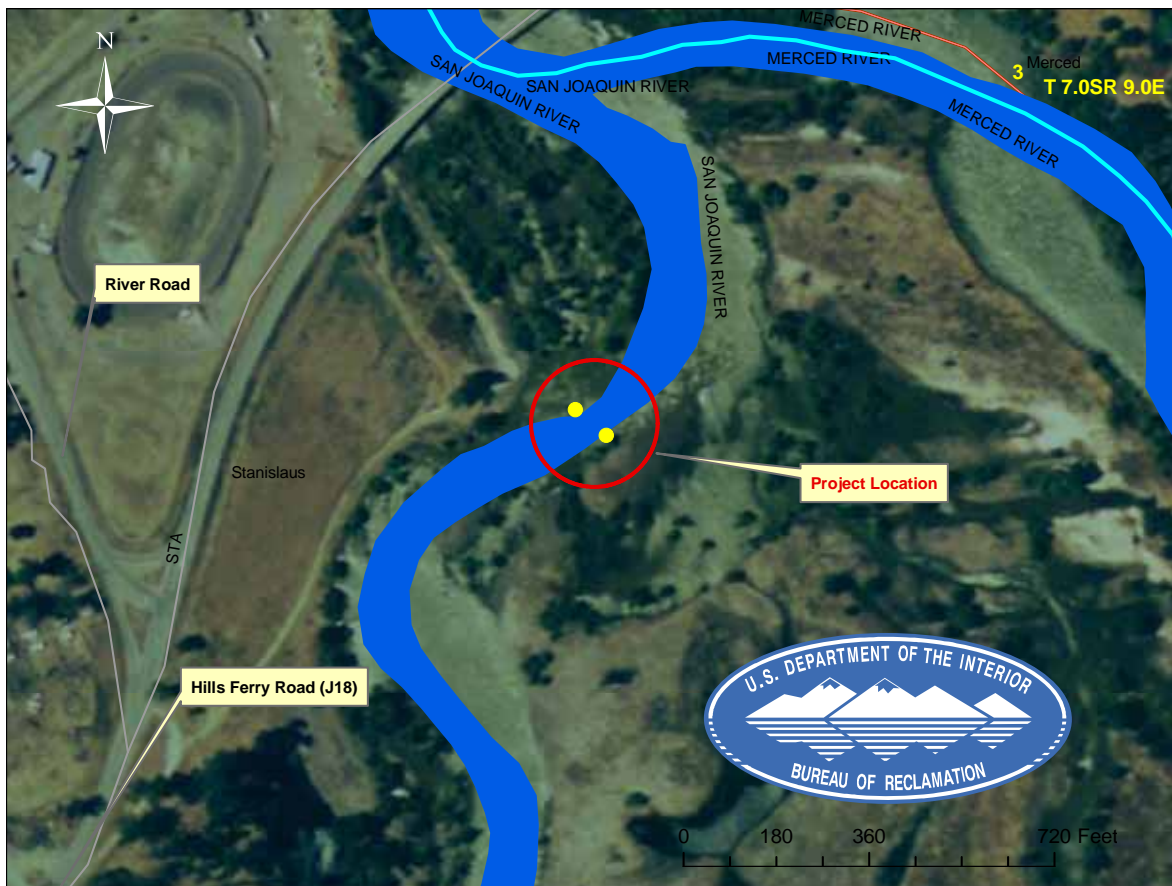
Figure 17: Aerial view of site with relevant project features.

Two sites are currently under consideration for the stream gage. The first site is on the left (descending) bank of the river ($37^{\circ}20'50.58''\text{N}$, $120^{\circ}58'33.35''\text{W}$) and the second is directly across the river on the right bank ($37^{\circ}20'49.894''\text{N}$, $120^{\circ}58'27.286''\text{W}$). The exact gage location would be selected based on availability of site access and other logistical considerations. The gage would be sited within the circle shown on Figure 17. A photo showing the sites is shown in Figure 18.

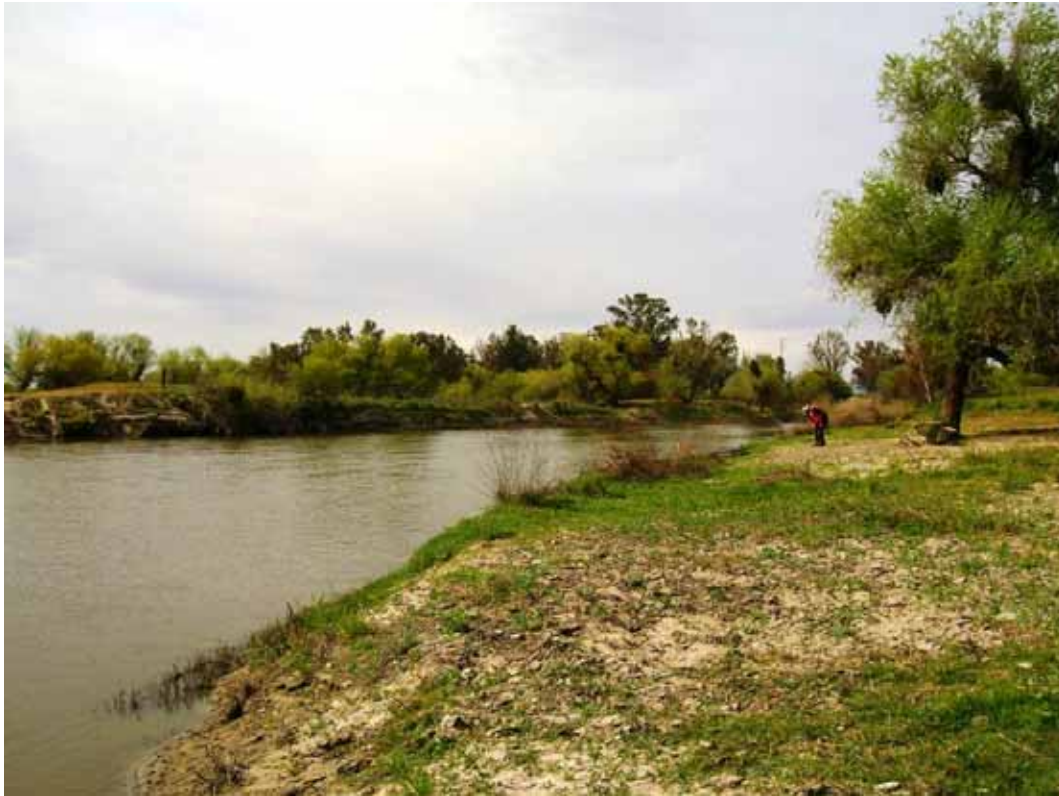
Figure 18: Proposed site locations. Left bank site is located in right foreground in photo; right bank site is located in the center of photo on the far bank (Photo is taken looking upstream).
