1 **APPENDIX F**  
2 **Friant-Kern Canal Middle Reach Capacity Correction Project**  
3 **Biological Resources Assessment**

**Bureau of Reclamation**  
**Interior Region 10 California-Great Basin**  
**California\*, Nevada\*, Oregon\***  
**\*Partial**

**Friant-Kern Canal Middle Reach  
Capacity Correction Project**

Biological Resources Assessment

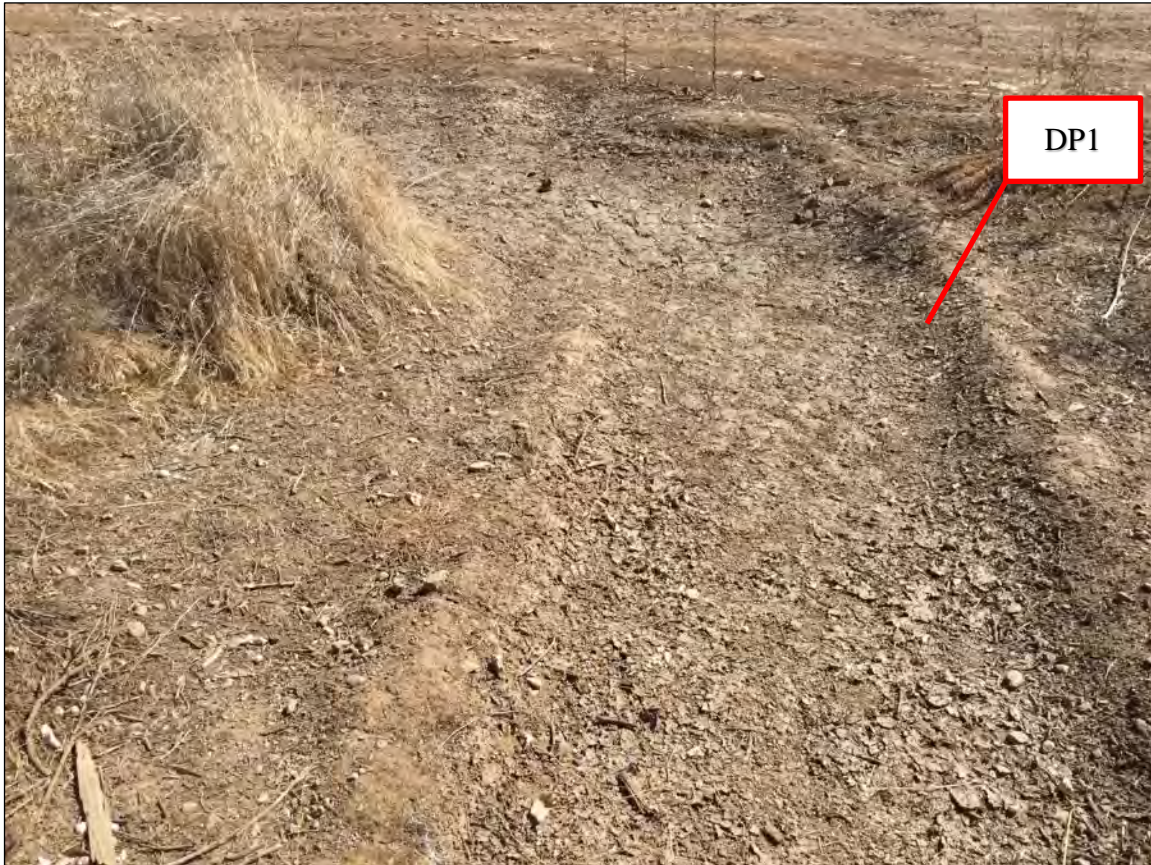
Photograph 1. Upland. Data Point 1 (DP1) documents upland conditions in a suspect area. Orientation: east.

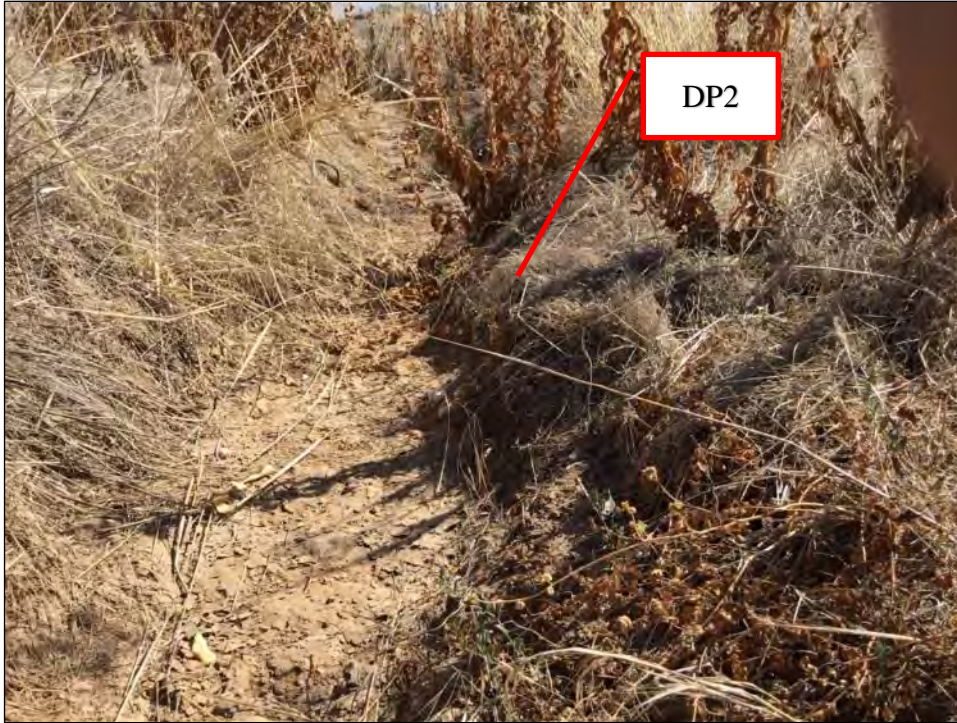
Photograph 2. Non-vegetated ditch (NVD1). DP2 documents the ordinary high water mark (OHWM) of a non-vegetated ditch. Orientation: east.

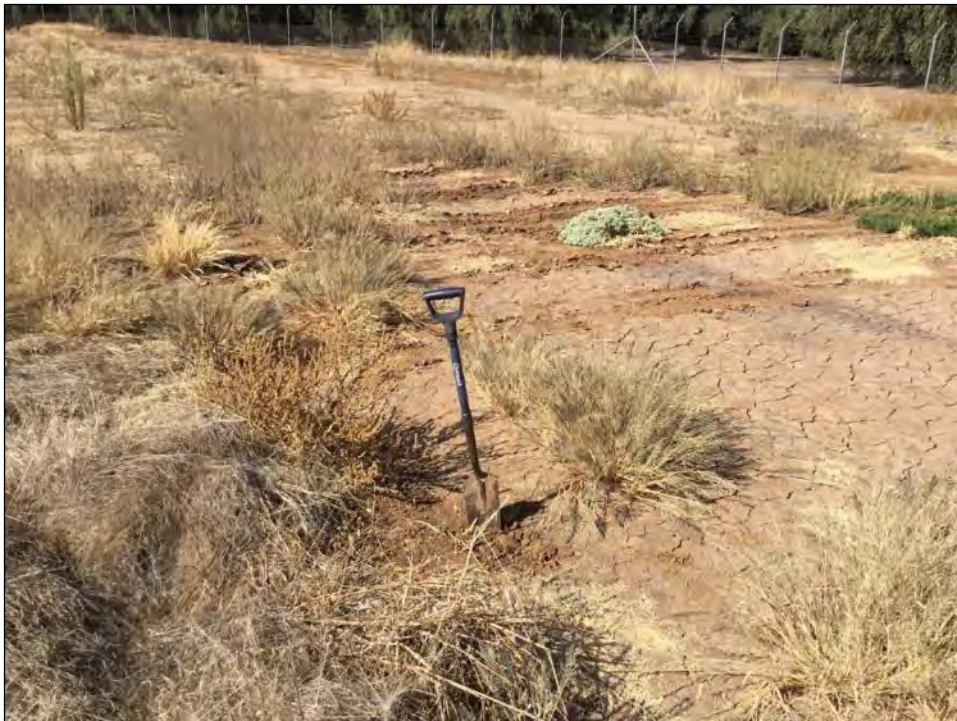
Photograph 3. Upland. DP3 documents upland conditions in a suspect area. Orientation: north.

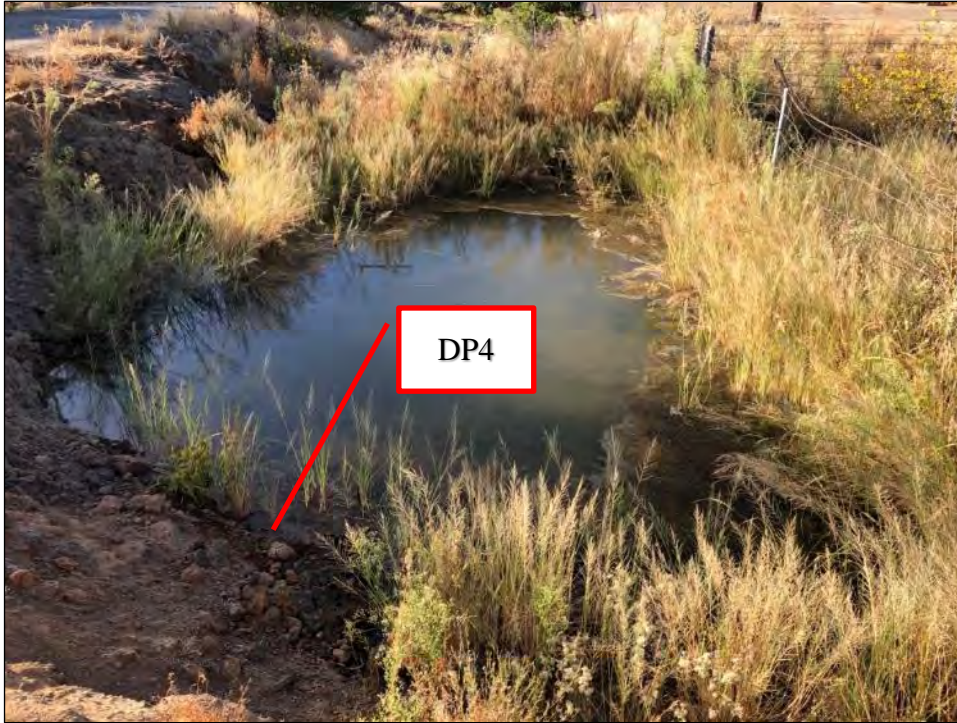
Photograph 4. Pond (PON1). DP4 documents pond that appears to have formed from a leak from the canal, as water was observed coming up from the ground under the surface of the pond. Orientation: north.

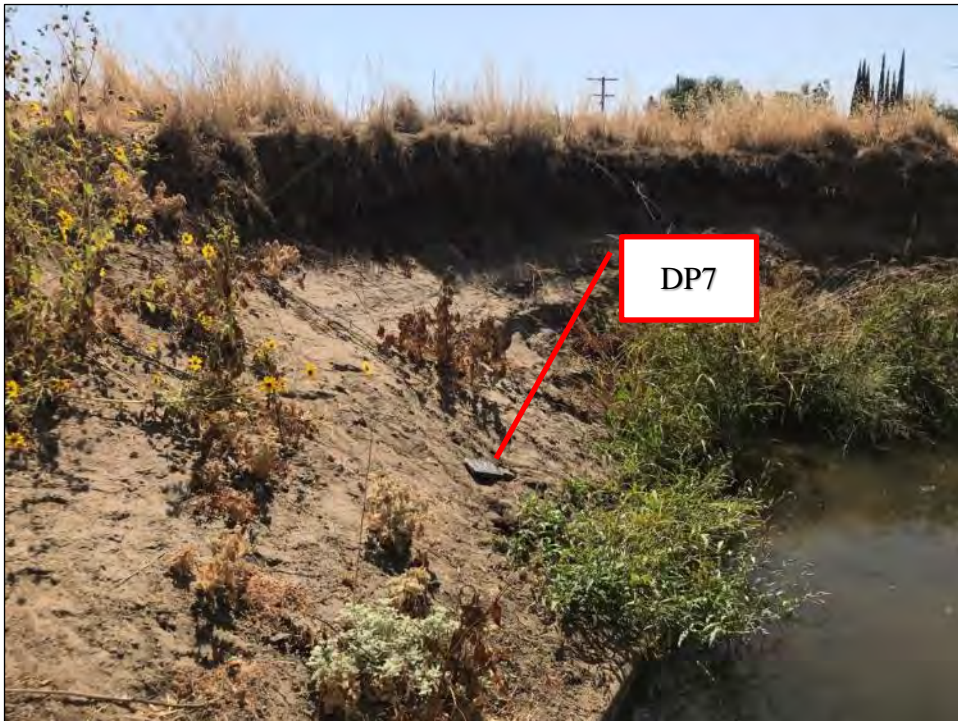
Photograph 7. Upland. DP7 documents upland conditions adjacent to DP6. Orientation: southwest.

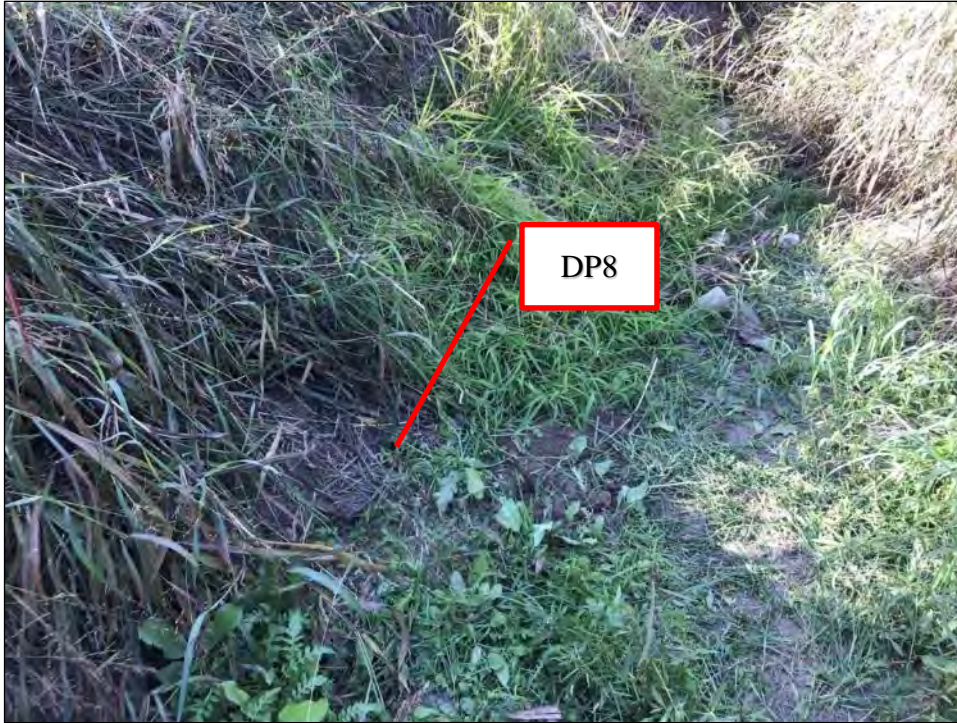
Photograph 8. Irrigation Canal (IC3). DP8 documents the OHWM and absence of hydric soil in an irrigation canal supporting dominant hydrophytic vegetation. Orientation: northwest.

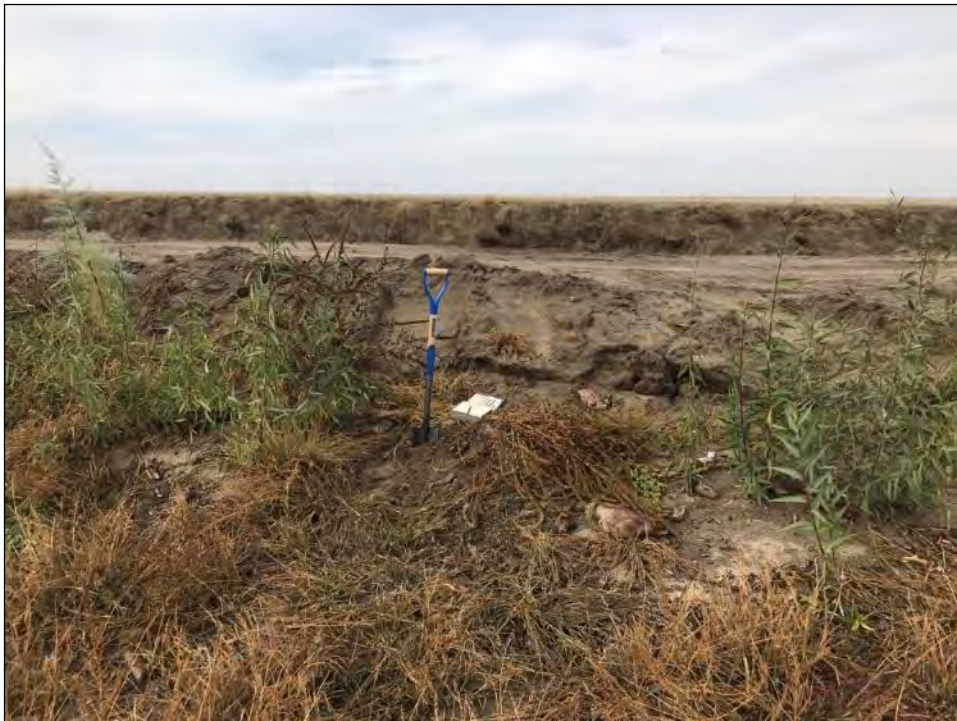
Photograph 9. Groundwater Recharge Basin (GRB2). DP9 documents non-wetland conditions within a groundwater recharge basin. Orientation: east.

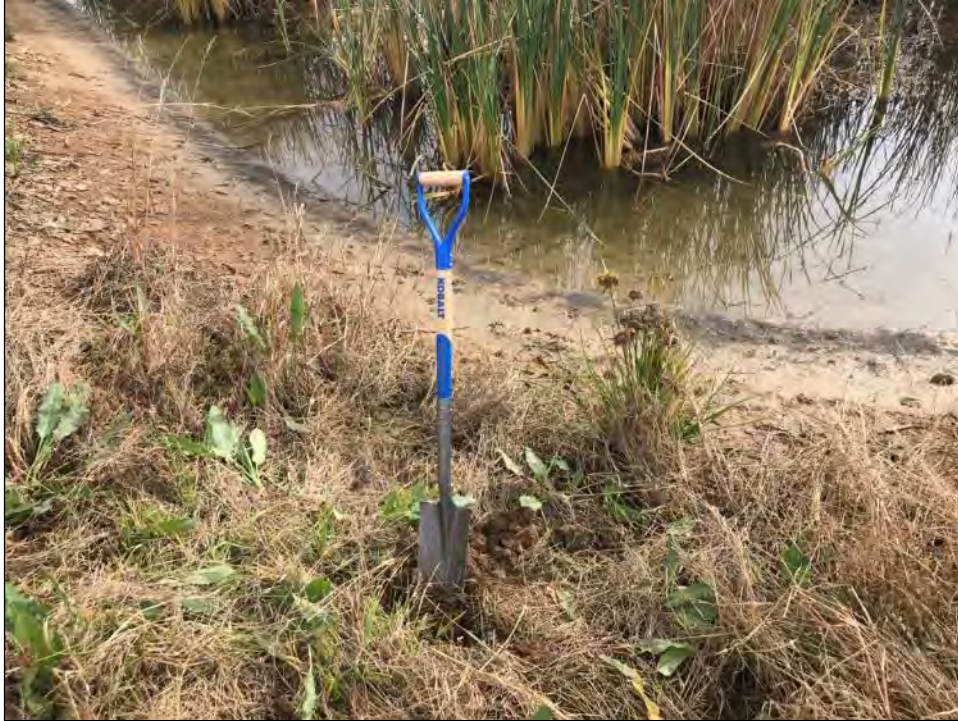
Photograph 10. Pond (PON6). DP10 documents non-wetland conditions within a pond supporting hydrophytic vegetation. Orientation: southeast.

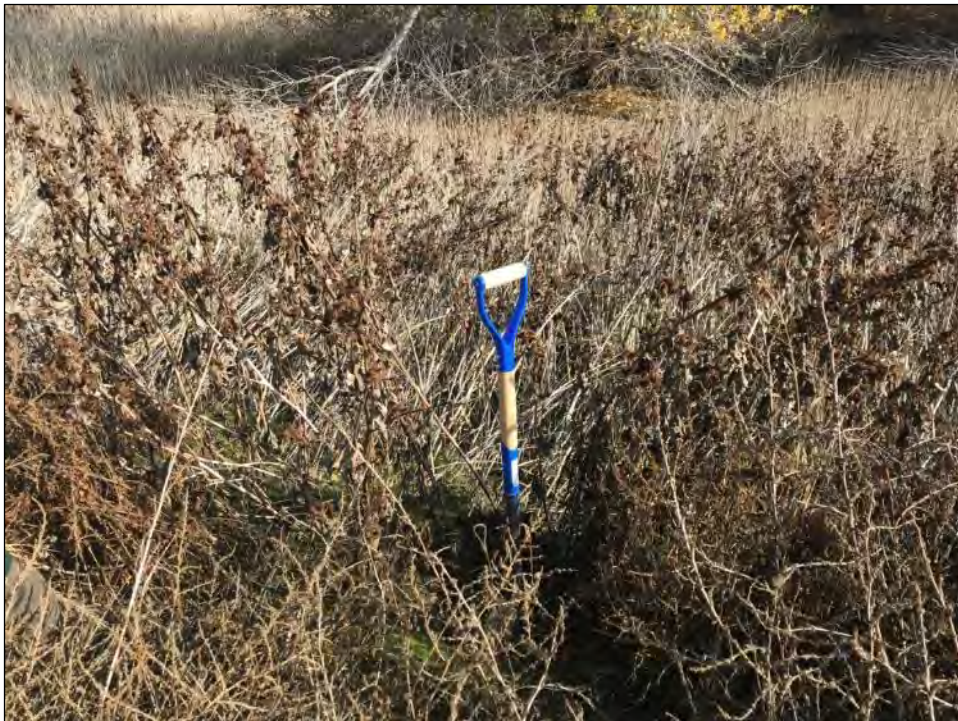
Photograph 11. Groundwater Recharge Basin (GRB4). DP11 documents wetland conditions within a groundwater recharge basin. Orientation: east.

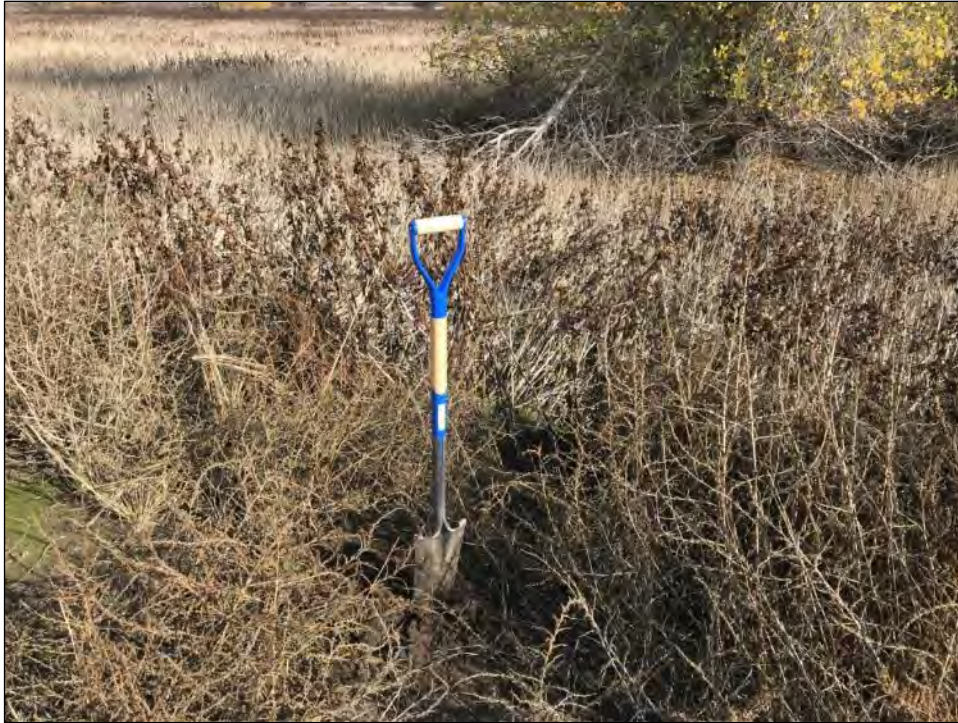
Photograph 12. Upland. DP12 documents upland condition adjacent to wetlands within a groundwater recharge basin. Orientation: northeast.

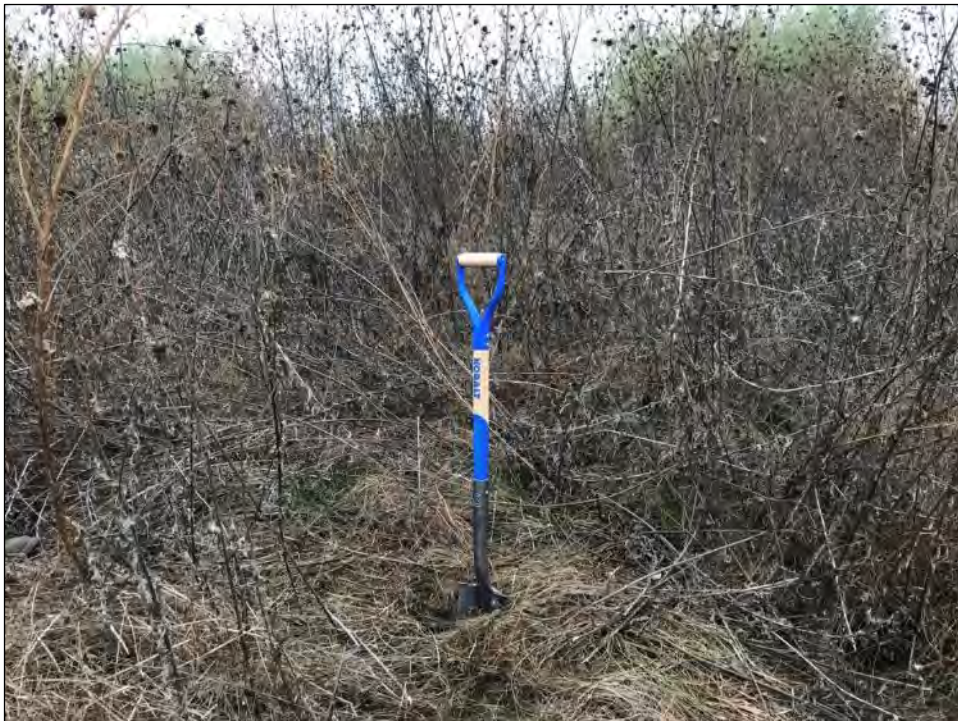
Photograph 13. Upland. DP13 documents upland conditions associated with a slight rise within a depression adjacent to Deer Creek. Orientation: southwest.

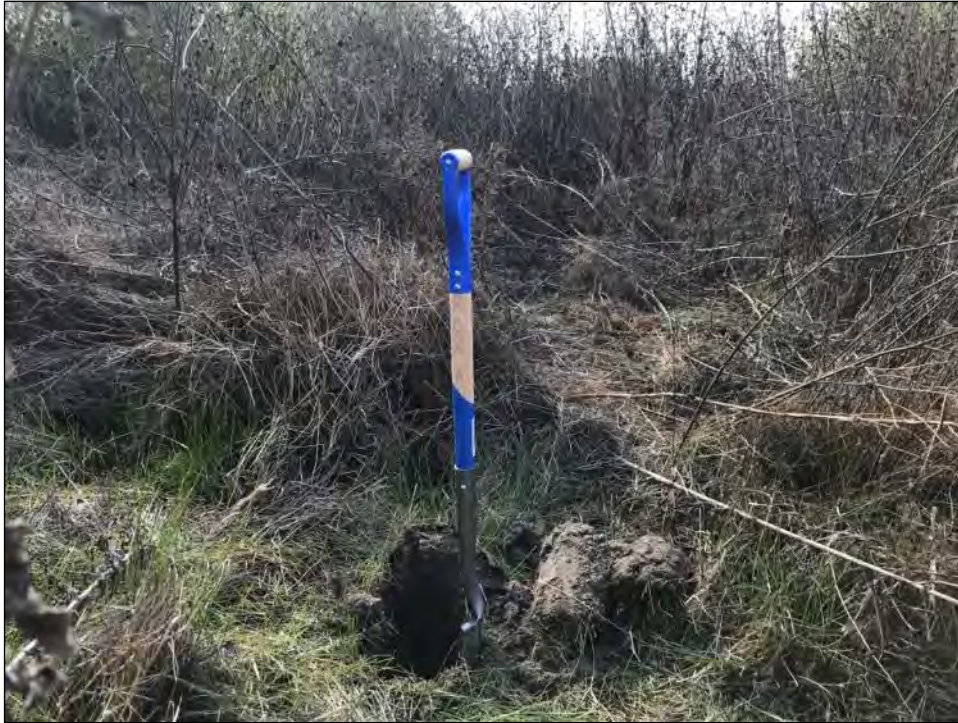
Photograph 14. Riparian Wetland (RW1). DP14 documents wetland conditions within a depression adjacent to Deer Creek. Orientation: southwest.

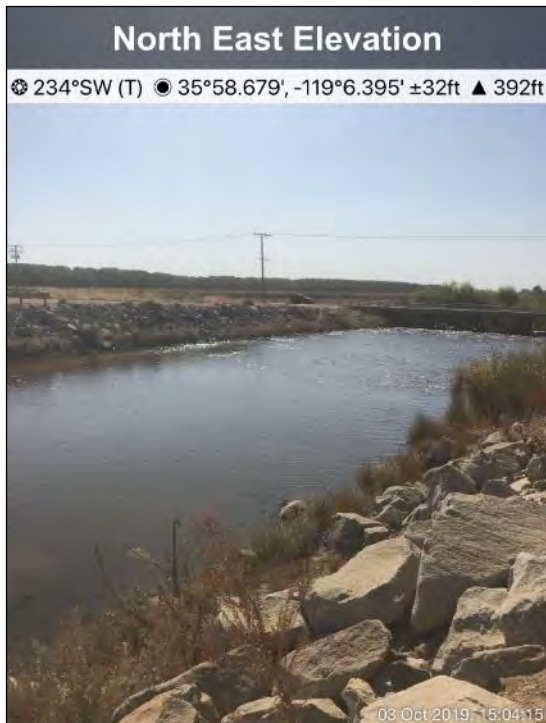
Photograph 15. Intermittent Stream (IS3). DP15 documents the OHWM of Deer Creek. Orientation: southwest

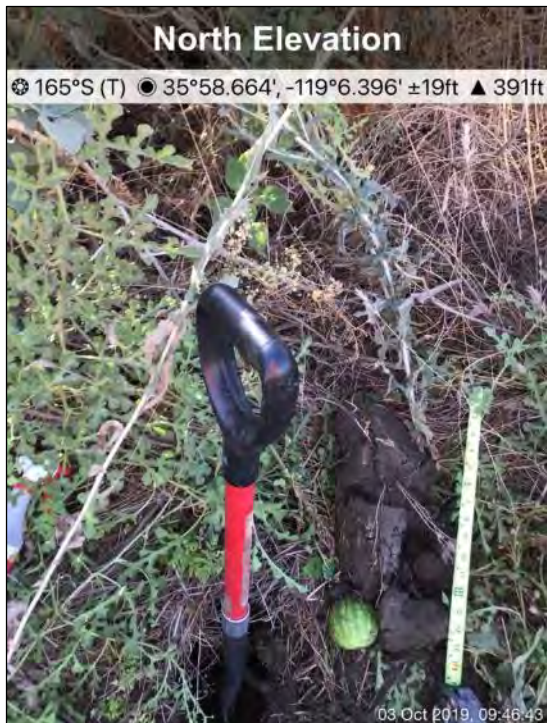
Photograph 17. Upland. DP17 documents upland conditions adjacent to a riparian wetland/fresh emergent wetland documented by DP16. Orientation: south.

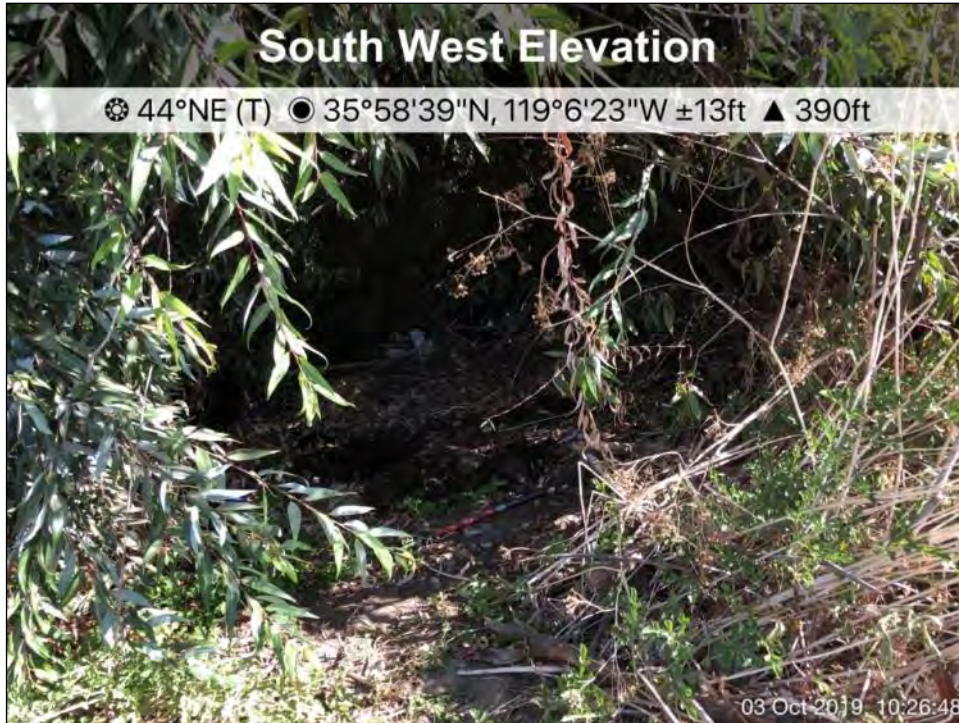
Photograph 18. Riparian wetland (RW3). DP18 documents riparian wetland adjacent to Deer Creek. Orientation: northeast.

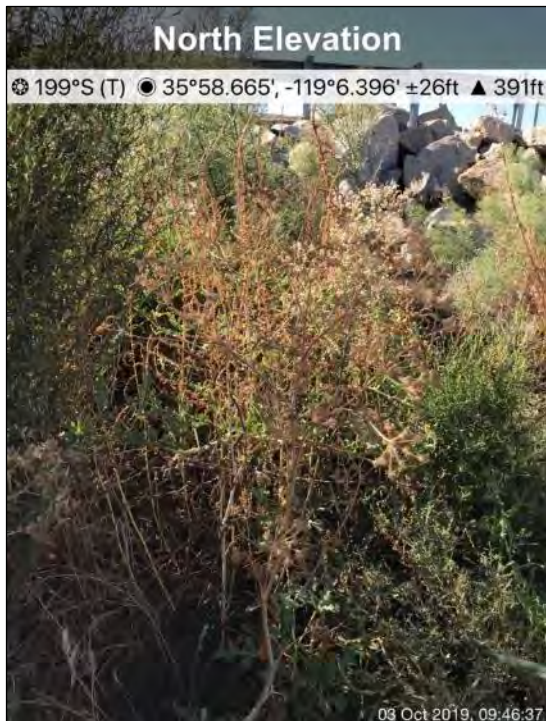
Photograph 19. Upland. DP19 documents upland conditions adjacent to a riparian wetland documented by DP18. Orientation: south.

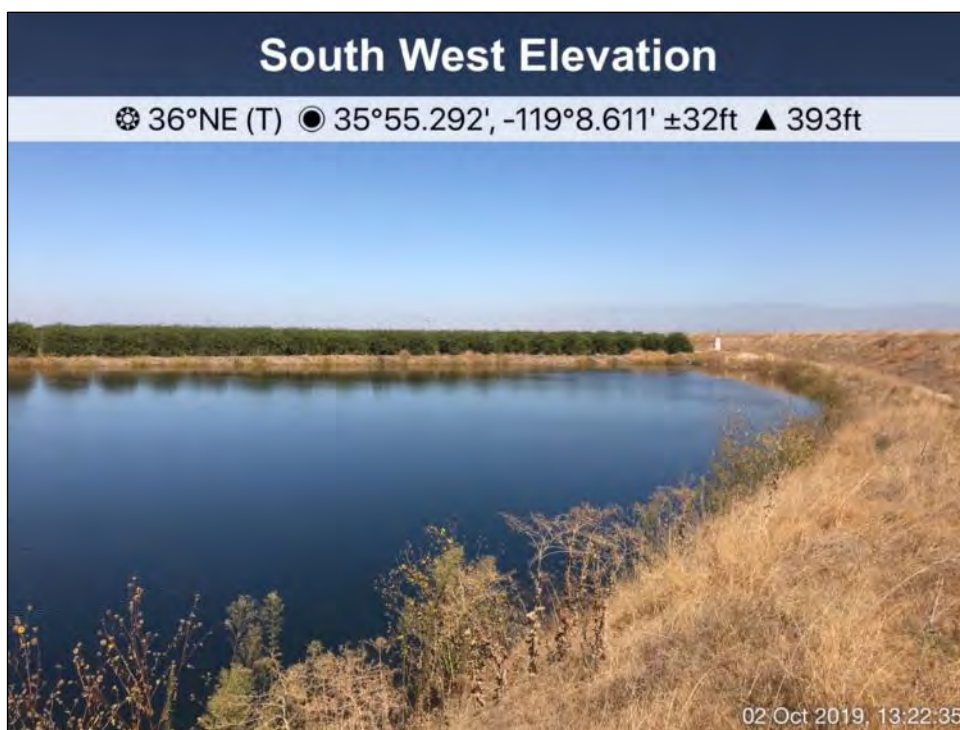
Photograph 20. Pond (PON9). DP20 documents the OHWM of an irrigation pond. Orientation: northeast.

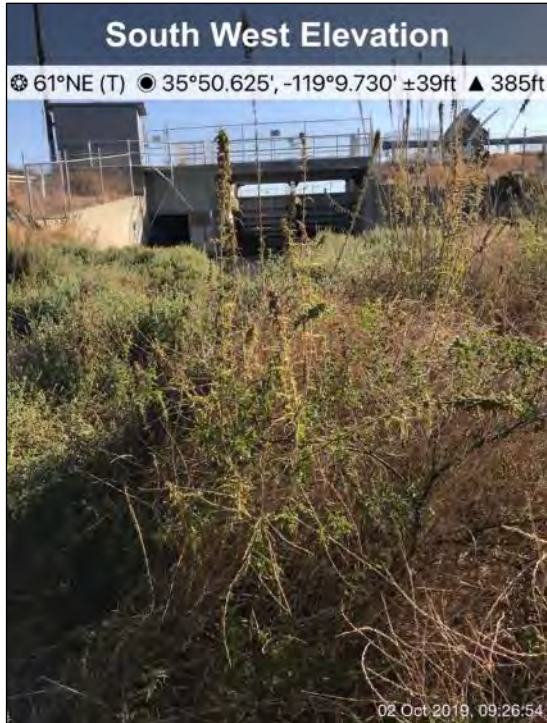
Photograph 26. Upland. DP24 documents upland conditions adjacent to riparian wetlands associated with the White River downstream of the Friant-Kern Canal documented by DP23. Orientation: northeast.

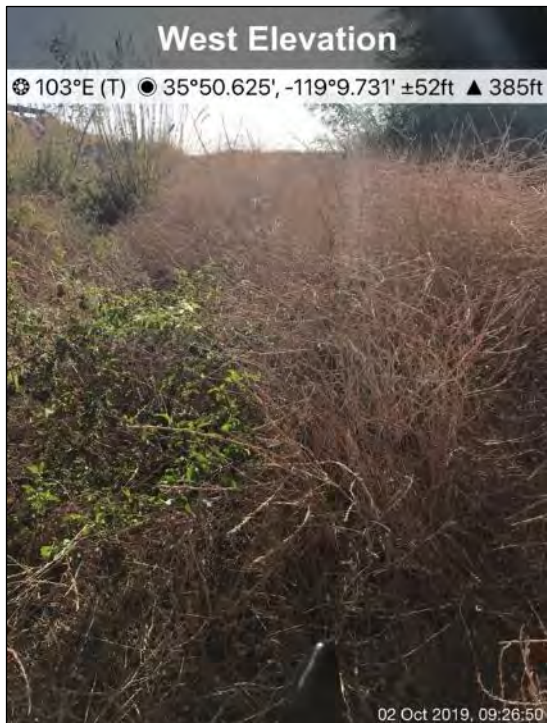
Photograph 27. Upland. DP24 documents upland conditions adjacent to riparian wetlands associated with the White River downstream of the Friant-Kern Canal documented by DP23. Orientation: east.

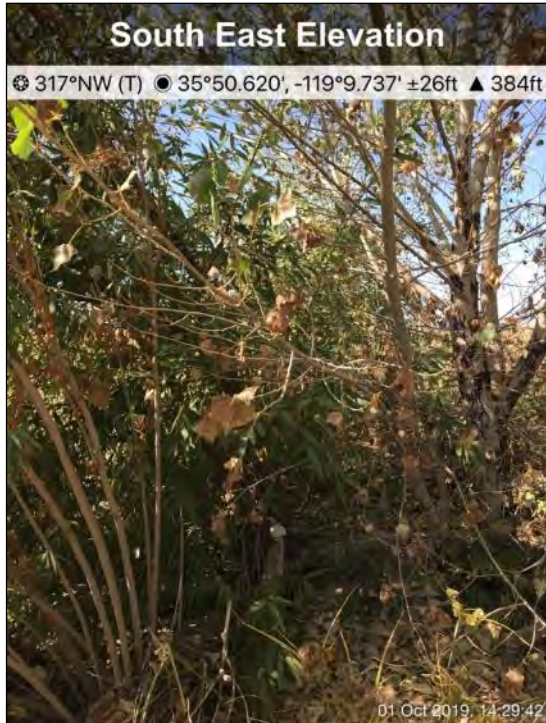
Photograph 30. Riparian wetland (RW6). DP26 documents a riparian wetland associated with the White River. Orientation: northwest.

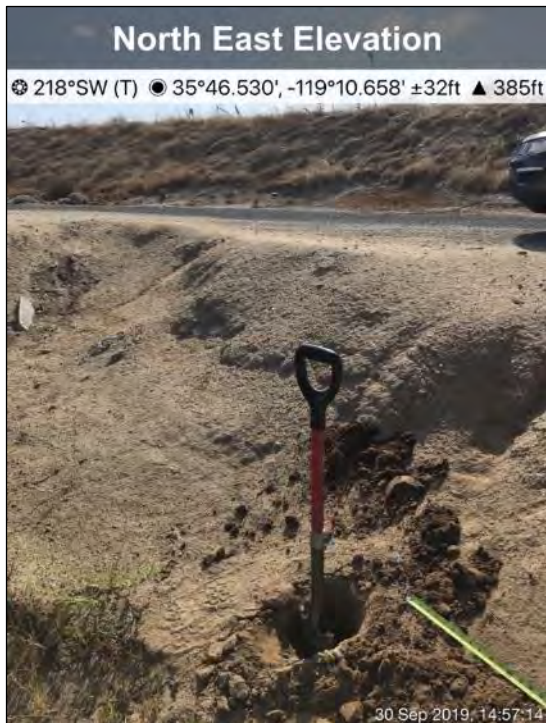
Photograph 35. Upland. DP29 documents upland conditions adjacent to the pond documented by DP28. Orientation: southwest.

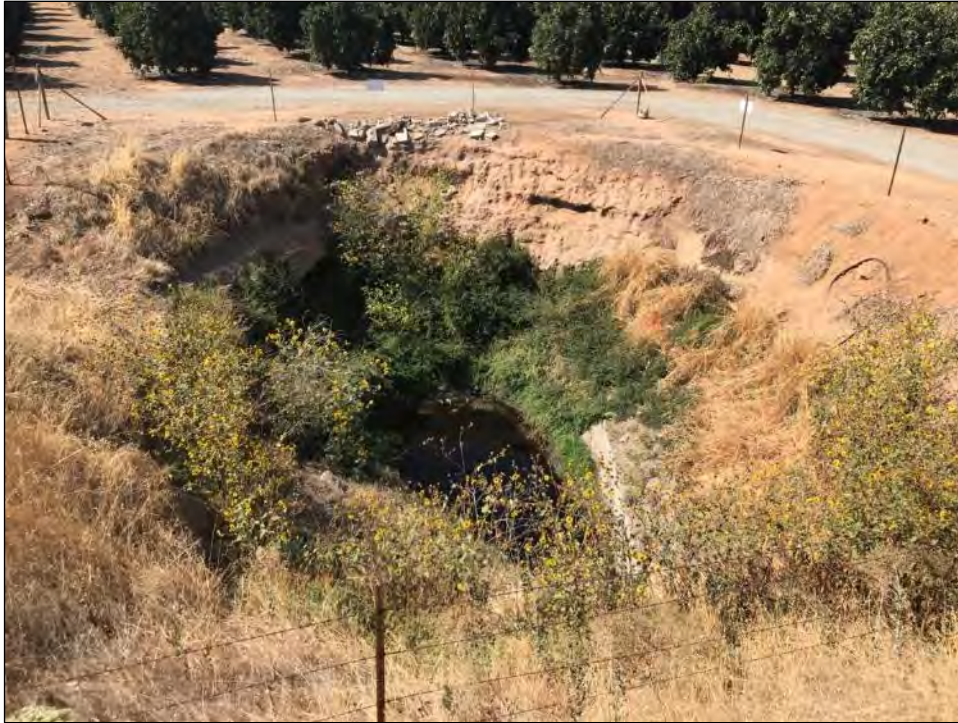
Photograph 36. Pond (PON3). Photograph shows pond in excavation for a siphon underneath the Friant-Kern Canal. Orientation: west.
