Photo 16
RM 286 DAMSITE

Upper San Joaquin River Basin Storage Investigation
View looking upstream (northwest) at the proposed damsite. Steep canyon walls expose hard, fresh to slightly weathered, jointed granitic rock. The portal of Adit 1, excavated as part of the excavation of the Kerckhoff No. 1 Tunnel in the early 1900's, is visible at photo right.

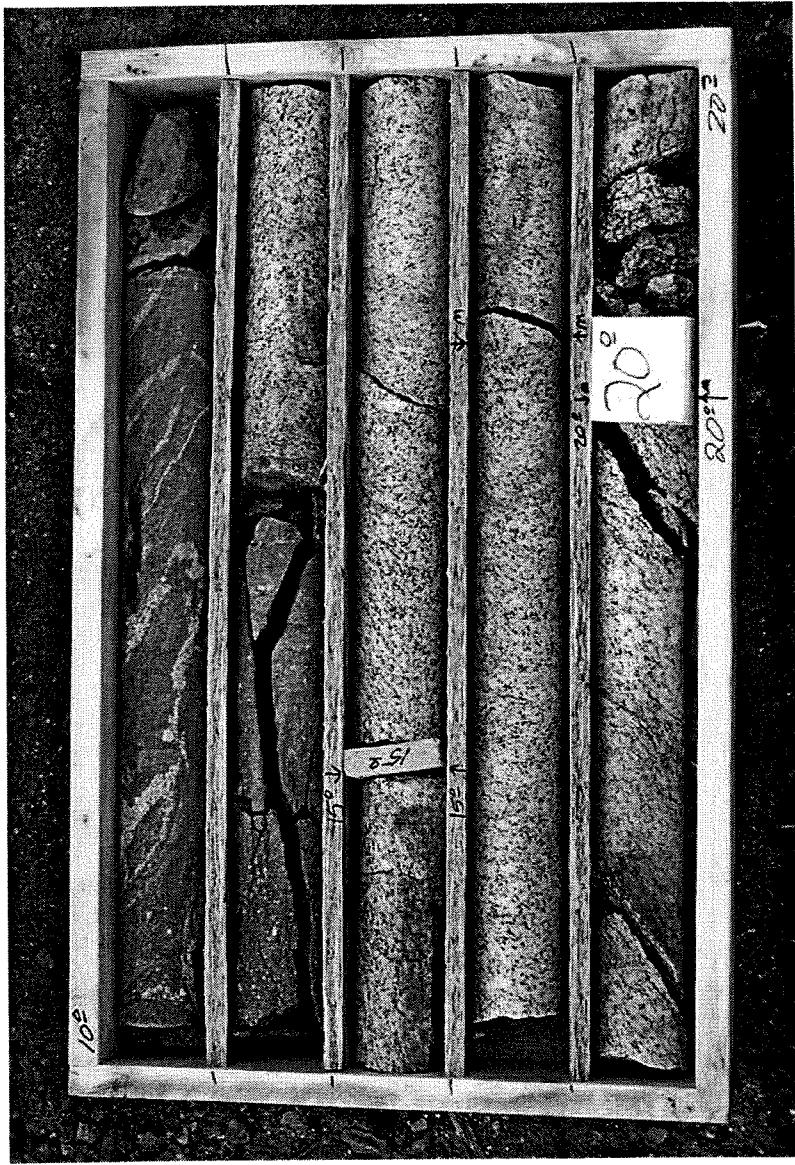
Photo 20

Drill core from the 10.0 to 20.5 depth interval of drill hole MP286-04-2 showing open joints and fresh, hard granitic rock. These engineering geologic rock properties are representative of the upper 20 to 30 feet of the rock at the proposed damsite.

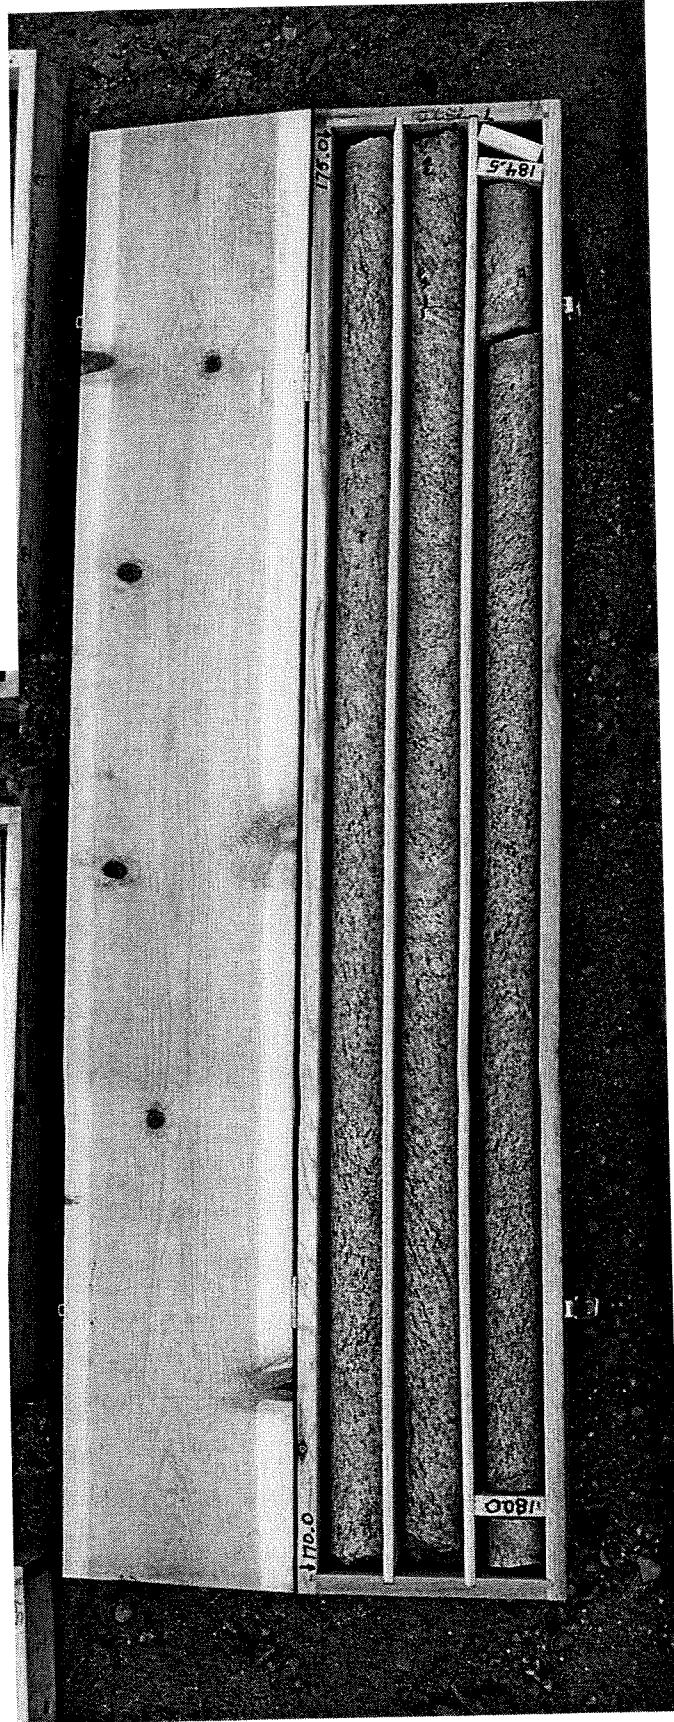
Photo 21

Drill core from the 170.0 to 184.5 depth interval of drill hole MP286-04-2 showing tight joints and fresh, hard granitic rock. These engineering geologic rock properties are representative of rock below a depth of 20 to 30 feet below the existing ground surface and extending to a depth of at least 200 feet at the proposed damsite.
