APPENDIX B

Environmental Field Trip Report

Friant Dam Enlargement

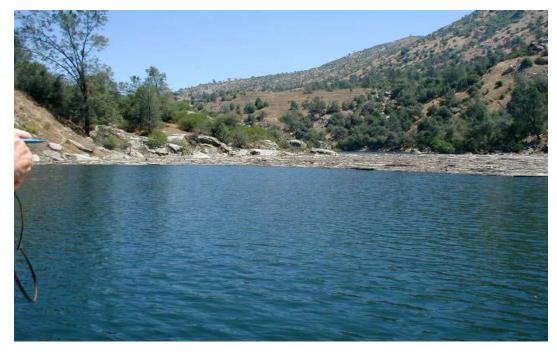
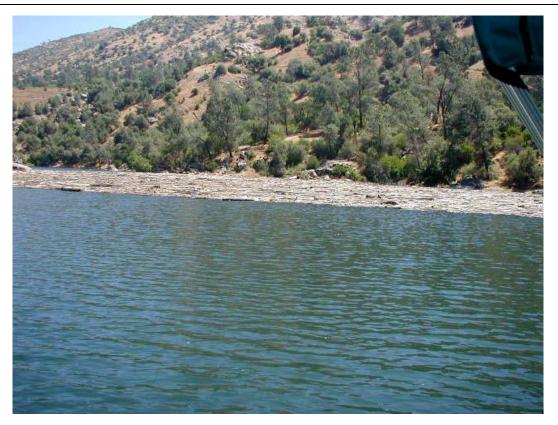
Picture: P52900110 Log jam at upper reach of Millerton Lake.

Picture: P52900111 Log jam at upper reach of Millerton Lake.

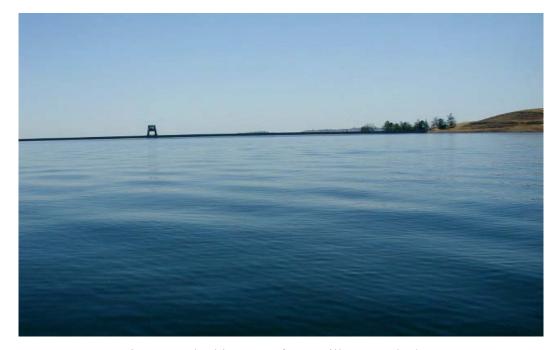
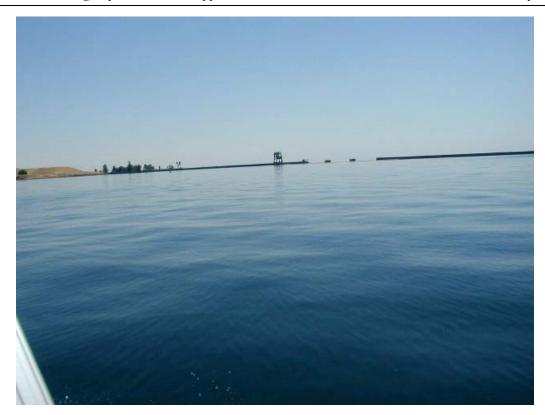
Picture: P52900112 Friant Dam looking west from Millerton Lake boat.

Picture: P52900113 Friant Dam looking west from Millerton Lake boat.

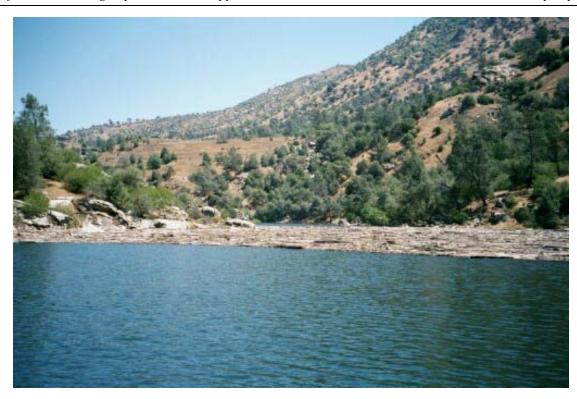
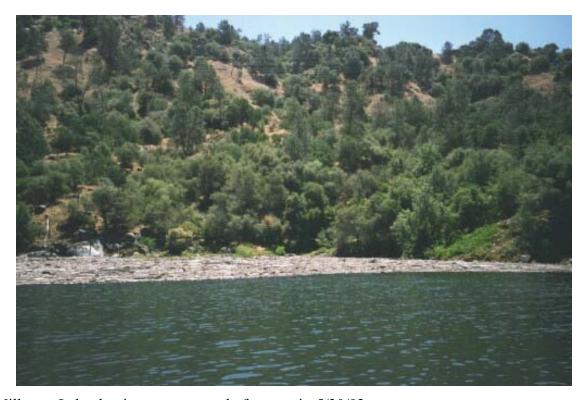
Millerton Lake, log jam at upper end of reservoir, 5/30/02

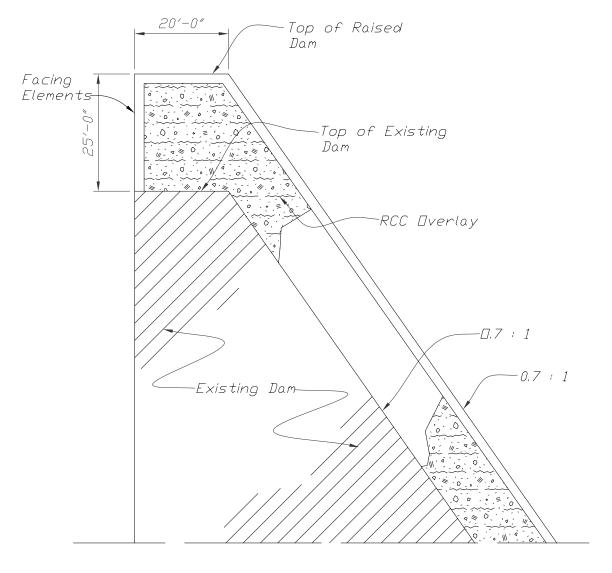
FRIANT DAM - 25' RAISE FIGURE 1

Appendix D contains a preliminary, pre-feasibility level drawing illustrative of the Friant Dam enlargement method under consideration. While only the 25 foot raise option is shown, the same basic approach is contemplated for a larger raise.
