Hydropower Team Trip Report

UPPER SAN JOAQUIN RIVER BASIN STORAGE INVESTIGATION - PHASE 1

HYDROPOWER ANALYSIS TRIP REPORT - SITE VISITS TO RETAINED SITES

Environmental Trip Report

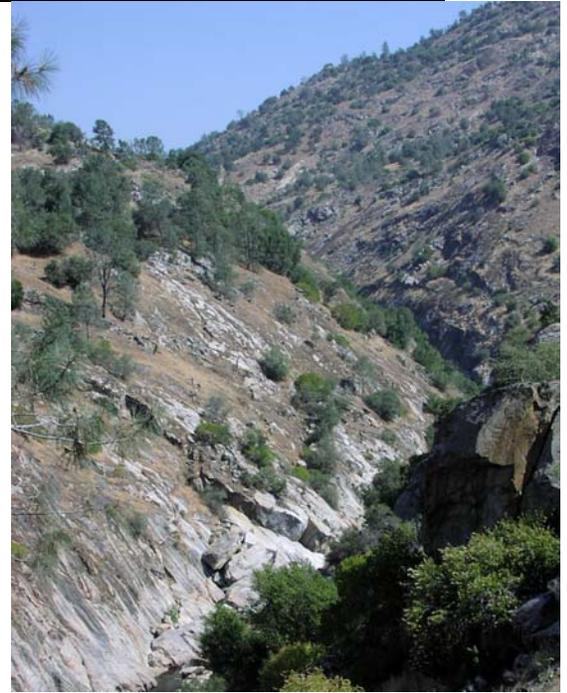
A – Downstream Adit ~04.jpg
6/18/2003
Upstream View from Downstream adit

Two adits exist in the area. One of these was viewed and comprised a short unlined portion leading to a concrete plug in which a steel man-way was contained. The adit was approximately 20 feet in diameter and the concrete plug was about 60 feet into the hillside. Examining the entrance to the adit, it was observed that the rock was only slightly weathered from the surface to a depth of some 10 feet. The underlying bedrock looked sound with very widely spaced jointing. In the adit itself, very little rock appeared to have spalled and fallen, even though the adit entrance has been open and unprotected for some 83 years.

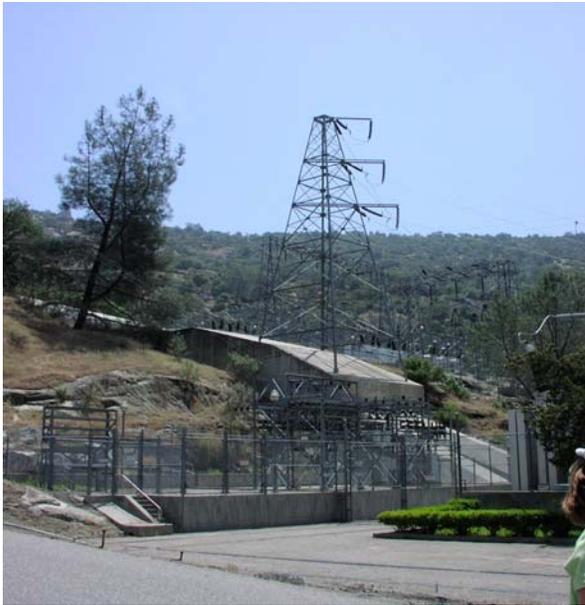
B – Big Creek 4 PH ~02.jpg
6/18/2003
Switchyard

SCE did not allow access inside their facilities. Nevertheless, the exterior of the powerhouse, the incoming penstocks, switchyard, tailrace and river channel downstream of the powerhouse were viewed.

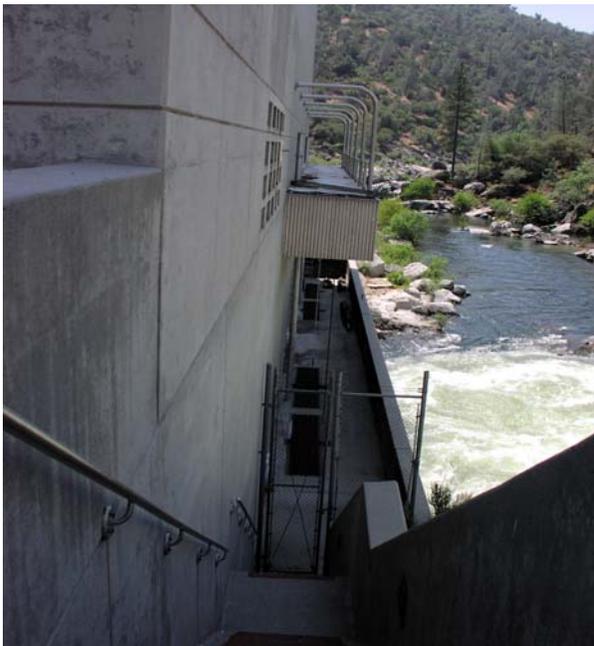
B – Big Creek PH ~06.jpg
6/18/2003
Tailwater of powerhouse.

The powerhouse structure is 91 feet by 135 feet and is constructed of reinforced concrete. Although not seen during this field trip, the powerhouse has five floors comprising a draft tube floor, turbine floor, generator floor, storage floor, and erection floor. Normal tailwater level is 986.5 feet.

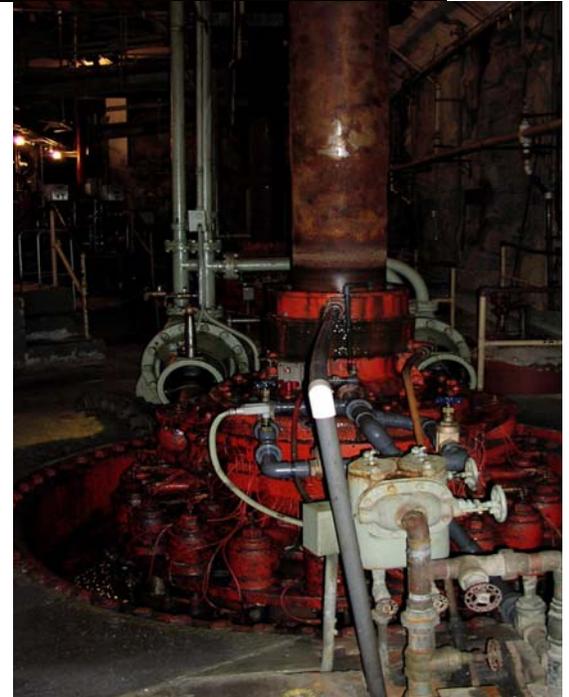
H – Kerckhoff 1 PH ~06.jpg
6/19/2003
Turbine

The powerhouse contains two Francis-type, vertical shaft, hydraulic reaction turbines. Each turbine is rated 66,000 hp, design head 383 feet and speed 257 rpm. Each turbine is equipped with a 120-inch turbine shut-off butterfly valve. Each main turbine is directly connected to a vertical shaft, totally enclosed generator. Unit No: 1 generator is an Allis Chalmers unit and Unit No: 2 is a General Electric unit. Each generator is rated at 50Mw. Generation voltage is 11.5 kV.

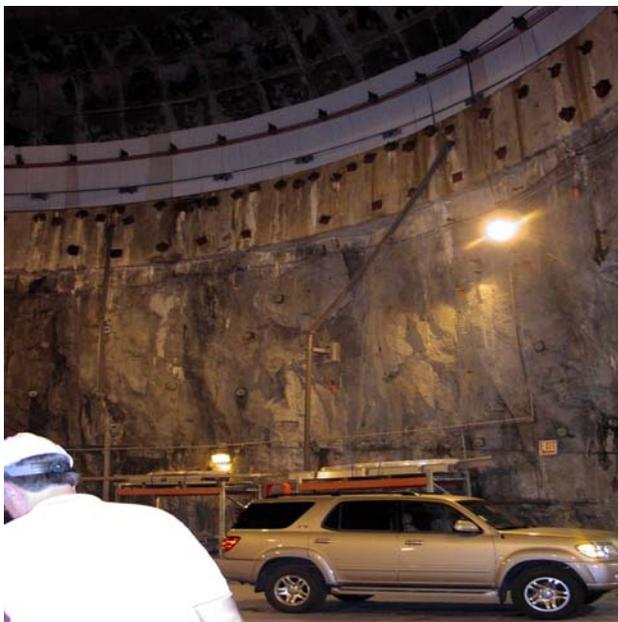
I – Kerckhoff 2 PH ~06.jpg
6/19/2003
View inside tunnel powerhouse

As with Kerckhoff No: 1 Powerhouse, much of the sides of the Kerckhoff No: 2 Powerhouse are unlined and very little spalling of rock appears to have taken place, providing additional evidence on the soundness of the rock formation.

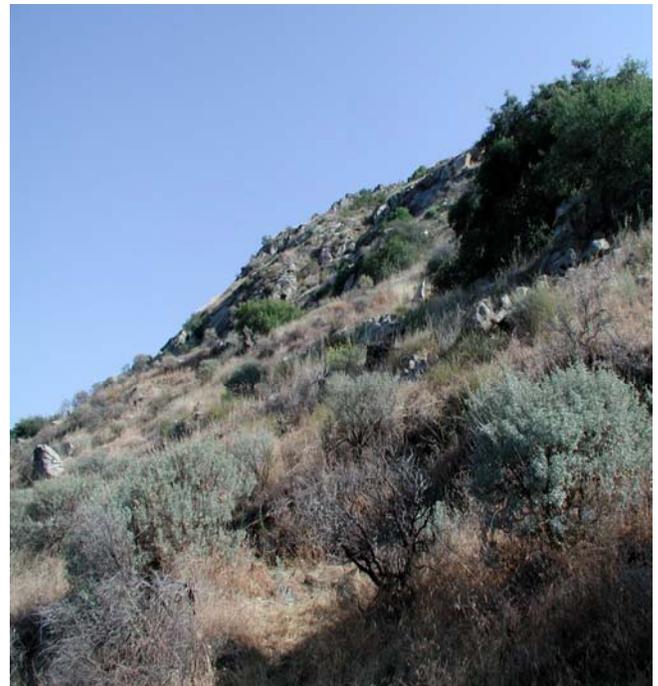
Historic: Various sites likely, associated with mining, logging, hydroelectric development, recreation and other activities. One dry-stacked rock wall, a possible game blind, was observed near the dam site.

Above: Dry stacked rocks (game blind?), view NE from end of jeep trail in NE ¼ Sect. 2, T10S, R22E (early morning). (P6180016.JPG)

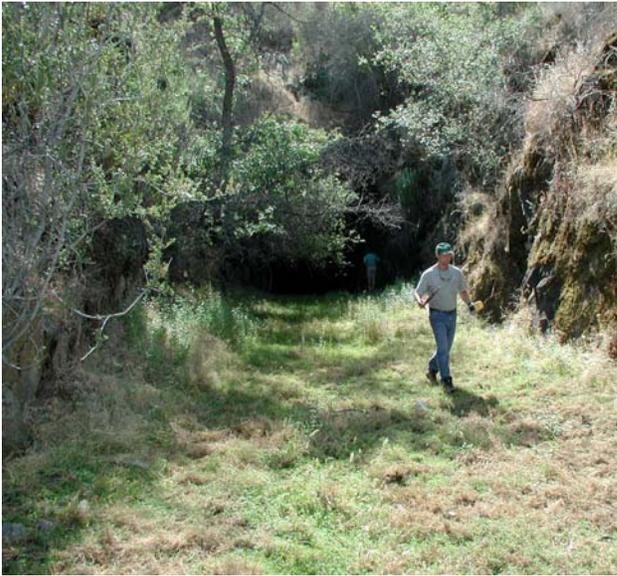
Above: Entrance to Adit #1 in NW ¼ Sect. 2, T10S, R22E (early morning). (P6180017.JPG)

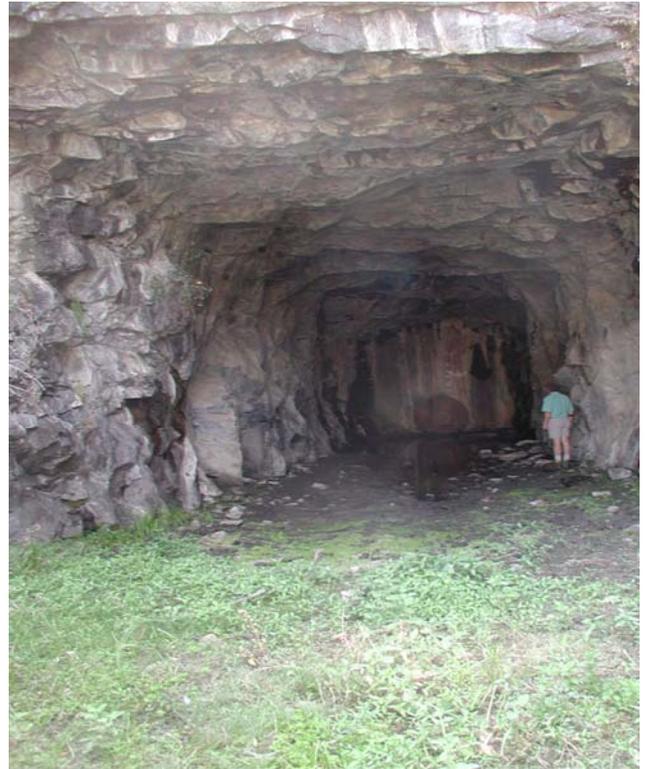
Above: Entrance to Adit #1 in NW ¼ Sect. 2, T10S, R22E (mid-morning). (P6180018.JPG)

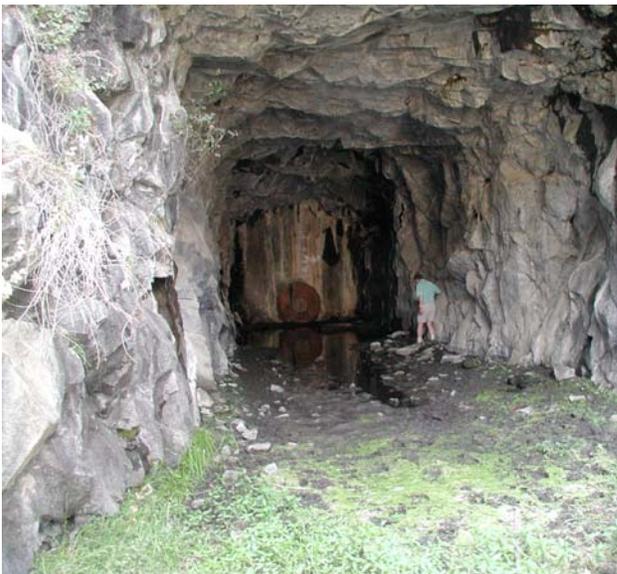
Above: Closer view of entrance to Adit #1 in NW ¼ Sect. 2, T10S, R22E (mid-morning). (P6180019.JPG)

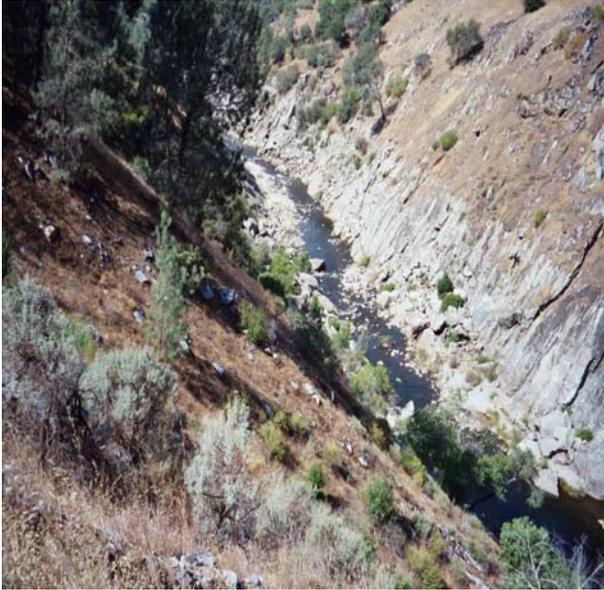
Above: San Joaquin River downstream of RM 286 dam site, showing extreme flood scour line (view downstream, June 18 2003) (008_5.JPG)

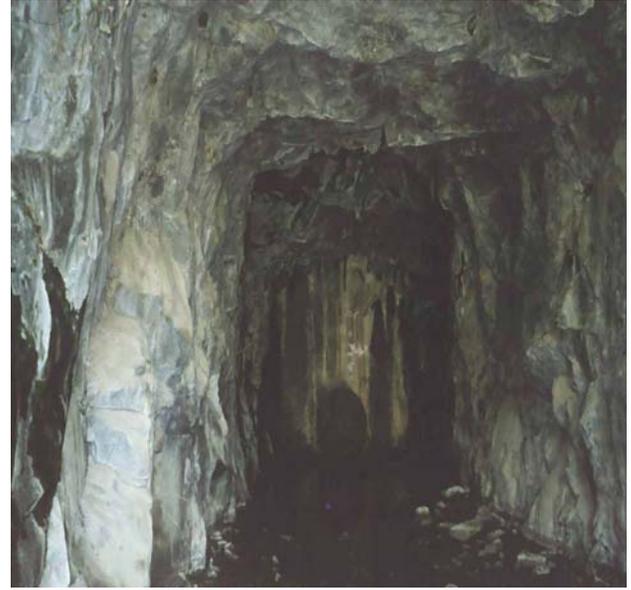
Above: Kerckhoff flow line Audit 2 near RM 286 dam site (008_5.JPG)
