Zebra & Quagga Mussel Research Program

Research Note

Quagga Mussel Control for Pipes Using Water Jetting

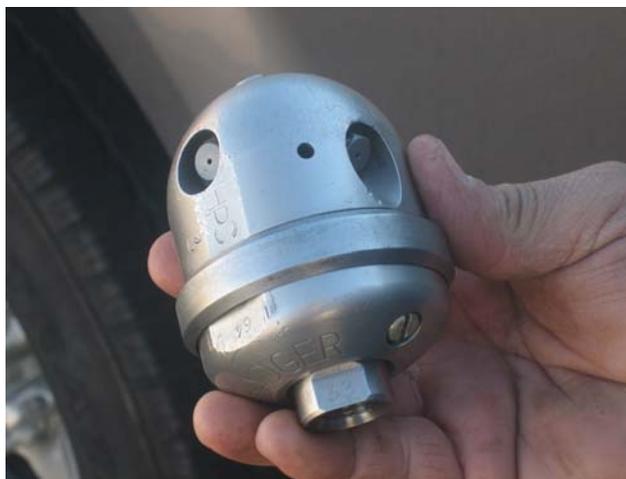
Figure 1. High pressure water jetting nozzle.

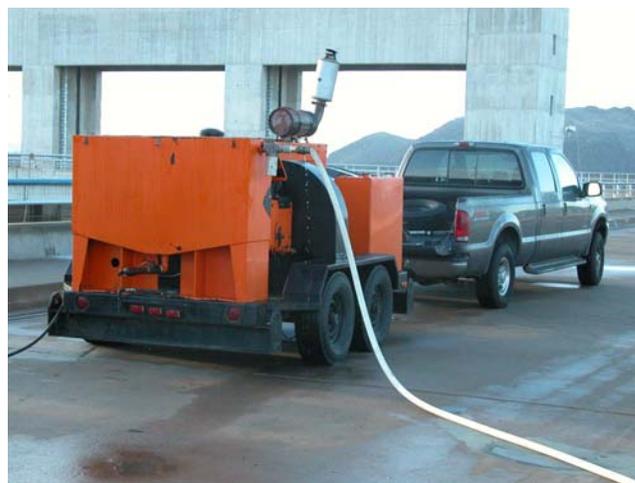
Prior to water jetting, a camera was inserted into the 10-in-diameter pipe to observe pre-cleanout condition. Heavy mussel settlement, biofouling, and rust nodules were observed over the 105-ft length of pipe. The water jetting system (Fig. 2) consisted of a pumped arrangement that delivered pressures ranging from 5,000-10,000 psi to the nozzle. For this demo, a 10,000 psi pressure setting was used.

Figure 2. High pressure water jetting pump.

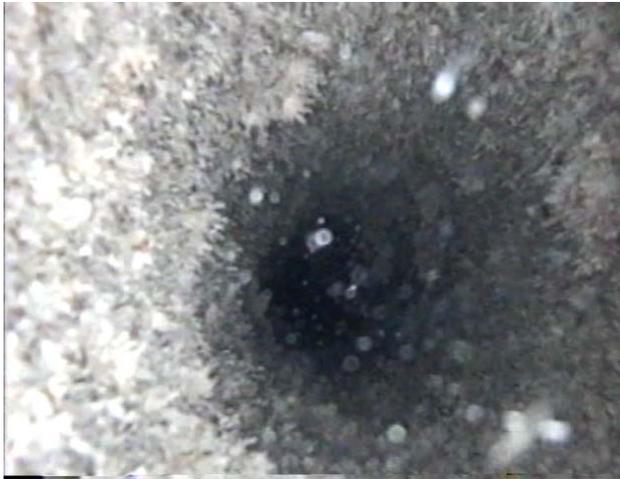
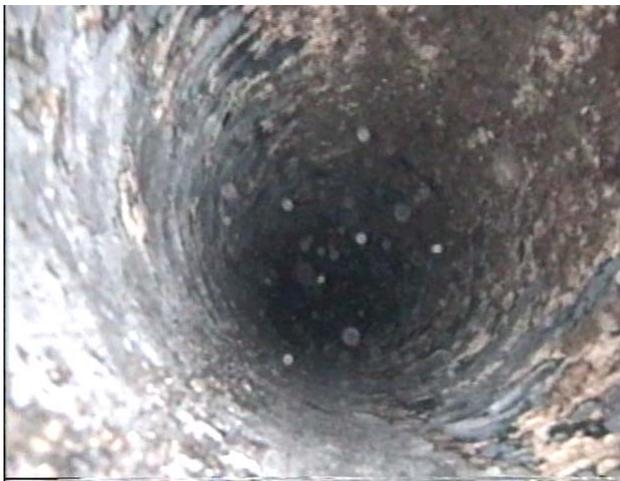
Following water jetting, the pipeline was again inspected (video documentation is available for both pre- and post-cleanout inspections). Figure 3 shows before and after images captured from the video. The results demonstrated this system is highly effective for removal of mussels and other

biogrowth. However, there were areas where rust nodules and some minimal biofouling remained. Furthermore, some coating removal was also observed (although it should be noted that coating failures pre-existed as evident from observed pre-test rust nodules). Nonuniform cleaning and coating removal was observed and is presumably due to nozzle head insertion along the bottom of the pipe rather than along the centerline. A crawler is recommended for use when possible to overcome these deficiencies. Reduced operating pressures may also prevent or limit coatings removal.

Figure 3. 10-in domestic water line before and after water jetting.
