Zebra & Quagga Mussel Research Program

RESEARCH NOTE

Field Evaluation of Coatings to Deter Attachment of Quagga Mussels

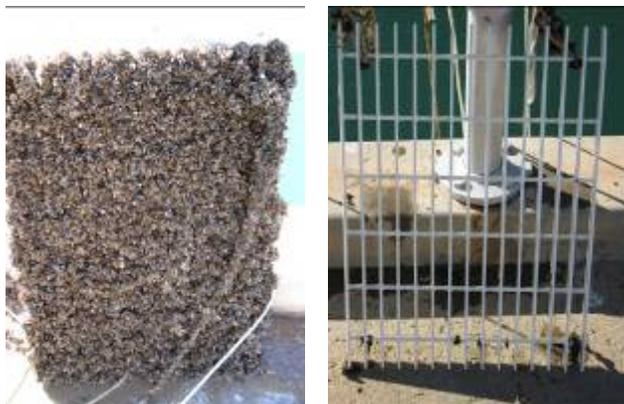
Figure 1. – Uncoated steel grate after 7 months (left). Non-toxic foul release coated steel grate (right).

The study began in May 2008 at Parker Dam and involved 20 different coatings to deter the attachment of mussels. After 7 months of exposure, 16 coatings were eliminated from the study due to moderate to heavy fouling. Four coatings have been identified that may prevent attachment of mussels. Figure 1 shows the effectiveness of some coatings to deter attachment. Further studies are needed to fully evaluate the coatings for durability and obtain projected service life information.

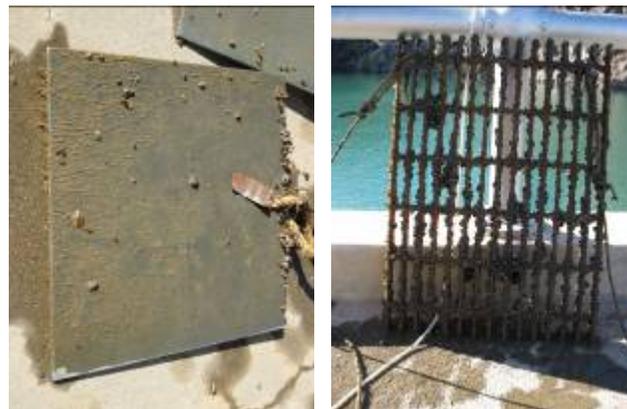
Figure 2. Flame sprayed zinc metalizing contrast between plates (minimal flowing conditions) and grates (flowing conditions).

Figure 2 shows the contrast of fouling that was observed between the grates exposed to considerable flow and plates exposed to minimal flow.
