THE CATHERINE CREEK TRIBUTARY
ASSESSMENT
GRANDE RONDE RIVER BASIN
Tributary Habitat Program, Oregon

U.S. Department of the Interior
Bureau of Reclamation
Pacific Northwest Region
Boise, Idaho

February 2012

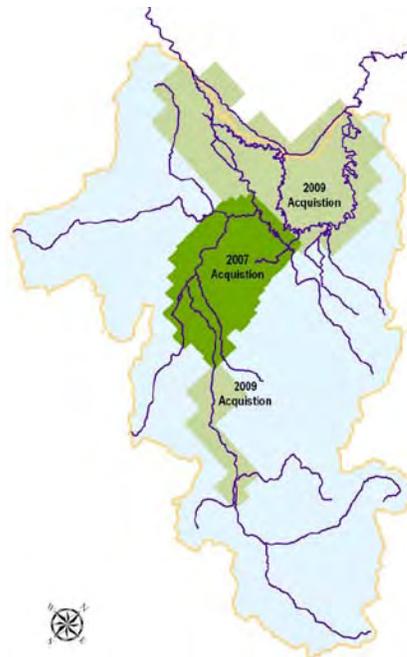
Figure 3. Catherine Creek floodplain and river corridor aerial photo and LiDAR data set collection areas including year of acquisition.

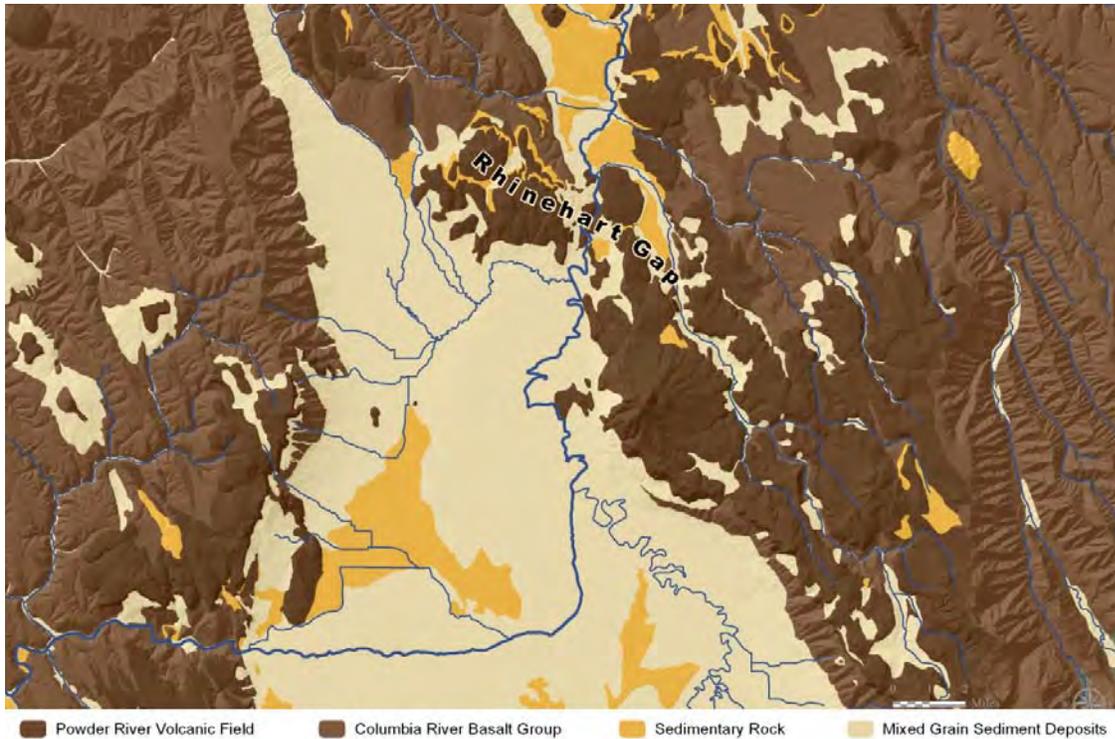
Figure 5. Geologic features comprising Rhinehart Gap.

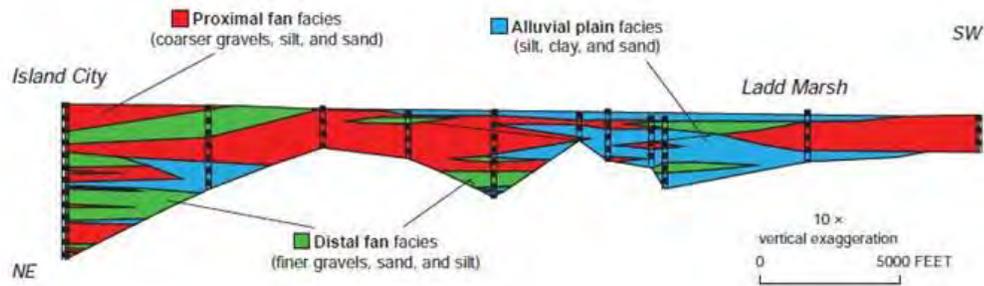
Figure 6. Interpretive cross section in the Grande Ronde valley illustrating interfingering valley fill deposits (Ferns et al. 2010).

resulted in a structural trap that is being filled by the deposition of alluvial sediments. Where the Grande Ronde River, Catherine Creek, Mill Creek, and Ladd Creek enter the valley, large alluvial fan deltas form gently sloping topography. The shape and gradient of the stream changes at the fan delta-alluvial plain interface, shifting from a single thread, and higher energy section on the fan structure to a lower energy environment on the valley floor as noted by the meandering planform. As a result, there is a decrease in channel and floodplain deposit grain size from gravel and sand to silt and clay and a broader distribution of the alluvial channel deposits into the meander zone (Figure 6).

The alluvial deposits vary in gradation, composition, and permeability; depending on their location within the valley and the energy under which they were deposited (e.g., coarser-grained, higher energy deposits on the fan delta or finer-grained, lower energy deposits on the alluvial plain). Alluvium, composed of moderately to well-sorted gravel, sand, and silt is found in the active stream channels and on adjoining floodplains of the Grande Ronde River, Mill Creek, Catherine Creek, and Ladd Creek. The alluvial deposits are reworked by the river and area approximately 15 to 30 feet thick (Ferns et al. 2002). They interfinger with fan delta deposits and are hydraulically connected to older, deeper, abandoned channels (Figure 6).

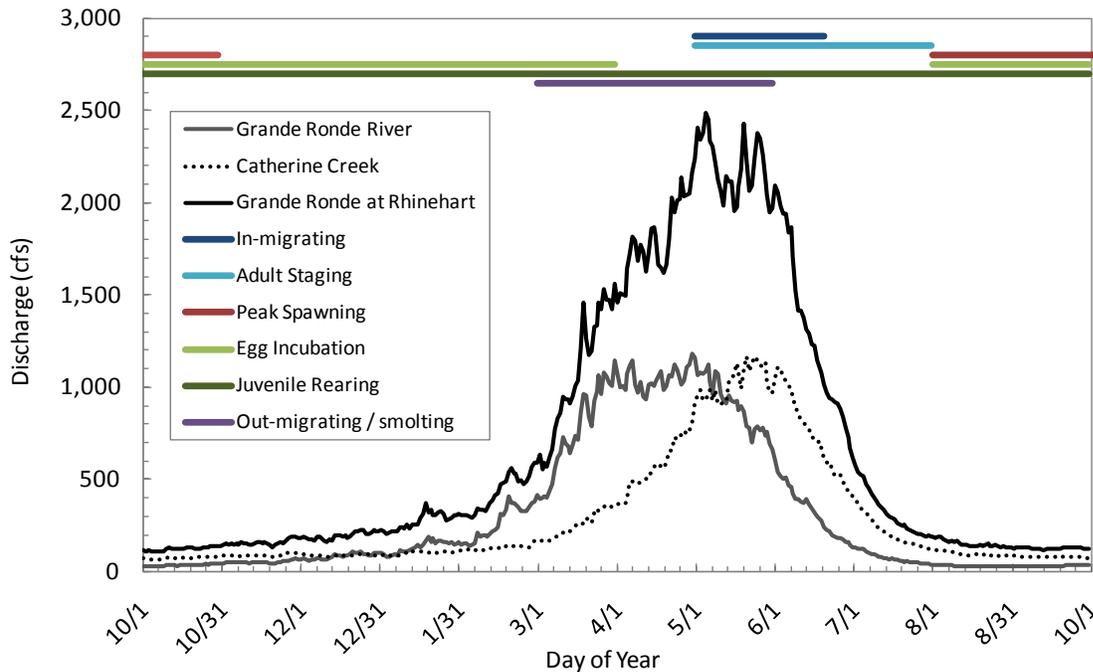
Figure 7. Average annual hydrograph for Catherine Creek near Union, Oregon (RM 46.7) and combined annual hydrographs for Grande Ronde River near Perry, Oregon and Grande Ronde River at La Grande, Oregon stream gages displaying present-day spring Chinook salmon life stages. The shaded area represents the approximate irrigation season during an average year.

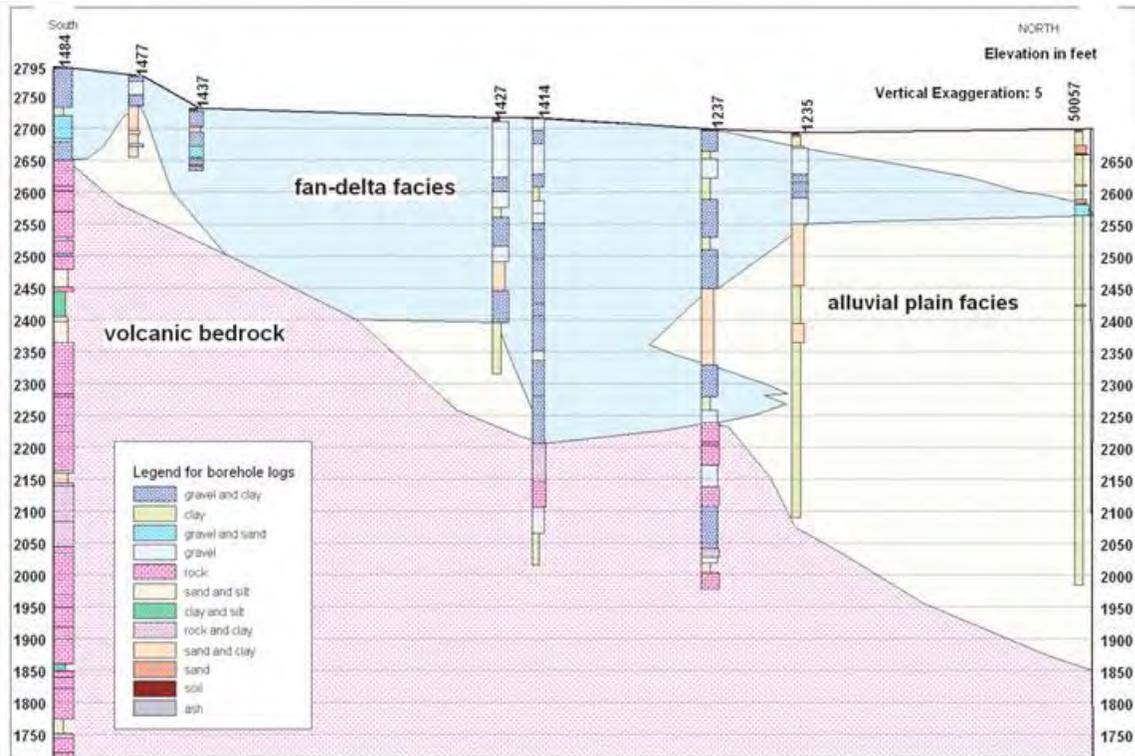
Figure 9. A schematic of the facies, associated rock types, and well log data across the Catherine Creek fan delta. The transect runs roughly north - south from Union to approximately 0.3 miles west of Phys Point (Ferns et al. 2010).

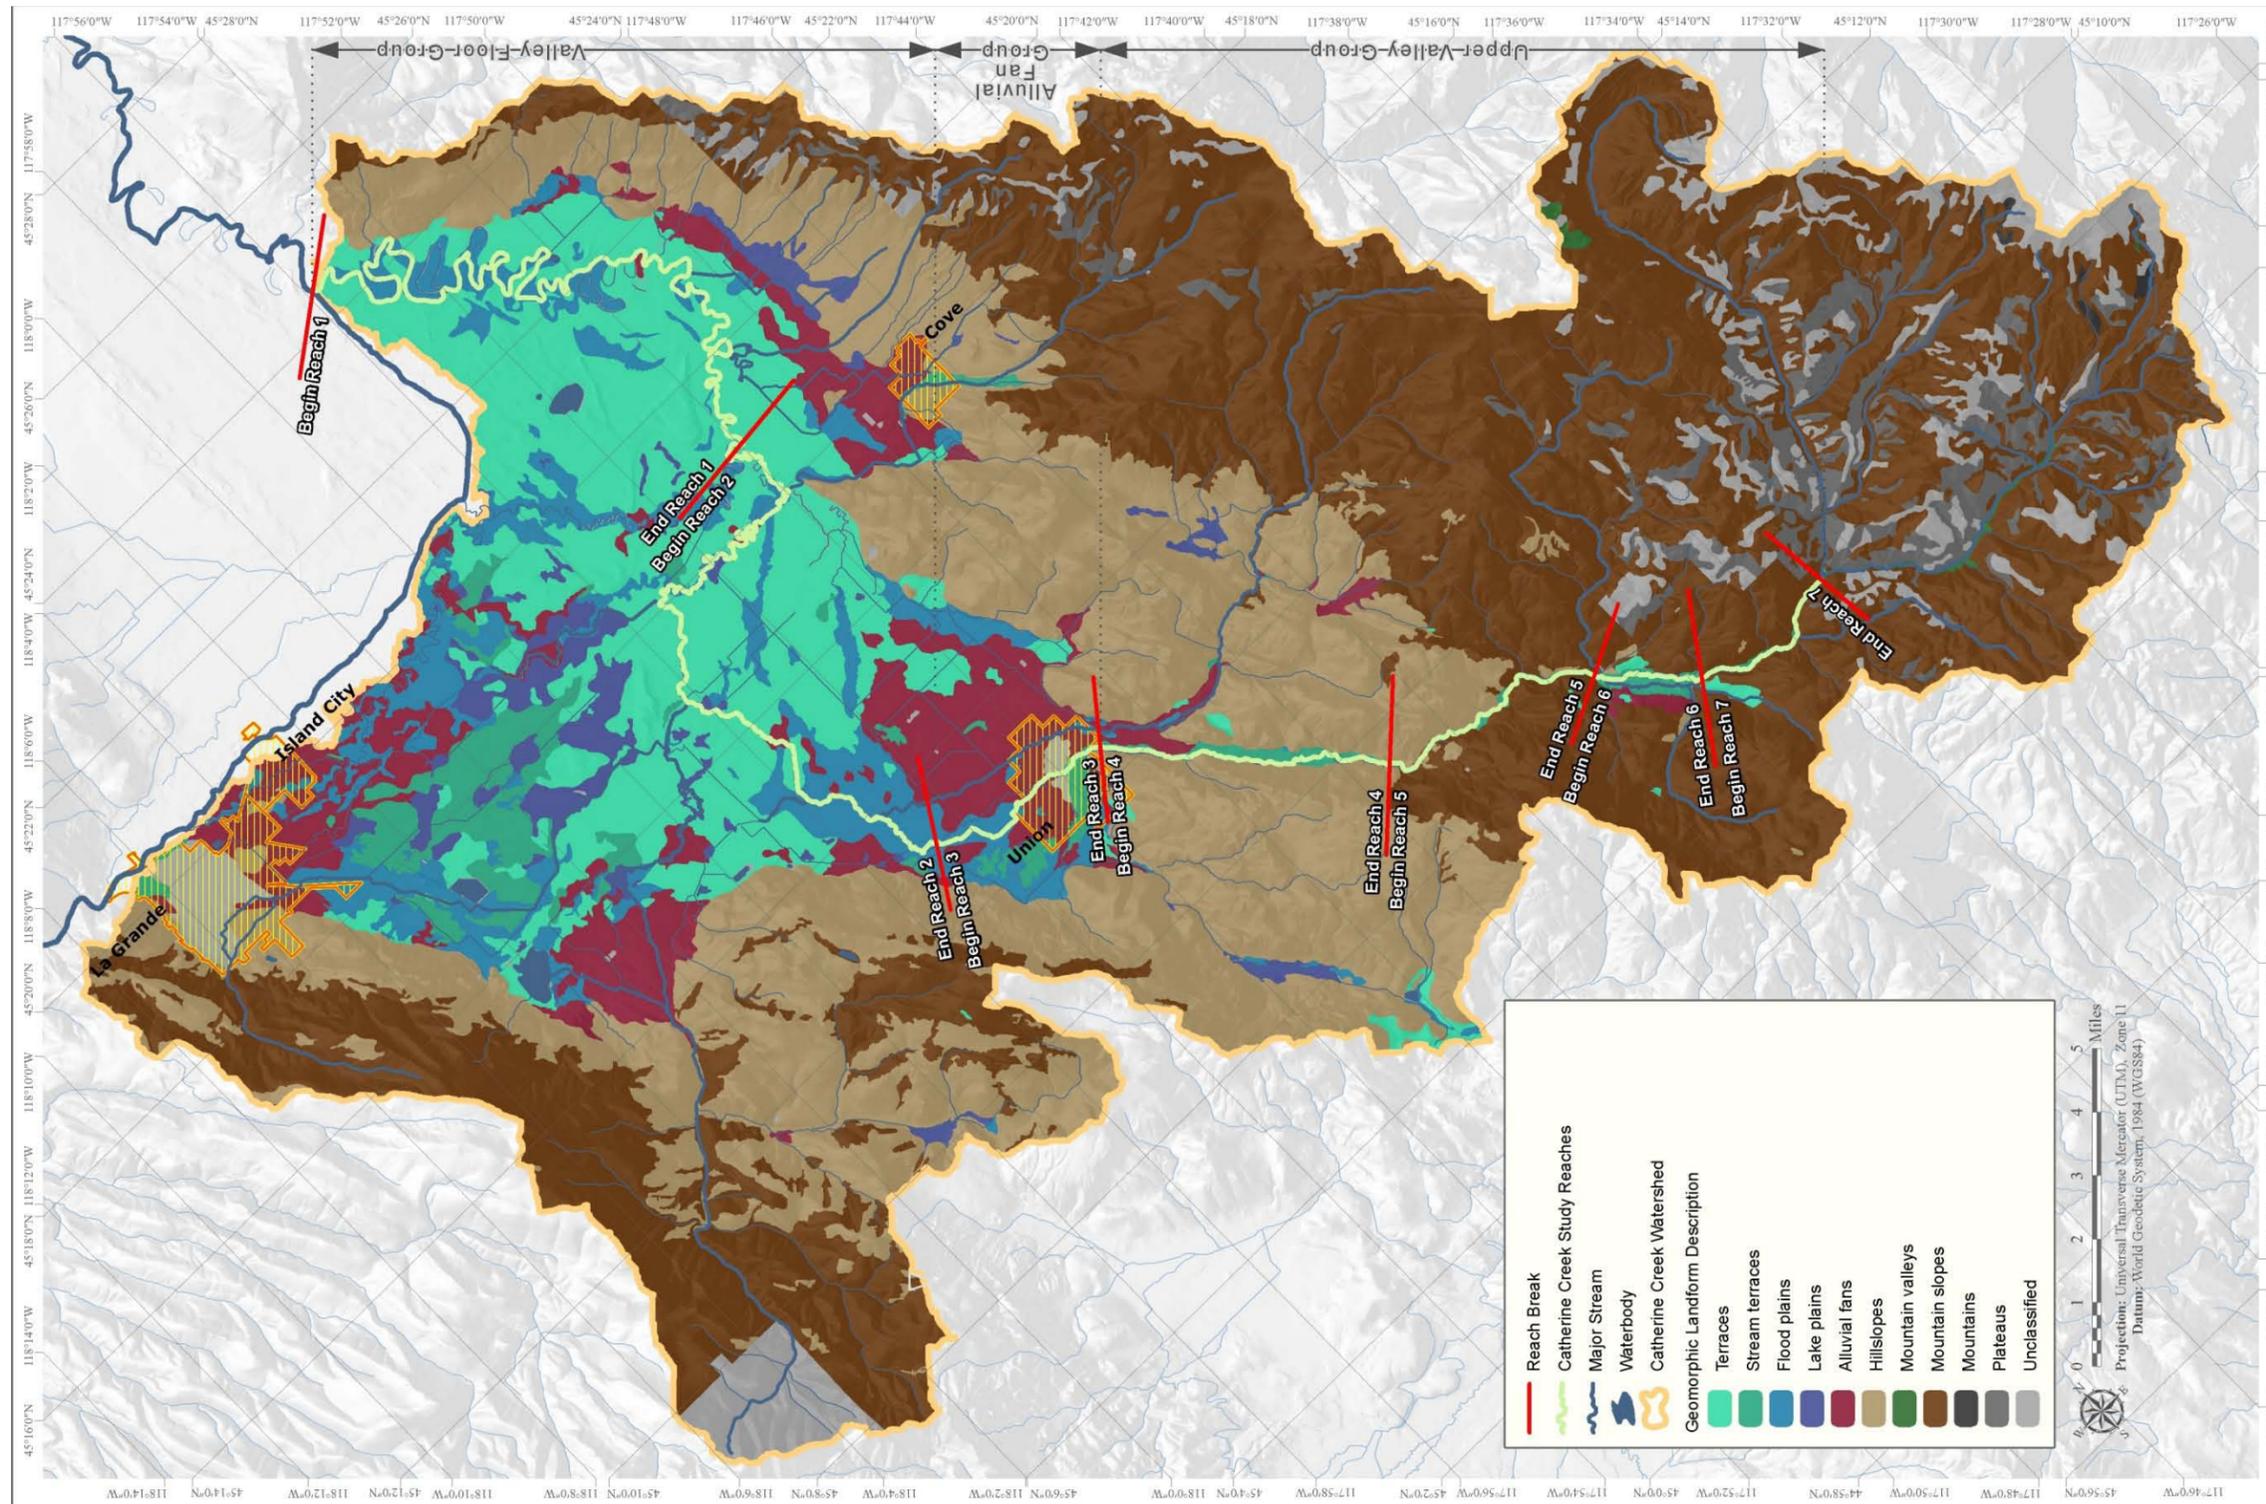
Figure 16. Geomorphic reaches identified in the Catherine Creek TA.

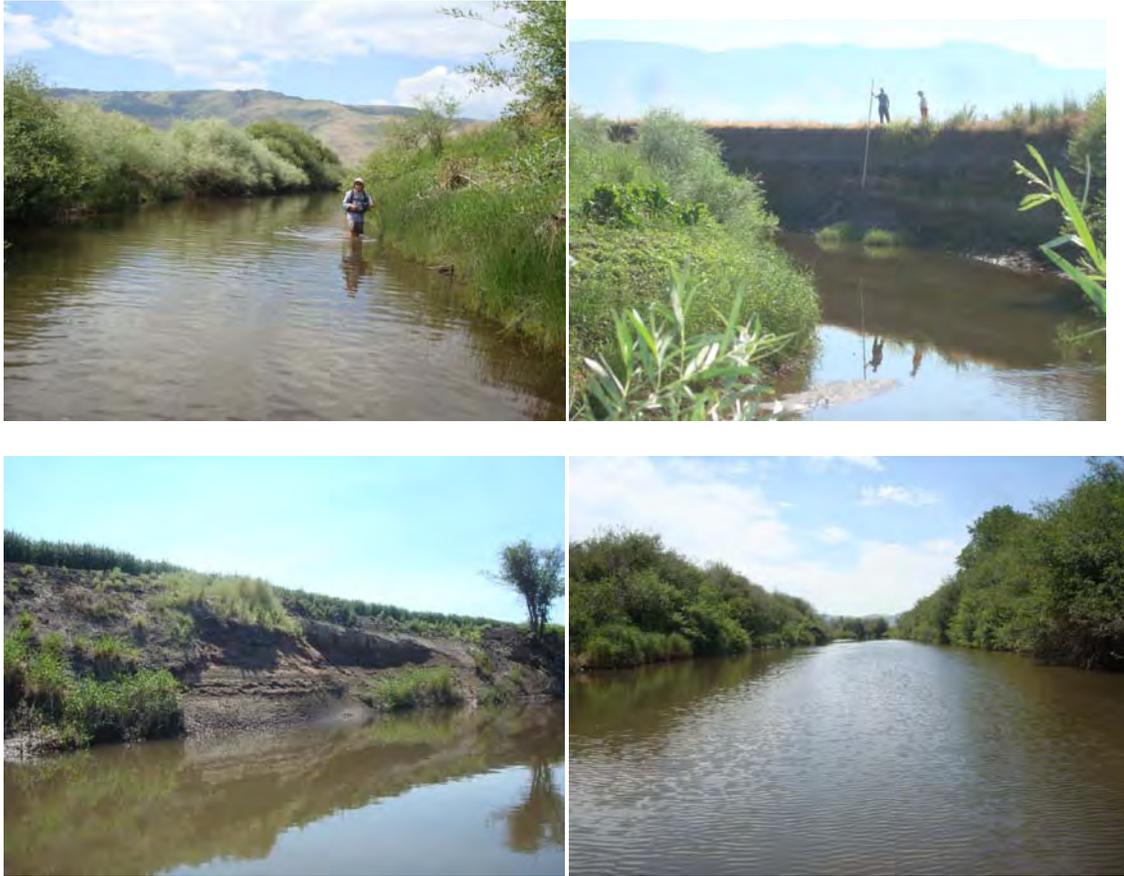
Figure 18. Typical streambank conditions and vegetation in the valley floor segment – Catherine Creek, Grande Ronde Subbasin (Reclamation photograph by D. Stelma – July 2010).

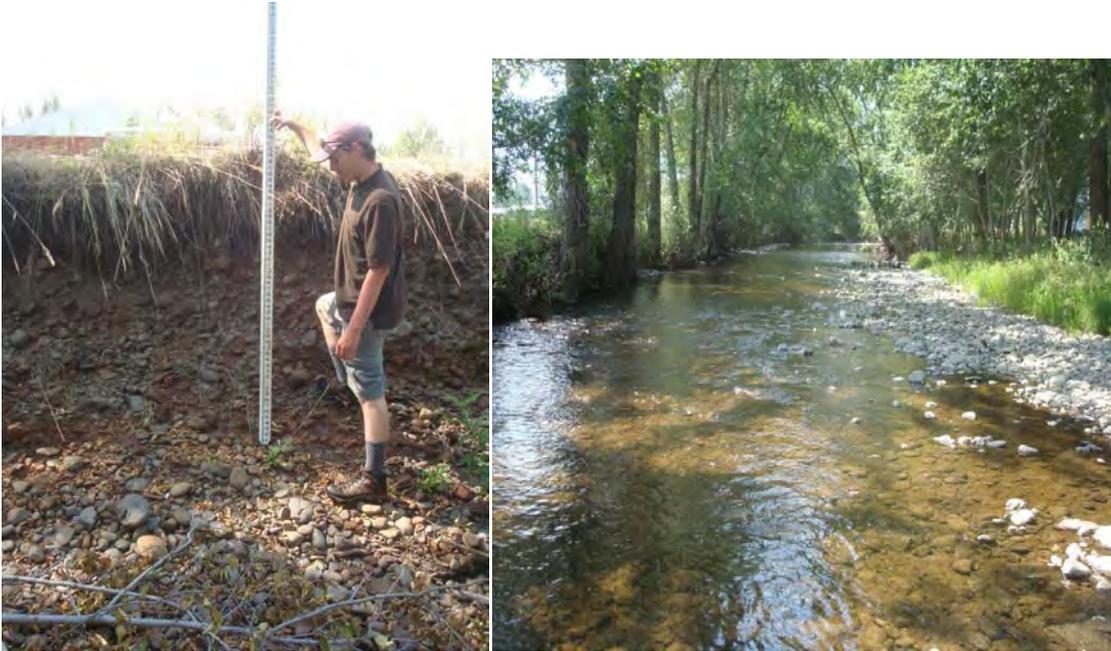
Figure 20. Typical bank conditions, vegetation, and substrate in reach 3 – Catherine Creek, Grande Ronde Subbasin. Subbasin (Reclamation photograph by D. Stelma – August 2010).

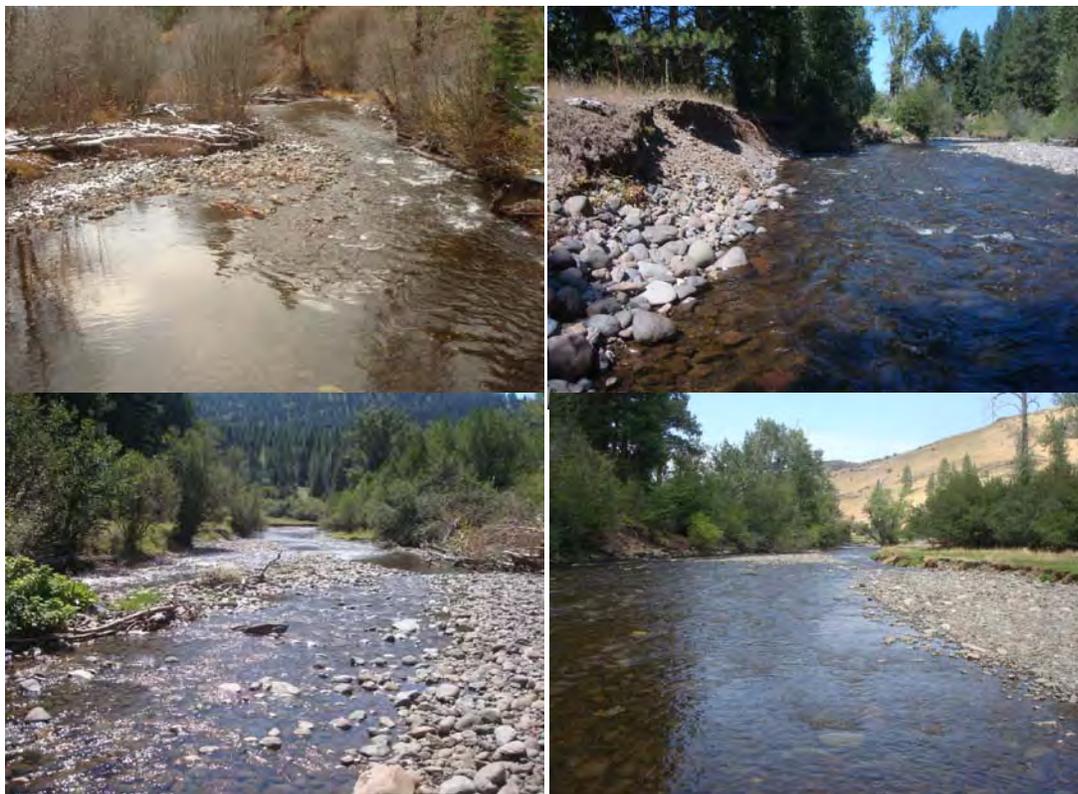
Figure 21. Typical bank conditions, vegetation, and substrate in the upper valley reach – Catherine Creek, Grande Ronde Subbasin. (Reclamation photographs by D. Stelma – August and November, 2010).

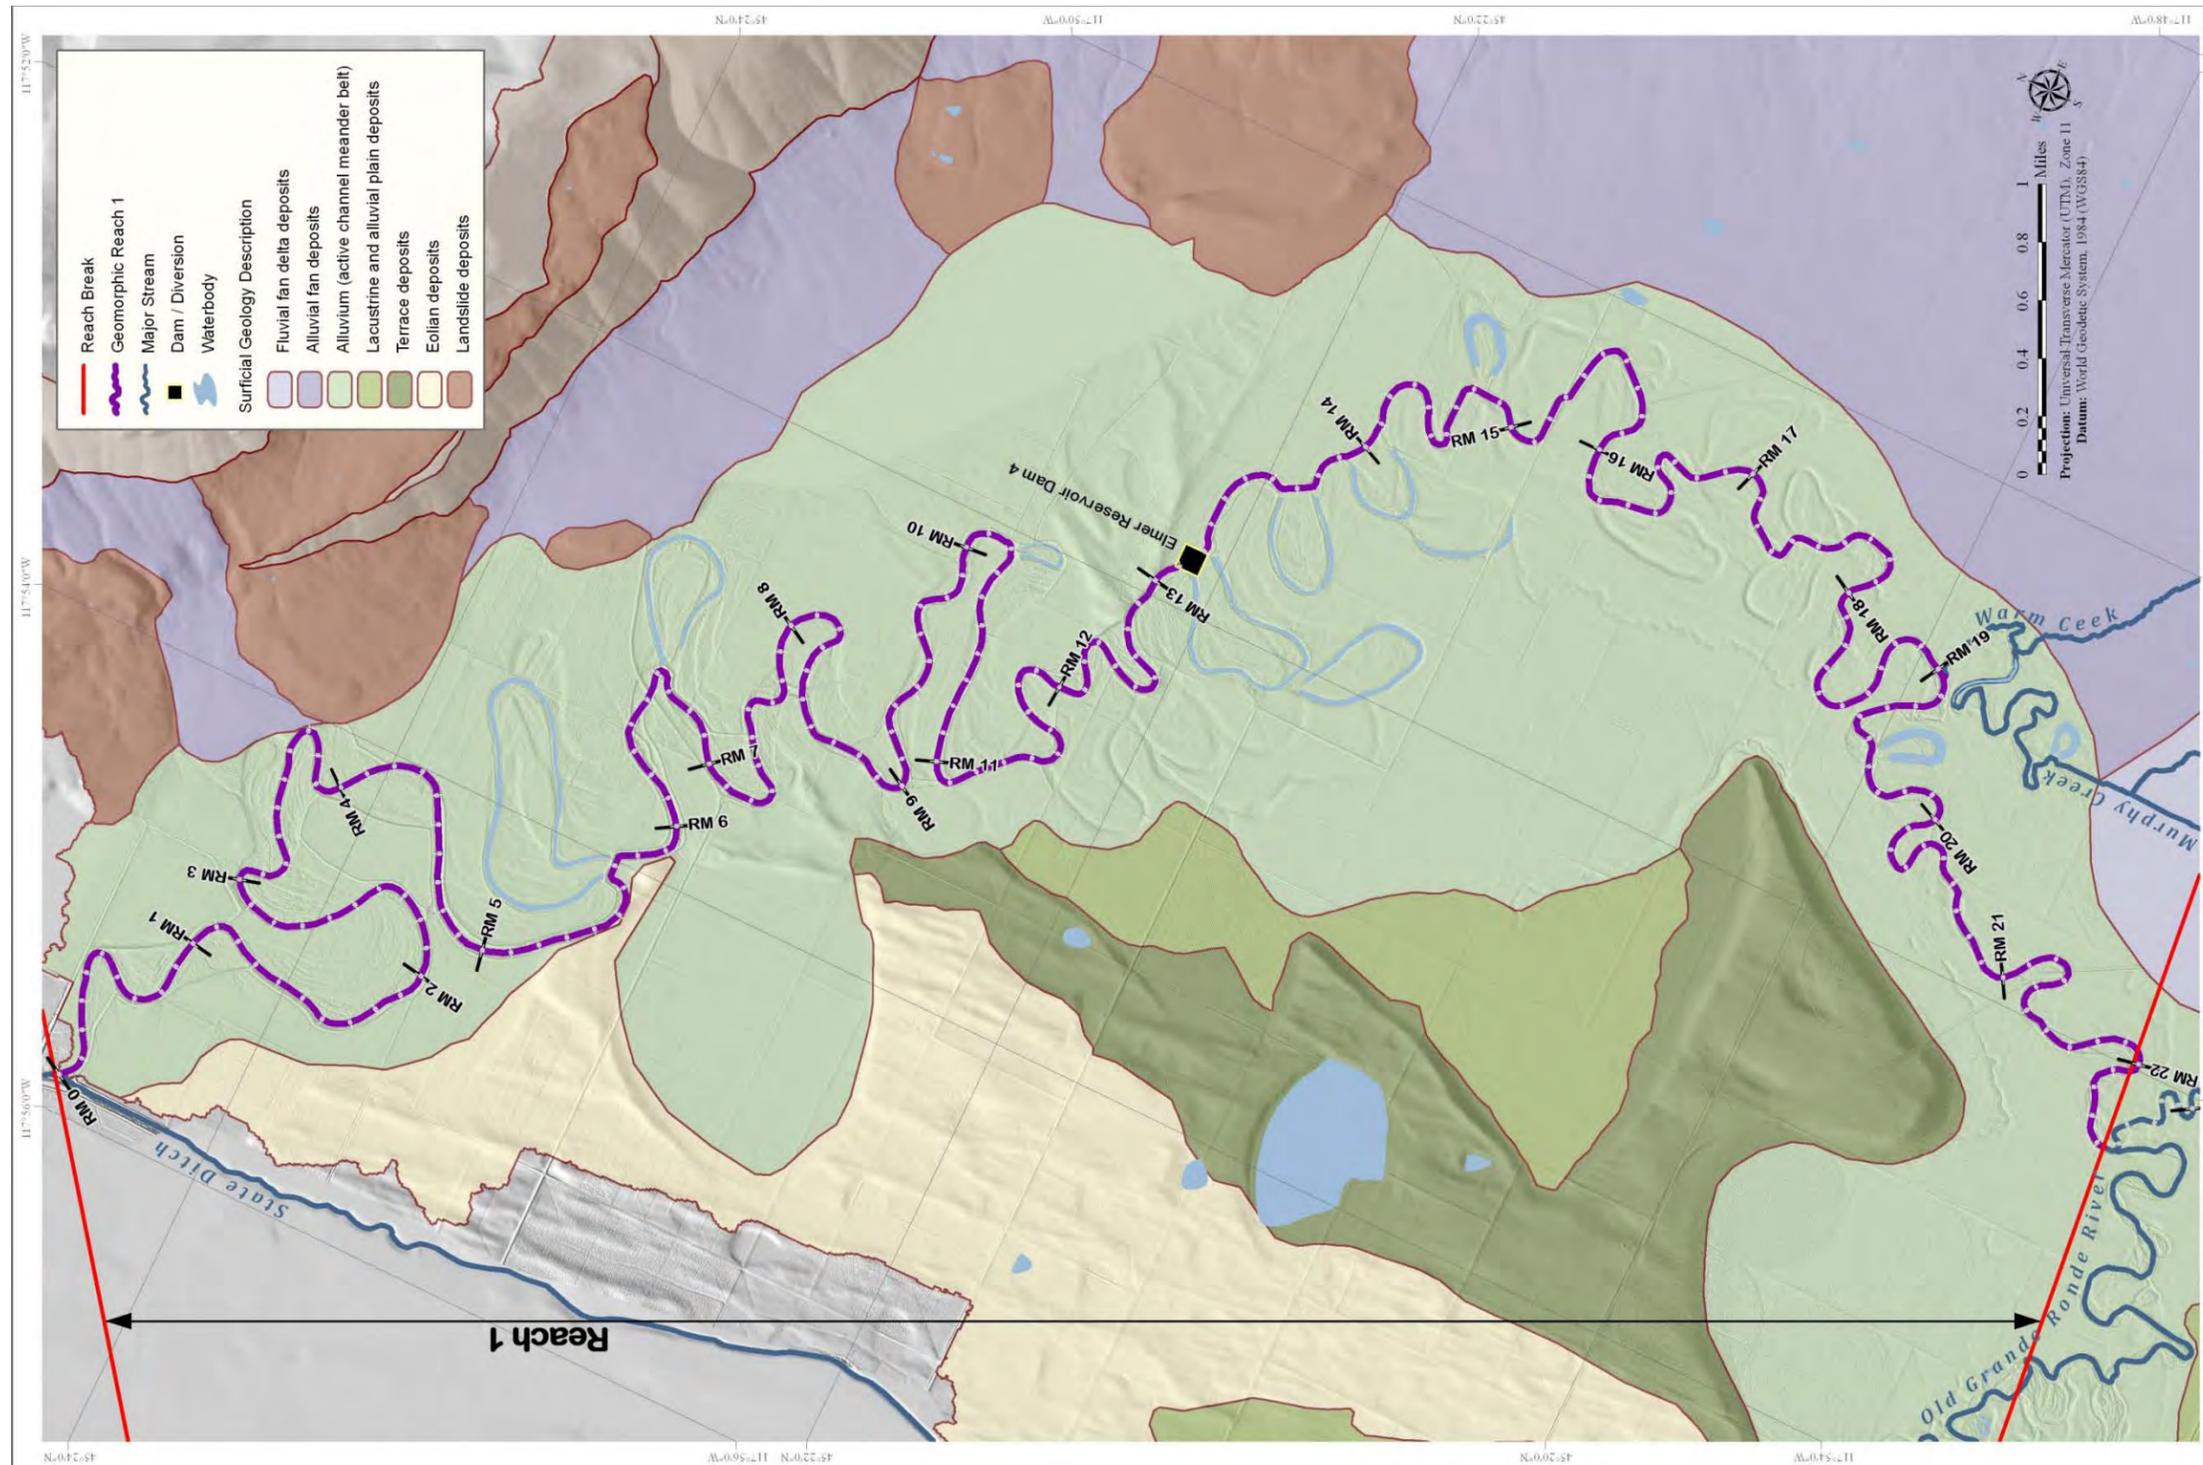
Figure 23. Reach 1 surficial geology and “bare earth” hillshade topography.

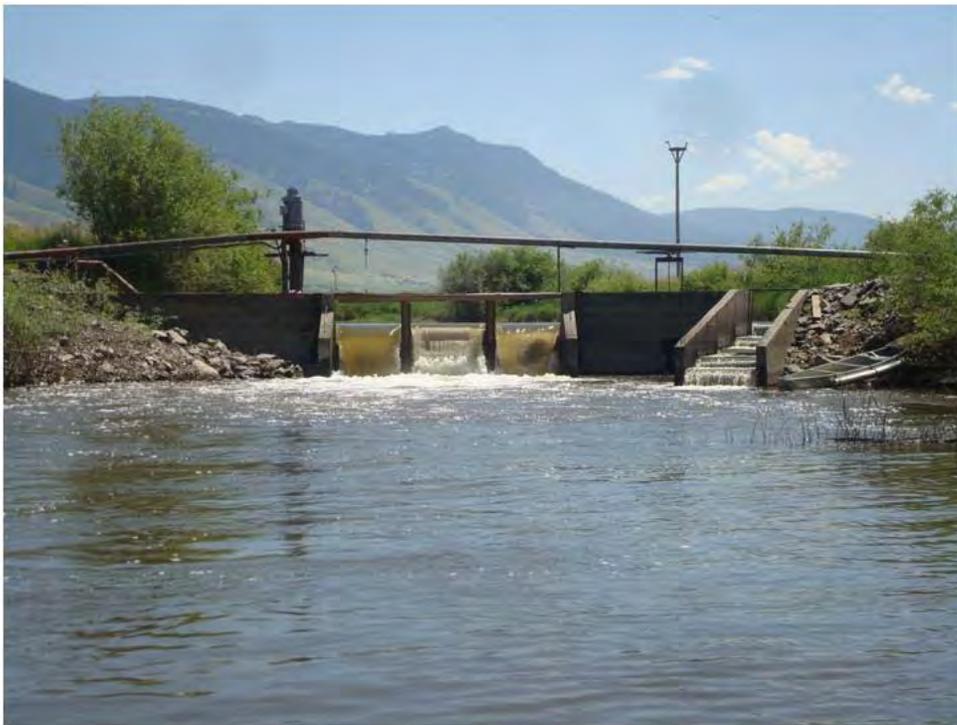
Figure 25. View looking upstream at Elmer Dam located at RM 13.1 used for irrigation water storage and diversion – Catherine Creek, Grande Ronde Subbasin. (Reclamation photograph by D. Stelma – July 9, 2010).

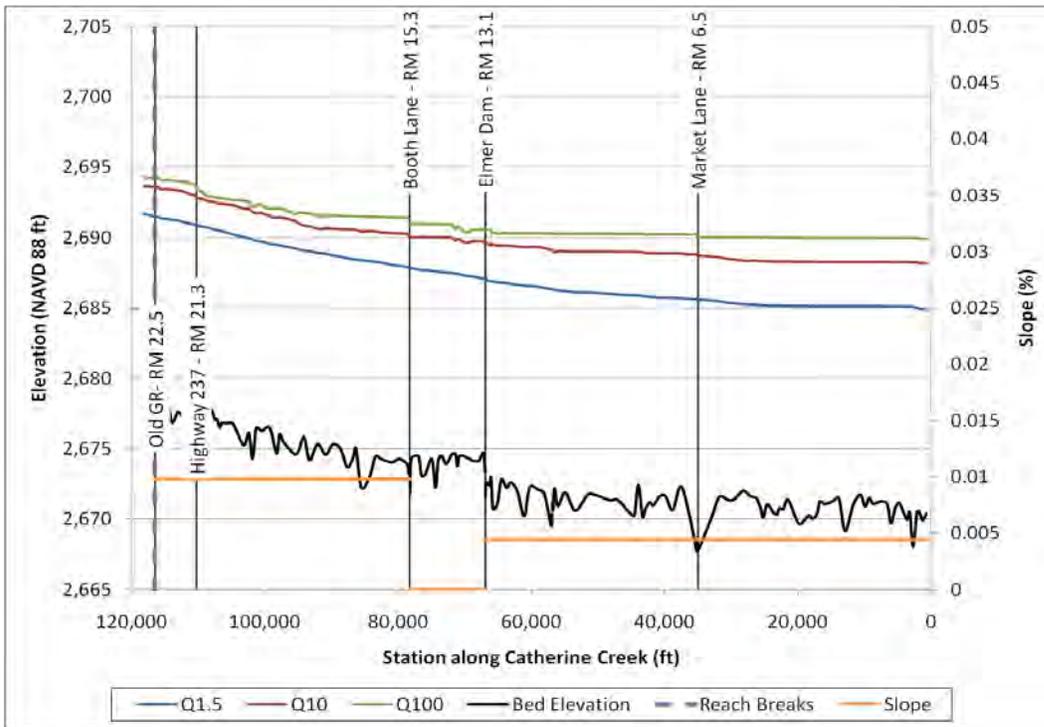
Figure 26. Computed water surface elevations along on Catherine Creek (Appendix D).

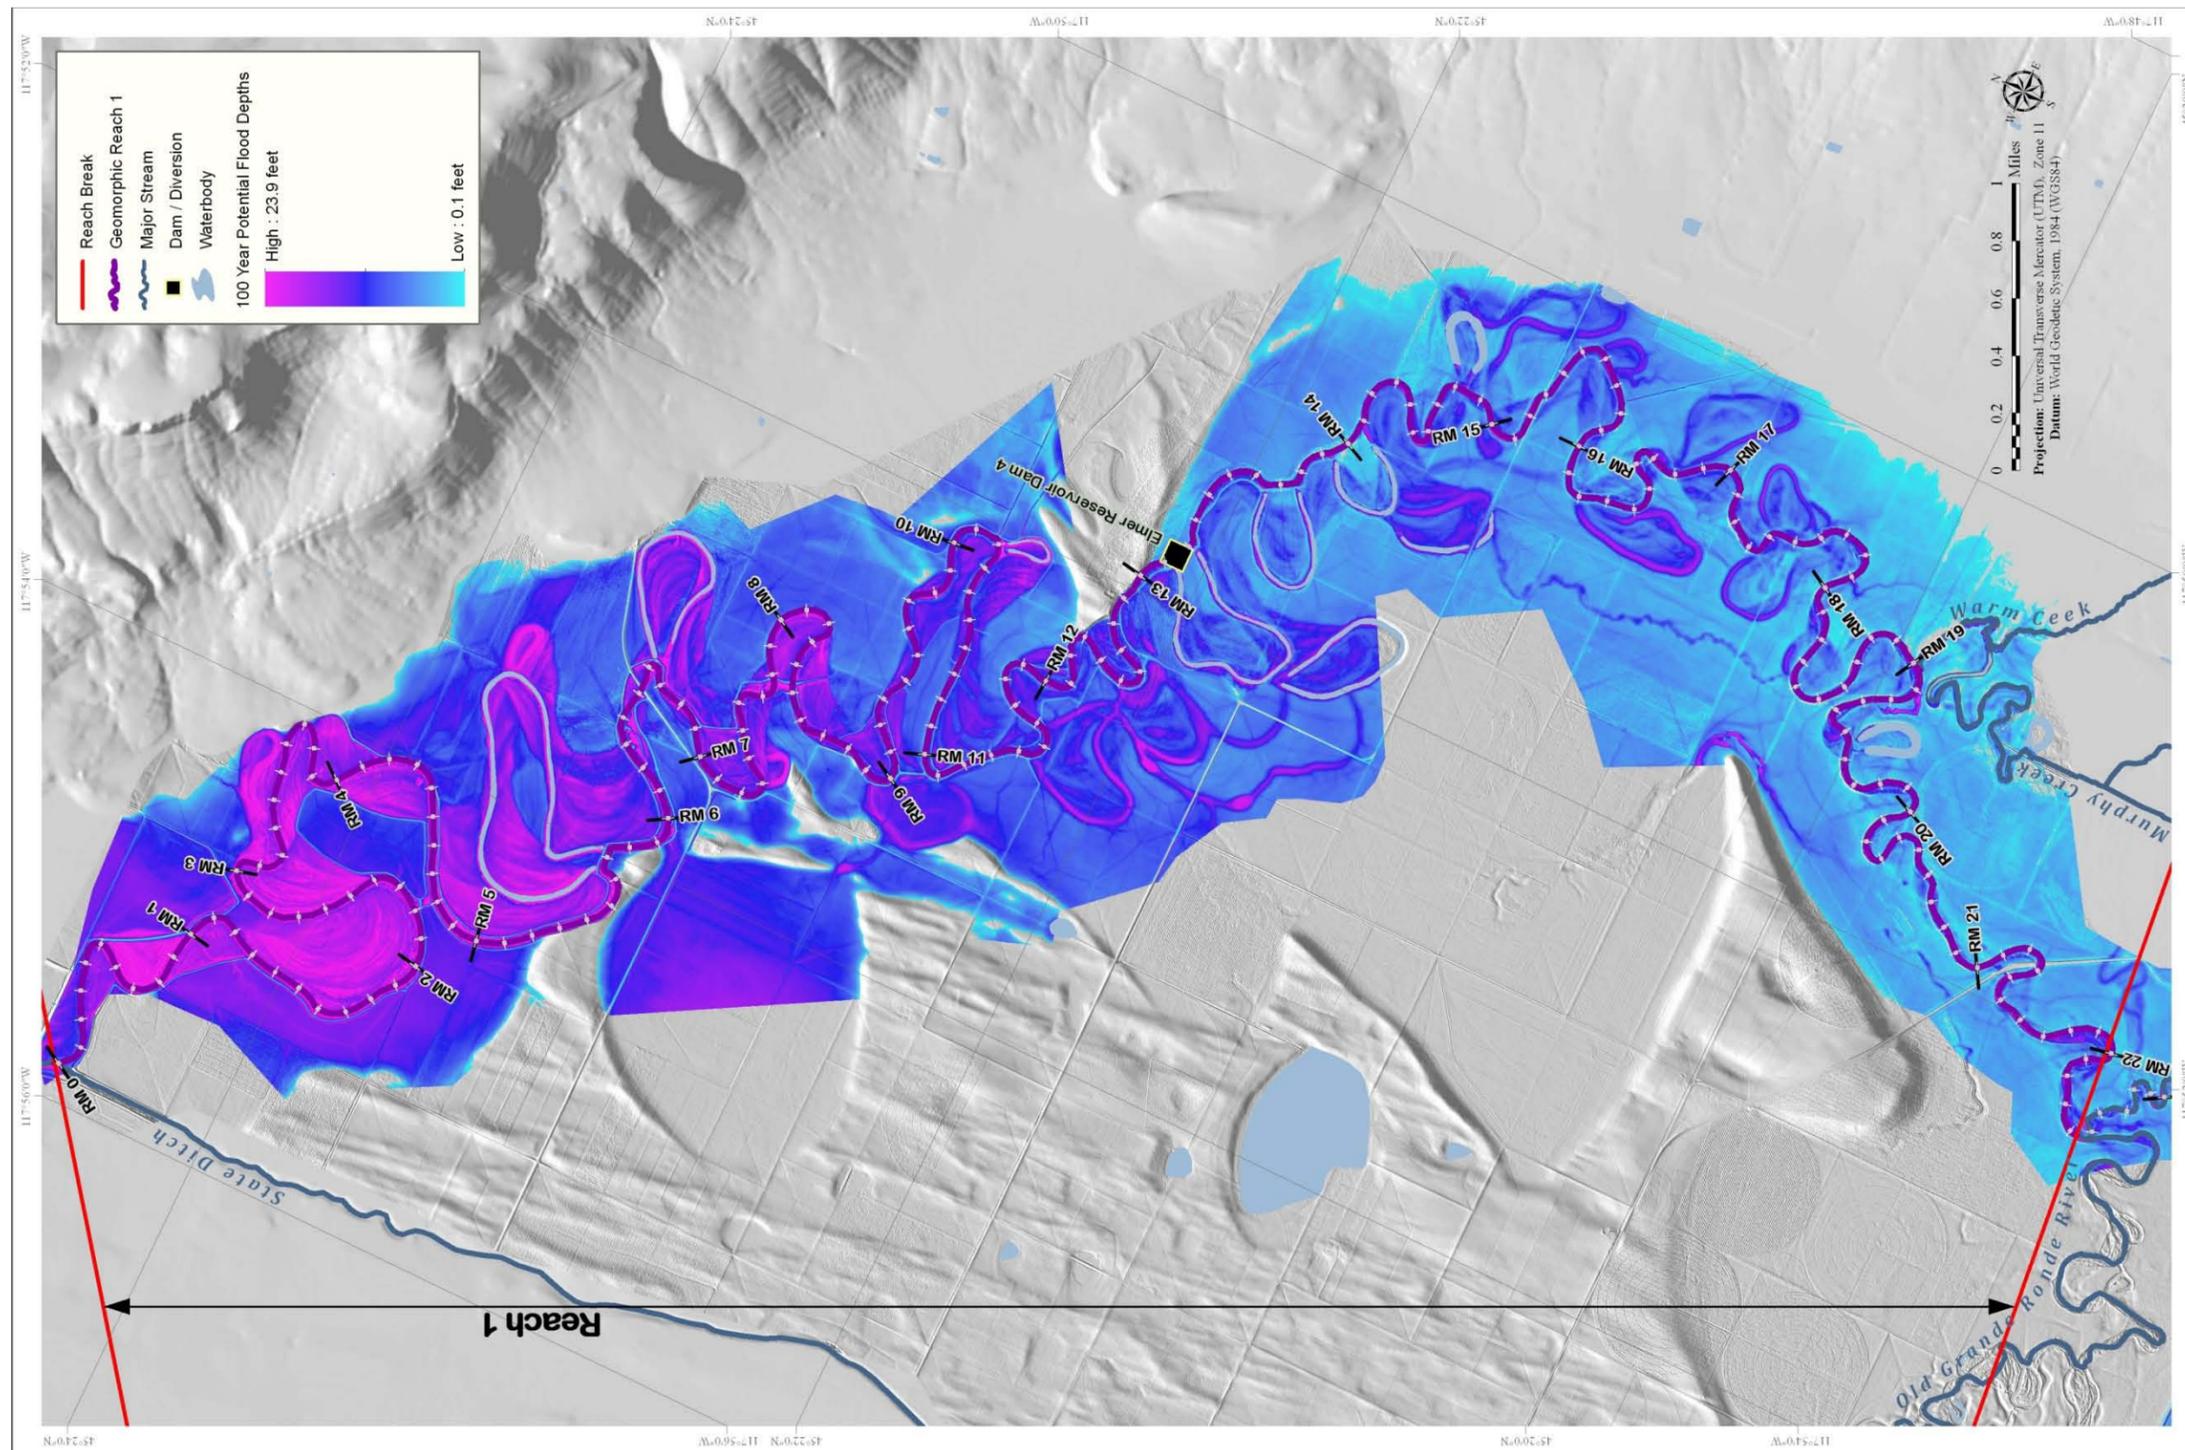
Figure 27. The 100-year floodplain depths of potential flooding within the bounds of the modeled cross sections for the 100-year discharge in reach 1.

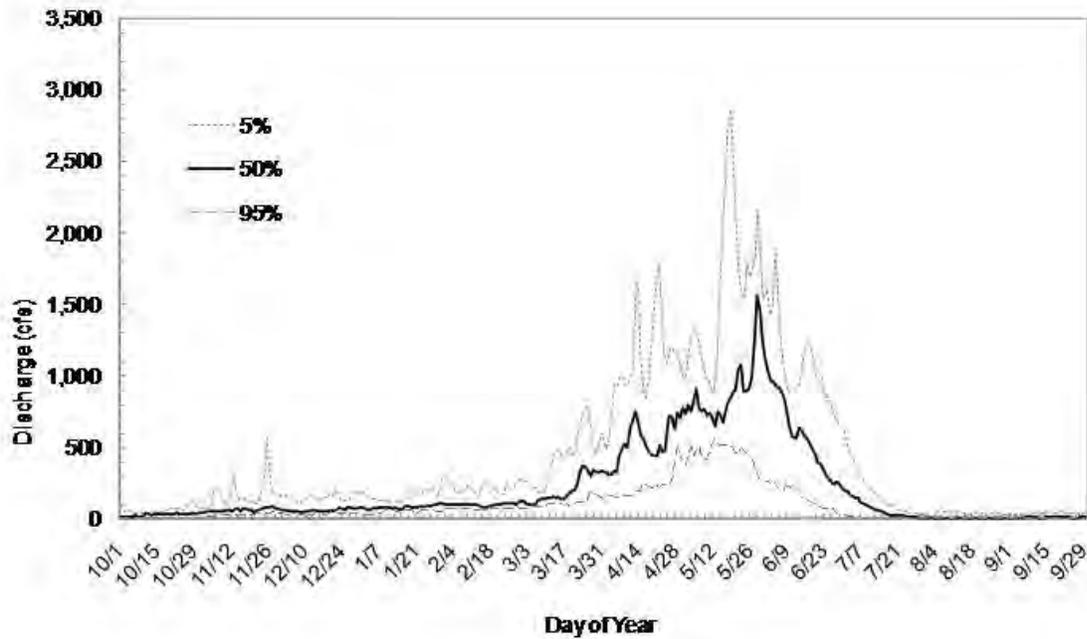
Figure 28. Estimated mean daily flow percent exceedance values for reach 1 using data extrapolated from the Catherine Creek at Union, Oregon stream gage. The 50 percent values indicate the average annual hydrograph.

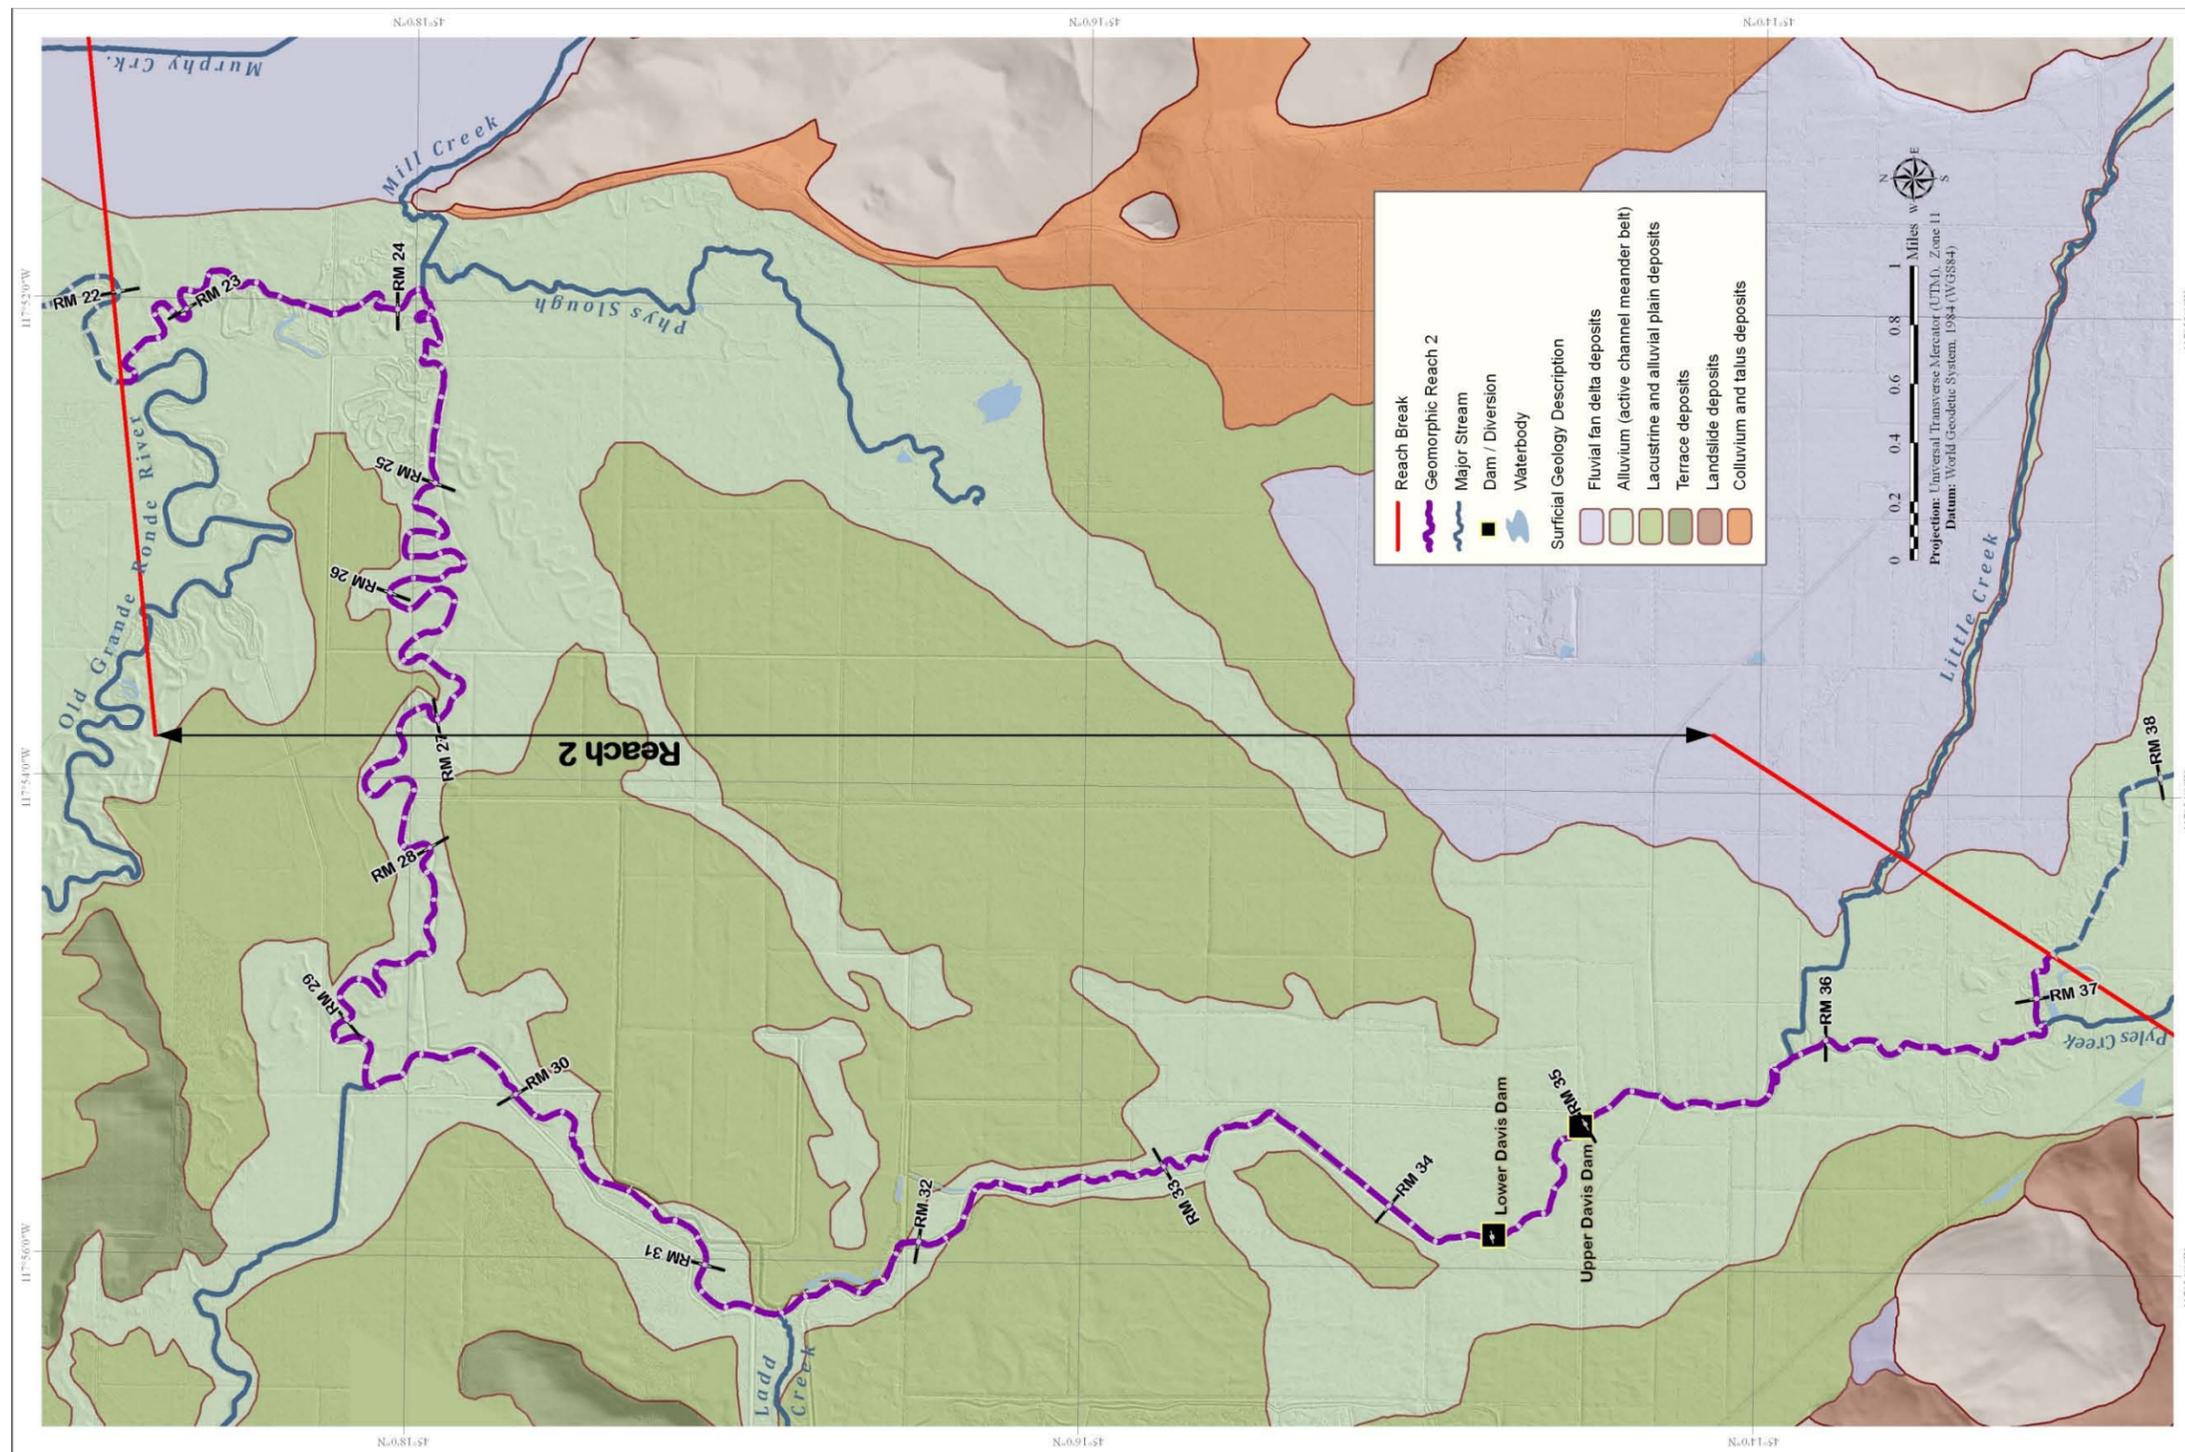
Figure 33. Surficial geologic deposits and “bare earth” hillshade topography in reach 2. This reach includes three substantial tributary confluences: Ladd Creek, Little Creek, and Mill Creek as well as two diversion dams.

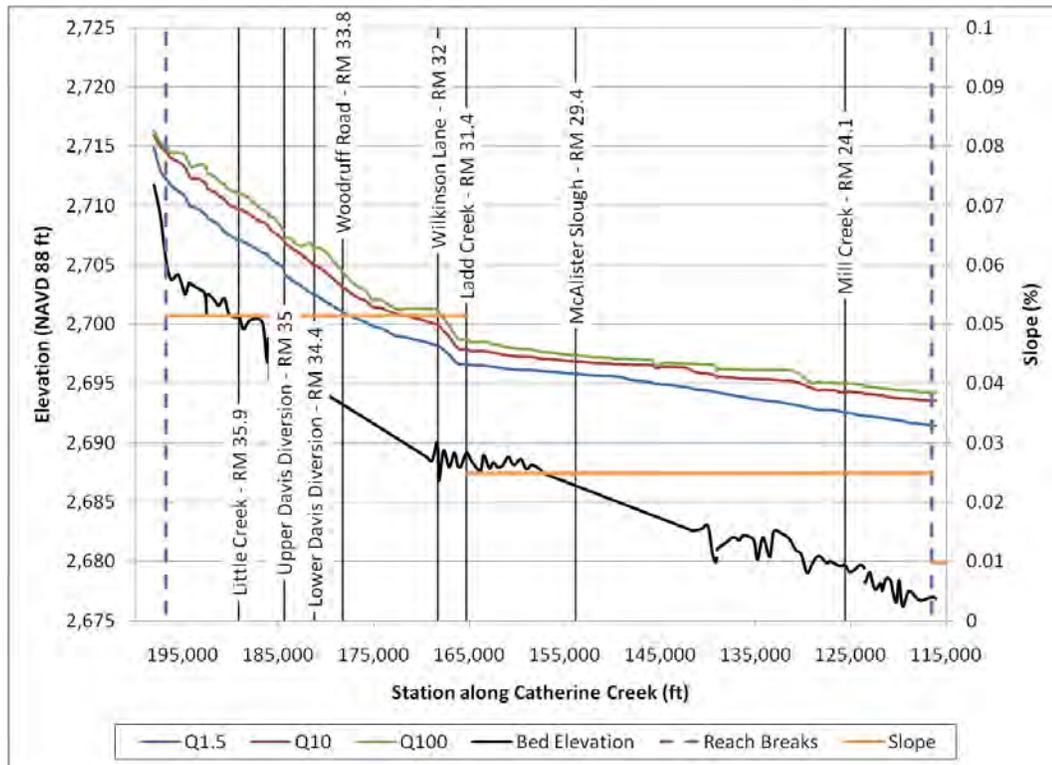
Figure 34. Computed water surface elevations along reach 2.
