THE CATHERINE CREEK TRIBUTARY
ASSESSMENT
GRANDE RONDE RIVER BASIN
Tributary Habitat Program, Oregon

U.S. Department of the Interior
Bureau of Reclamation
Pacific Northwest Region
Boise, Idaho

February 2012

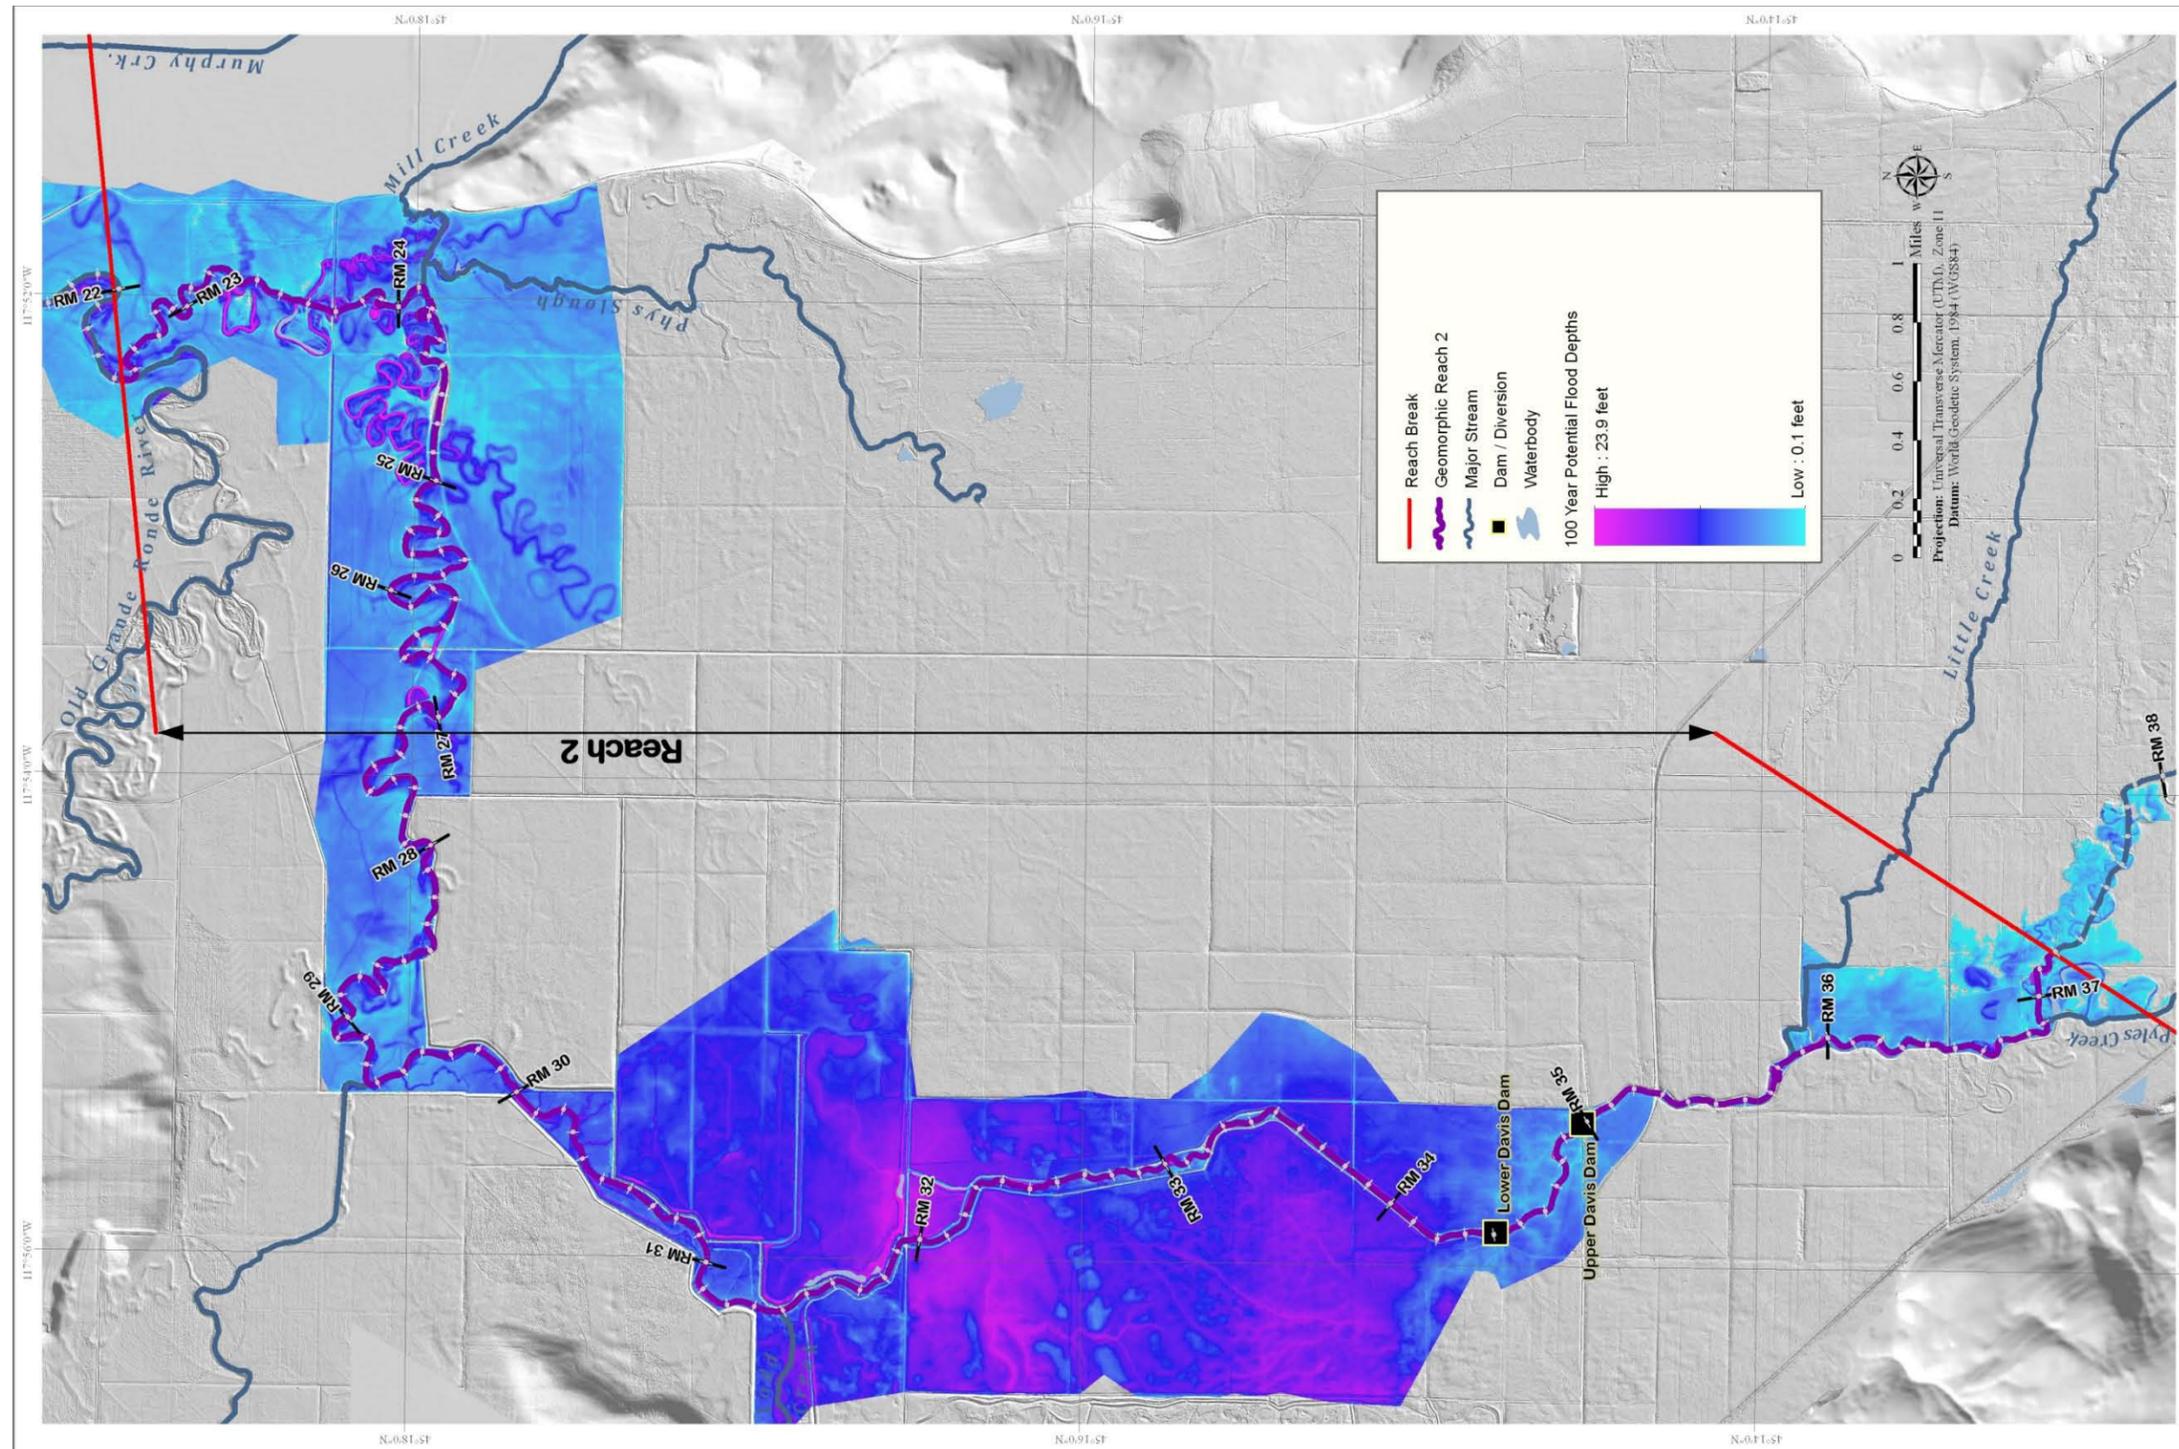
Figure 35. The depths of potential flooding within the bounds of the modeled cross sections for the 100-year discharge along reach 2.

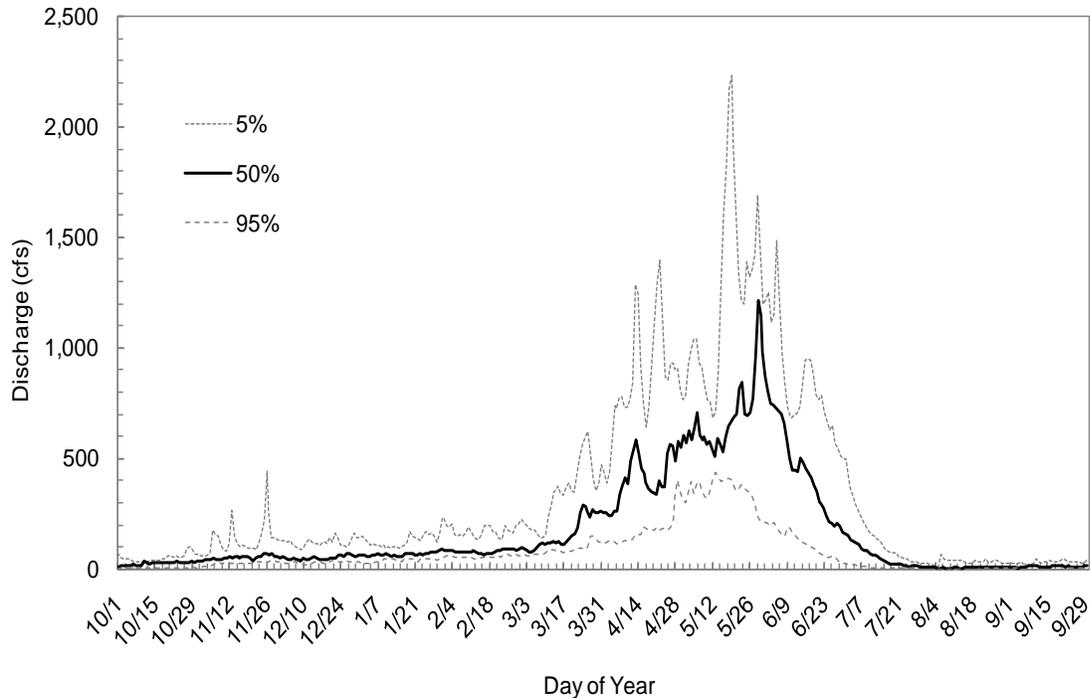
Figure 36. Estimated mean daily flow percent exceedance values for reach 2 using data extrapolated from the Catherine Creek at Union, Oregon stream gage. The 50 percent values indicate the average annual hydrograph.

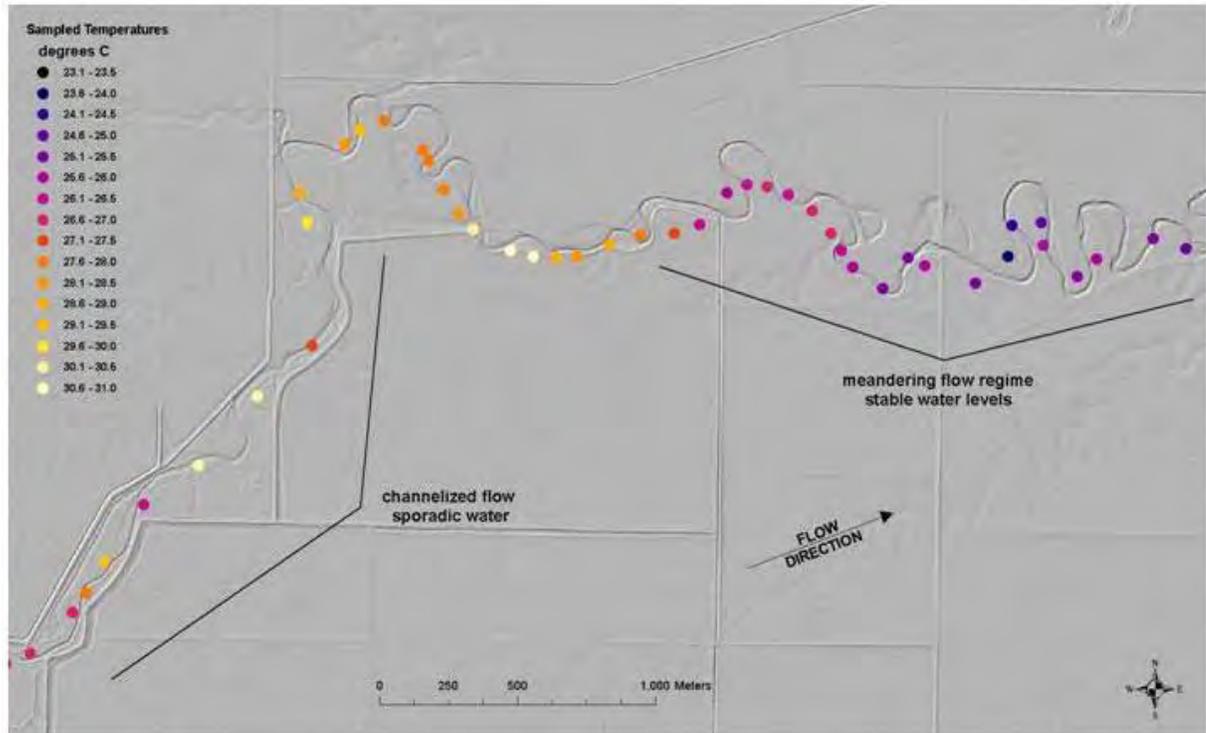
Figure 38. Hillshade of “bare earth” LiDAR data showing sampled temperatures along the lower section of reach 2.

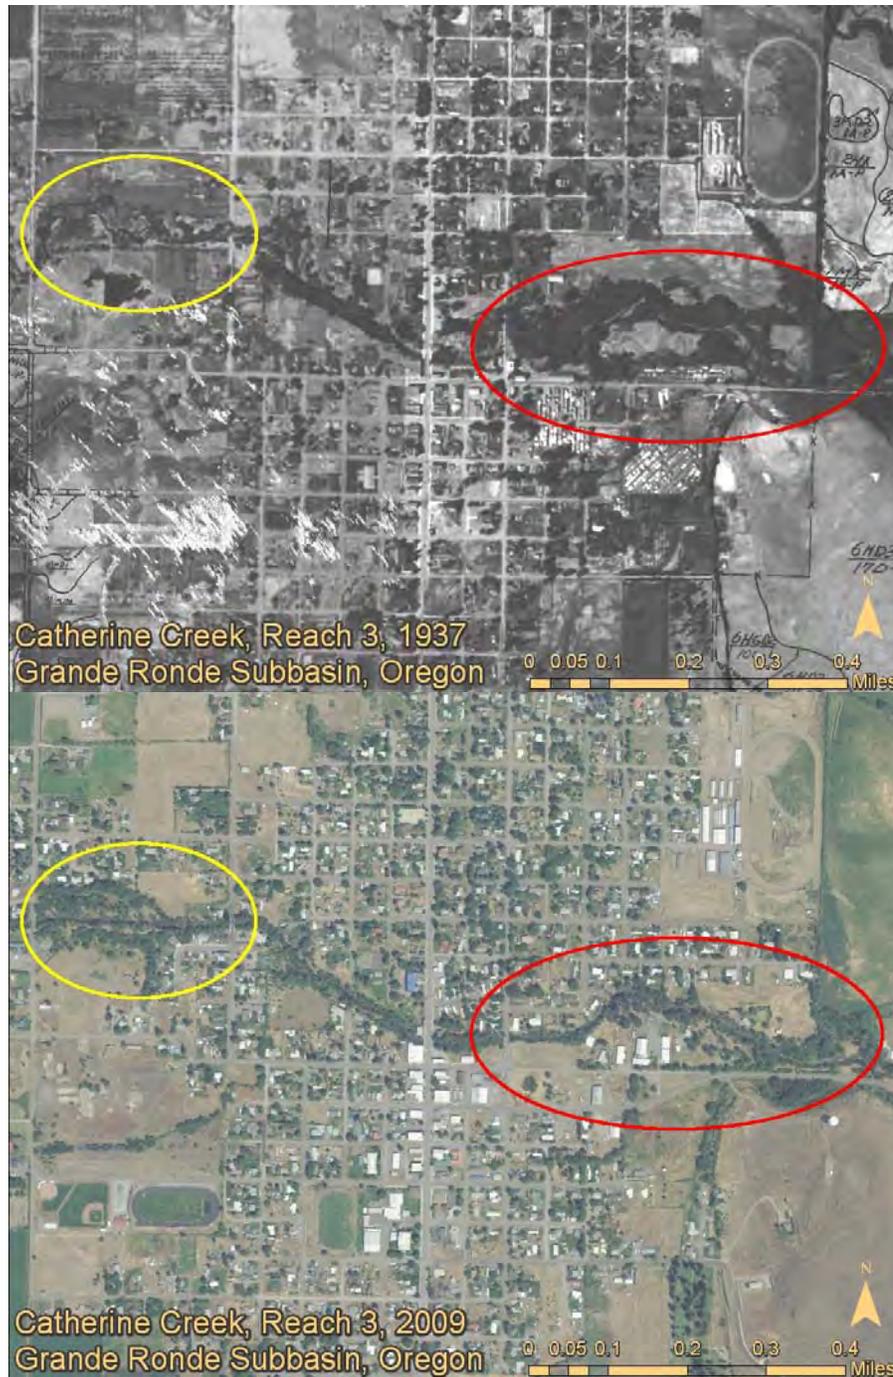
Figure 41. A comparison of areas along Catherine Creek in Union between 1937 and 2009. The yellow oval indicates an area where vegetation along the bank has increased and the red oval indicates an area where the vegetation has decreased since 1937.

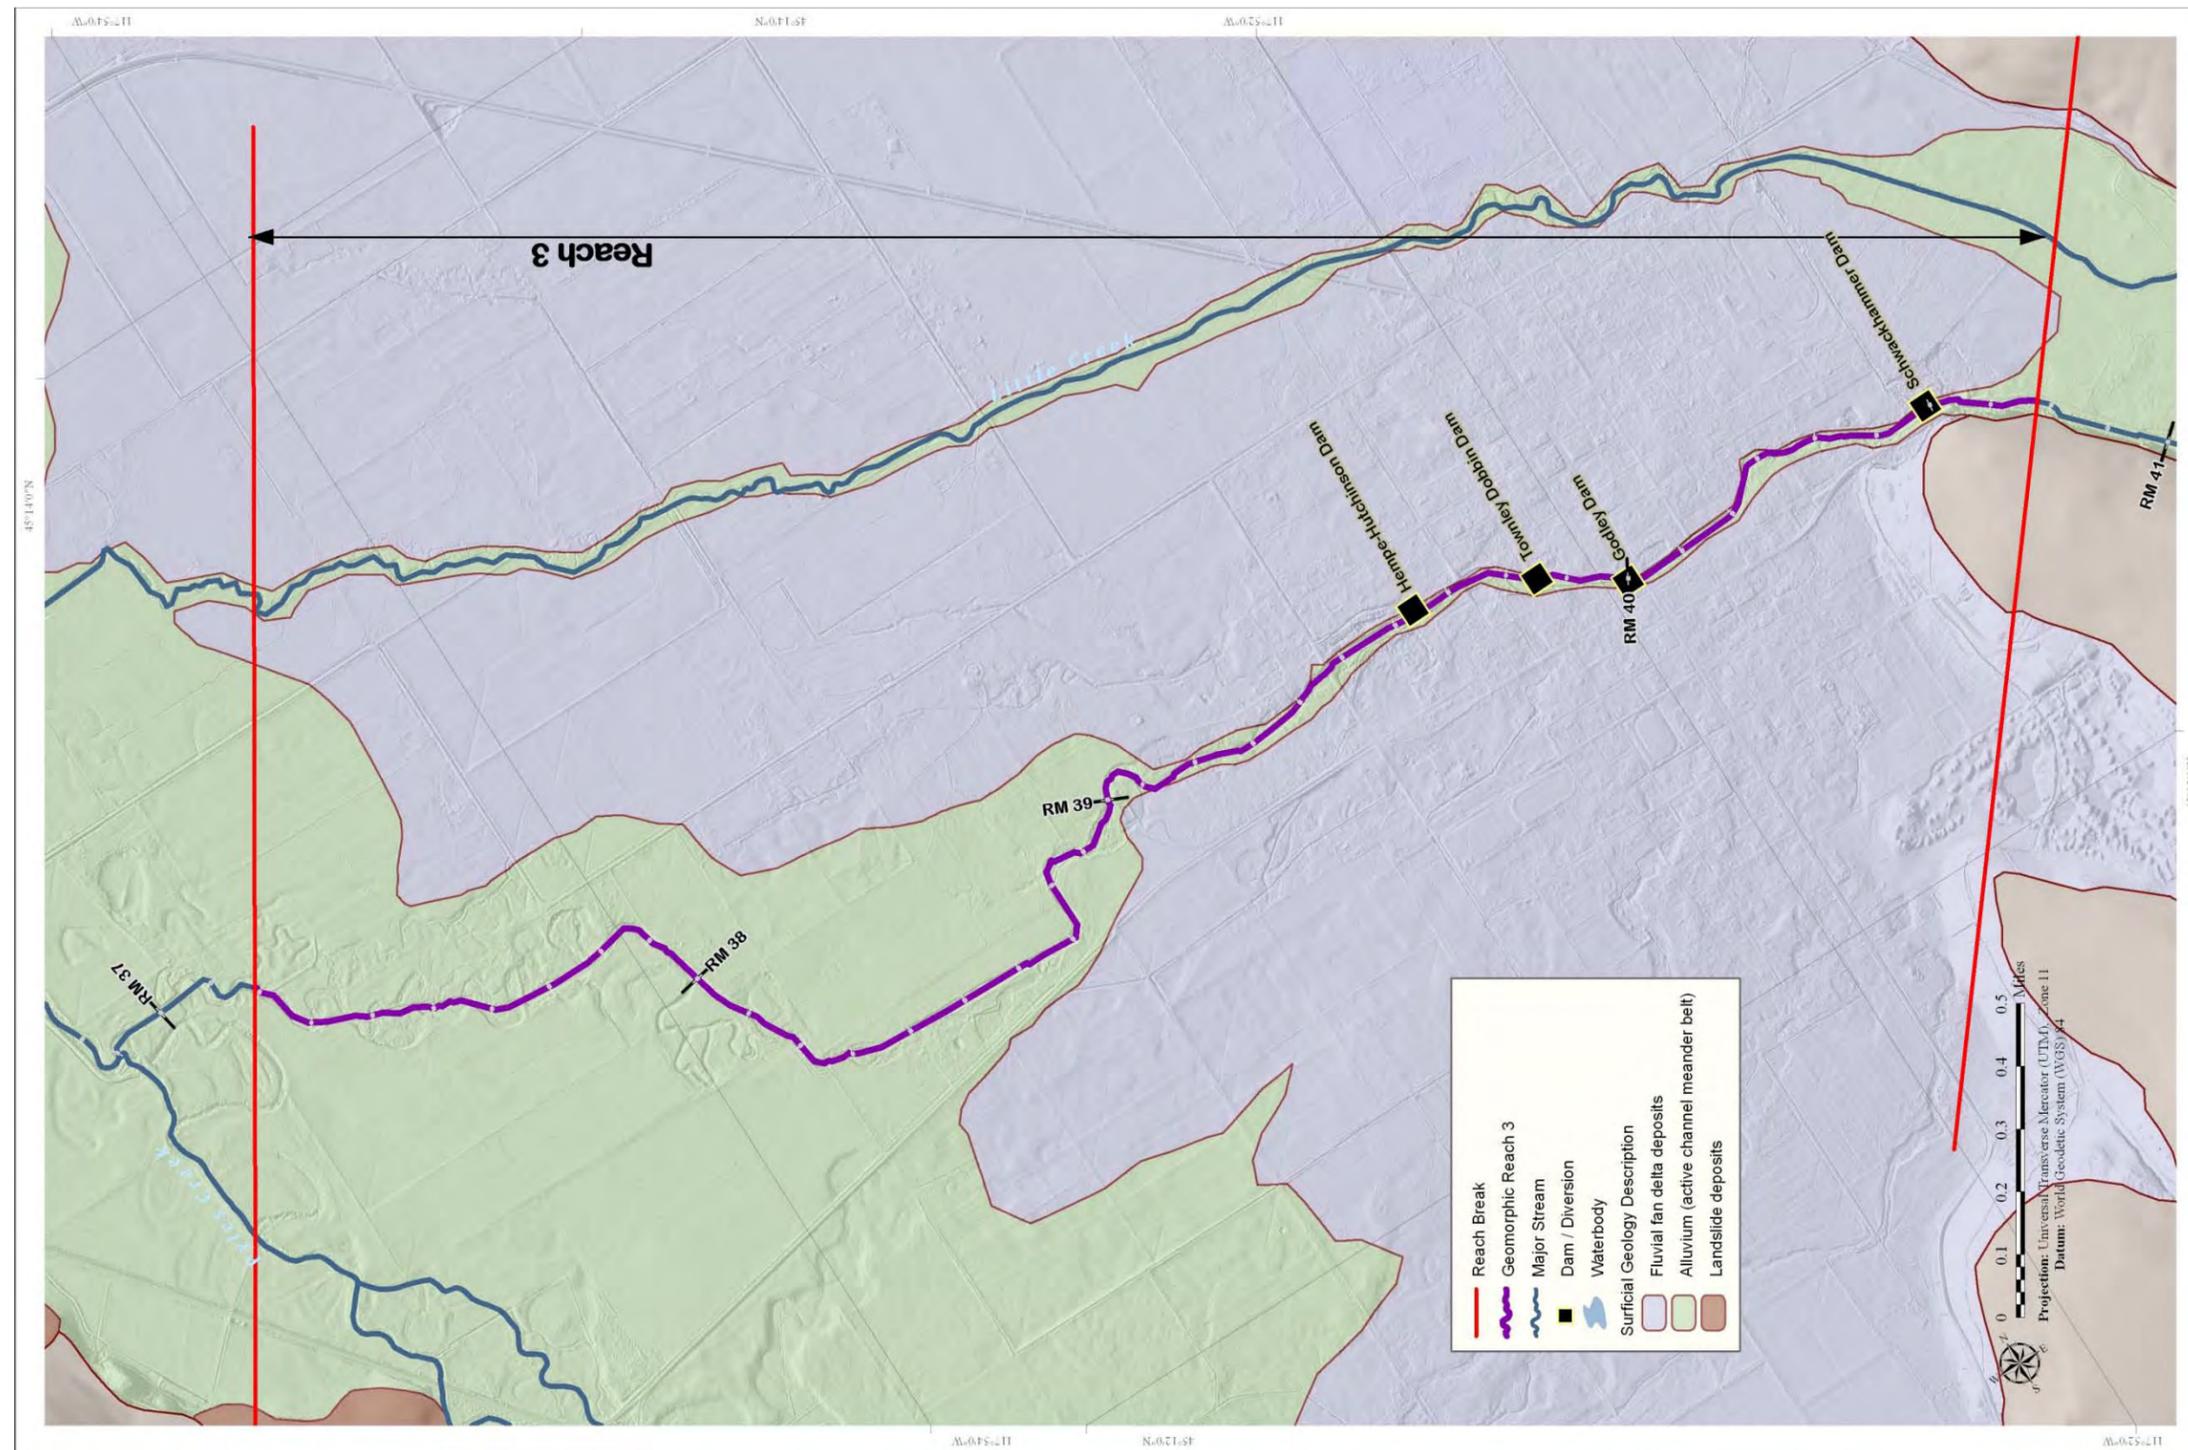
Figure 42. Surficial geologic deposits and “bare earth” hillshade topography in reach 3. This reach encompasses the Catherine Creek alluvial fan, Union, Oregon, and four diversion dams.

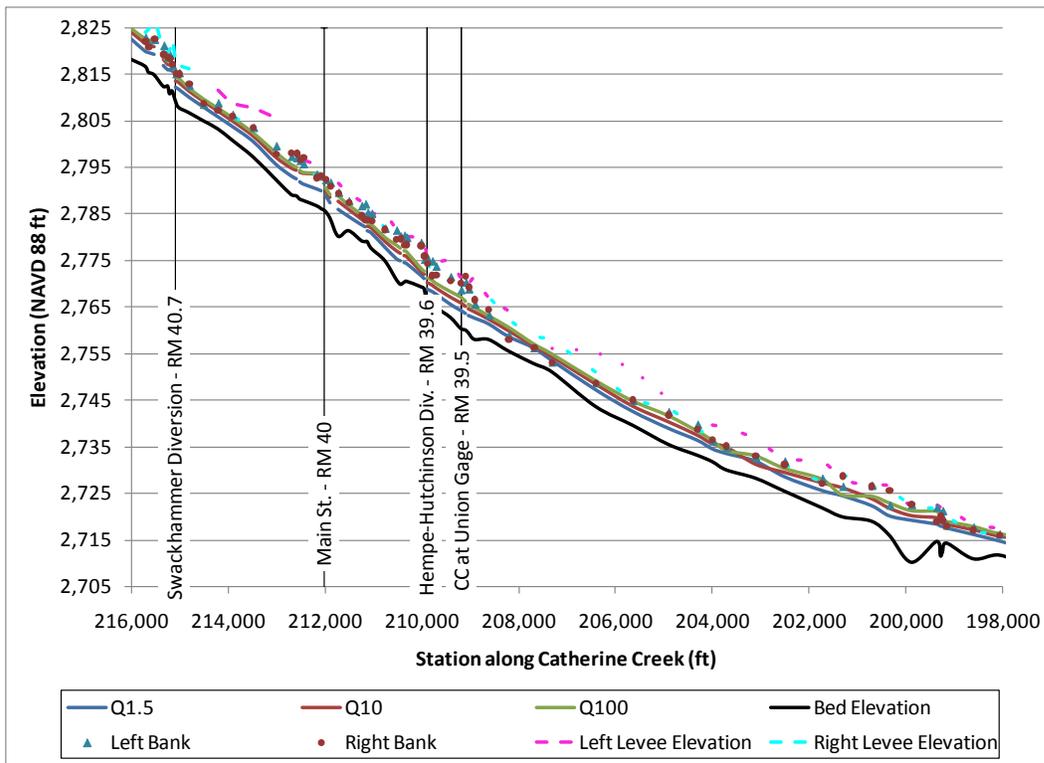
Figure 43. Reach 3 water surface profiles and levee elevations (Appendix D).

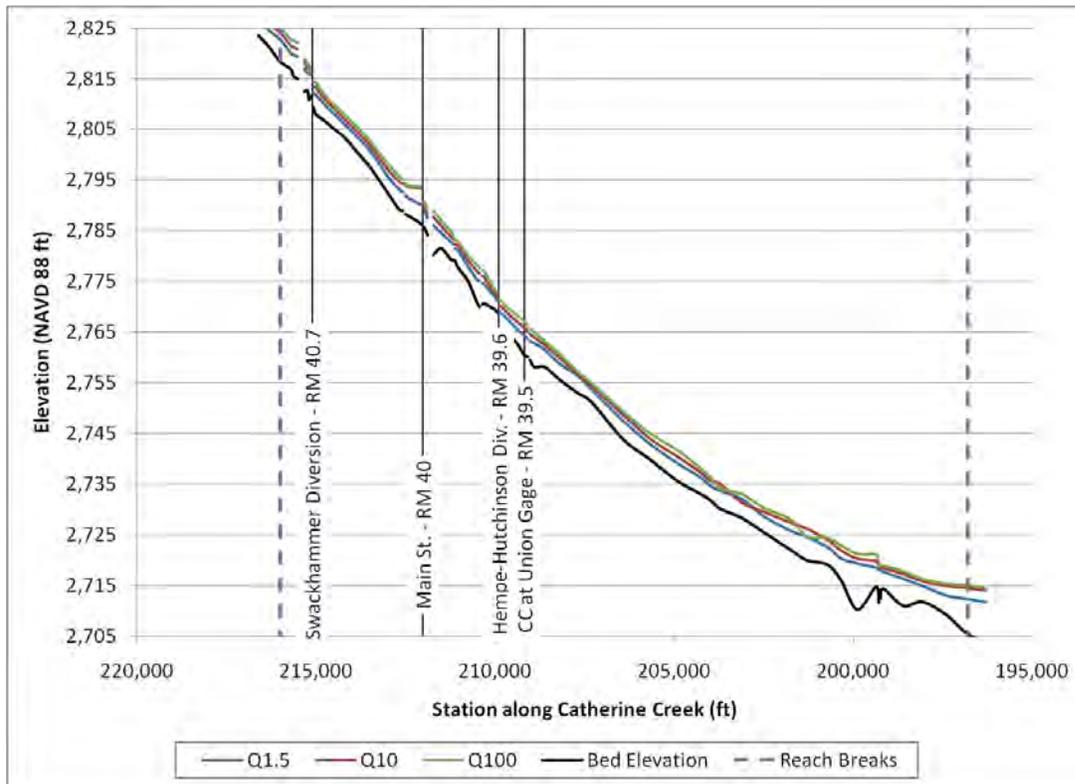
Figure 44. Computed water surface elevation for reach 3 of Catherine Creek (Appendix D).

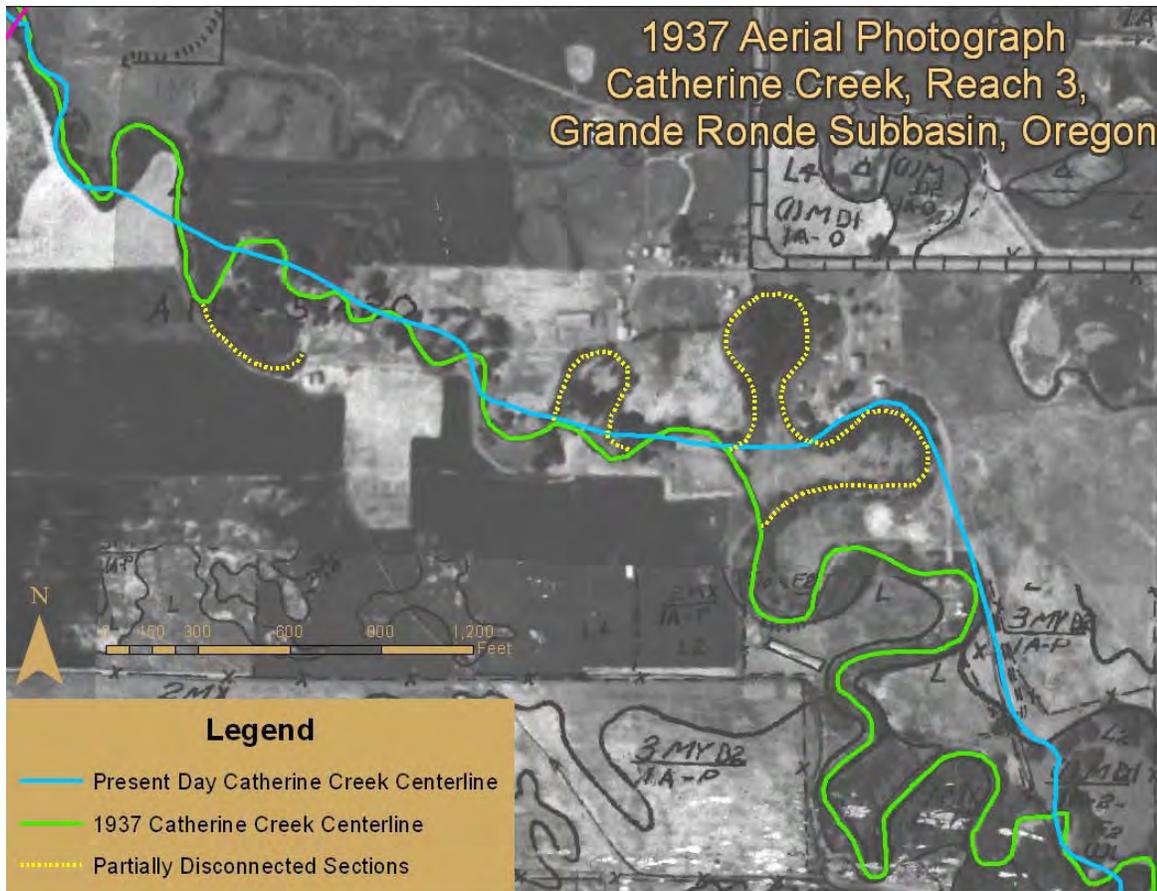
Figure 45. A 1937 aerial image of reach 3 with the 1937 and present day channel centerlines.

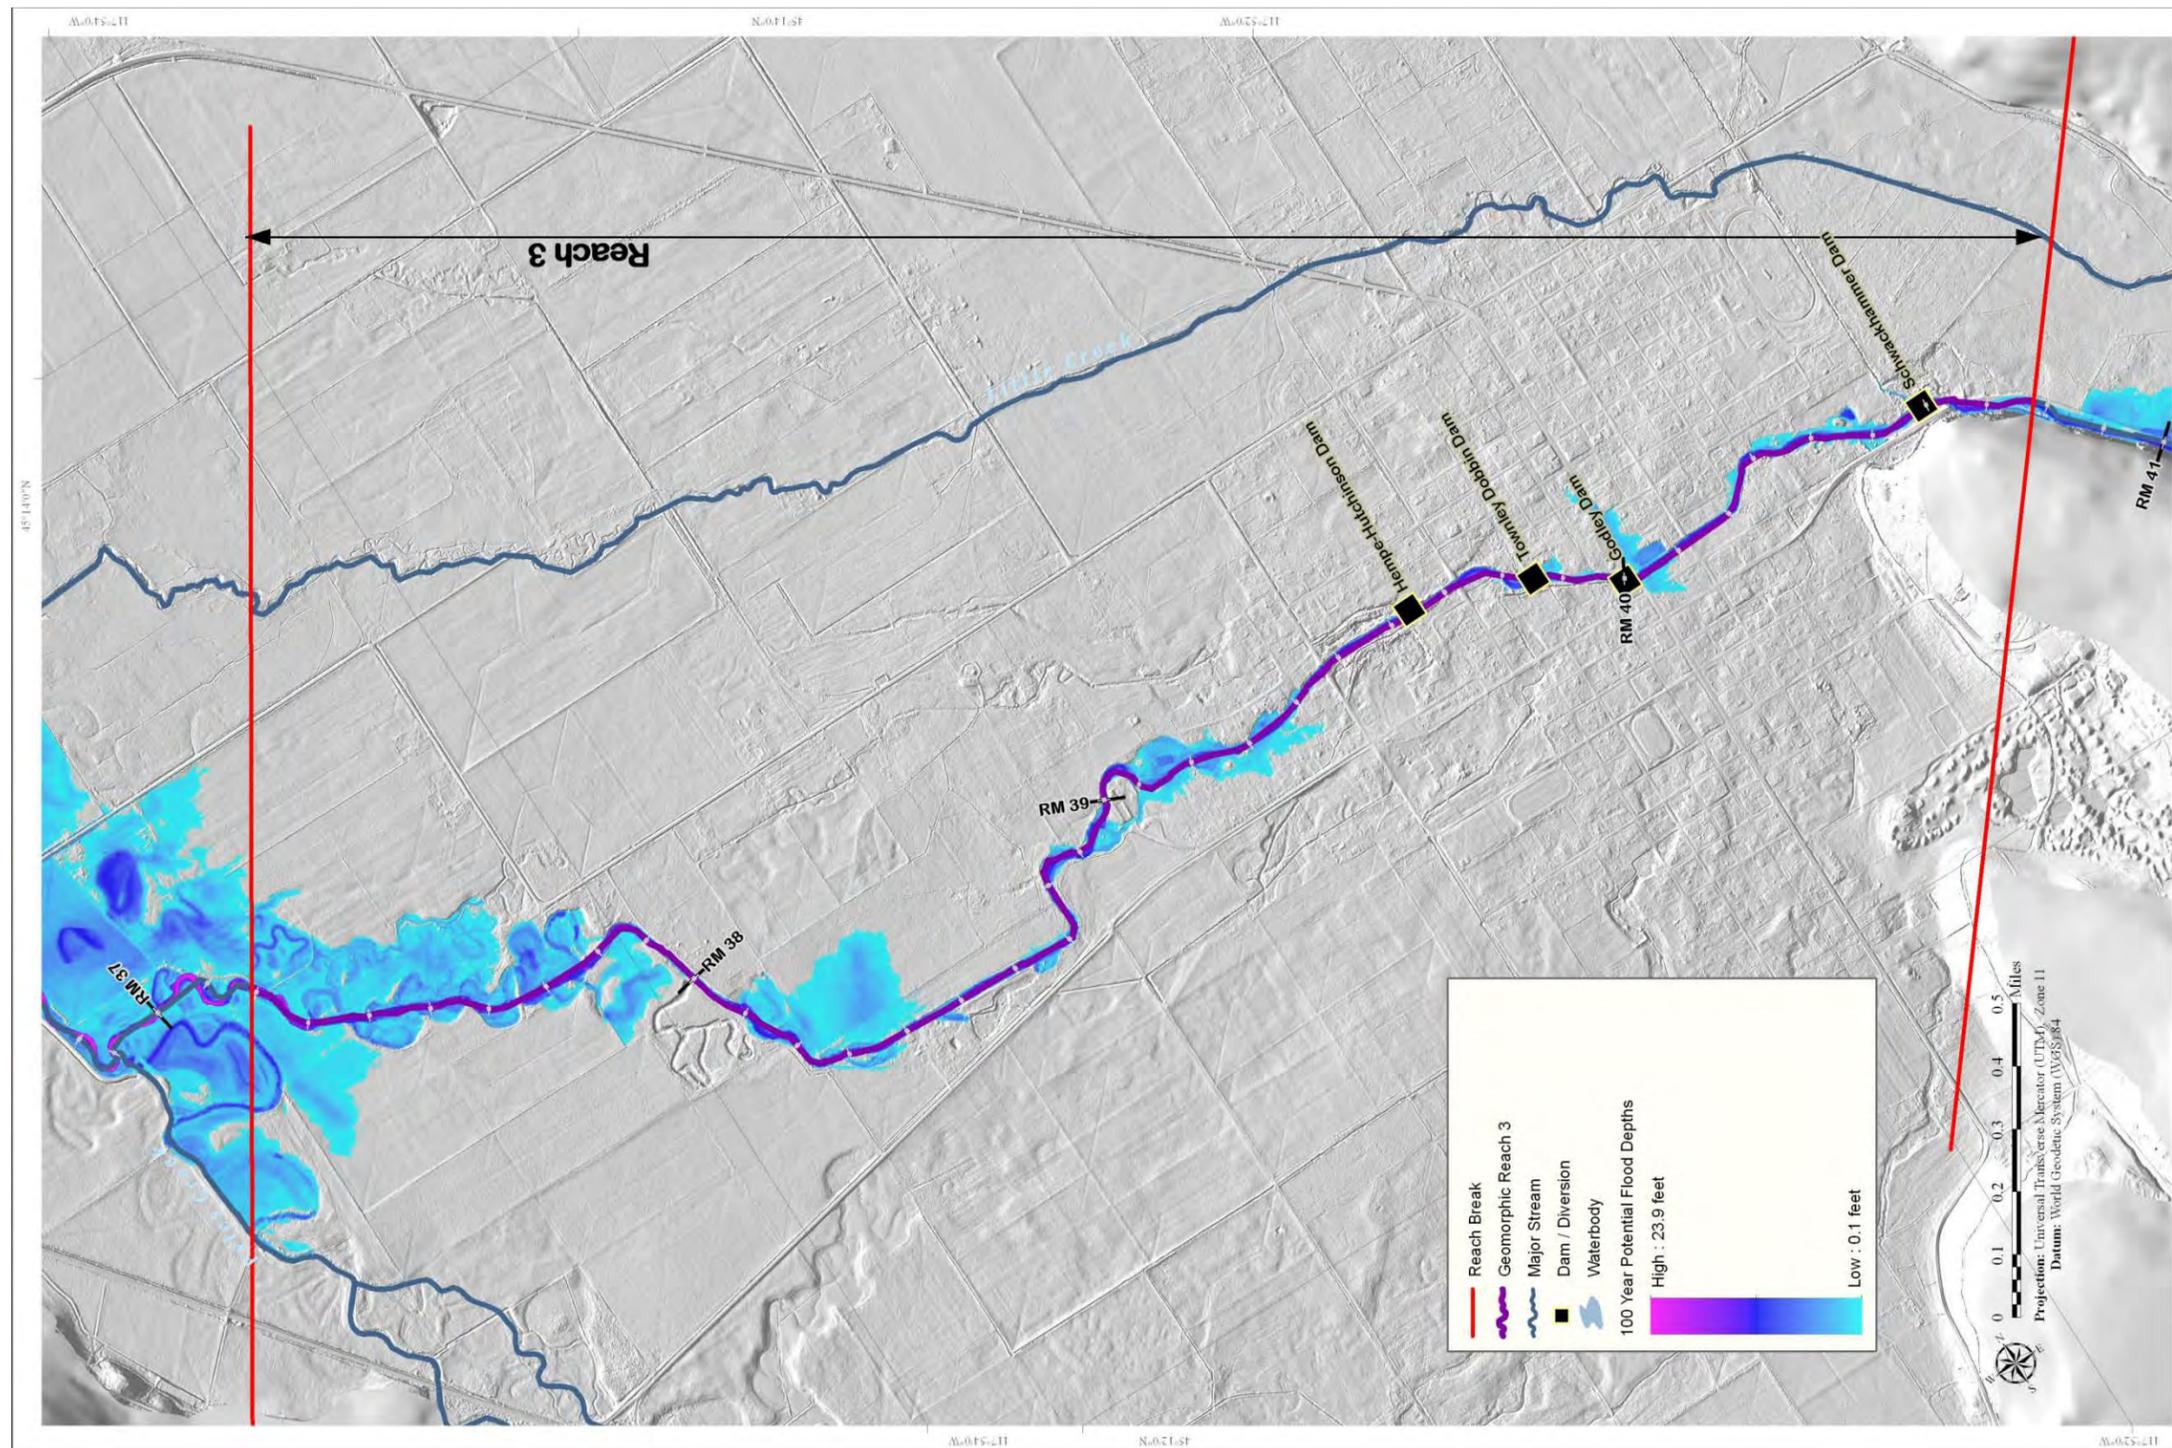
Figure 47. The depths of potential flooding within the bounds of the modeled cross sections for the 100-year discharge in reach 3.

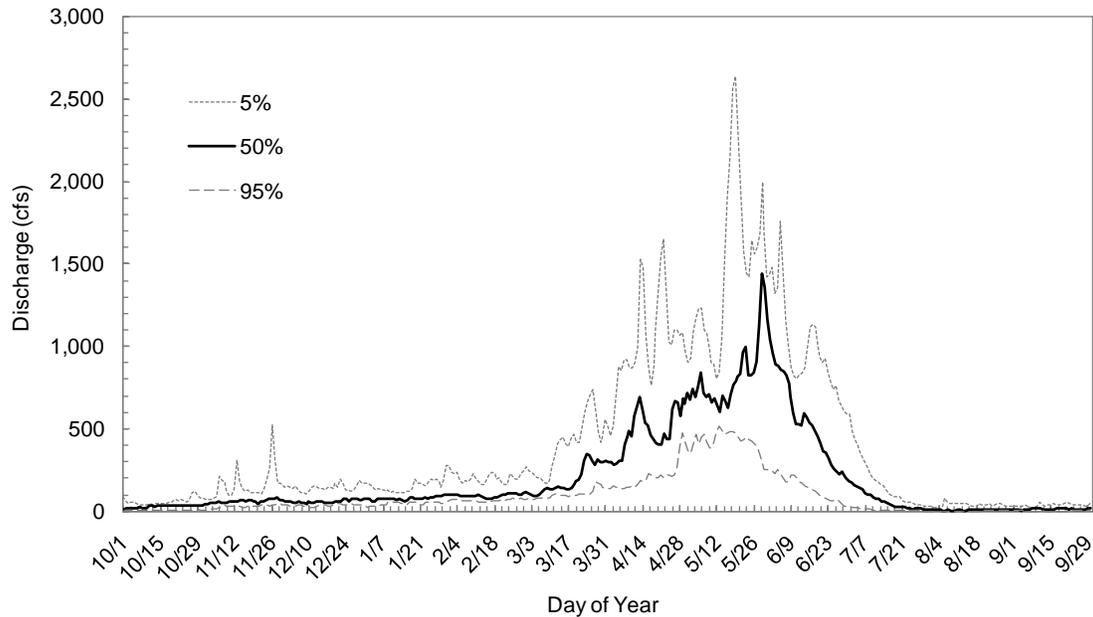
Figure 48. Mean daily flow percent exceedance values for Catherine Creek at Union, Oregon stream gage. This stream gage lies within reach 3. The 50 percent values indicate the average annual hydrograph.

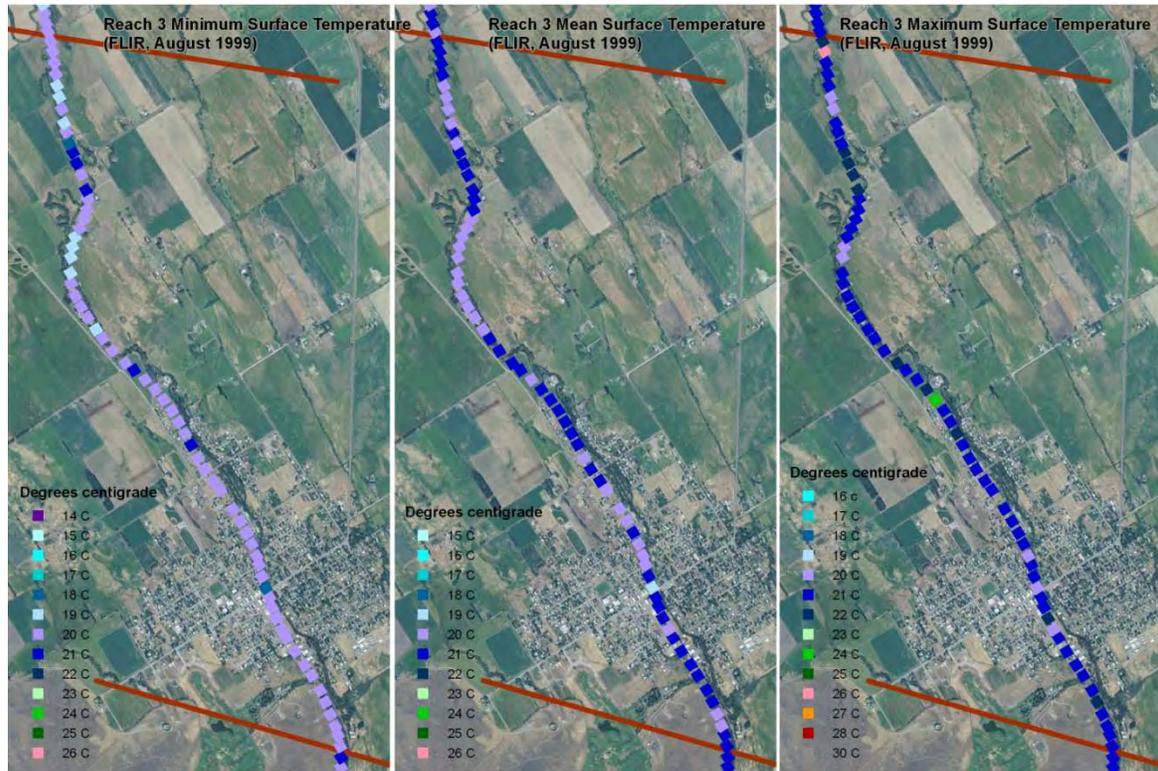
Figure 49. Minimum, mean, and maximum stream temperature results along reach 3 from August 1999 FLIR data.

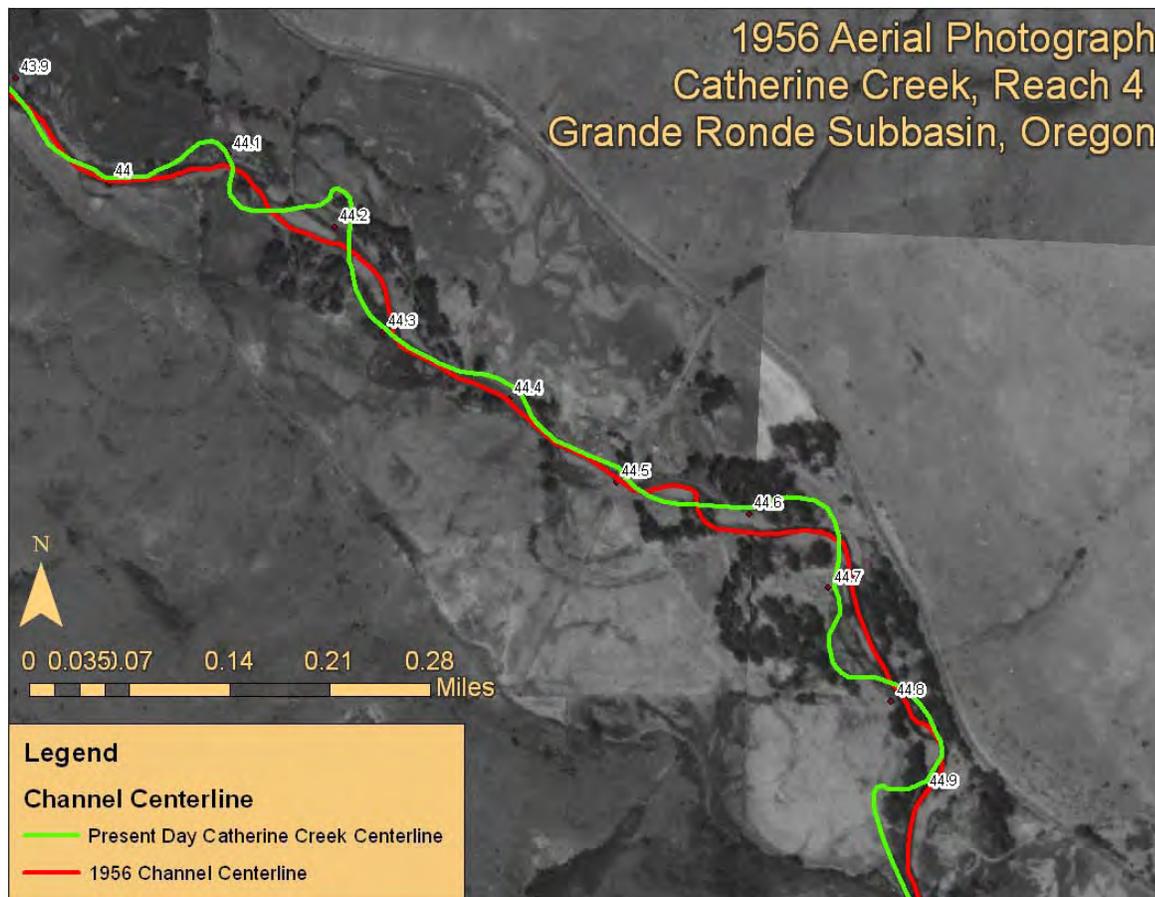
Figure 52. A 1956 aerial image of reach 4 with the 1956 and present-day channel centerlines digitized to show an increase in sinuosity.

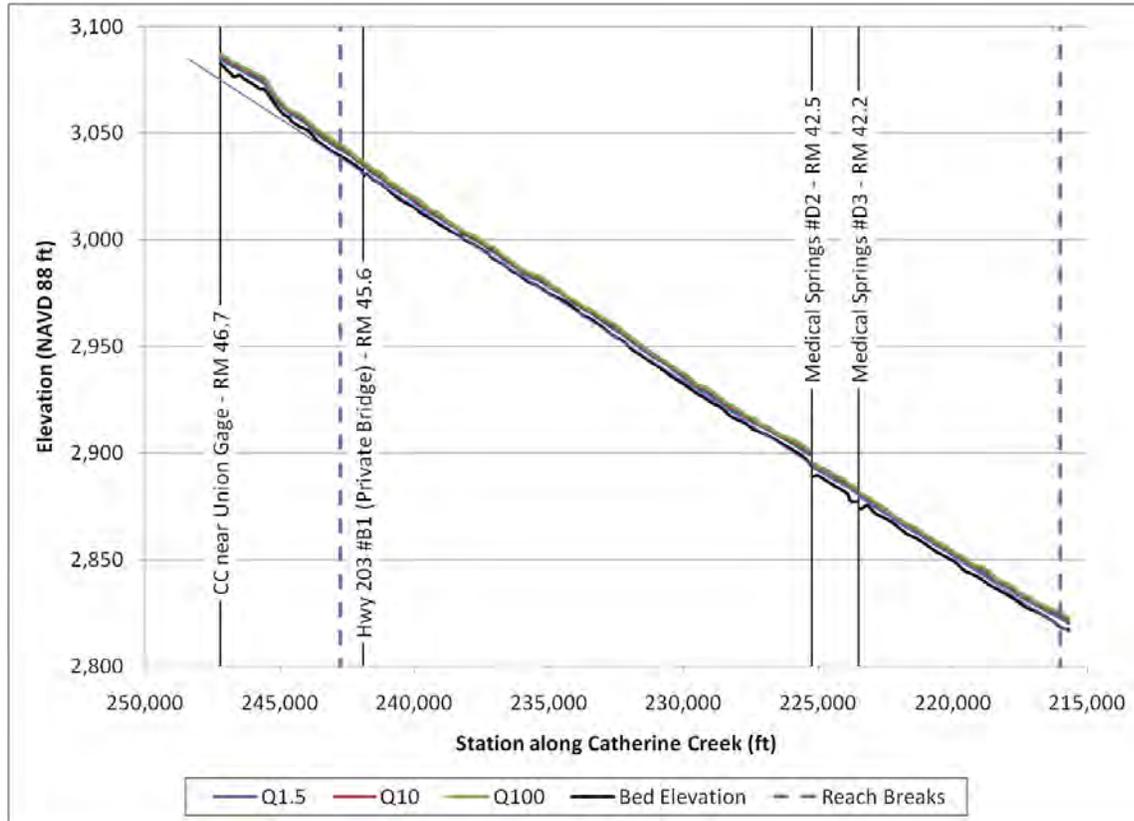
Figure 53. Computed water surface elevations along reach 4 (Appendix D). Medical Springs #2 is more commonly known as the Catherine Creek Adult Collection Facility (CCACF) and Medical Springs #3 is more commonly known as State Diversion.

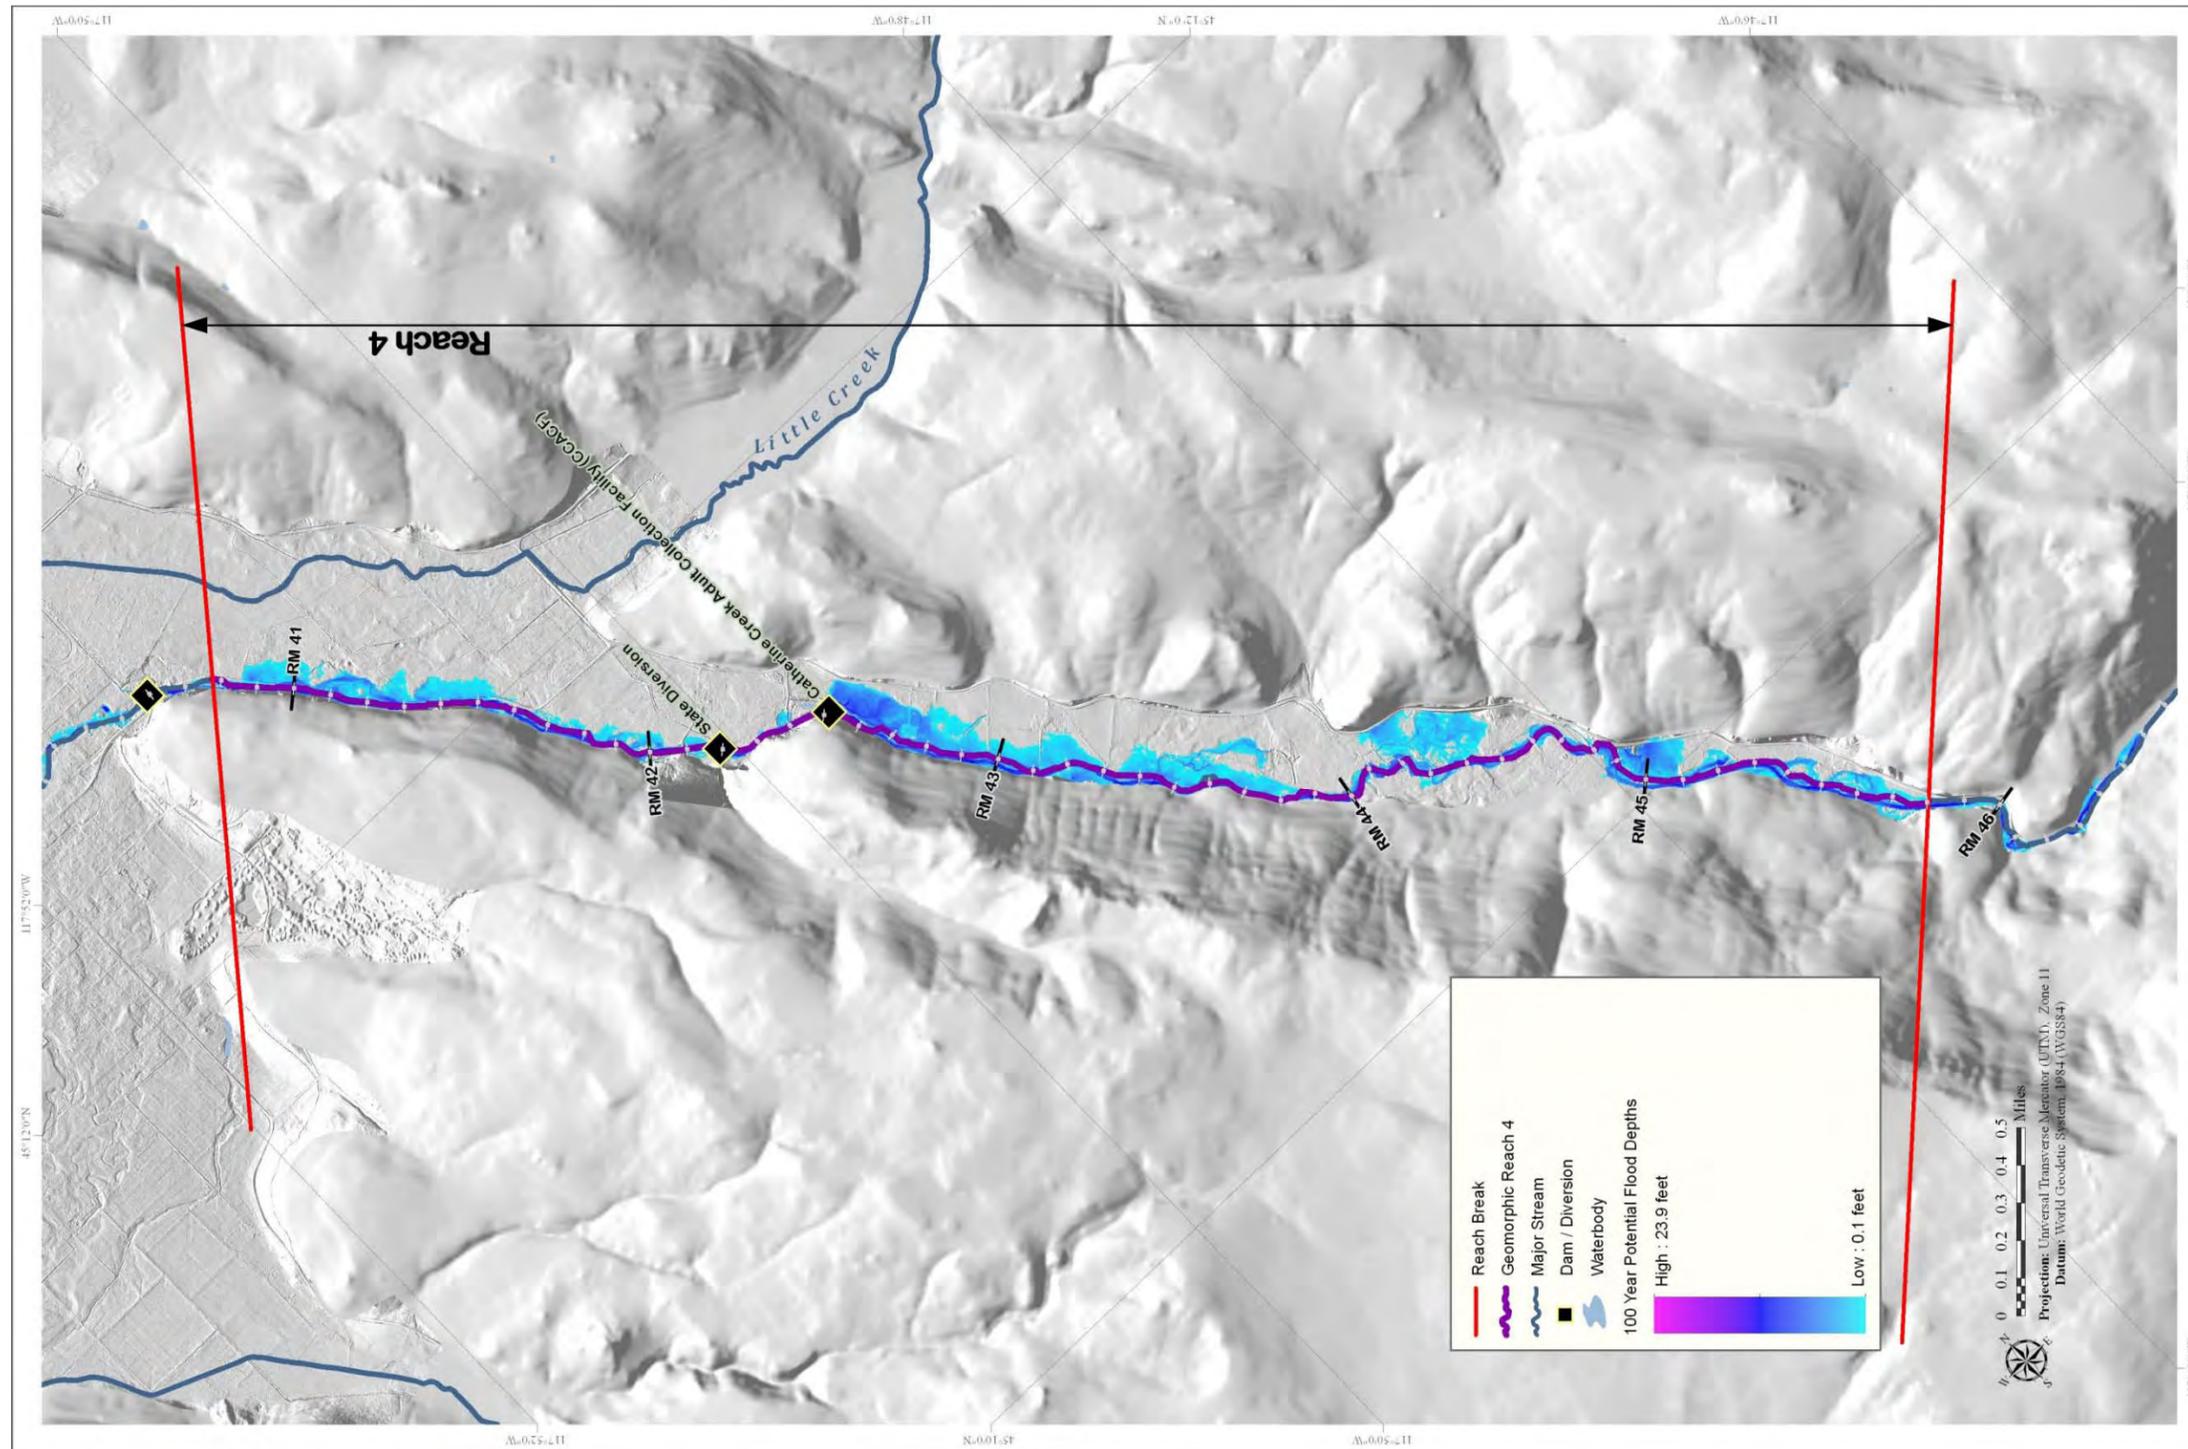
Figure 54. The depths of potential flooding within the bounds of the modeled cross sections for the 100-year discharge along reach 4.

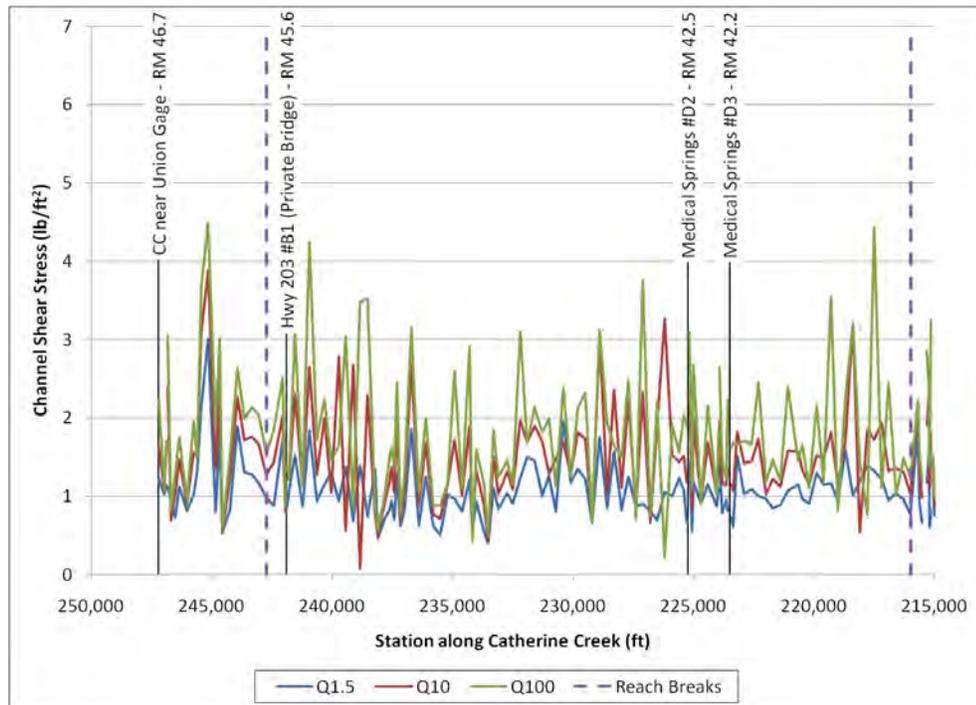
Figure 55. Channel shear stress in reach 4 on Catherine Creek (Appendix D). Medical Springs #2 is more commonly known as the CCACF and Medical Springs #3 is more commonly known as State Diversion.
