THE CATHERINE CREEK TRIBUTARY
ASSESSMENT
GRANDE RONDE RIVER BASIN
Tributary Habitat Program, Oregon

U.S. Department of the Interior
Bureau of Reclamation
Pacific Northwest Region
Boise, Idaho

February 2012

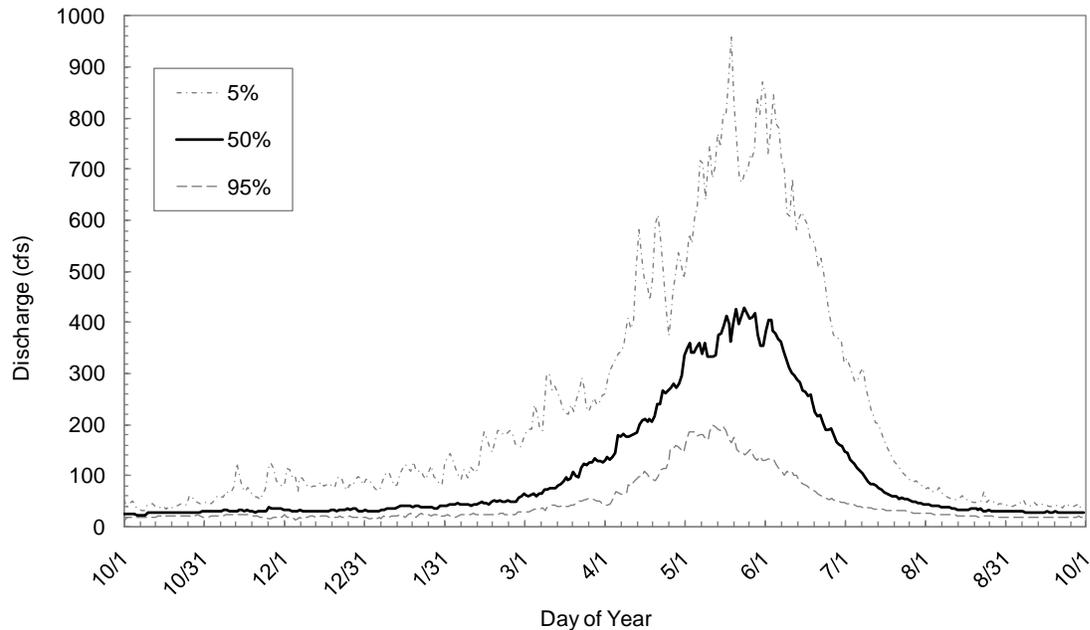
Figure 57. Mean daily flow percent exceedance values for the Catherine Creek near Union, Oregon stream gage. The 50 percent values indicate the average annual hydrograph.

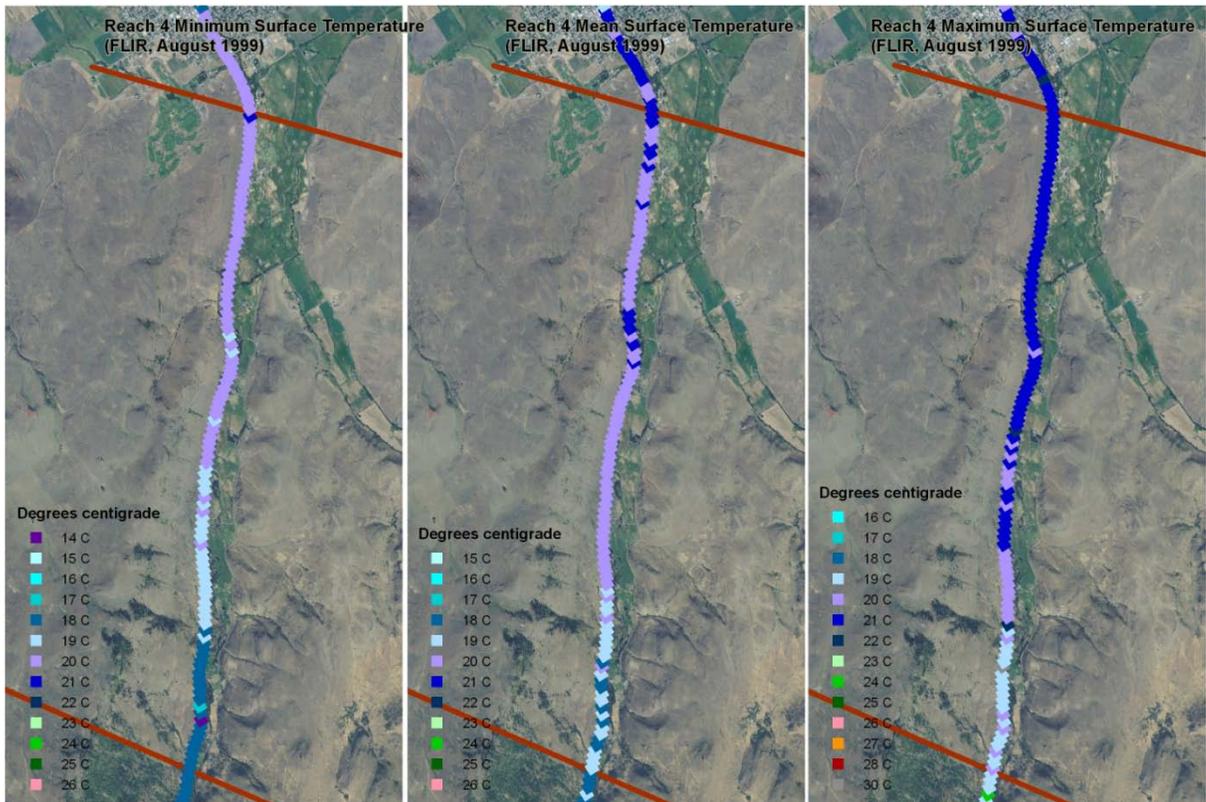
Figure 58. Stream temperature results for reach 4 from August 1999 FLIR data.

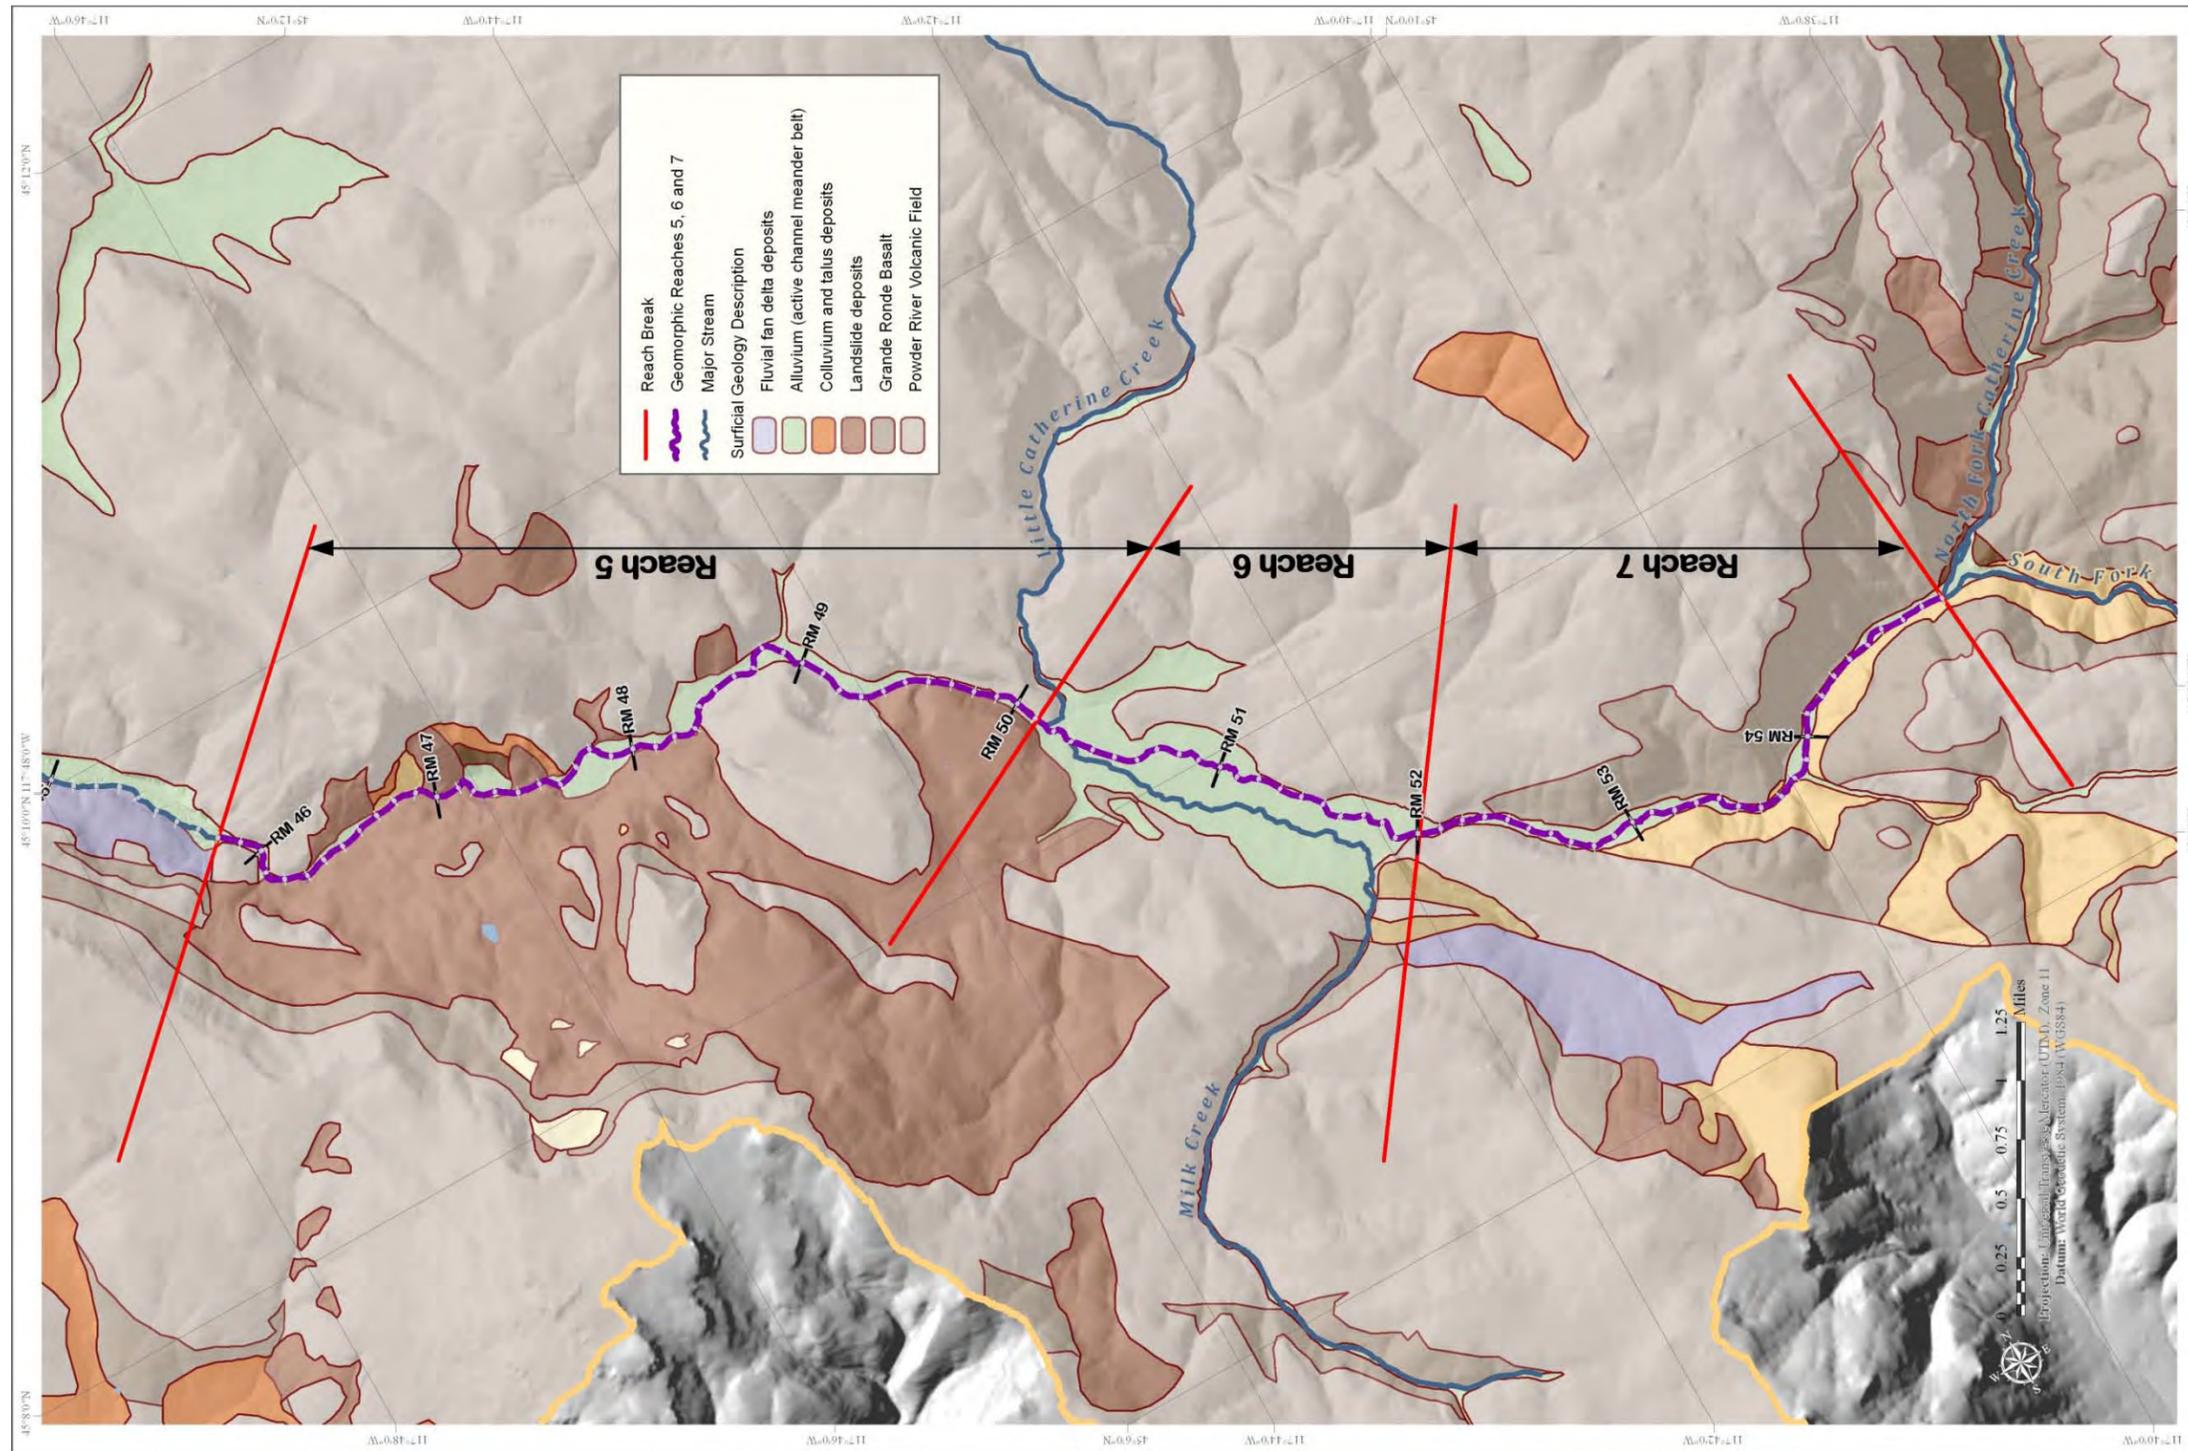
Figure 61. Surficial geologic deposits and “bare earth” hillshade topography along reaches 5, 6, and 7.

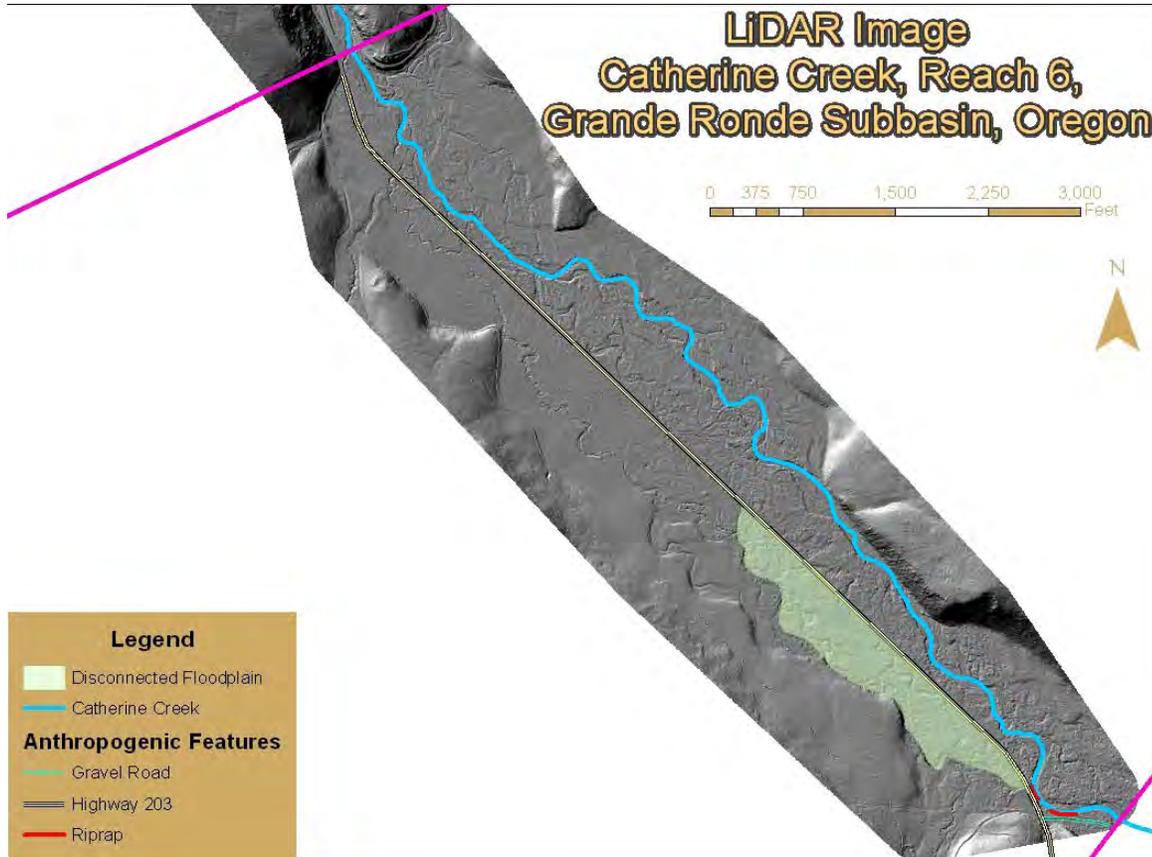
Figure 62. A LiDAR based image of reach 6 showing the current location of Catherine Creek, the anthropogenic features, and a section of disconnected floodplain.

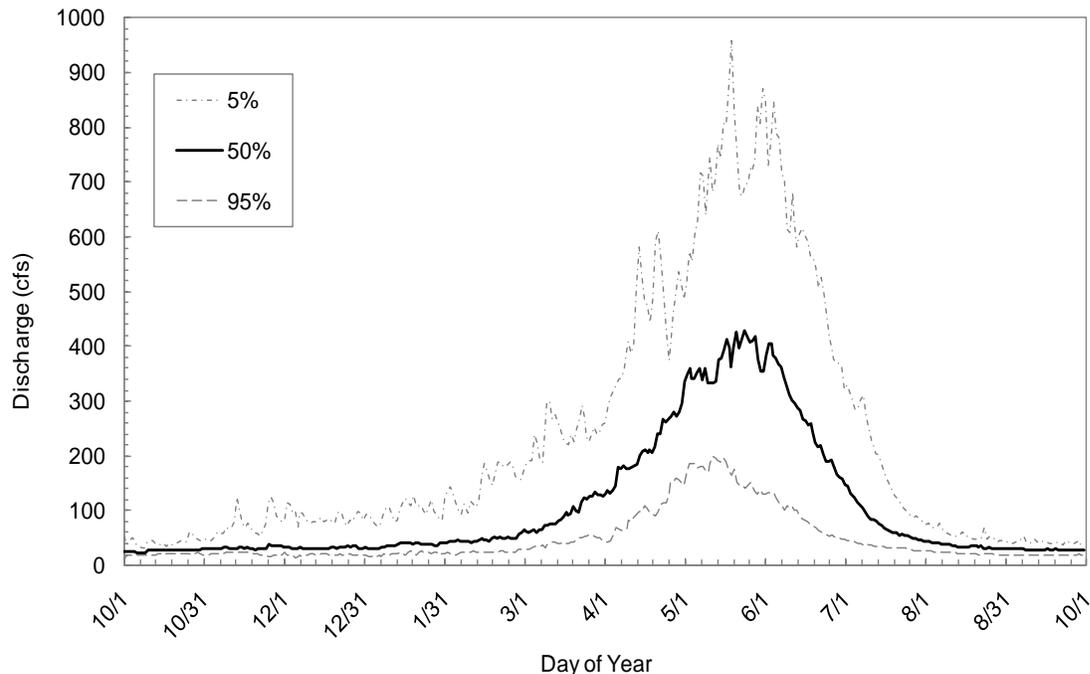
Figure 63. Mean daily flow percent exceedance values for the Catherine Creek near Union, Oregon stream gage which is in the lower end of reach 5. The 50 percent values indicate the average annual hydrograph.

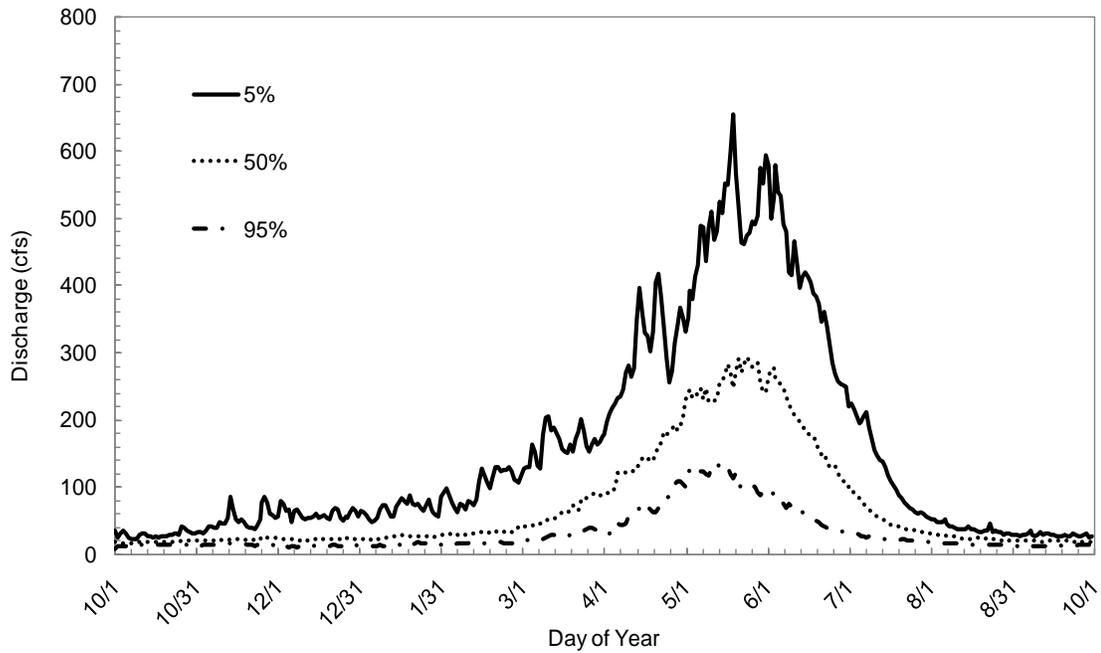
Figure 64. Estimated mean daily flow percent exceedance values for reach 6 based on the Catherine Creek near Union, Oregon stream gage. The 50 percent values indicate the average annual hydrograph.

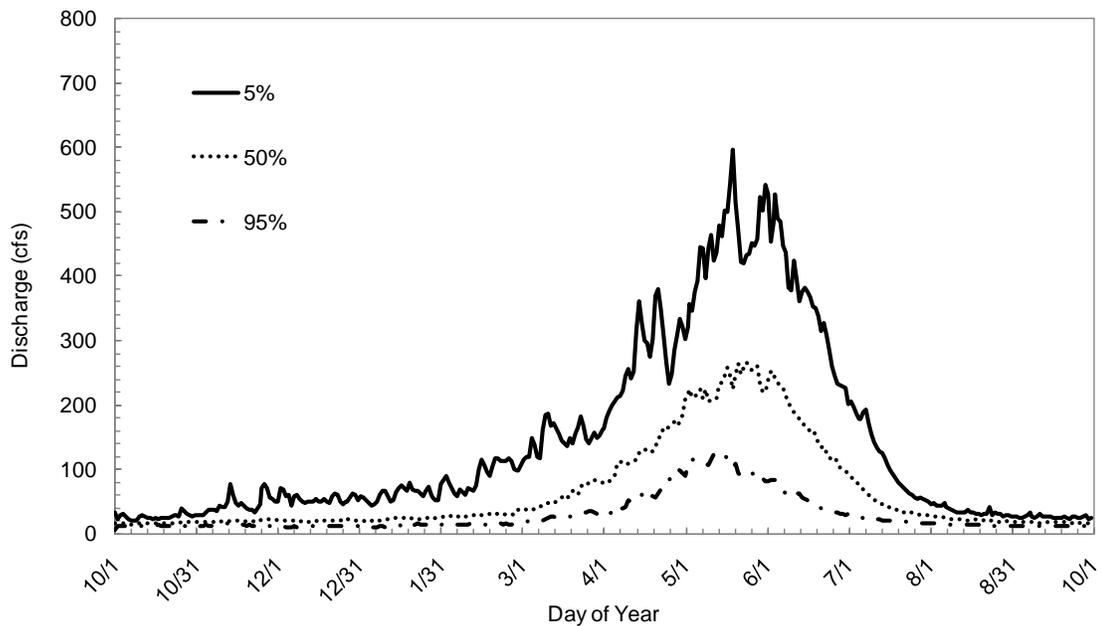
Figure 65. Estimated mean daily flow percent exceedance values for reach 7 based on the Catherine Creek near Union, Oregon stream gage. The 50 percent values indicate the average annual hydrograph.
