APPENDIX G

Geomorphology

The purpose of this geomorphic assessment was to provide information in support of the Yankee Fork Tributary Assessment that describes (1) the large scale geomorphic processes occurring within the watershed; (2) the basis for delineation of geomorphic reaches within the tributary assessment area; and (3) identifying geomorphic reaches that have the greatest potential for improving geomorphic processes, reconnecting isolated habitats, and improving habitat quantity and quality.

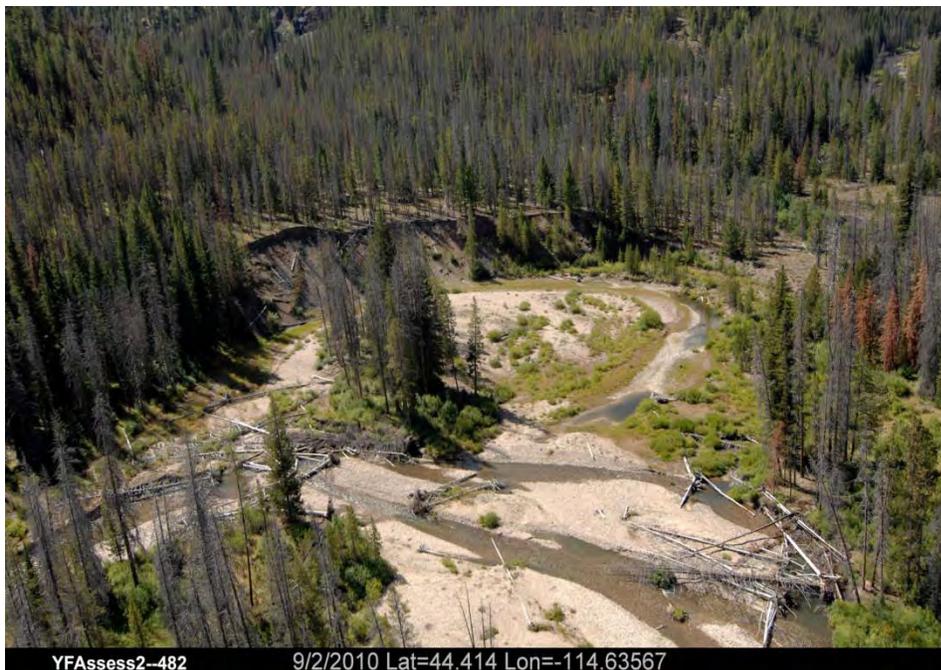
Figure 10. View to the west near RM 14.9 showing forced alluvial channel variability. *Wood in this reach influences variability in geomorphic channel processes and habitat complexity. Lake deposits (eroded high bank in the background) are common in this reach and provide sediment inputs of fine gravel and sand with fine.* Bureau of Reclamation photograph by Dave Walsh, September 2, 2010.

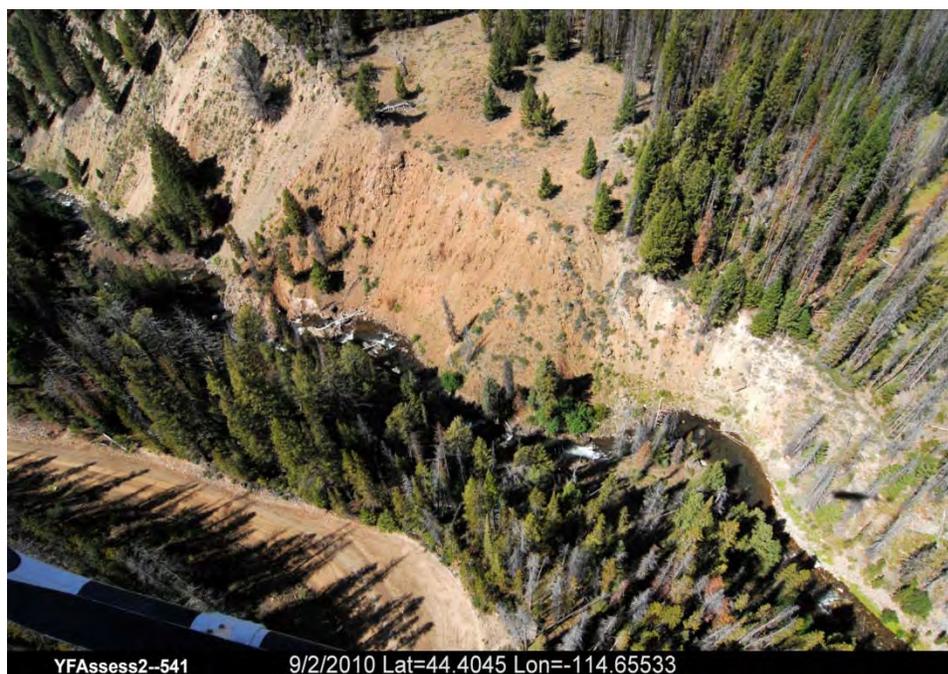
Vegetation along the banks of the active channel is sparse between about RM 13.2 and 12.8, and is comprised primarily of upland trees along the steep slopes (Figure 14). Riparian vegetation becomes more prominent along the banks starting near RM 12.8 to the end of the reach where the channel has been able to erode the landslide deposit. Wood is relatively rare based on examination of the 2010 aerial photographs. The pieces that do remain in the canyon form small jams that are keyed by large boulders. Wood frequency and quantity may seem relatively low, but large quantities of wood would not be expected in confined channel that has high transport capacity.

Figure 14. View to the northwest near RM 12.9 showing bedrock channel. *The channel has been incising through the landslide deposit in what is essentially a bedrock channel reach and has developed a steep step-pool bed-form.* Bureau of Reclamation photograph by Dave Walsh, September 2, 2010.

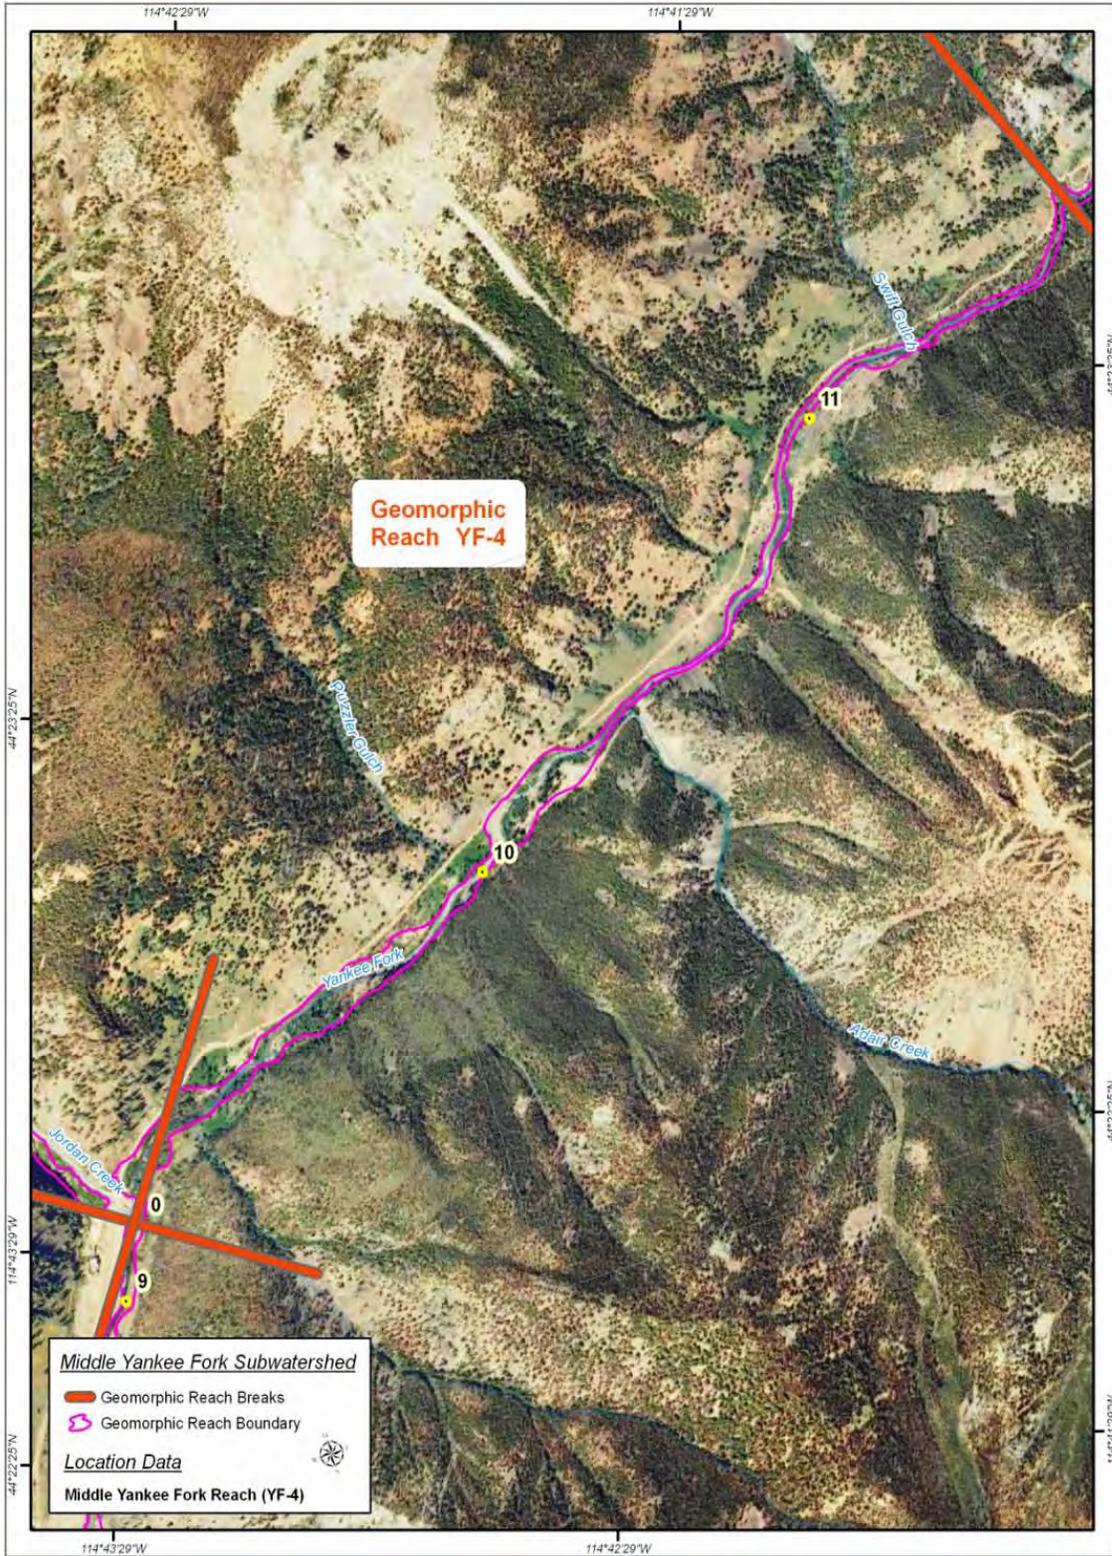
Figure 15. Yankee Fork Reach YF-4 in the middle Yankee Fork subwatershed.

Geomorphic Reach YF-4 (Figure 15) is located between about RM 11.6 and 9.1 in a moderately confined valley segment. Average channel slope is about 1.1 percent and the channel pattern is straight-to-meandering which indicates a low-to-moderate rate of lateral channel migration is occurring as compared to other reaches in the assessment area. Channel type is a plane-bed, free-formed alluvial channel with a gravel substrate.

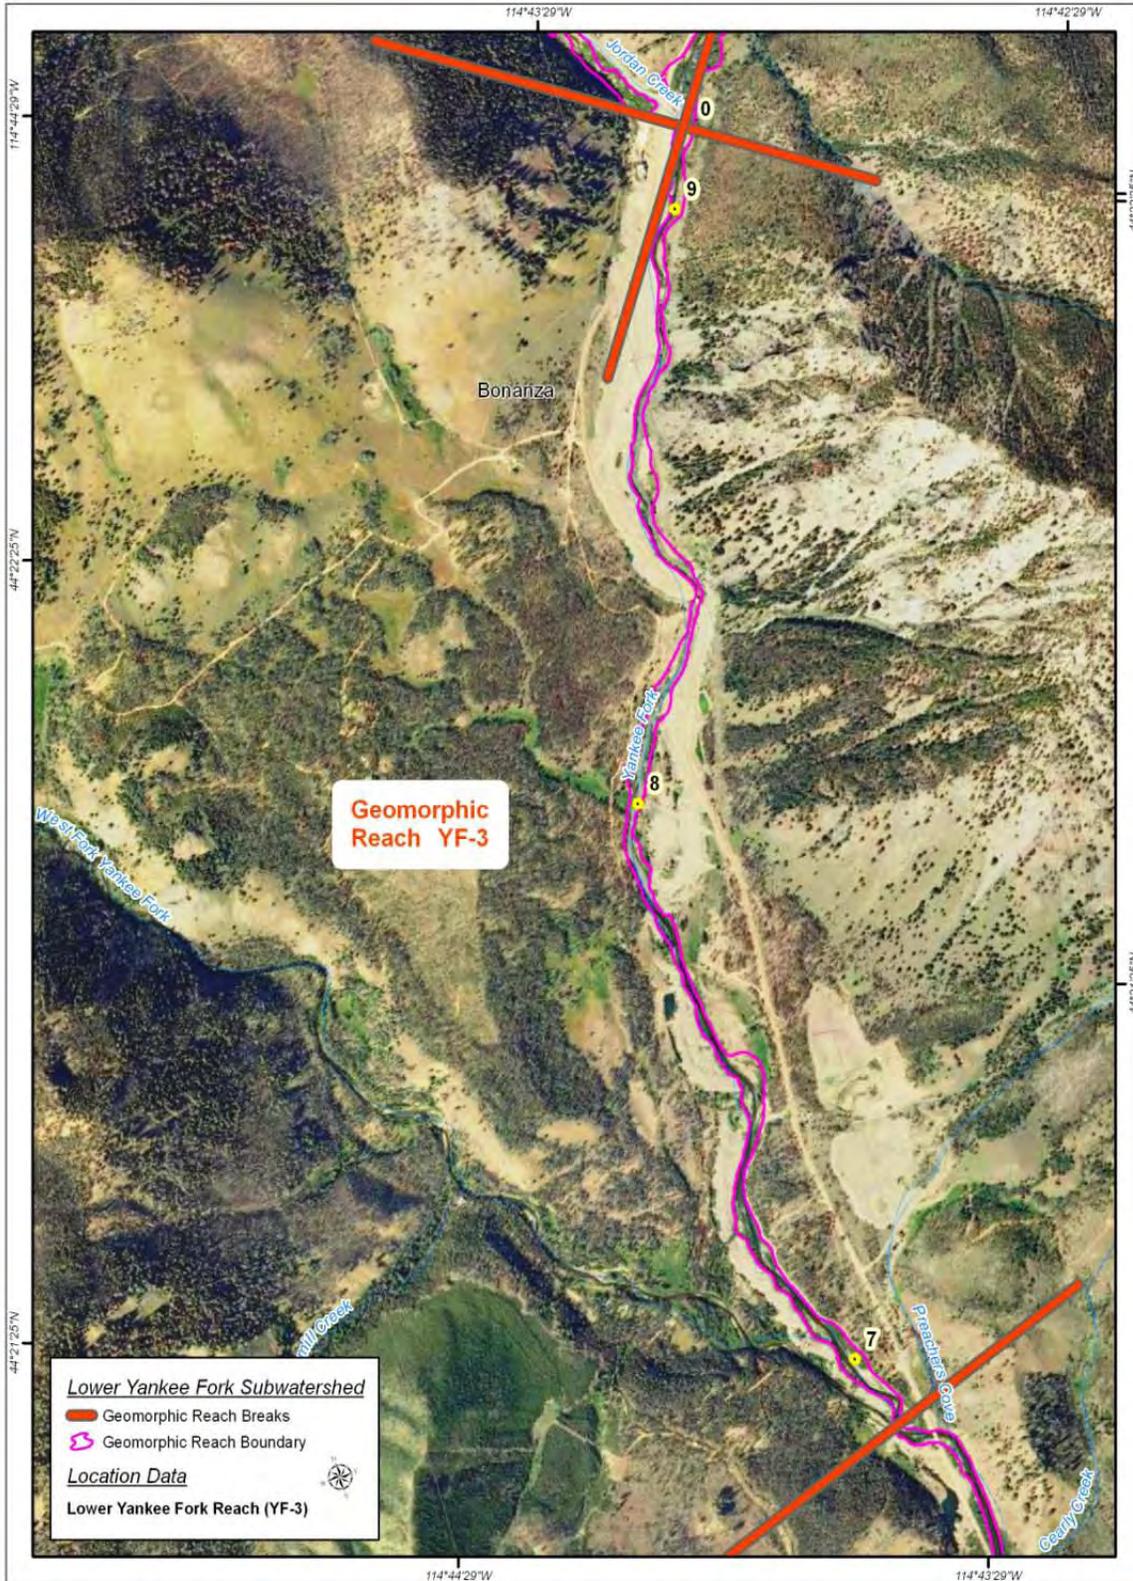
Figure 21. Yankee Fork Reach YF-3 in the lower Yankee Fork subwatershed.

Geomorphic Reach YF-3 (Figure 21) is located between about RM 9.1 and 6.9 in a moderately confined valley segment that is constrained by dredge tailings throughout most of the reach. The channel type is a free-formed alluvial channel with a plane-bed and a straight-to-meandering channel pattern. Channel slope is about 1 percent with a cobble dominated substrate.

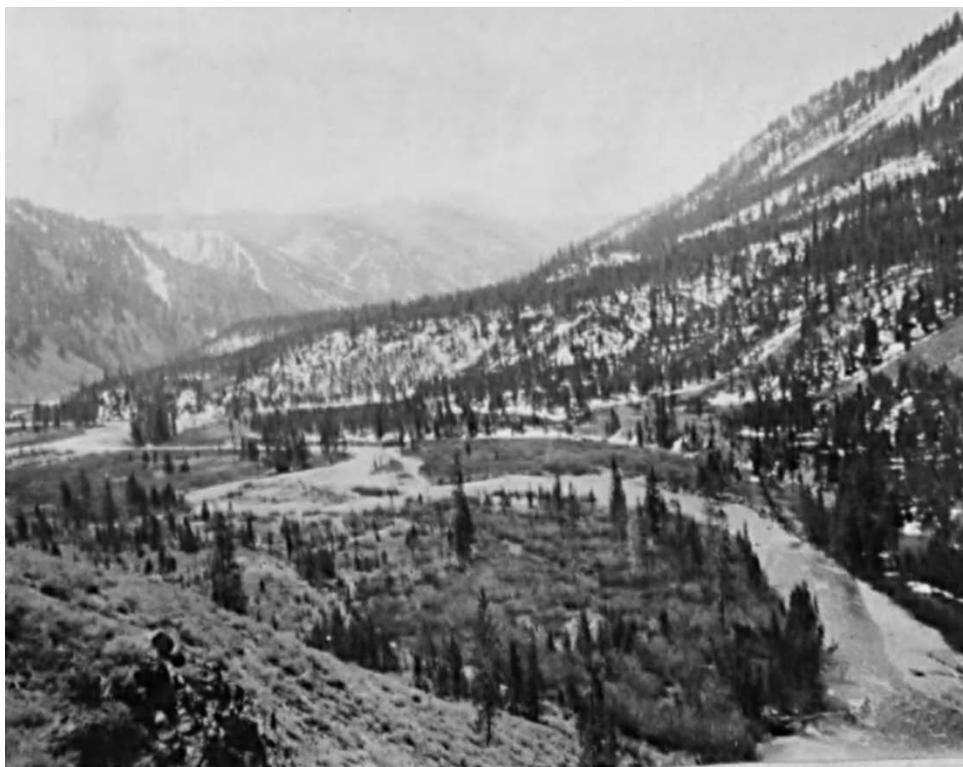
Figure 23. View is to the north looking upstream from Preachers cove alluvial fan near RM 6.8 on river right towards West Fork confluence (Smith 1911). *Photograph taken by Maven Sawyer, winter of 1910.*

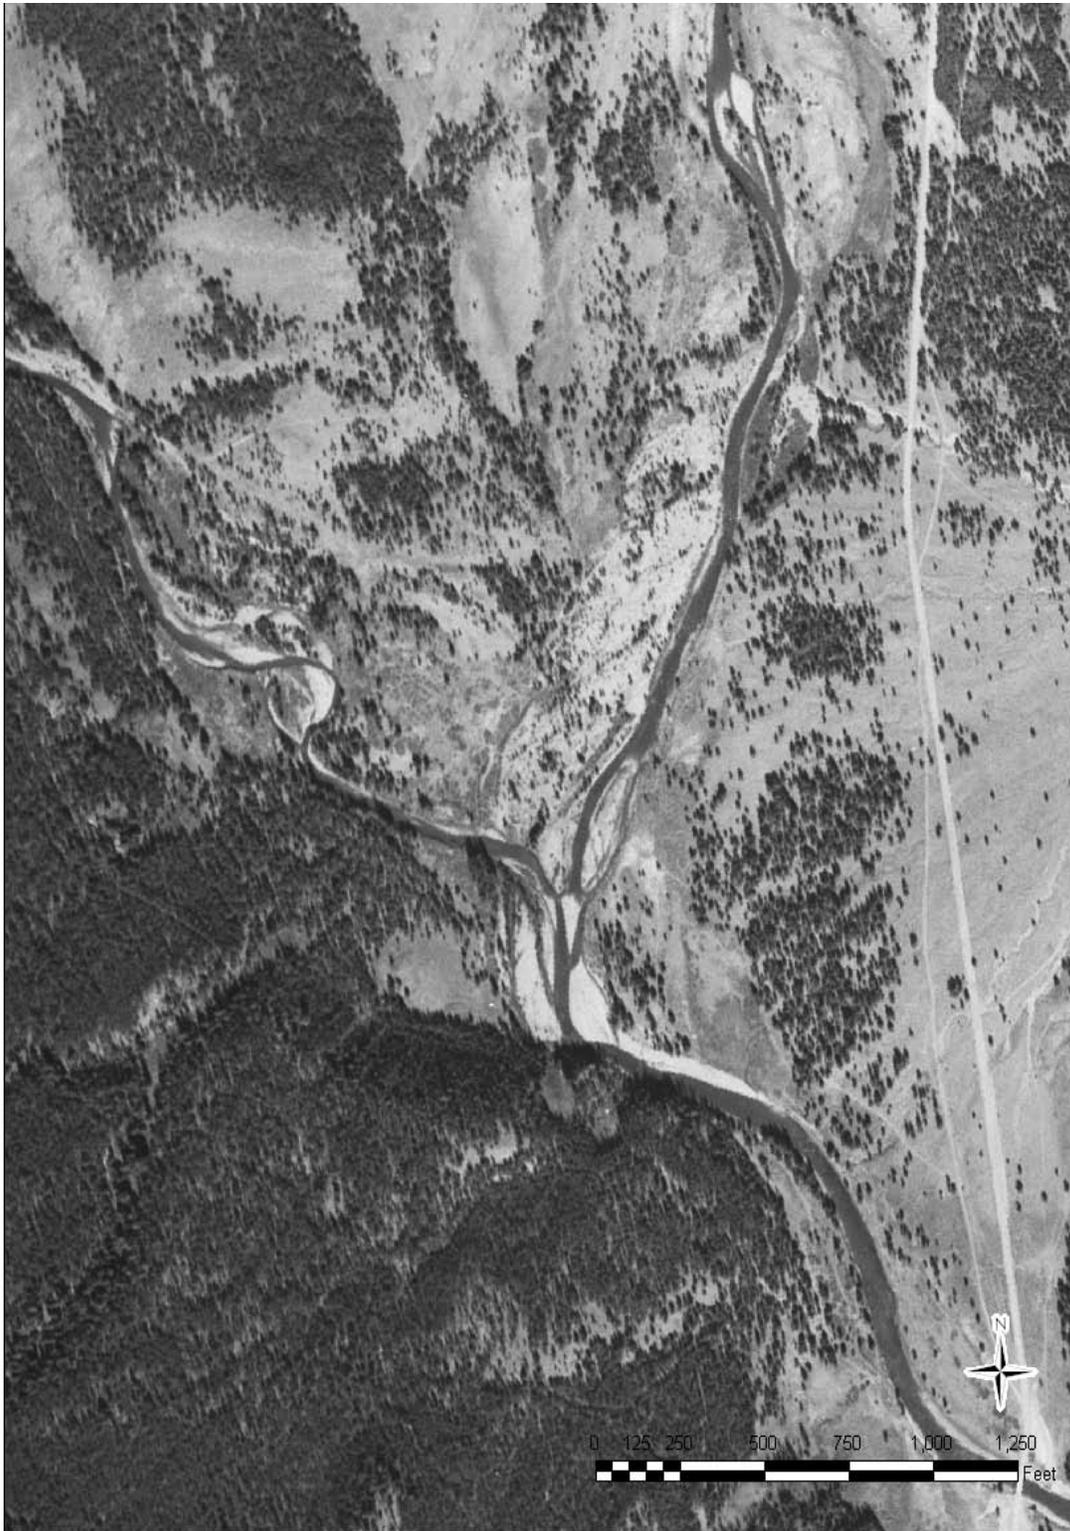
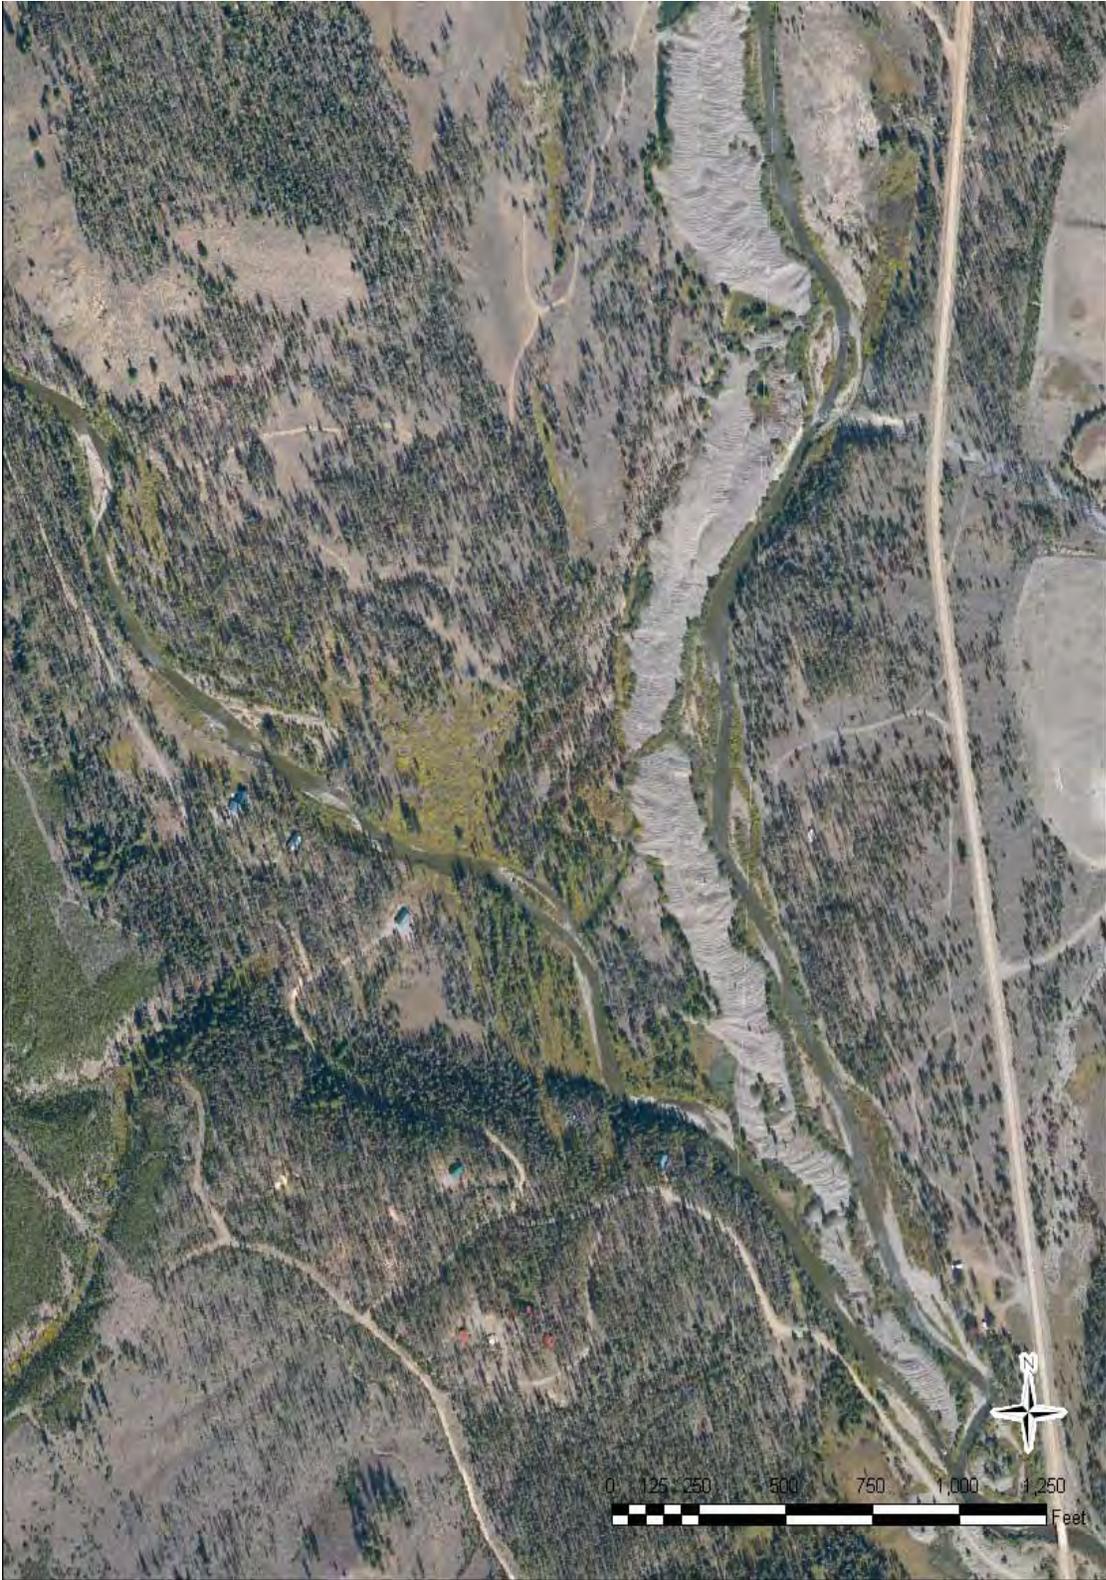
The river was manipulated in order to maintain the dredging operations by rerouting and/or impounding flows to support the floating dredge. In the 1945 aerial photographs the channel flowed along the right valley wall between RM 9.1 and 8.4, and a new channel was constructed through the dredge tailings along the left valley wall by the 1966 aerial photographs. Between about RM 8.3 and 7.5, the channel has essentially remained in the same location based on the 1945-2010 aerial photographic record; however, in order for the dredge to have operated in this location the channel had to be at least temporarily impounded or otherwise manipulated to support the floating dredge. From RM 7.3 to 6.8 the channel was rerouted away from the West Fork confluence and disconnected from floodplain areas (Figure 25 and Figure 26) by dredge tailings sometime between 1945 and 1952.

Figure 25. 1945 aerial photograph of West Fork and Yankee Fork confluence.

Figure 26. 2010 aerial photograph of West Fork and Yankee Fork confluence.

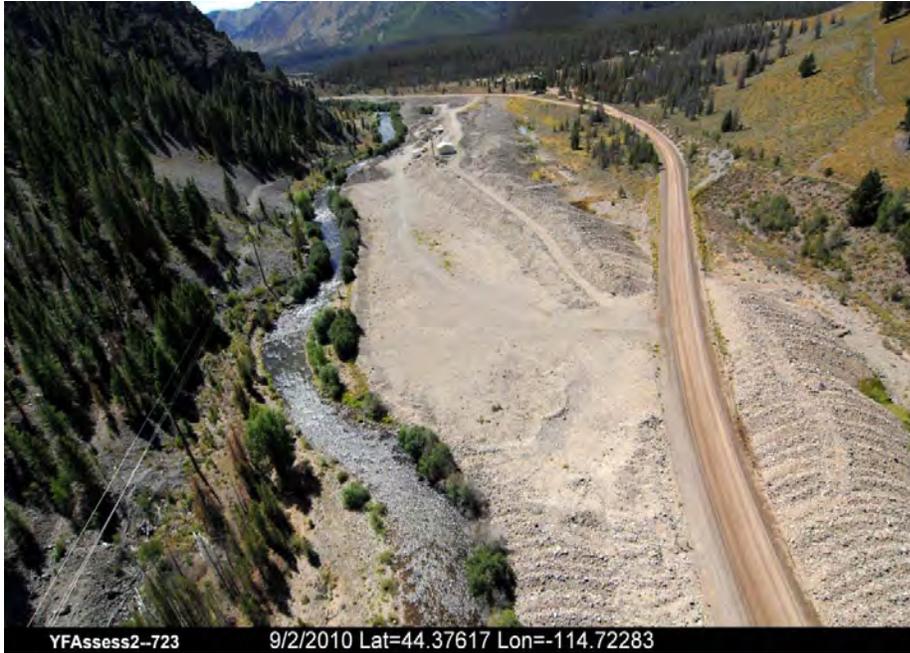
Figure 27. View to the south near RM 7.8 showing dredge tailings constraining channel against valley wall. Bureau of Reclamation photograph by Dave Walsh, September 2, 2010.

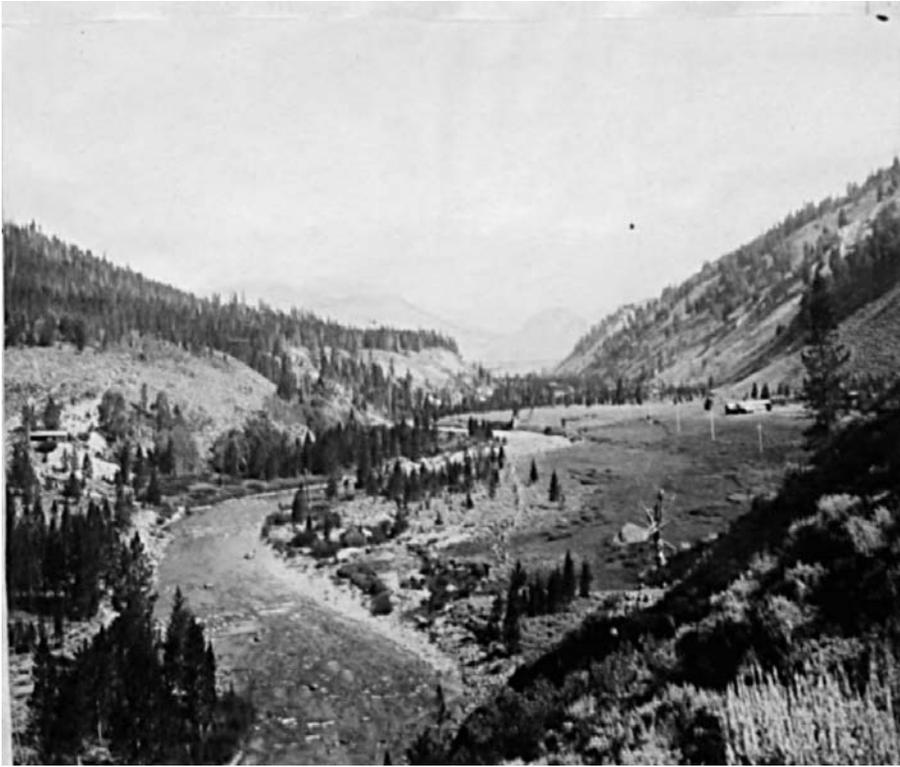
Figure 30. View is to the north looking upstream from glacial terrace near RM 5.2 on river left at Jerrys Creek alluvial fan (Smith 1911).

Historically (pre-dredging), the channel was moderately confined to confined based on valley bottom constraints from glacial terraces and outwash, alluvial fans and bedrock (Figure 30). The river had a straight-to-meandering channel pattern that indicates a low rate of lateral channel migration was occurring. Channel type was a plane-bed (USDC 1934), free-formed alluvial channel with a cobble dominated substrate. There were small-to-moderate sized floodplain areas accessible to the river during high flows, but these floodplain areas were not extensive (Figure 31), and qualitatively appear similar to their present (2010) extent. In addition, three perennial tributaries were connected to the Yankee Fork that included Cearley Creek, Jerrys Creek, and Silver Creek.

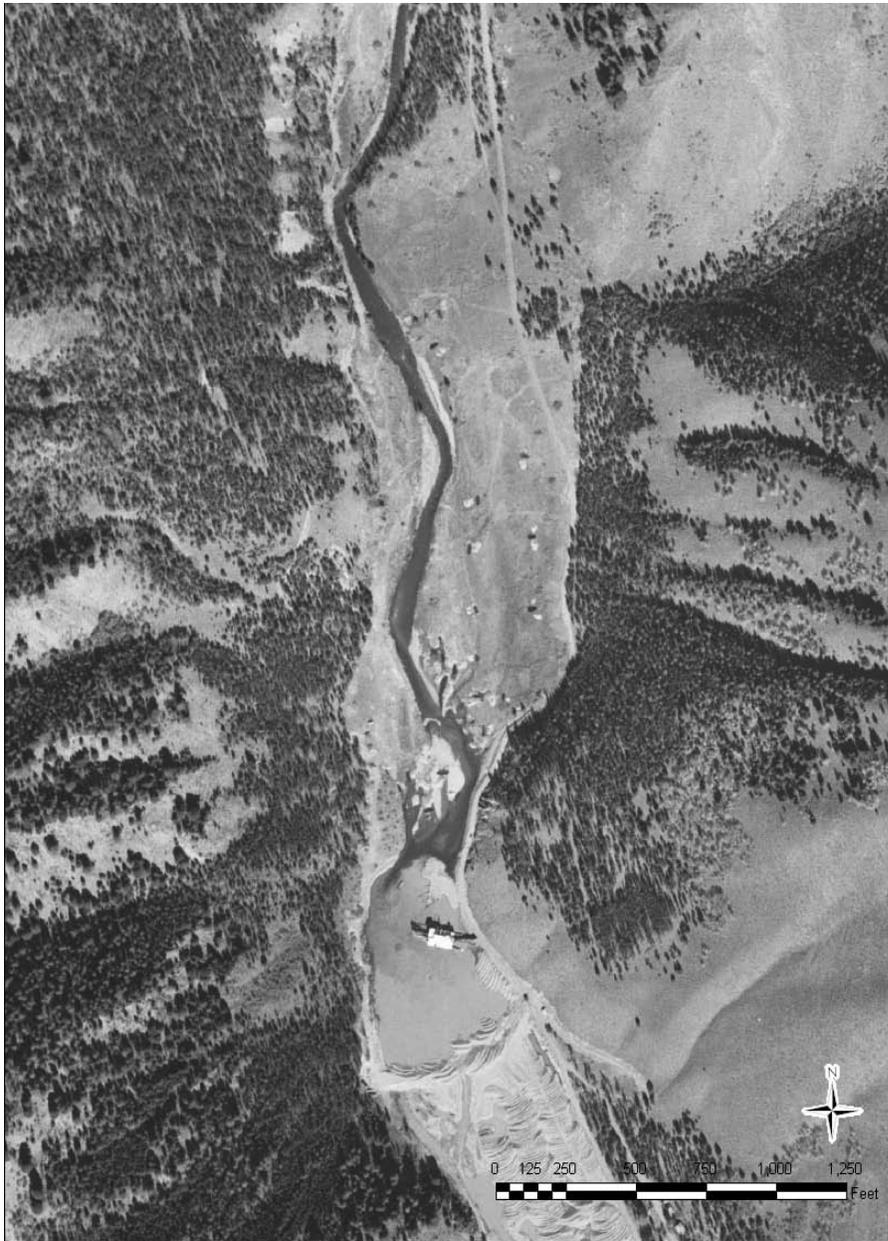
Figure 31. 1945 aerial photograph of Yankee Fork near Jerrys Creek. *Note the floating dredge in the lower center of the photograph and the dredge tailings deposited across the valley floor.*

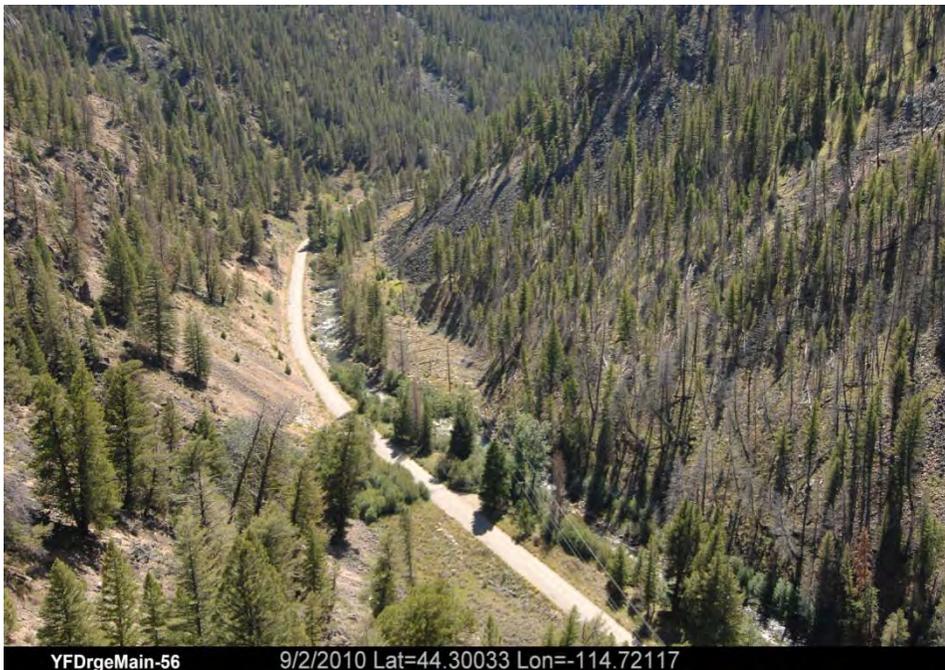
There are small overbank areas in the reach that appear to be connected to the channel. Road embankments do encroach on the channel, but do not significantly impact channel processes. Vegetation along the active channel banks is comprised predominantly of upland trees along the steep, valley side-slopes. Few pieces of large wood were observed which would be expected for this high energy transport reach (Figure 35).

Figure 35. View to the southeast looking downstream at reach YF-1 near RM 3. Bureau of Reclamation photograph by Dave Walsh, September 2, 2010.

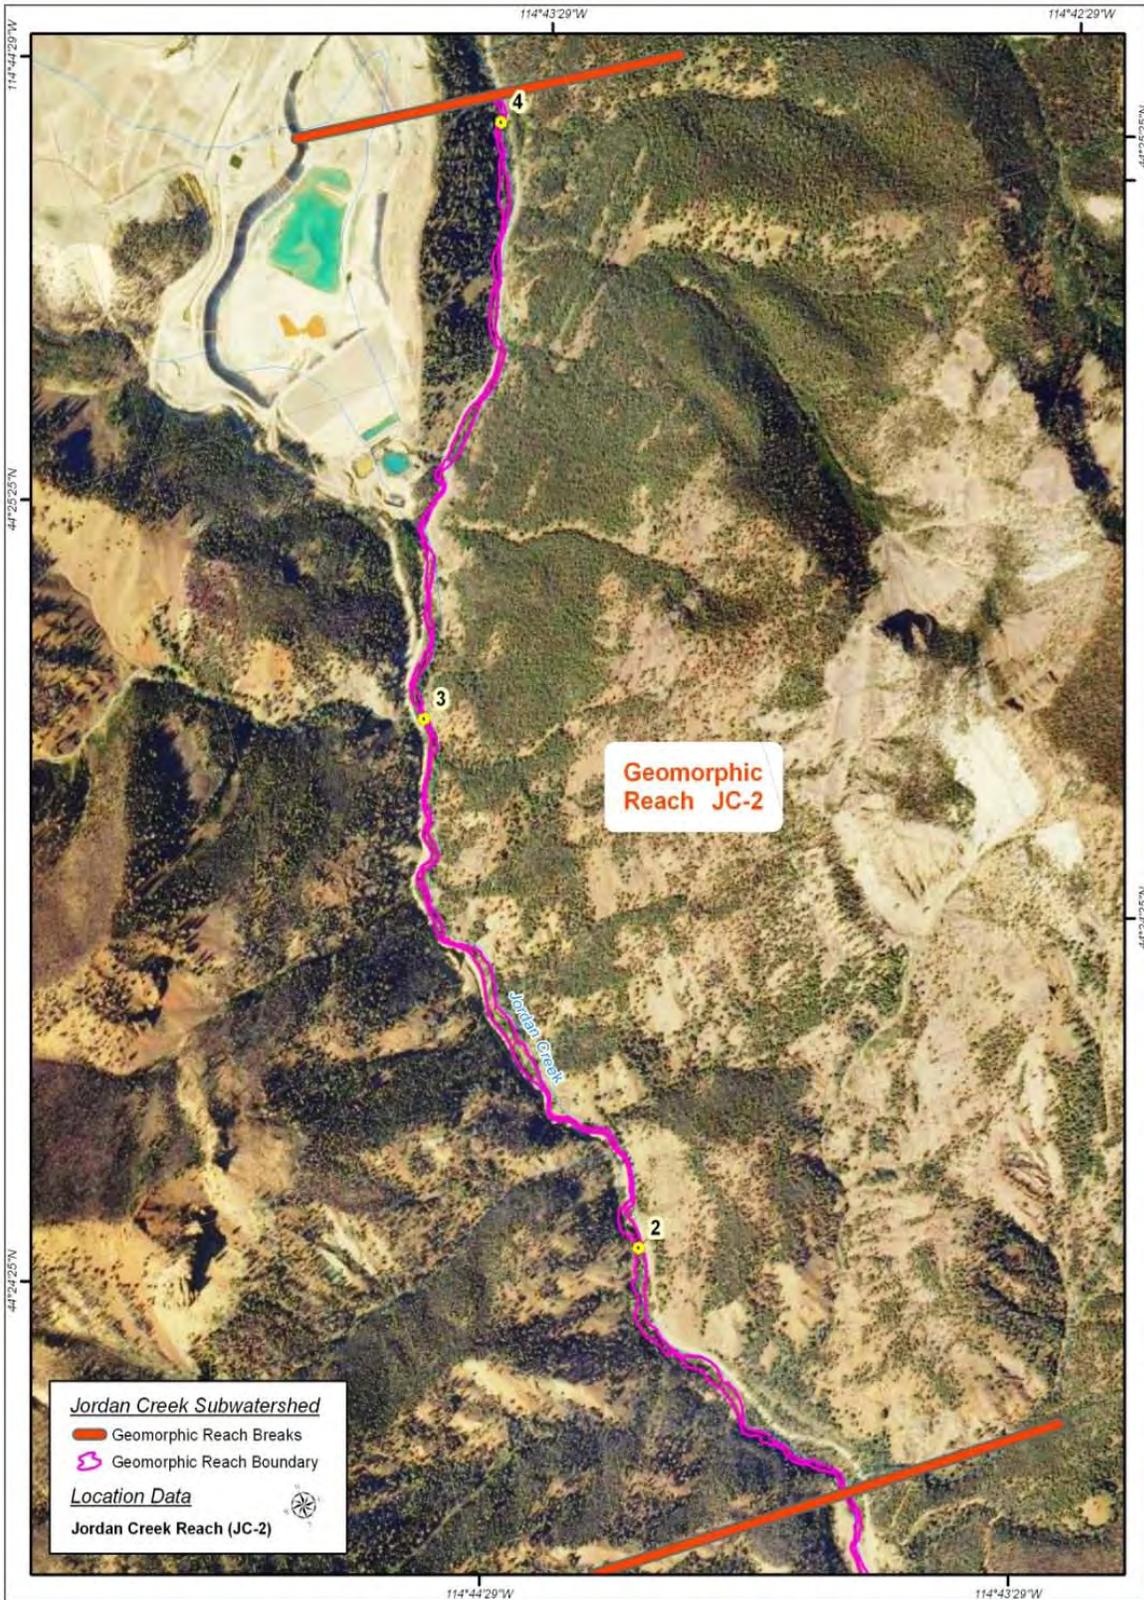
Figure 38. Jordan Creek Reach JC-2 in the Jordan Creek subwatersheds.

Geomorphic Reach JC-2 (Figure 38) is located between about RM 4 and 1.4 in a moderately confined valley segment that is constrained by bedrock with colluvial, glacial, alluvial fan, and landslide deposits that further constrain the channel. The channel type is predominantly a bedrock channel with alternating plane-bed and pool-riffle bed-forms and a straight channel pattern. Channel slope is about 2.9 percent with a cobble dominated substrate with boulders and bedrock common.

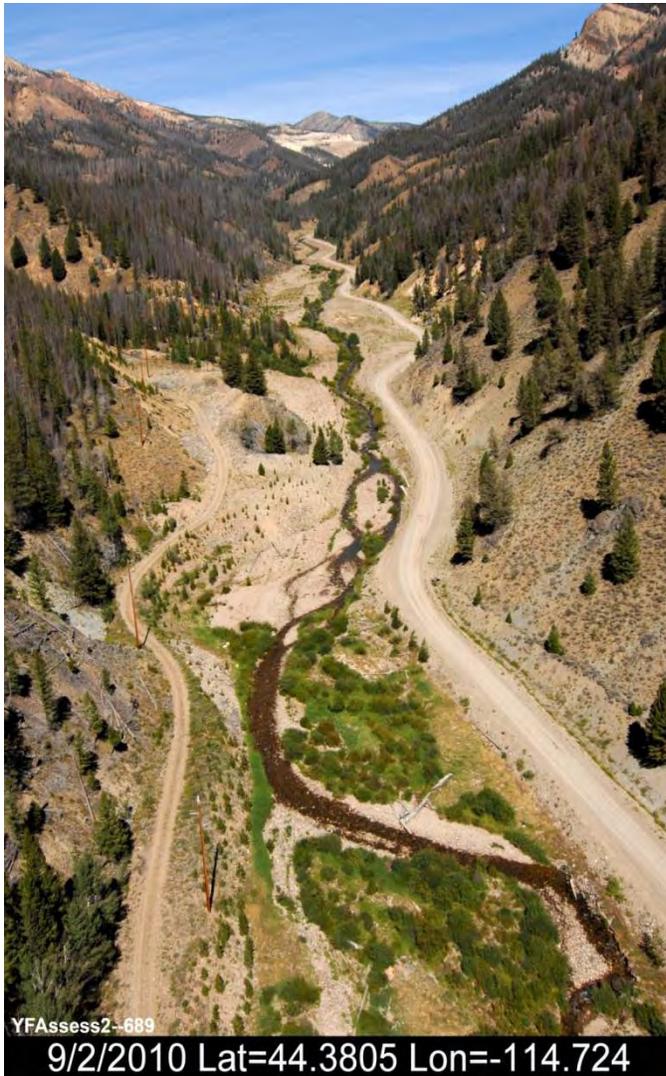
Figure 44. View to the north-northwest looking upstream near RM 0.3. *The rehabilitated area is in the foreground; and mine tailings and mining activity is visible in the background. Grouse Creek Mine can be seen in the distance as the barren ground below hilltop.* Bureau of Reclamation photograph by Dave Walsh, September 2, 2010.
