BIOLOGICAL ASSESSMENT

CATHERINE CREEK RM 37 STREAM AND FISH HABITAT RESTORATION PROJECT

February 2012

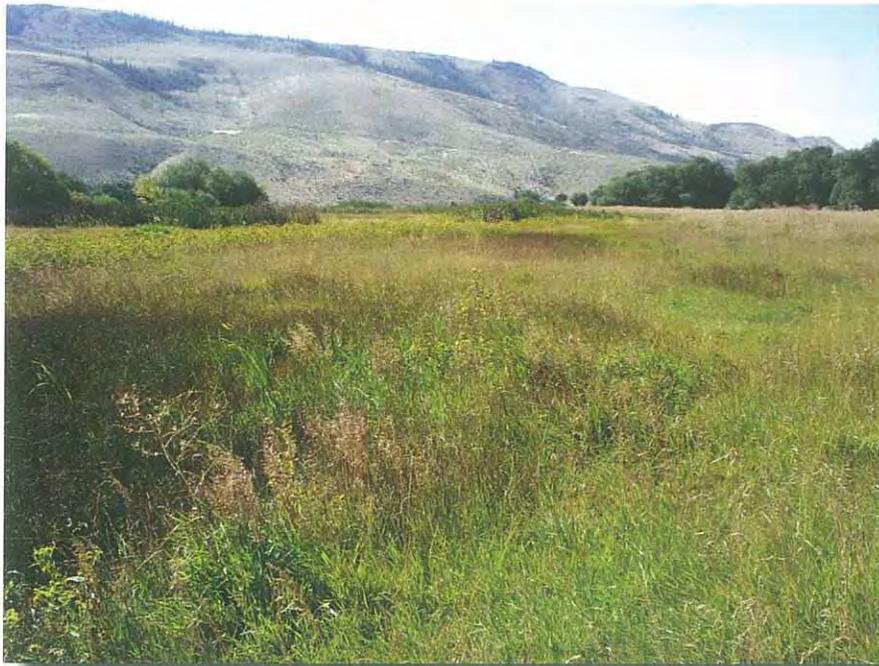
PHOTOGRAPH 11 - Wetland 11. Photograph taken by Sue Brady on September 9, 2011.

Hydric Soil. Soils in most of Wetland 11 are mapped as Catherine silt loam, which is listed as Partially Hydric (NRCS, 2011). Soils in a portion of the eastern end of the wetland are mapped as La Grande silt loam, which is listed as Not Hydric (NRCS, 2011) (see Figure 4). The hydric soil indicator recorded was Redox Dark Surface (F6). No problematic soils were observed.
