APPENDIX D – HYDRAULICS

Catherine Creek Tributary Assessment Hydraulics Appendix

Grande Ronde Project, OR
Pacific Northwest Region
SRH Report 2012-05

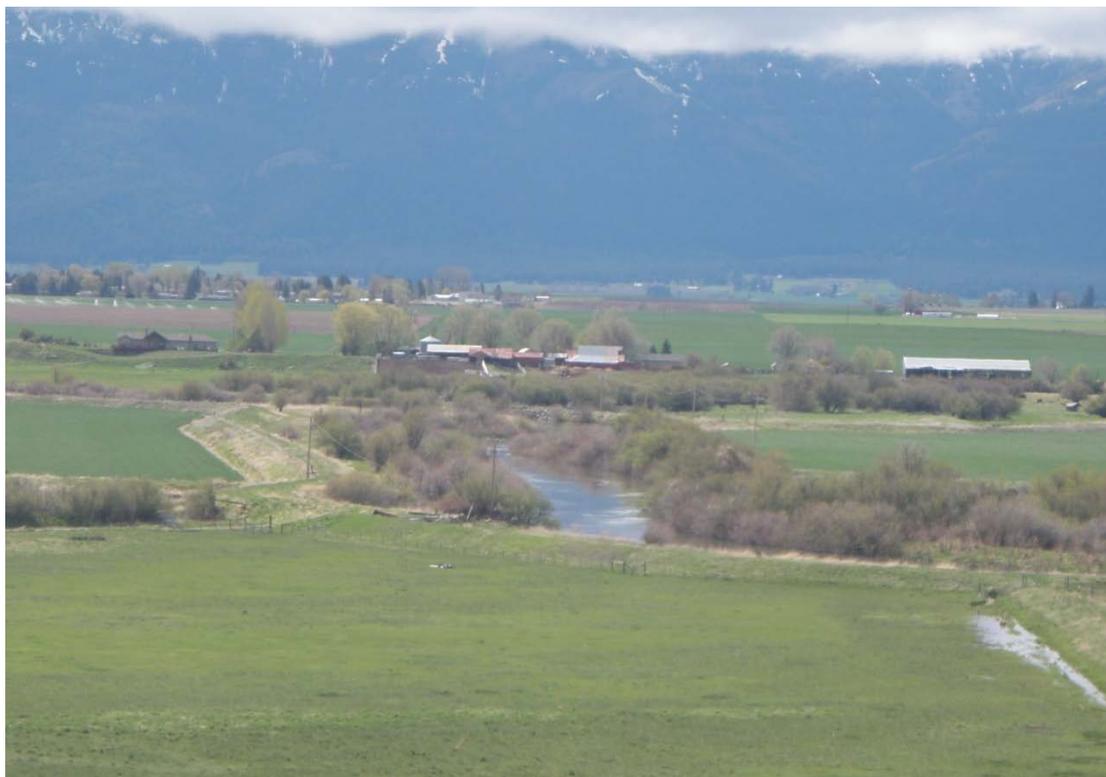
Photo taken on Grande Ronde River near station 25,265 on April 27, 2010.

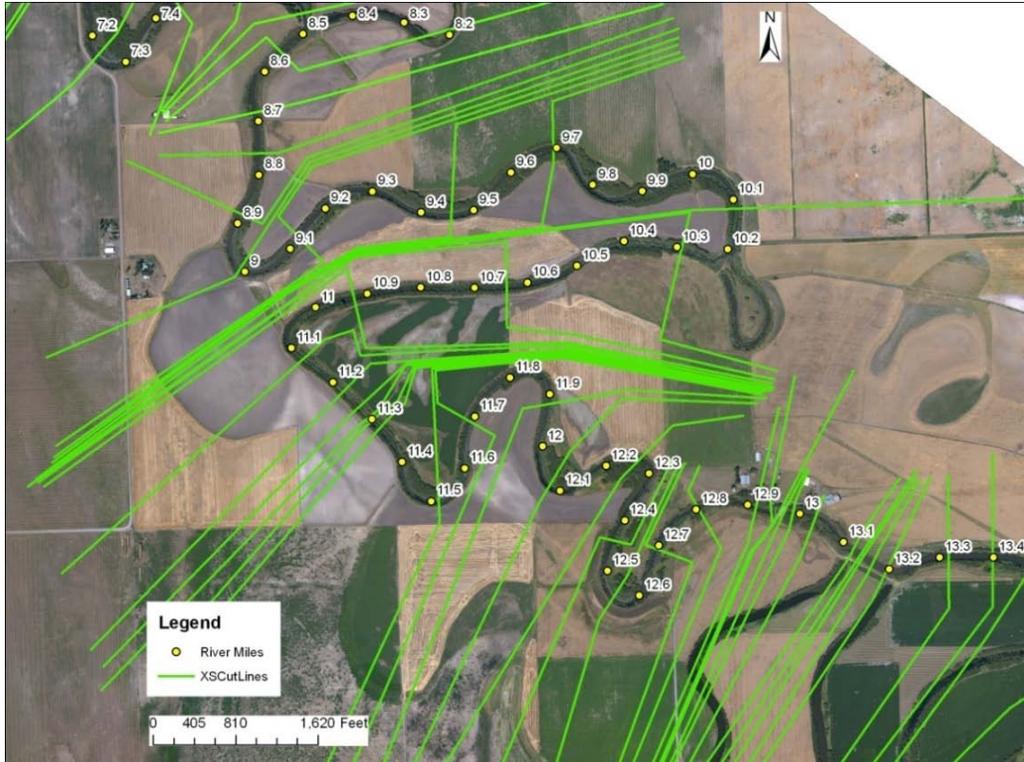
Figure 4. Example portion of lower Catherine Creek with delineated cross sections.

across the three streams. Figure 3 shows a portion of the cross sections delineated upstream of Union, OR near RM 44. Figure 4 shows a portion of the cross sections delineated on Catherine Creek near RM 10. A module within HEC-GeoRas was then utilized to convert all of the delineated line work and topographic information into a HEC-RAS format. The stream channel is extremely sinuous and the dominant flow paths may be different at bankfull and flood flows. There was an attempt to represent the main channel flow paths and overbank flow paths as accurately as possible. However, because of the complex stream channel alignment, this is difficult and it may be necessary to alter the over bank representation to better represent flood flows.

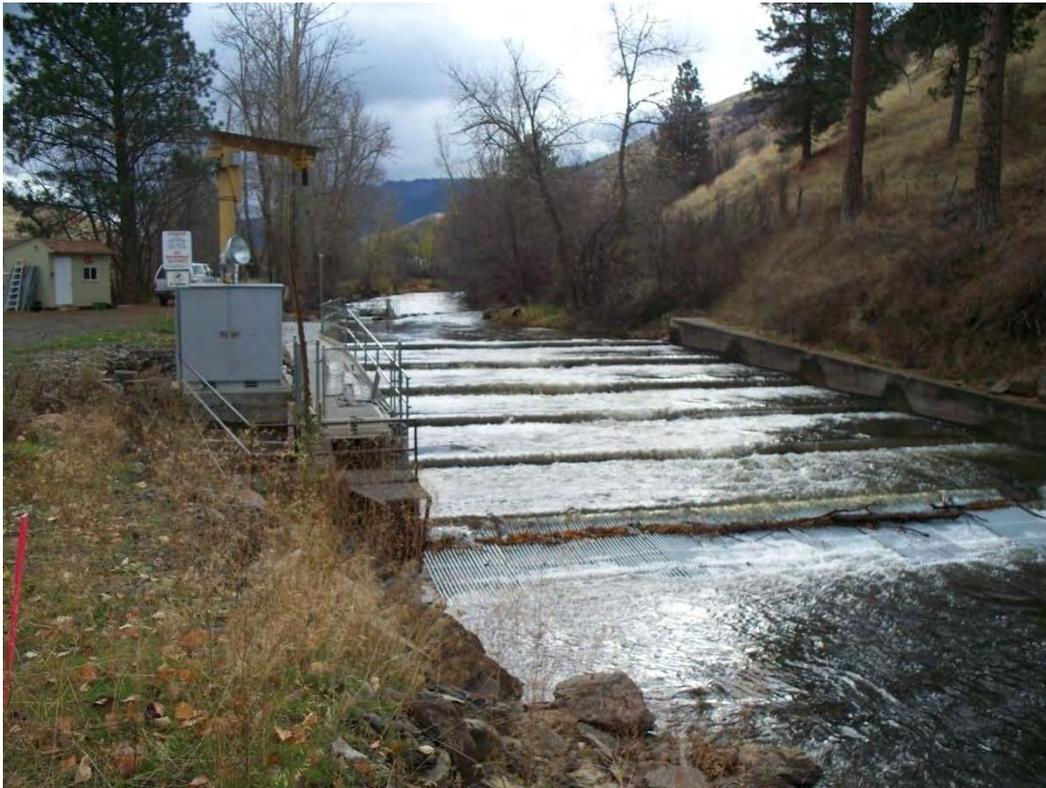
Figure 6. Medical Springs #D2 Diversion (aka Catherine Creek Adult Collection facility, CCACF) looking upstream. Photo courtesy of AP, taken on November 16, 2010.

Nine diversion dams were included in the HEC-RAS model. Only the grade control portion of a diversion dam was included. For example, Medical Springs Diversion #D2 is a series of notched weirs (shown in Figure 6). To include this structure, the four adjacent cross sections were adjusted in a similar manner to the bridge cross sections. Then, the highest weir (typically the most upstream) elevations, width, and dimensions were input as an inline weir structure in HEC-RAS. The highest weir acts as a water surface control and the other weirs would have only a small local effect on the hydraulics.

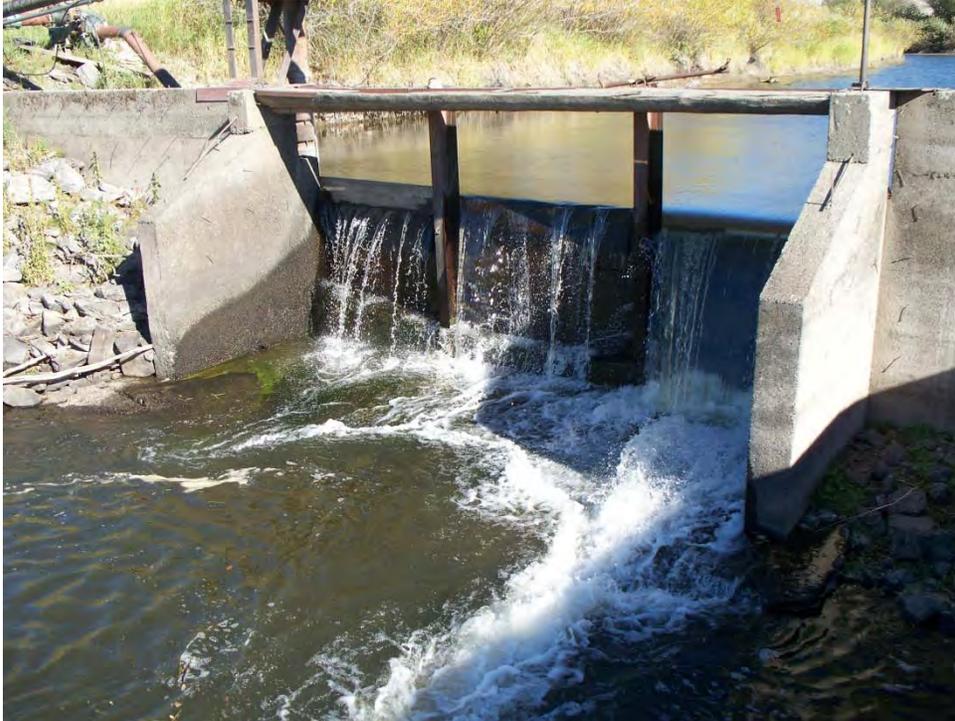
Figure 7. Photo of Diversion Structure located at station 67045 on Catherine Creek, illustrating the use of boards to increase backwater. Photo from Anderson Perry Surveys, September 28th 2010.

Three of the diversion dams (Elmer, Lower Davis, and Upper Davis) have boards placed to increase the backwater behind the dams during the irrigation season. The surveys of all three structures were conducted while boards were in place (see Figure 7). The usage of the boards, such as how many are in place and for what months of the year, is not well documented and highly variable. Therefore, the structures were all modeled assuming that no boards were in place and irrigation was not occurring. Additionally, the primary purpose of the model is to evaluate high flows, during which time the boards would likely be removed. Further refinement of the modeled structures can occur if the operating conditions of the dams are defined.

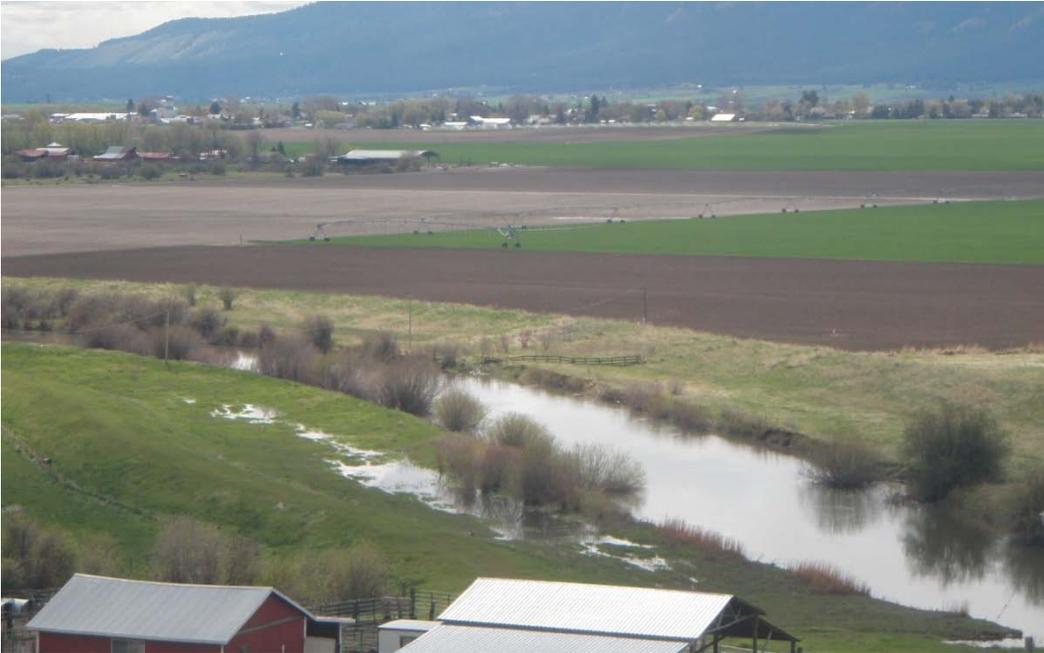
Figure 11. Example of the floodplain along Catherine Creek. Photo taken April 27, 2010.

For the floodplain areas, except the upstream end of Catherine Creek, the roughness was determined assuming the area was agricultural land with crops such as mint. Figure 11 shows an example of the land adjacent to Catherine Creek.

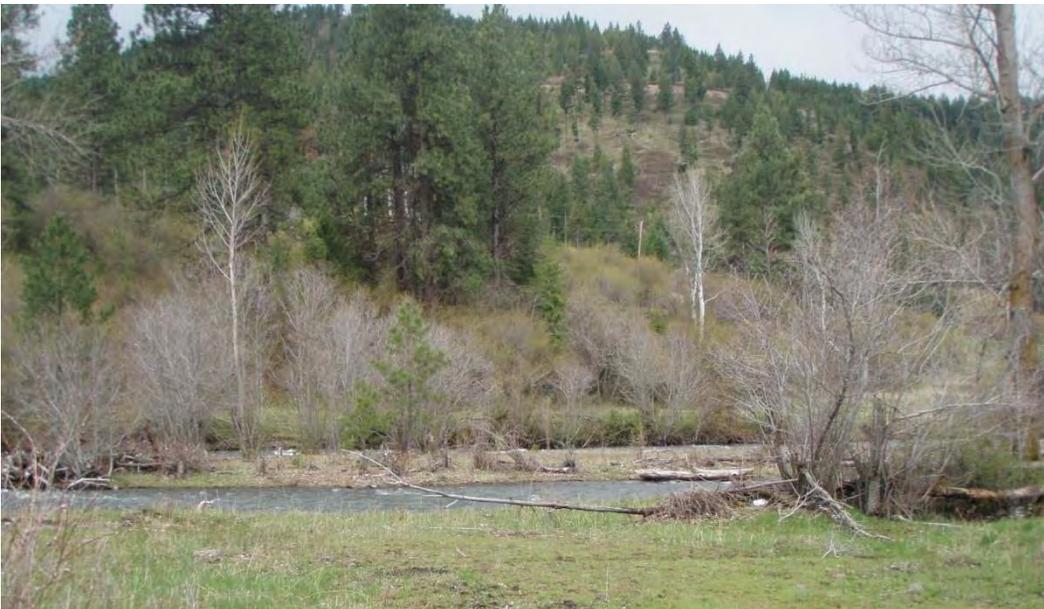
Figure 12. Example of the floodplain along the upstream portion of Catherine Creek in Reach 4. Photo taken April 28, 2010.

At the upstream end of Catherine Creek, agricultural areas are more sparse, and more trees and high relief areas are present (Figure 12). The roughness in the floodplain was increased for this area from 0.035 to 0.075.

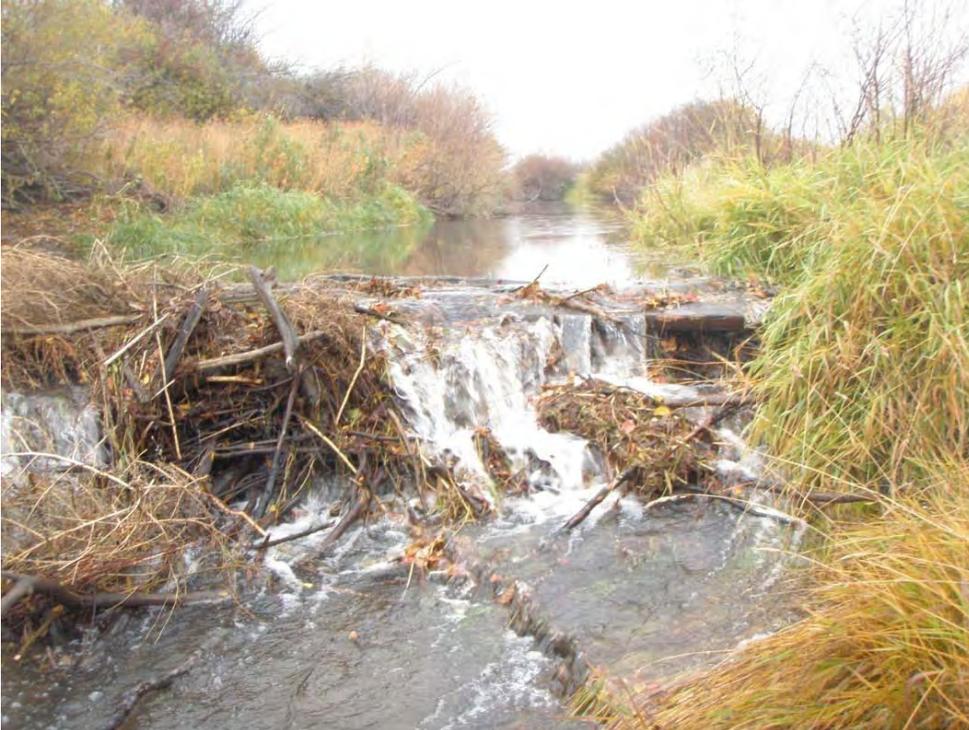
Figure 22. Photograph of Beaver Dam located at RM 24.9 taken October 30, 2010.
