Winthrop Area (W2)

Assessment of Geomorphic and Ecologic Indicators  
Methow River, Methow Subbasin

Okanogan County, Washington

December 2011

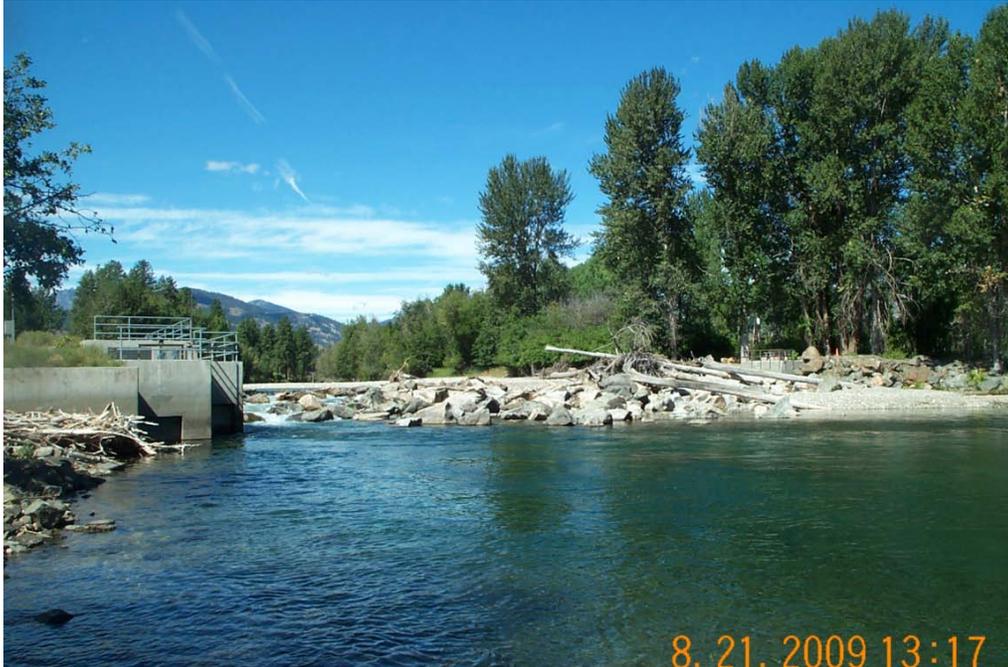
**Figure 7. View to the northwest looking upstream at Foghorn Diversion Dam.** W2 Assessment Area – Methow Subbasin, Washington – Bureau of Reclamation Photograph by E. Lyon, August 21, 2009.

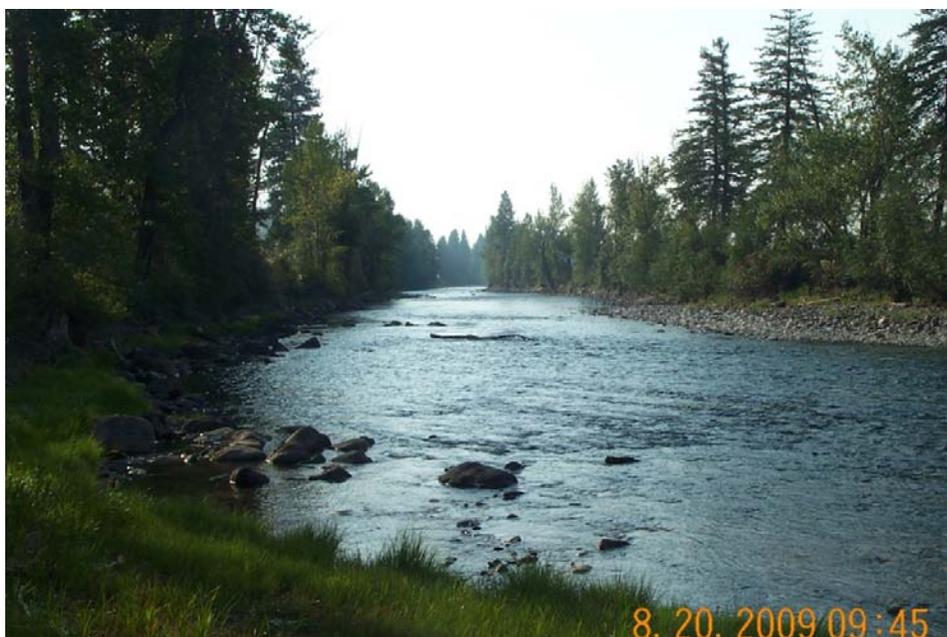
This segment is a steep, straight, moderately confined, plane-bed system. Lateral channel migration is naturally low and is restricted by the Wolf Creek alluvial fan to the south and glacial deposits to the north (Figure 9). Near RM 54.15 bedrock crops out along river left which locally restricts lateral channel migration (Table 14).

**Figure 9. View is to the southeast looking downstream along Channel Segment M8.** W2 Assessment Area – Methow Subbasin, Washington – Bureau of Reclamation Photograph by E. Lyon, August 20, 2009

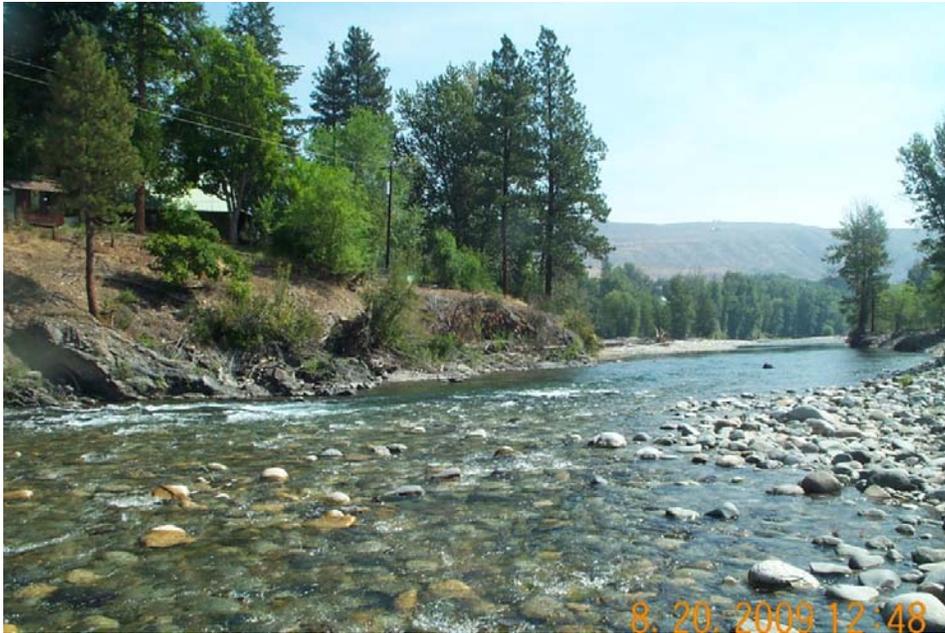
**Figure 15. View is to the northeast looking downstream at a bedrock outcrop along river left near RM 51.6.** W2 Assessment Area – Methow Subbasin, Washington – Bureau of Reclamation Photograph by E. Lyon, August 20, 2009

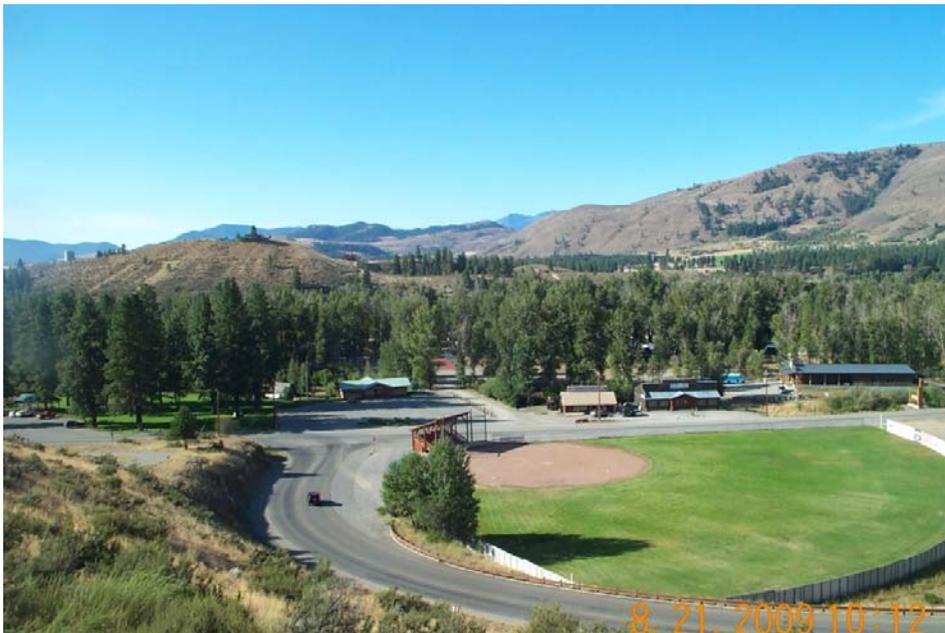
**Figure 17. View is to the south looking at fill and ground leveling for development of floodplain.** W2 Assessment Area – Methow Subbasin, Washington – Bureau of Reclamation Photograph by E. Lyon, August 21, 2009

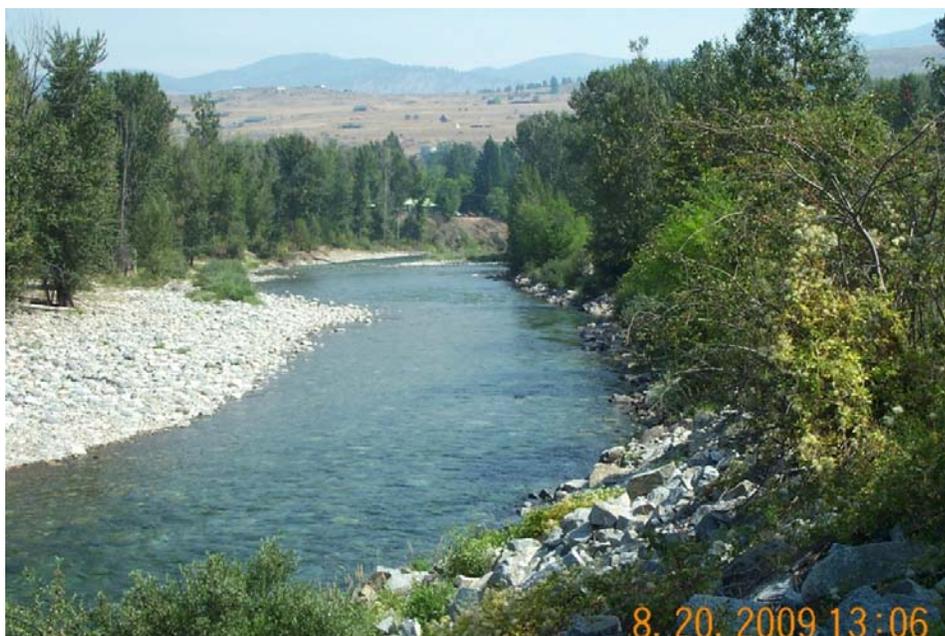
**Figure 18. View to the northeast looking downstream along the hatchery levee on river right.** W2 Assessment Area – Methow Subbasin, Washington – Bureau of Reclamation Photograph by E. Lyon, August 20, 2009

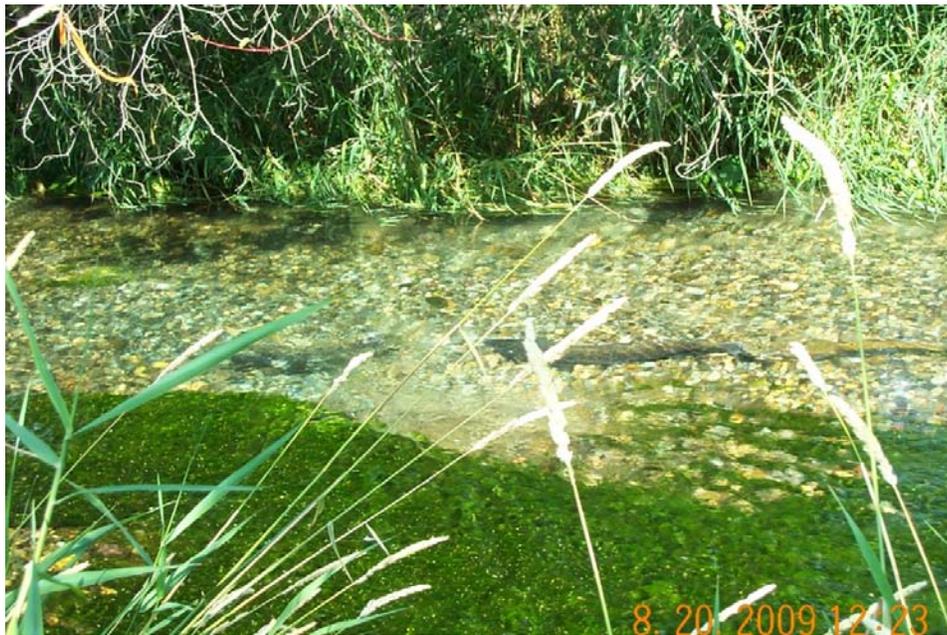
As part of this assessment, side channels were mapped as a separate channel unit and provide the primary off-channel habitat in the section. Side channels were relatively numerous and were generally associated with wood accumulated high on gravel bars and the floodplain. Eight side channels were mapped totaling about 6.15 acres. About 90 percent of the side channels were classified as floodplain-type side channels which typically provide complex micro-habitat and ecological function. One of these side channels that was mapped as a floodplain-type side channel (SC\_51.70R\_FP/ART) was a constructed outfall channel from the fish hatchery that provided spawning and rearing habitat (Figure 23). The remaining side channels were classified as gravel bar-type side channels which generally provide spawning and rearing habitat (Table 27).

**Figure 23. Salmon spawning along the hatchery outfall channel.** W2 Assessment Area – Methow Subbasin, Washington – Bureau of Reclamation  
Photograph by E. Lyon, August 20, 2009

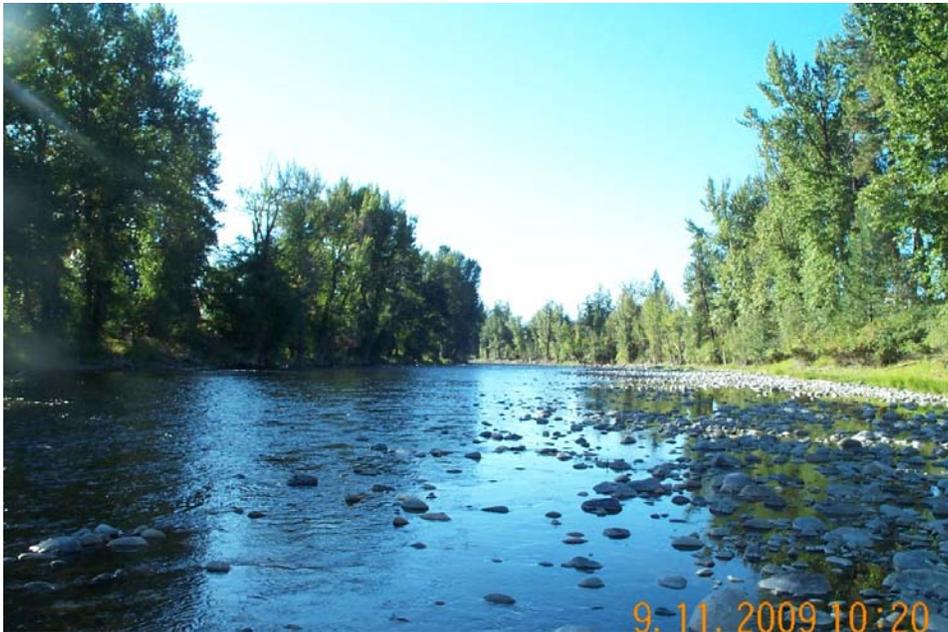
**Figure 26. View to the southeast looking downstream at the thin strip of vegetation along the floodplain.** W2 Assessment Area – Methow Subbasin, Washington – Bureau of Reclamation Photograph by E. Lyon, September 11, 2009

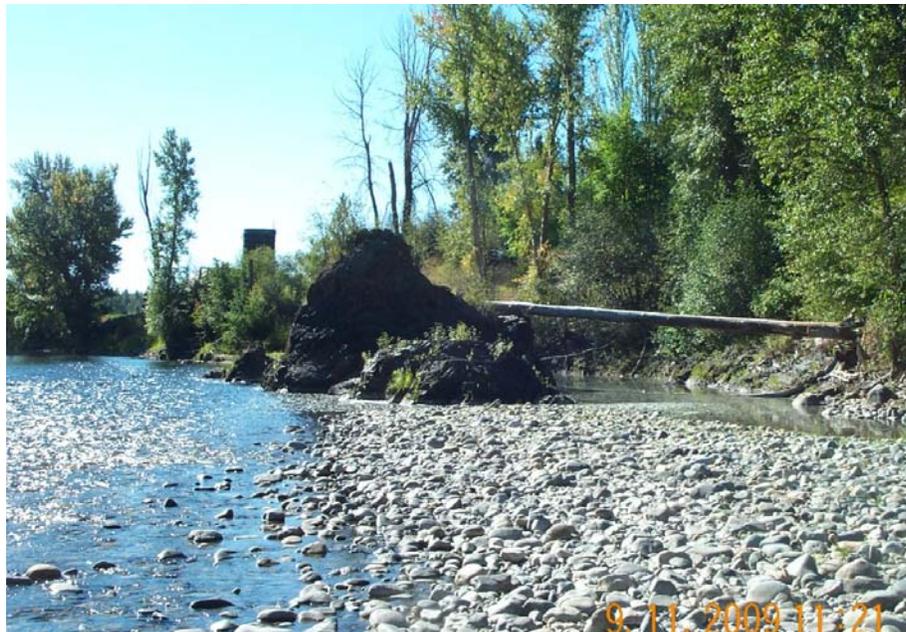
**Figure 31. View to the south looking downstream at low flow gravel bar-type side channel along river right and bedrock outcrop.** W2 Assessment Area – Methow Subbasin, Washington – Bureau of Reclamation Photograph by E. Lyon, September 11, 2009

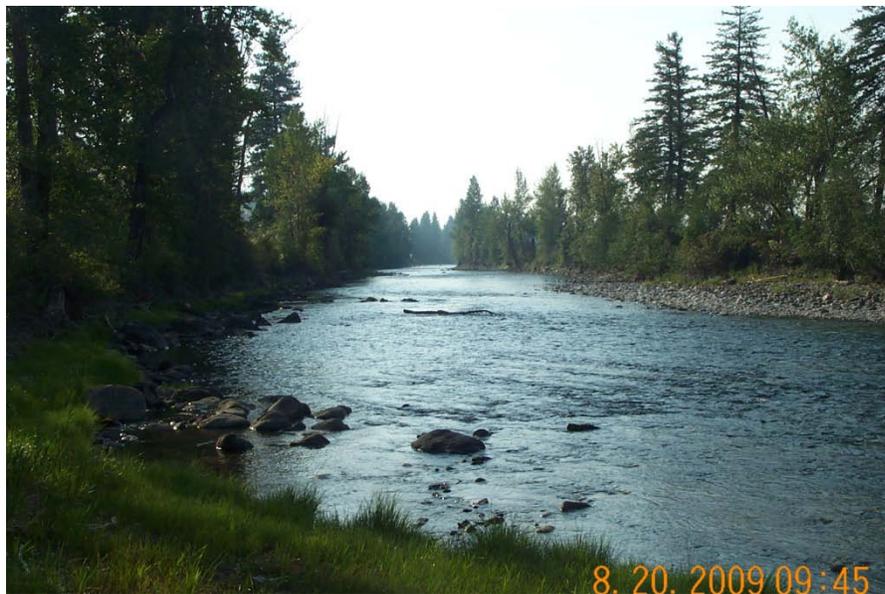
**Photograph No. 1. View to the southeast looking downstream at pocket-pool habitat created by large boulders.** W2 Assessment – Methow Subbasin, Washington – Bureau of Reclamation Photograph by E. Lyon, August 20, 2009.

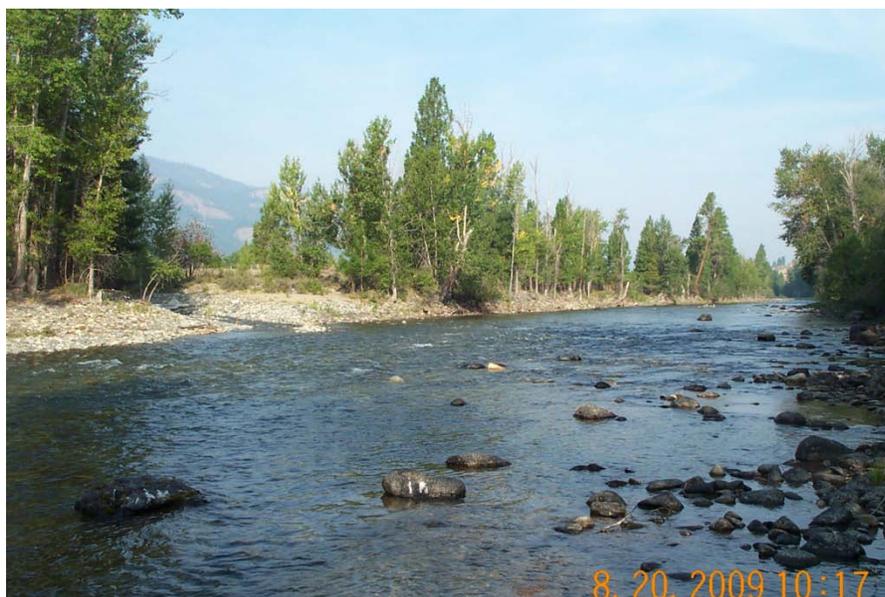
**Photograph No. 2. View to the northwest looking across the river at the confluence of Wolf Creek.** W2 Assessment – Methow Subbasin, Washington – Bureau of Reclamation Photograph by E. Lyon, August 20, 2009.

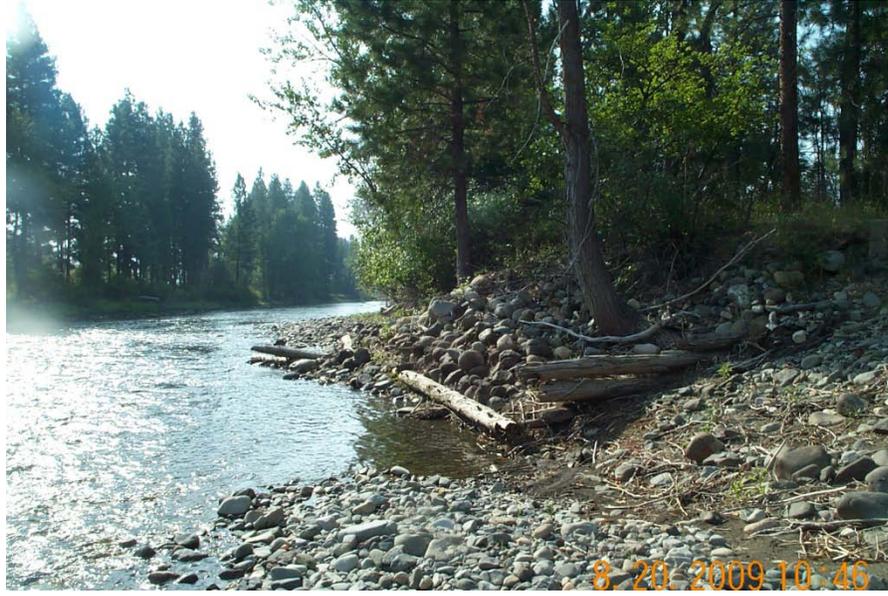
**Photograph No. 3. View to the southeast looking downstream along river right at bank protection at a historic diversion site downstream of Wolf Creek. W2 Assessment – Methow Subbasin, Washington – Bureau of Reclamation Photograph by E. Lyon, August 20, 2009.**

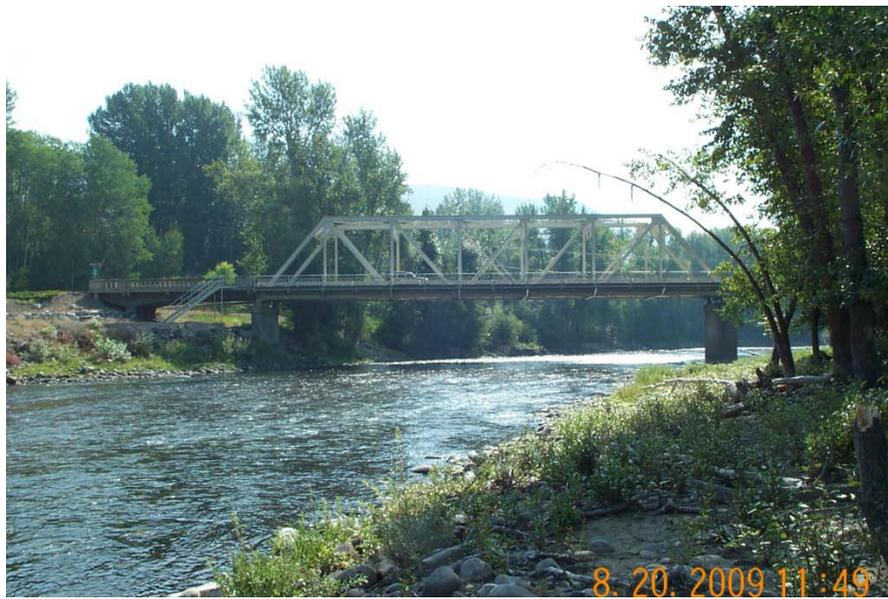
**Photograph No. 4. View to the southeast looking downstream at the Winthrop Bridge. W2 Assessment – Methow Subbasin, Washington – Bureau of Reclamation Photograph by E. Lyon, August 20, 2009.**

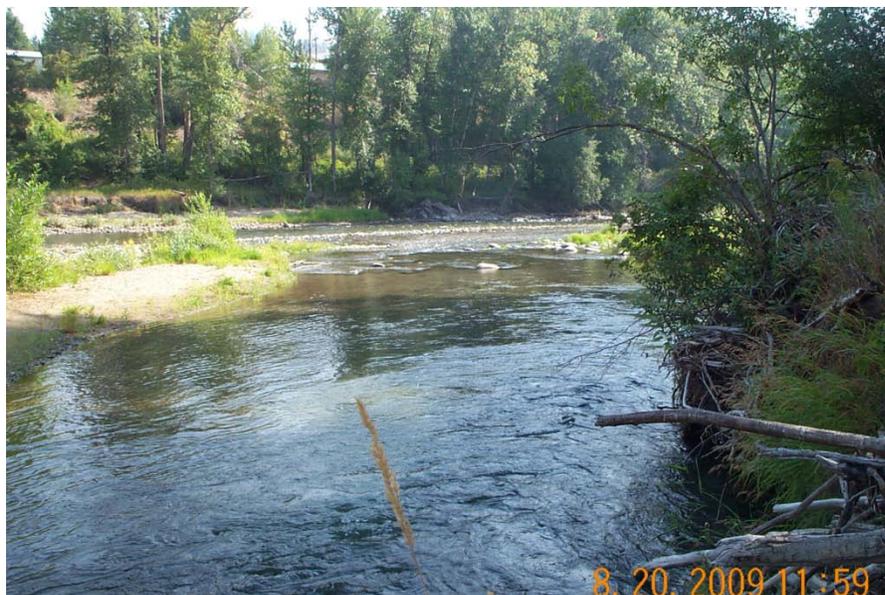
**Photograph No. 5. View to the east looking downstream at a pool in the Winthrop Hatchery side channel where salmon were holding.** W2 Assessment – Methow Subbasin, Washington – Bureau of Reclamation  
Photograph by E. Lyon, August 20, 2009.

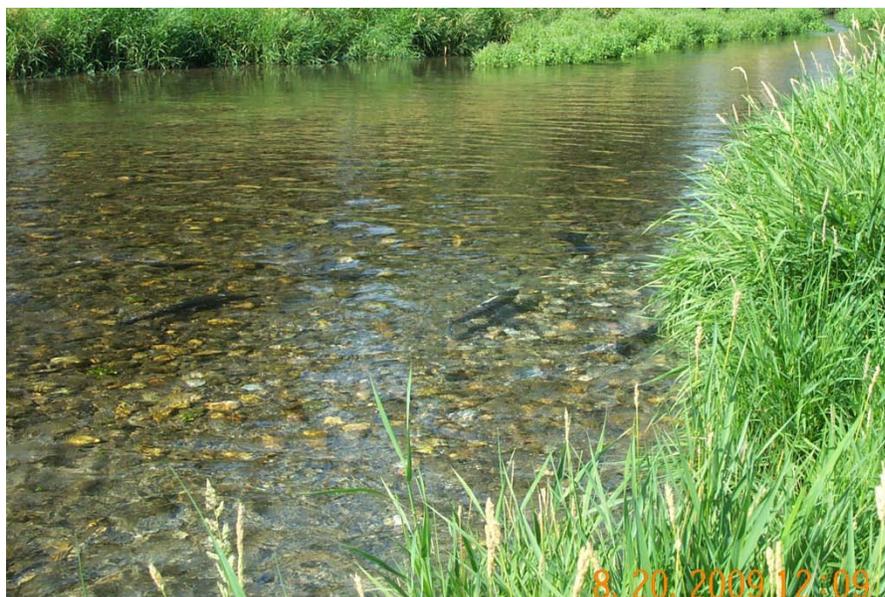
**Photograph No. 6. View to the southwest looking at salmon spawning in a run along the Winthrop Hatchery side channel.** W2 Assessment – Methow Subbasin, Washington – Bureau of Reclamation  
Photograph by E. Lyon, August 20, 2009.

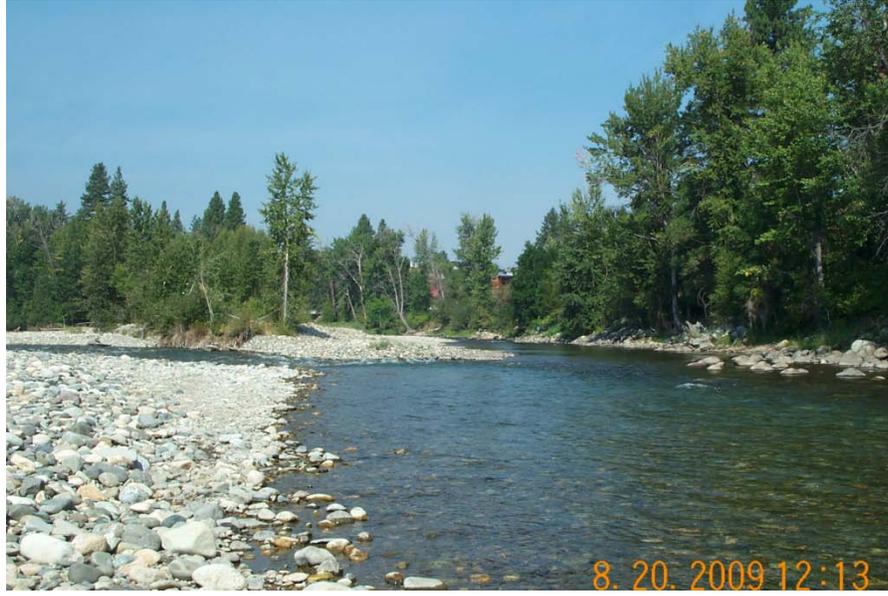
**Photograph No. 7. View to the northeast looking upstream at the confluence of the Chewuch River.** W2 Assessment – Methow Subbasin, Washington – Bureau of Reclamation Photograph by E. Lyon, August 20, 2009.

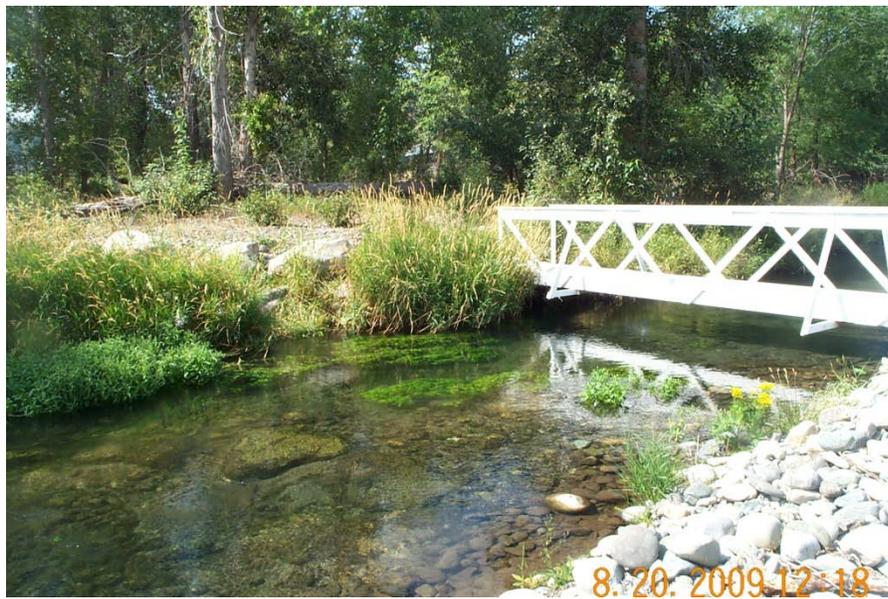
**Photograph No. 8. View to the west looking upstream at foot-bridge along the Winthrop Hatchery side channel. Note riprap along river right and grade-control structure in stream.** W2 Assessment – Methow Subbasin, Washington – Bureau of Reclamation Photograph by E. Lyon, August 20, 2009.

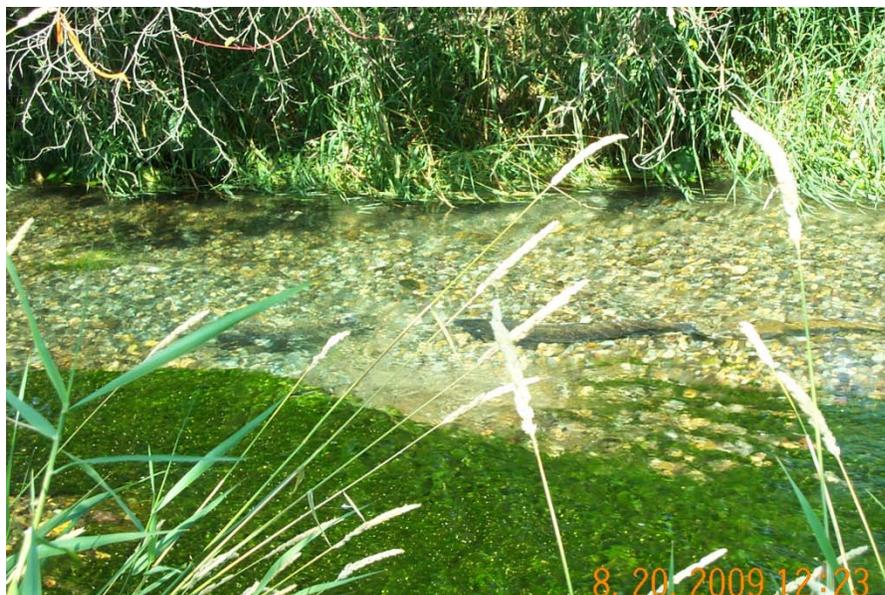
**Photograph No. 9. View to the west looking at salmon spawning in a run along the Winthrop Hatchery side channel. W2 Assessment – Methow Subbasin, Washington – Bureau of Reclamation Photograph by E. Lyon, August 20, 2009.**

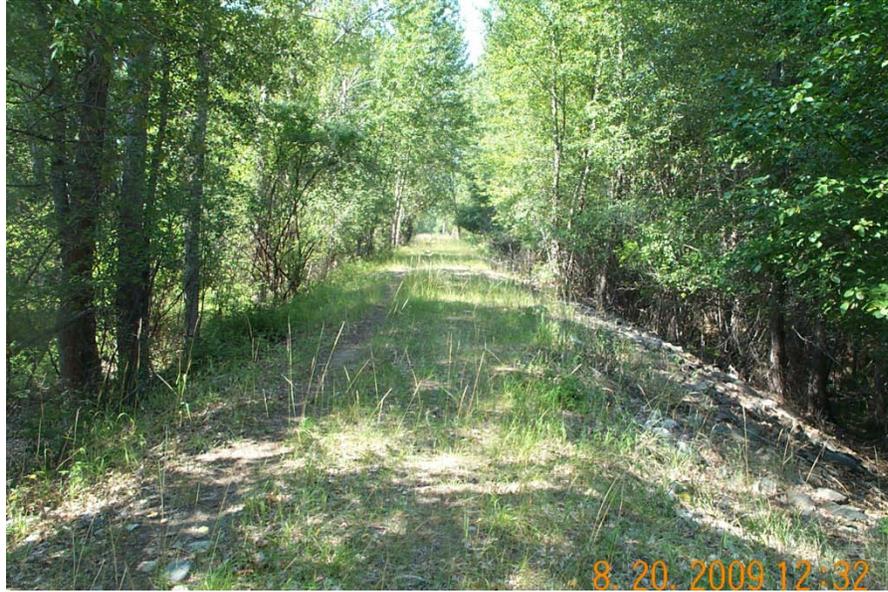
**Photograph No. 11. View to the west looking at the Winthrop Fish Hatchery levee.** W2 Assessment – Methow Subbasin, Washington – Bureau of Reclamation Photograph by E. Lyon, August 20, 2009.

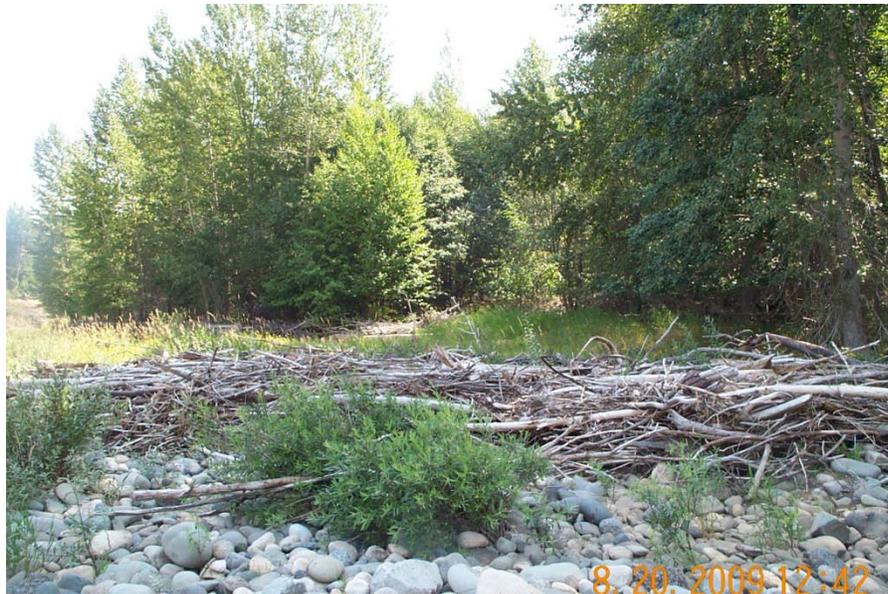
**Photograph No. 12. View to the east looking downstream at a small-to-medium size wood complex deposited at the head of a developing side channel.** W2 Assessment – Methow Subbasin, Washington – Bureau of Reclamation Photograph by E. Lyon, August 20, 2009.

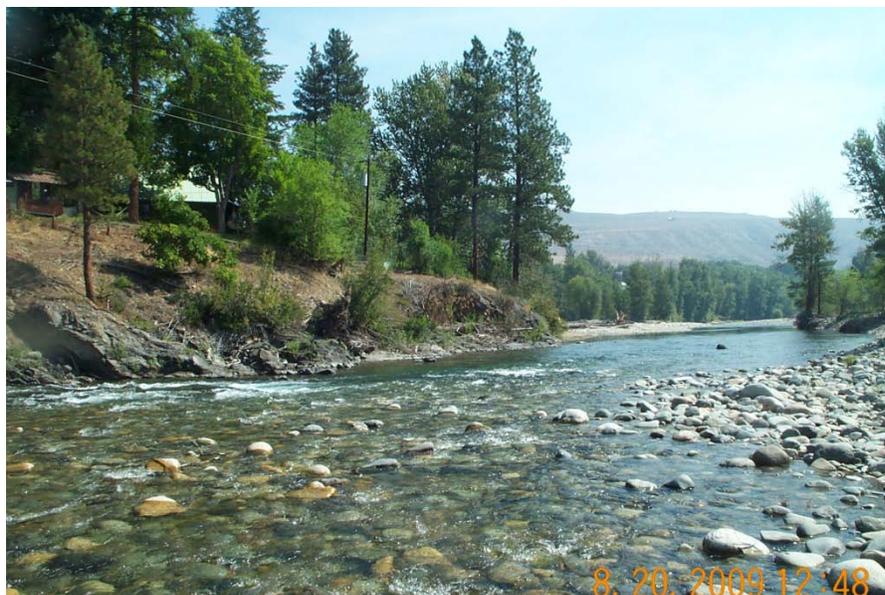
**Photograph No. 13. View to the northeast looking downstream at a bedrock outcrop along river left and the developing pool created by lateral scour.** W2 Assessment – Methow Subbasin, Washington – Bureau of Reclamation Photograph by E. Lyon, August 20, 2009.

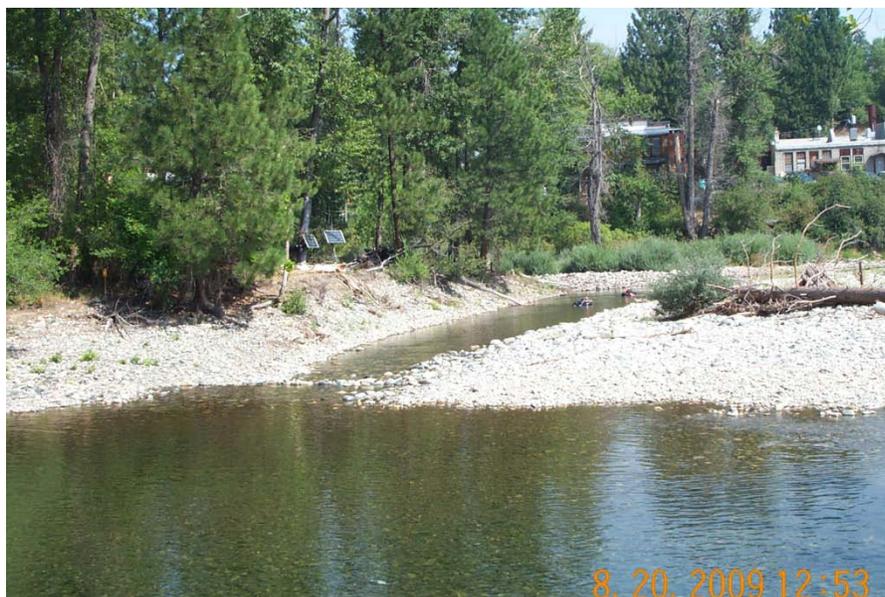
**Photograph No. 14. View to the north looking across at a gravel bar type side channel that flows from the Methow River into the Chewuch River.** W2 Assessment – Methow Subbasin, Washington – Bureau of Reclamation Photograph by E. Lyon, August 20, 2009.

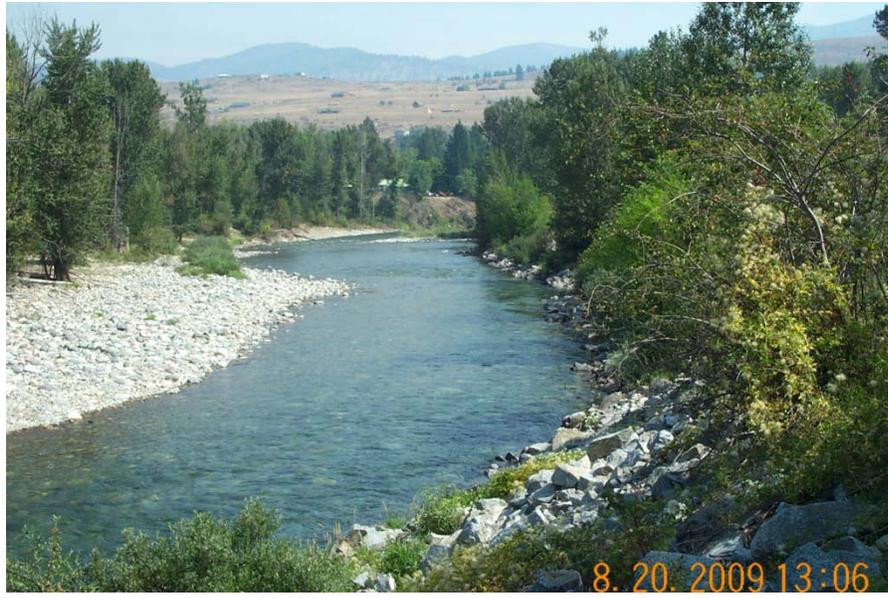
**Photograph No. 15. View to the northeast looking downstream along the Winthrop Fish Hatchery levee along river right.** W2 Assessment – Methow Subbasin, Washington – Bureau of Reclamation Photograph by E. Lyon, August 20, 2009.

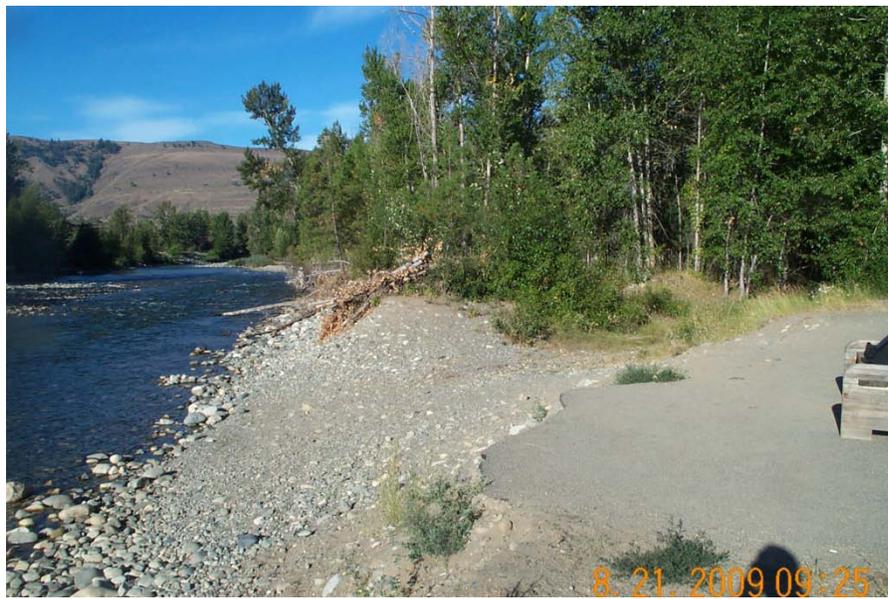
**Photograph No. 16. View to the west looking upstream at the tail of a side channel in Winthrop Park.** W2 Assessment – Methow Subbasin, Washington – Bureau of Reclamation Photograph by E. Lyon, August 21, 2009.

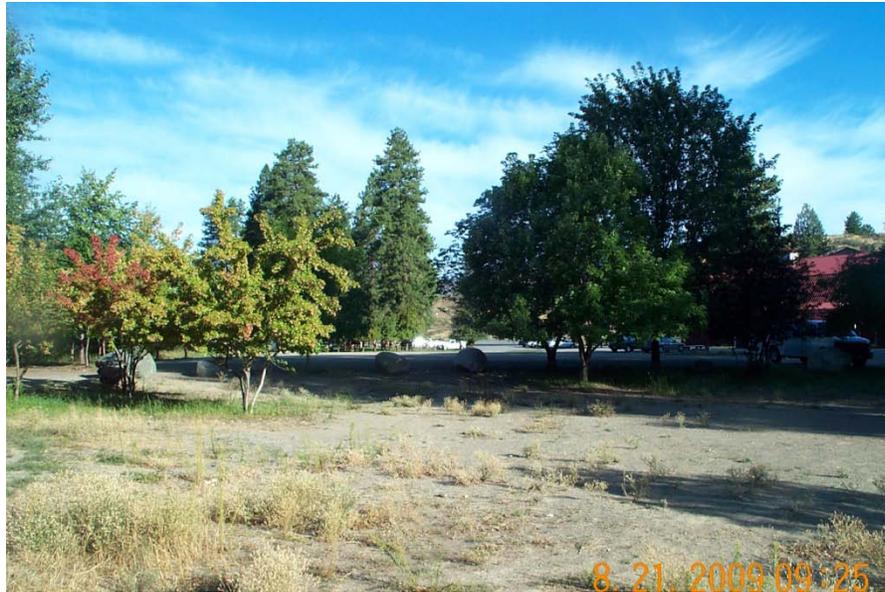
**Photograph No. 17. View to the northeast looking at fill placed in floodplain in Winthrop Park. W2 Assessment – Methow Subbasin, Washington – Bureau of Reclamation Photograph by E. Lyon, August 21, 2009.**

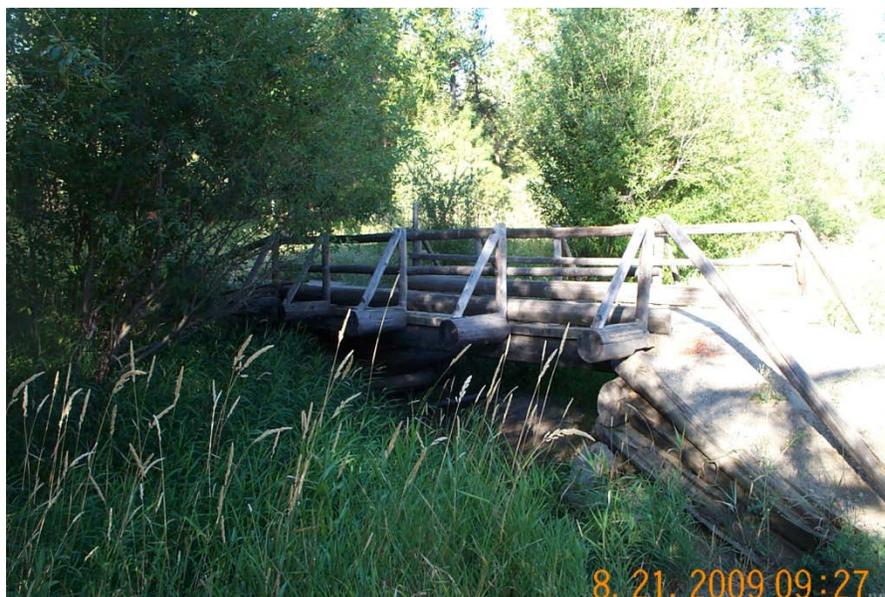
**Photograph No. 18. View to the west looking at a footbridge placed across a side channel in Winthrop Park. W2 Assessment – Methow Subbasin, Washington – Bureau of Reclamation Photograph by E. Lyon, August 21, 2009.**

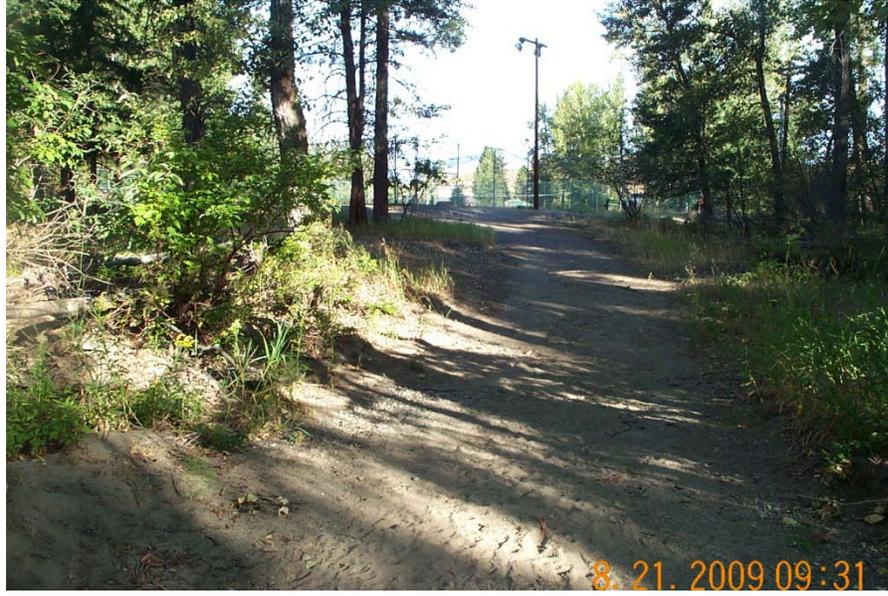
**Photograph No. 19. View to the north looking at a side channel crossing and relative elevation of fill placed in the floodplain in Winthrop Park. Note the sandy flood deposits in side channel. W2 Assessment – Methow Subbasin, Washington – Bureau of Reclamation Photograph by E. Lyon, August 21, 2009.**

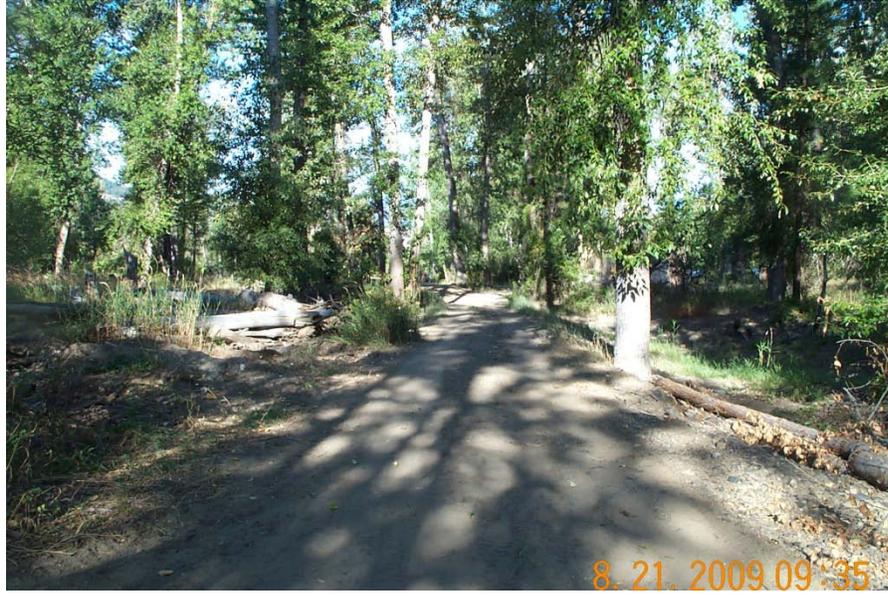
**Photograph No. 21. View to the west looking at an elevated road embankment placed across floodplain near Winthrop Park. W2 Assessment – Methow Subbasin, Washington – Bureau of Reclamation Photograph by E. Lyon, August 21, 2009.**

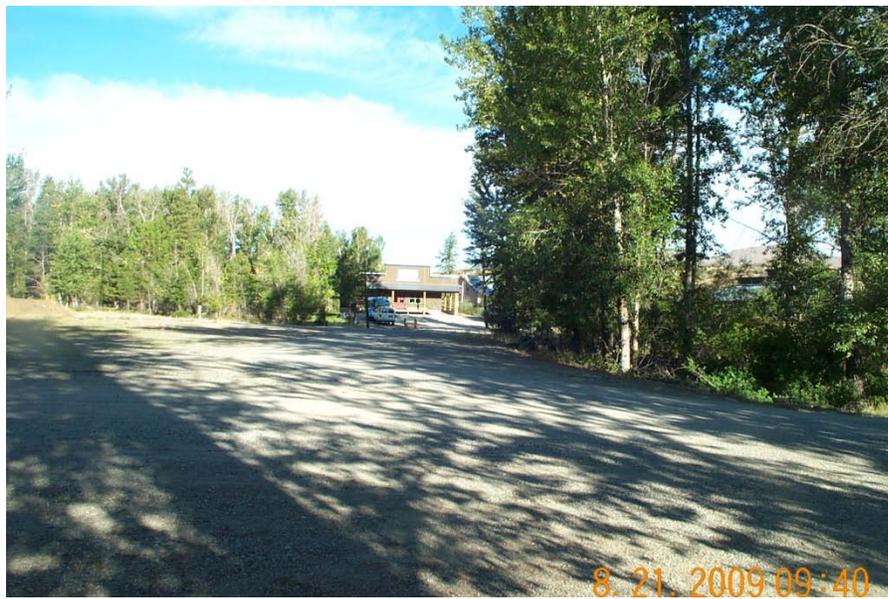
**Photograph No. 22. View to the west looking at fill placed in floodplain near Winthrop Park. W2 Assessment – Methow Subbasin, Washington – Bureau of Reclamation Photograph by E. Lyon, August 21, 2009.**

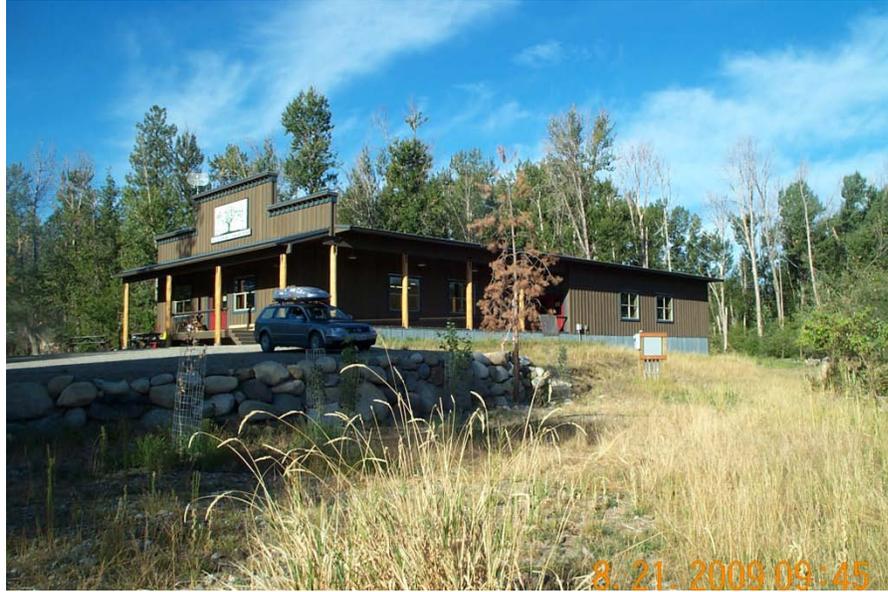
**Photograph No. 23. View to the southwest looking at a school building built on fill placed within the floodplain.** W2 Assessment – Methow Subbasin, Washington – Bureau of Reclamation Photograph by E. Lyon, August 21, 2009.

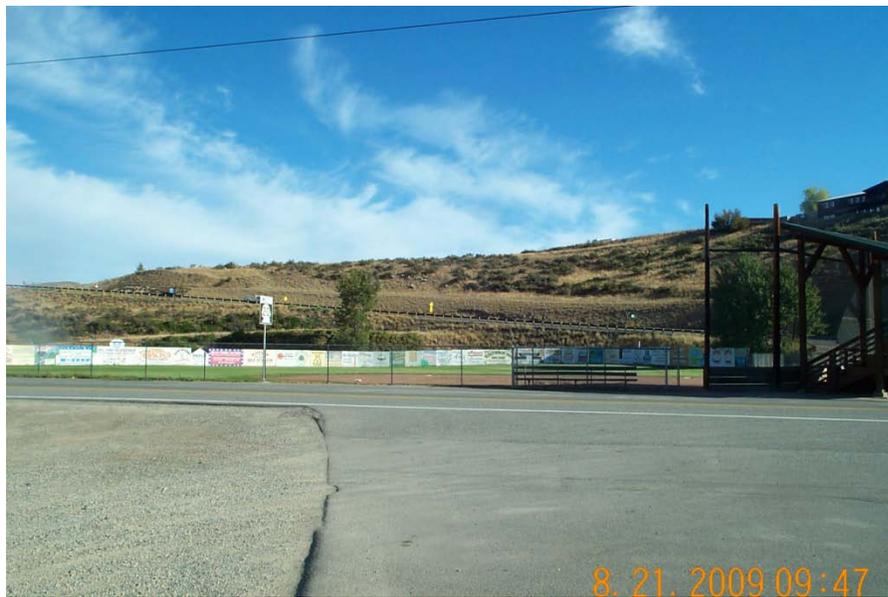
**Photograph No. 24. View to the northwest looking at a baseball field built on fill placed within the floodplain.** W2 Assessment – Methow Subbasin, Washington – Bureau of Reclamation Photograph by E. Lyon, August 21, 2009.

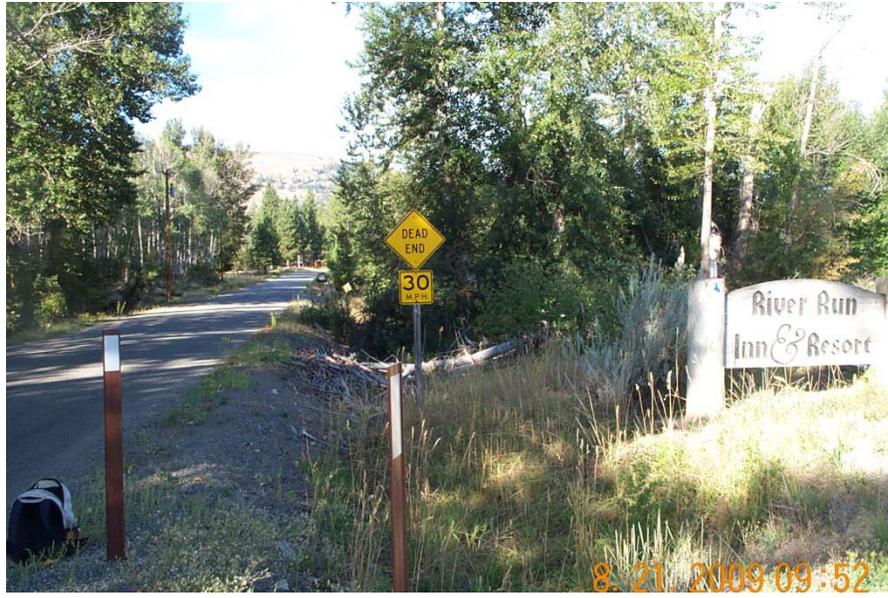
**Photograph No. 25. View to the southwest looking at an elevated road embankment placed within the floodplain.** W2 Assessment – Methow Subbasin, Washington – Bureau of Reclamation Photograph by E. Lyon, August 21, 2009.

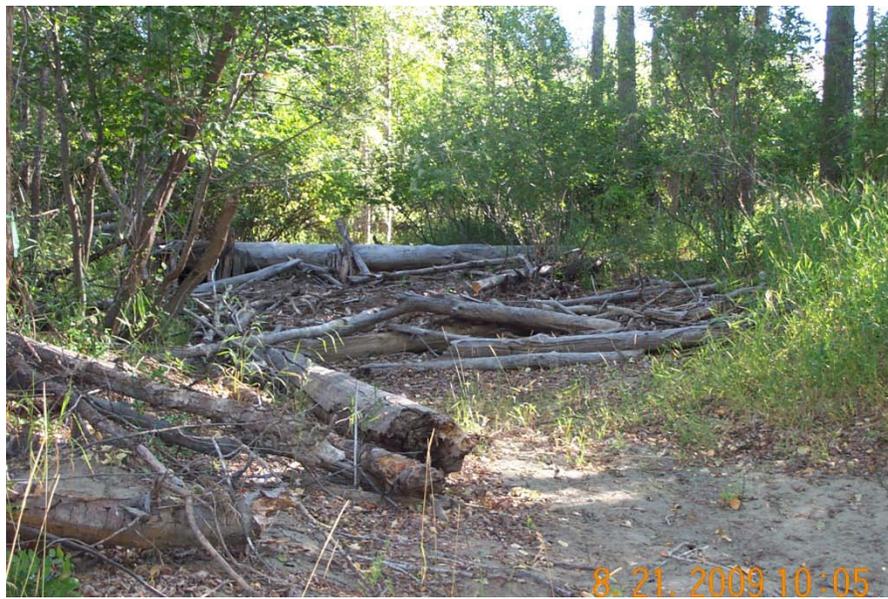
**Photograph No. 26. View to the northeast looking downstream along a side channel near Winthrop Park.** W2 Assessment – Methow Subbasin, Washington – Bureau of Reclamation Photograph by E. Lyon, August 21, 2009.

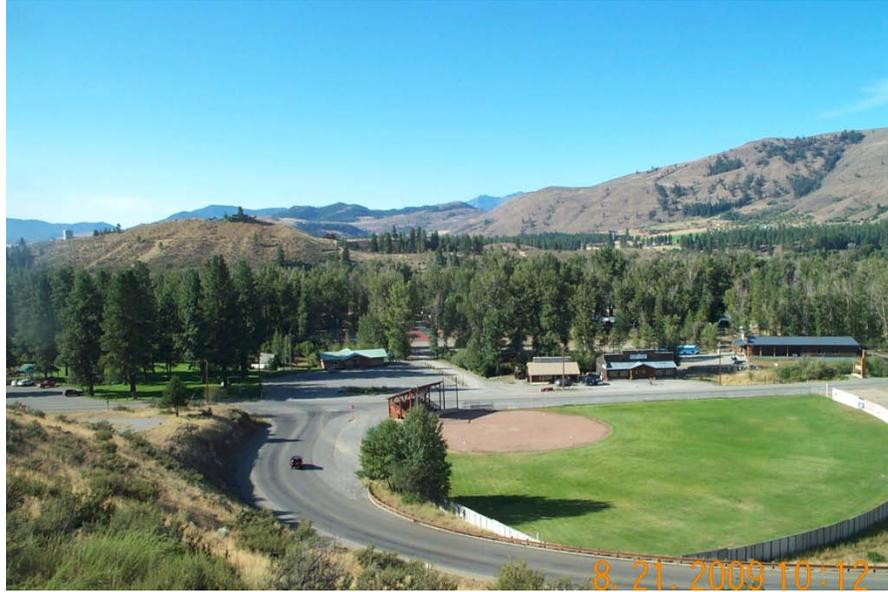
**Photograph No. 27. View to the south looking at the development that has occurred in the floodplain.** W2 Assessment – Methow Subbasin, Washington – Bureau of Reclamation Photograph by E. Lyon, August 21, 2009.

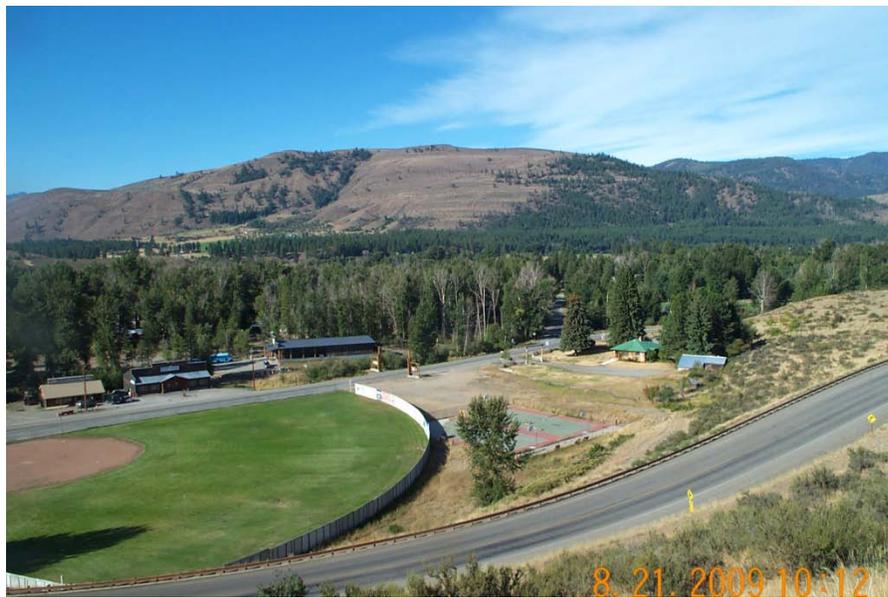
**Photograph No. 28. View to the southwest looking at the development that has occurred in the floodplain.** W2 Assessment – Methow Subbasin, Washington – Bureau of Reclamation Photograph by E. Lyon, August 21, 2009.

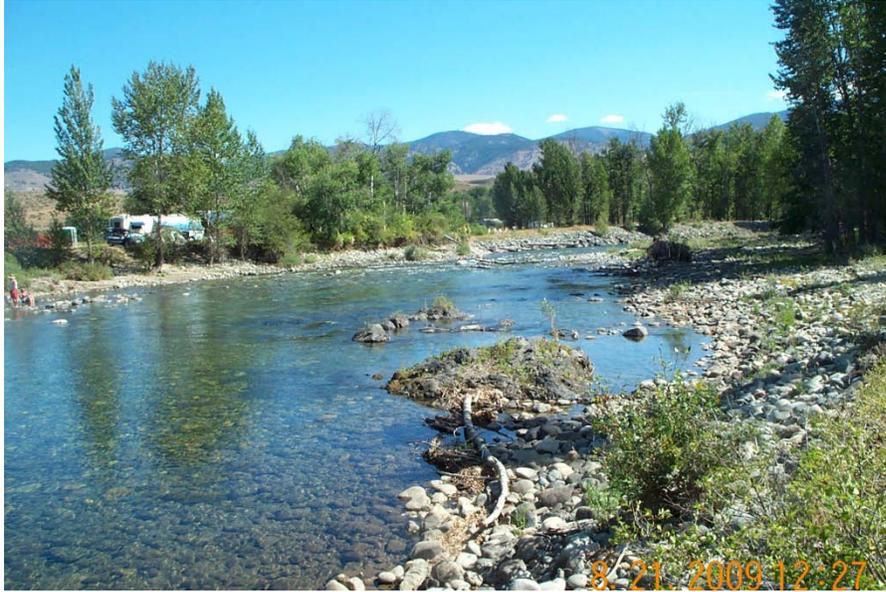
**Photograph No. 29. View to the northwest looking downstream at bedrock in the channel. W2 Assessment – Methow Subbasin, Washington – Bureau of Reclamation Photograph by E. Lyon, August 21, 2009.**

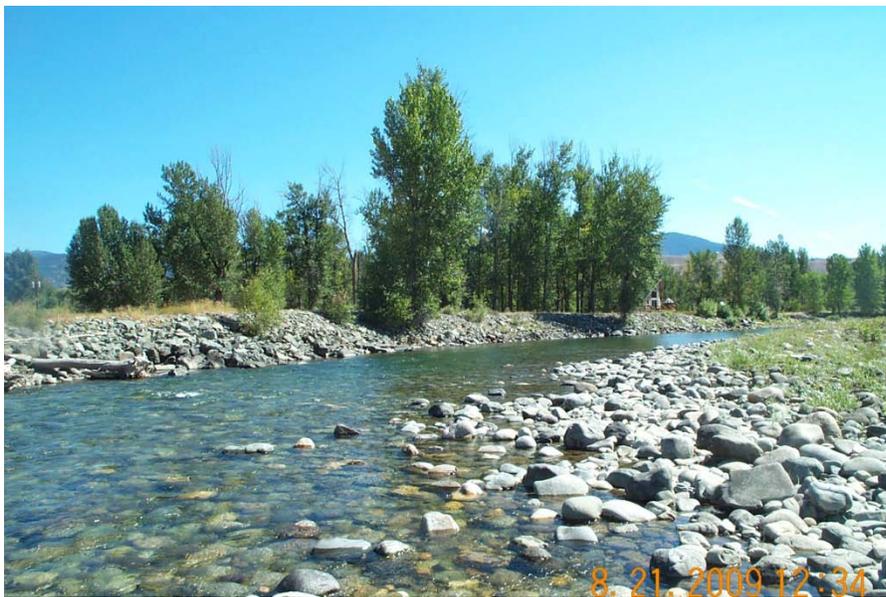
**Photograph No. 30. View to the east looking downstream at riprap placed along river left. W2 Assessment – Methow Subbasin, Washington – Bureau of Reclamation Photograph by E. Lyon, August 21, 2009.**

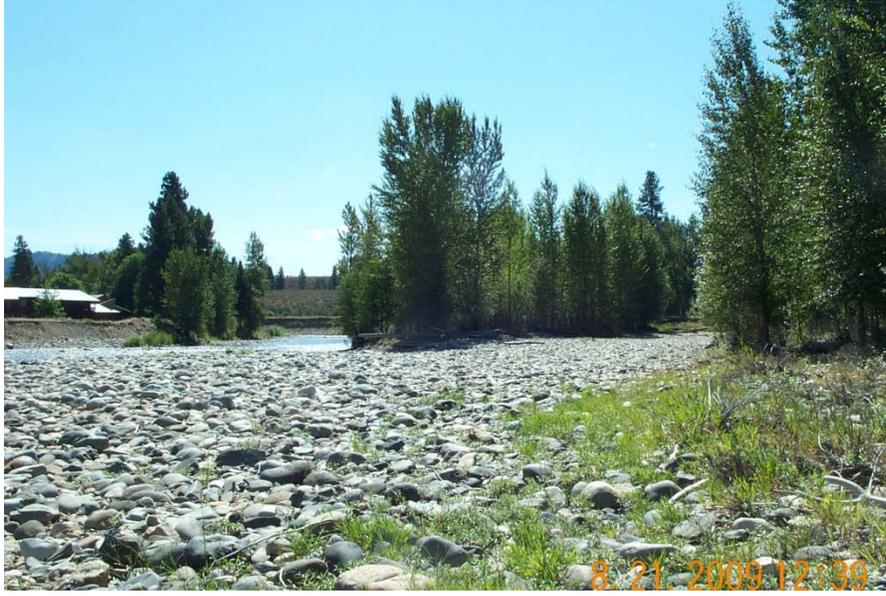
**Photograph No. 31. View to the southeast looking downstream at head of side channel along river right.** W2 Assessment – Methow Subbasin, Washington – Bureau of Reclamation Photograph by E. Lyon, August 21, 2009.
