Winthrop Area (W2)

Assessment of Geomorphic and Ecologic Indicators  
Methow River, Methow Subbasin

Okanogan County, Washington

December 2011

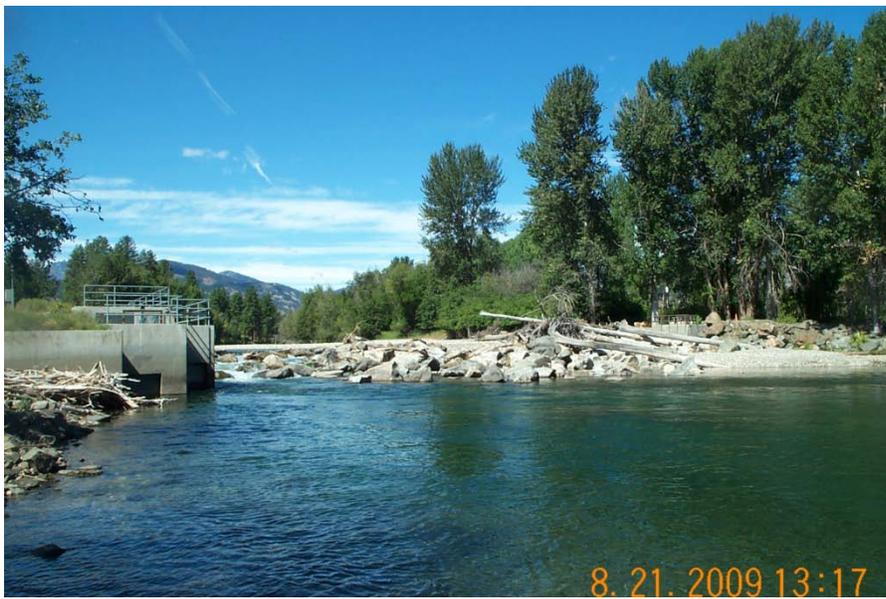
**Photograph No. 32. View to the northwest looking upstream at Foghorn Diversion Dam.** W2 Assessment – Methow Subbasin, Washington – Bureau of Reclamation Photograph by E. Lyon, August 21, 2009.

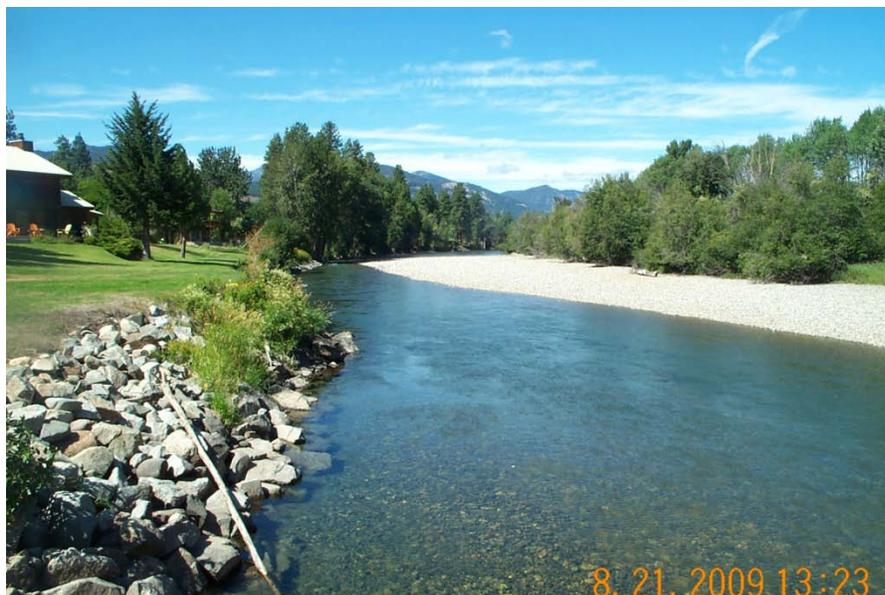
**Photograph No. 33. View to the west looking upstream at riprap placed along river right upstream of Foghorn Diversion Dam.** W2 Assessment – Methow Subbasin, Washington – Bureau of Reclamation  
Photograph by E. Lyon, August 21, 2009.

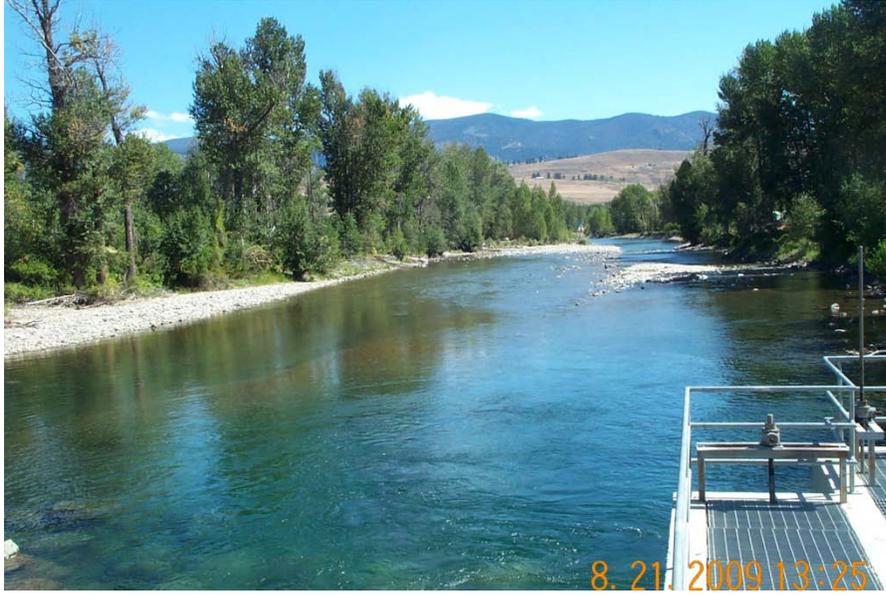
**Photograph No. 35. View is to the east looking downstream from Foghorn Diversion Dam at scour pool below the dam where numerous salmon were holding.** W2 Assessment – Methow Subbasin, Washington – Bureau of Reclamation Photograph by E. Lyon, August 21, 2009.

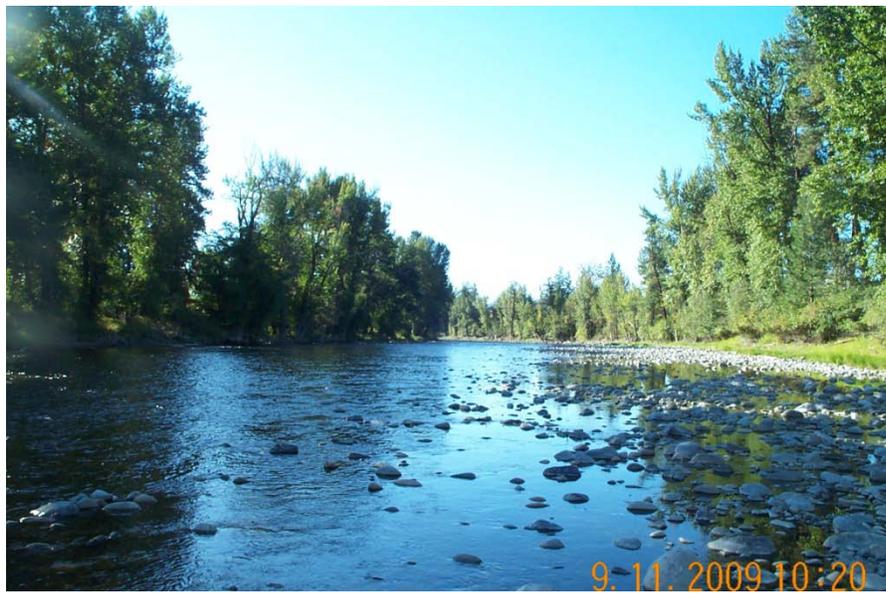
**Photograph No. 36. View to the south looking downstream at active channel area and riparian vegetation along the channel margin.** W2 Assessment – Methow Subbasin, Washington – Bureau of Reclamation Photograph by E. Lyon, August 21, 2009.

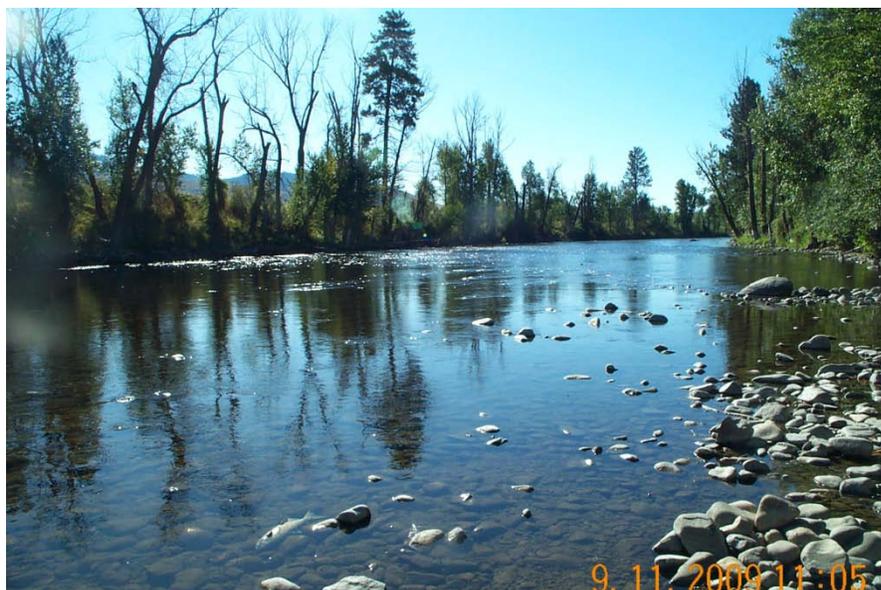
**Photograph No. 38. View to the south looking downstream at active channel and riparian vegetation along the channel margin.** W2 Assessment – Methow Subbasin, Washington – Bureau of Reclamation Photograph by E. Lyon, August 21, 2009.

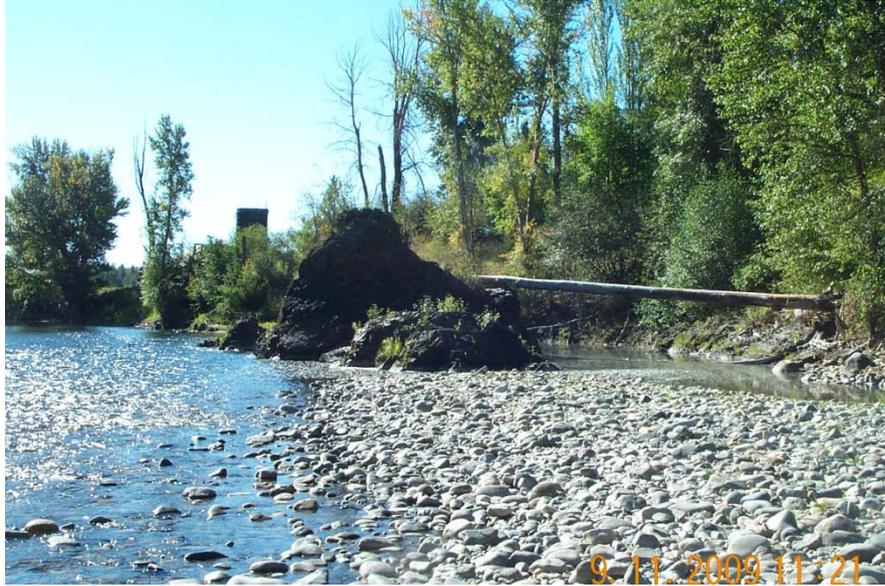
**Photograph No. 39. View to the south looking downstream at bedrock in active channel area that had contributed to the development of a lateral scour pool to the left and side channel to the right. W2 Assessment – Methow Subbasin, Washington – Bureau of Reclamation Photograph by E. Lyon, August 21, 2009.**
