Caspian Tern Deterrence at Reclamation's Columbia Basin Project Facilities

2023 Final Report to Bureau of Reclamation

**United States Department of Agriculture
Animal and Plant Health Inspection Service
Wildlife Services**

19 December 2023

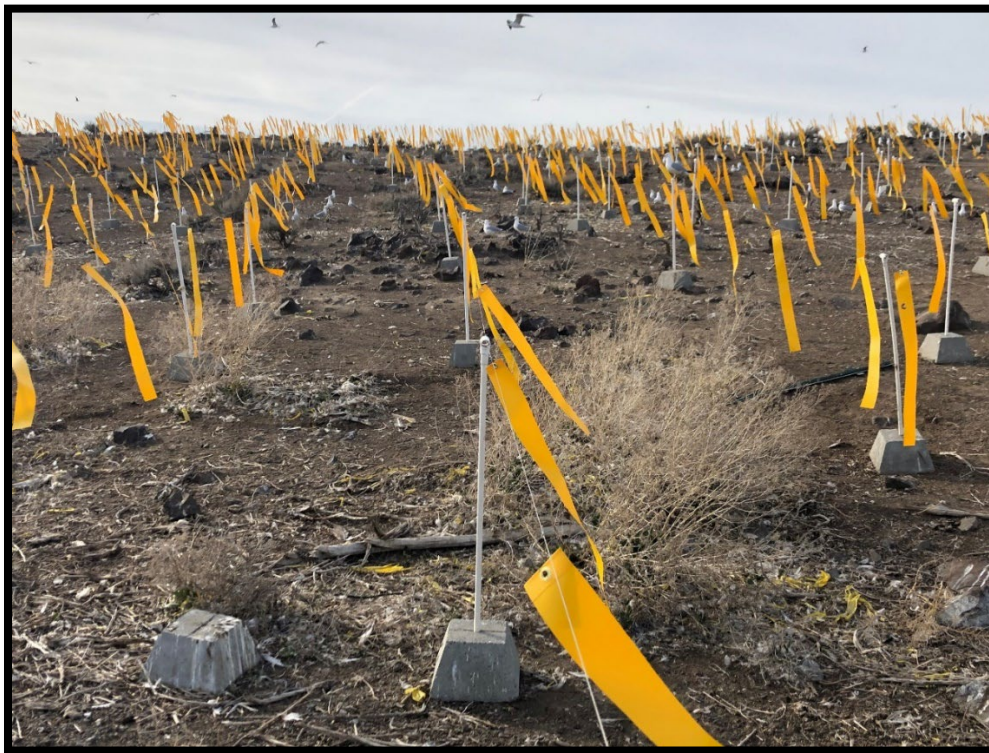
FIGURE 1. EASTERN ASPECT OF MAIN ISLAND ROCKS OF THE UPGRADED PASSIVE DISSUASION SYSTEM CONSTRUCTED BY USDA-WS IN 2022.

The polyurethane rope and caution tape flagging system used during the 2020 season required nearly weekly maintenance. In 2021, flagging was updated from polyurethane rope to stainless steel cables and vinyl flagging (Figure 1), reducing maintenance after high-wind events. In 2022, USDA-WS began tracking flagging maintenance. In 2023, heavier gauge cables and wire clips were deployed on high wind surfaces (Figure 2), resulting in only one day in 2023 with maintenance actions reported. Although the flagging approach was approved through coordination with the U.S. Fish and Wildlife Service, these updates reduce litter and reduce disturbance to nesting gulls from flagging maintenance compared to the previous systems.

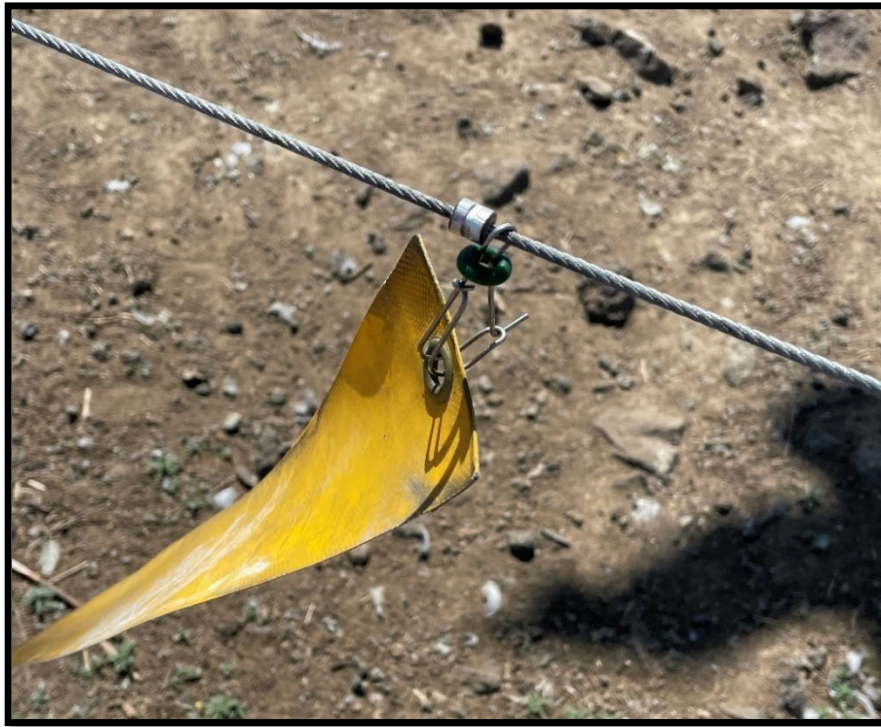
FIGURE 2. HEAVIER GAUGE CABLE AND NEW FLAG ATTACHMENT.

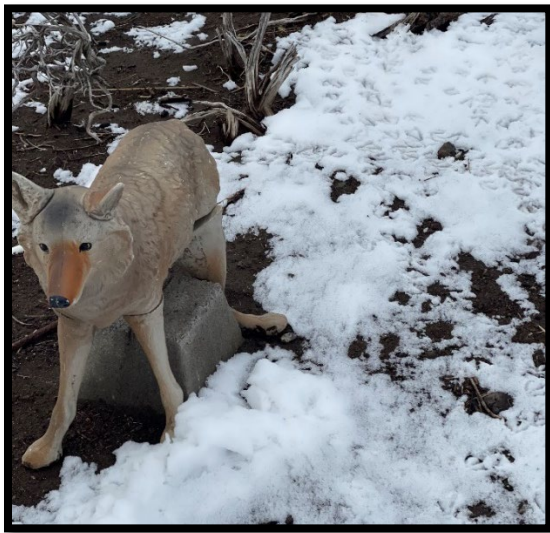
FIGURE 3. PHOTO SHOWING THAT THE COYOTE EFFIGY DID NOT NEGATIVELY IMPACT GULLS, AS EVIDENCED BY THE NUMEROUS GULL TRACKS SURROUNDING THE EFFIGY.

In 2022, USDA-WS incorporated a coyote effigy to enhance CATE dissuasion and its use was continued in 2023. The effigy remained effective in 2023, as CATE did not attempt to nest in proximity to the coyote effigy, but it did not deter geese or gulls (Figure 3) as had been expected based on prior experiences. The coyote effigy was stolen in 2023; once a replacement was procured, it was deployed in the region of Goose Island where CATE nesting was most concentrated.

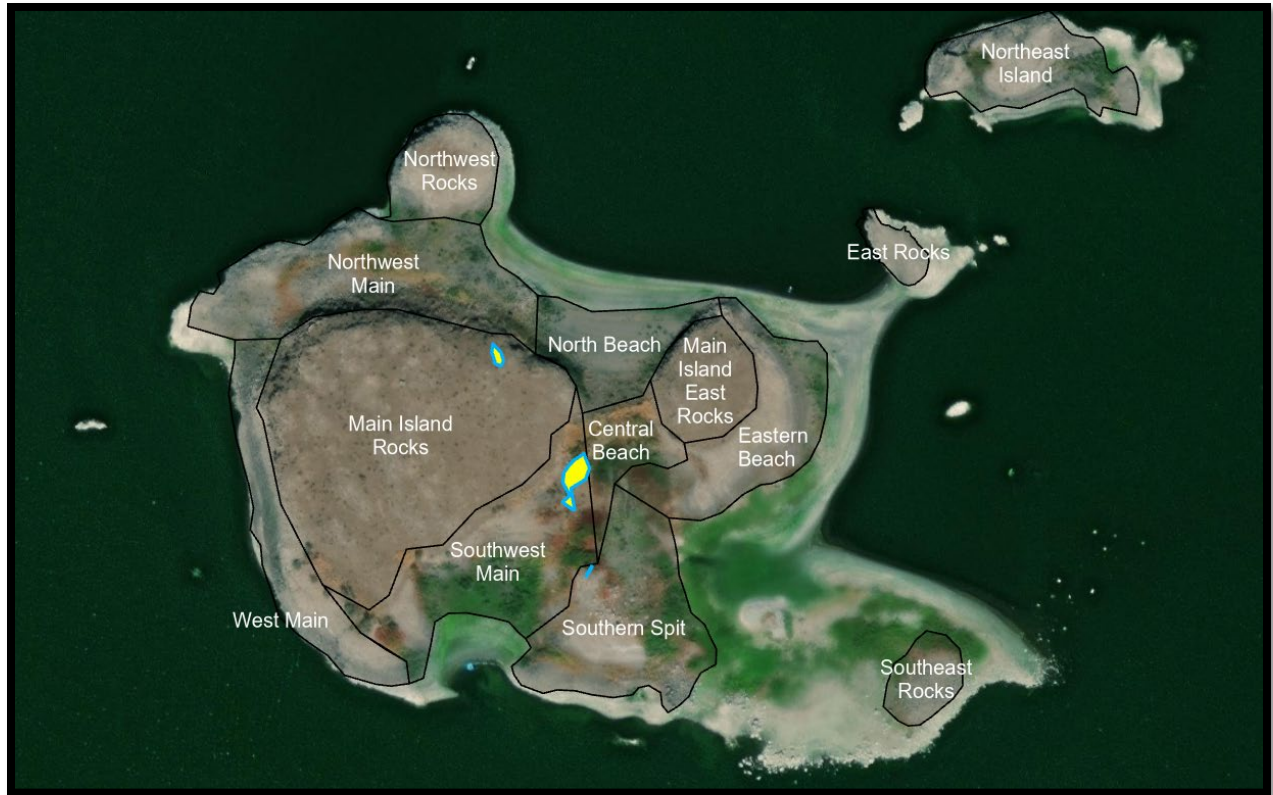
FIGURE 4. AERIAL DELINEATION AND TEMPORARY FLAGGING ADDITIONS FOR 2023, GOOSE ISLAND, POTHOLAS RESERVOIR.

Where CATE attempted to nest, additional temporary flagging was deployed to disrupt those attempts (Figure 4). In areas with existing flagging, additional polyurethane rope or cable was added to existing anchors and flags were added to the lines. In areas where no existing flagging was deployed, silt fence or PVC pipes were driven into the sand with rebar to support additional rope/cable and flags. In some cases, CATE started nesting on the periphery of existing flagging, necessitating additional temporary flagging. In other situations, lowering water levels exposed new nesting areas; once CATE nesting was observed, additional temporary flagging was deployed.

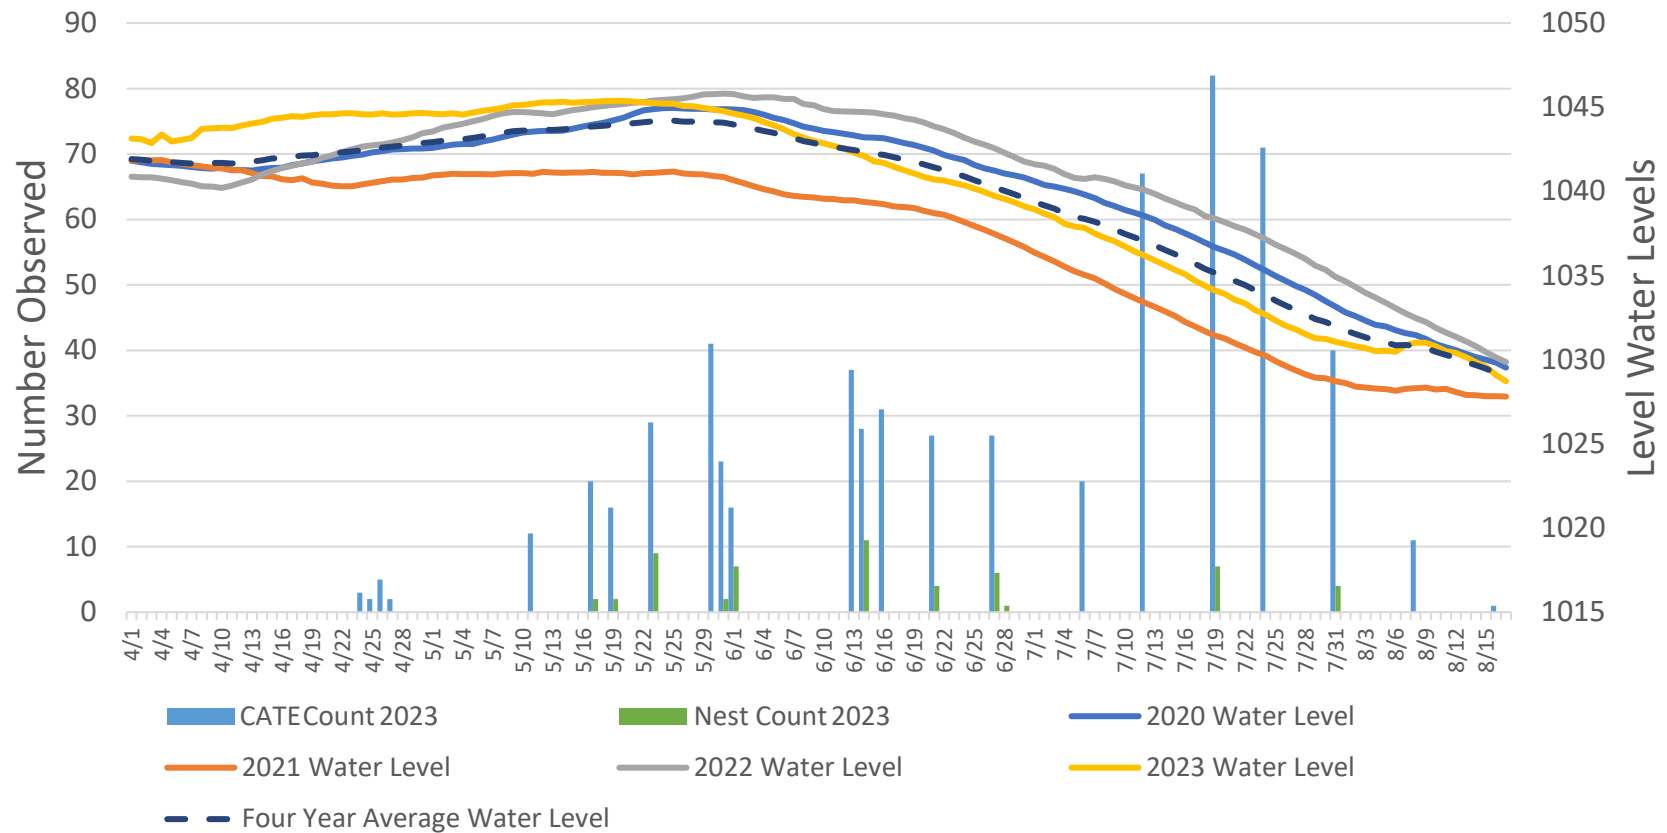
Number of CATE Observed at Goose Island in 2023 and Lake Water Levels

FIGURE 7. 2023 CATE COUNTS RELATIVE TO LAKE LEVELS, POTHOLES RESERVOIR.

USDA-WS documented the lake water level recorded via the Reclamation Hydromet website during each survey. April 2023 had higher water levels than the past 3 years, but June-July water levels were below the 4-year average (Figure 7). The highest count of nests was on Goose Island on June 14 ($n=11$; Figure 7). An island's nest count is considered the minimum number of active breeding CATE pairs. Therefore, when breeding CATE were present, between 2 and 11 (average 5) CATE nesting pairs were observed intermittently attempting to nest on Goose Island; the assumption is that each reported attempt was likely a different nesting pair over the course of the breeding season.

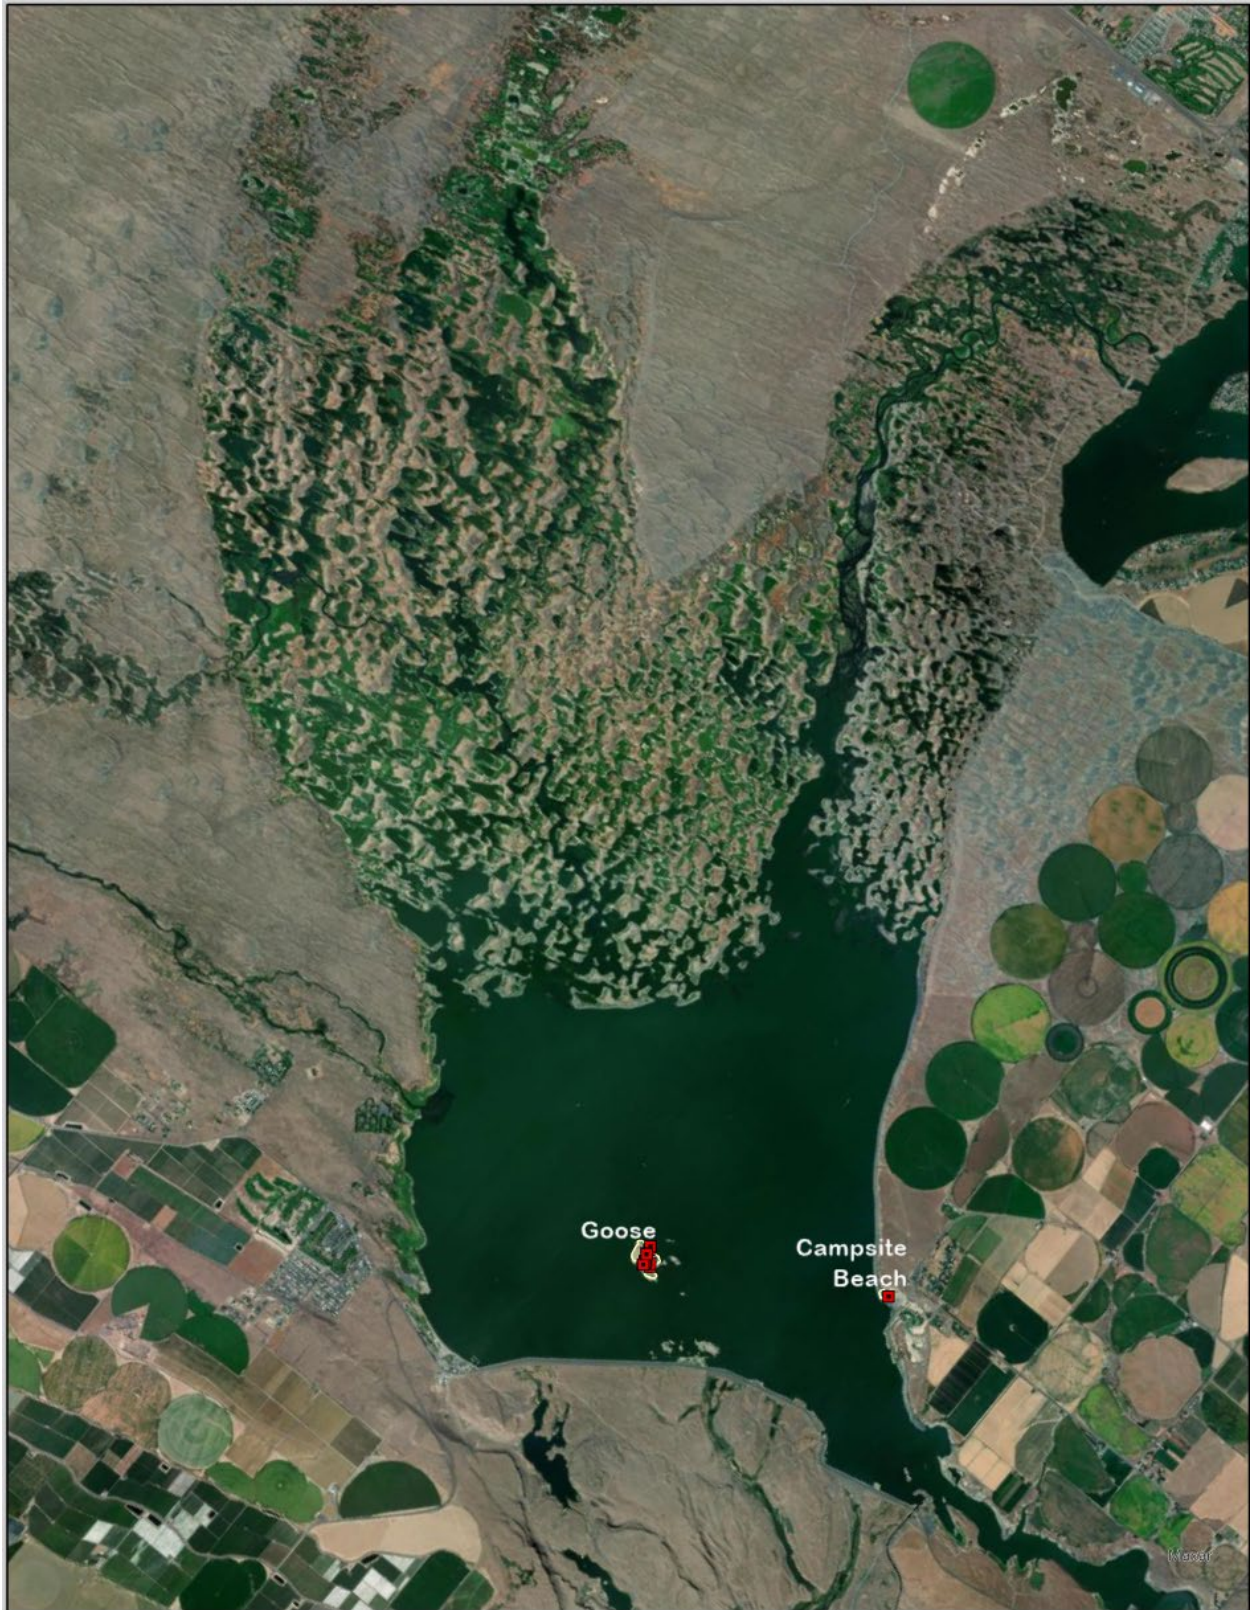
FIGURE 10. MAP SHOWING ALL CATE NEST LOCATIONS IN 2023, POTHOLE RESERVOIR.

One nest was taken from Campsite Beach and the remainder were taken from Goose Island (Figure 10). This was the first nesting attempt off Goose Island reported since USDA-WS began dissuasion efforts in 2020.

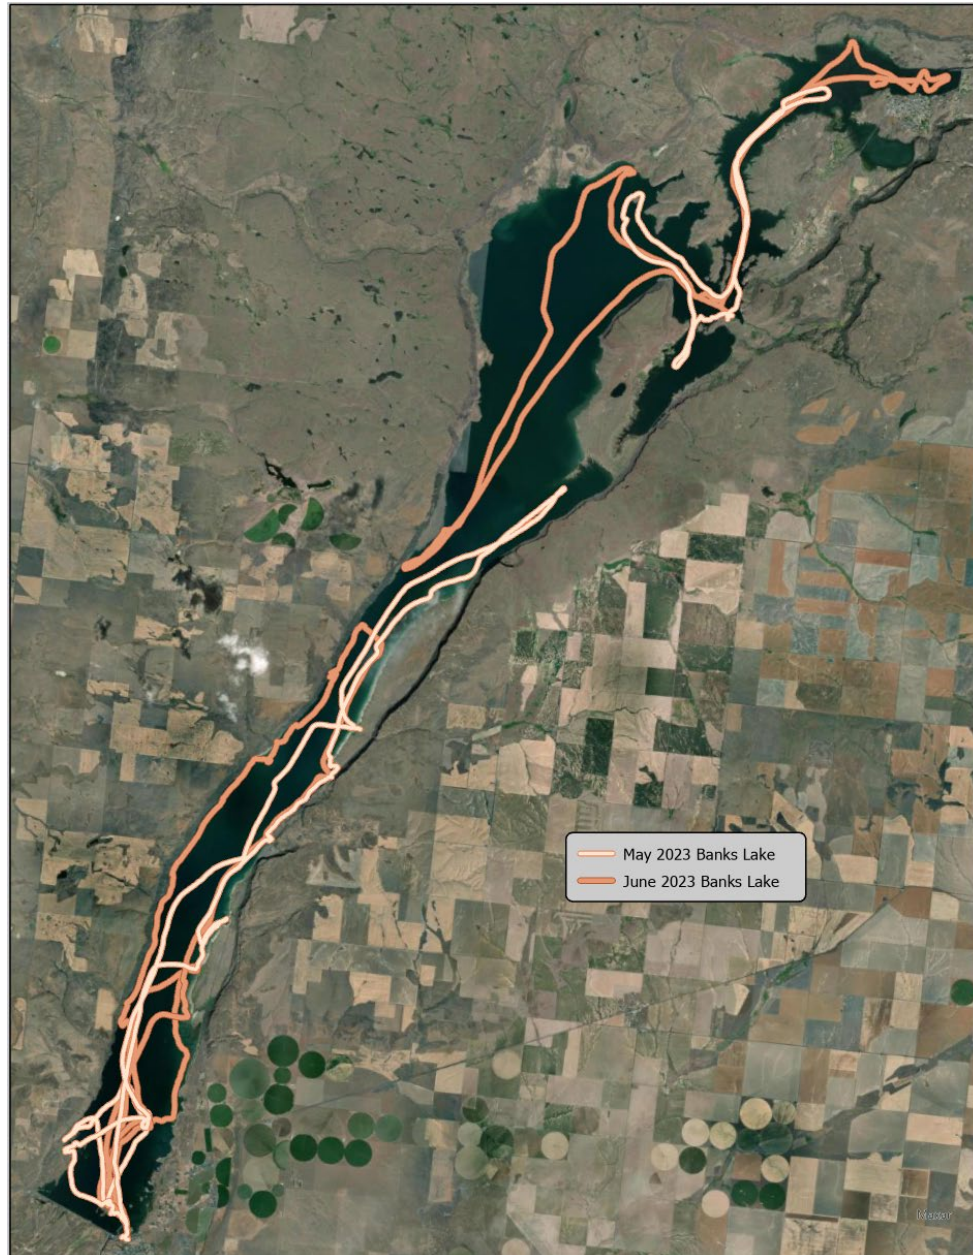
FIGURE 11. BANKS LAKE CATE SURVEYS 2023. FIGURE REPRESENTS ALL SURVEY TRACKS OCCURRING FOR A GIVEN SURVEY MONTH.

In 2023, Reclamation requested exploratory surveys¹ to be conducted at Banks Lake for tern activity. Five total surveys were conducted in which 89 CATE were observed (Figure 11). The two surveys conducted in May observed no CATE breeding activity and eight CATE. The three survey days conducted in June observed 25 breeding CATE on Goose Island starting on June 15 and 81 CATE counted during the survey.
