## **Pacific Lamprey 2012 Annual Report and 2013 Plan**

**Columbia/Snake River Salmon Recovery Office  
Pacific Northwest Region**

Prepared to document and communicate Reclamation's actions in calendar year 2012 pertaining to Pacific Lamprey under the commitments in the 2008 Columbia River Fish Accords.

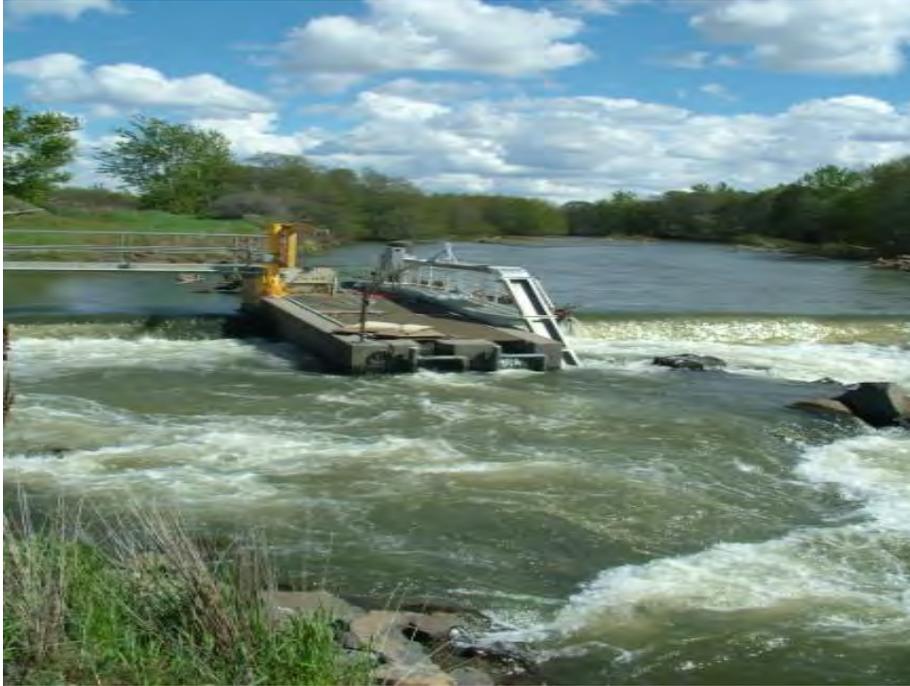
**Photograph 1. LPS at Feed Diversion Dam.**

2.9 days. Of the fifteen fish released below Feed Diversion Dam, one had a non-working transmitter, and two immediately fell back downstream and then eventually came back up and passed Feed Diversion Dam. Twelve of these fish immediately approached Feed Diversion Dam and four (33 percent) passed with relatively short delay time (average 11.6 hours at the dam) either through the existing fish ladder (one fish) or other routes at the dam (three fish). Eight lamprey were not successful in passing Feed Diversion Dam and spent an average of 19.1 days below the dam exploring, and appeared to move into the fish ladder and slot but were unable to pass. No lamprey were detected attempting to use the LPS at Feed Diversion Dam.

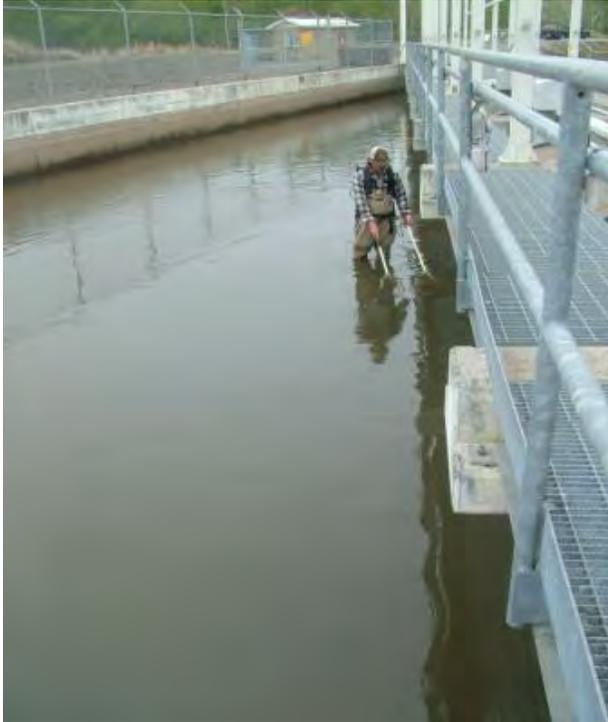
**Photograph 2. Lamprey sampling below Feed Diversion screen structure.**

For the second consecutive year, Feed, Maxwell, and West Extension canals were sampled by backpack electrofisher and other methods to search for stranded lamprey both in front of and behind the screens, including down the length of the canals. Entire sampling efforts (above/below screens in minutes) for Feed, Maxwell, and West Extension canals was 351/660 min, 384/275 min, and 160/361 min, respectively. In this second year of systematic sampling, a total of 33 Pacific lamprey were collected: 14 in Feed Canal, zero in Maxwell Canal, and 19 in West Extension Canal. No lamprey were collected below the screens in Feed or Maxwell canals. However, two juvenile lamprey (macrophthalmia life stage) were captured below the screen at West Extension Canal, and an additional four lamprey were collected in the vicinity of the screen structure after the screen was raised for annual maintenance.

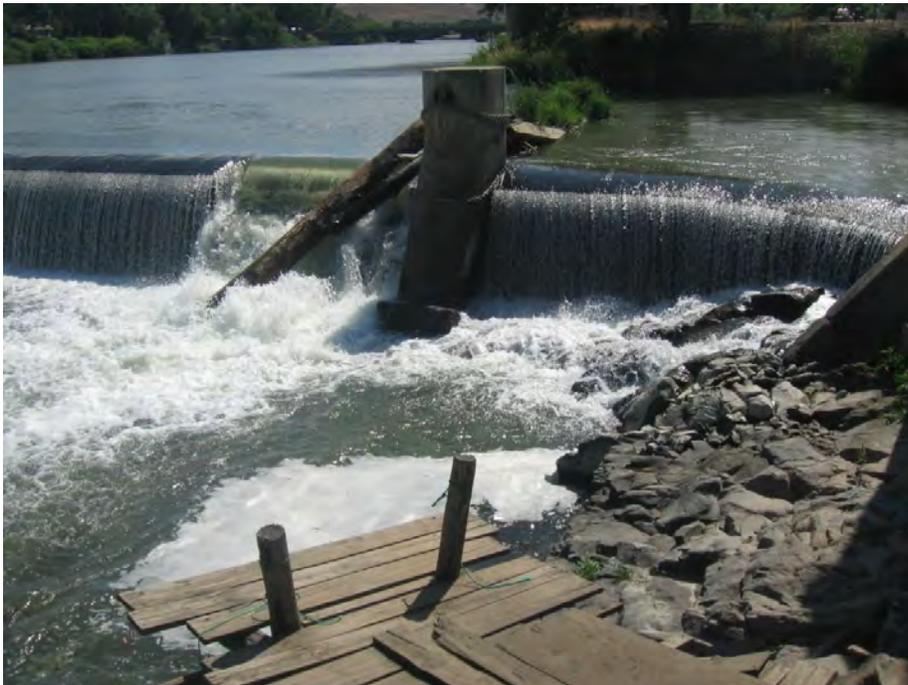
**Photograph 3.** Pool and whitewater along left bank of Prosser Dam where the majority of lamprey are held.

Lampreys were detected on all three stations at Prosser Dam while they searched for upstream passage with the greatest number occurring on the left island antennas. Lampreys spent little time near the face of Prosser Dam during holding periods or daylight hours, residing instead just downstream of the bedrock ledge the dam was built upon. The greatest concentration occurred in a pool along the left bank (Photograph 3). This area included a boulder filled pool and areas of whitewater coming off the face of the dam. Pacific lampreys were consistently detected in this area during both day and night hours. Night observations during July showed tagged lampreys attempting to climb over the dam using the bedrock at face of the dam along the left bank (Photograph 4). High velocities over the dam and the overhanging crest prevented these lampreys from being successful in their attempts.

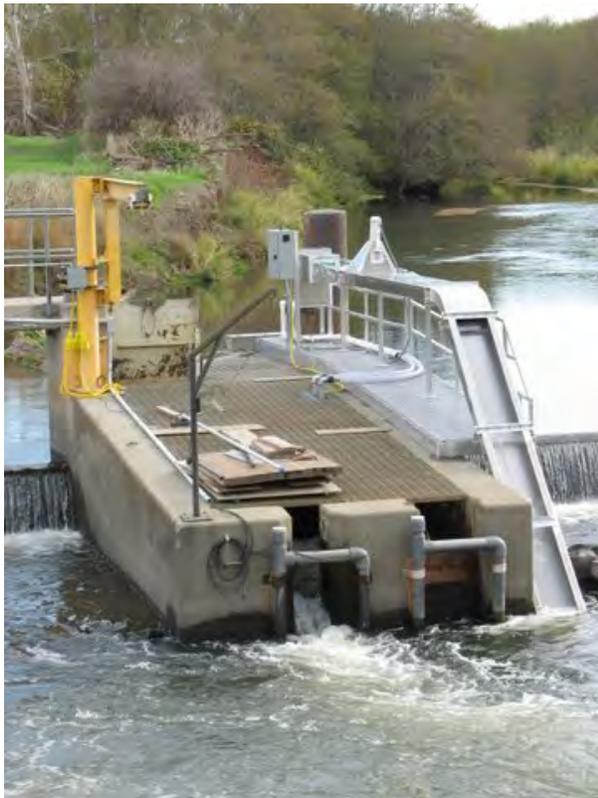
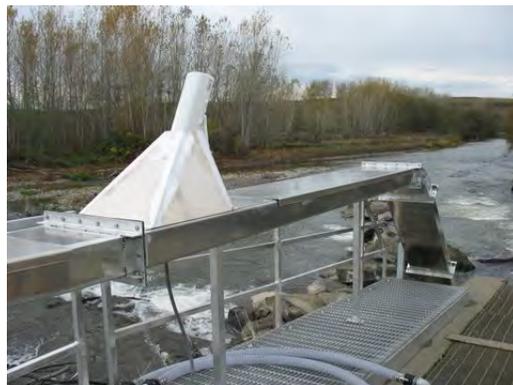
Figure 5 Security camera and housing installed at Feed LPS to monitor lamprey passage.

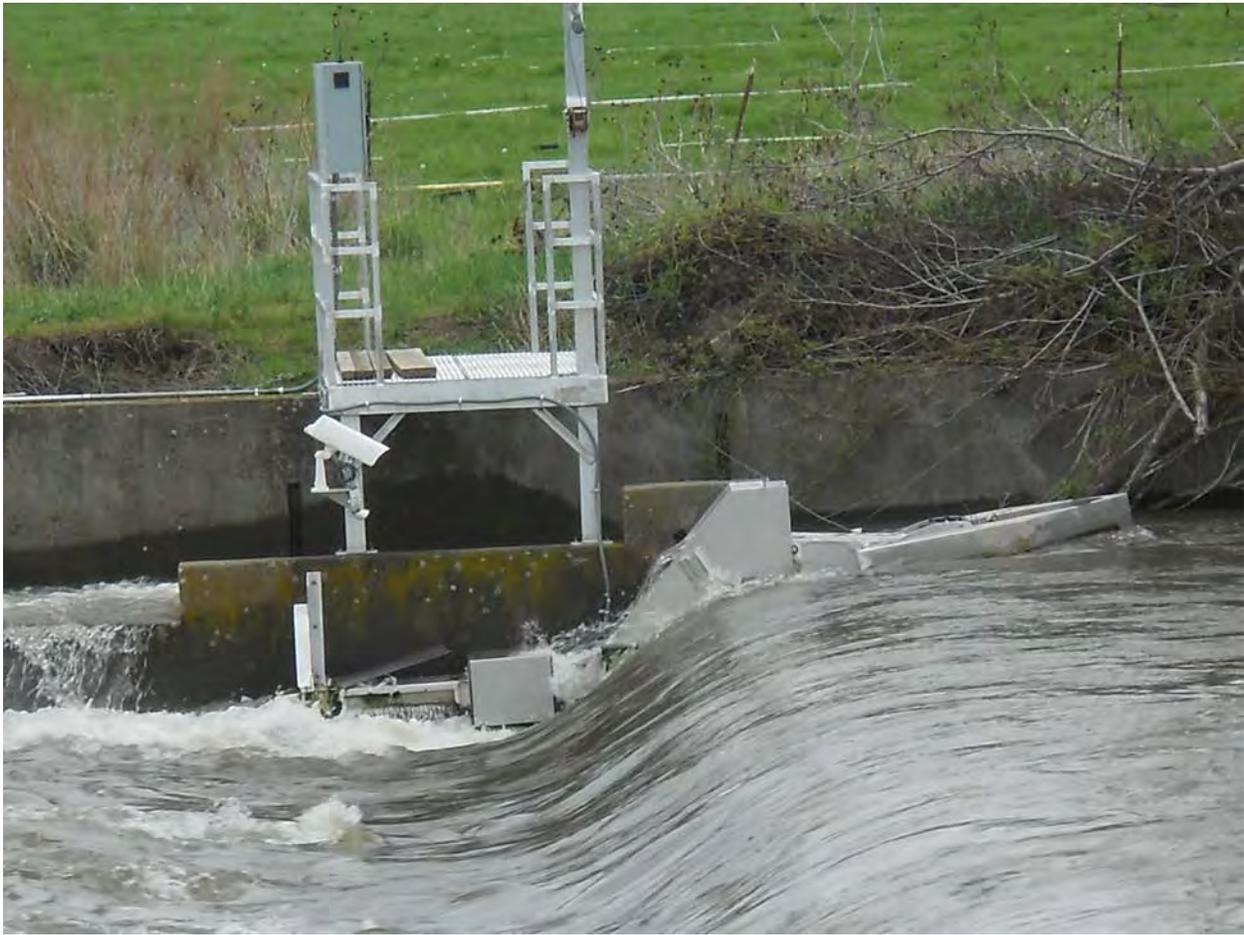
Figure 6. Float at the upstream end of the LPS (right side of photo) controls water flow into the infiltration gallery (left side of photo at dam crest) at high flows in 2012. Note inundation of PIT antenna (gray square in center of photo).

No lamprey were observed using the structure in 2011 and only three of five fish that approached the dam were able to pass over. In 2012 the sample of radio-tagged lamprey was slightly higher ( $n = 8$ ) and all of these fish were able to pass the dam. However, there was only one record of a lamprey using the structure (Figure 7). High spring flows in 2012 (Figure 11) resulted in inundation of the LPS infiltration gallery and PIT antenna (Figure 6). However,

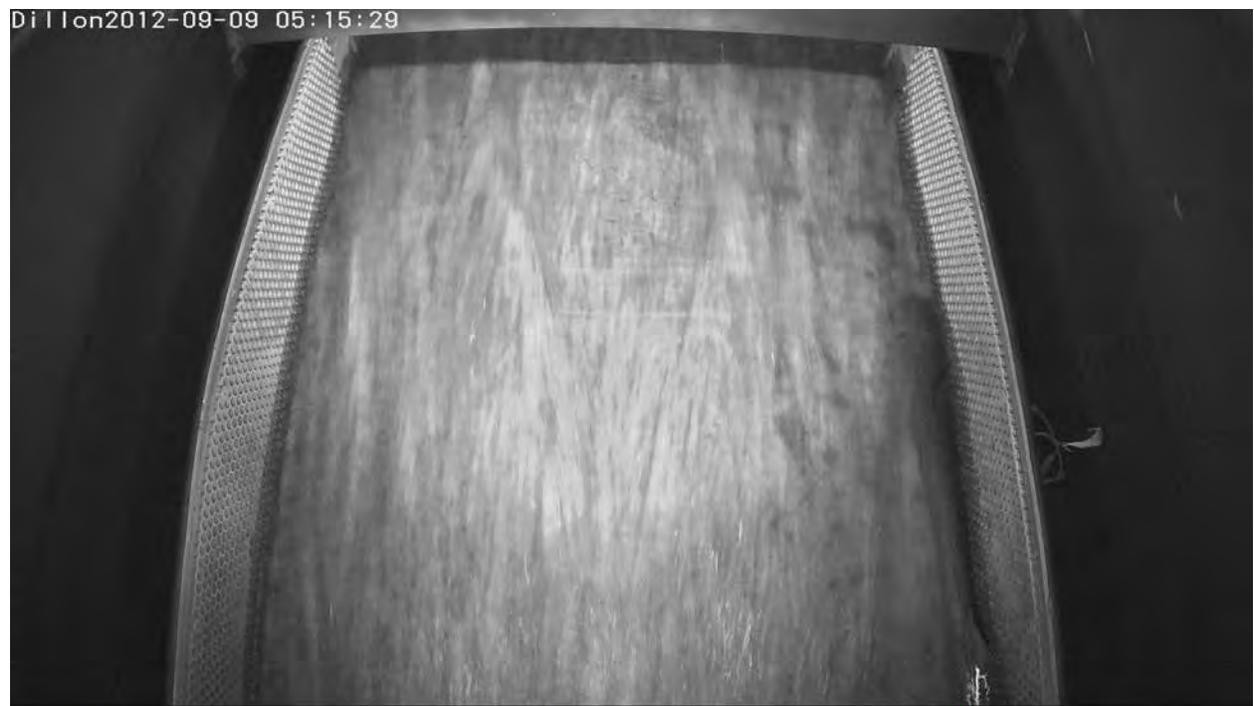
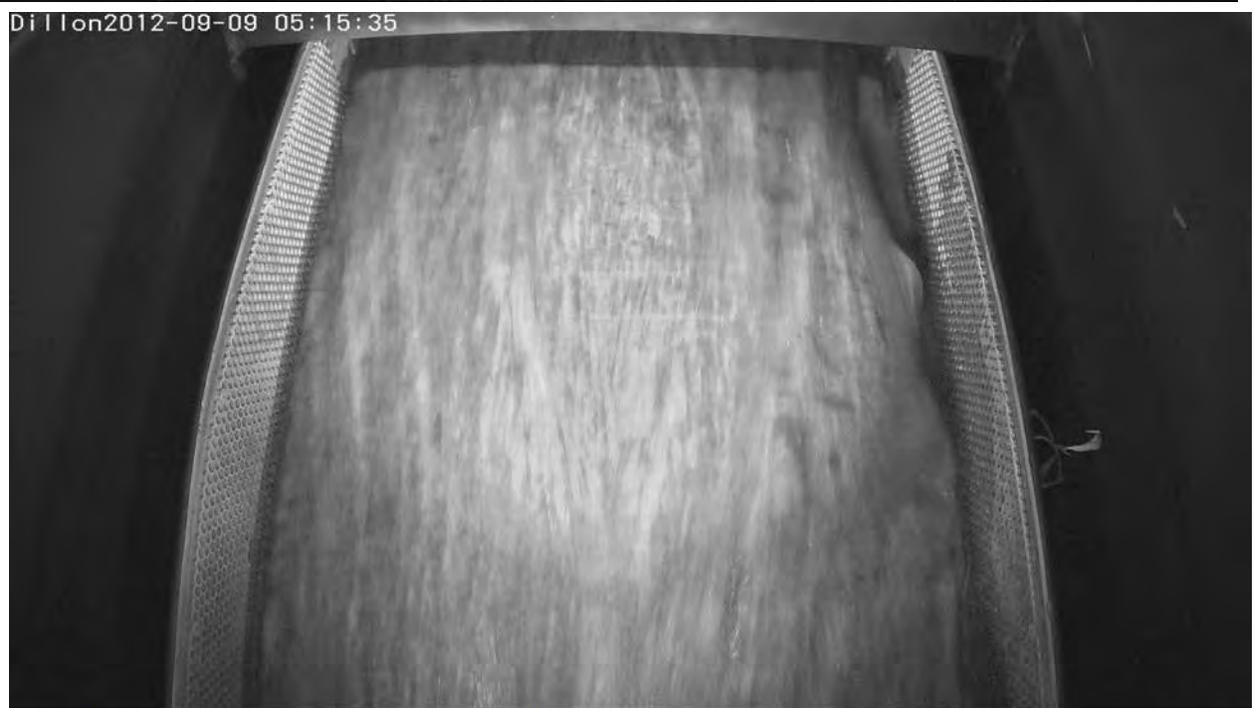
Figure 7. Lamprey detected using the Dillon LPS on September 9, 2012 at 0515 hr.

The camera system at Dillon was also undamaged and yielded imagery of a single lamprey using the passage structure on September 9, 2012 at 5:15 am (Figure 7). Imagery at Feed was plagued by low resolution due to cloudy conditions, or lens obstructions. Much greater success was obtained with the security camera at Three Mile, where lamprey images matched up nicely with recordings at the terminal counter and with PIT detections.

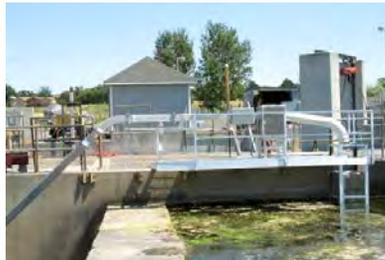
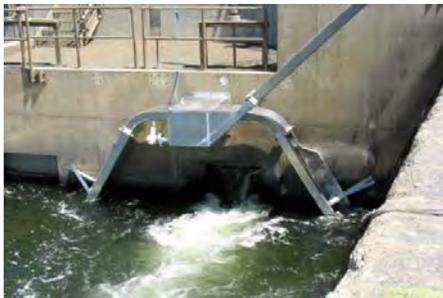
Mainstem		3 Mile
8/12/10	MN (6%)	5/22/11
7/13/11	BO	
8/08/11	JD (0.5%)	8/14/11
8/4/2011	BO	
9/2/2011	JD (0.5%)	5/14/12

Figure 8. Summary of results from PIT-tagged fish detections at the Three Mile Falls LPS.

The LPS at Three Mile Falls Dam provided an important passage route for lamprey (Figure 8). Three HD-PIT tagged fish were detected and 48 untagged lamprey were counted as they exited the structure into the dam forebay. The PIT-tagged fish that were detected in the LPS represented 13% of the tagged lamprey released into the Umatilla River downstream from Three Mile. Similar LPS passage efficiencies were recorded in 2010 and 2011 (Figure 8).

Detections of PIT-tagged fish also provided information on over-wintering behavior of lamprey tagged in other studies. One fish that was originally tagged at Bonneville Dam on 8/4/2011 and passed John Day Dam on 9/2/11 was detected at Three Mile on 5/14/12. In contrast, a second fish tagged at Bonneville Dam on 7/13/11 and detected at John Day Dam on 8/8/11 was detected at Three Mile on 8/14/11. Hence, 1% of the lamprey that passed John Day Dam in 2011 was detected at the Three Mile LPS and there was evidence for tributary entry both in the year of tagging and after over-wintering in the John Day Reservoir (Figure 8).

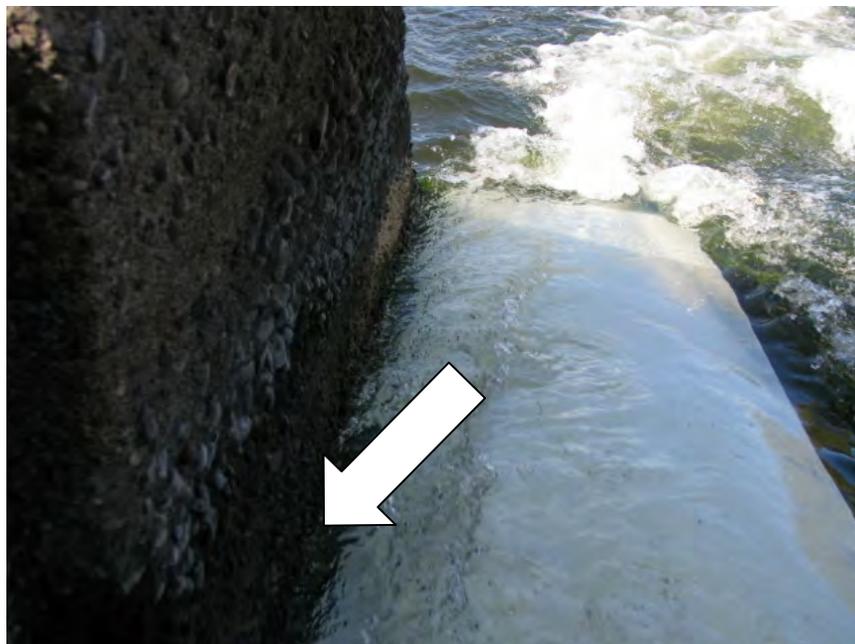
Figure 10. Flat plate installed at Maxwell Diversion Dam. Flaring the side of this plate (indicated by the white arrow) to make a smooth attachment surface with the adjacent wall could improve its performance.

Sample sizes at Maxwell Diversion Dam (the next upstream dam that migrants would encounter) were higher in 2012 than in any previous year (n=17) and continued to show relatively high lamprey passage success (Table 1). Following the installation of a flat plate to provide a lamprey passage route in 2010, mean passage efficiency showed a modest increase from 69% to 78%. Modifications to this structure could potentially improve lamprey passage even more. For example, the flat plate design is not integrated with the side of the bulkhead where it is attached (Figure 10). By flaring the ramp up onto the wall lamprey could maintain attachment under a variety of flow regimes that occur during the migration season (Figure 11).

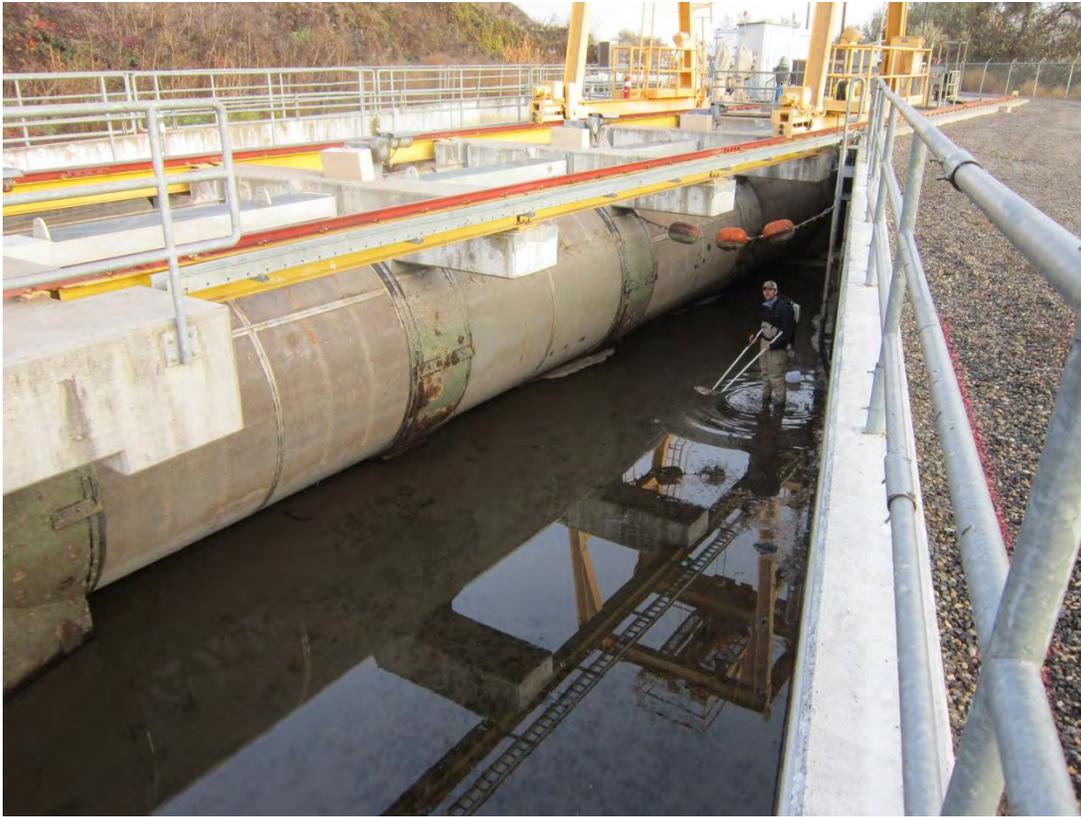
**Figure 1.** Bureau of Reclamation Biologist Zak Sutphin using backpack electrofisher to sample for Pacific lamprey above drum screens at West Extension Canal.

effective sampling. Similar to Year 1, sampling efforts were concentrated immediately above and below canal screening structures (Figure 1), while targeting lamprey preferred type-I habitat (soft small grain sediments). Specific sample locations details (maps and GPS coordinates) are available in Sutphin et al. 2012. When sample locations assessed or sampled in Year 1 were dewatered, an attempt was made to find additional locations with similar habitat conditions to supplement sampling effort.

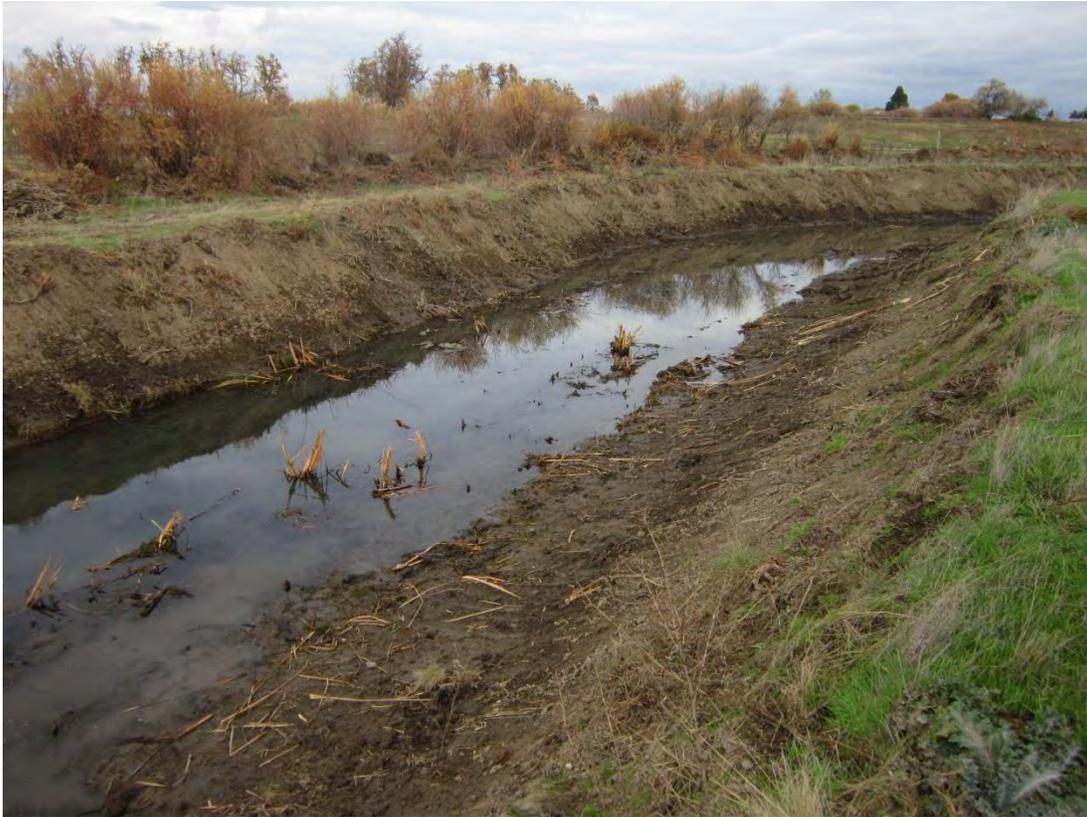
**Figure 2.** Feed Canal sample location #13 that remains watered year round and was sampled on November 7, 2012 after initial canal sampling efforts (April 18-19, 2012).

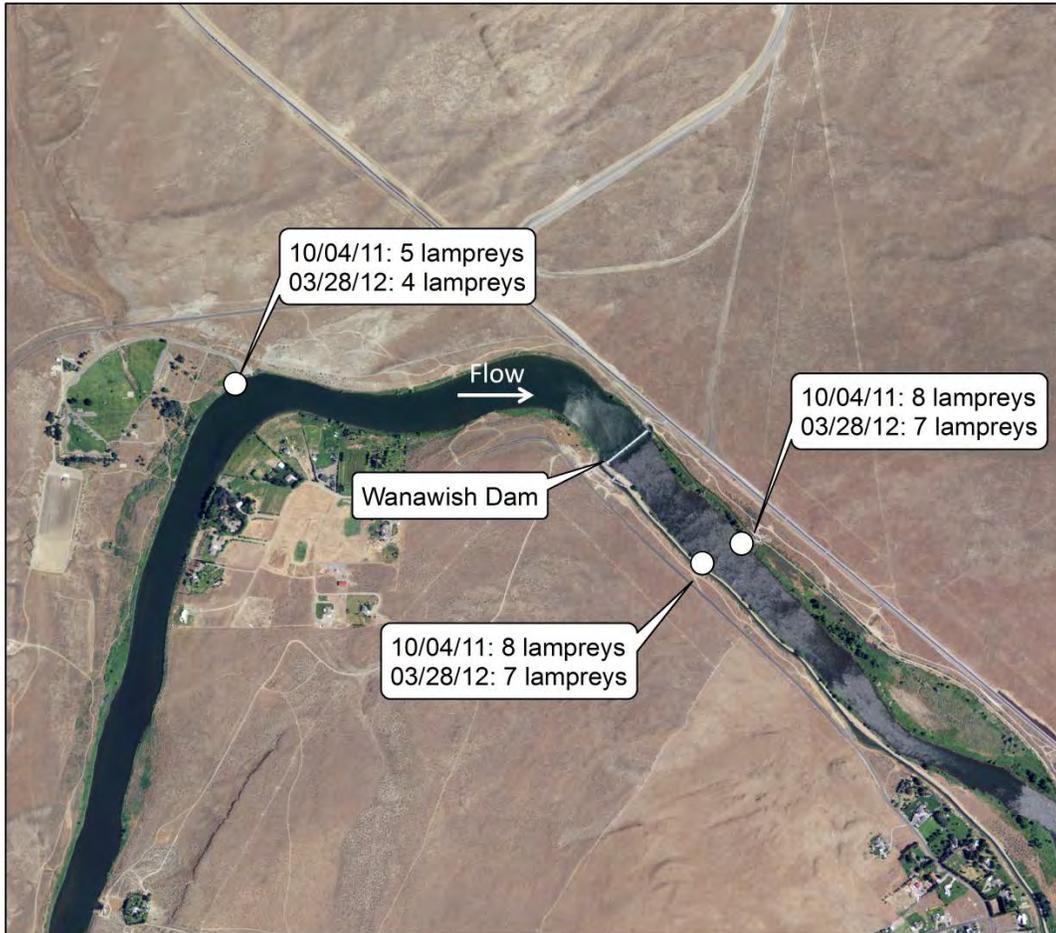
**Figure 11. Aerial photograph showing the release locations of radio-tagged adult Pacific lampreys in the vicinity of Wanawish Dam on October 4, 2011 and March 28, 2012.**

*Fall release-* A total of 41 tagged lampreys were released on October 4, 2011. Five were released from the left bank 1.2 km upstream of Wanawish Dam; sixteen were released 0.45 km downstream of the dam, eight on each bank (Figure 11). The upstream release location was in a slow water area consisting of submerged grasses and an undercut bank. The downstream release locations were in areas consisting of various sized cobbles. Sixteen lampreys were released on the left bank 0.30 km downstream of Prosser Dam amongst large boulders in a slow, deep pool. Four lampreys were released 1.1 km upstream of the dam on the right bank in a slow water area with boulders and floating debris (Figure 12).

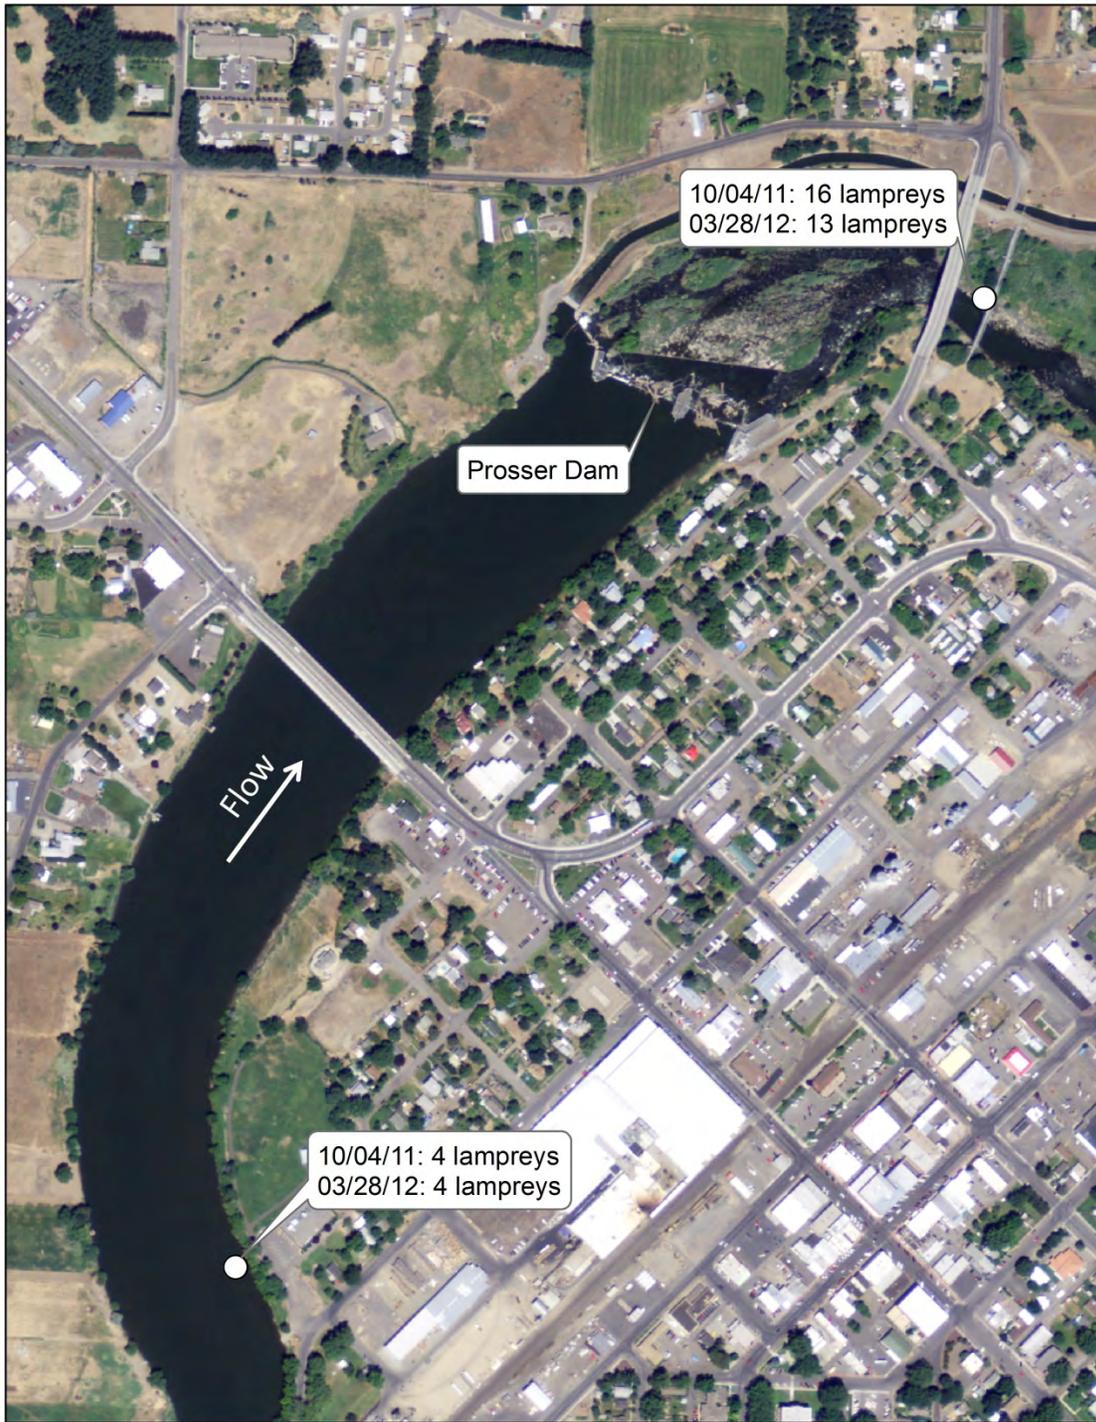
**Figure 12. Aerial photograph showing the release locations of radio-tagged adult Pacific lampreys in the vicinity of Prosser Dam on October 4, 2011 and March 28, 2012.**

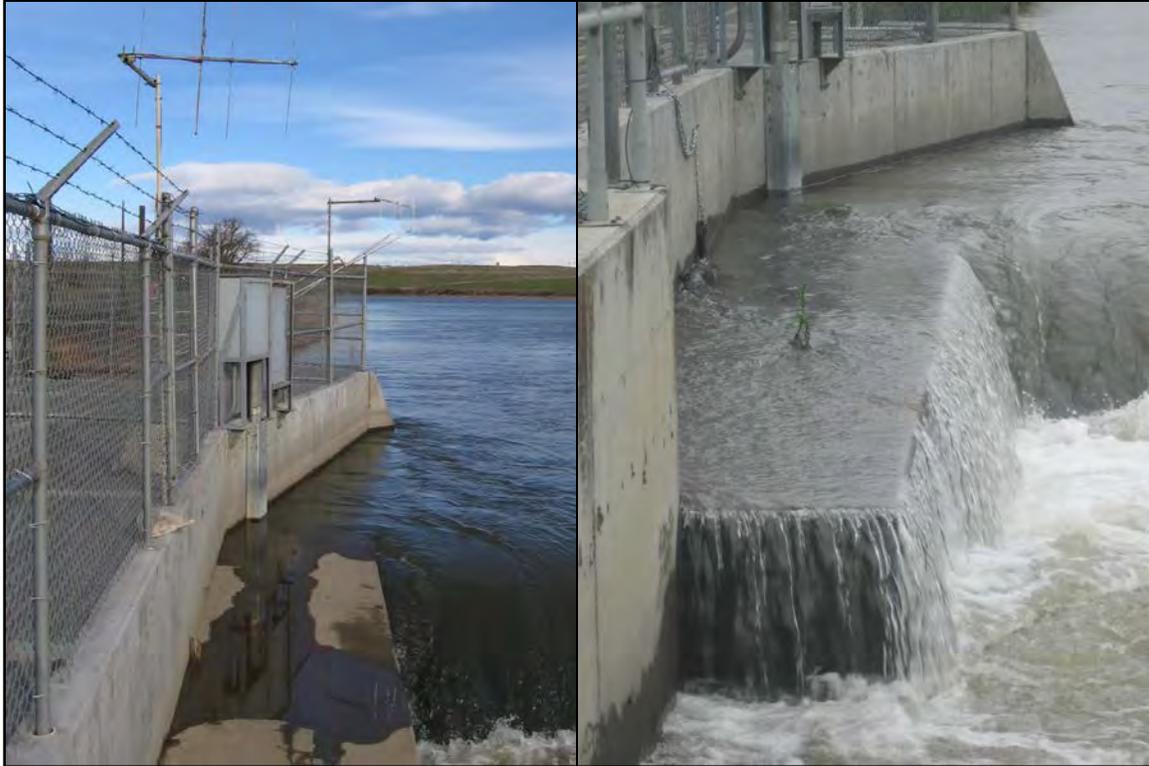
**Figure 15. The ledge on the right bank of Wanawish Dam that it appears most Pacific lampreys used to pass upstream. The flow is approximately 5,500 ft<sup>3</sup>/s in the left picture and 10,500 ft<sup>3</sup>/s on the right. The entrance to the fishway is just out of the picture on the left hand side.**

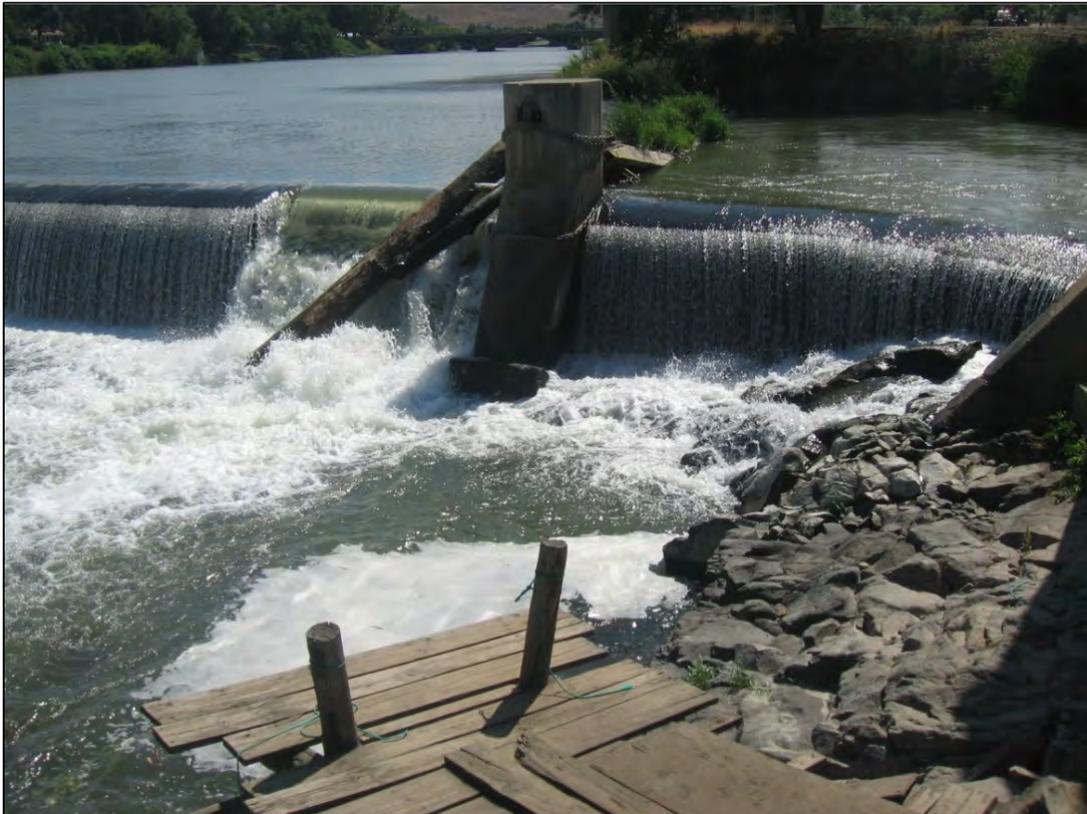
**Figure 21. Pool and whitewater along the left bank of Prosser Dam where the majority of Pacific lampreys held during the day and night hours.**

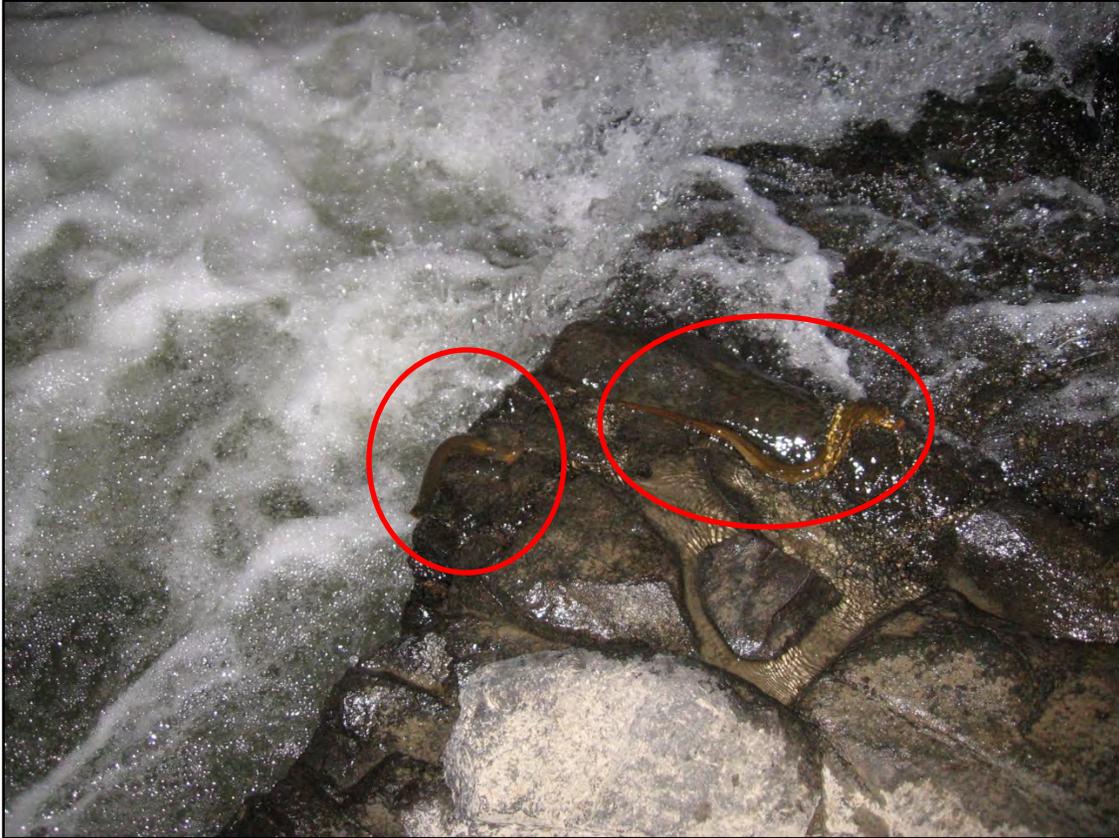
**Figure 22. Radio-tagged Pacific lampreys (circled in red) attempting to climb over Prosser Dam by way of the dam face and exposed bedrock, July 3, 2012.**

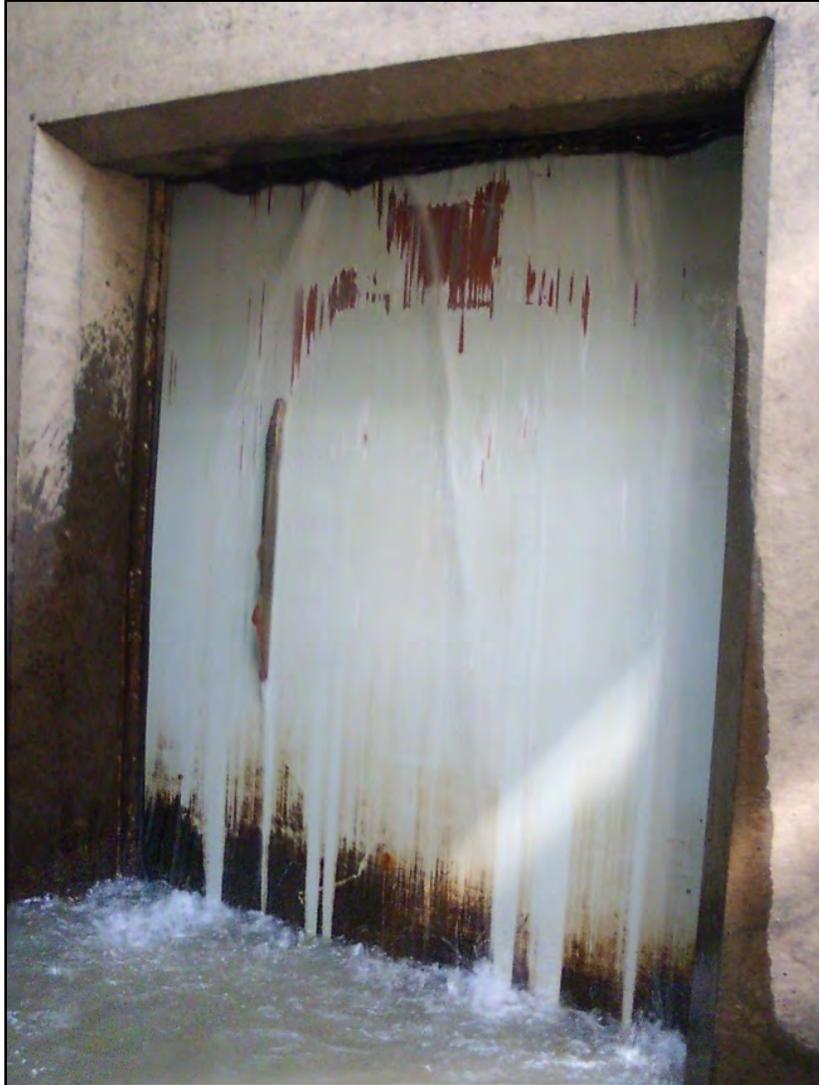
**Figure 23. Radio-tagged Pacific lamprey code 69 attempting to exit the right bank fishway at Prosser Dam by climbing the closed headgate, April 30, 2012.**

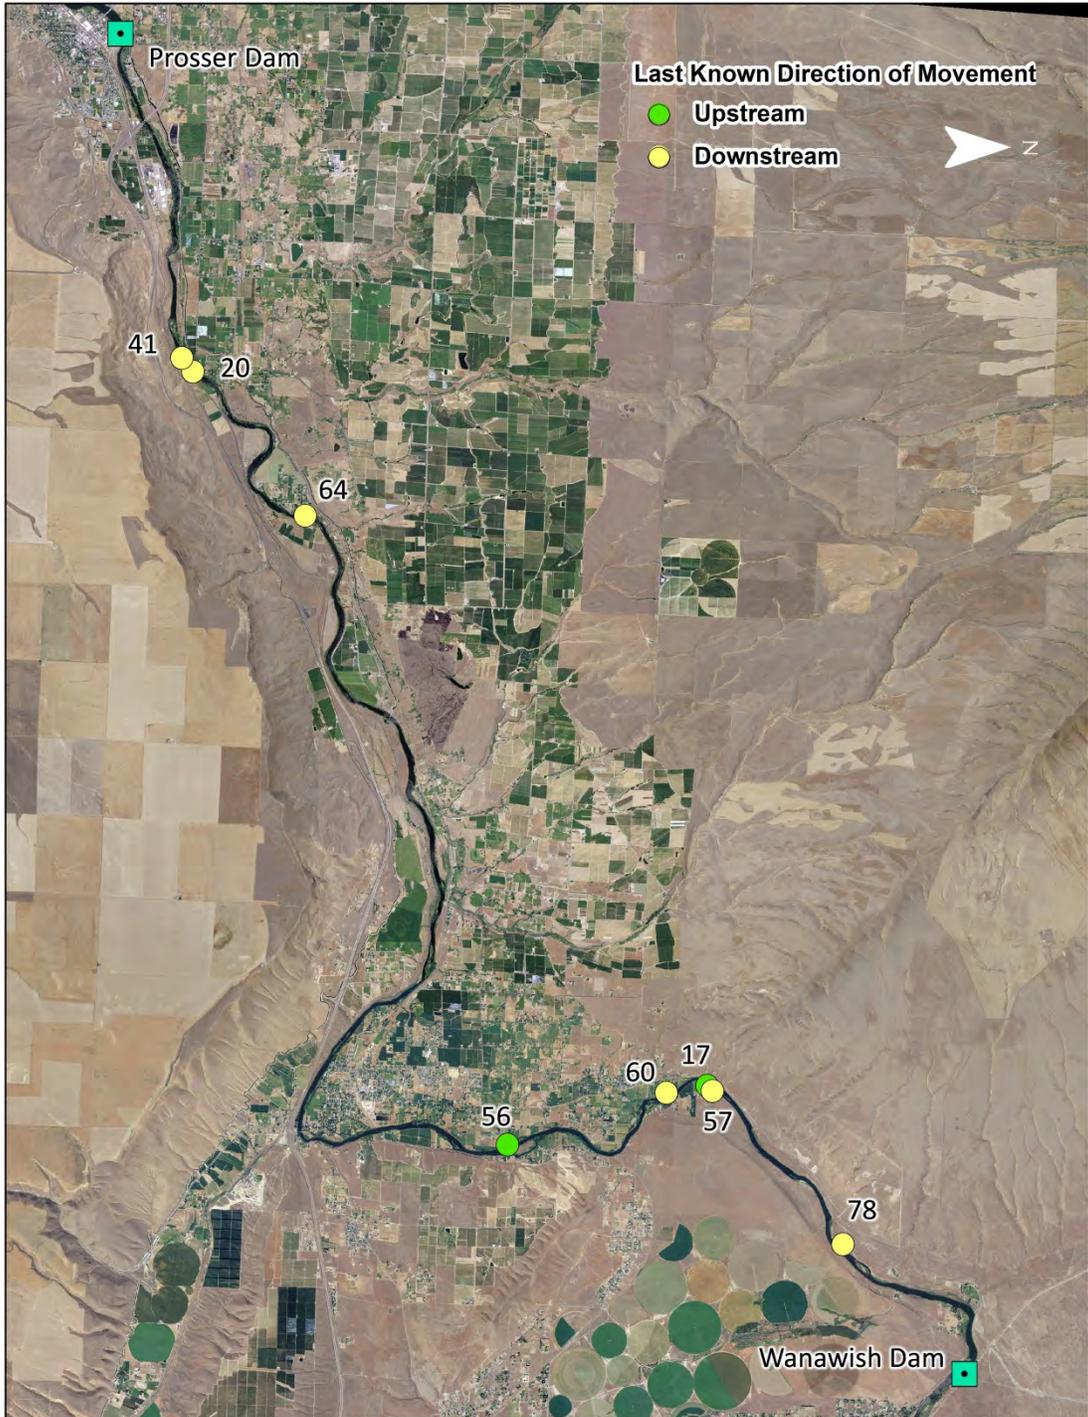
**Figure 40. The last known locations of radio-tagged Pacific lampreys between Wanawish Dam and Prosser Dam on the Yakima River, 2011-2012. The number represents the code of each radio tag.**

Not all lampreys that passed a dam continued their migrations upstream to the next dam. These “dropouts” consisted of both lampreys that passed a dam and never arrived at the next and also those that were unsuccessful at passing a dam and ultimately moved back downstream. Last known locations between dams were obtained for thirty of these individuals. Eight lampreys were present between the mouth of the Yakima River and Wanawish Dam (Figure 39). Eight lampreys were between Wanawish and Prosser dams (Figure 40), including six that approached Prosser Dam and then moved downstream and two that moved upstream from Wanawish but never reached Prosser Dam. In the reach between Prosser Dam and Sunnyside Dam a total of fourteen last known locations were recorded (Figure 41). Six were lampreys that had moved downstream from Sunnyside Dam. Eight ceased their upstream migrations and never reached Sunnyside Dam. No lampreys were in between Sunnyside and Wapato dams at the end of the study period. In addition to these known locations, another twenty-six lampreys dropped out in the reaches between the lower four dams (Table 12). Lampreys released in the spring upstream of Prosser Dam had the highest rate of dropouts with 100%. Percentages for all other releases were between 69% and 80%.

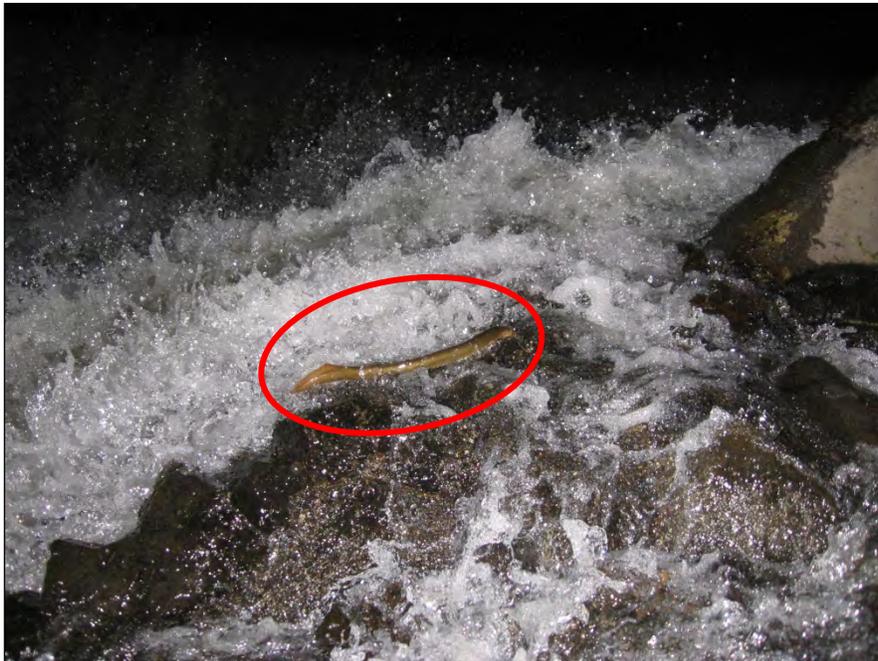
**Figure A-1. Pacific lamprey (circled in red) climbing bedrock on left bank at base of Prosser Dam.**

Telemetry data show that lampreys gather and hold in the pool area at the left bank of the dam. Adults have been observed attempting to move upstream by climbing the bedrock there (Figure A-1).

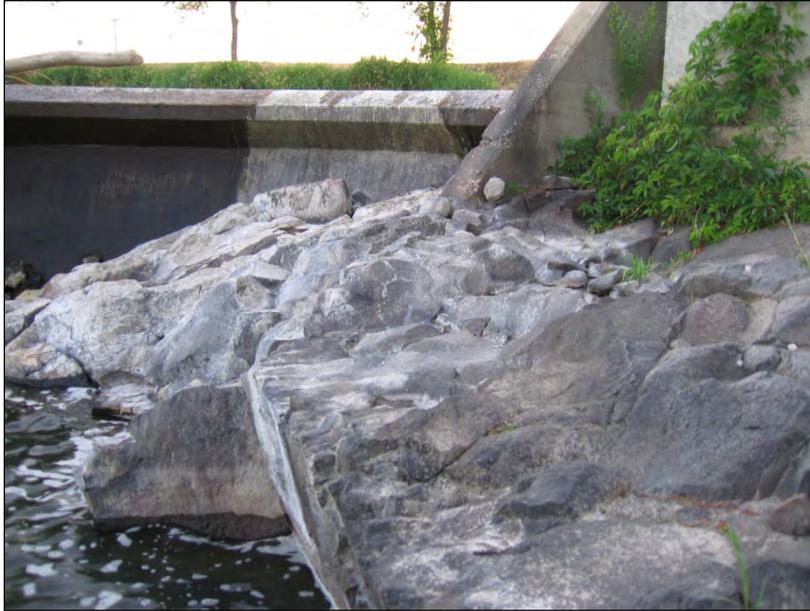
**Figure A-2. Proposed site of LPS on the left bank of Prosser Dam at low flow.**

The area on the river-left side of the dam would be the best place to build a LPS for adult lamprey passage. The ramp would start at the bedrock on the downstream side of the dam between the canal and the river (A-2). The ramp would then angle up and over the

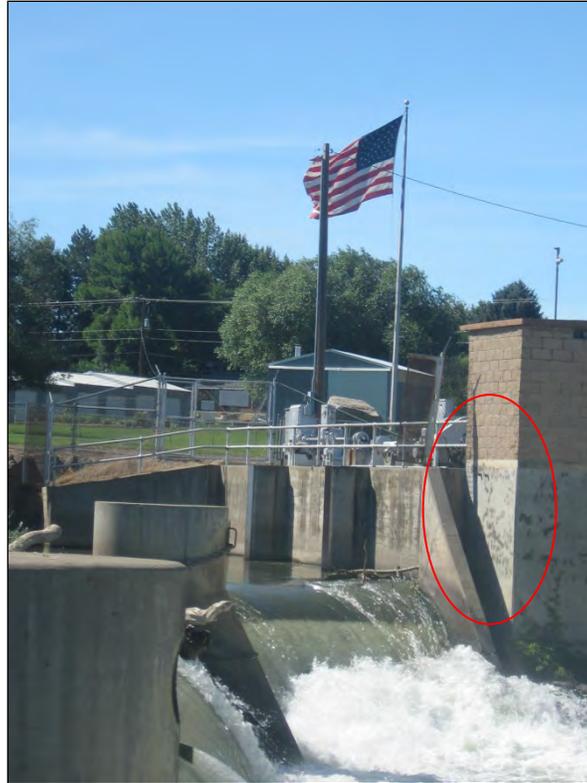
**Figure A-3. Prosser dam and the head of the Chandler Canal. The ramp would be placed in the space (circled in red) between the gate house and the slanted wall at the left bank of the dam.**

dam in the space between the gatehouse wall at the head of the canal and a wall at the end of the dam (Figure A-3).

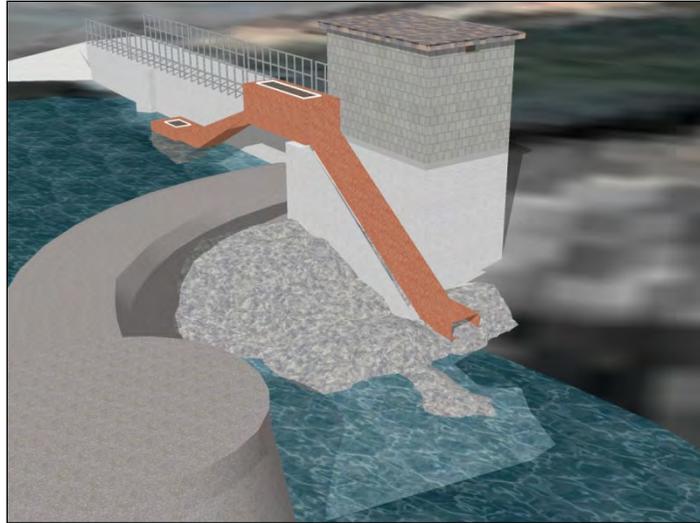
The entire system would consist of a covered ramp, a pump, and either a collection box at the top end of the ramp or an outlet into the river above the dam (Figure A-4). Water would be pumped from the river on the upstream side of the dam to the highest section of the ramp and then flow down the ramp, out the entrance, and over the bedrock. At base flows, this pumped water would be the only attraction water in the area.

**Figure A-4. Concept of proposed LPS on the left bank at Prosser Dam. The existing structures of the dam are shown in grey with the proposed lamprey ramp in red.**

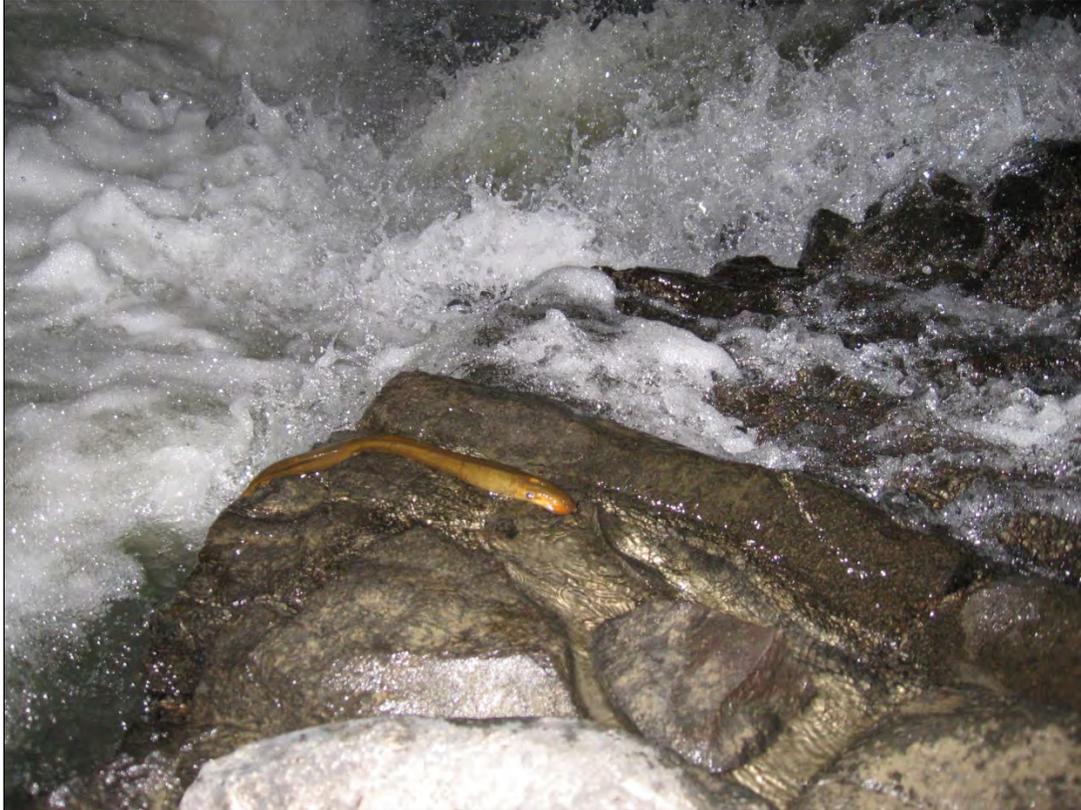
**Figure A-6. Pacific lamprey climbing bedrock at the base of Prosser Dam.**

Provided suitable surfaces to hold onto, Pacific lampreys have the ability to climb over steep and turbulent sections of river. For example, Pacific lampreys are known to climb Willamette Falls (Clemens et al. 2011). We observed lampreys at Prosser Dam attempting to move upstream by climbing natural bedrock but the rock does not extend up to the dam crest (Figure A-6).

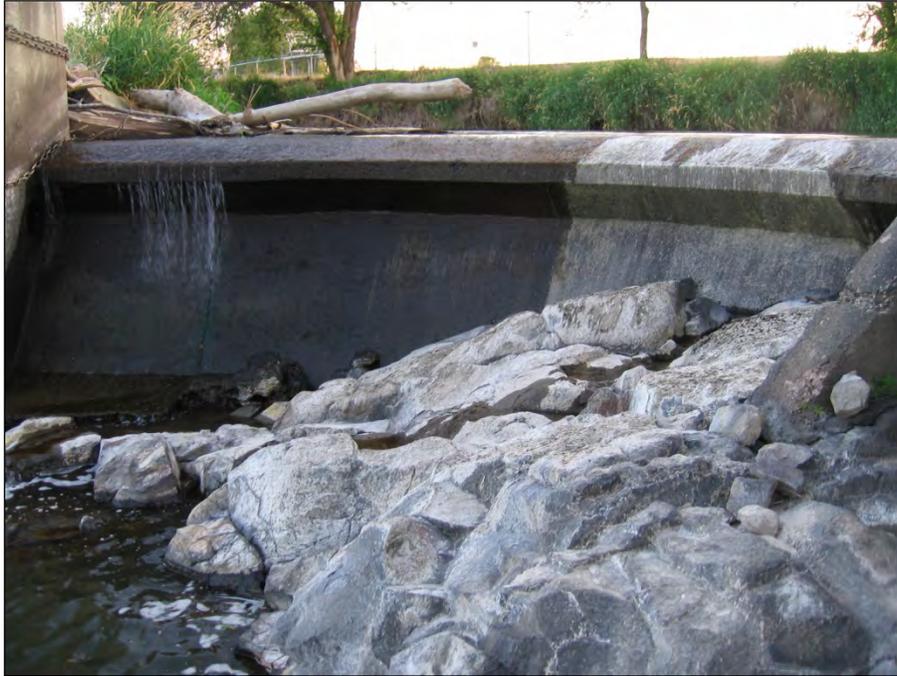
**Figure A-7. Proposed site at Prosser Dam of rock ladder showing bedrock at low flow. The head of the Chandler Canal is just right of the edge of the frame.**
