## **Pacific Lamprey 2012 Annual Report and 2013 Plan**

**Columbia/Snake River Salmon Recovery Office  
Pacific Northwest Region**

Prepared to document and communicate Reclamation's actions in calendar year 2012 pertaining to Pacific Lamprey under the commitments in the 2008 Columbia River Fish Accords.

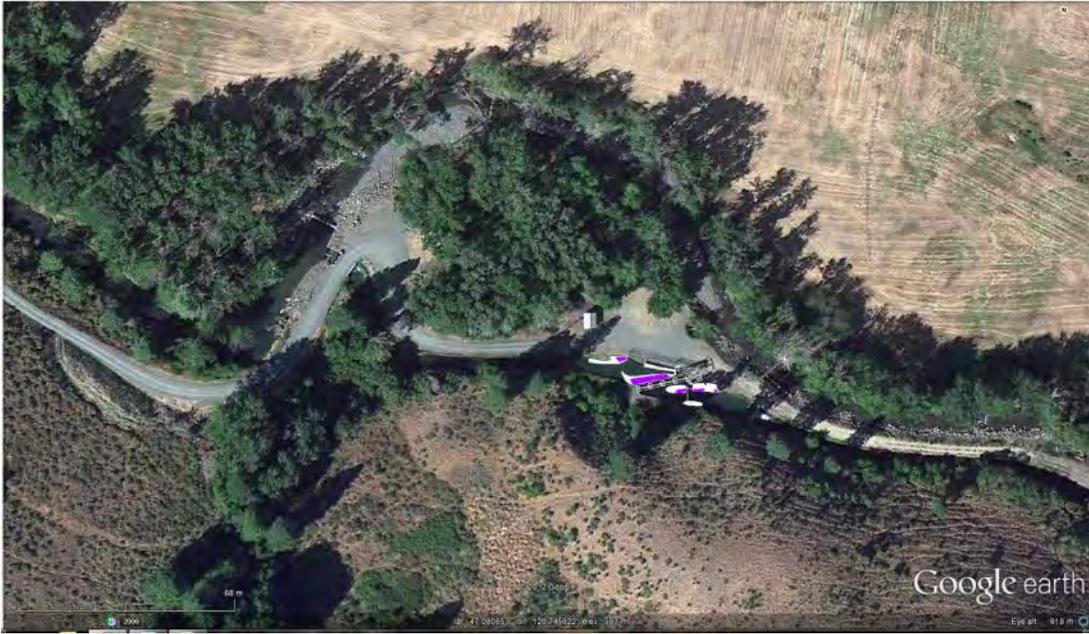
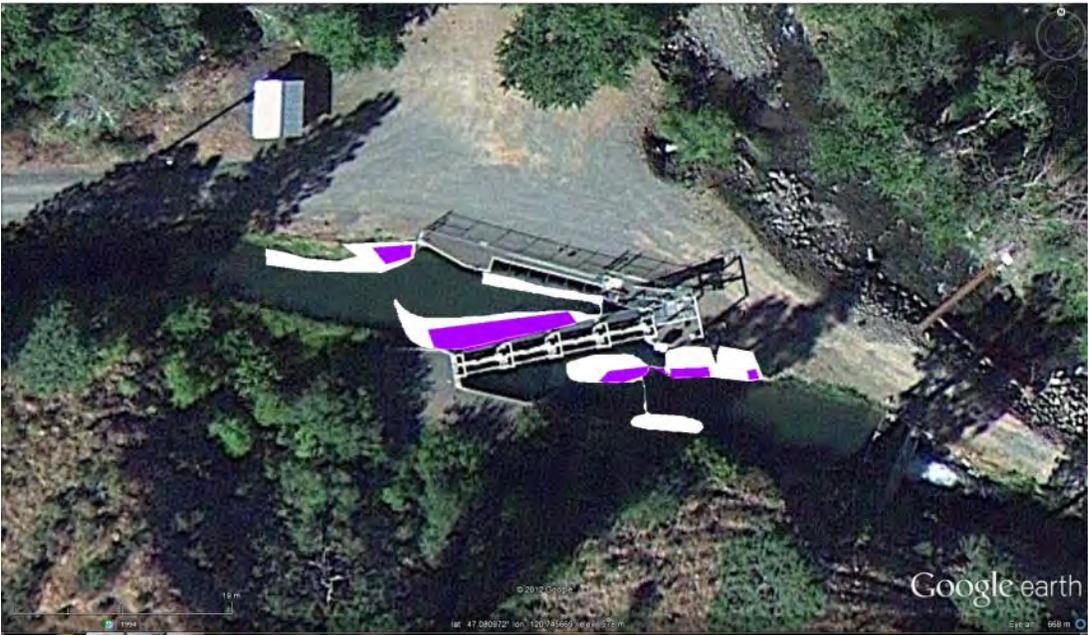
The first area that was surveyed on the Taneum Diversion of was above the screens while the water was still high on October 15<sup>th</sup>. Here the only section that was surveyed was along the bank where the Eschocker could reach both above and below the screens with a total area of 4m. There were 4 lampreys found on this day and they were released into the Yakima River.

The next survey session was on October 16<sup>th</sup> and it began above the screens after the canal was dewatered. The sediment in this area was fine and coarse sand mixed with lots of woody debris and detritus along the screens and the further upstream you traveled cobble and gravel became spaced around about 6m up. In this area we captured 44 lampreys, 17 of which were stranded on top of the dry sand after the dewatering. All were still alive and was a mixture of ammocoetes and macrophthalmia. There were also crawfish, water skippers, worms, sculpin and trout observed. One 4in trout and one 7in trout were captured and released into Taneum Creek.

The next area surveyed was below the screens after surveying above the screens. The area we surveyed was piles of sediment spaced around on top of the cement bottom and 9 lampreys were captured. The sediment here was a combination of fine and coarse sand mixed with detritus. The lamprey captured on October 16<sup>th</sup> was released into the Yakima River off of Old Hwy 10 outside of Thorp.

Figure 1: Overview of Taneum Diversion

Figure 2: Close up of Taneum Screens

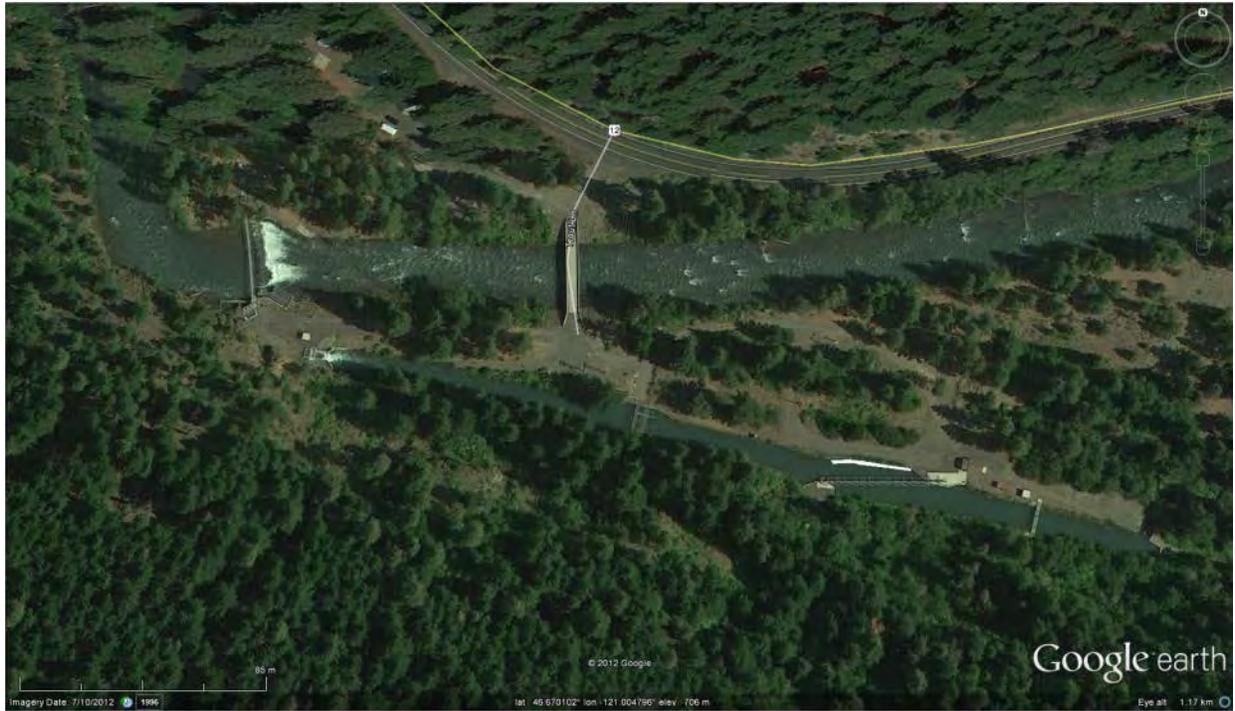
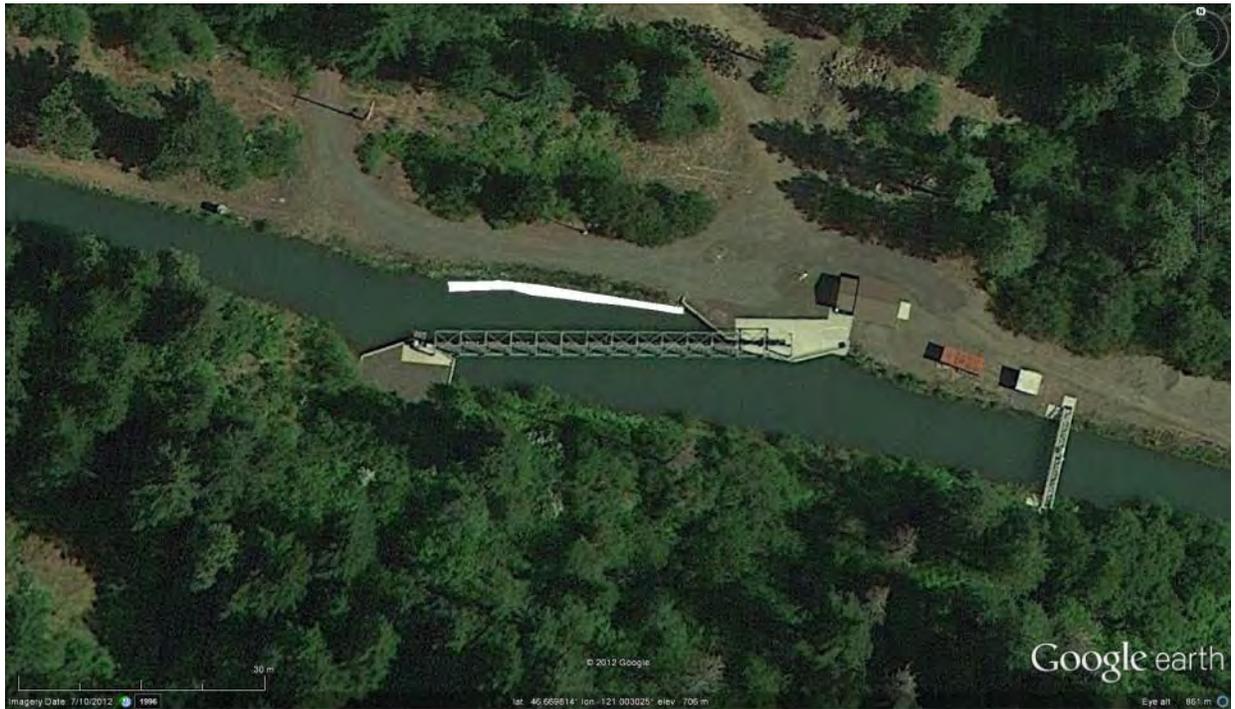
Only above the screens was sampled because there were no collections of sediments below the screens on the cement floor. The area that was sampled was along the bank in the more shallow water and was composed of thick clay, and fine and coarse sand with some large woody debris mixed in. The survey started at the screens and we worked our way upstream and more gravel and cobble became present to where there was no more sediment to sample. There were no lampreys found here as well as no other life seen.

Figure 3: Overview of Yakima-Tieton Diversion

Figure 4: Close up of Yakima-Tieton Screens

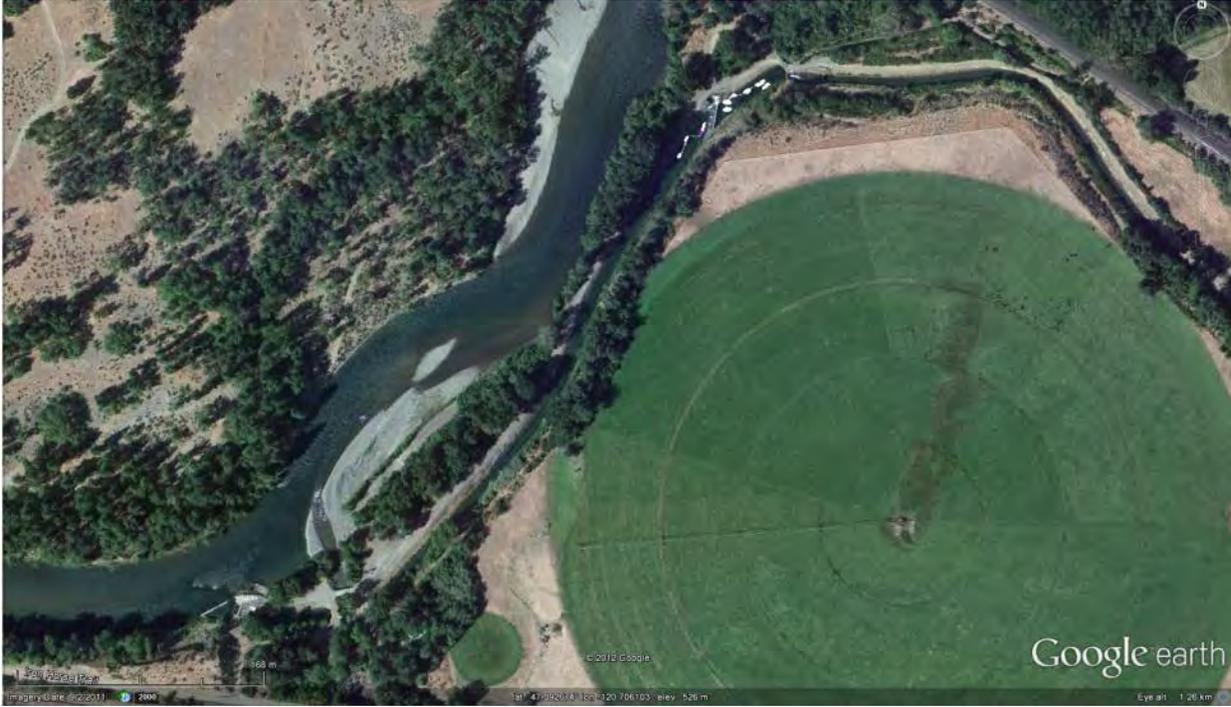
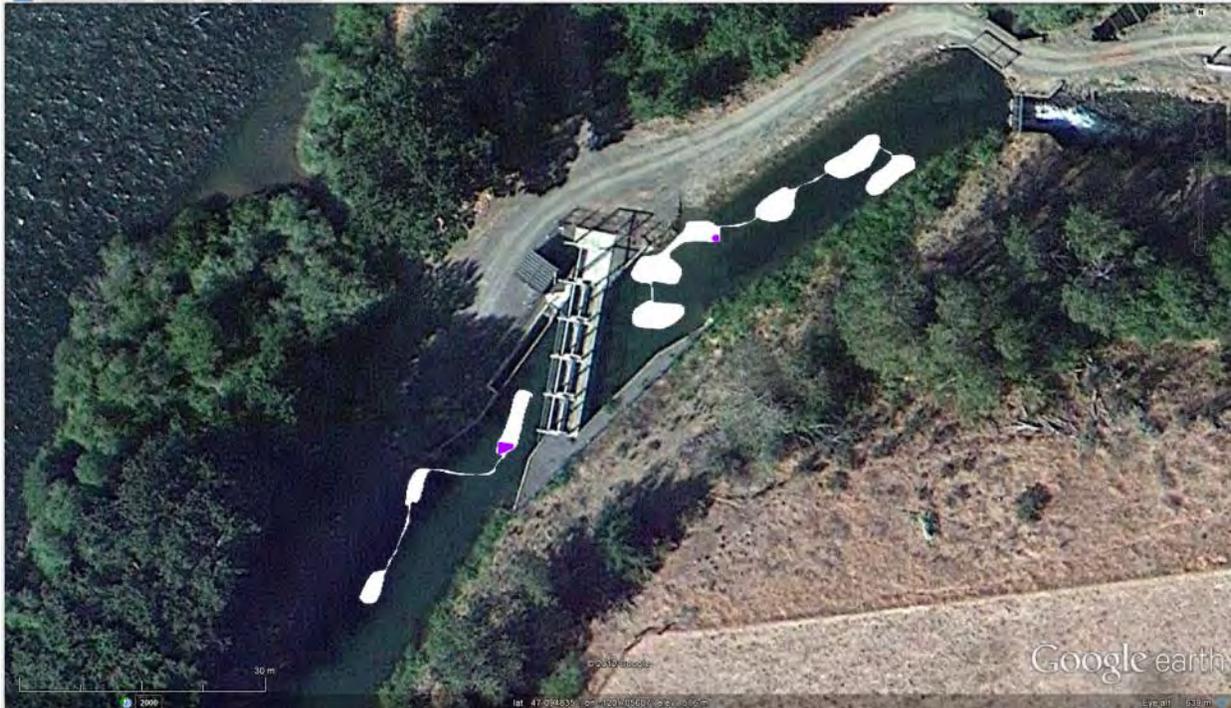
At this diversion, the first survey was conducted above the screens in the shallow areas nearest to the diversion because the further upstream you traveled the deeper the water got and we were unable to sample with the backpack Eshocker. In this area the sediment was composed mostly of fine sand with mixed with coarse sand along the banks and also had many long aquatic grasses growing out of it decreasing visibility. We found three lampreys before moving to the next sampling section

The next area that was sampled was below the screens starting where the cement ended. There was very little sediment that collected on the cement while the entire channel bottom past that point for 20yds was composed of fine and coarse sand mixed with silt, clay, long aquatic grasses, small and medium woody debris and small amounts of detritus. In this area there was only one lamprey found while small sculpin, crawdads, and stickleback fish were observed. The lampreys that were caught were released in the Yakima River below the diversion.

Figure 5: Overview of Westside Diversion

Figure 6: Close up of Westside Screens

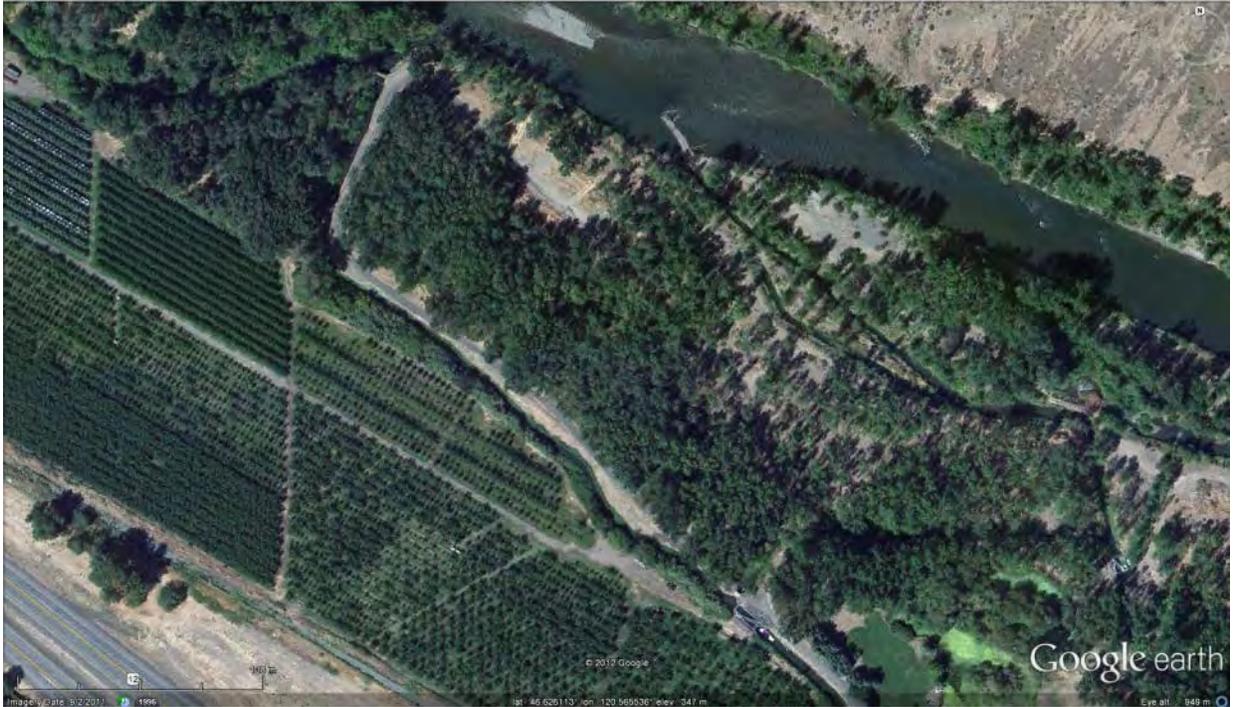
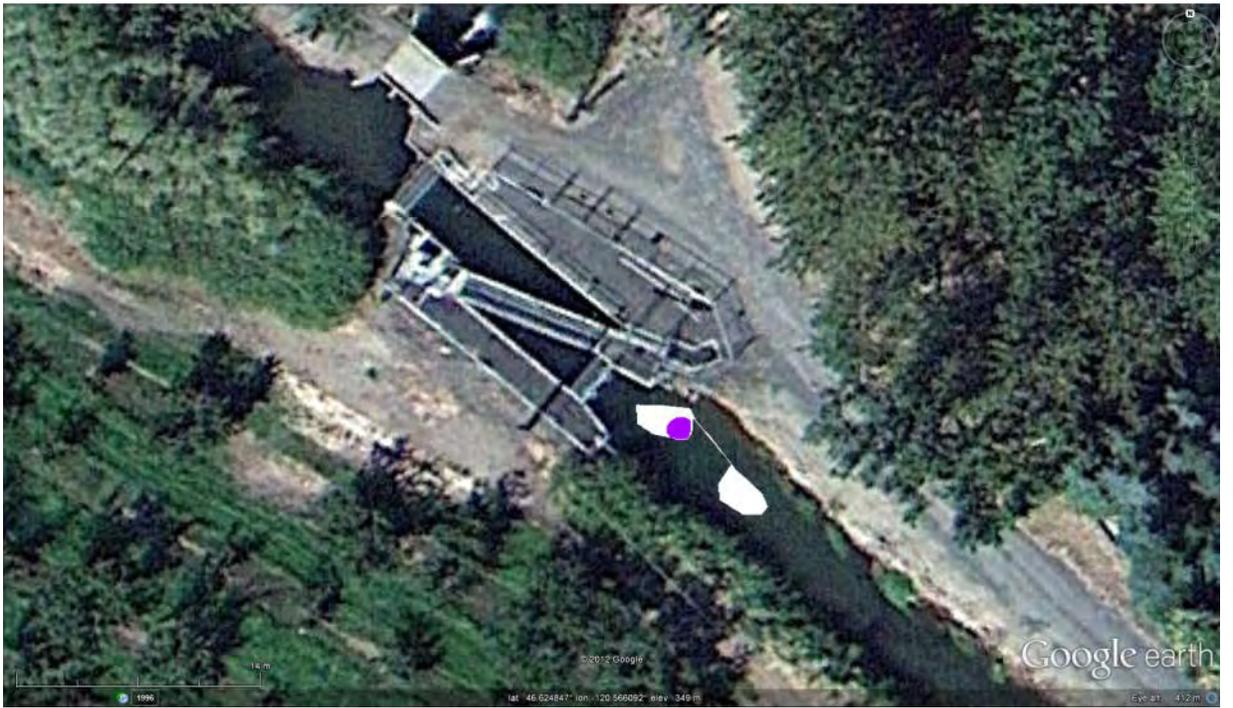
The only area that was sampled on the Cowiche Diversion was directly below the screens due to the lack of water and available habitat. In this area there was a small pool touching the screens and then about 2m away was a small puddle. The sediment was composed of clay and silt mixed with small amounts of cobble and gravel. There were at one time long aquatic grasses that were no dried up along the bottom of the thick mud. There were 10 lamprey found here and were released into the Naches River at the 16<sup>th</sup> St. Ext. outside of Yakima.

Figure 7: Overview of Cowiche Diversion

Figure 8: Close up of Cowiche Screens

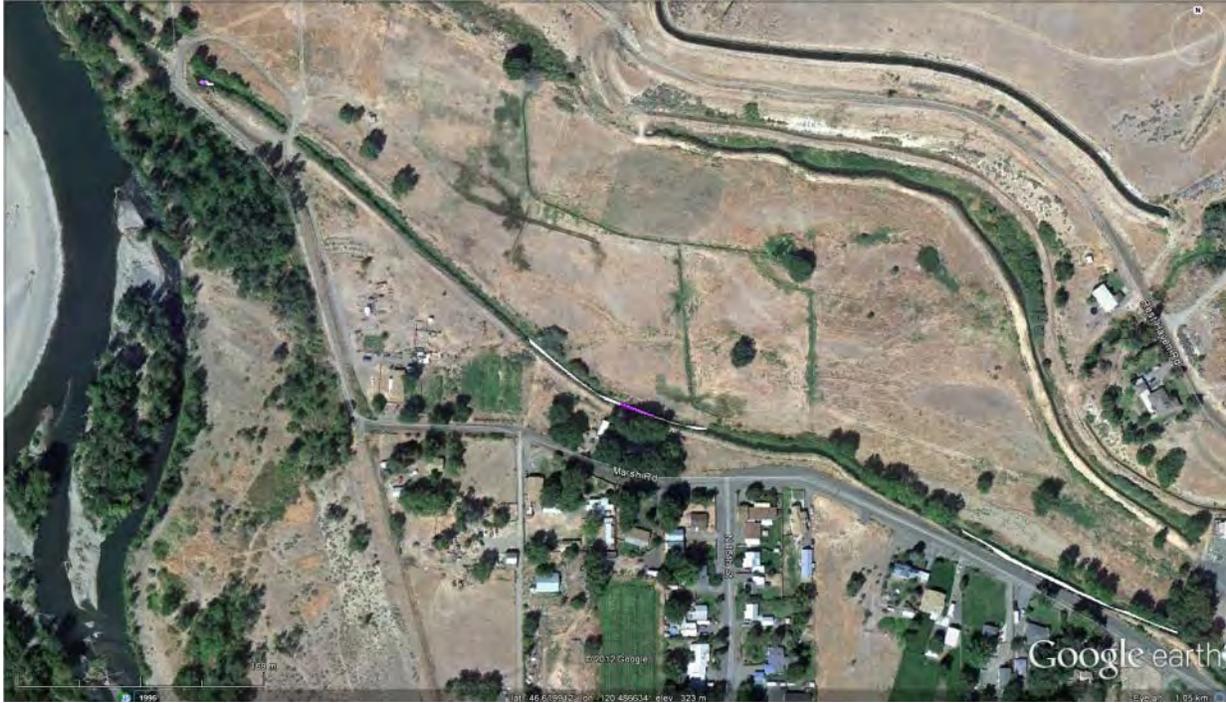
The Area that was surveyed in this diversion was the channel above the screens. We started behind private property and walked .60miles down to the screens surveying the entire section. At the start area there was a deep pool with thick clay and silt mixture along the banks with cobble spaced around. This was where the only macrothamia were found through the survey while only a few ammocoetes were observed.

Walking further down the canal was more sediment made of thick clay and silt with long aquatic grasses that grew in and out of the water. Throughout the midsection of the canal there was no more cobble, and the grasses made visibility very poor to the point where we were unable to capture the entire lamprey that emerged from the sediment. This midsection was where most of the lamprey was found and a majority of them were below 40mm in length. Other fish that were observed included whitefish and other salmonids, sculpin, crawfish, and caddis flies. The area below the screens was composed of bare sediment so it was not surveyed due to lack of habitat. There were 217 lamprey captured and taken to Prosser for further study

Figure 9: Overview of Union Gap Diversion

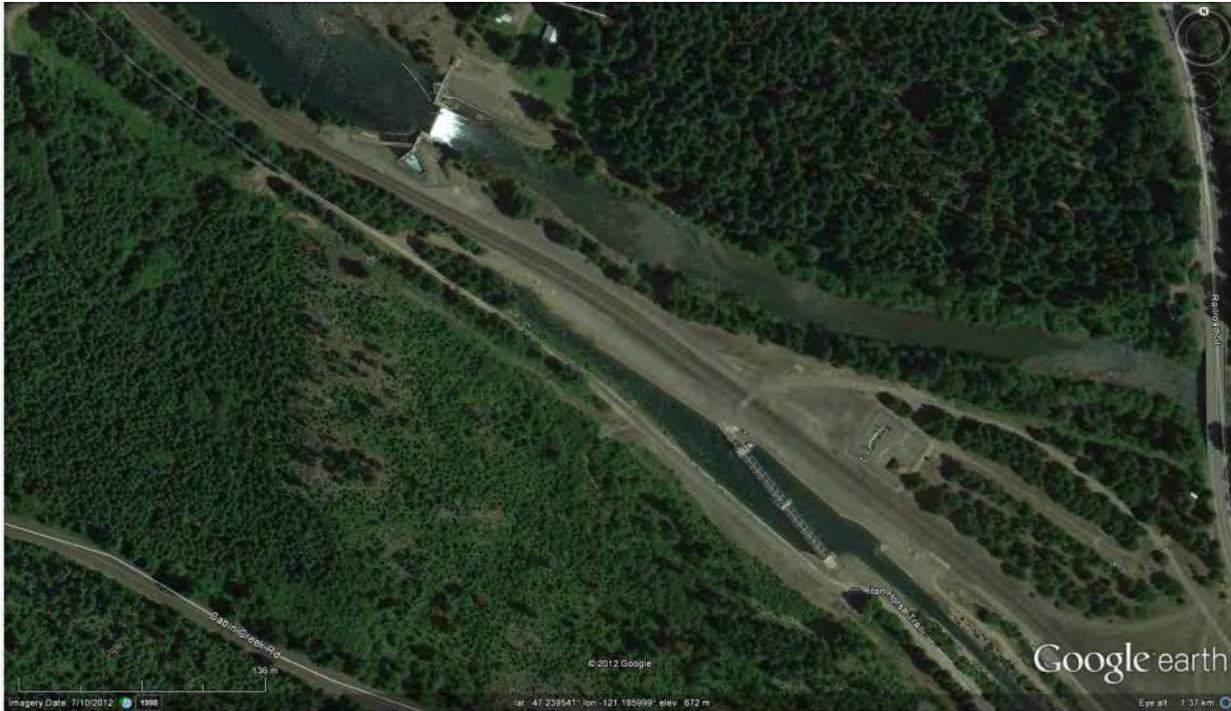
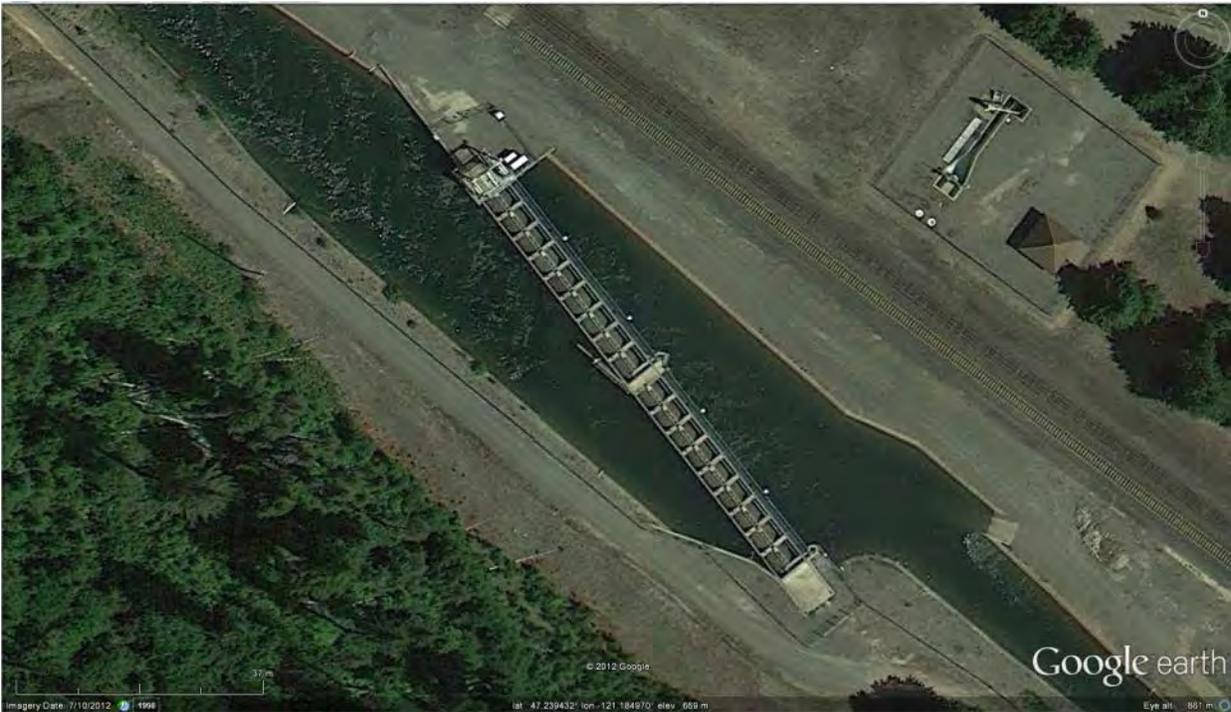
The diversion was accessible but there was no habitat to sample. The bottom of the cement floor was exposed with very little sediment spaced around in a thin layer. There was some large woody debris but no detritus below the screens. Above the screens there was gravel and cobble with a very small amount of coarse sand mixed in but no good depositional areas.

Figure 11: Overview of Kittitas-Easton Diversion

Figure 12: Close up of Kittitas-Easton Screens

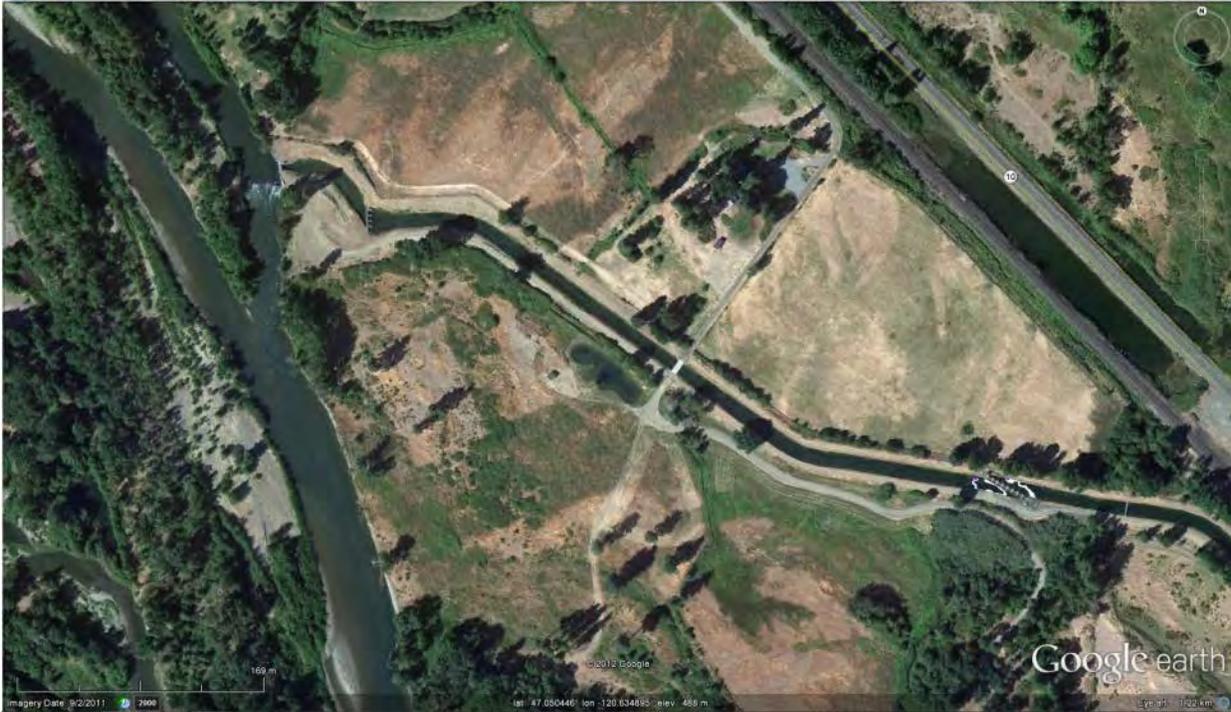
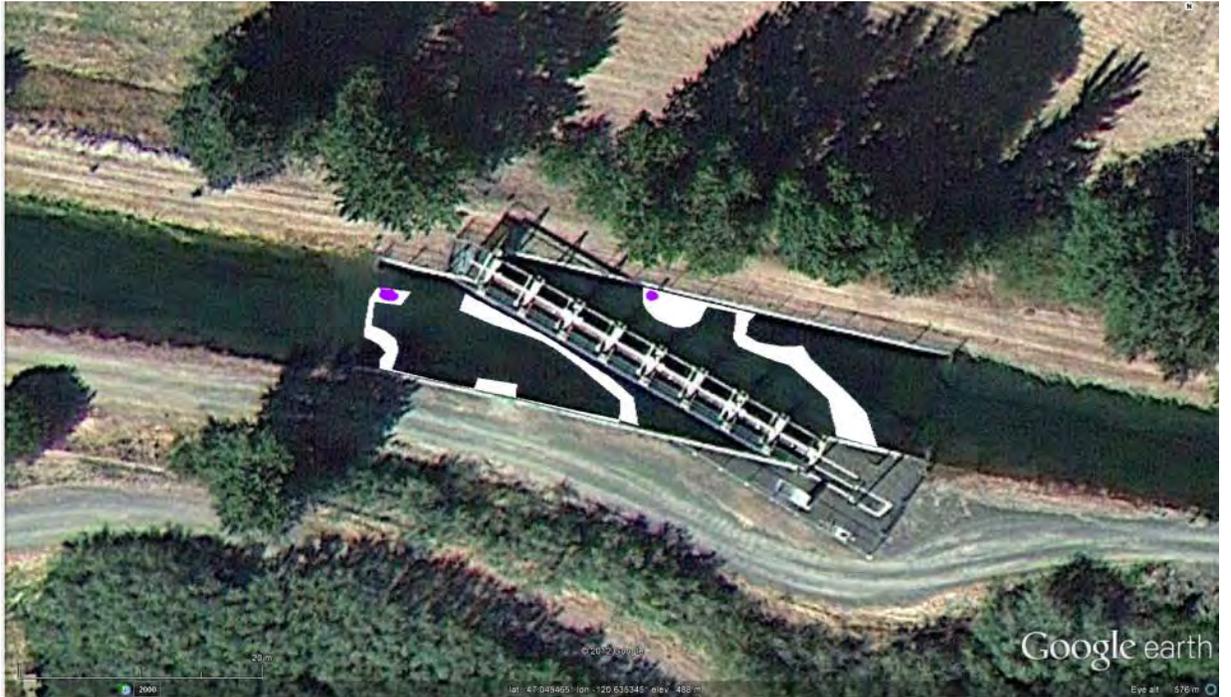
The first area surveyed was below the screens where there was still water collected. In this area it was over the cement floor but there was some sediment that collected along the edge of the water. It was thick clay and silt mixture with long aquatic grasses growing out of it and only one lamprey was found here. There were many small trout and one salamander observed.

The next area that was surveyed was above the screens and the sediment here was composed of fine sand with a small amount of clay mixed in along with long aquatic grasses. The sediment here was raised above water level in the midsection of the cemented area before the screens and there were a variety of bird and small animal tracks in the mud. There were 3 lampreys found in this area and all lampreys were released at the Ringer Loop public fishing area outside of Ellensburg near the Yakima Canyon.

Figure 13: Overview of New Cascade Diversion

Figure 14: Close up of New Cascade Screens

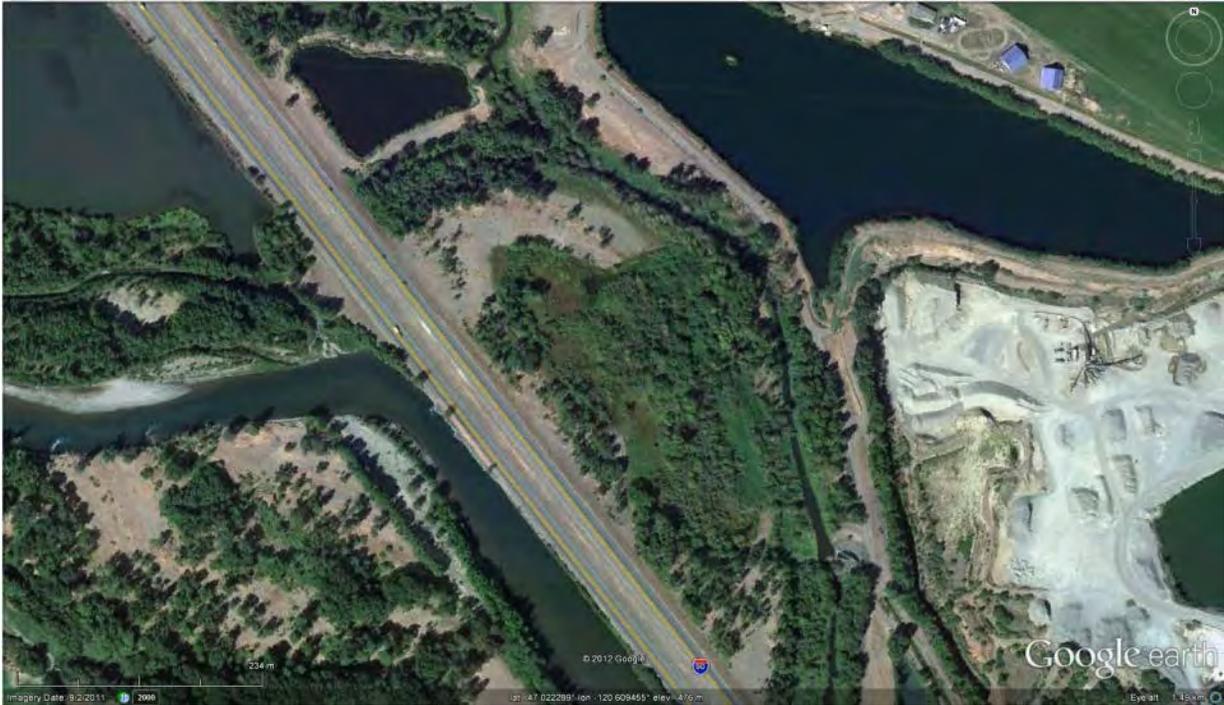
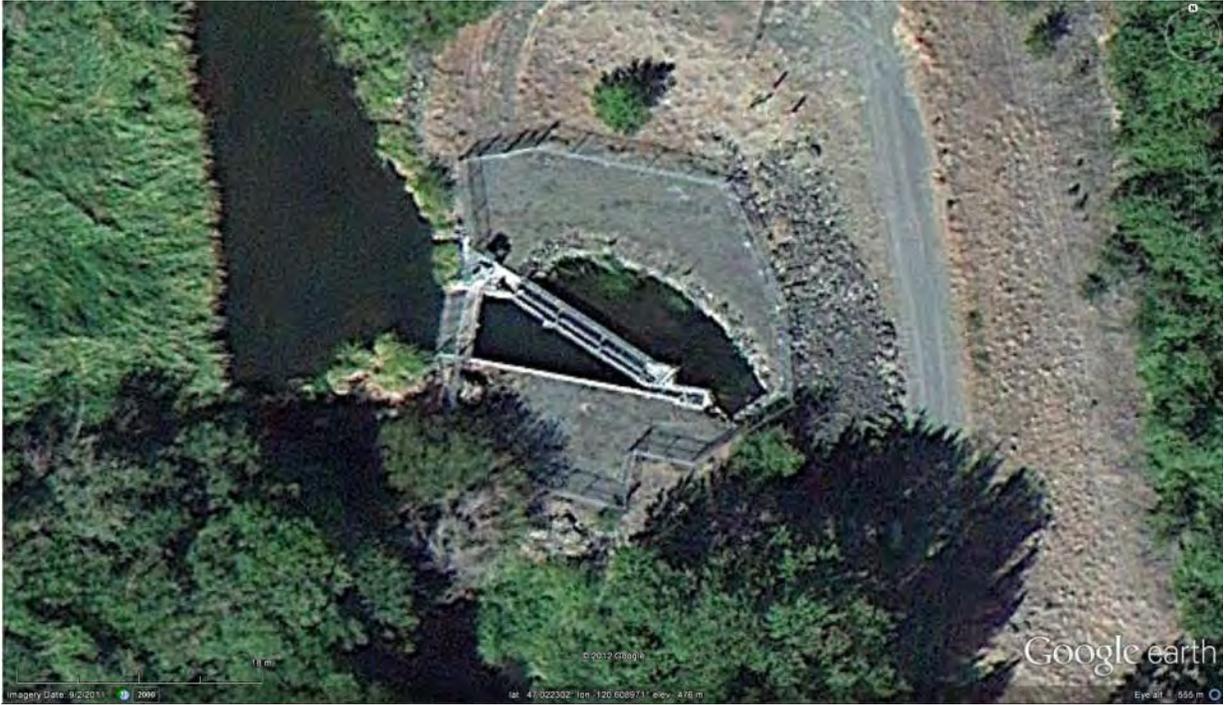
The gates were locked and there was no access to this diversion so no survey was conducted. While there we observed that the water was still high and long grasses were growing in and out of the water decreasing visibility.

Figure 15: Overview of Ellensburg Mill Diversion

Figure 16: Close up of Ellensburg Mill Screens

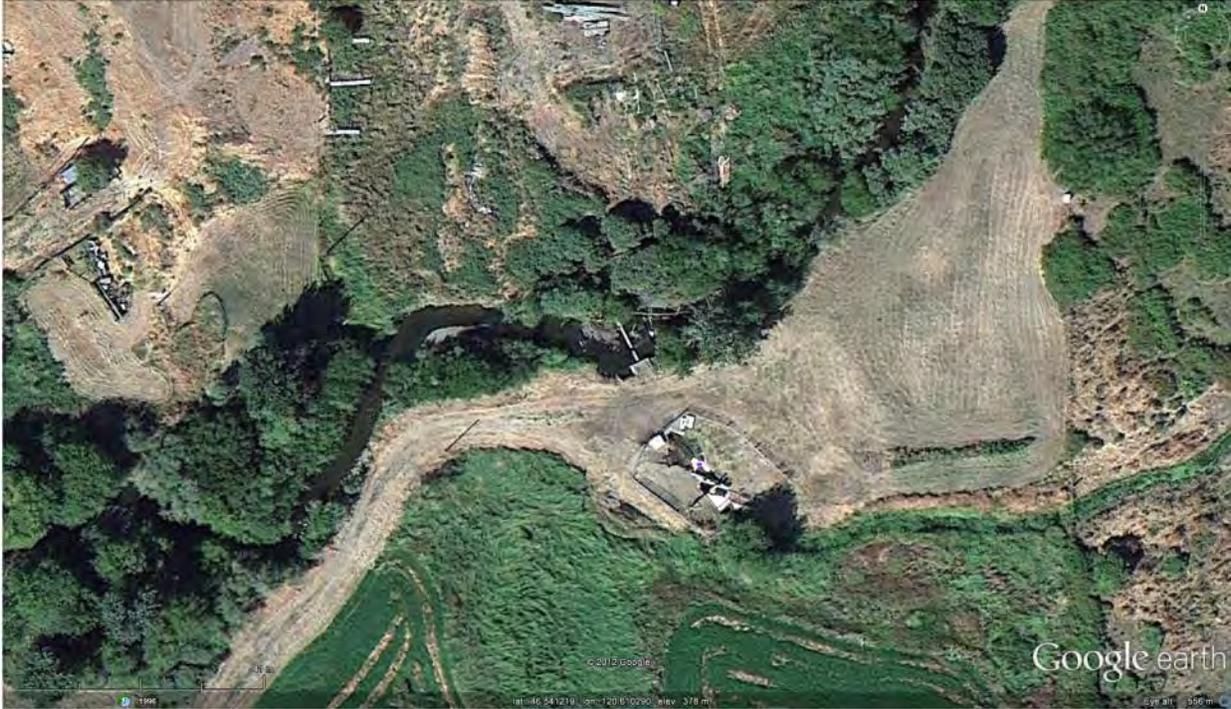
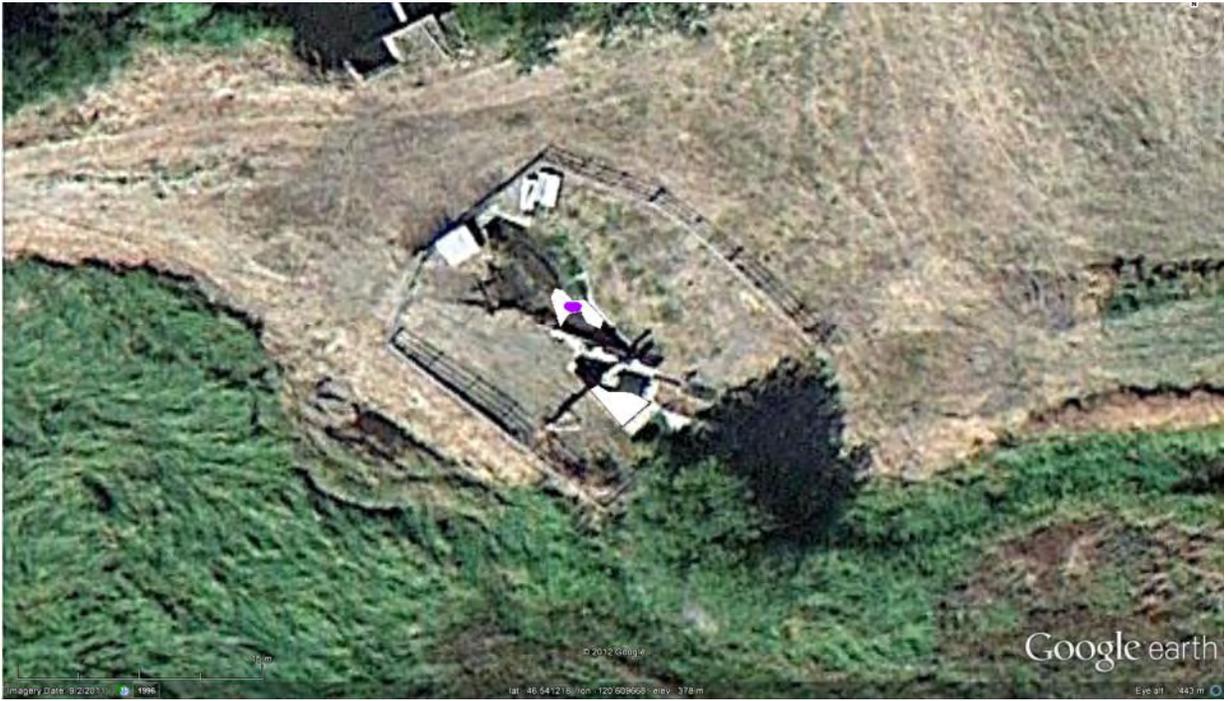
The first area that was surveyed was above the screens. At this diversion there are two small drum screens so the sample area was only a 3mx2m section above them. The sediment was composed of thick silt and fine sand mixed with large, medium, and small woody debris and detritus. There were also long grasses and cattails growing out of the water that decreased visibility with their stalks. There were 17 ammocoetes found in this area and sculpin, crawfish, stickleback, and small trout were also observed. The lamprey was found in all areas above the screens but none were found below the screens. Below the screens the water was deeper and murky so visibility was very low. The sky had a cloudy overcast that created a glare on the water, the breeze created ripples, and there was no current to the mud took a while to settle and that all decreased visibility. All lampreys were taken to Prosser for further study.

Figure 17: Overview of Lower WIP Diversion

Figure 18: Close up of Lower WIP Screens

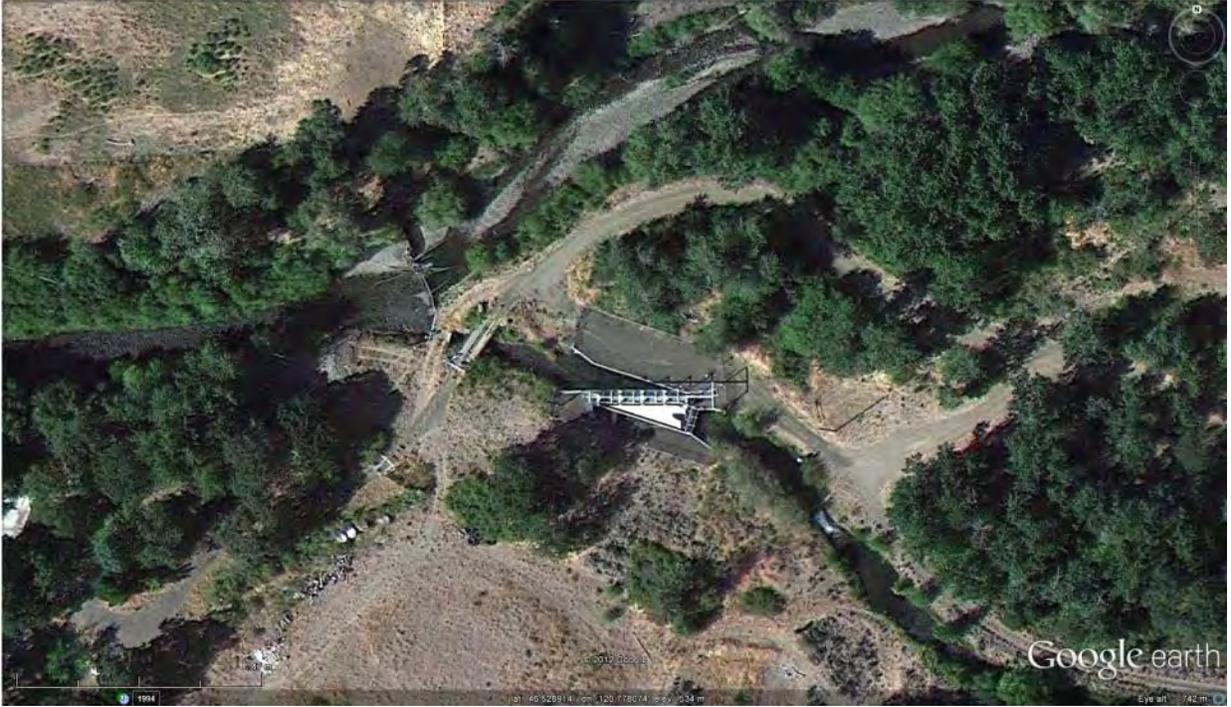
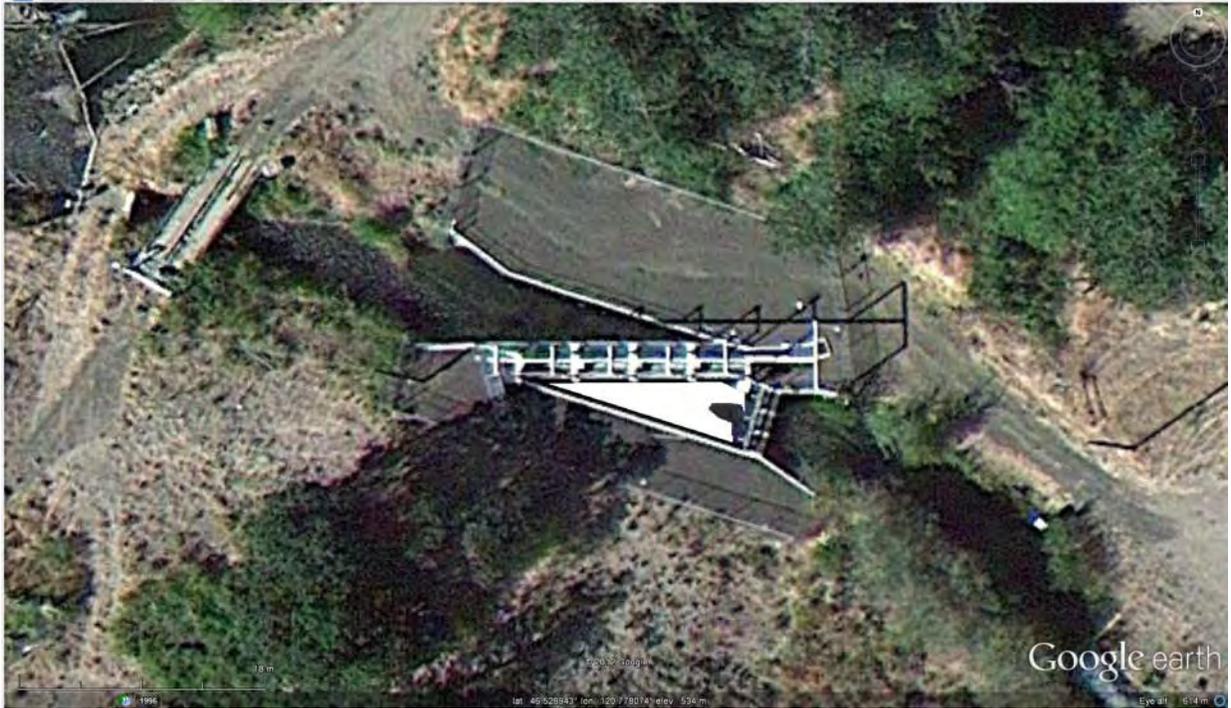
The Area that was sampled was located below the screens on the Upper WIP Diversion. While Eshocking, 2 dead lampreys were found on top of the silt, fine sand, woody debris, and detritus mixed sediment. There were also 50 sculpin and 30 crawfish observed during this survey. The screens were lifted up after the dewatering and the sediment depths were 36cm, 10cm, and 18cm.

Figure 19: Overview of Upper WIP Diversion

Figure 20: Close up of Upper WIP Screens

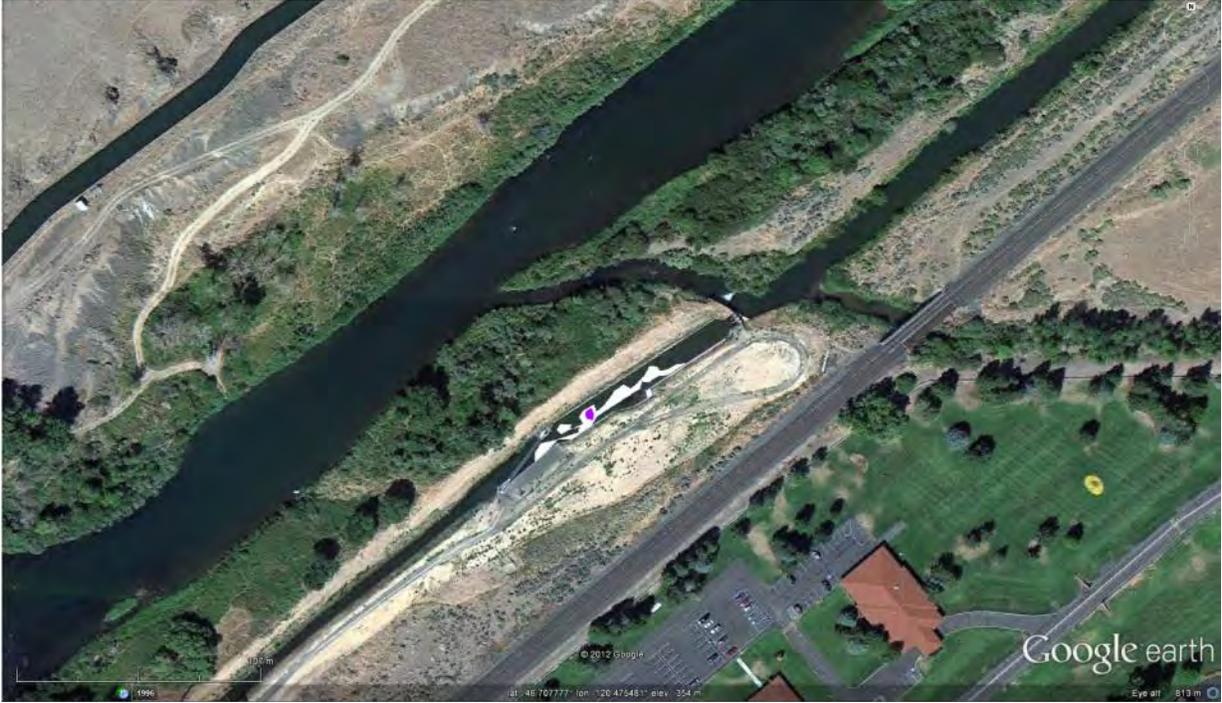
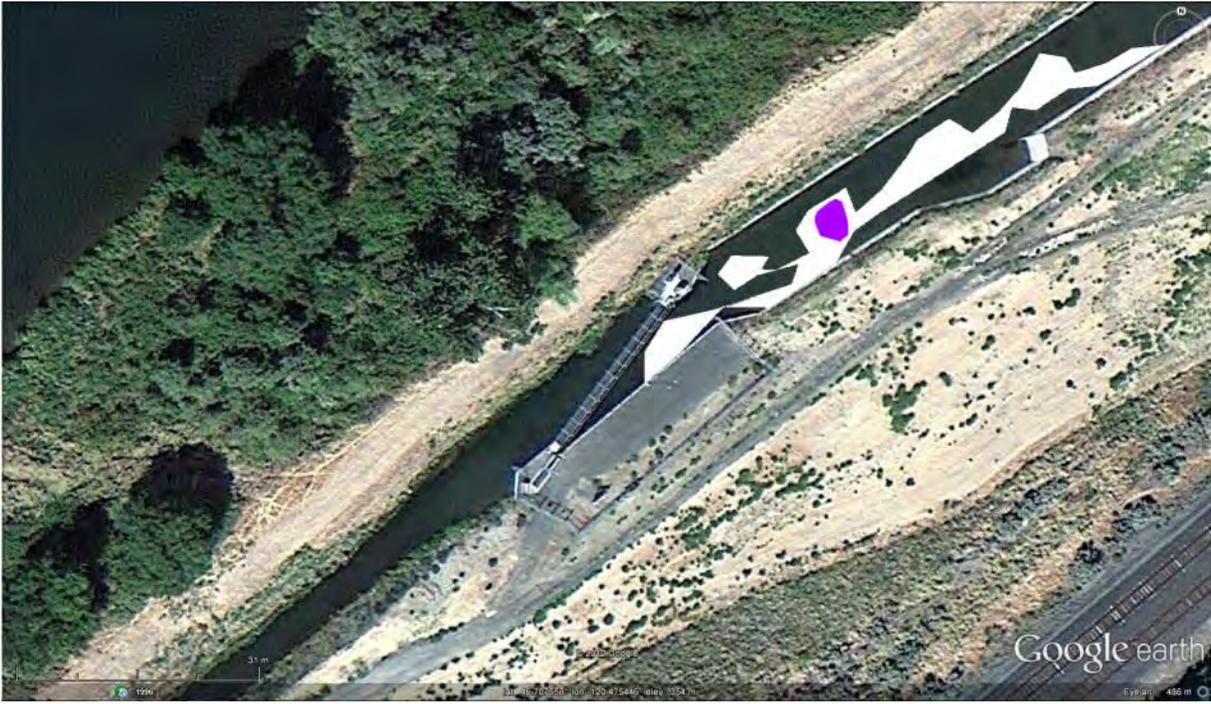
The only area that was surveyed was the section above the screens to the head gate. The area below the screens had no available habitat to survey and was composed of an armored channel. The sediment that was located above the screens was a mixture of fine sand and silt with long aquatic grasses growing out of it which decreased visibility. The entire section was also cement and the sediment thinned and eventually was no long along the bottom near the head gate. In the section where the sediment was raised above the water level there was a mixture of smells being emitted, such as plant decomposition, manure and other animal fecal matter. There were also some oil residues on top of the mud which could have been natural plant oils or pollution. There was also a variety of bird and small animal tracks imprinted into the mud.

There were 29 ammocoetes found above the screens along the midsection of the canal and all measured below 100mm. There were water skippers, small aquatic beetles, worms, and leeches observed in this area. The entire lampreys captured were taken to Prosser for further study.

Figure 21: Overview of Selah-Moxee Diversion

Figure 22: Close up of Selah-Moxee Screens

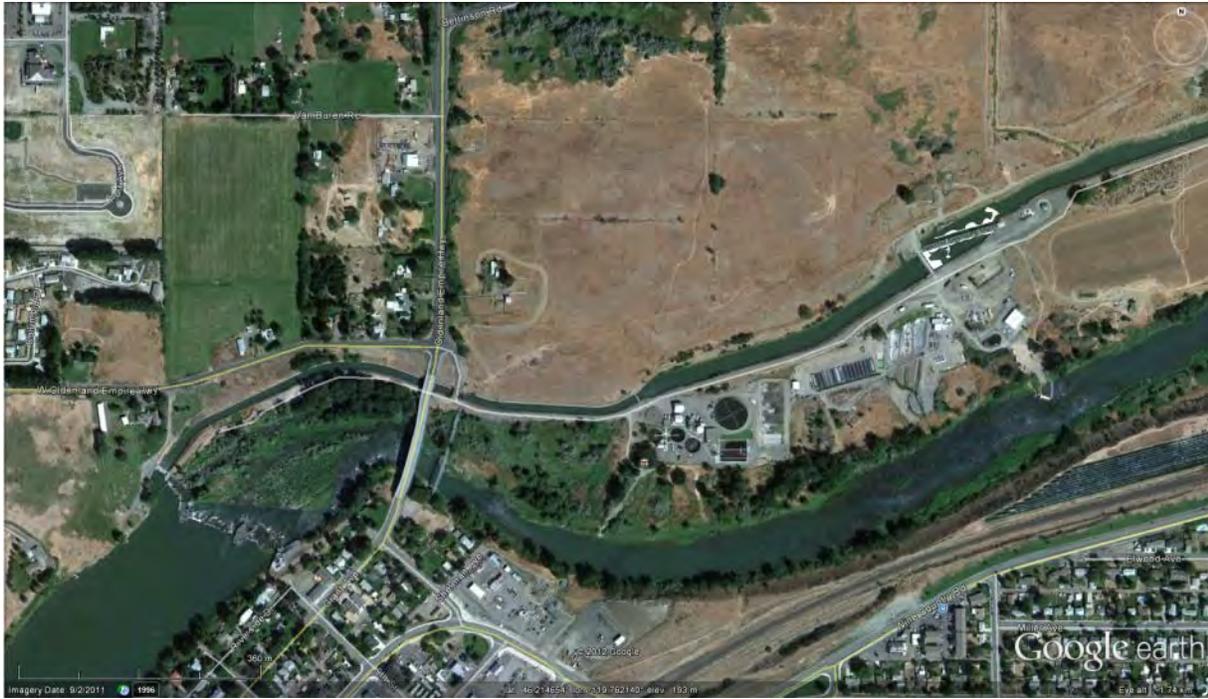
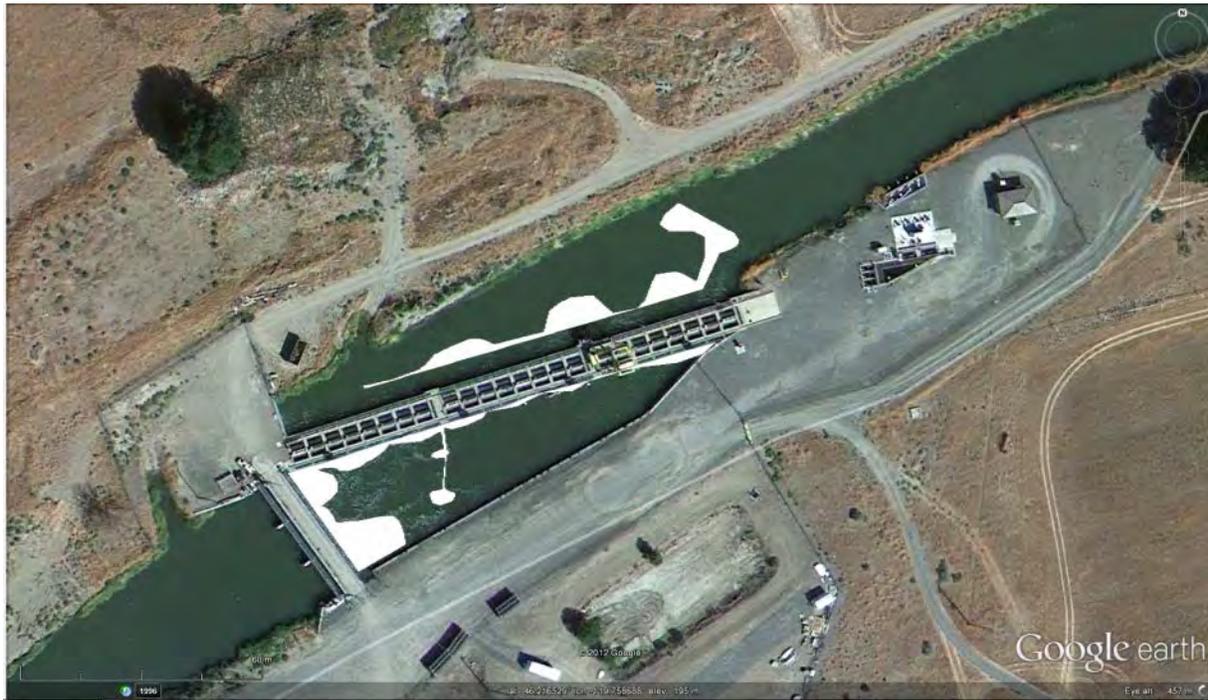
The first day of surveying the diversion was the day of the fish salvage for Chinook and Coho Salmon. Our crew got clearance for the survey during the salvage before the canal was watered up again. The first area that was surveyed was above the screens between the screens and the trash racks. This diversion has not been dredge for a few years so the sediment build up was around 4ft at its deepest. The sediment was composed of coarse and fine sand mixed with small amounts of woody debris and detritus located against the screens and trash racks. The sediment top formed mounds and water had collected in the valleys creating small areas to survey along the midsection. The only places to survey other than that were directly in front of the trash racks and screens with an average width of 1m due to the lack of water flow. No lamprey were found above the screens but over 100 whitefish were seen stranded on top of the sand barely in the water and small juvenile salmon, stickleback, chisel mouth, channel and bullhead catfish, worms, and crawfish were also observed.

The next area of the diversion that we surveyed was below the screens. There wasn't nearly as much sediment behind the screens as there was above. The cement shelf that was built under the drums screens was exposed with no sediment on top. The water depth average 40cm in its deepest parts and was shallower along the sediment banks. The survey area was composed of coarse sand and fine sand mixed with small woody debris and detritus with cobble and gravel spaced around. There were many aquatic insects and large numbers of catfish observed but no lamprey were found.

Figure 23: Overview of Chandler Diversion

Figure 24: Close up of Chandler Screens
