## **Pacific Lamprey 2012 Annual Report and 2013 Plan**

**Columbia/Snake River Salmon Recovery Office  
Pacific Northwest Region**

Prepared to document and communicate Reclamation's actions in calendar year 2012 pertaining to Pacific Lamprey under the commitments in the 2008 Columbia River Fish Accords.

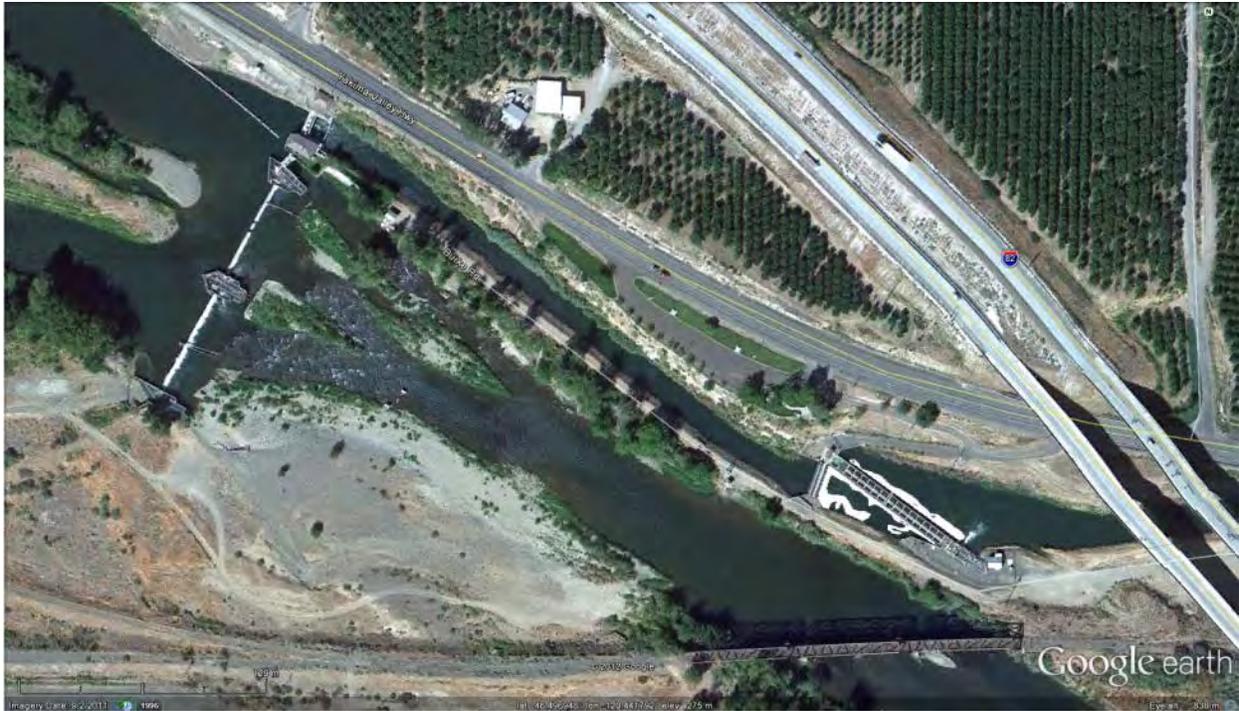
The first area that was surveyed at the Sunnyside Diversion was located below the screens. The diversion had not been dredge before we started our survey so there were large mounds of coarse and fine sand that had collected throughout the year. Because of this, we were only able to survey along the screens where the water ran alongside the sediment banks. There was a total of 357 lamprey captured throughout the entire survey area and small juvenile fish were observed as well. There was a large area of exposed sediment that was raised above the water level and there were many bird and small animal tracks imprinted into it. There were also approximately 20 dried up dead lamprey found on top of the dry sediment that must have gotten stranded during the dewatering process.

The next area that was surveyed was above the screens. During this survey, we joined Joel Hubble's fish salvage crew assisting in capturing salmonids along with lamprey. The area that was surveyed above the screens was located along the screens, the trash racks, and part of the bank due to the available habitat. These areas were composed of fine and coarse sand mixed with high densities of woody debris and detritus. The majority of lamprey found here were macropthalmia and large ammocoetes. The midsections of the survey area were composed of large cobble mixed with small amounts of sand and gravel.

Figure 27: Overview of Sunnyside Diversion

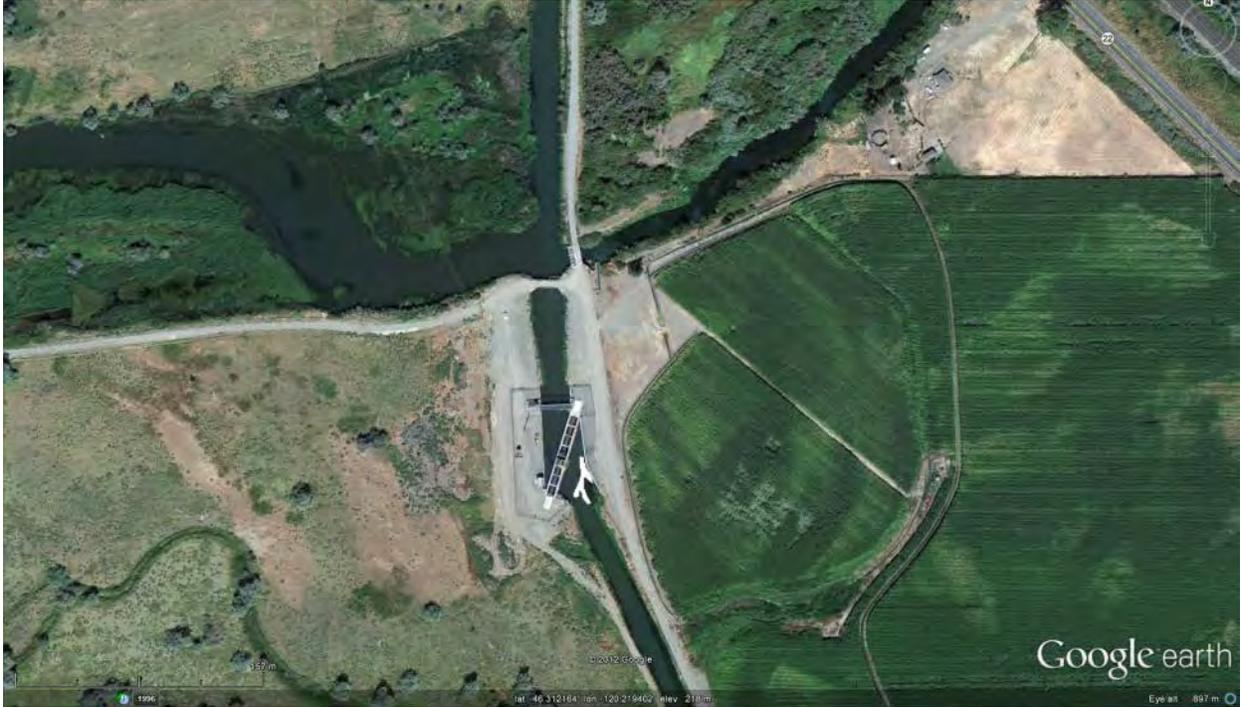
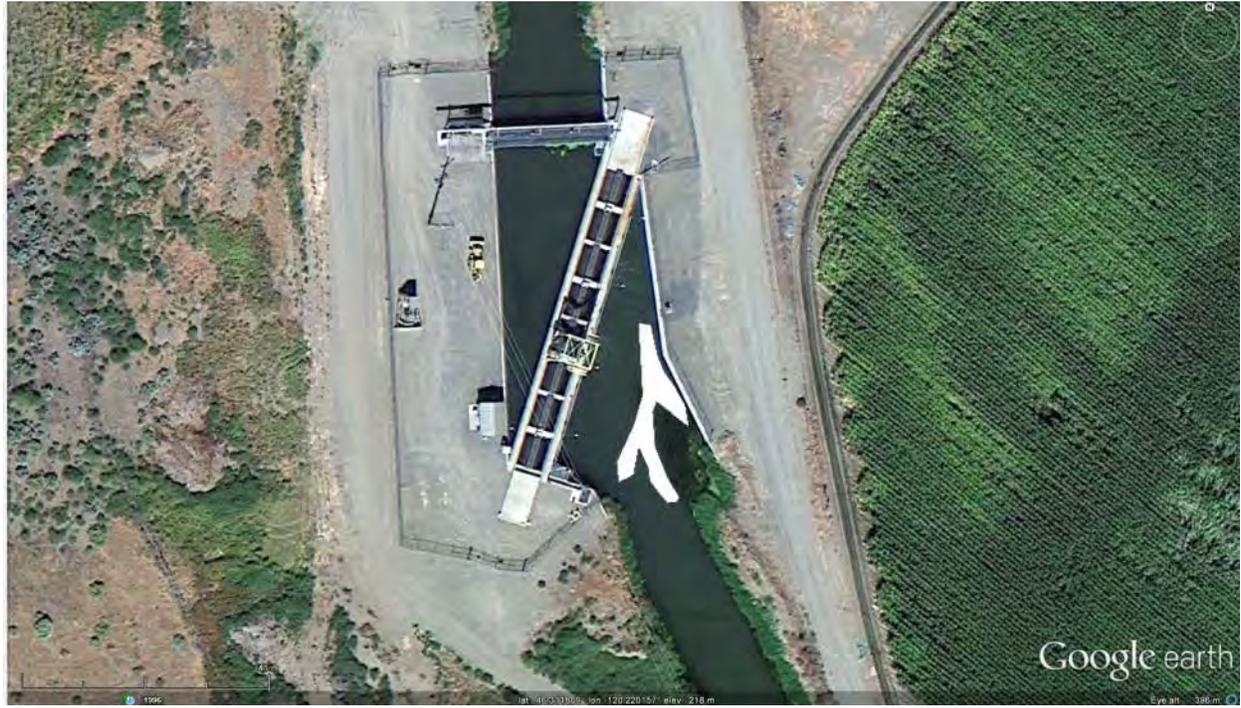
Only below the screens were sampled, above the screens was completely locked so there was no access and above the trash racks was stagnant water with very little sediment mixed with cobble along its armored bottom. Below the screens held the most habitat with many good depositional areas along the bank consisting of thick clay, silt, and fine sand. In most areas there were long aquatic grasses growing out of the sediment decreasing visibility. While there, a water pump was on and was lowering the water level decreasing the available habitat for the survey. No lampreys were found at this site but other life was observed including worms, leeches, beetles, skippers, stickleback, and spotted dace. Sediment samples were also taken and frozen at the Toppenish Fisheries office for further study.

Figure 29: Overview of Toppenish-Satus Diversion

Figure 30: Close up of Toppenish-Satus Screens

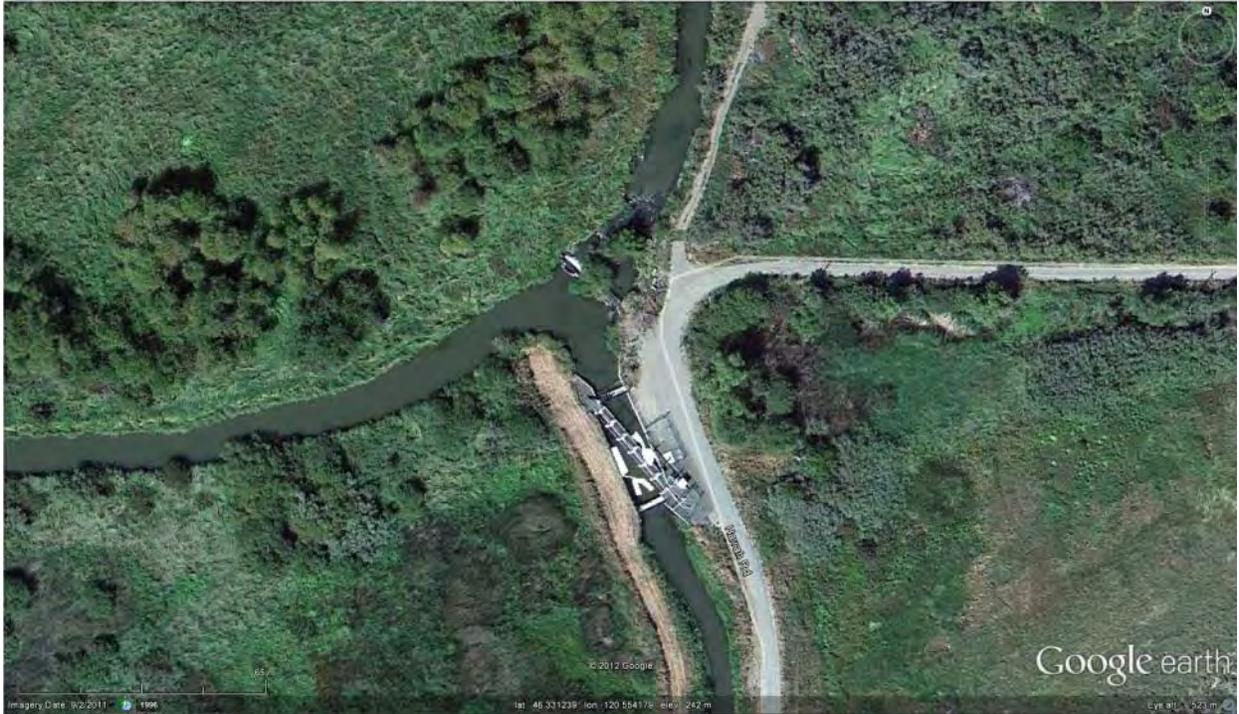
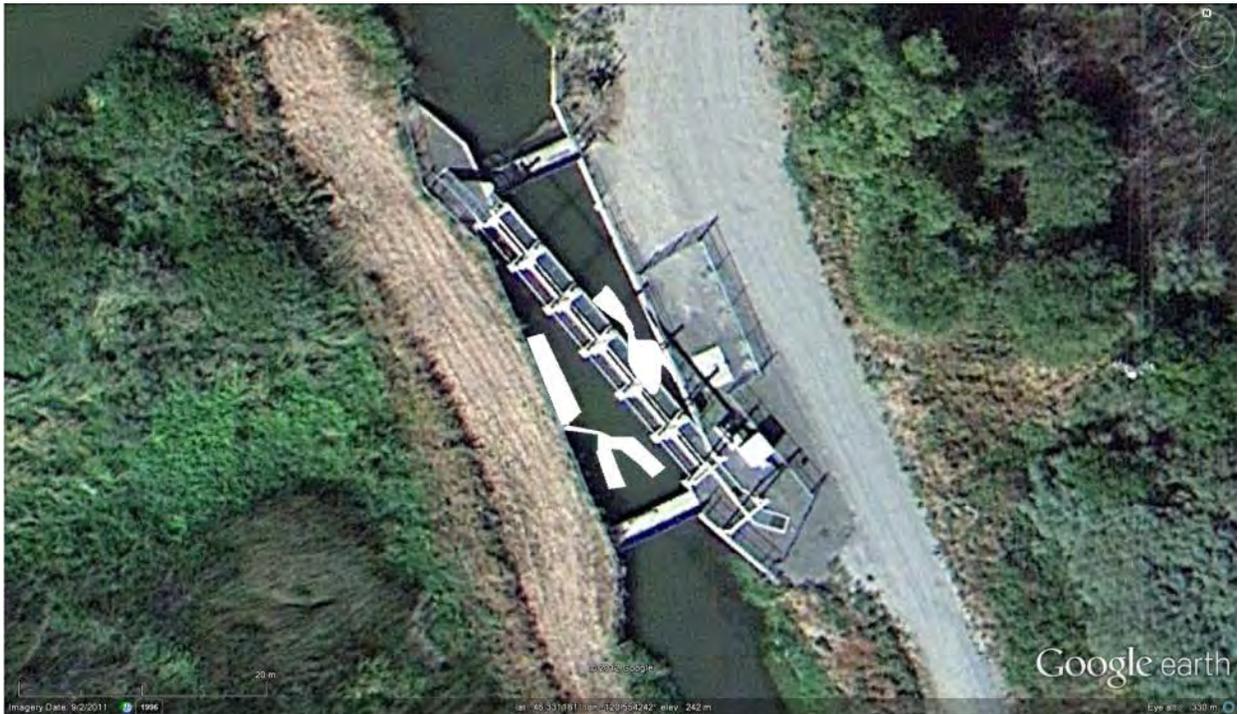
Both above and below the screens was sampled but no lamprey were found. There seemed to be good depositional areas with thick clay, silt, and sand mixed with woody debris and detritus although the only fish observed were stickleback and small dead trout. There were also water skippers, crawfish, leeches, and small aquatic beetles seen. In the sample area there was a variety of garbage and also an oily substance in parts of the stagnant water.

Figure 31: Overview of Unit 2 Feeder Diversion

Figure 32: Close up of Unit 2 Feeder Screens

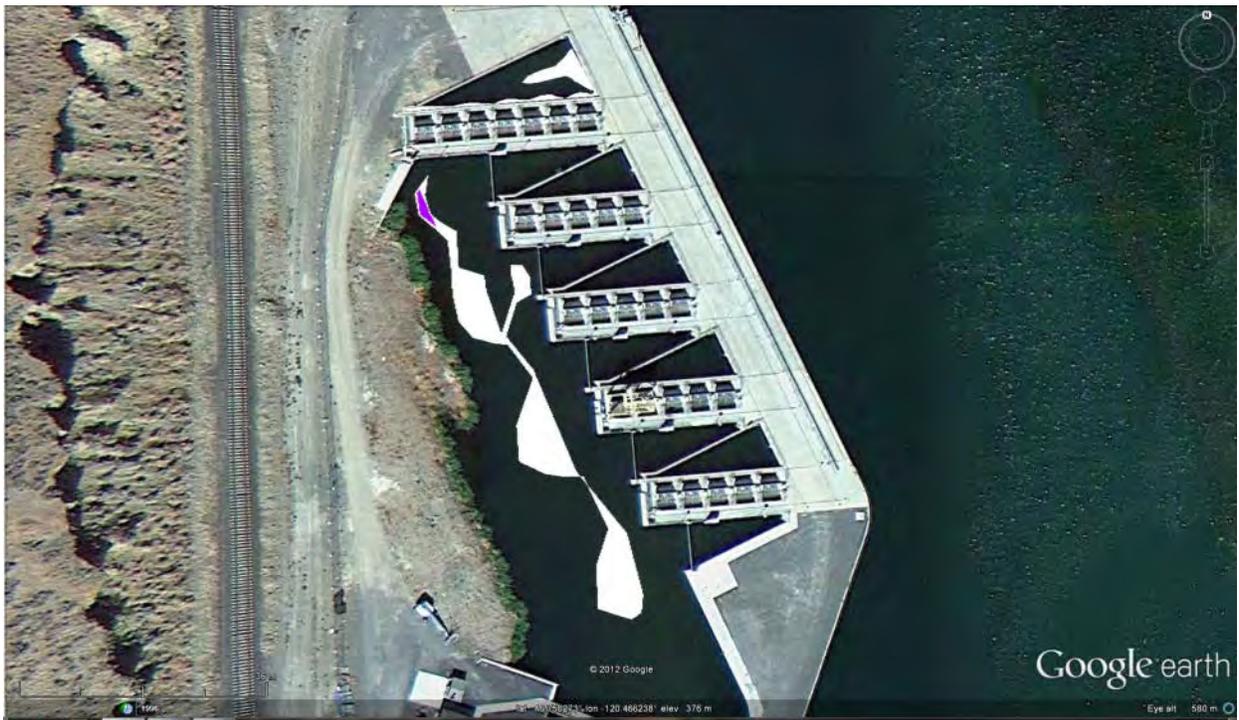
The first area that was sampled was above the screens on the upper most part of the diversion. This area had a very thin layer of sediment in all areas except directly in front of the screens. In that area there was sediment mounds with lots of woody debris and detritus and is where the entire lamprey was captured from. There were 98 lampreys captured in this area. There were also small trout, stickleback, and spotted dace observed as well.

The next area that was sampled was located below the screens and was composed of hard clay along the banks with soft clay and sand mixed with gravel and cobble along the midsection. The best depositional areas collected below the screens where the cement had ended leaving a drop off for sediment to settle. Here there was woody debris and detritus. Along the banks there were many animal tracks from birds and small animals and even a few dried up dead lamprey. There were small trout, stickleback, spotted dace, crawfish, skippers, and other small aquatic insects observed.

Figure 34: Close up of Roza Screens

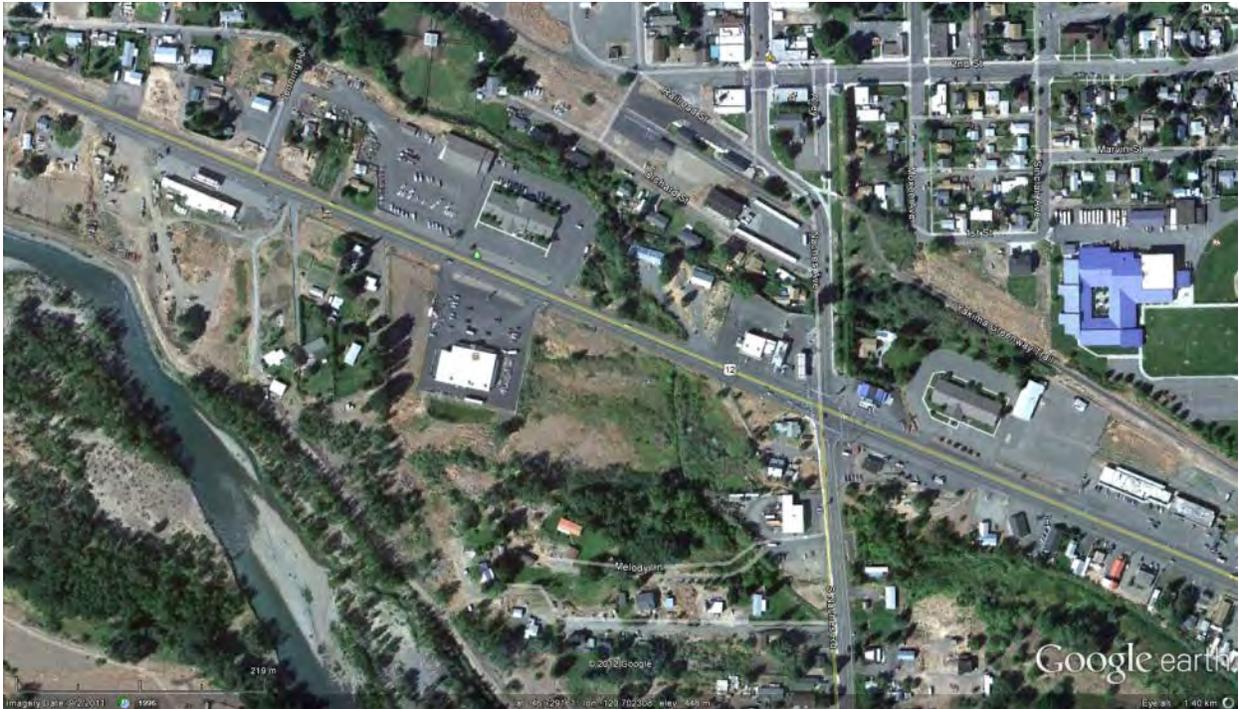
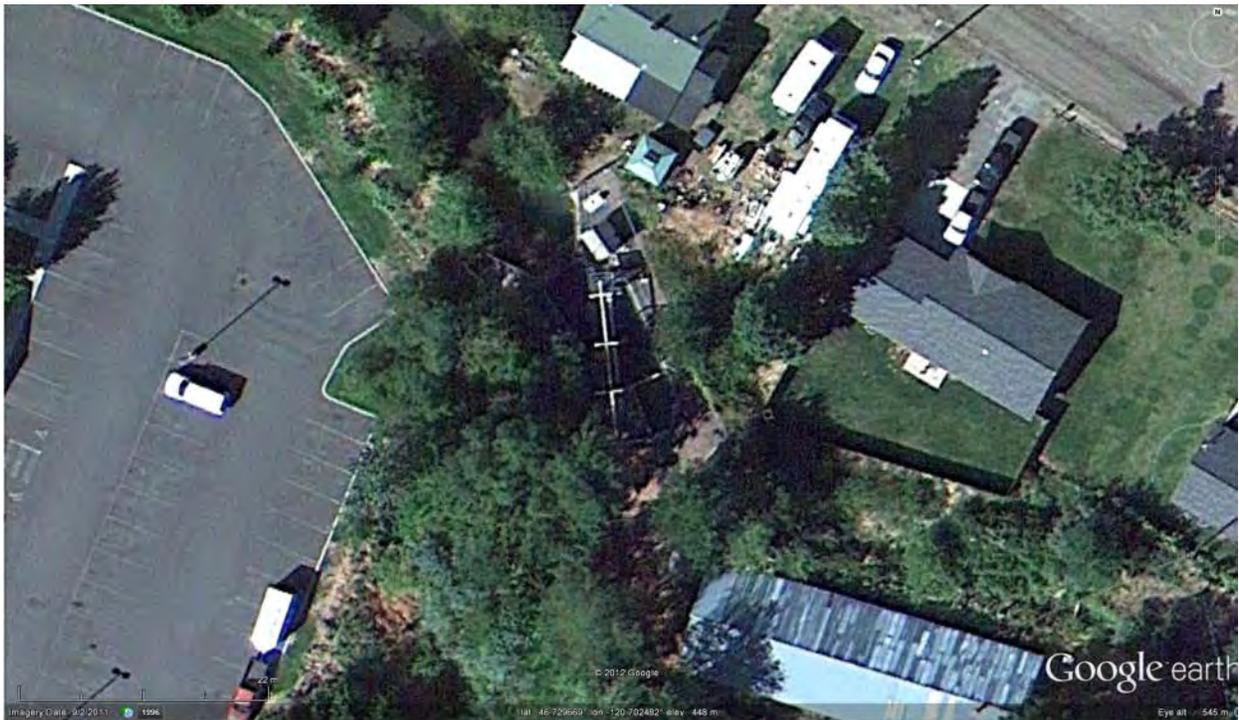
We were unable to access this diversion at an earlier date due to the gate being locked and no key but when we finally did there was no water in the diversion. Because of the lack of water no survey was taken although there would have been a good depositional area. The thick mud consisted of clay, silt, and fine sand mixed with small amounts of detritus.

Figure 35: Overview of Kelly-Lower Diversion

Figure 36: Close up of Kelly-Lower Screens

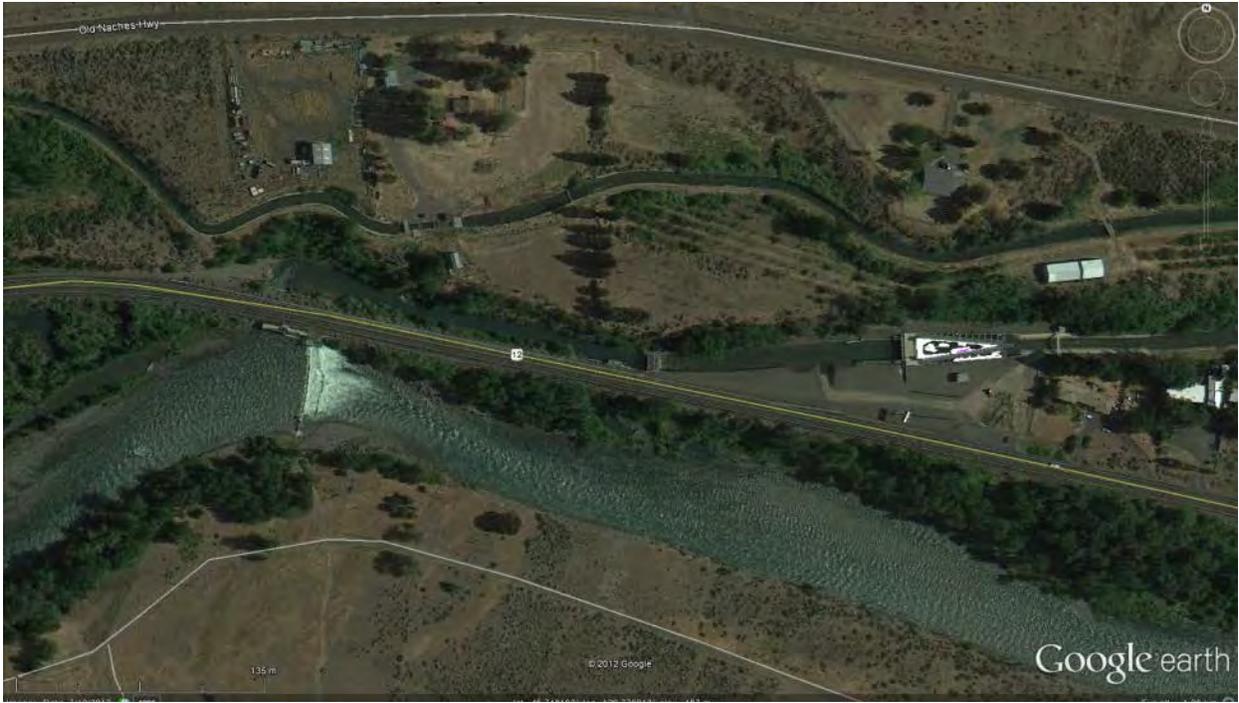
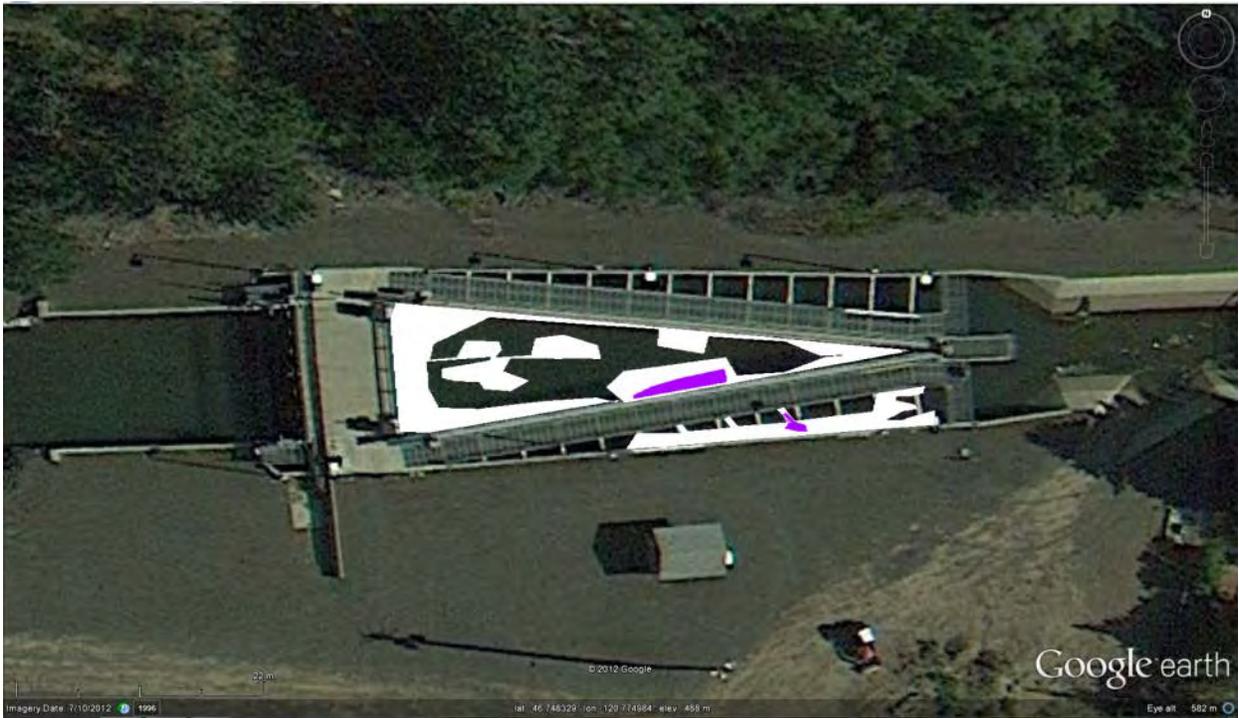
This Diversion was only surveyed above and below the screens and not down the canal due to lack of sediment along its cement bottom. The first place that was sampled was above the screens and required a ladder for access. The sediment here was thick and composed of clay, silt, and fine sand with long aquatic grasses growing along the bottom. 87 lampreys were captured above screens and were taken to Prosser to the hatchery for further study. The next area that was sampled was below the screens. This area was composed of clay and fine sand and 52 lampreys were captured. After captured, data was collected, they the lamprey were released back into the diversion were they were found for further study. The lamprey that was found varied in sizes from 5mm-150mm, indicating different age groups.

Figure 37: Overview of Wapatox Diversion

Figure 38: Close up of Wapatox Screens

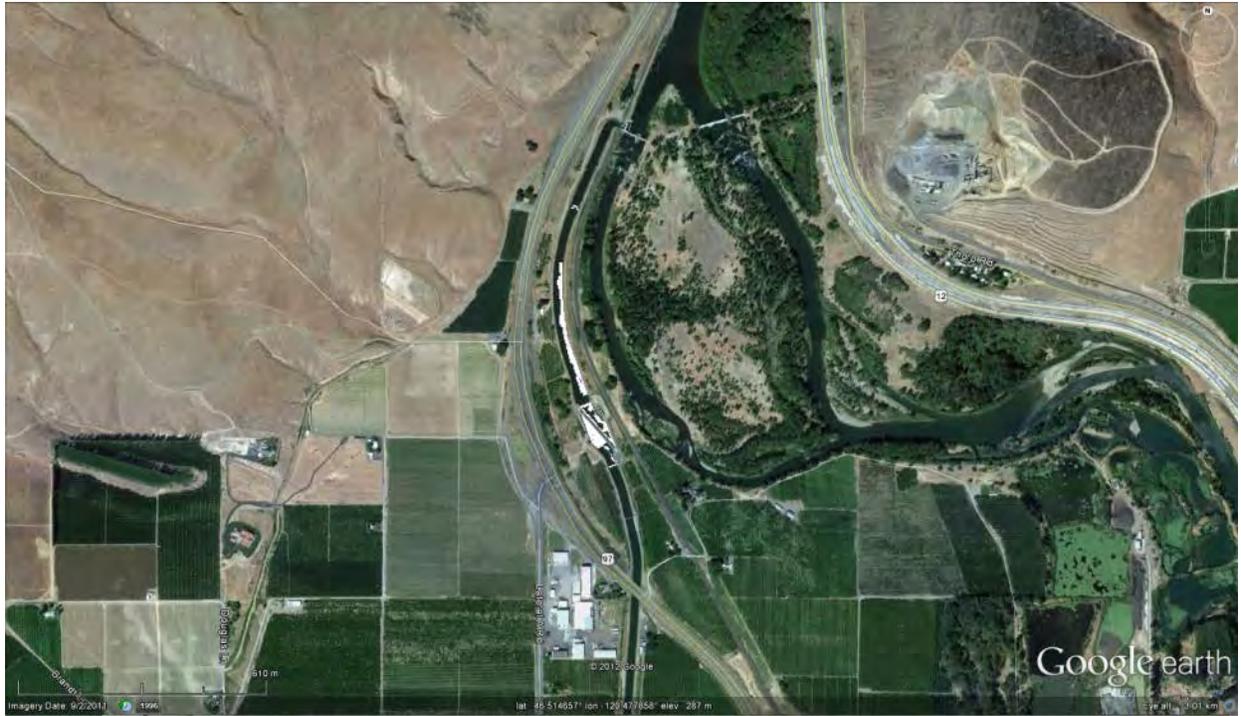
The diversion consisted of a mixture of gravel, cobble, fine and coarse sand, silt, and clay with small amounts of detritus and woody debris located near the screens (above and below) and above the trash racks toward the head gates. In some areas the sediment was thick and up to 3ft deep below water level while some areas the mounds were raised above creating islands. On the sediment mounds there were a variety of tracks from small animals and birds. There was also many small dried up dead lamprey in all areas with exposed sediments. Sediment samples were also taken and frozen at the fisheries office for further studies. In the canal there was also an oily residue located along the banks in the mud and on the water along with garbage consisting of tires, plastics, glass, cans, large metal bars and other house hold containers. Traveling down the canal there was significantly less sediment and gravel, cobble, boulders, and long aquatic grasses. There was other life observed including squawfish, carp, stickleback, spotted dace, whitefish, steelhead, sculpin, trout, crawfish, and many aquatic insects.

Many lamprey were found in this diversion ranging from above the screens past the trash racks to below the screens down the canal approximately 8 miles downstream including Westernbrook's and Pacific's ranging in sizes from 5mm-170mm indicating different age groups. There were many new born fish of this year seen and were unable to catch due to their small size because they would slip right through the net of there would be too many to catch at once. Out of the lamprey captured, some were taken and preserved while others were taken to Prosser to the hatchery for study, or were released into the Yakima River at the Zillah public fishing area in the Wapato Reach.

Figure 39: Overview of New Rez Diversion

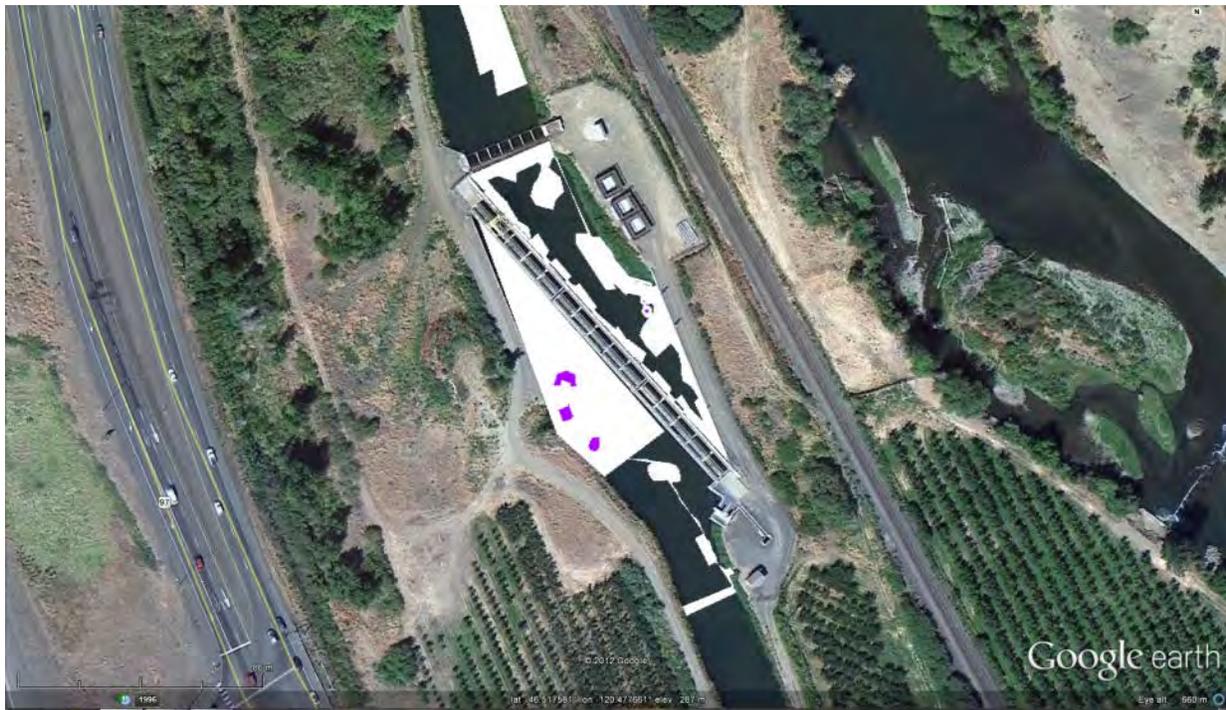
Figure 40: Close up of New Rez Screens
