#### Assessment Units for Steelhead

- Eldorado Creek
- Jim Brown Creek
- Lolo Creek
- Musselshell Creek
- Yoosea Creek
- Lolo Creek Watershed

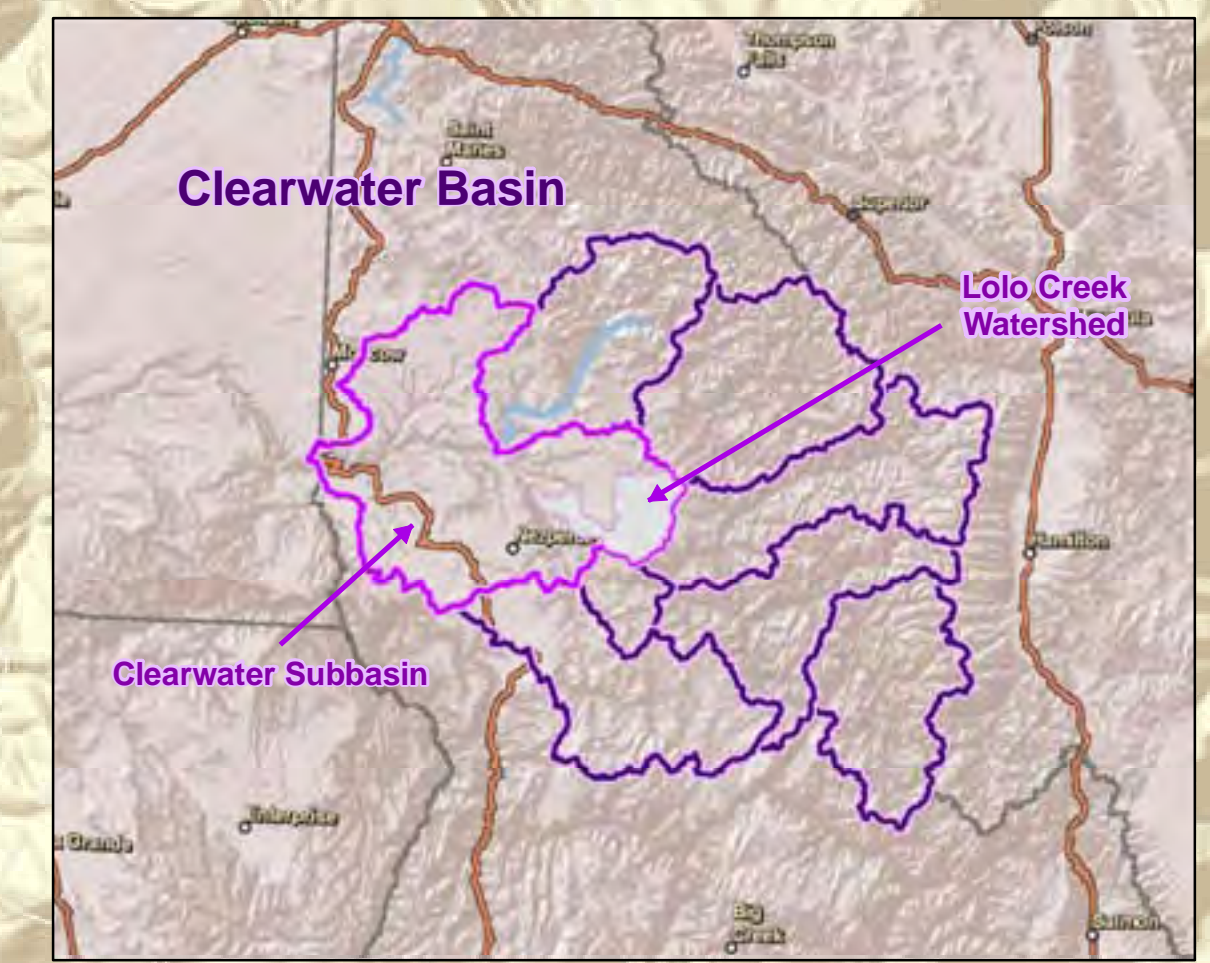
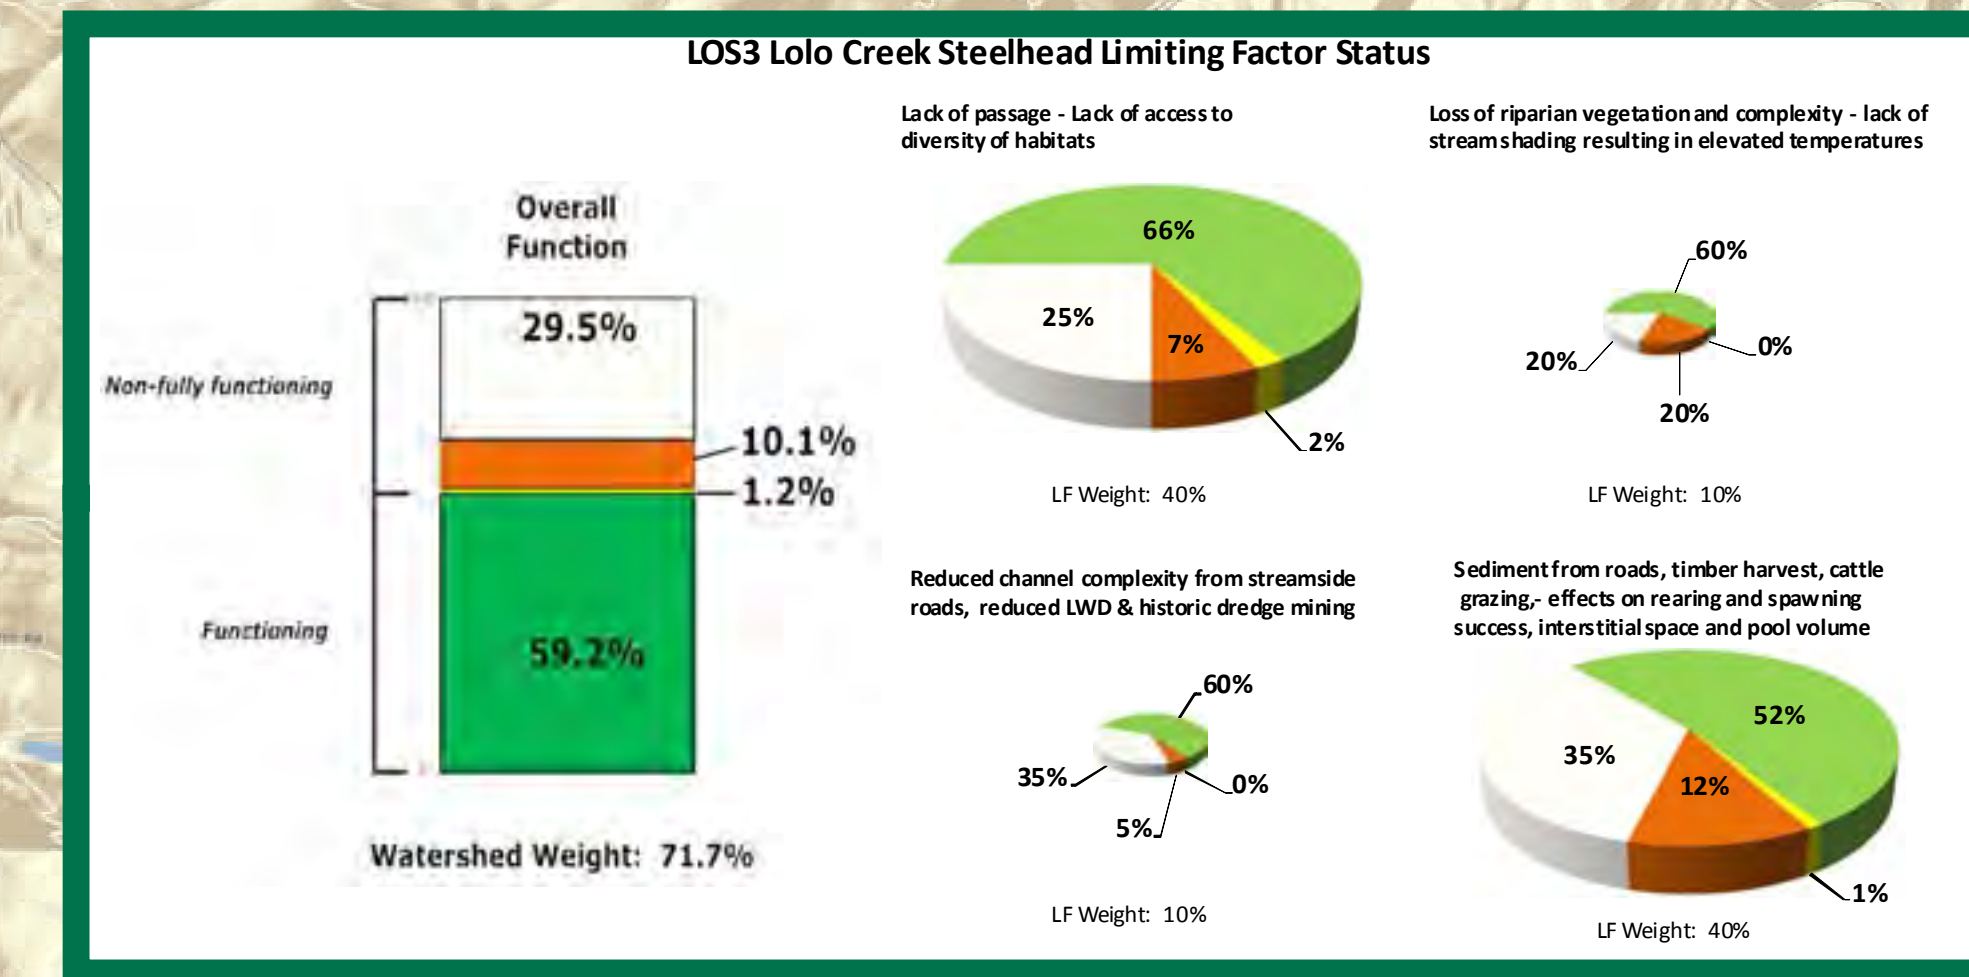
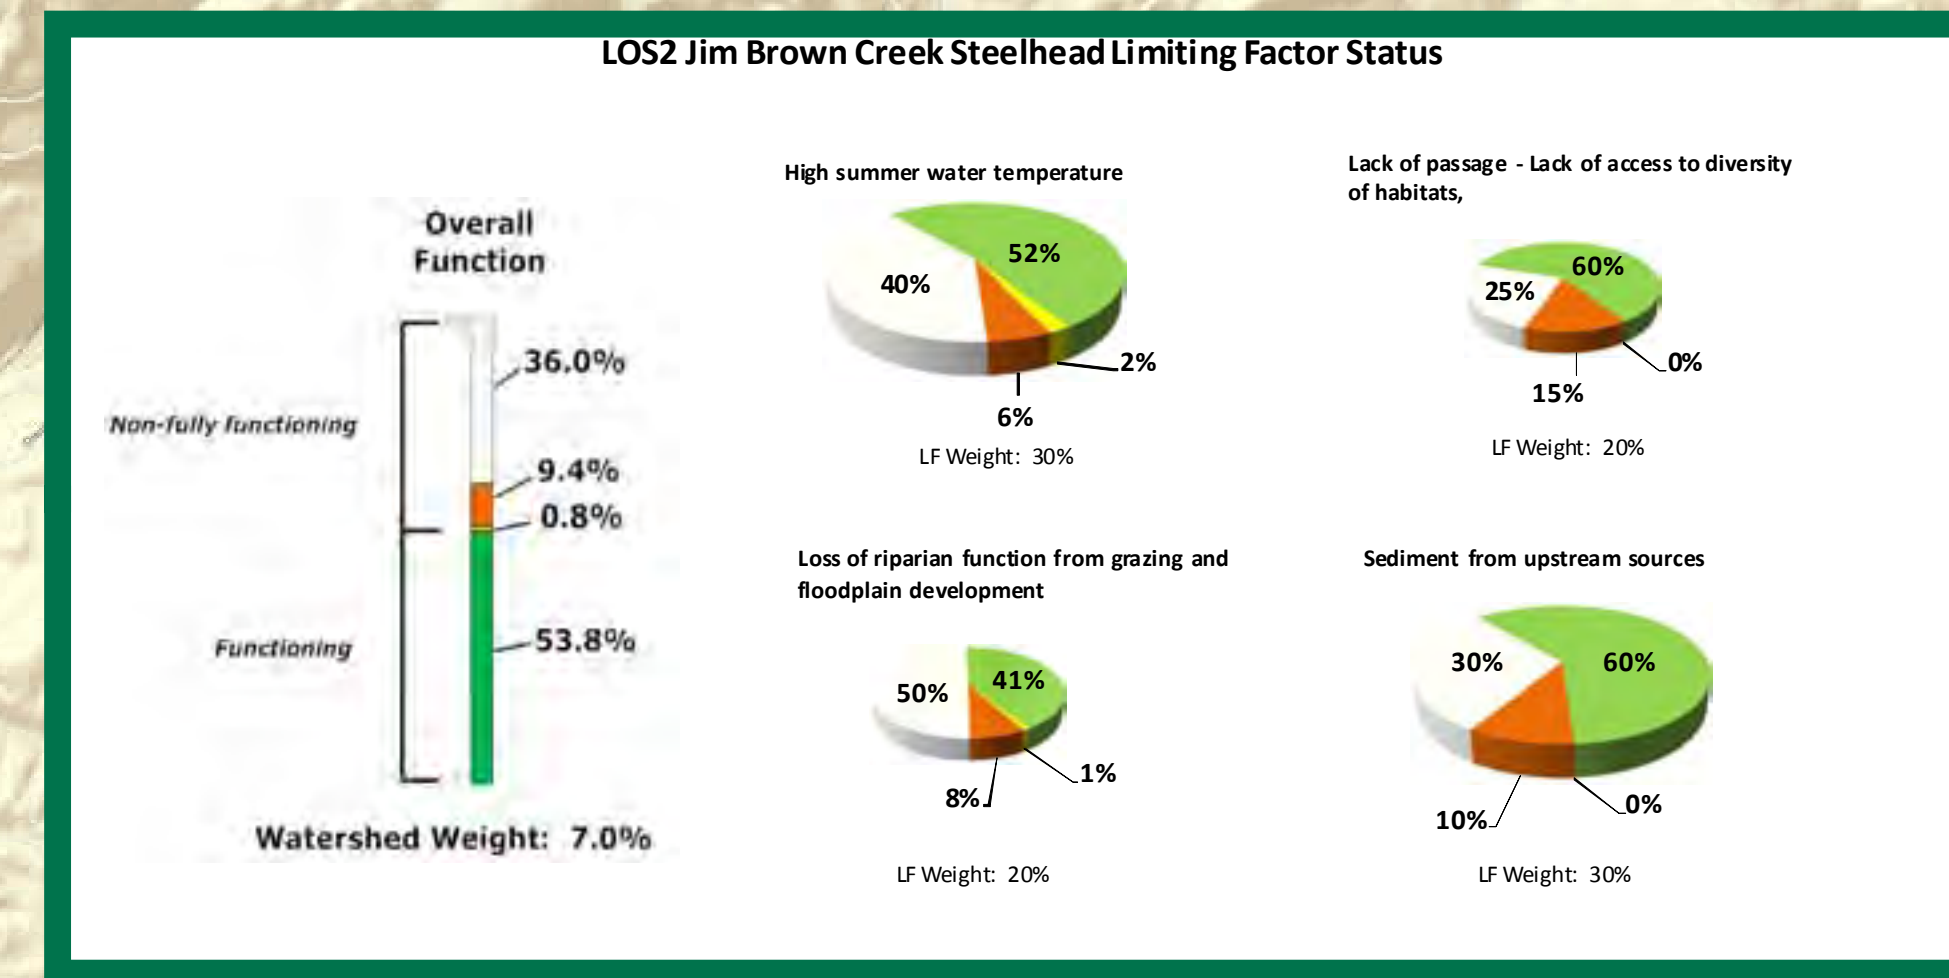
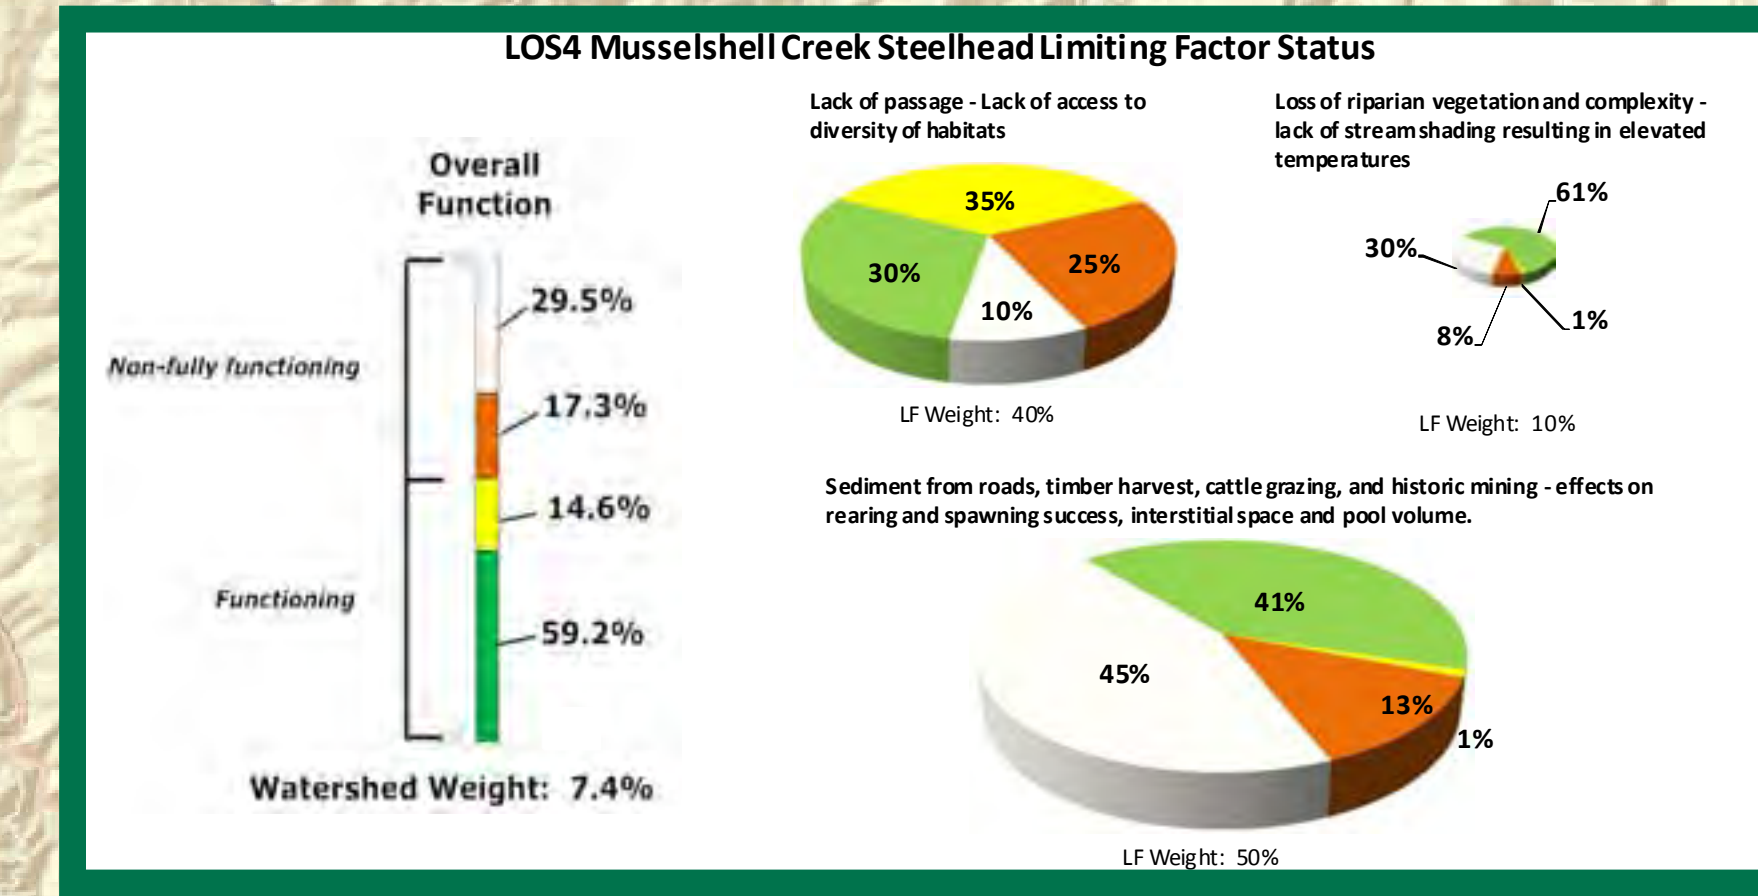
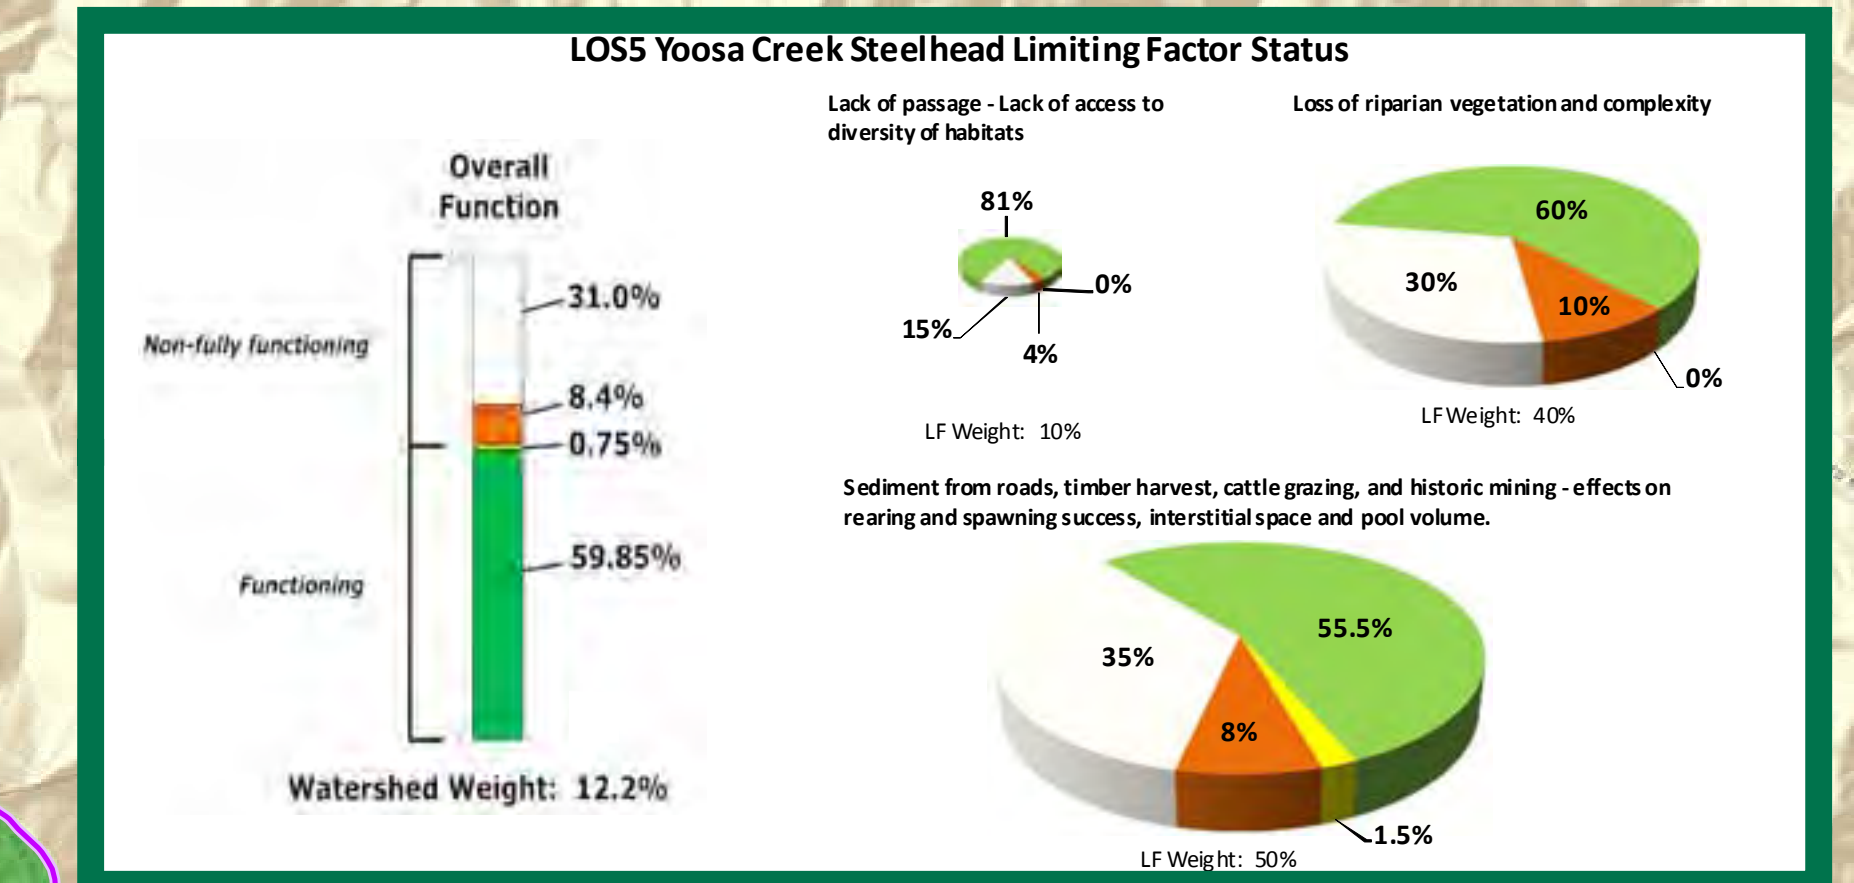
**Pies and Charts:**  
Pies and bars were generated from estimates of the habitat condition of key limiting factors associated with habitat actions planned to be completed for the FCRPS BICp through 2012. The pies and bars only represent conditions for the term of the FCRPS BICp (2007-2018), do not include conditions associated with habitat actions completed by other parties within this time period, and, therefore, may not represent the status of these key limiting factors for other than FCRPS BICp purposes.

**Details:**  
Stacked bars and values of Overall Function (%) represent differences between functioning (green) and non-fully-functioning (red) key limiting factors aggregated for each assessment unit.

**Size of each pie is relative to the Intrinsic Potential of each Assessment Unit within the population as defined for Recovery Plans by the Interior Columbia Basin Technical Recovery Team. The Intrinsic Potential weighting factor (Watershed Weight) is denoted below each pie.**

**Pie slices and values indicate the relative proportion of each limiting factor that comprise the non-fully-functioning (red) part of the bar. Zero values indicate a limiting factor was identified for FCRPS BICp purposes, but habitat condition values have not yet been assigned.**
