Washington State Salmon Recovery Funding Board

Reach-Scale Effectiveness Monitoring Program

2008 Annual Progress Report

April 2009

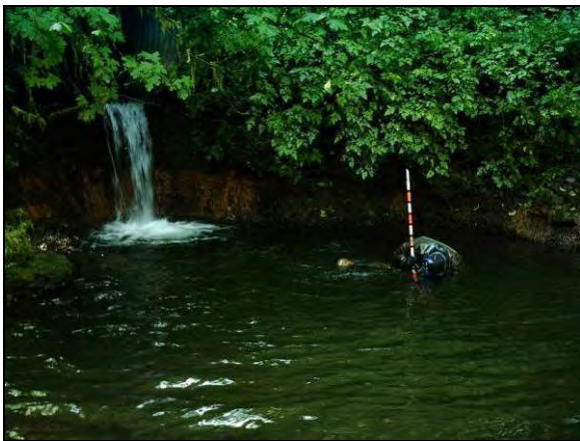
Pool depth check at downstream end of culvert at outfall before construction (2004)

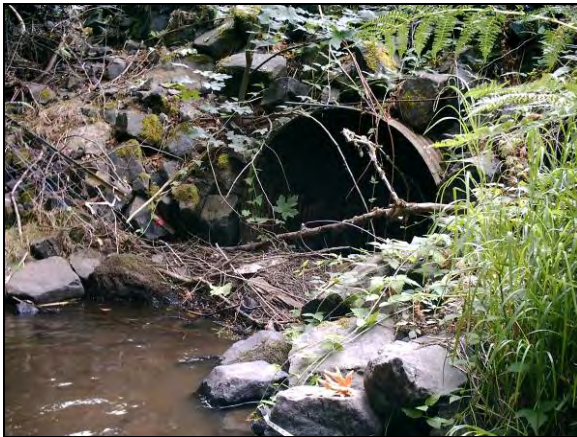
Culvert prior to implementation (2004)

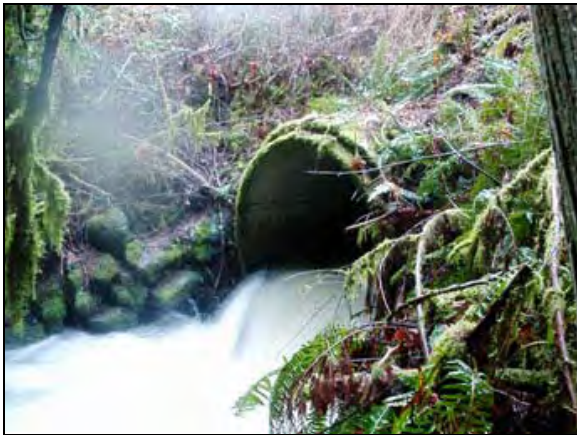
Downstream end of culvert prior to project (2005)

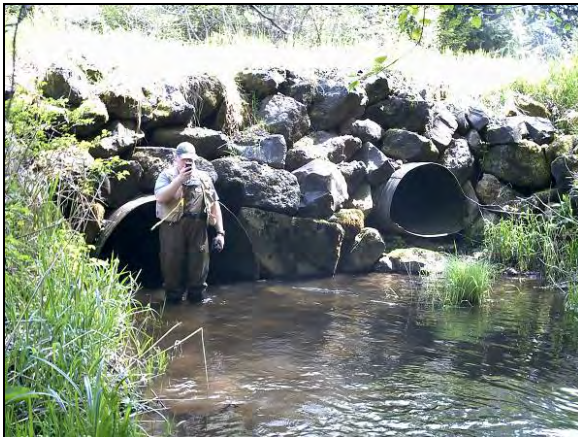
Beeville Road culverts pre-implementation (2005)

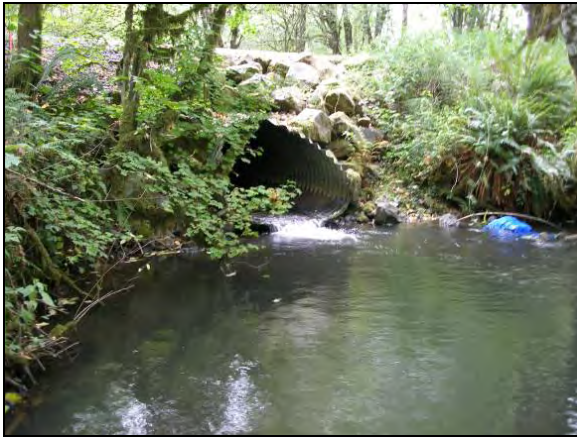
Culvert prior to implementation (2005)

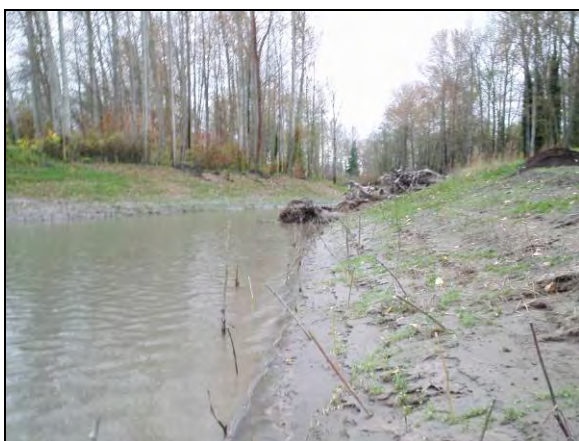
Willow plantings along bank of new channel in Year 1 (2005)

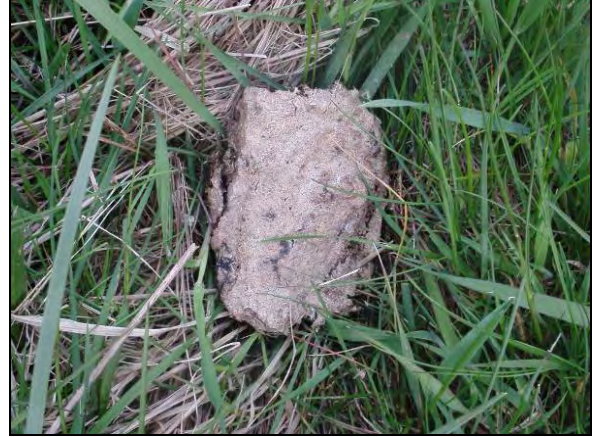
Cattle droppings observed along the exclusion fence within the riparian planting area in 2008 (Year 3)

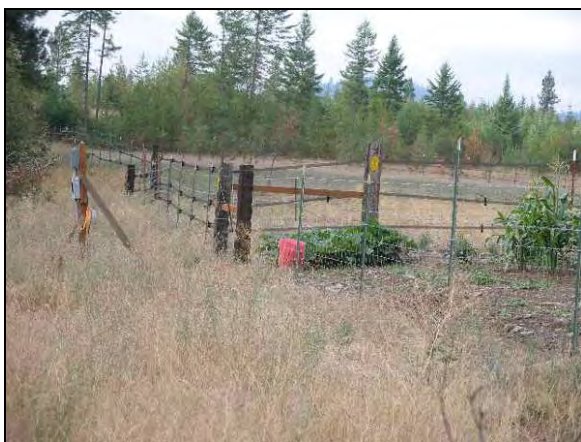
Exclusion fencing installed in Year 1 (2007)

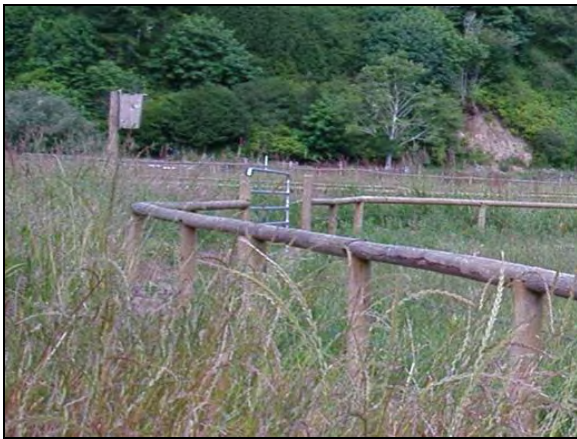
Impact reach - gate in livestock exclusion (2007)

The Johnson Creek exclusion was constructed prior to the site visit in 2007, and the fencing appeared to be very strong and effective at keeping livestock out of the impact reach. All livestock were observed to be excluded from the creek in the impact reach at the time of the survey. Although at the time of the survey no livestock were observed within the exclusion area, gates were incorporated into the fence structure (see photos below). These gates were secure and required manual opening to allow cattle to cross the creek or access the exclusion area. There was no indication that livestock grazed within the exclusion, but there was some physical evidence that livestock had, at some point, crossed the creek and compressed the vegetation inside the exclusion. Monitoring was not conducted at Johnson Creek in 2008.

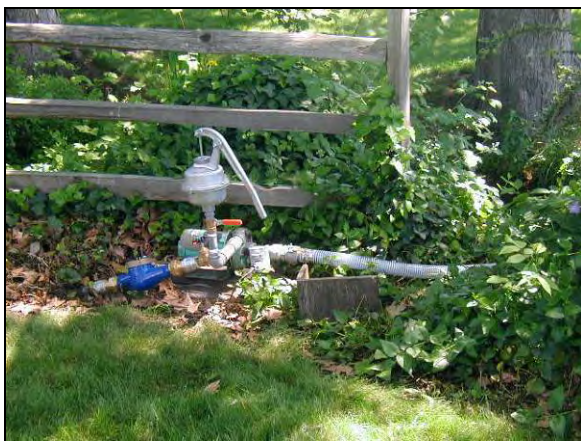
Water pump at Walla Walla site

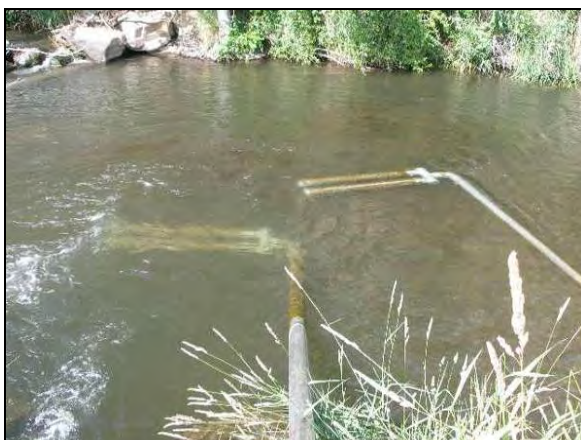
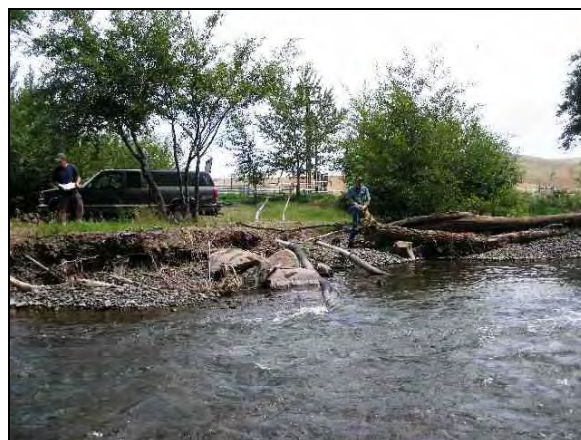
Upper fish screens on the Tucannon River in Year 1 (2007) Lower fish screen site surveyed in Year 2 (2008)
