## **APPENDIX B – WATER QUALITY**

## WATER QUALITY REPORT CATHERINE CREEK TRIBUTARY ASSESSMENT – GRANDE RONDE RIVER BASIN **Tributary Habitat Program, Oregon**

**U.S. Department of the Interior  
Bureau of Reclamation  
Pacific Northwest Region  
Boise, Idaho**

**February 2012**

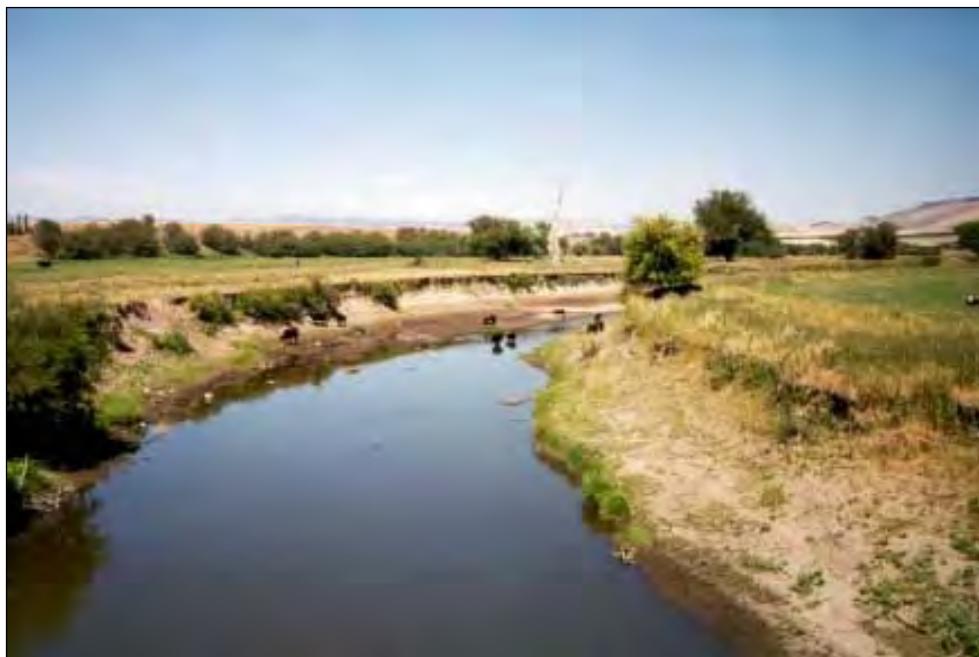
**Figure 24. Grande Ronde River downstream of the Catherine Creek confluence, August 1999. (ODEQ 2000)**

Riparian vegetation is especially sparse and provides little shade cover in lower Catherine Creek (Favrot et al. 2010). Low shade levels result from a combination of lack of streambank vegetation and/or wide stream channels (ODEQ 2000). Often, low shade levels result from lack of tall streambank vegetation. In many areas that do have tall streambank vegetation but low shade levels, channel widths are too great to effectively shade. Temperature monitoring of stream reaches on Catherine Creek within riparian fencing projects demonstrated that the improved vegetation vigor and density reduced thermal loading of the stream, which suggested a correlation of stream temperature to riparian vegetation's ability to shade the stream (Miles nd).
