THE CATHERINE CREEK REACH ASSESSMENT GRANDE RONDE RIVER BASIN Tributary Habitat Program, Oregon

U.S. Department of the Interior
Bureau of Reclamation
Pacific Northwest Region
Boise, Idaho

December 2012

Tributary Habitat Program for the Federal Columbia River Power
System Biological Opinion, Grande Ronde River, OR
Pacific Northwest Region
Revision 1, SRH Report 2013-03

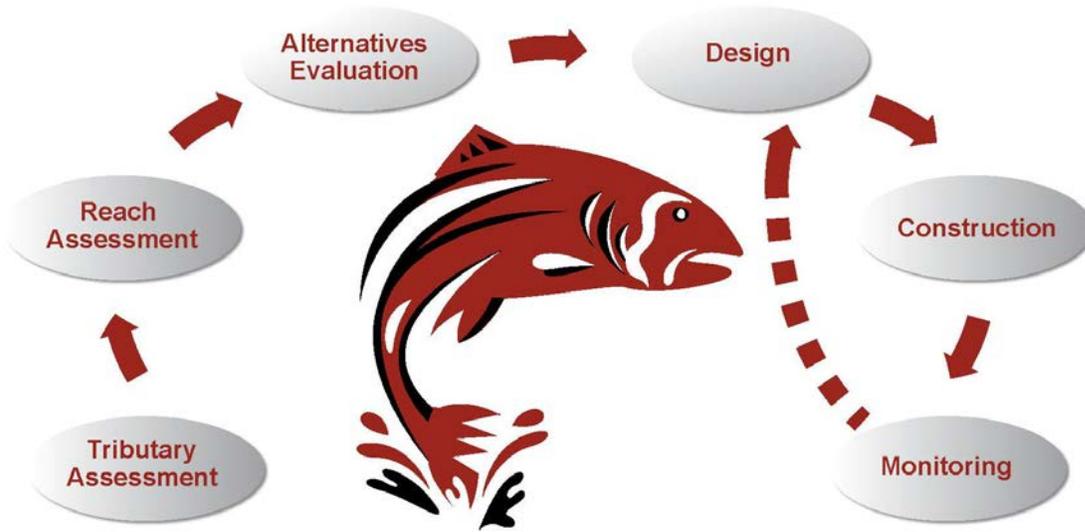
Figure 1. Flow chart illustrating typical steps in the approach to habitat improvement.

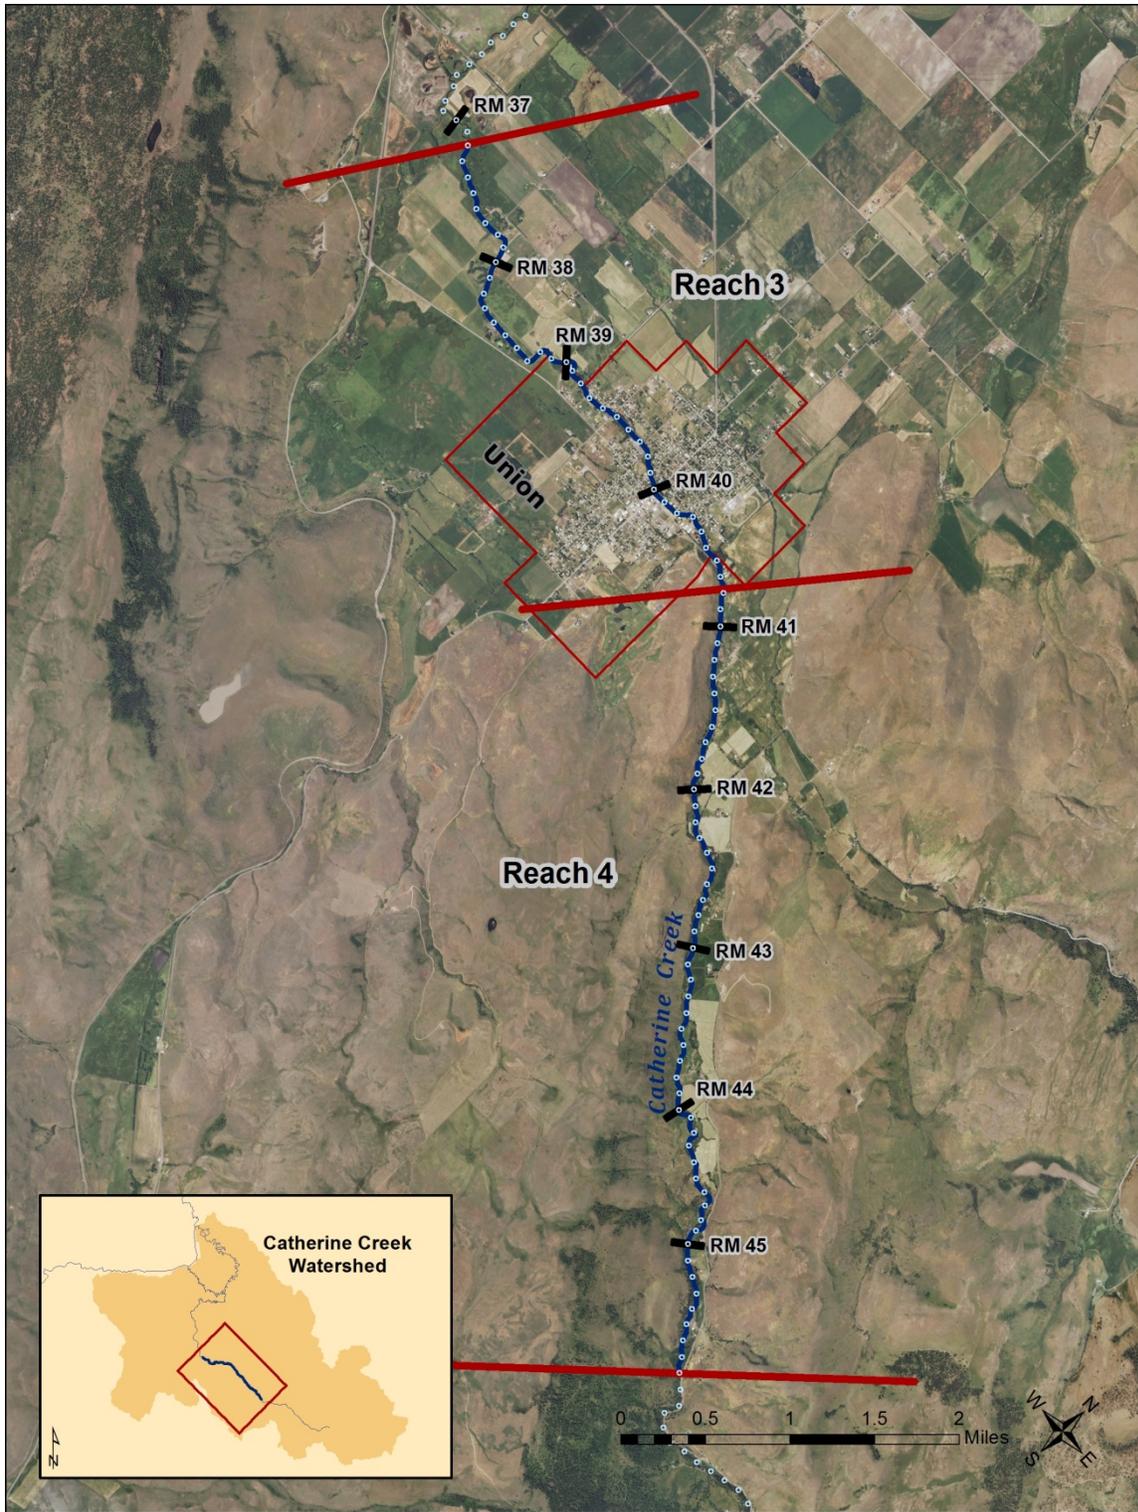
Figure 3. Aerial image of the assessment area, reach breaks, and the city of Union, Oregon on Catherine Creek.

The North and South Forks of Catherine Creek come together and flow for 55 miles through the southwestern edge of the Wallowa Mountains before joining the Grande Ronde River on the Grande Ronde Valley floor at RM 140 (NOAA Fisheries 2008) (Figure 2). The assessment area consists of a portion of Catherine Creek from RM 45.8 downstream to RM 37.2 that includes geomorphic reaches 4 and 3 (Figure 3).

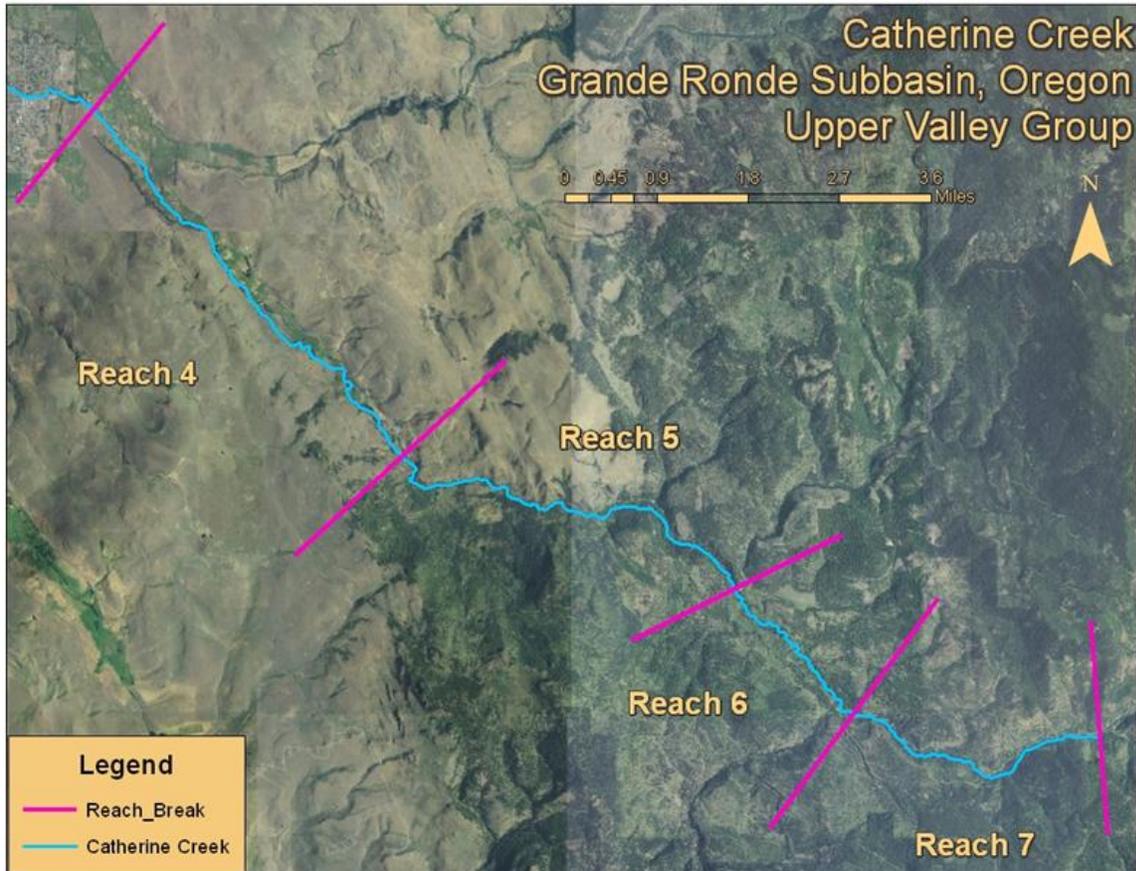
Figure 4. Location of reach 4 within the upper valley group on Catherine Creek. Reach 7 runs from RM 54.9 to 52.0. Reach 6 runs from RM 52.0 to 50.11. Reach 5 runs from RM 50.11 to 45.8. Reach 4 runs from RM 45.8 to 40.78.

Reach 4 is the downstream reach of the upper valley group that encompasses from RM 54.9 at the top downstream to RM 40.78 at the downstream end of reach 4 (Figure 4) (Reclamation 2012a). Within the reach, the stream is relatively straight with bed material consisting of gravel and cobble with sand and boulders. The banks are comprised of similar material, but are also overlain by a layer of silty fine sand with clay that varies in thickness from 0.5 feet up to 2 feet. Within reach 4, sediment is supplied by upstream sources locally within the reach, particularly the upper section of the reach. Overall, the reach is a sediment supply limited transport regime with more capacity to transport sediment than the amount of sediment supplied.

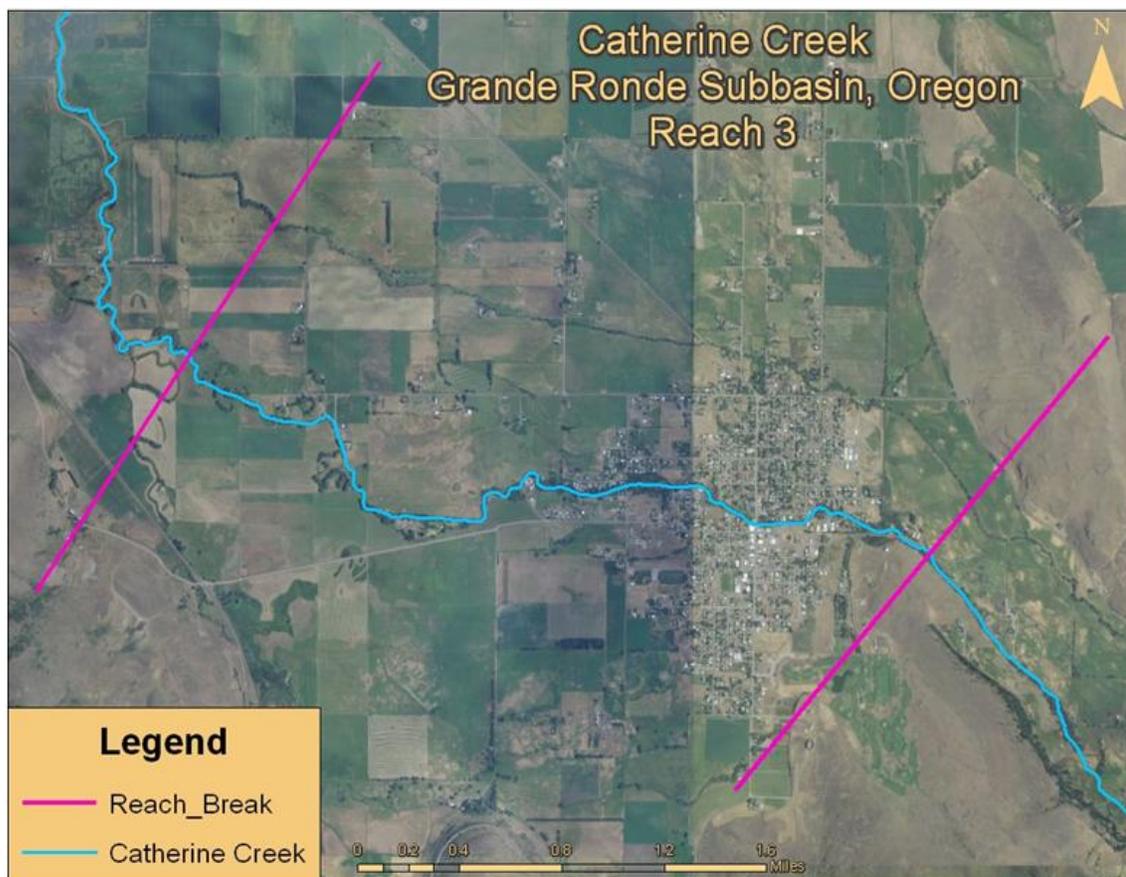
Figure 5. Location of reach 3 from RM 40.7 downstream to RM 37.2 on Catherine Creek.

Reach 3 encompasses a historical alluvial fan and transitions into fluvial plain in the downstream end (Figure 5). Typical morphological features of a fan include the apex or head where channel incision is common but may not be present, the medial or upper section and the distal, or downstream end. Channel incision, when present, commonly terminates in the medial sections at what is called the intersection point, but can also persist all the way to the distal margin (Blair and McPherson 1994). Incision can also work upstream from the distal end in the form of a head cut. The channel may be a single thread trunk stream or spilt into multiple distributary channels (Blair and McPherson 1994).

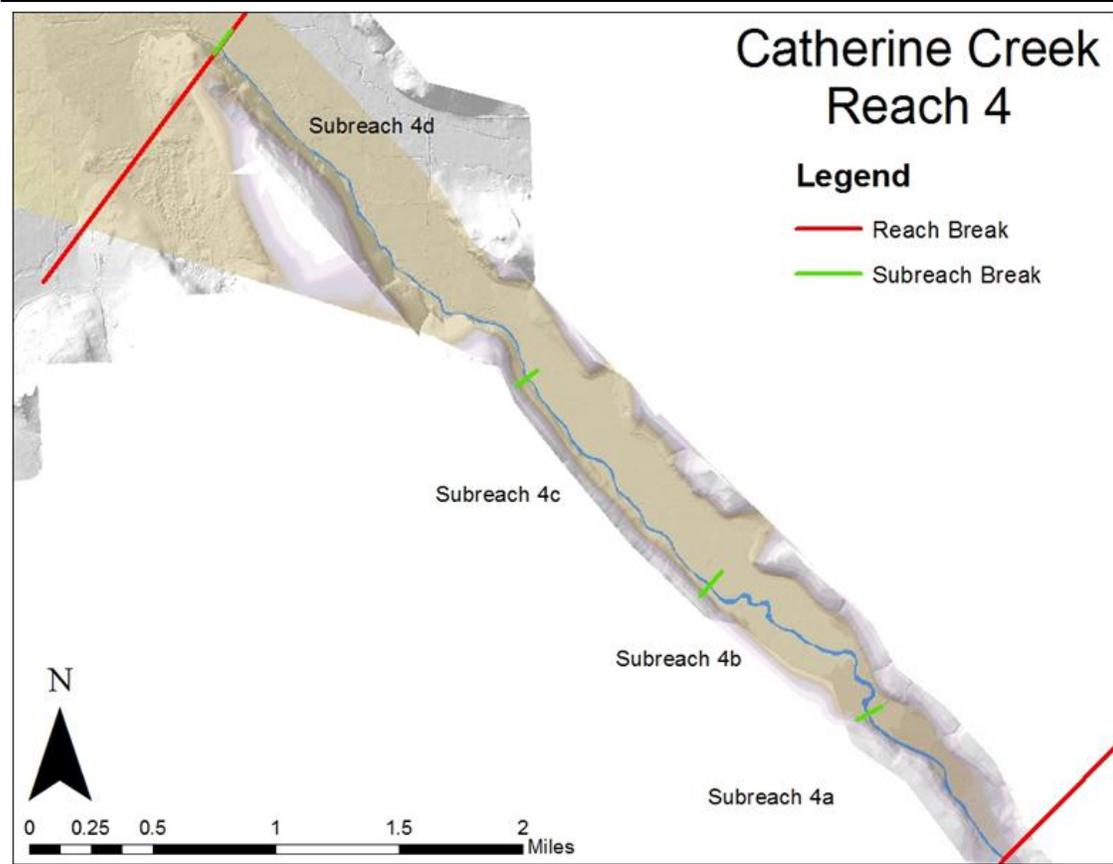
Figure 6. LiDAR and shaded digital elevation model (DEM) image showing reach and subreach boundaries within reach 4 on Catherine Creek.

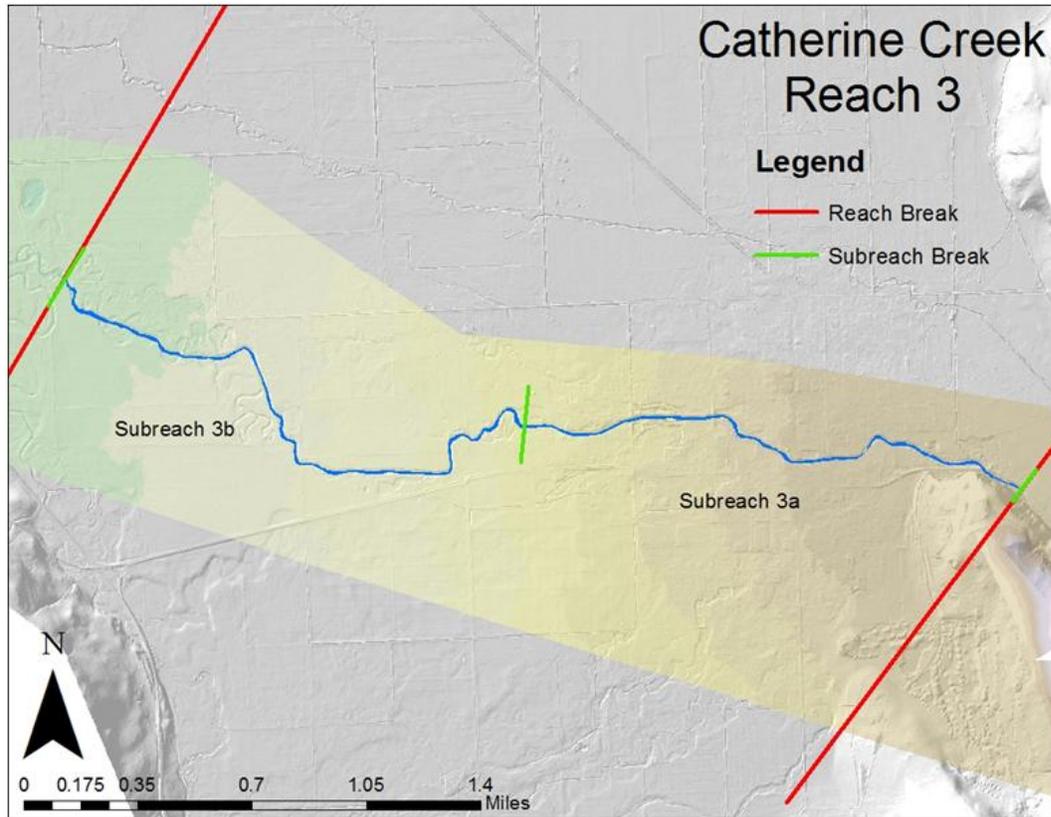
Figure 7. LiDAR and shaded DEM image showing reach and subreach boundaries within reach 3 on Catherine Creek.

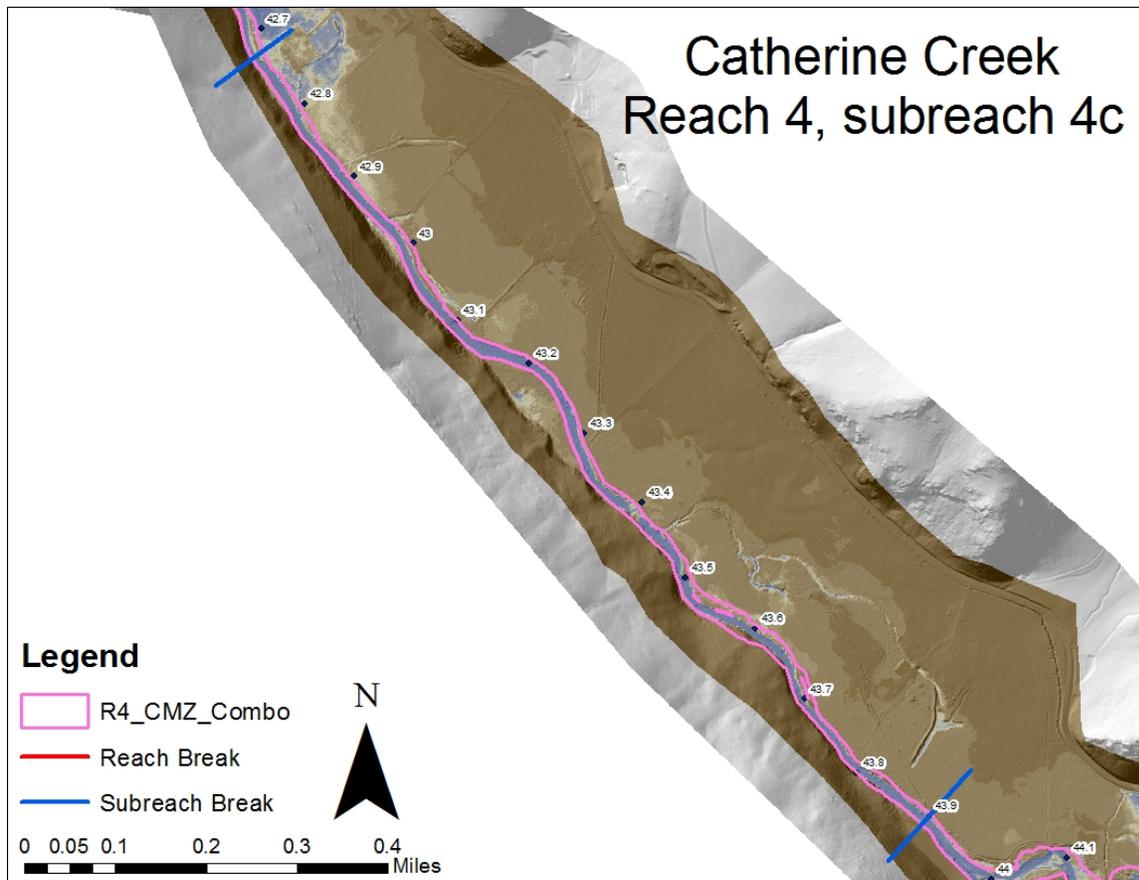
Figure 8. Historic channel migration boundary in subreach 4c with approximate average 2-year recurrence interval.

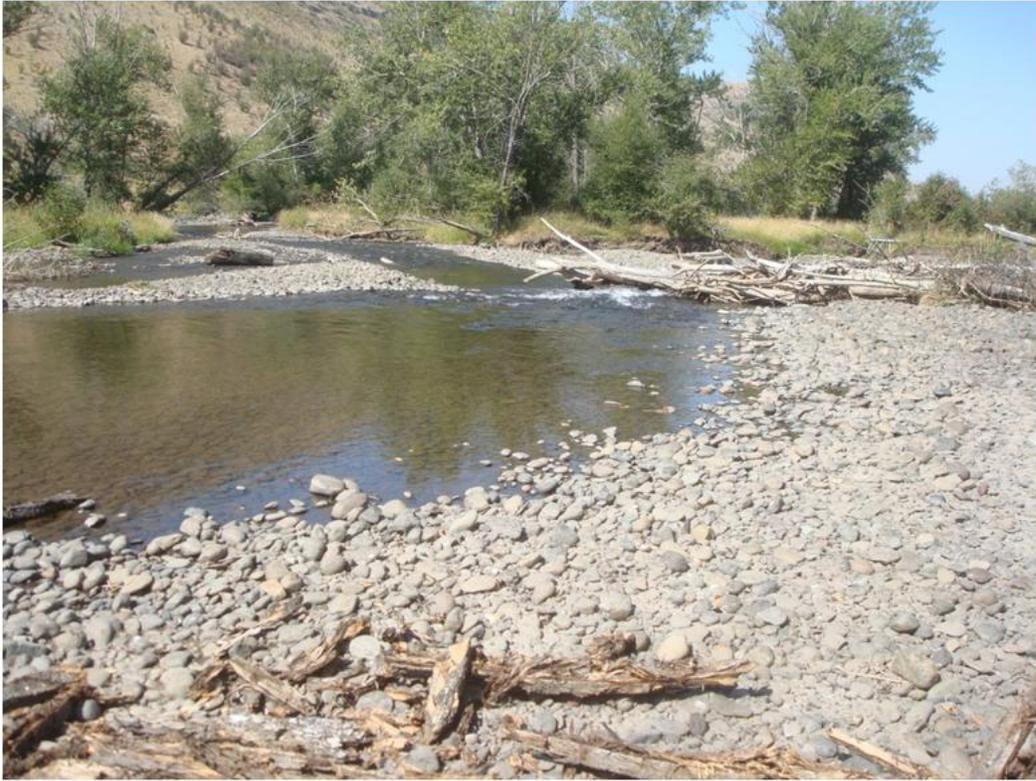
Figure 9. Pool riffle bedform in subreach 4b, reach 4, Catherine Creek. Note the LWM accumulation.

Bed material in reach 4 was generally observed to be predominantly cobble with gravel, sand, and boulders. Data from pebble counts show that the average D50 (mean grain size) of the reach was 56 mm (coarse gravel). It should be noted that pebble counts were conducted at locations with a riffle cross over. No substrate measurements were taken in sections with plane bed features and cobble and boulder substrate. Bed forms within the reach were predominantly riffle bar (defined as an intermediate bedform between plane bed and pool riffle (Montgomery and Buffington 1997), with the exception of subreach 4b, which has a pool/riffle bed form (Figure 9).

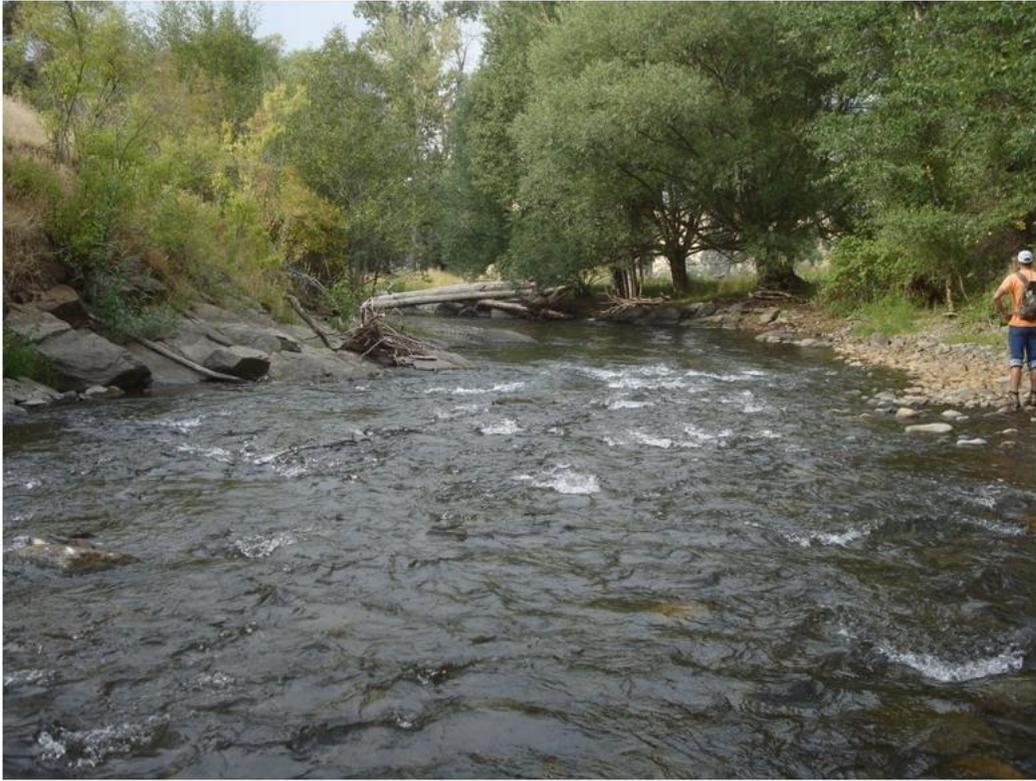
Figure 10. Bedrock outcropping along the left bank in the vicinity of RM 41.9 in subreach 4d on Catherine Creek.

Banks within reach 4 range from gently sloping to vertical, and when comprised of alluvial material, generally consist of subrounded to rounded sand, gravel, and cobble with small boulders, overlain by a layer of silt and silty clay up to 2 feet thick. In instances where colluvial material is present, bank material is subangular to subrounded boulders supplied by the hillslope that comprises the left bank throughout much of the reach. Bedrock also occurs in the channel banks along the left valley wall (and channel bottom) and was observed cropping out from the hillslope along the left bank in subreach 4d (Figure 10).

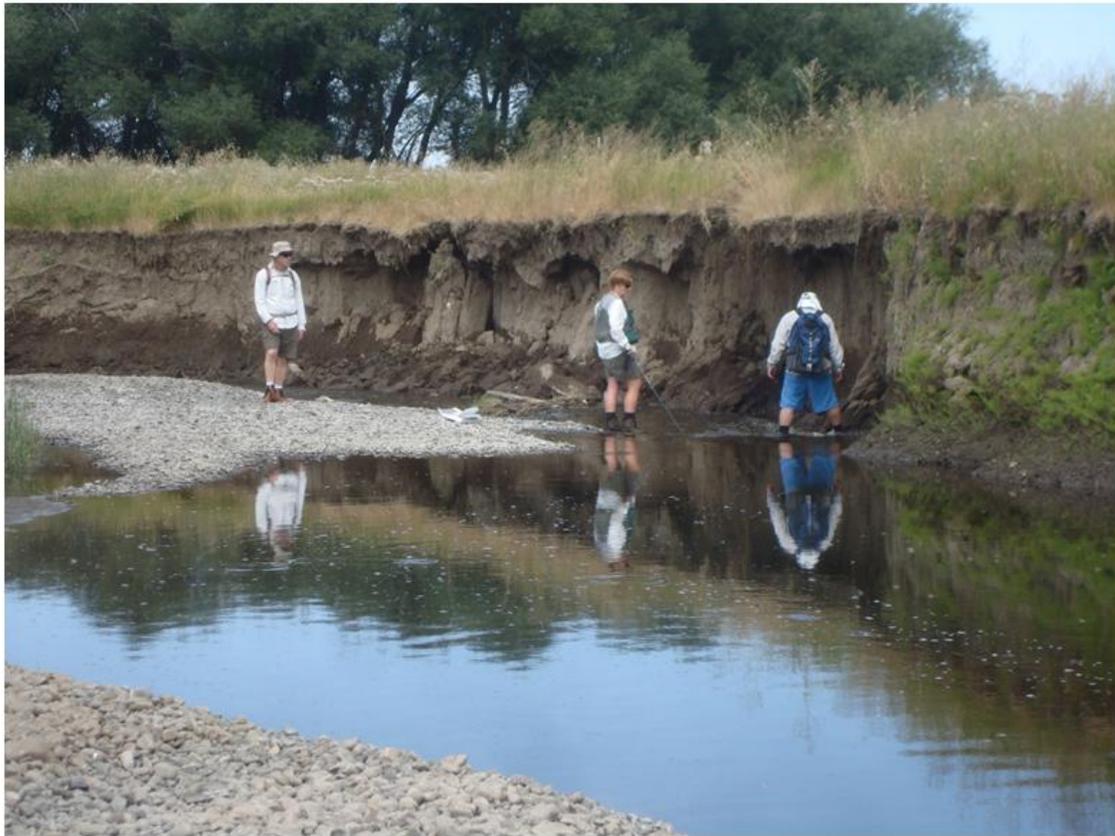
Figure 11. Tall vertical banks comprised of cohesive fine-grained material near RM 38.1 in subreach 3b of Catherine Creek. Note the lack of riparian vegetation on top of the bank.

Banks within reach 3 range from gently sloping to vertical, and are comprised of alluvial material of mixed grain sizes that include subrounded to rounded sand, gravel, and cobble with local limonite (hydrated undifferentiated iron oxide) cementing, overlain by silt and clay. The silt and clay material thickens in the downstream direction to a thickness of up to 8 feet at the downstream end of the reach in subreach 3b (Figure 11).

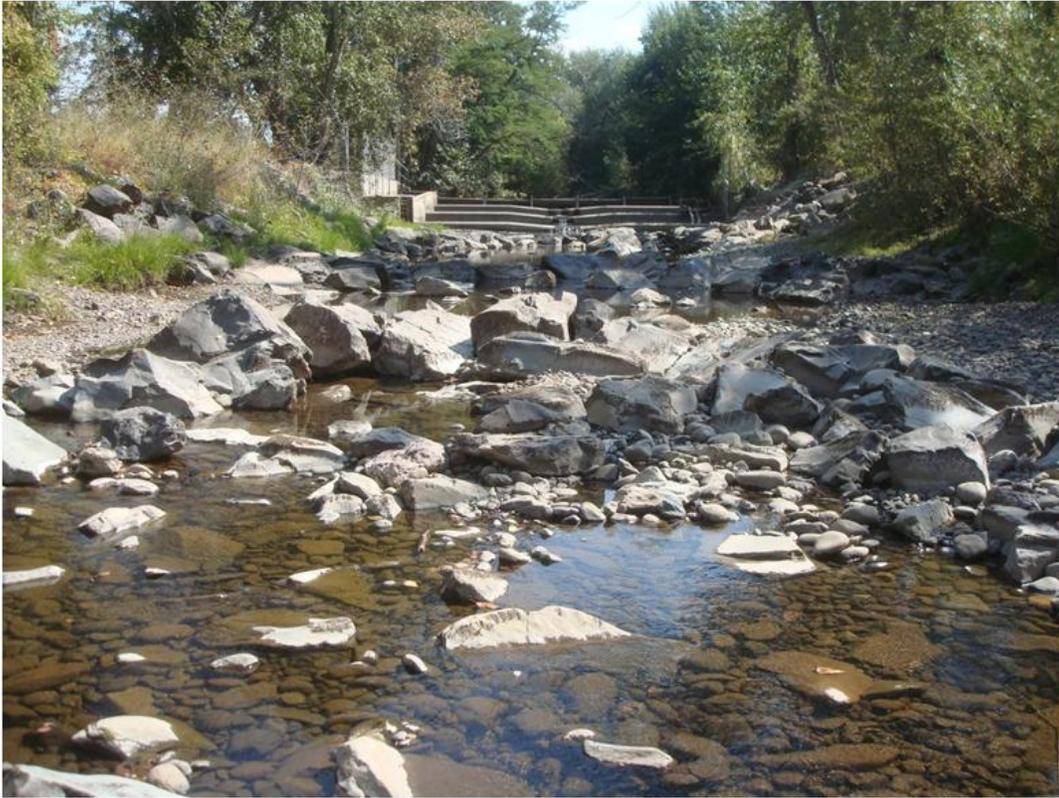
Figure 12. Constructed weirs downstream of the Townley-Dobbin Diversion. Note the lack of scour downstream of the apex.

flow into the center of the channel and develop enough flow convergence to force a scour pool just downstream of the apex. The weirs, particularly at the Townley-Dobbin site have not provided enough convergence to scour the bed significantly (Figure 12).

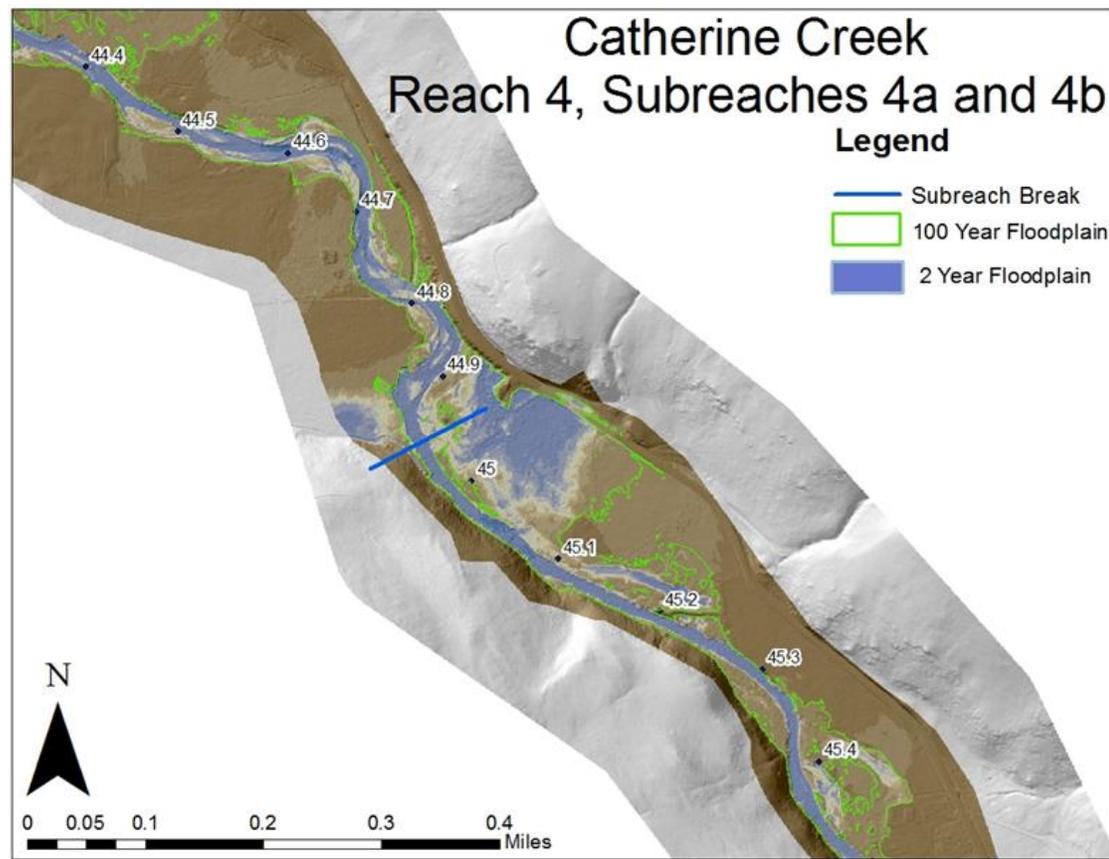
Figure 13. LIDAR image showing the active (2-year) and recent (100-year) floodplains in reach 4 on Catherine Creek.

Within reach 4, modeling results indicate that discharges at and more frequent than the 2-year event are mostly contained within the channel, and the 10-, 25-, and 100-year discharges overtop 1, 3.7, and 9.2 percent of all model cross sections, respectively (Appendix A). This means that the channel has the capacity to contain even large flood events and there is very little connected floodplain in either reach. Although flows with a recurrence interval of 2 years and less are contained within the channel, this is likely due to increased local entrenchment combined with local anthropogenic manipulations, including levees. Water elevation data output from the HEC-RAS hydraulic model suggest that there is potential to access the floodplain at flows with a recurrence interval of 2 years with the removal or breaching of existing levees (Figure 13).

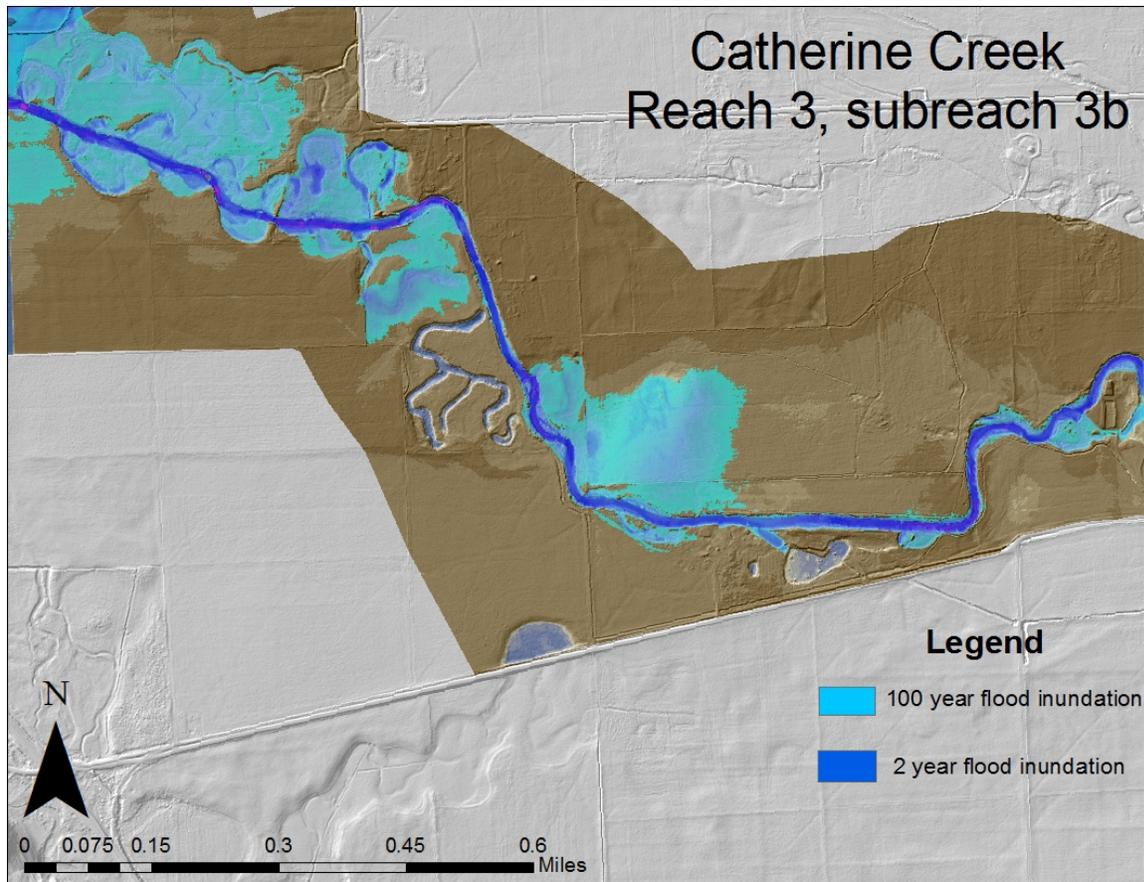
Figure 14. LiDAR image showing the active (2 year) and recent (100-year) floodplains in reach 3 on Catherine Creek.

Within reach 3, underfit stream conditions, local channelization with levees, concrete walls, and anthropogenic channel relocation that potentially included widening and deepening of the channel contribute entrenched conditions that range from moderate to locally severe. HEC-RAS model results indicate that the majority of flood flows with a recurrence interval of 2-years or less are all contained within the channel and levees constructed along Catherine Creek. Flows up to the 2-year event are all contained in-channel, and the 10-, 25-, and 100-year discharges overtop only 4.5, 9, and 15 percent of model cross sections, respectively (Figure 14; Appendix A).

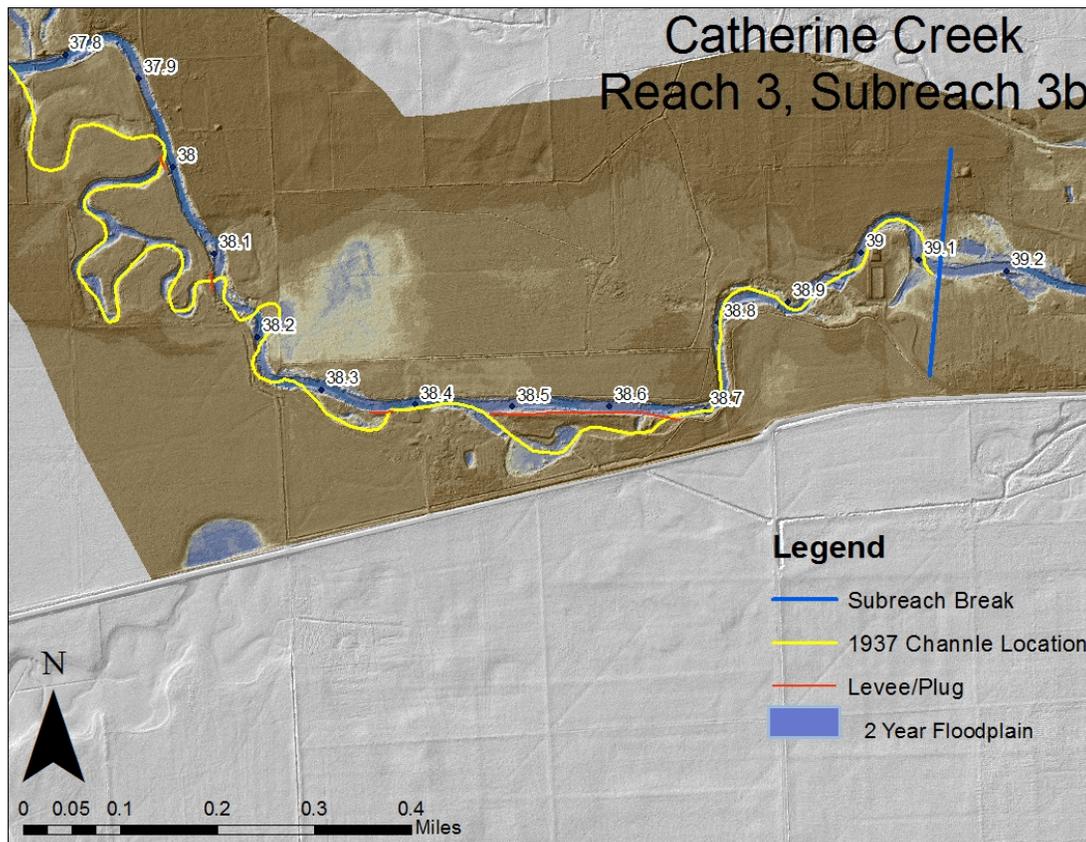
Figure 15. Potential location for floodplain connection via culvert, headgate, or other water-metering device in subreach 3b, reach 3 on Catherine Creek.

if the levee or plug is removed or breached based on elevation. Further evaluation is required before moving forward with concepts.

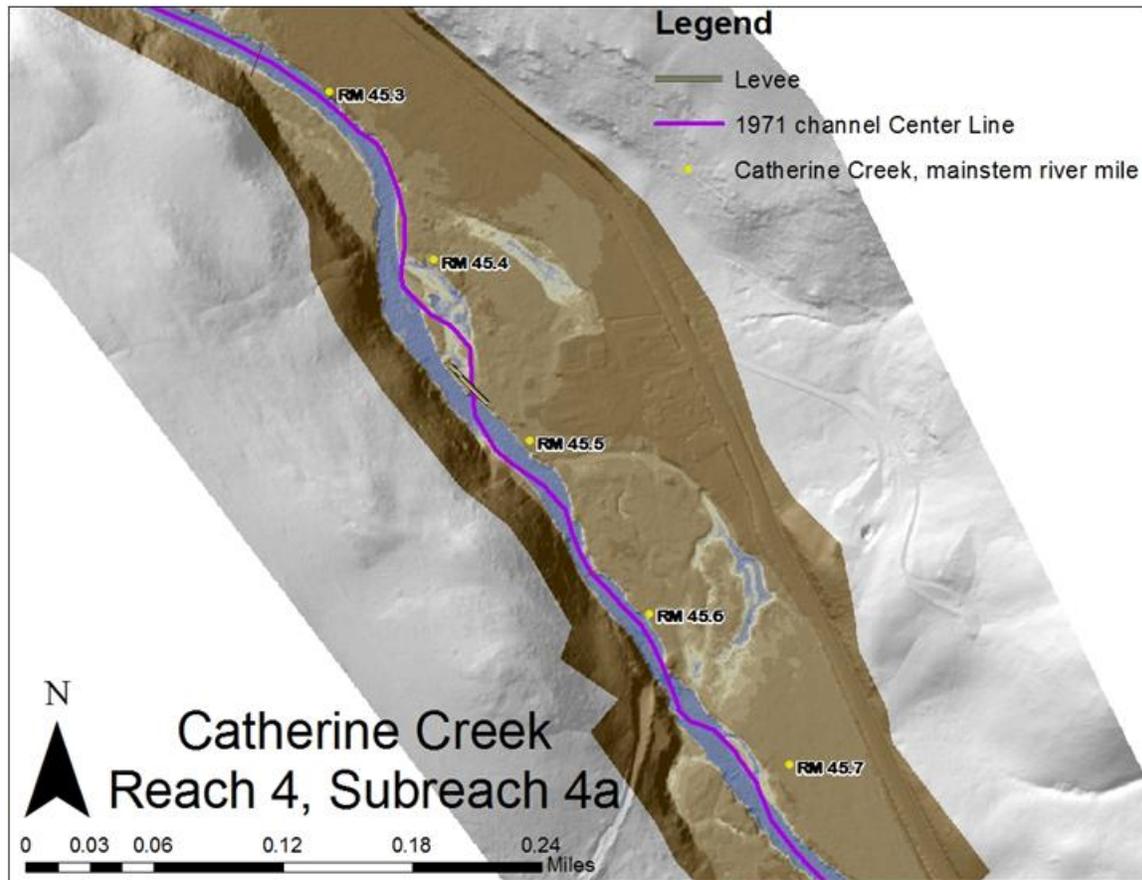
Figure 16. Location in reach 4, subreach 4a where off channel habitat can potentially be developed.

Off-channel habitat is related to floodplain connectivity. Within reaches 4 and 3, off channel habitat could be developed in areas where the former channel has been artificially blocked, if the former channel has not been filled in (Figure 16).

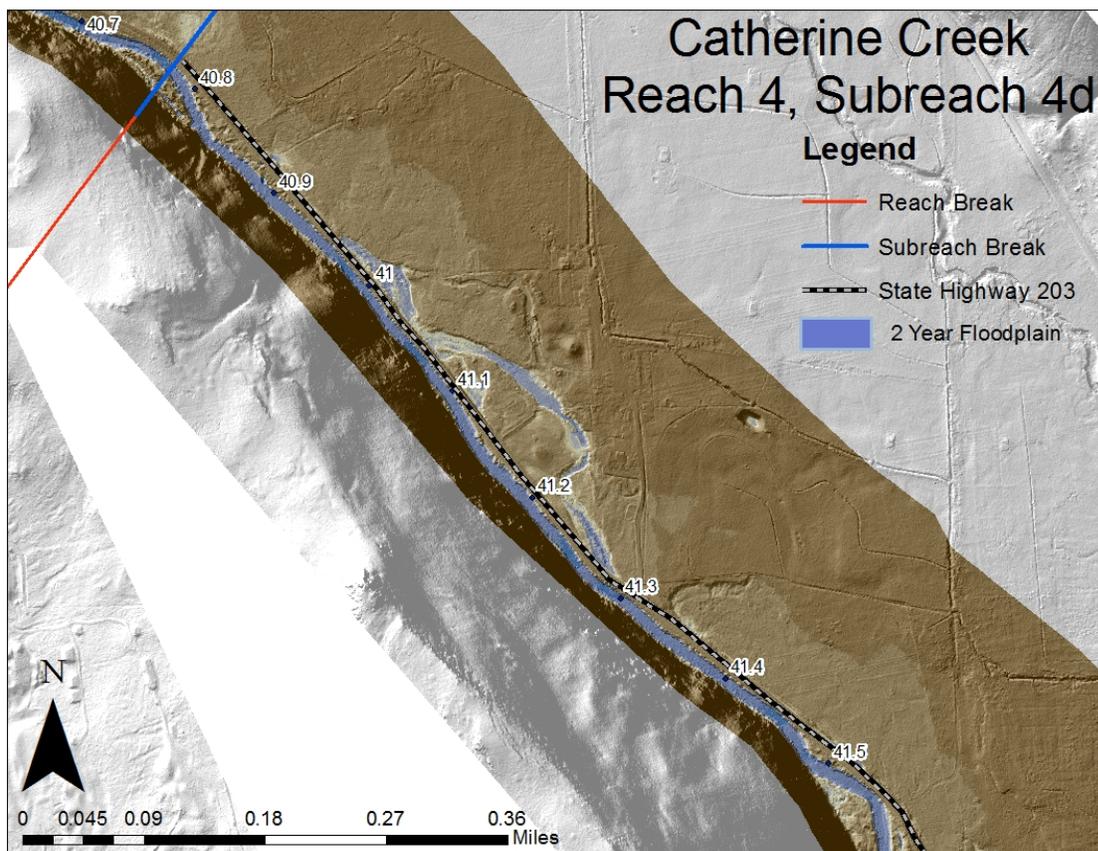
Figure 17. Potential location for floodplain connection via culvert, headgate or other water-metering device at RM 41.3, 41.1., and 41.03 in subreach 4d, reach 4 on Catherine Creek.

Planning for levee alteration projects may require the additional evaluation of LWM placement to facilitate and maintain connectivity, evaluation of the invert elevation and the number of inlets to address sediment issues and evaluation of impacts to land uses adjacent to the remnant channel areas. Much of the risk associated with side-channel function and flooding in remnant main channel sections can be addressed by utilizing a flow-regulating device such as a culvert or headgate that passes a controlled volume of water through a levee rather than removing the entire levee. In areas where levee removal is not feasible due to constraints, culvert-fed or regulated side channels represent an option with potentially fewer risks to property and infrastructure behind the levee. In reach 4, the potential to reactivate off-channel habitat in the form of side channels exist in the downstream end of the reach where Highway 203 acts as a levee along the right bank of Catherine Creek at RM 41.3, 41.1, and 41.03 (Figure 17).

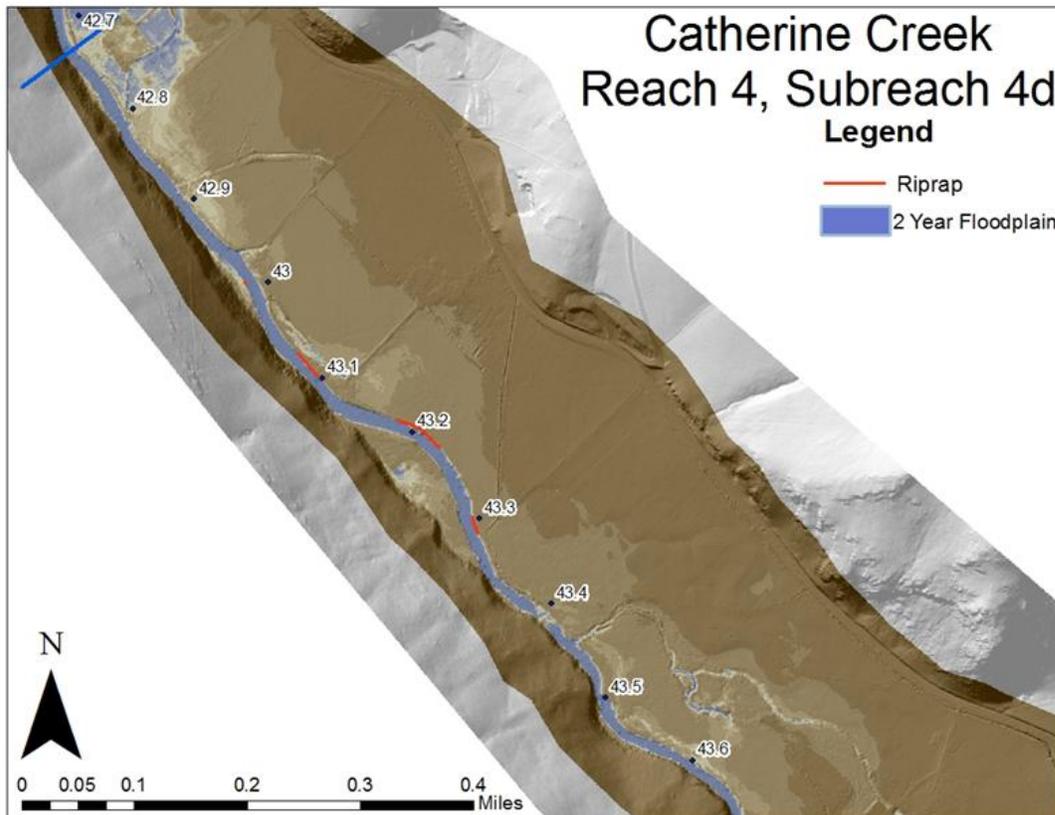
Figure 18. Location of riprap in subreach 4, reach 4, Catherine Creek.

Riprap has a minor impact on channel form and process in reaches 3 and 4 of Catherine Creek. Local natural coarse bed and bank material and underfit conditions result in local channel confinement, preventing significant local migration. Despite limited migration potential, there are several locations where the addition of riprap has reduced bank erosion processes in areas where channel migration would have otherwise occurred (Figure 18).

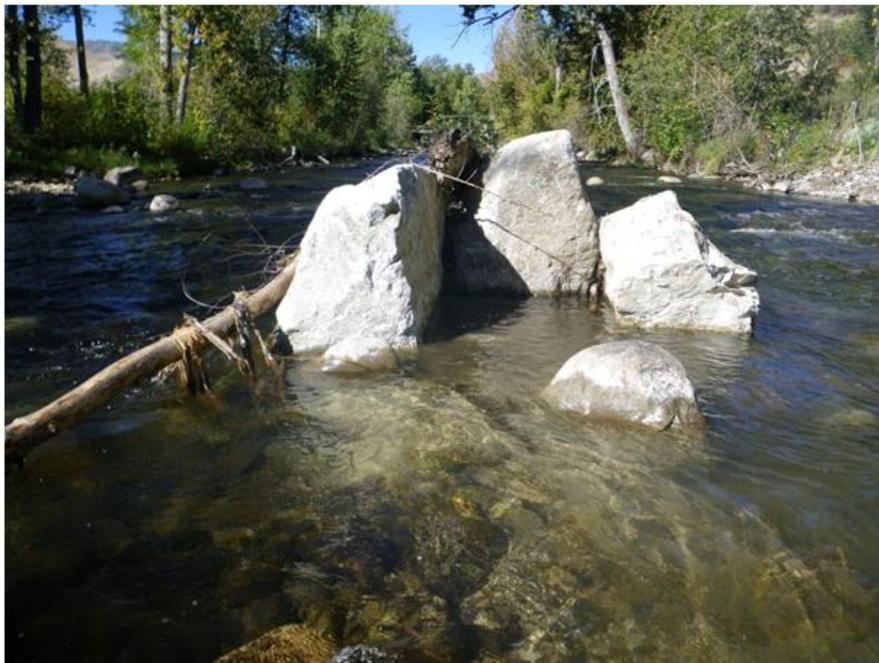
Figure 19. Constructed instream boulder cluster in the Entiat River, Entiat, Washington (Reclamation 2012a).

Large boulder clusters (Figure 19) are groups of large rocks placed in a stream to improve habitat, and create scour pools as well as areas of reduced velocity (Bergstrom 2008). The effect of the boulder cluster on the local hydraulics is forced flow separation around the boulders that leads to the formation of eddy or vortices in their wake. Boulder clusters also affect sediment transport by generating local scour that develops pockets of deeper water and associated bar formation that add to the physical diversity of a stream reach (Fischenich and Seal 2000). Similar to LWM structures, boulder clusters provide a potential site for naturally incorporated LWM to rack on, with the same increase in effect to the local hydraulics and sediment transport. Local habitat is created by the boulder clusters when the vortices diffuse sunlight and create overhead cover.

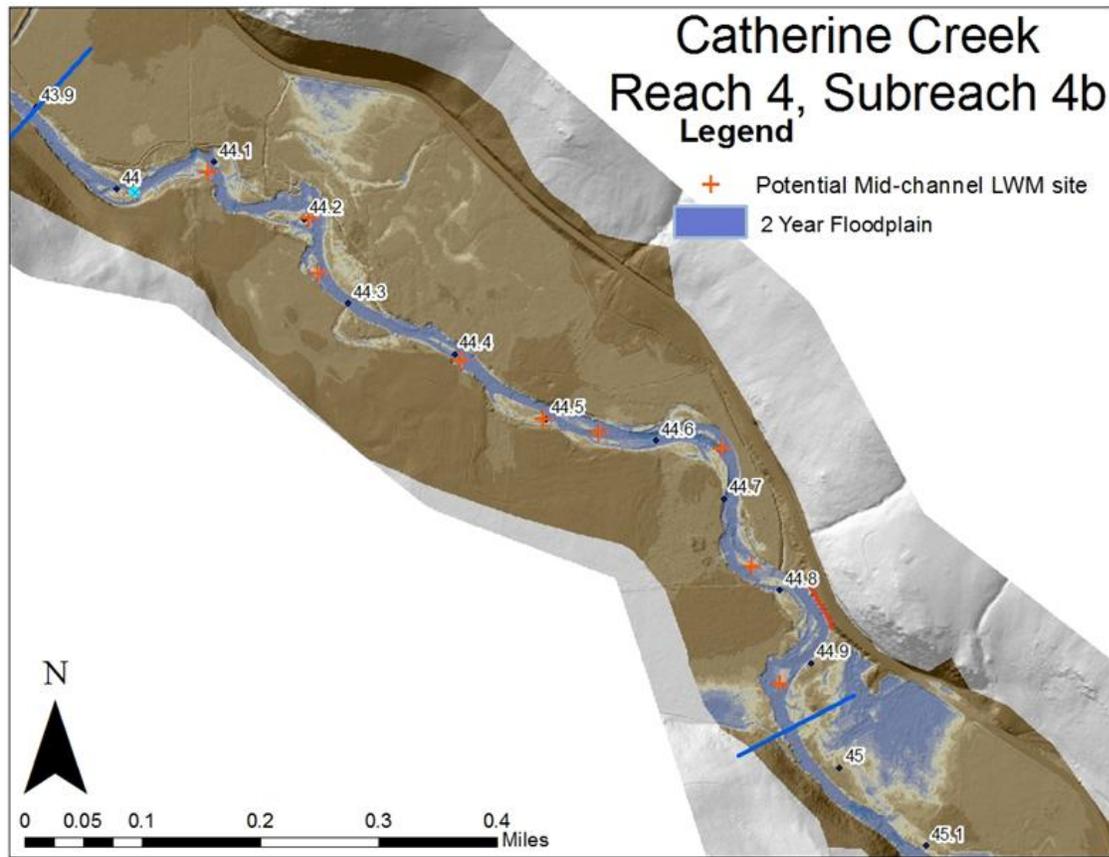
Figure 20. Potential locations of mid-channel LWM structures in subreach 4b, reach 4, Catherine Creek.

Catherine Creek is predominantly a single thread channel within reaches 4 and 3, but within reach 4, subreach 4b has multiple sites where split flow conditions around bars occurs and mid-channel LWM structures could be appropriate (Figure 20).

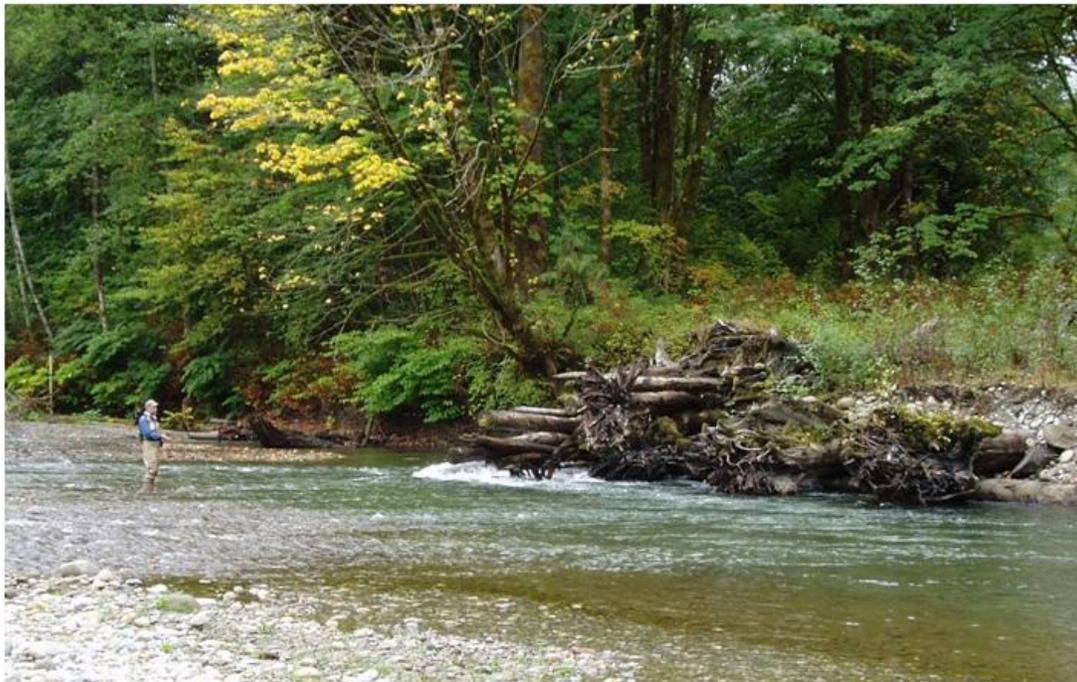
Figure 21. Bank engineered logjam in the Stillaguamish River, Washington (courtesy of Anchor QEA).

Bank ELJs are LWM structures located along the bank that provide hydraulic variability and cover (Figure 21). Logjams naturally accumulate and are most appropriate in those areas where high flows first overtop the banks and where gravel bars are first exposed in receding flows. Floating logs and debris will accumulate in the shallow waters of these overflow areas where the moving water is forcing the logs against the bank rather than pushing the logs farther downstream. For this reason, bank ELJs are most appropriate at or adjacent to the inlets of overflow channels and floodplain side channels or alcoves. In some instances, a large tree or other obstruction protruding from the bank may begin to rack additional wood and form a logjam. This type of logjam was historically less common in Catherine Creek, but would have occasionally formed along the outside of a bend or near bedrock.

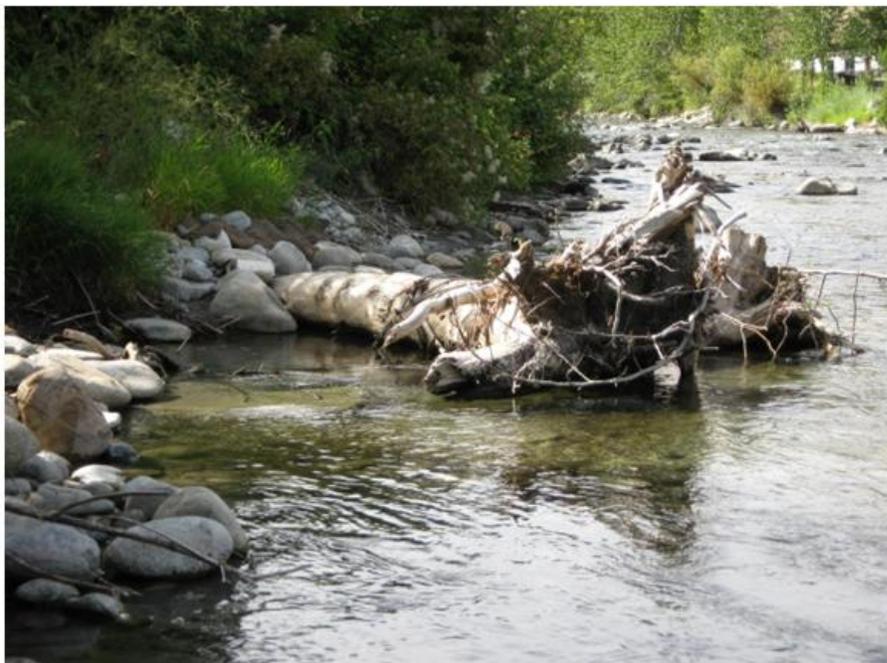
Figure 22. LWM barb in the Entiat River, Entiat, Washington.

Streambank barbs are relatively low profile structures that can be constructed of wood or rock or a combination of both that protrude from the bank and are intended to be overtopped during annual high flows (Figure 22).
